Work Category No.	215 – STRUCTURES COMPONENT REPLACEMENT			
Sub-category Description	215F - GUARDRAIL AND BARRIER COMPONENT REPLACEMENTS (NOT ON BRIDGES)	Quality Assurance Statements		
Author:	s 9(2)(a)	Capital Journeys Marine Parade Petone Wellington  PO Box 38 208 Wellington Mail Centre 5045	Prepared by	Date
Owner (NZTA)	s 9(2)(a)		s 9(2)(a)	
Audience:	NZTA; Capital Journeys		Reviewed by	Date
Stakeholders:	NTA; Capital Journeys			
Status:	DRAFT			
Distribution:	s 9(2)(a)			
Security:	Open	Version	Dates	Purpose
Document purpose:	Support Annual Plan Submission	0.1	13/9/16	Document creation
Document linkage:	2017/18 Annual Plan	0.2	9/12/16	General revision
Document expiry:	February 2017	0.3	24/01/17	General revision
Key Words:	AP17/18

Summary of Proposed Activities
<p><b>Purpose Statement</b></p> <p>Road safety barriers are designed to contribute to road safety outcomes by containing and redirecting errant vehicles and thereby preventing them from leaving the road or crossing into the path of oncoming traffic. They also contribute to a forgiving roadside environment reducing the probability of a fatality or serious injury to the occupants when a vehicle leaves the highway.</p> <p>R

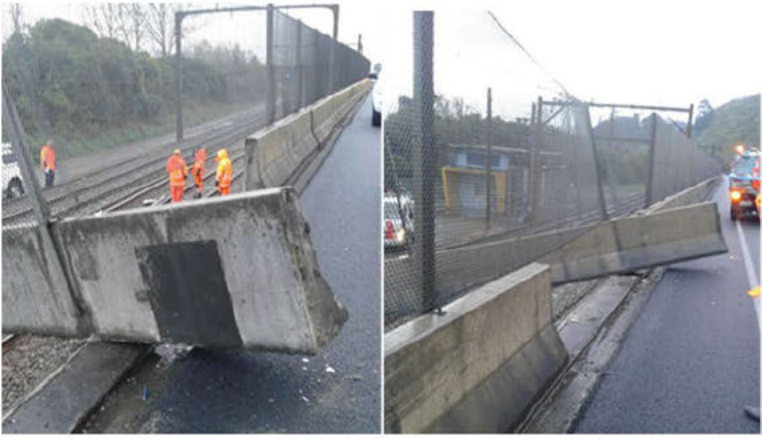
In both examples the New Jersey Barrier units were not connected to the adjacent units and ground pins were in poor condition, rusted and only embedded in the in-situ ground. This resulted in there being no ribbon strength along the length of the new jersey barrier or ability of the individual units to resist the impact loads.

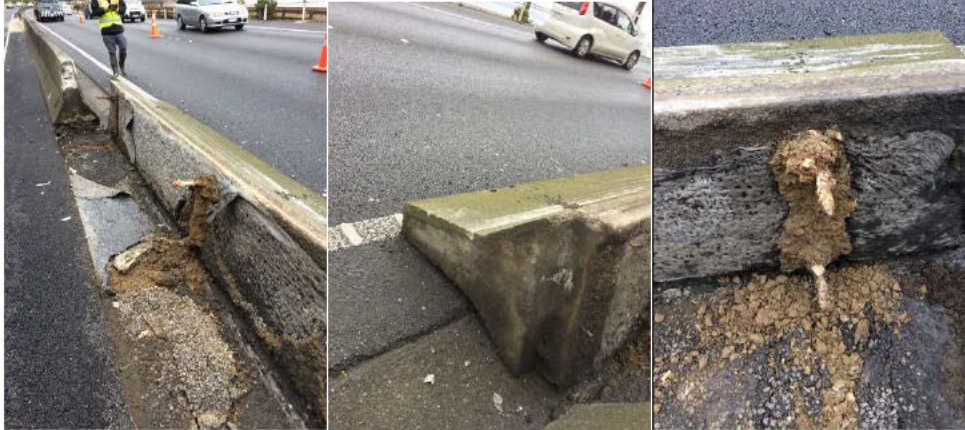
The second example occurred on the median New Jersey Barrier of State Highway 2 Hutt Road running from RP12,929m to 14,514m on the 11th of November 2016. The barrier was struck by a light passenger vehicle and toppled over immediately behind the right hand edge line of the southbound traffic lanes. This occurred at the start of the morning peak traffic period and was a significant hazard to vehicles travelling in the right hand lane in both directions. Fortunately peak travel speeds were relatively slow but, the traffic volume was high. The barrier was subsequently righted and placed back into position

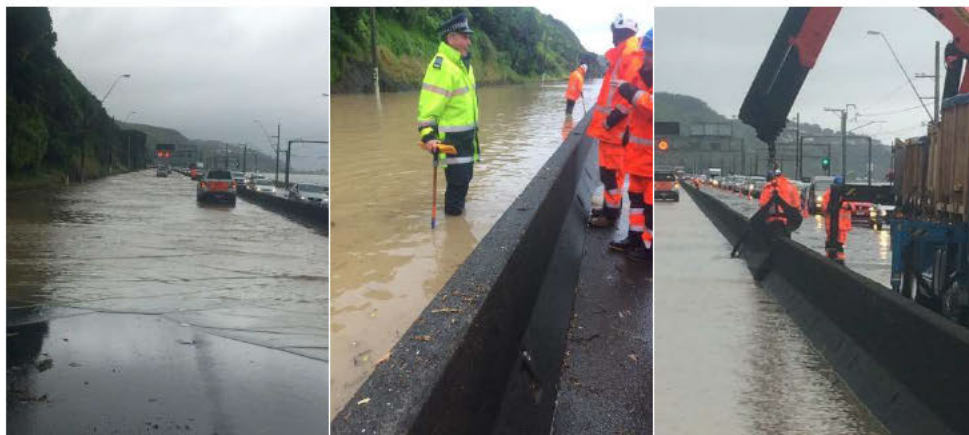
Furthermore, during the rainfall event on the 15<sup>th</sup> of November the new jersey barrier in the median of State Highway 2 RS962/12.85-1 acted as a dam preventing water from draining from the road surface, due to insufficient drainage at the base of the barrier units.

Remedial solutions to improve connections between the barrier units will prevent individual units from being lifted in similar events to allow flood water to be drained, as shown in the photo below. Where as the full renewal option allows for an opportunity to improve the drainage capacity and reduce the likelihood of further flooding.

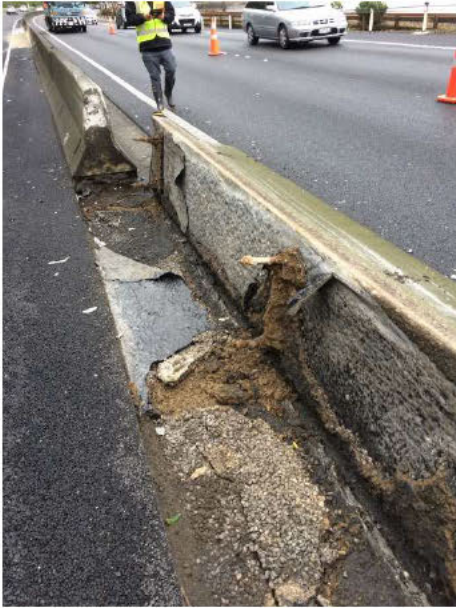
Sample Photographs		
	Photograph	RS/RP
Example 1

<p style="text-align: center;">Topped New Jersey barrier unit showing minimal embedment and founding of the barrier units, significant lengths of this type of barrier have historically been installed in the Wellington network.</p>	SH2- RS962/12.85-I 12,929m to 14,514m

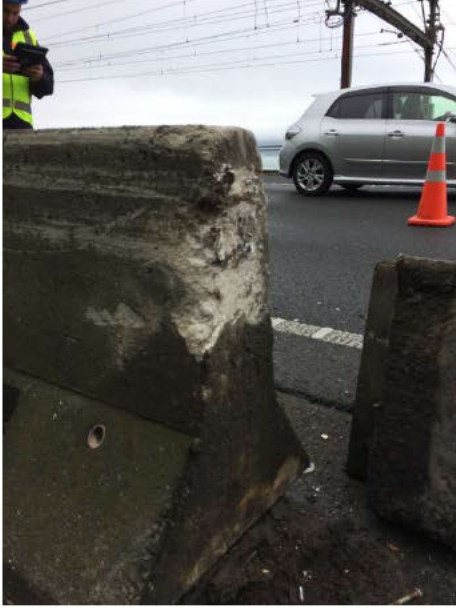
Sample Photographs		
	Photograph	RS/RP
Example 2

<p>Lack of mechanical connection between pre-cast concrete new jersey barriers and thus not allowing transfer of impact load along the length of the barrier</p>	SH2- RS962/12.85-I 12,929m to 14,514m
Example 3

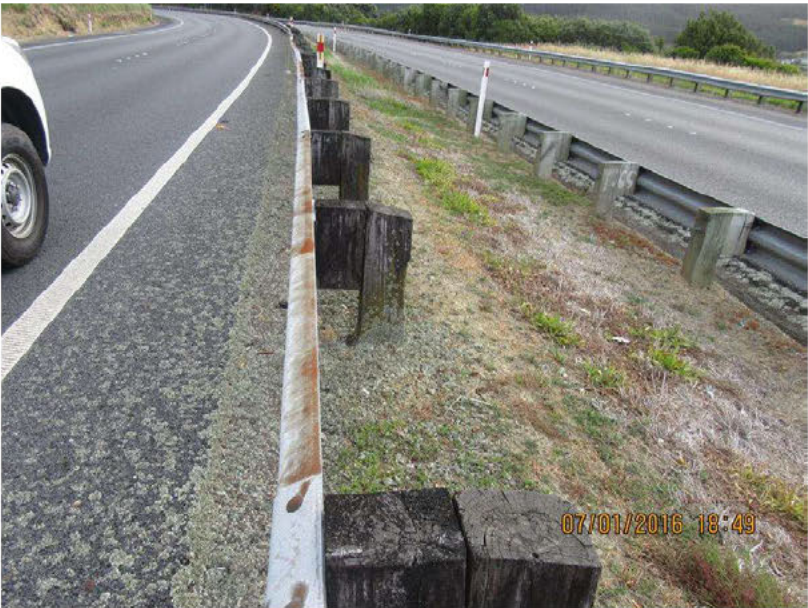
<p>Lengths of w-section guard rail showing surface rust and older aged posts</p>	SH01N- RS1050-I 9164m to 9628m

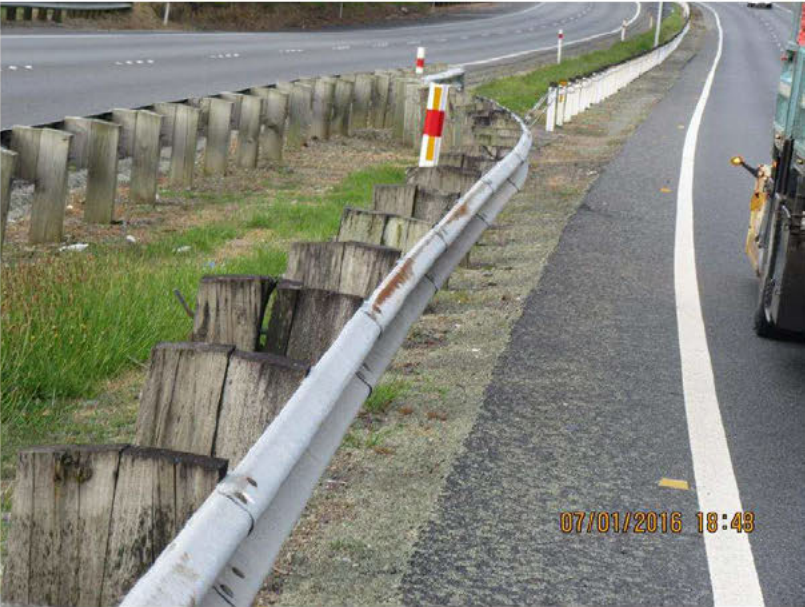
Sample Photographs		
	Photograph	RS/RP
Example 4

<p>Lengths of w-section guard rail showing surface rust and older aged posts</p>	SH01N- RS1050-I 9164m to 9628m
Example 5

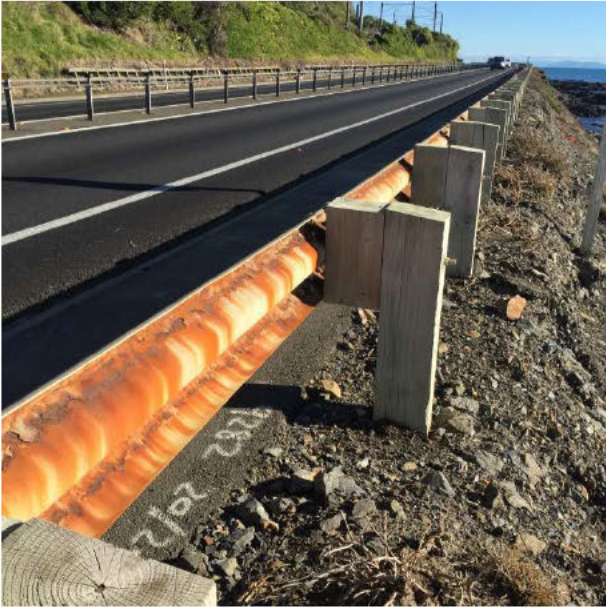
<p>Extensive rust along back of w-section guardrail</p>	SH01N- RS1035/0.154- D 1801m to 2309m

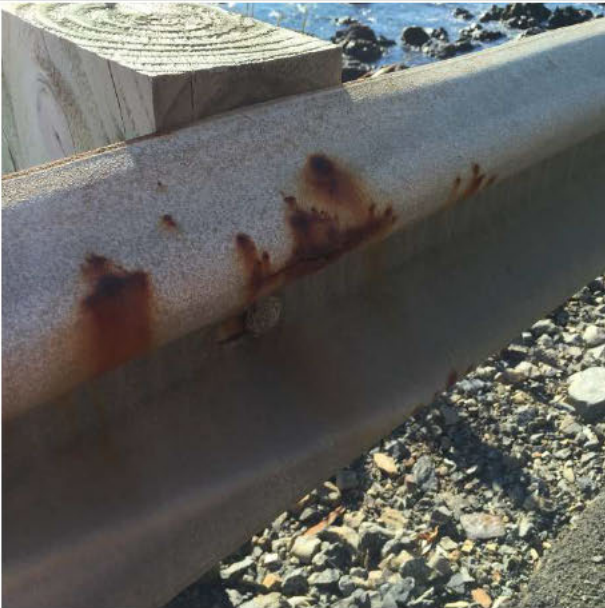
Sample Photographs		
	Photograph	RS/RP
Example 6

<p>Rust extending to front face of the guardrail around bolt connections</p>	SH01N- RS1035/0.154- D 1801m to 2309m
Example 7

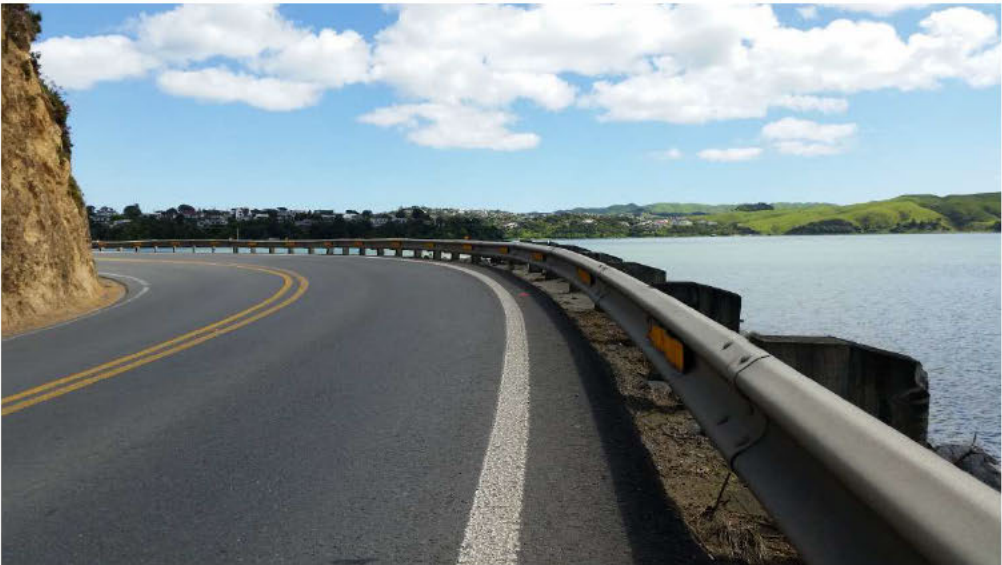
<p>Non-compliant low guardrail height</p>	SH58 RS000/10.13 12767m to 12994m
Add additional lines as required
