**PERFORMANCE OF HIGHWAY STRUCTURES
DURING THE DARFIELD AND CHRISTCHURCH
EARTHQUAKES OF 4 SEPTEMBER 2010
AND 22 FEBRUARY 2011**

NEW ZEALAND TRANSPORT AGENCY

Final Revision: 26 February 2012

**Report prepared for New Zealand Transport Agency by:
J H Wood, H E Chapman and P Brabhaharan**

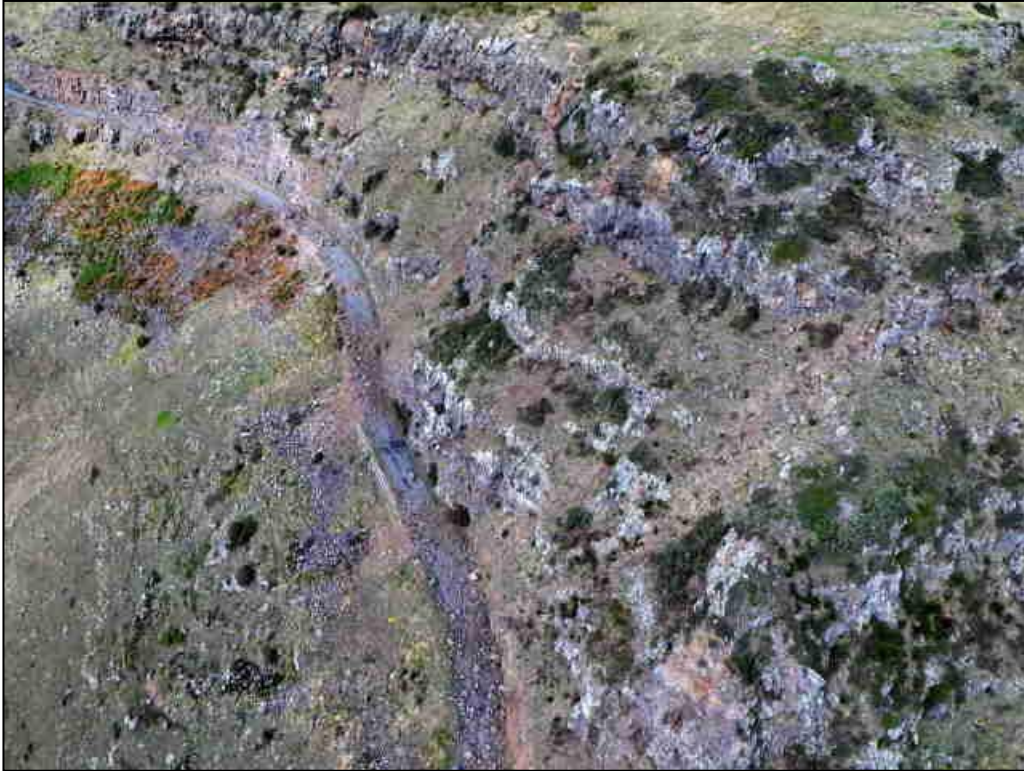
Figure 8. Rockfall on the Summit Road over the Port Hills

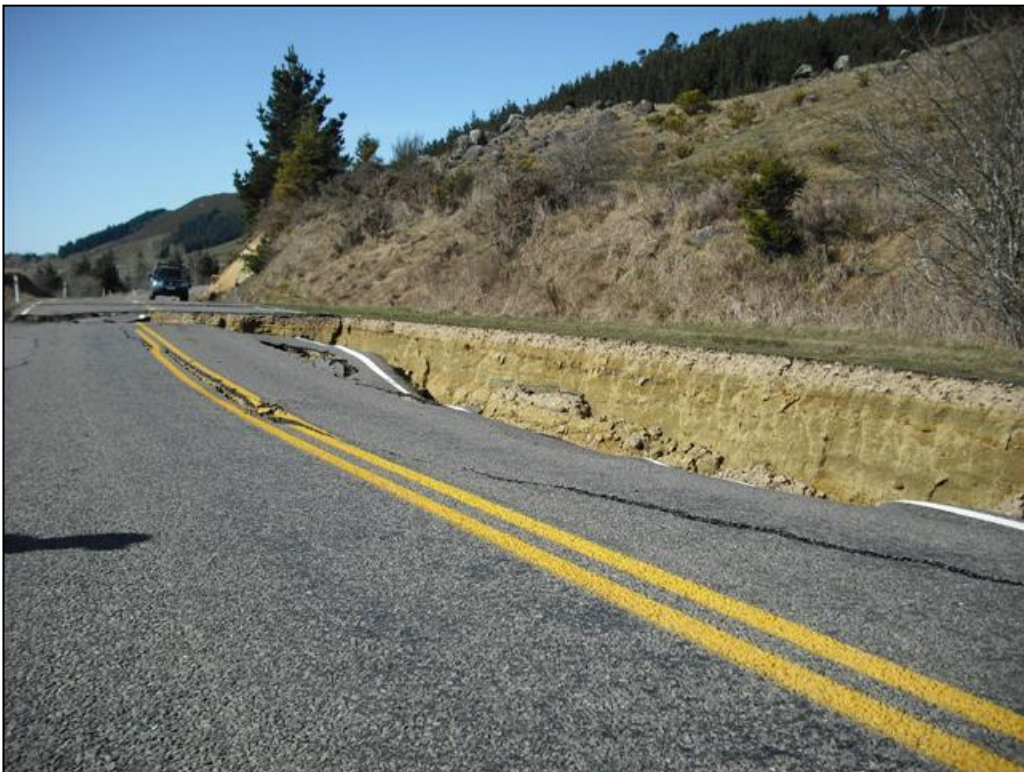
Figure 9. Earthquake induced landslide affecting road (SH77)

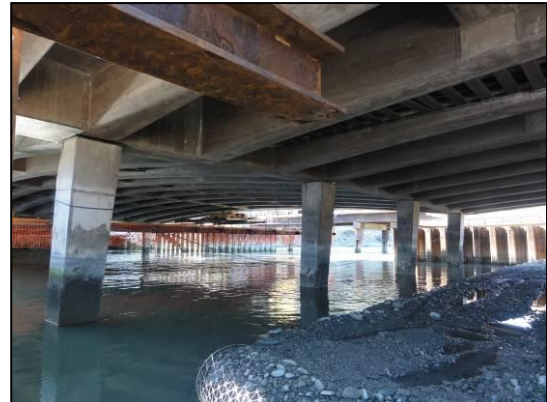
Figure 10. CCC Ferrymead Bridge. Lateral spreading damage to abutment wall and piers in the 22 February 2011 Christchurch earthquake.

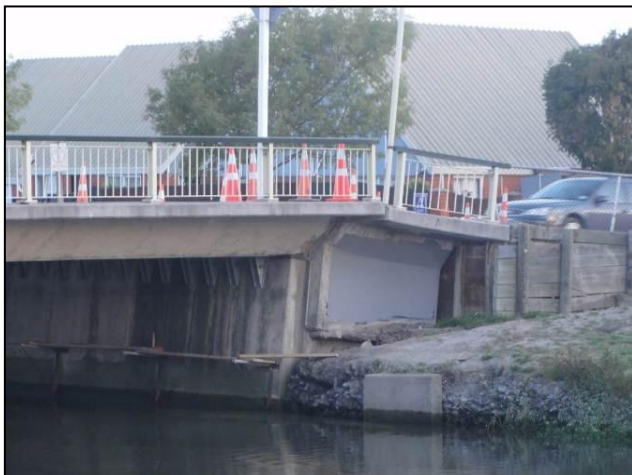
Figure 11. CCC Avondale Bridge. Damage to bridge abutment in the 22 February 2011 earthquake event.

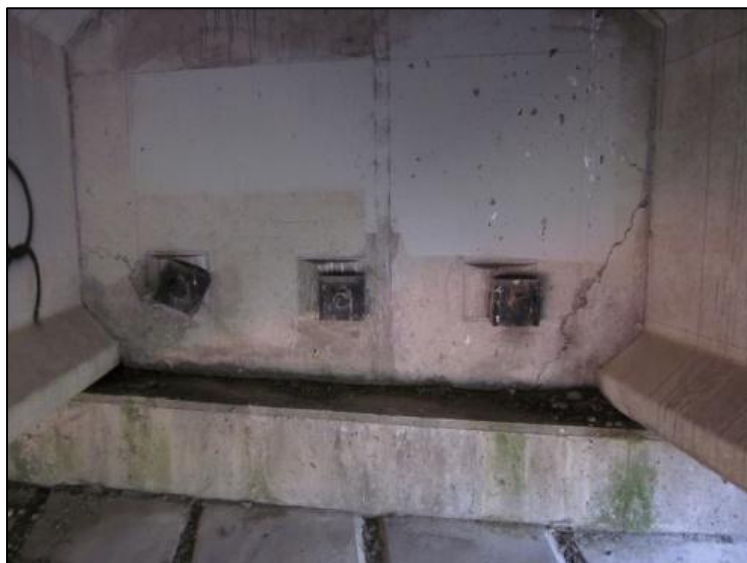
- Failure of the diaphragms between the span beams at the abutments (Figure K1). There was severe spalling at the bottom corners of all diaphragm sections and cracking across the top corners in some sections, suggesting primarily a shear failure of the connection to the beams near the bottom of the diaphragms. They are loaded by three linkage bolts positioned about 380 mm from the bottom edge of the diaphragm sections. It is understood that the damage was less pronounced at the south abutment, which was not inspected.
- Two of the 12 linkage bolts on the eastern side of the northern-most pier failed with fractures occurring through threads on the head end of the 38 mm diameter bolts (Figure K2). There was fine cracking across the bottom corners of some of the diaphragm sections on this pier.

Figure K1
Damaged diaphragm at
abutment.

- The Kaiapoi Railway and River Bridge diaphragms and linkage bolts. These will be straightforward but nevertheless costly, with complete breakout and reinstatement required on at least all the eight diaphragms at the northern abutment. It may be necessary to strengthen the other diaphragms (88 in total) or upgrade the linkage system to avoid loading them. Further repairs may be necessary if damage to the bases of the pier columns and pier piles is found.

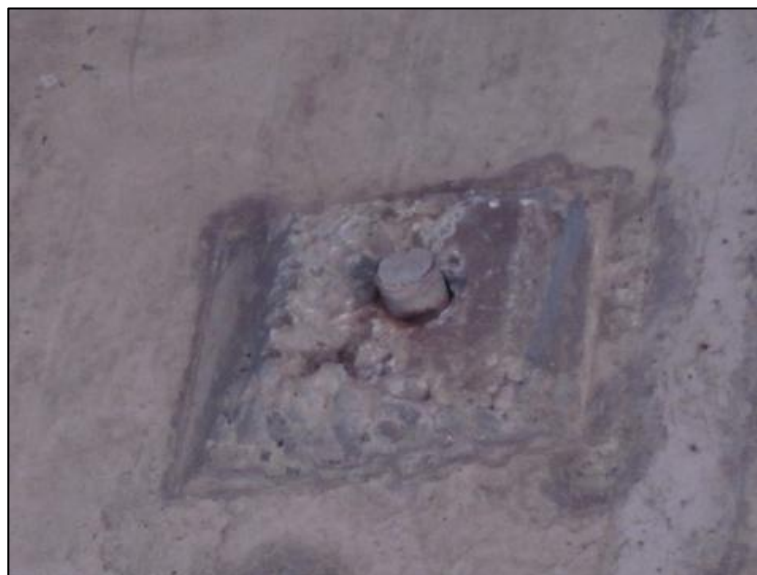
Figure K2
Fractured linkage bolt in
pier diaphragm.

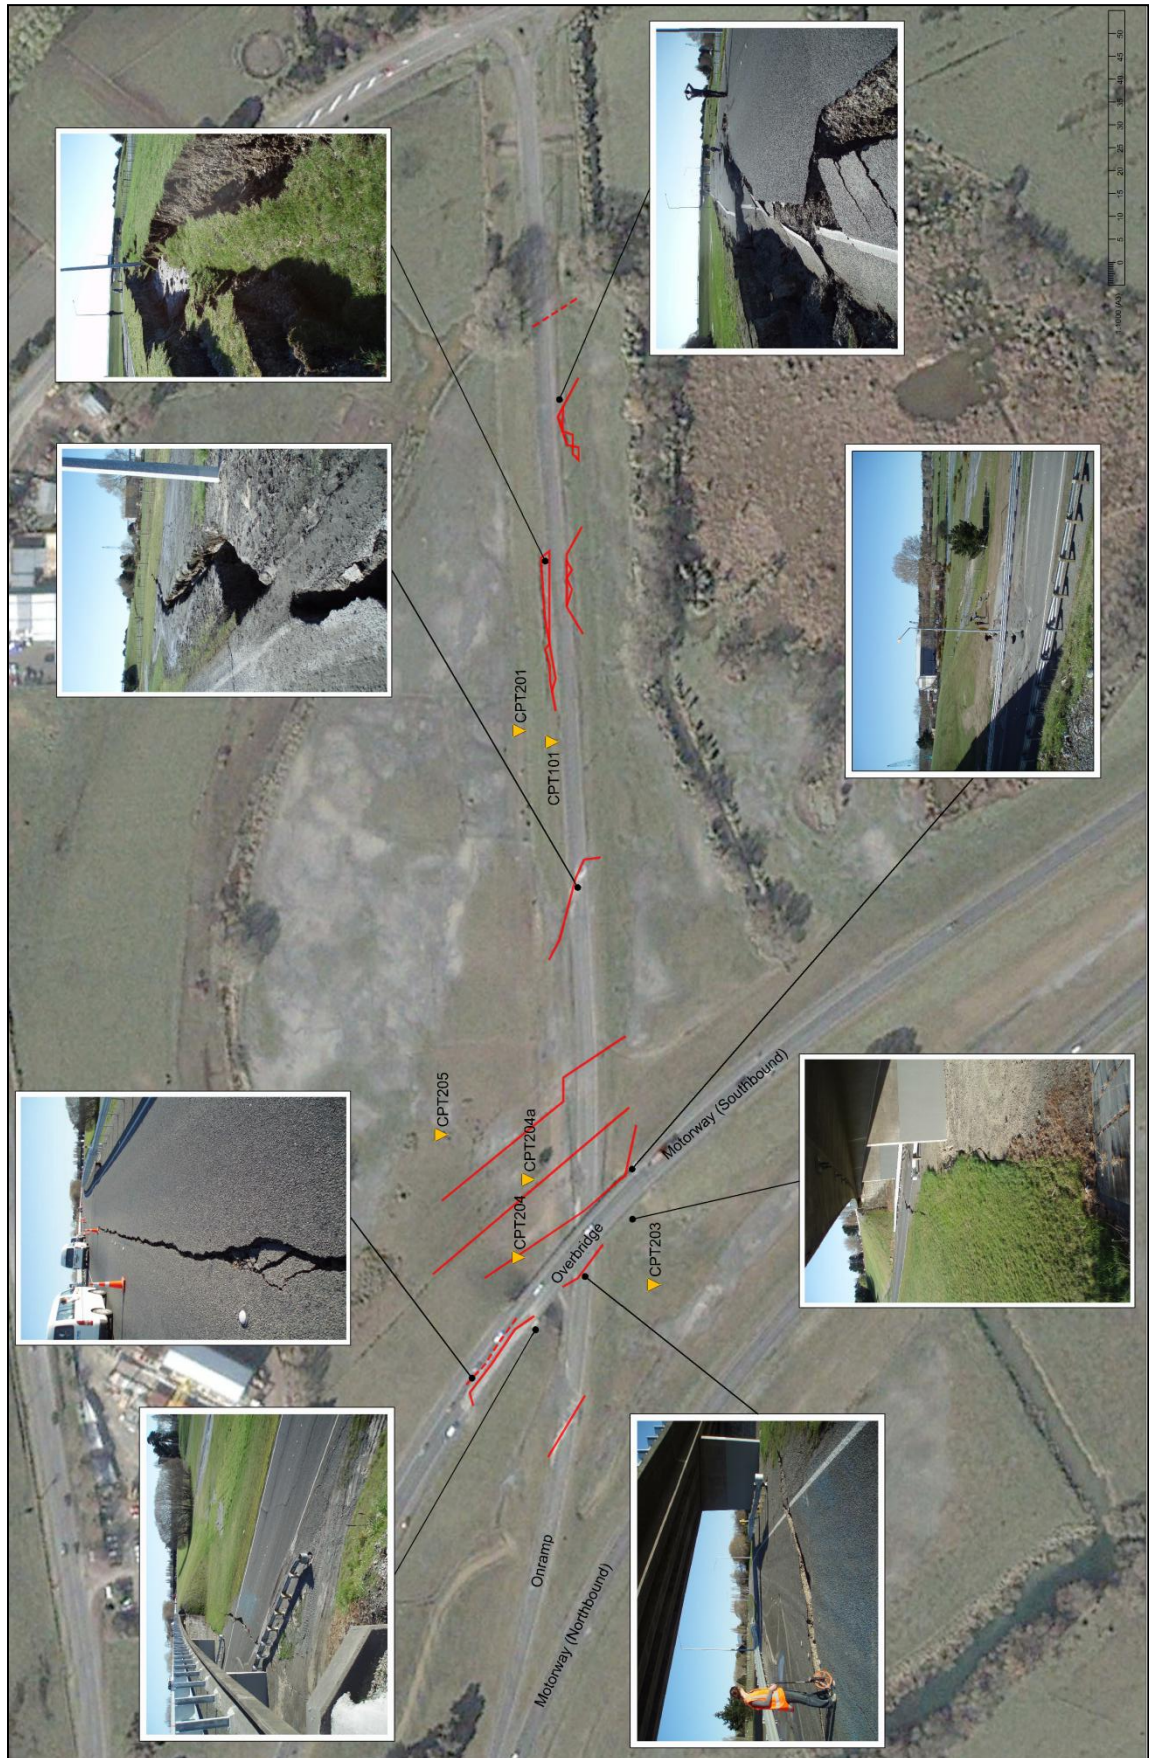
Figure C7. Ground damage observed near Chaney's Road Overpass.

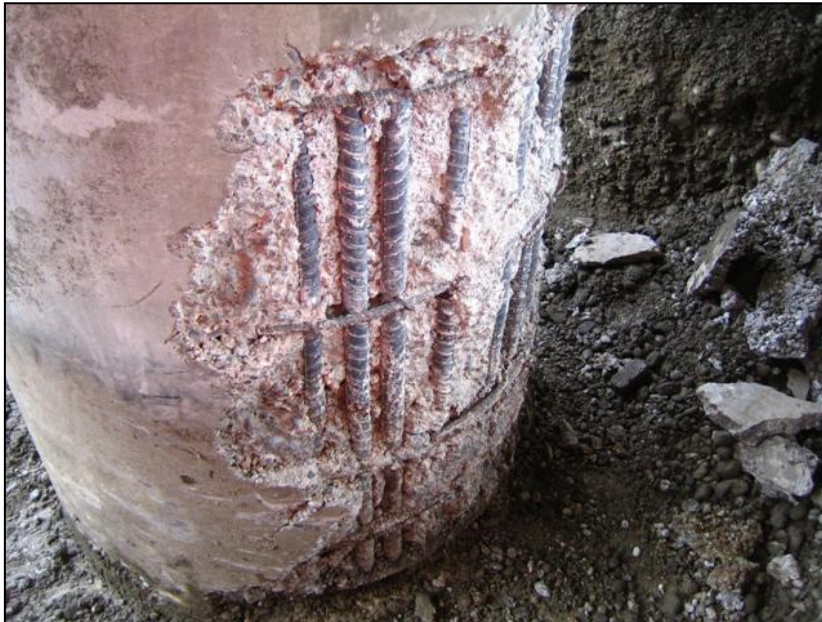
Figure O1
Spalling damage at the base of the south column of the eastern pier.
The cracked concrete has been removed to reveal poorly compacted
concrete around some of the reinforcing.

- The Ohoka Road Undercrossing needs repairs to the spalling and cracking damage at the bases of pier columns.
- The Chaney's Road Overpass requires repairs to the north abutment linkage bolts, south abutment deck joint and paved abutment slopes.
- The Styx Overbridge No 2 needs repairs to the spalling and cracking damage on several pier columns.
- The twin Port Hills Road Overpass bridges need repairs to the spalling and cracking at the base of the piers.
- The twin Horotane Valley Overpass bridges need repairs to the abutments and abutment linkage bolt system. Improvements to the soil embankments may also be required.
- The Hawkins River Bridge needs repairs to the spalling and cracking in the tops of the piles at the piers.

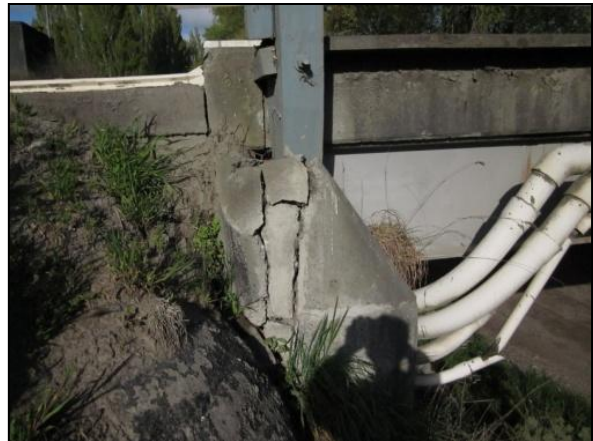
Figure W1
Damaged abutment return wall
at south abutment.

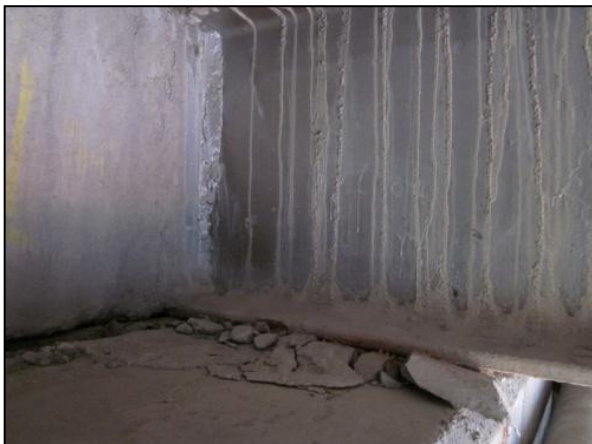
Figure W2
Damaged mortar seating under beam
at south abutment.

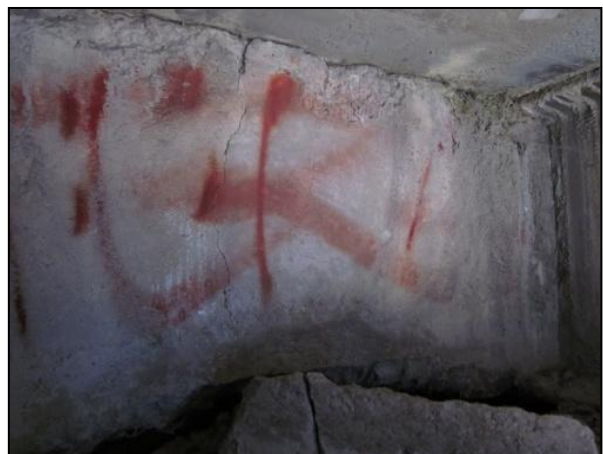
Figure W3
Cracked and spalled diaphragm
at south abutment.

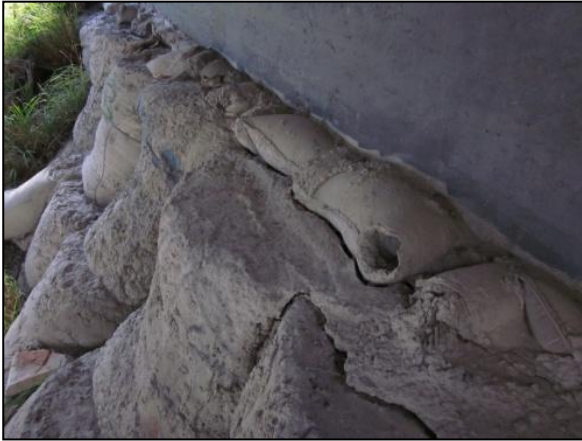
Figure W4
Cracked underpinning at
south abutment.

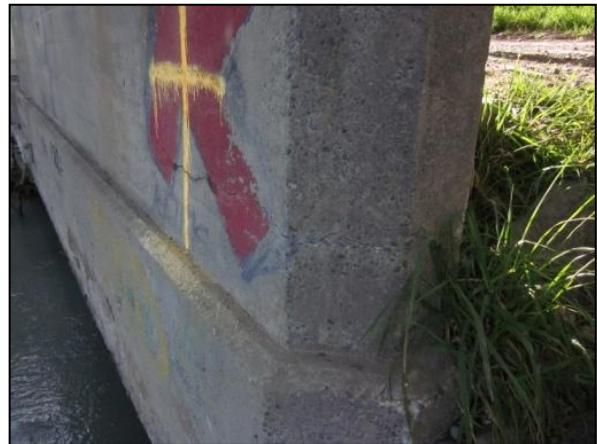
Figure W5
Horizontal crack in
Pier 2.

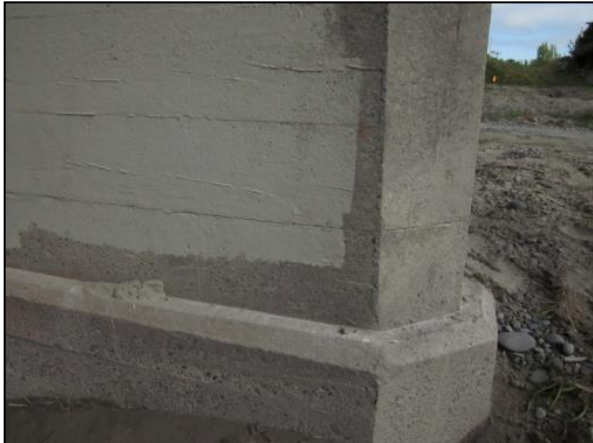
Figure W6
Horizontal crack in Pier 23
400 mm above pilecap.

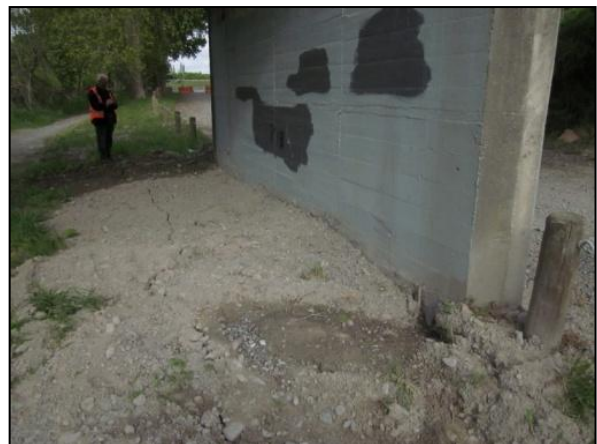
Figure W7
Cracking in ground
around Pier 29.

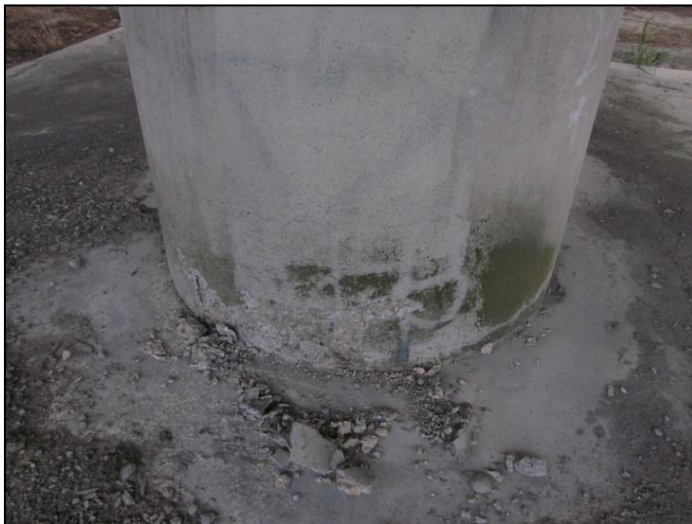
Figure ST1
Spalling in pier of Bridge
No 2.

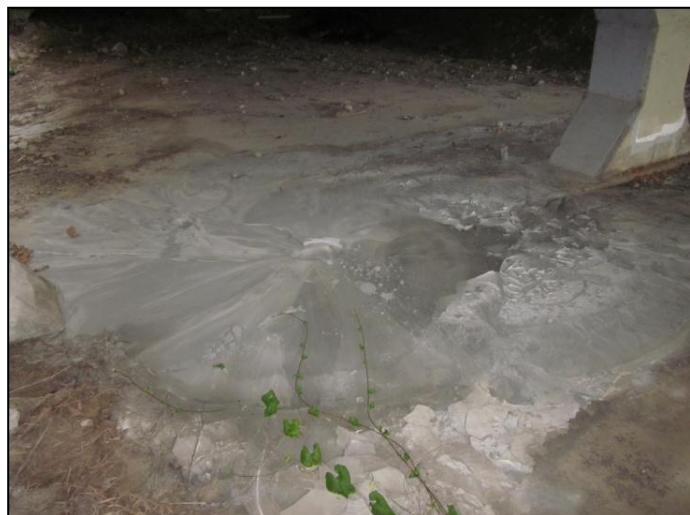
- Liquefaction sand boils under the Bridge but no obvious damage to this bridge, which is founded on spread footings (Figure ST2).

Figure ST2
Sand boils near
Bridge No 1 pier.

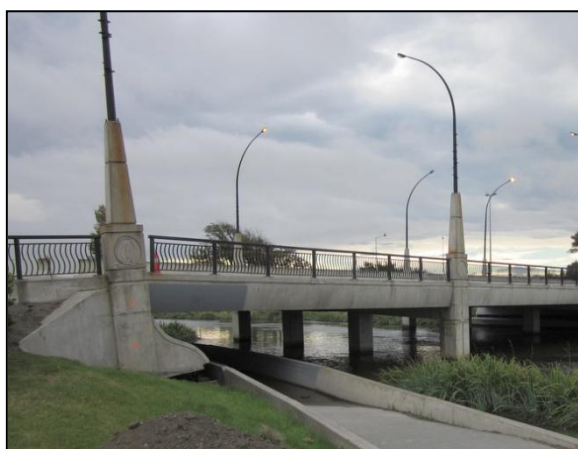
Figure AD1

- Pressures from liquefaction induced lateral spreading of the approaches had caused the abutment piles and beam seatings to rotate about 5° (Figures AD1 and AD2).
- There was cracking and spalling at the beam-column joints in both piers. Damage was more pronounced at the outer of the four columns in each pier. The columns in the southern pier had significant permanent displacement with up to a 2° tilt (Figures AD3 and AD4) apparently caused by liquefaction lateral spreading.
- There was significant lateral spreading and settlement of the approach pavements and embankments. The settlements near the abutments were of the order of 300 mm.
- The concrete walkway structures under each end of the bridge had moved towards the river about 500 mm at the south end (Figures AD1 and AD2) and about 300 mm at the north end.

The south abutment showing the extensive ground settlement, lateral spreading, rotation of the abutment and displacement of the walkway. The north abutment showed similar damage.

- The Anzac Drive Bridge and Bridge Street Bridge abutment structures, including their piles, may need to be replaced, with measures to mitigate future liquefaction and lateral spreading. This will be a costly and difficult operation.

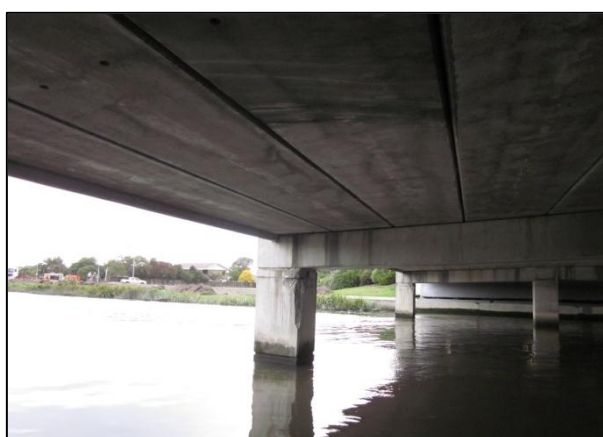
Figure AD3

Spalling damage at the beam/column joints in the northern pier.

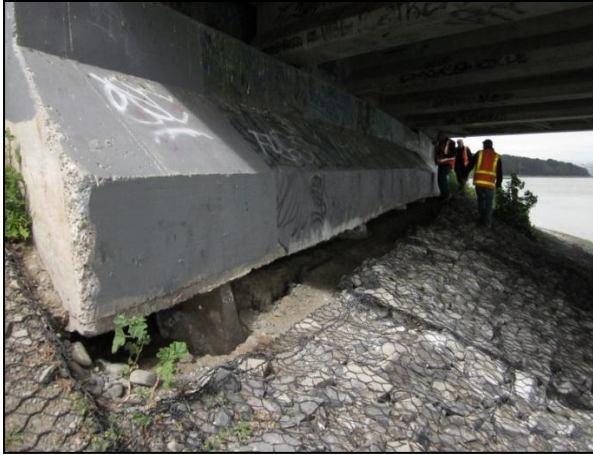
Figure BS1
Settlement at east abutment.

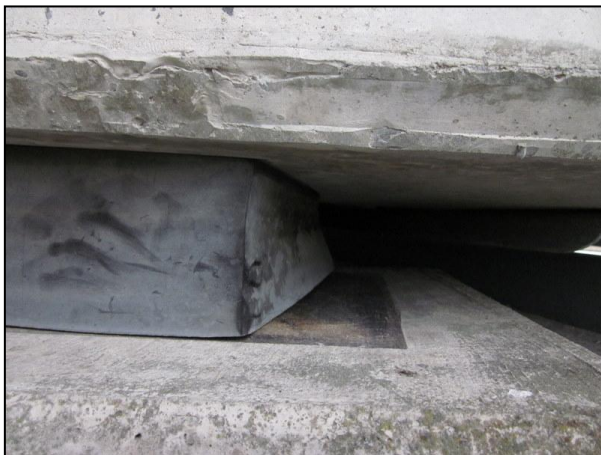
Figure BS4
Bearing displacement at east abutment.

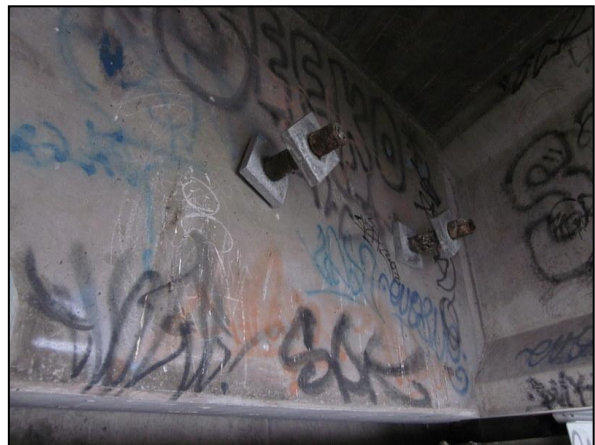
Figure BS5
Loose linkage bolts at east abutment.

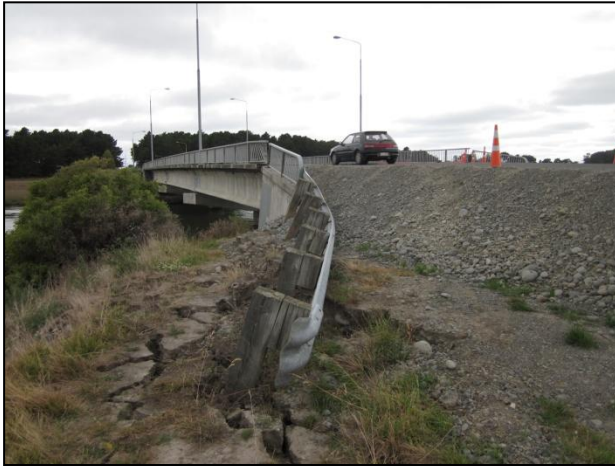
Figure BS6
Lateral spreading on west approach.

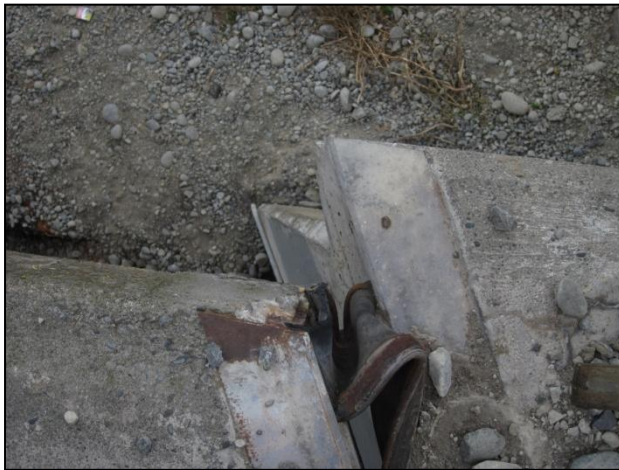
Figure BS8
Horizontal rotation at south-west corner.

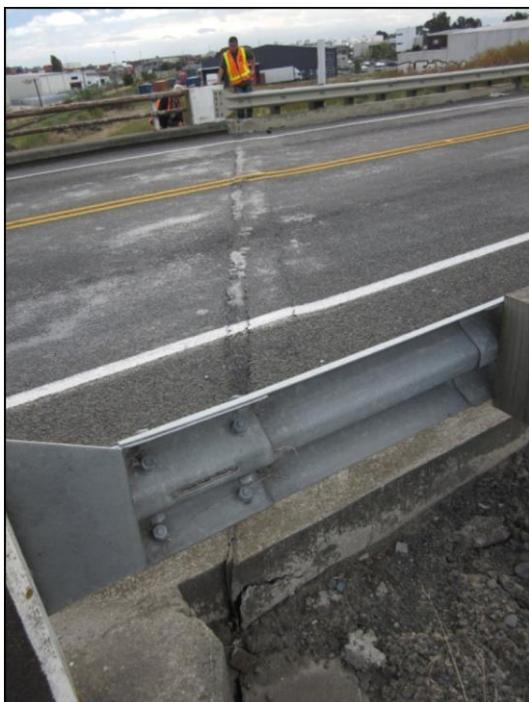
Figure RO1
Deck joint at north abutment.

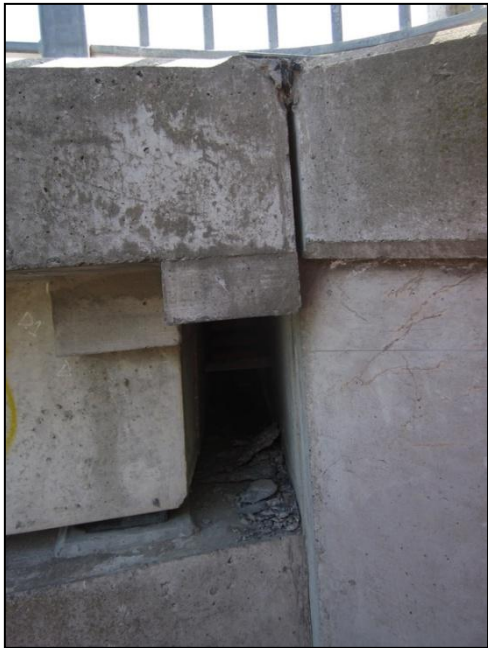
Figure R1
Closed deck joint at north abutment.

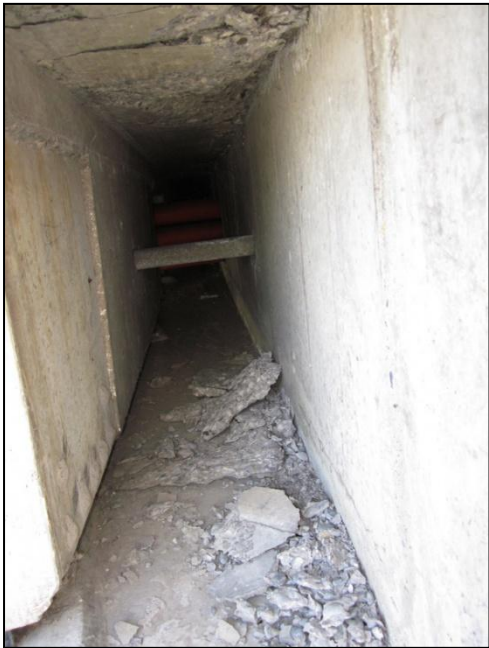
Figure R2
Pounding damage at north abutment.

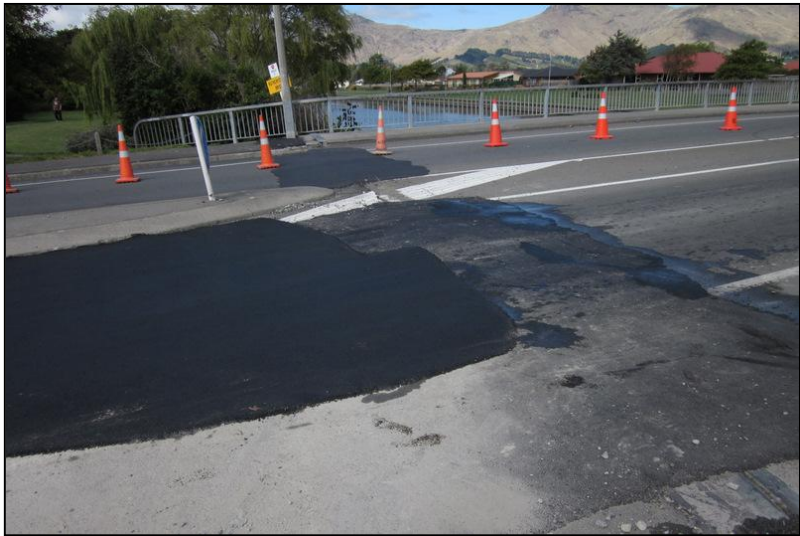
Figure R3
Settlement at north abutment.

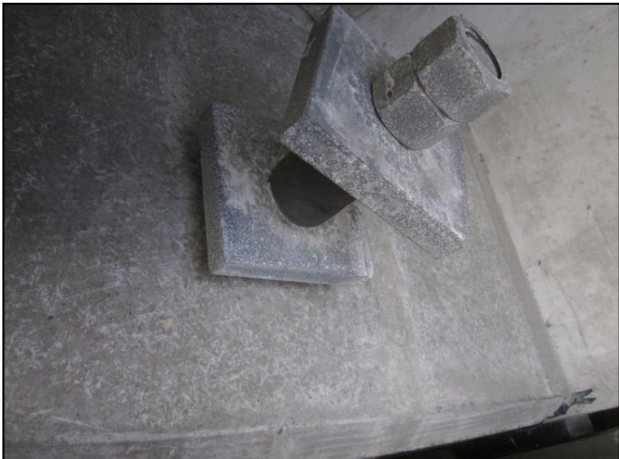
Figure R4
Loose linkage bolts at south abutment.

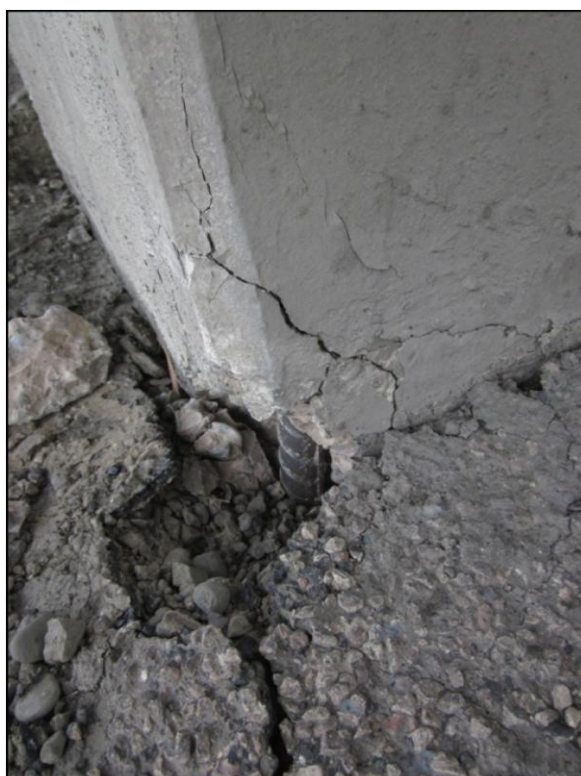
Figure PH1
Spalled concrete and buckled
column reinforcement.

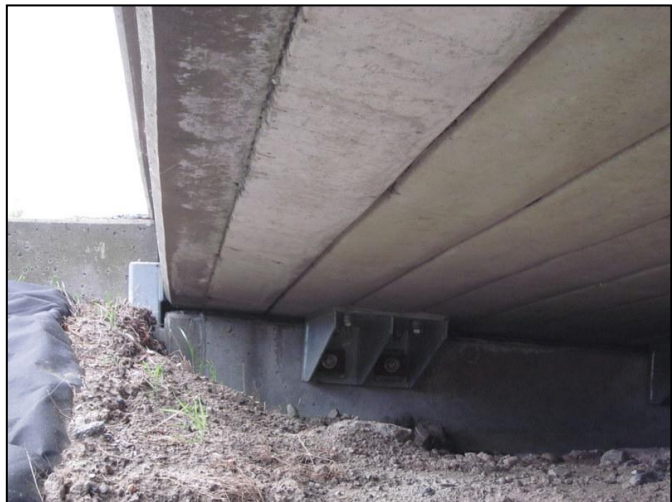
Figure PH3
Abutment shear keys.

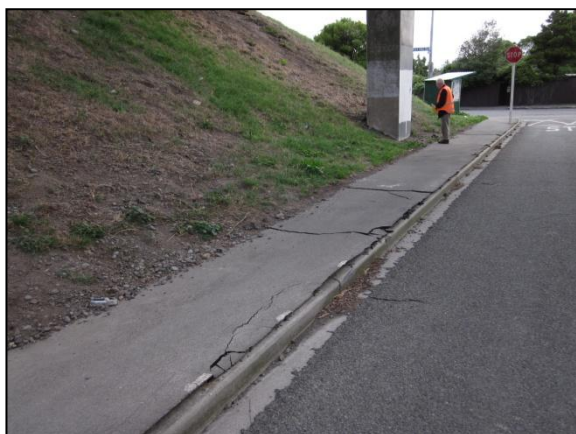
Figure HO1
Cracked footpath at Lyttelton end.

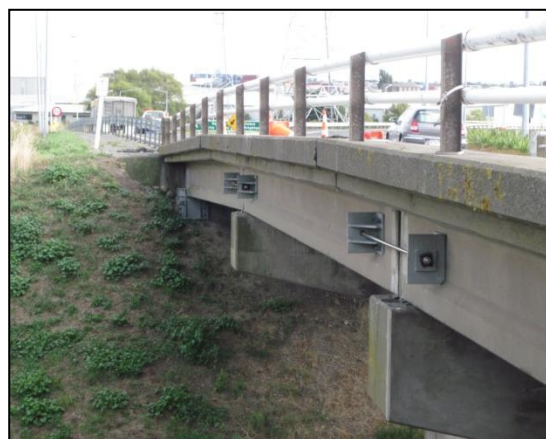
Figure HO2
Settlement of abutment
at city end.

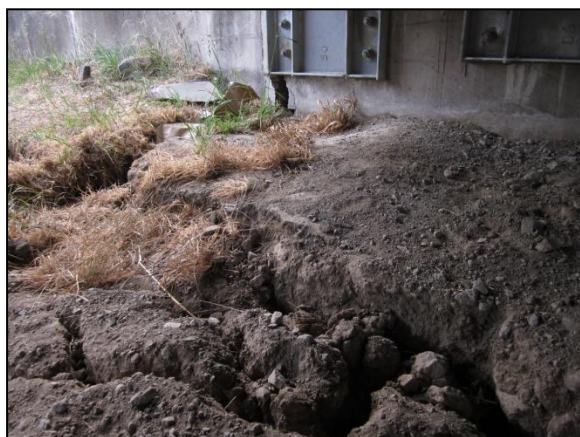
Figure HO3
Cracking from down-slope
movement at abutment at
Lyttelton end.

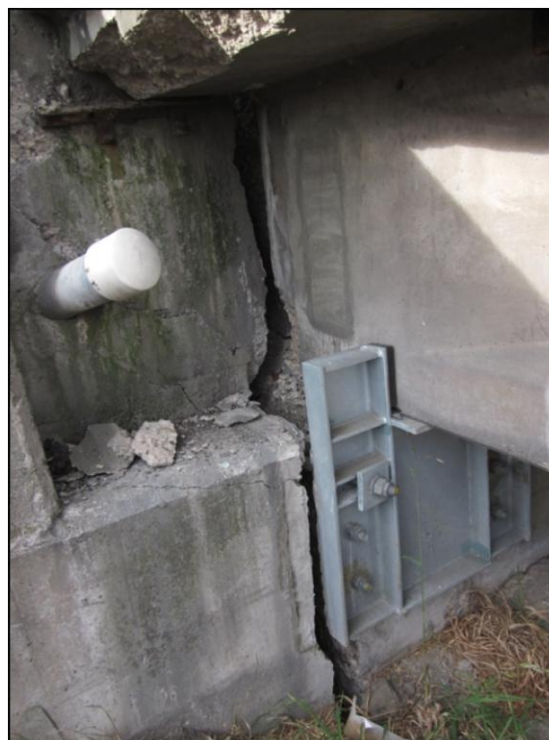
Figure HO4
Cracking in abutment at
Lyttelton end.

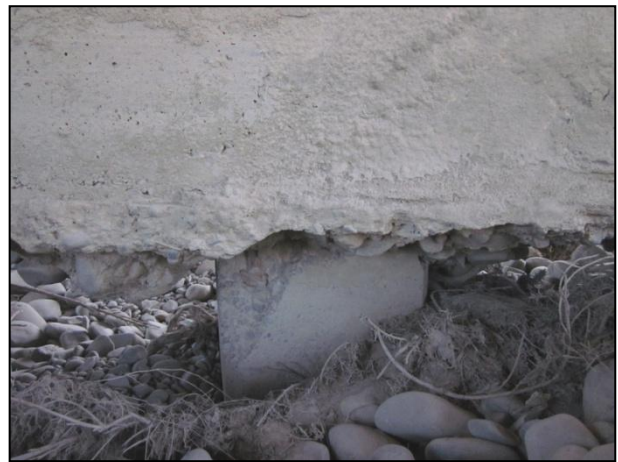
Figure HA2
Spalling in pile under pier
pilecap, probably due to
transverse loading on
bridge.

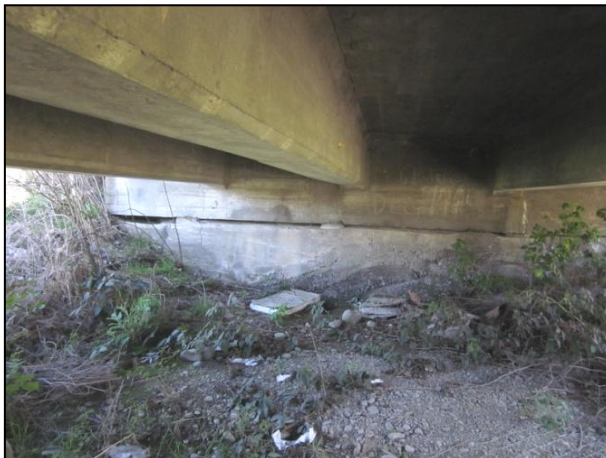
Figure HA3
Infill concrete below west
abutment.
