SH1: MacKays Crossing to Peka Peka, Kapiti Coast Expressway

ROAD SAFETY AUDIT of the TOC DESIGN

**A REPORT PREPARED FOR
NZ TRANSPORT AGENCY**

**Reference: 10341
August 2012**

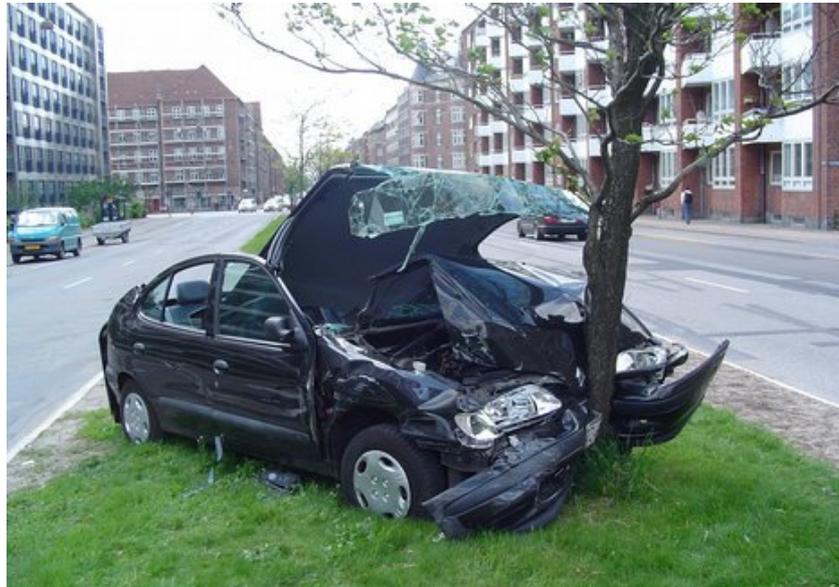
- 6) Drawing UD-LV-214: any trees in the “mass planting with tree enrichment” that are planted alongside Mazengarb Road may be a hazard and if on the inside of the curve could restrict forward sight distance

- 7) Drawings UD-LV-230 and 231: “mass planting” or trees planted near the roundabouts can be a hazard for any errant vehicles as well as restricting sight line requirements

Even small trees can be a significant hazard for errant vehicles:

Recommendation: Ensure that the detailed landscaping proposals take account of road safety requirements, especially any potential effects on visibility and the locations of unprotected trees that could be hazards.
