From: s 9(2)(a)
 Sent: Wednesday, 11 March 2020 4:30 PM
 To: Barry Wright <Barry.Wright@nzta.govt.nz>
 Subject: RE: Welded rebar in bridge decks - confidential

I have been investigating deck solutions for the Okahu and Puhoi Viaducts.

6.10.3.3 Okahu and Pūhoi composite deck solution

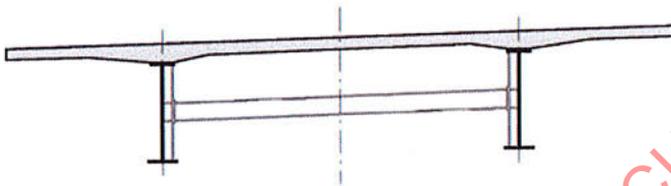
Figure 1: Cross girder at mid depth (Europe detail shown).

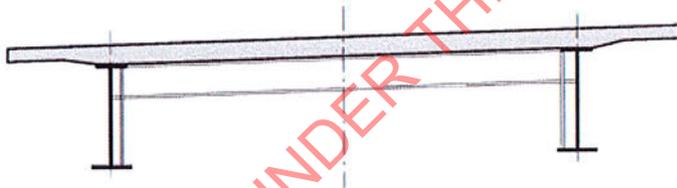
Figure 2: Cross girder also supporting the slab (Europe detail shown).

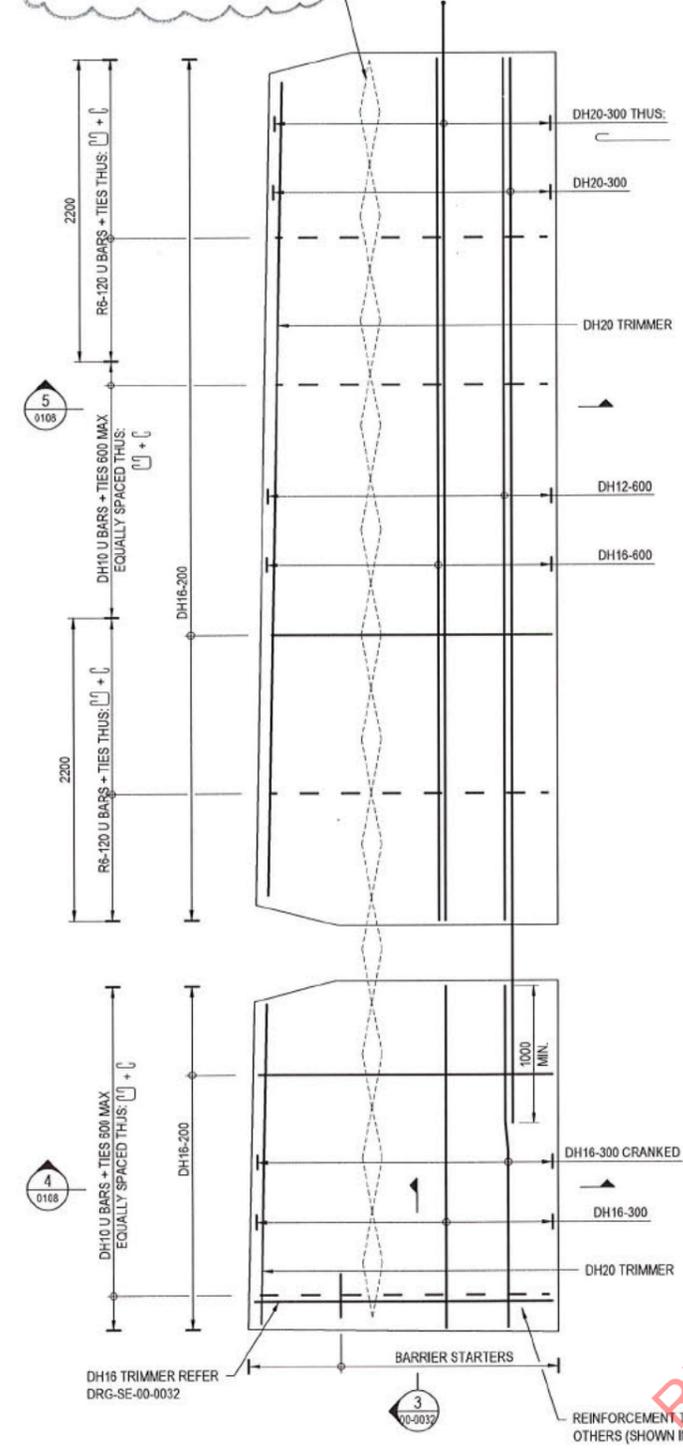
C PANEL TYPE S REINFORCEMENT DETAILS
1:25(A1), 1:50(A3)

REINFORCEMENT TRUSSES BY OTHERS. SIZE AND SETOUT TO BE DETERMINED BY C.J.V. (SINGLE TRUSS SHOWN INDICATIVELY)
