New Zealand Transport Agency

**Lessons from the 2016 Kaikoura
Earthquake for Resilience Studies**

Opus International Consultants Ltd

Report No GER 2017 - 29

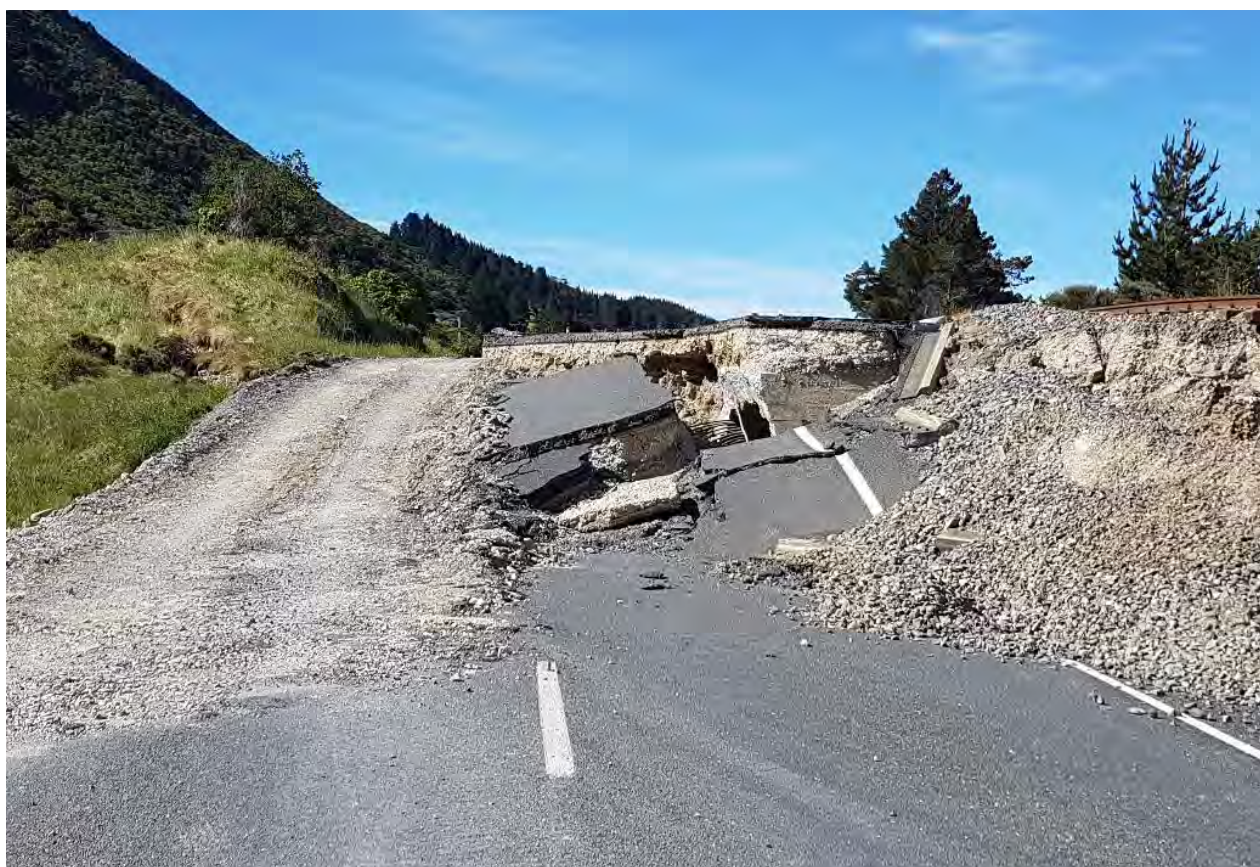
Illustration 5.1. Damage from Fault Rupture across SH1S at Waipapa Bay

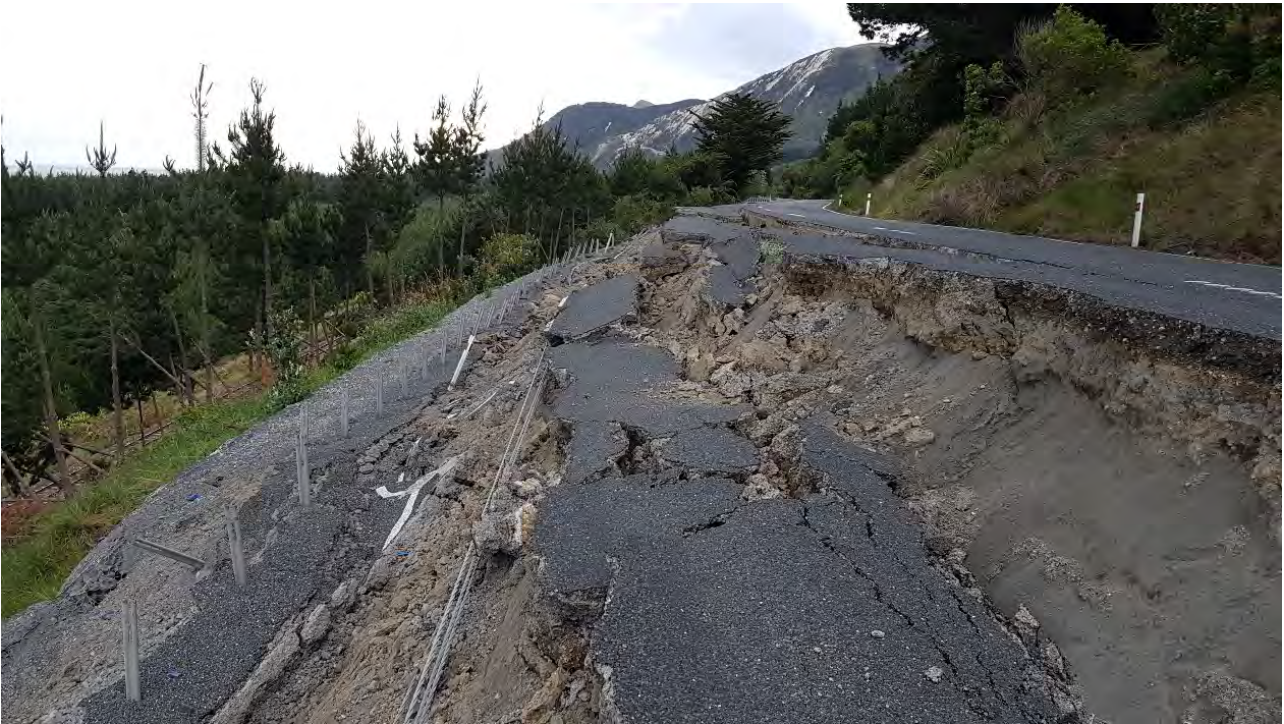
Illustration 5.2. Road embankment slope failure affecting SH15 on 14th November 2016

Landslides and embankment failures caused the most damage and disruption to the transportation infrastructure. Landslides caused extensive closure along the Kaikoura coast section. Failures of low height cut slopes were able to be cleared quickly and only caused short term closure of the road / lane width. Extensive slumping of low height embankments in the Ward / Seddon to Clarence area reduced the available road or lane width.

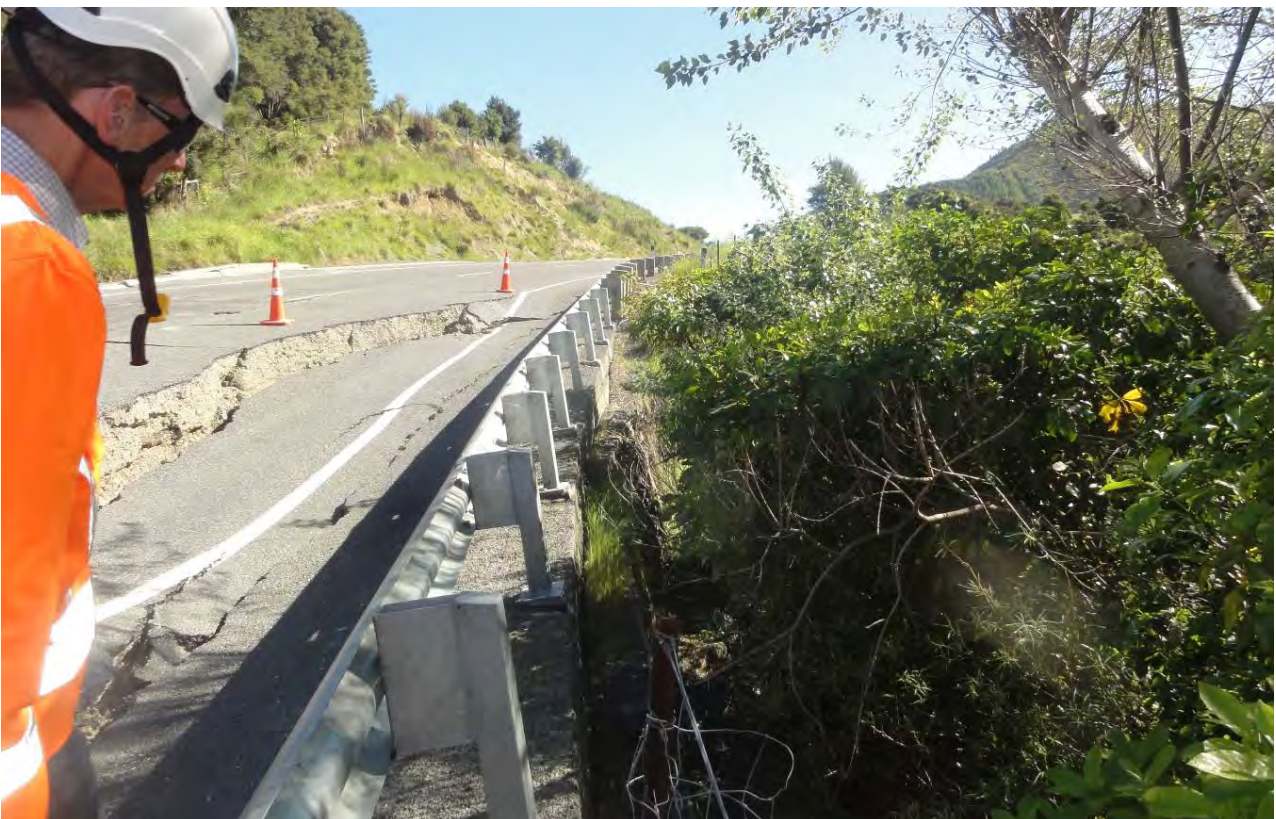
Illustration 5.3. Retaining wall failure

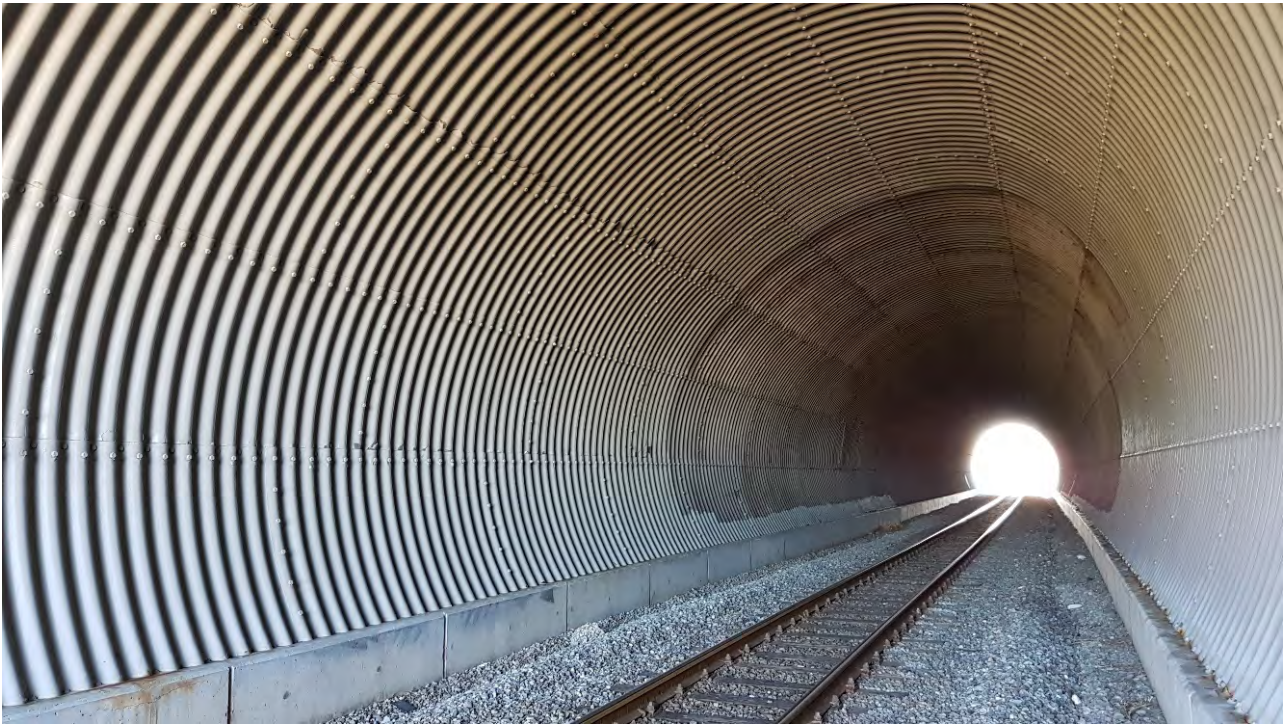
Illustration 5.4. Deformation and cracking of Armco culvert at rail underpass

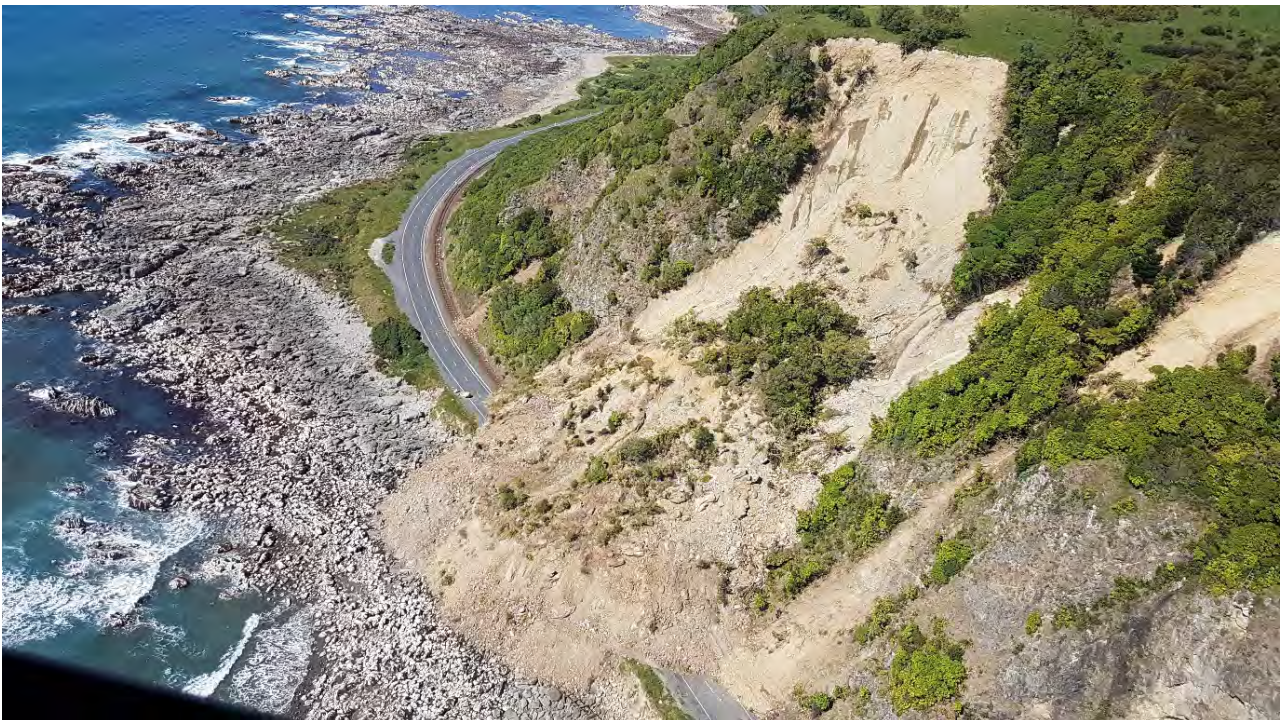
Illustration 5.5. Large Block Landslides of SH1s

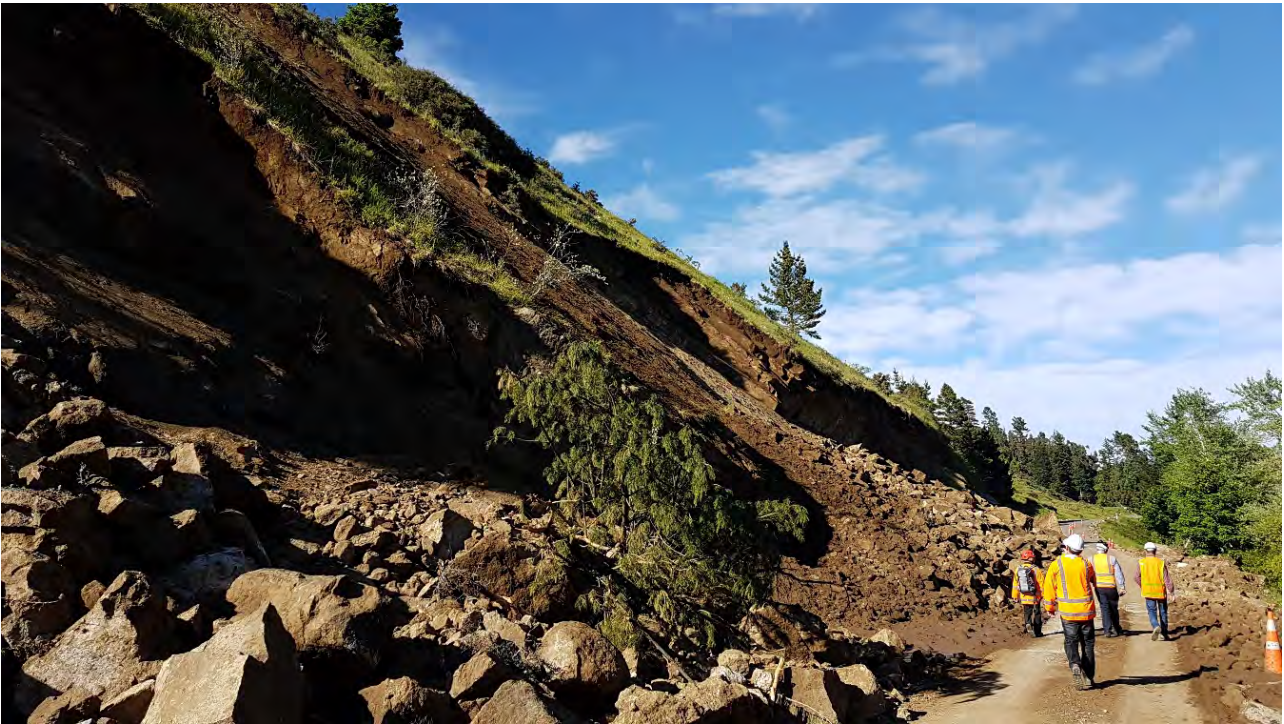
Illustration 5.6. Rock slides on dip slope on the inland route to Kaikoura

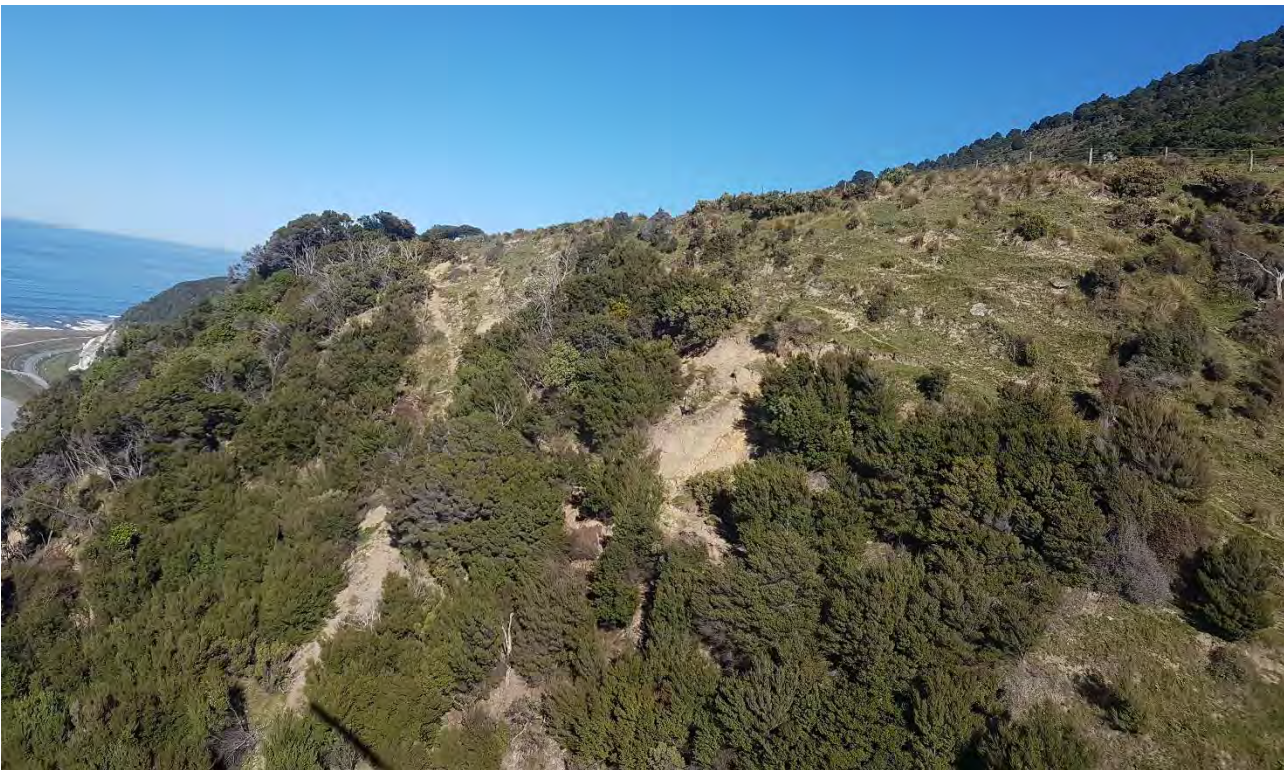
Illustration 5.7. Incipient cracking of slopes above State Highway 1S

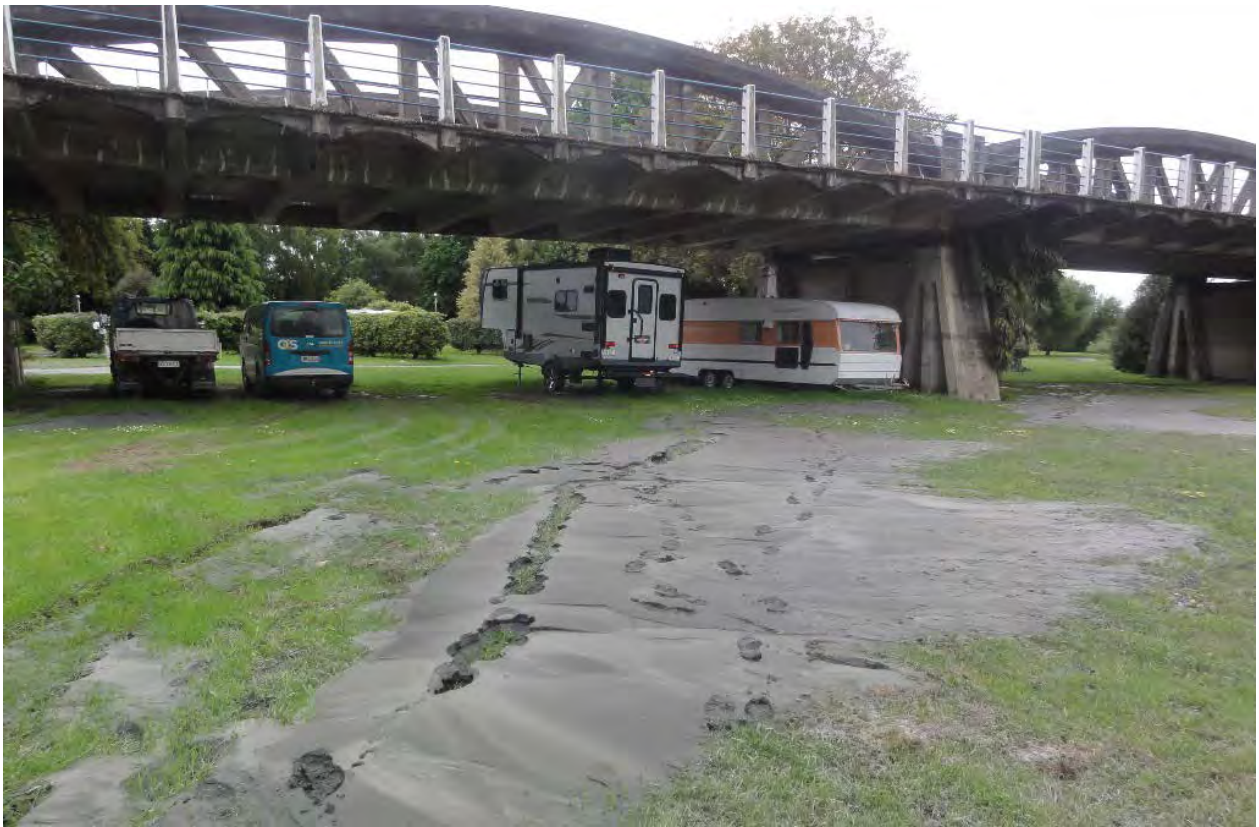
Illustration 5.8. Liquefaction adjacent to bridge near river in Blenheim

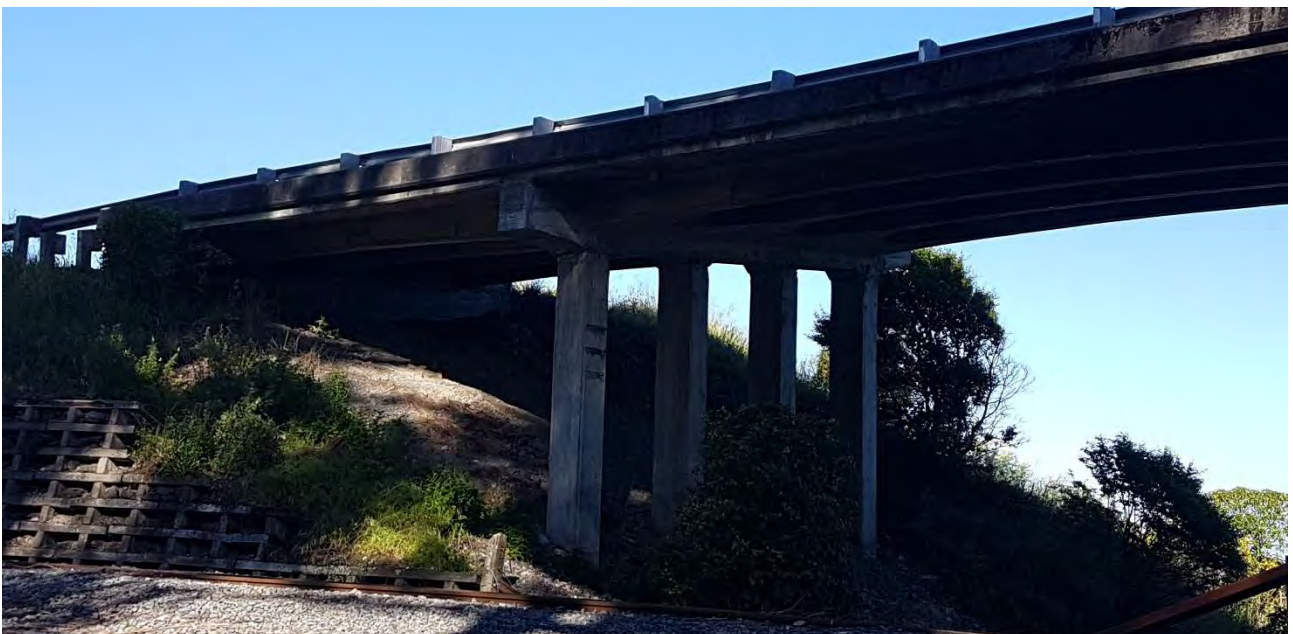
Illustration 5.9. Damage to rail overbridge at Oaro

Damage to some bridges occurred in the earthquake, but most bridges along State Highway 1 were able to be opened quickly with restrictions, except perhaps the state highway overbridge over the railway lines at Oaro (Illustration 5.9), but this was able to be bypassed with a temporary level crossing. Settlement at bridge abutments was widespread and in some cases prevented access over the bridges until fill or asphaltic concrete was used to form small ramps onto the bridges.

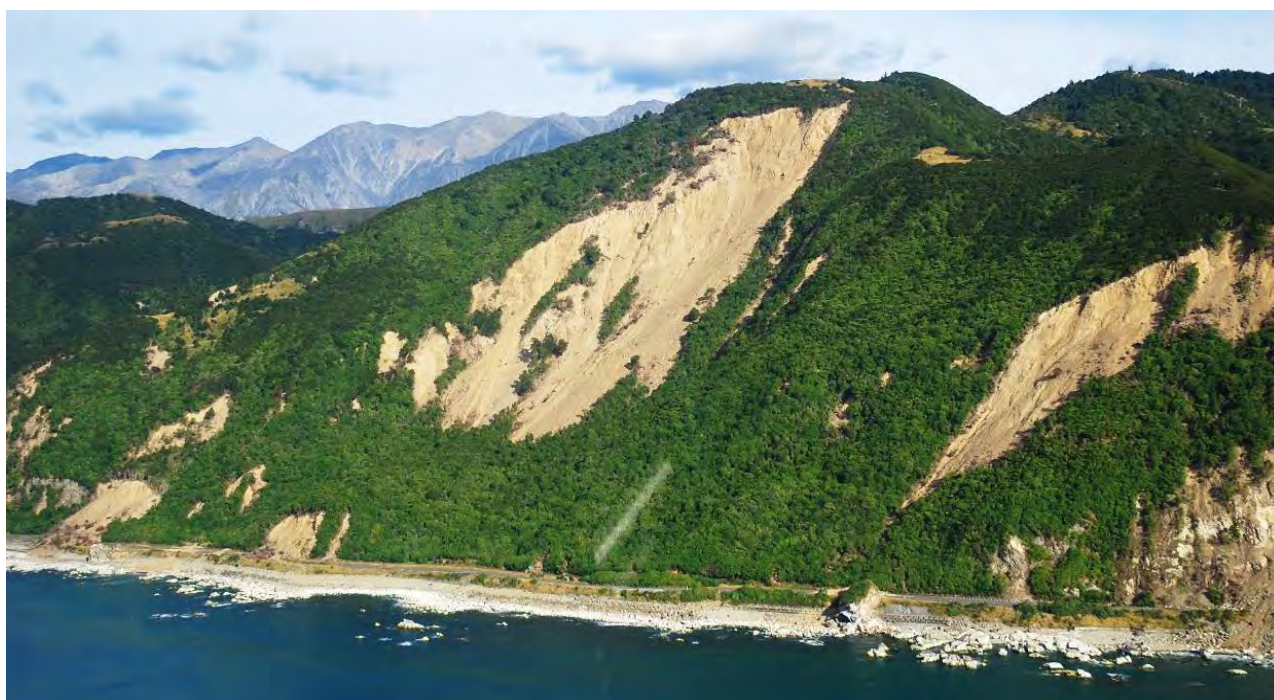
Illustration 5.10. Large landslides with debris hung up on the hillsides

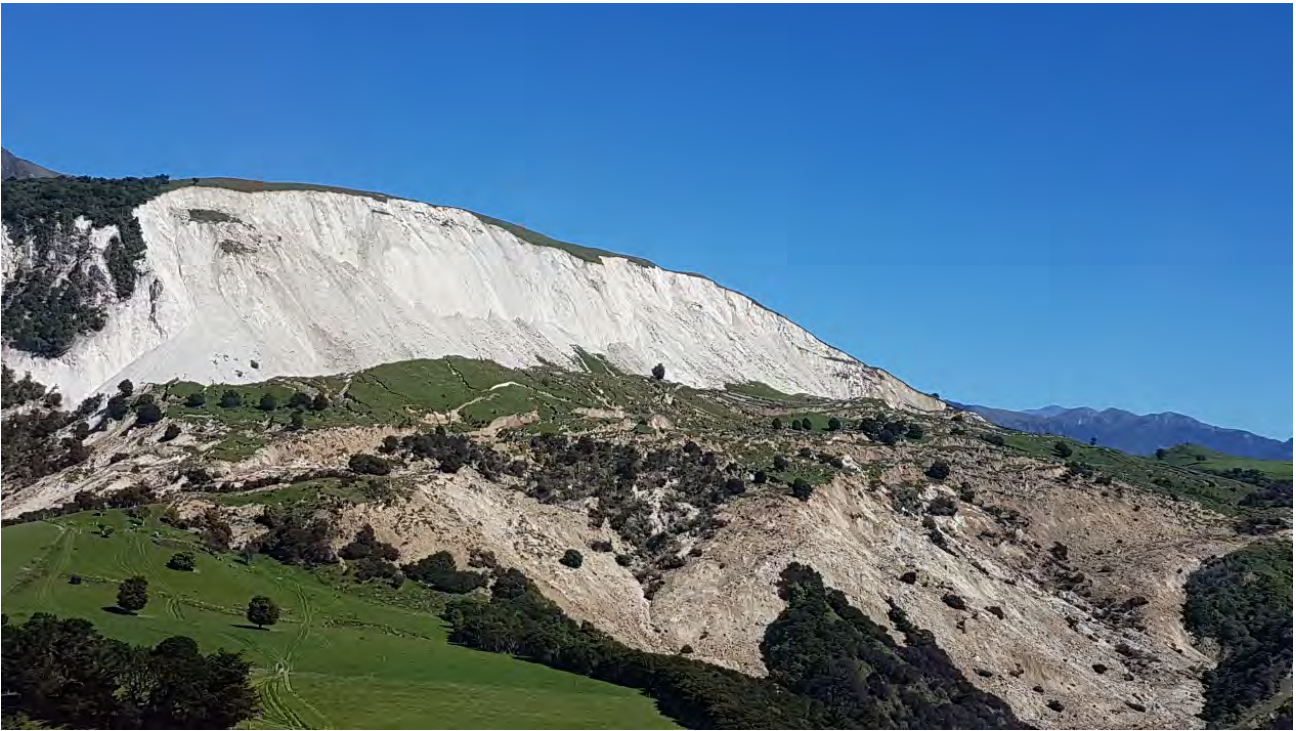
Reconnaissance from past earthquakes overseas, such as after the 2008 Wenchuan earthquake in China (Yu et al 2009) and the 2016 Kumamoto earthquake in Japan (Chiaro et al, 2017) had indicated that ongoing slope failures following storms and debris flows are likely after earthquake induced slope failures affecting steep terrain. The potential for such failures following the Kaikoura earthquake and the potential ongoing impact on the transportation routes was identified by Brabhakaran (2017), given the loosening of the hillsides and incipient cracking observed (Illustration 5.7), the landslides that had initiated but still the debris was hung up in the hillsides (Illustration 5.10) and the extensive landsliding in the back country that is likely to feed debris flows (Illustration 5.11).

Illustration 5.11. Large landslides in back country likely to feed debris flows

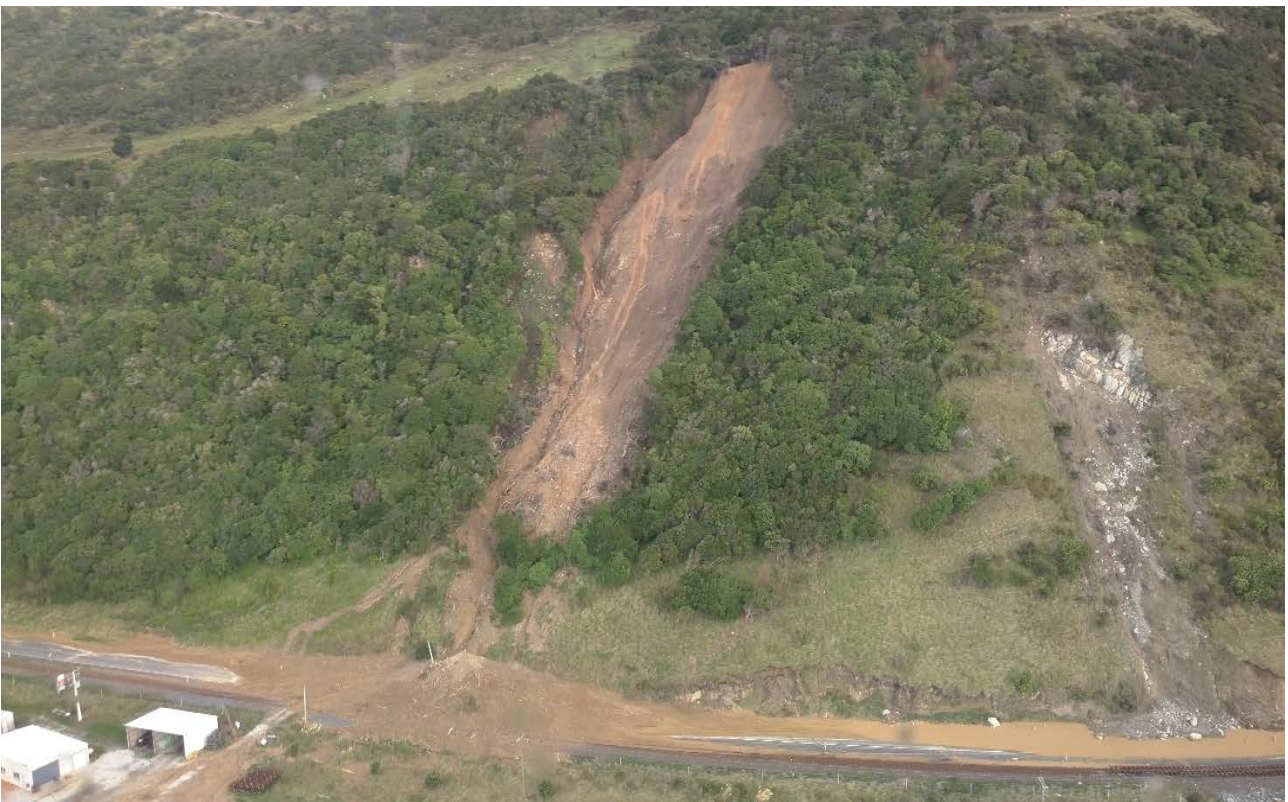
Illustration 5.12. Debris flows in April 2017 affecting access along State Highway 1S

Recent storms such as Cyclone Debbie and Cyclone Cook in April 2017 caused further landsliding and debris flows that have affected State Highway 1 (Illustration 5.12). In particular a new landslide in mid-April near Rosy Morn south of Kaikoura on a section of hillside that had not failed in the earthquake. The state highway from the south to Kaikoura remains closed by this landslide.

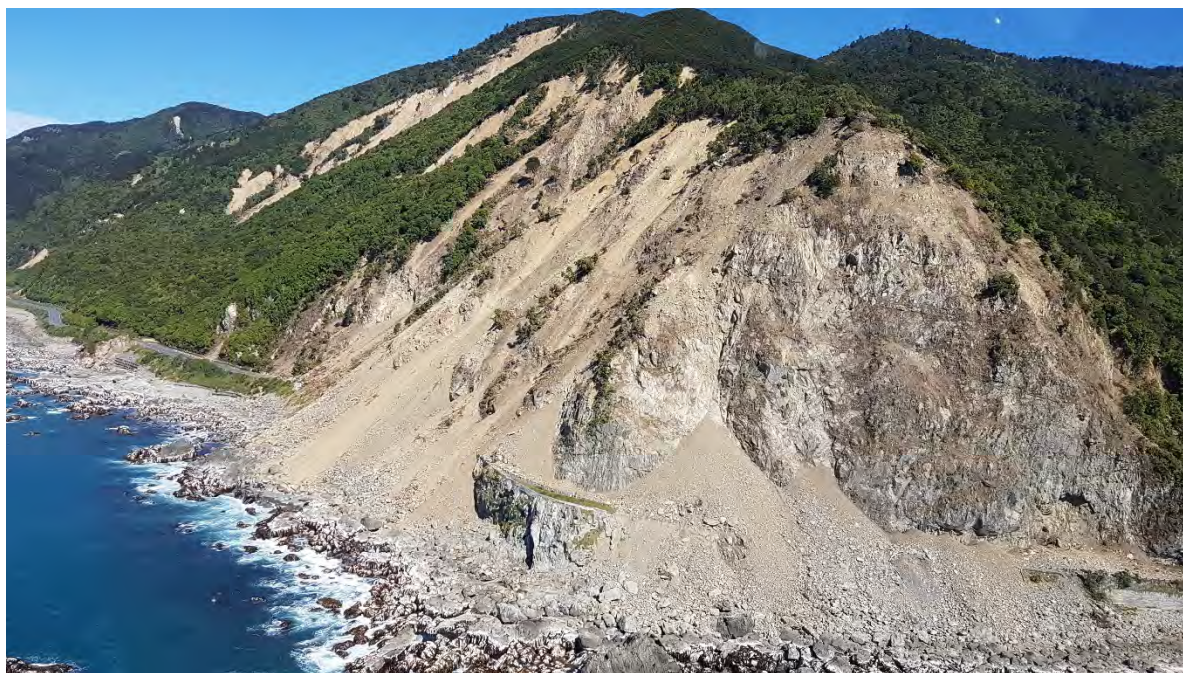
Recent research has identified the potential for topographical amplification of earthquake shaking that leads to most landslides affecting the upper slopes or initiating from the crest of the slopes and running down the slope face (Brabhaharan et al, 2017). The study also shows that ridge top amplification is larger and slope ridges are more affected by earthquakes than terrace slopes. This reinforces observations from past earthquakes in China (Yu et al, 2009) and Japan (Chiaro et al, 2017). This was confirmed by observations following the Kaikoura earthquake in New Zealand (Illustration 5.12). Such mechanisms make access to stabilise the upper slopes more time consuming which greatly lengthens the time required to clear debris from the toe of the slopes and has caused greater outage durations following closure of the roads.

Figure 5.12. Landslides originating from upper ridge slopes due to topographical amplification

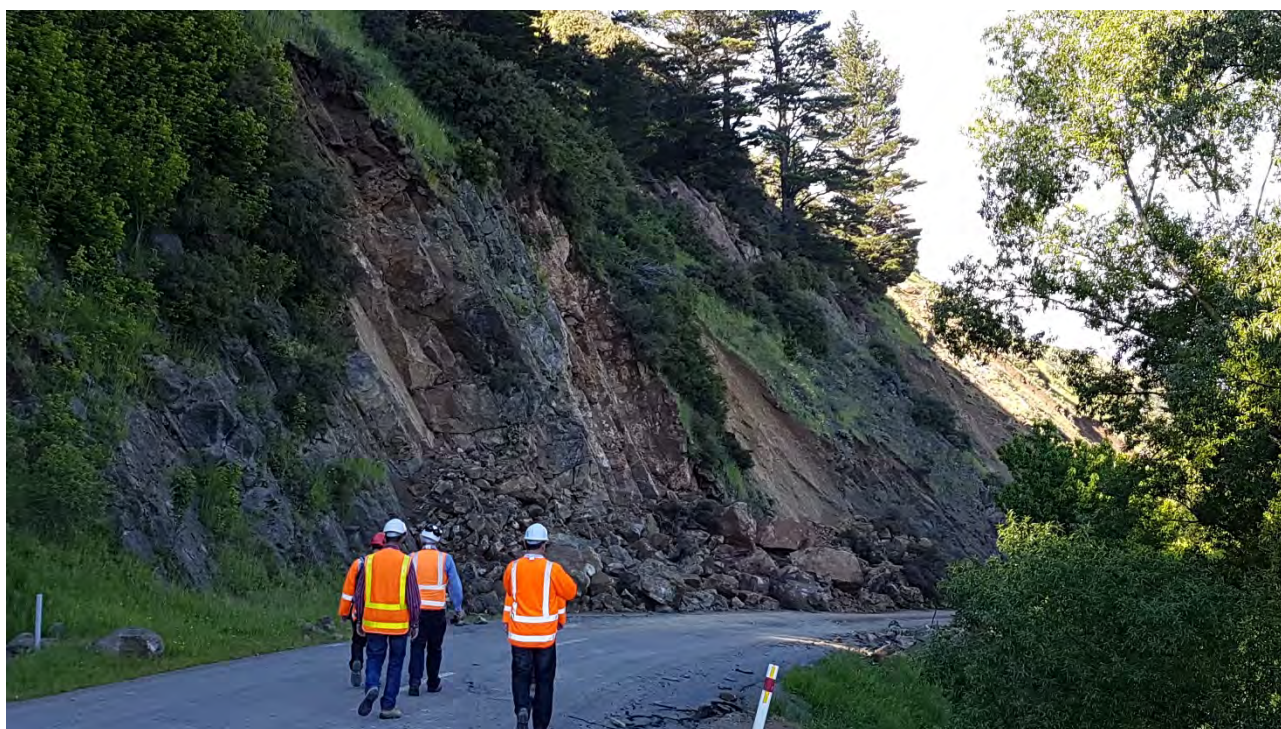
Failures on slopes with limited slope height (10 m to 40 m) were able to be cleared more readily and the road reopened (see Illustration 5.13) compared to failures on high hillsides extending 50 m to 100 m or more. Therefore the high slopes where access was more difficult involved a much longer duration for clearing of debris with sluicing, abseil access and forming access for gaining access to clear debris safely. Therefore the outage periods were much longer in these cases.

Illustration 5.13. Lower Cut slope failures on Inland route to Kaikoura

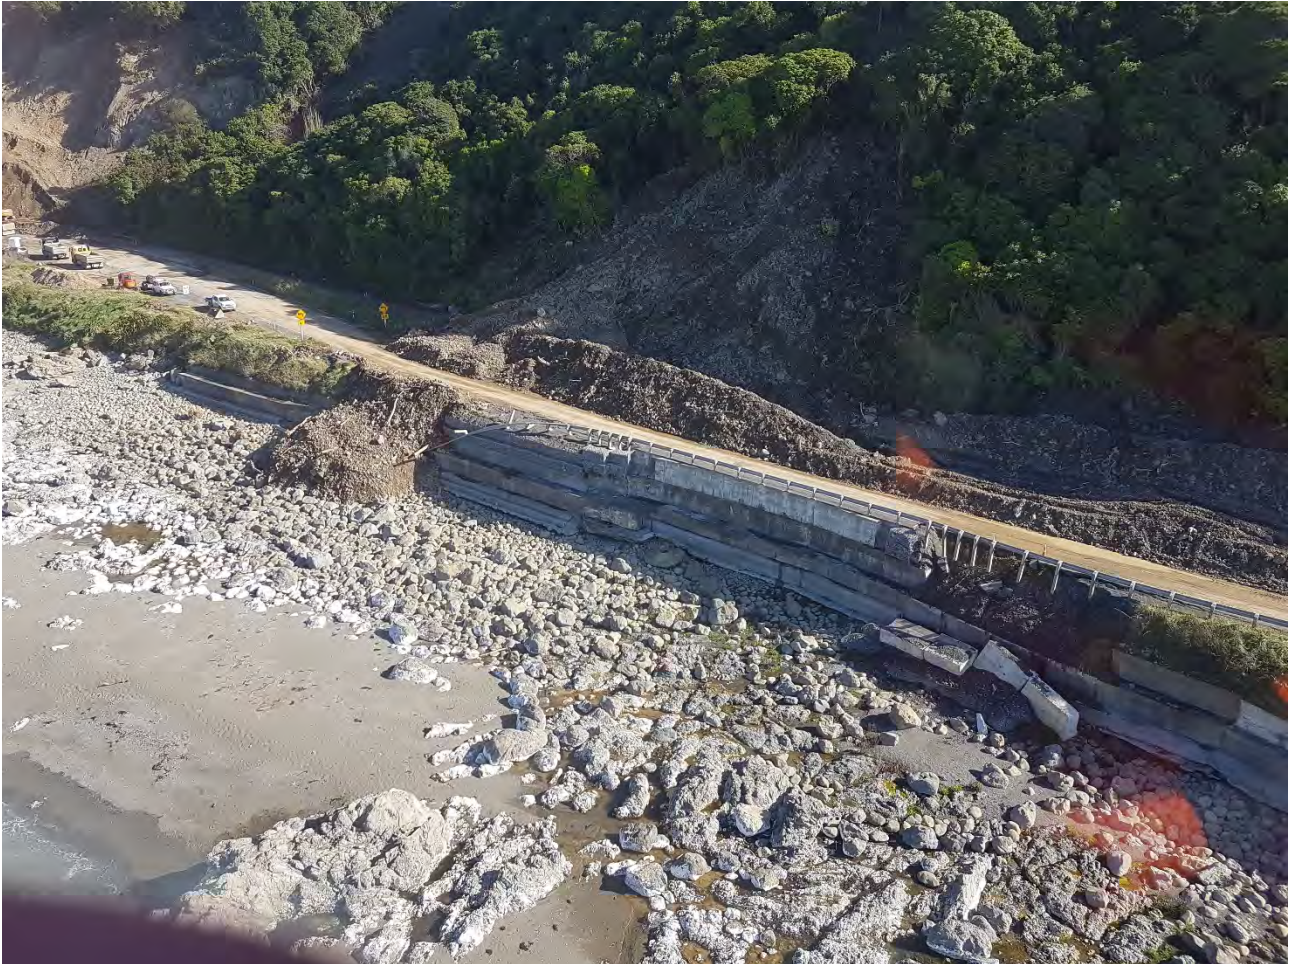
The sea walls appeared to have performed better than expected, with some gabion and crib walls having failed, but some concrete walls founded on rock appears to have performed better than expected, while others have failed, see Illustration 5.14. The wall performance will also depend on the orientation of strong ground shaking relative to the orientation of the sea walls.

Illustration 5.14. Seawall below State Highway 1S
