Appendix C

Existing Building Preliminary Assessment

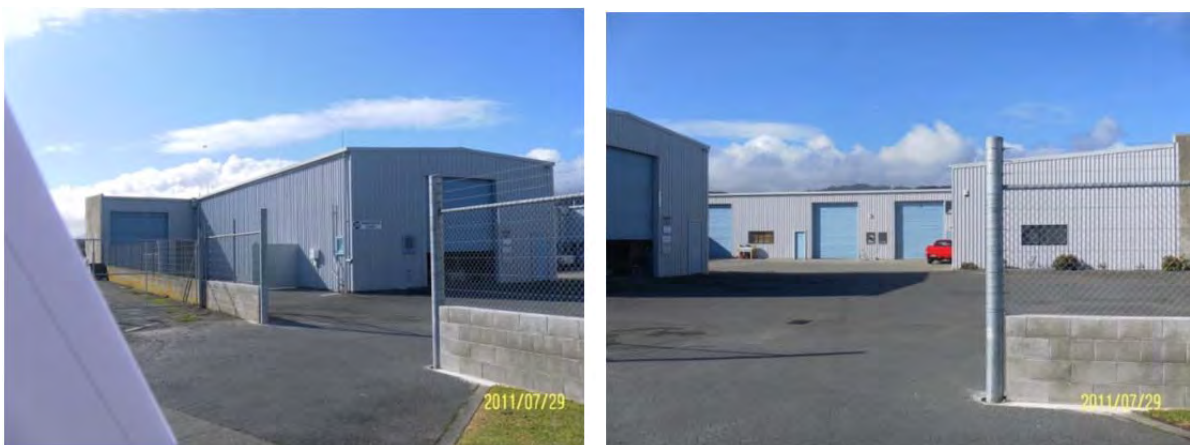
Figure 2: 20 Manchester St – street view

This is a series of portal frame buildings situated on the boundary of the construction designation and shown in Figure 1 and Figure 2. The buildings consist of steel portal frames and precast reinforced concrete walls with steel cladding. Due to the construction type these buildings are not expected to be susceptible to visual cracking in the event of slight differential ground movement.

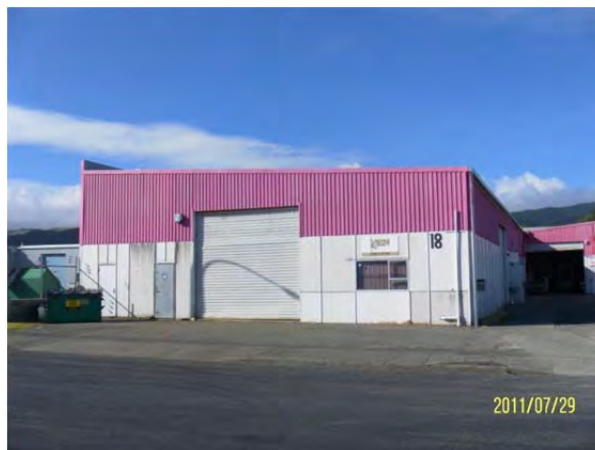
Figure 4: 18 Manchester St – street view

This is a portal frame building situated on the boundary of the construction designation and shown in Figure 3 and Figure 4. The building is a steel portal frame structure with some precast reinforced concrete walls and steel and a board material cladding. This building is not expected to be susceptible to visual cracking in the event of slight differential ground movement.

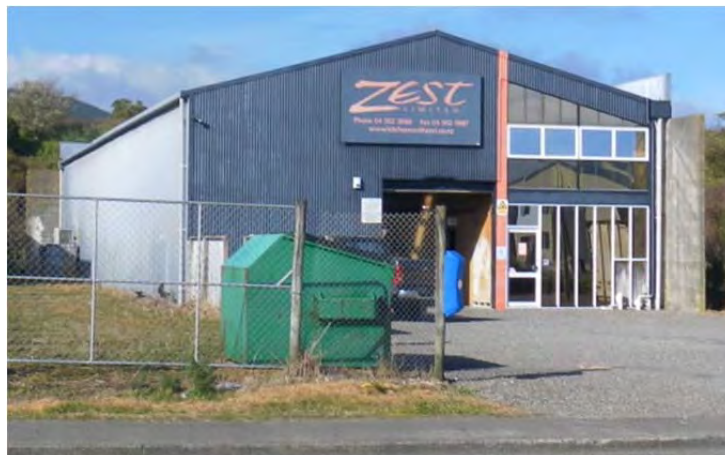
Figure 6: 16 Manchester St – street view

This is a portal frame building situated on the boundary of the construction designation and shown in Figure 5 and Figure 6. The building is a steel portal frame structure with a concrete block wall on two faces of the building and steel cladding. The concrete block wall is expected to be reinforced. Due to the concrete block walls it is expected the building will be susceptible to visual cracking in the event of slight differential ground movement.

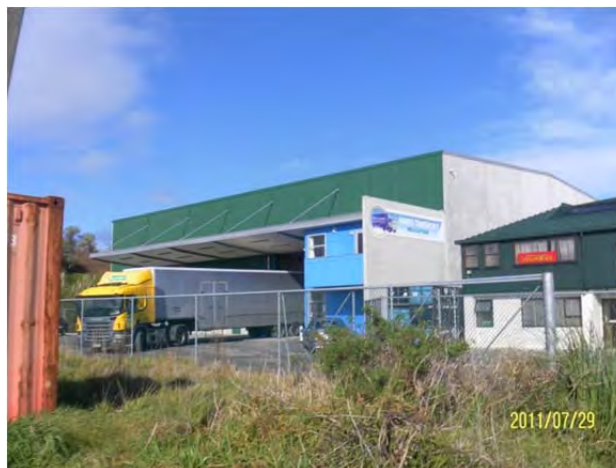
Figure 8: 12 Manchester St – street view

This is a portal frame building situated on the boundary of the construction designation and shown in Figure 7 and Figure 8. The building is a steel portal frame structure with some precast reinforced concrete walls and steel cladding. This building is not expected to be susceptible to visual cracking in the event of slight differential ground movement.

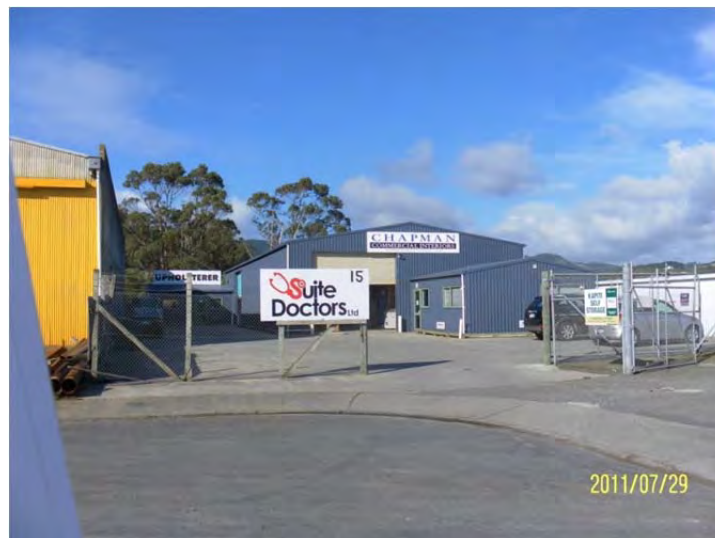
Figure 14: 15 Sheffield St – street view

This is a portal frame building situated on the boundary of the construction designation and shown in Figure 13 and Figure 14. The building is a steel portal frame structure with no obvious concrete walls and steel cladding. This building is not expected to be susceptible to visual cracking in the event of slight differential ground movement.

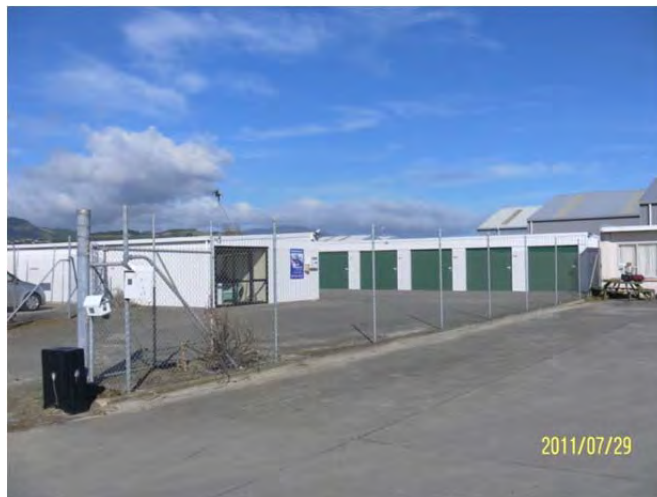
Figure 16: 17 Sheffield St – street view

This is a series of 1-storey frame structures located on the boundary of the construction designation and shown in Figure 15 and Figure 16. The buildings are steel clad and likely to be steel framed structures (otherwise timber). The buildings are not likely to be susceptible to visual cracking in the event of slight differential ground settlement.

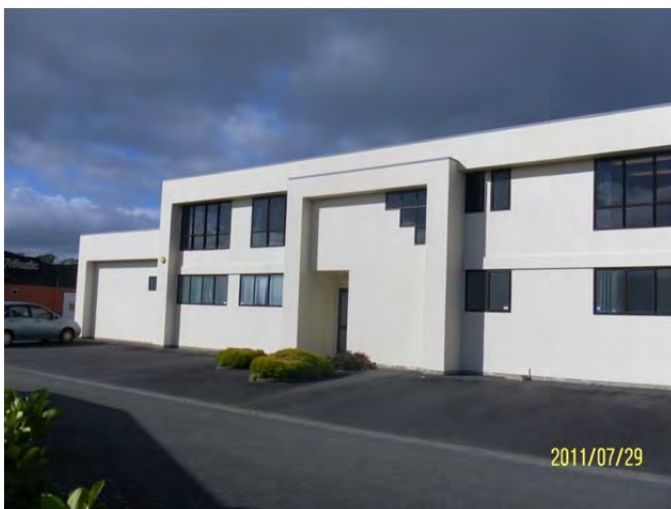
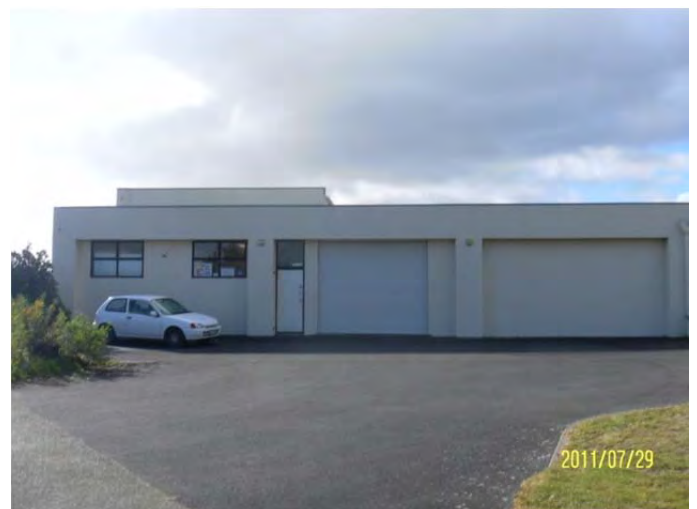
Figure 18: 31 Milne Dr – street view

This building is a 2-storey structure located on the boundary of the construction designation and shown in Figure 17 and Figure 18. The material used in the structural system of the building is unknown (*may be steel frame with boxed members similar to the front of 23 Milne Dr*), but there is a wall down one side of the building that is plastered and could be reinforced concrete or concrete block and the building has stucco cladding. Due to this the building is expected to be susceptible to visual cracking in the event of slight differential ground settlement

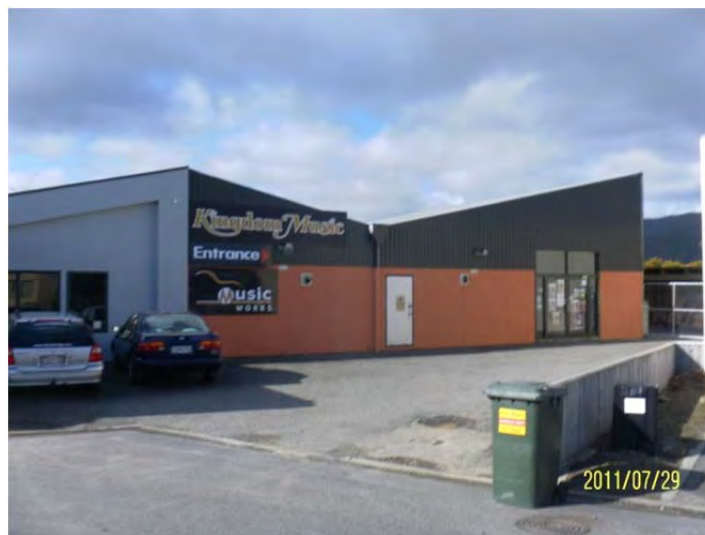
Figure 20: 27 Milne Dr – street view

This building is located on the boundary of the construction designation and shown in Figure 19 and Figure 20. It is connected to the building at 23 Milne Drive which can be seen on the left of Figure 20. The building is steel portal frame structure with stucco cladding. Due to the stucco it is expected to be susceptible to visual cracking in the event of differential ground movement.

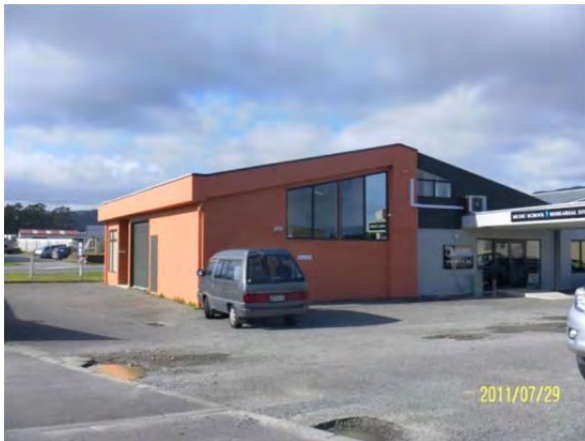
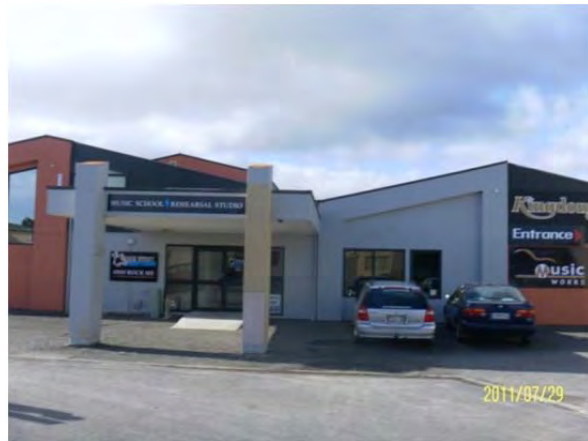
Figure 22: 23 Milne Drive – street view

This building is located 20m from the boundary of the construction designation and is shown in Figure 21 and Figure 22. It is connected to the building at 27 Milne Drive which can be seen on the right of Figure 22. The building is steel portal frame structure with stucco cladding. Due to the stucco it is expected to be susceptible to visual cracking in the event of differential ground movement.

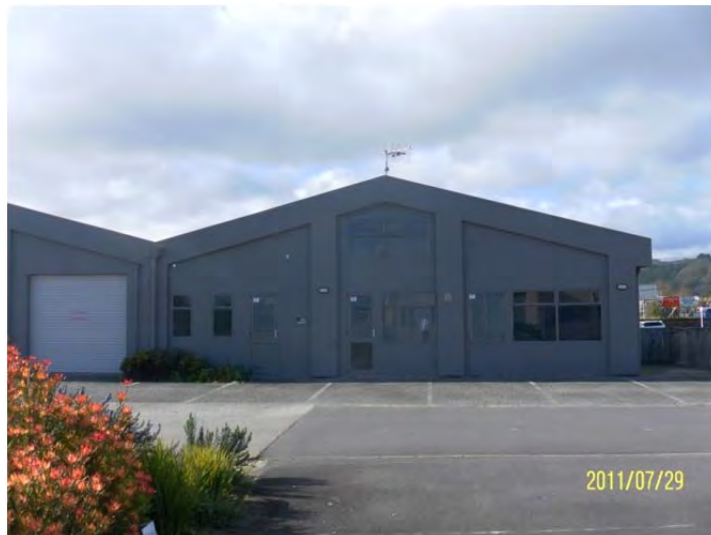
Figure 24: 11 Kodax PI – street view

This building is located on the boundary of the construction designation and is shown in Figure 23 and Figure 24. It is a portal frame structure with stucco cladding. Due to the stucco cladding this building is expected to be susceptible to visual cracking in the event of slight differential ground settlement.

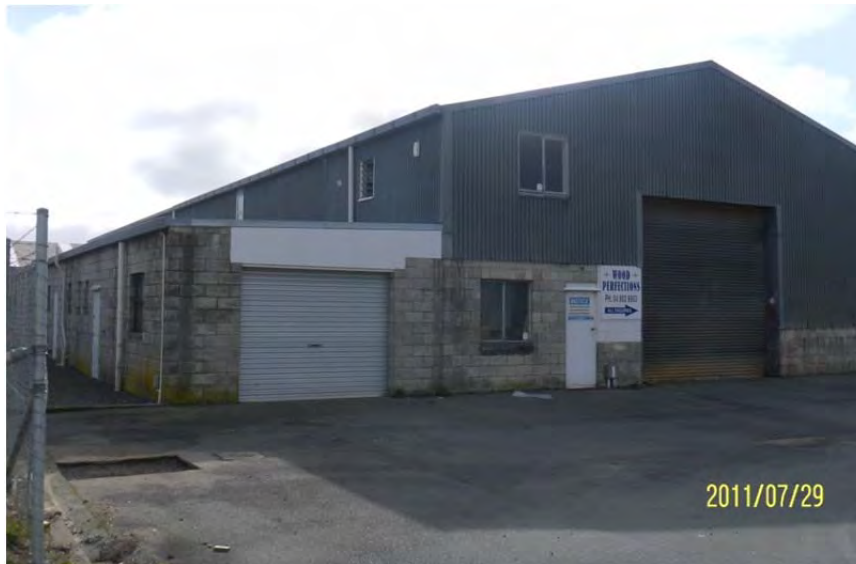
Figure 26: 106A Kapiti Rd – street view

This building is located 50m from the construction designation and is shown in Figure 25 and Figure 26. The main structure is a steel portal frame with a smaller concrete block structure attached to it. The main structure has both steel cladding and concrete blocks. The concrete blocks would be expected to be reinforced. Due to the concrete blocks this structure is expected to be susceptible to visual cracking in the event of slight differential ground settlement.

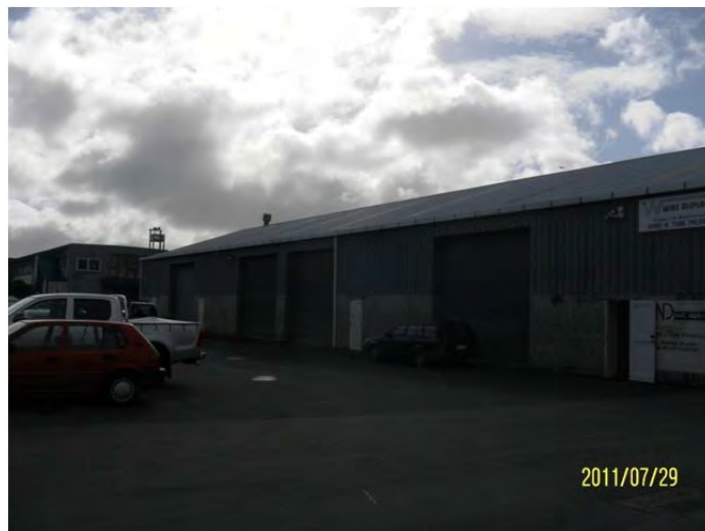
Figure 28: 106B Kapiti Rd – street view

These buildings are located 50m from the construction designation and are shown in Figure 27 and Figure 28. The structures consist of a steel portal frame and concrete block and steel cladding. The concrete blocks would be expected to be reinforced. Due to the concrete blocks this structure is expected to be susceptible to visual cracking in the event of slight differential ground settlement.

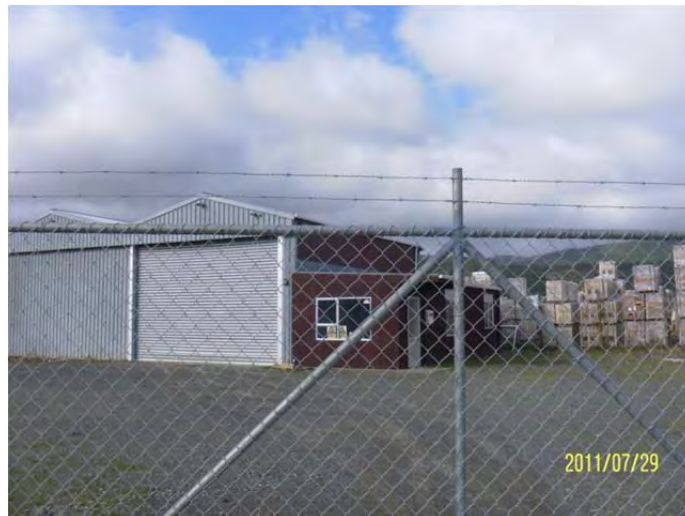
Figure 30: 104 Kapiti Rd – street view

This building is located on the boundary of the construction designation and is shown in Figure 29 and Figure 30. It is a steel portal frame structure with steel cladding and a small timber structure on the side. This structure is not expected to be susceptible to visual cracking in the event of slight differential ground movement.

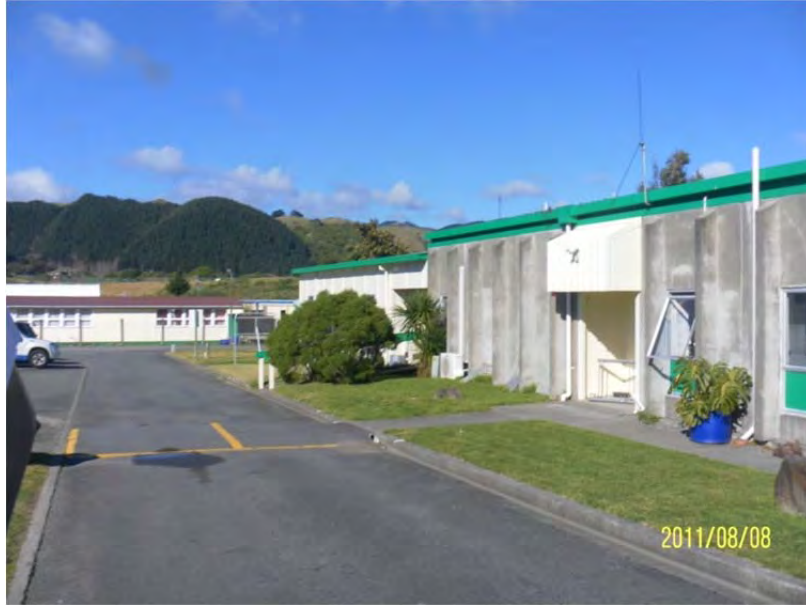
2.1 Office Building

This 1-storey office building is of both timber and reinforced concrete wall construction. Due to the construction type it is not expected to be susceptible to visual cracking in the event of slight differential ground settlement.

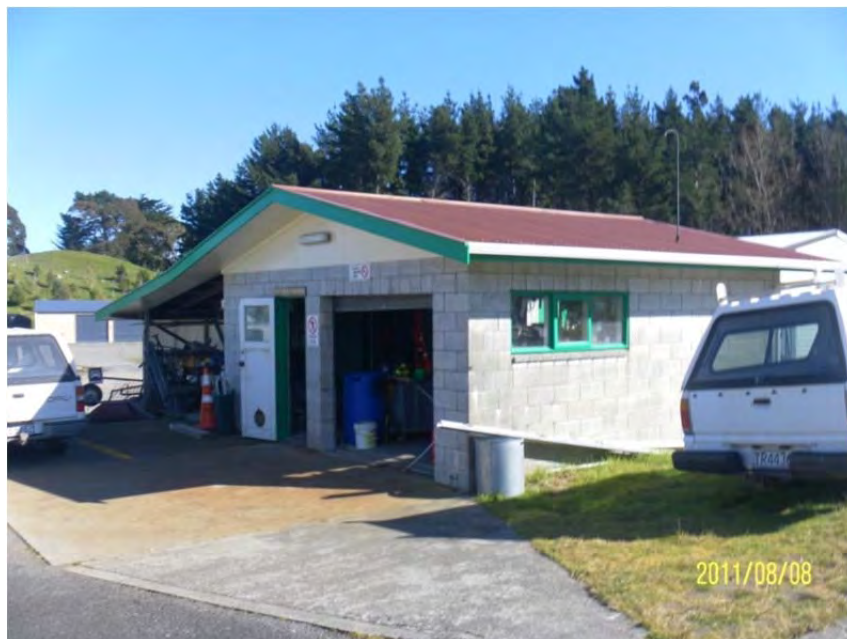
2.2 Storage shed

This 1-storey storage shed is of concrete block construction and is therefore expected to be susceptible to visual cracking in the event of slight differential ground settlement.

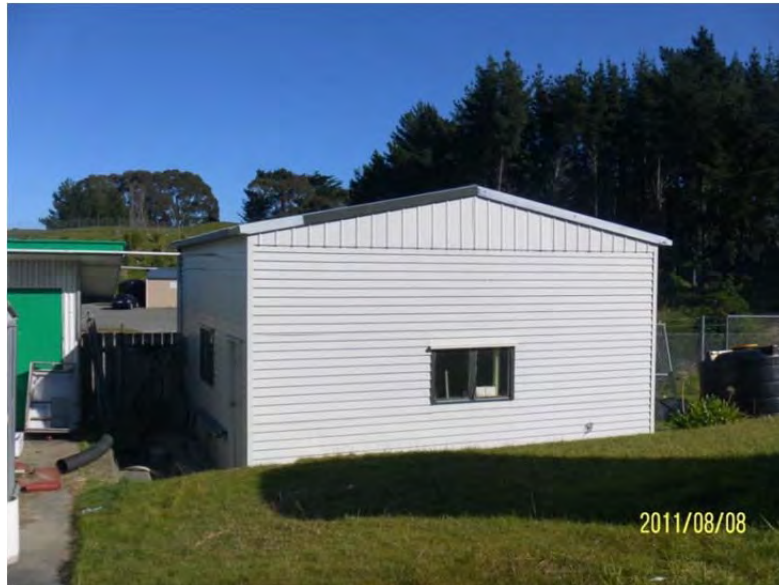
2.3 Storage shed

This 1-storey storage shed is of timber and steel construction and therefore is not expected to be susceptible to visual cracking in the event of slight differential ground settlement.

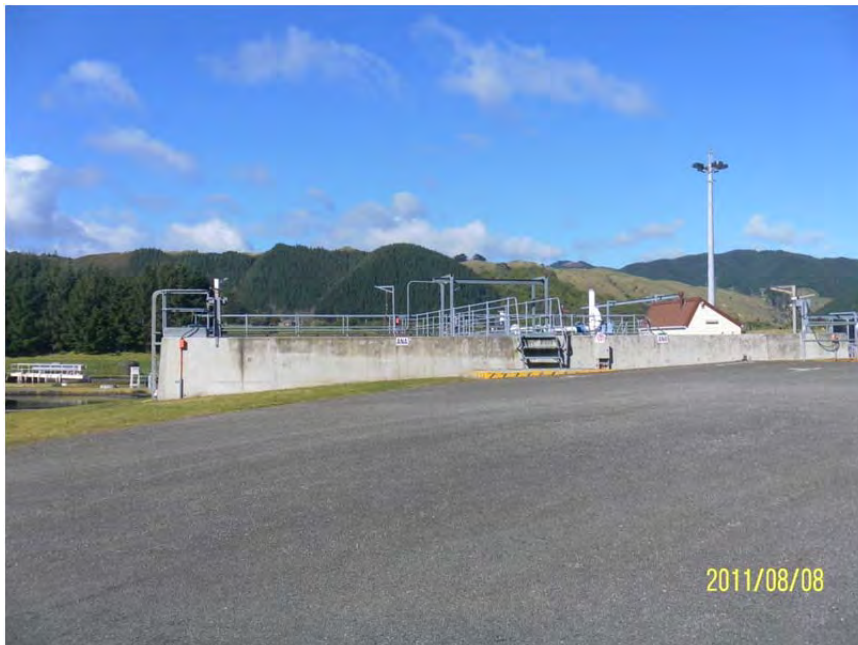
2.4 Tank

This tank is of reinforced concrete construction and sits in the ground. It is not expected to be susceptible to visual cracking in the event of slight differential ground settlement.

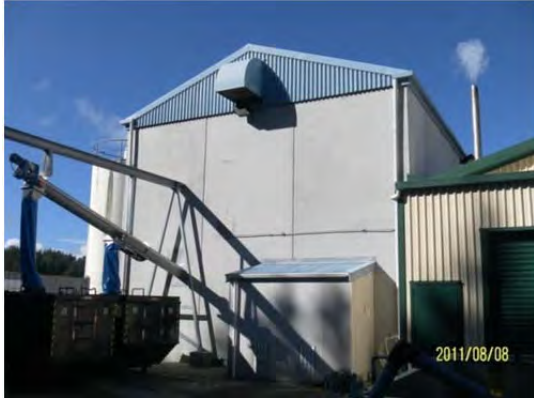
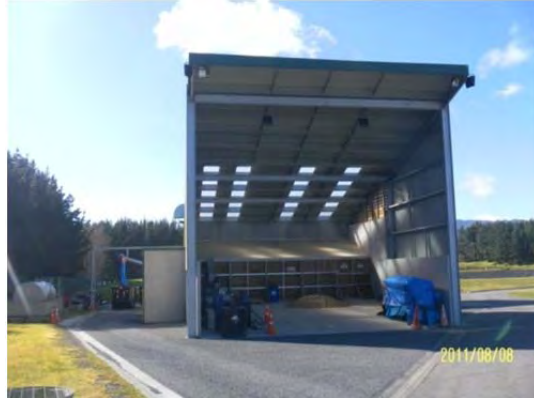
2.5 Fuel storage shed

This building consists of two separate structures, one is of steel construction and the other consists of precast concrete panels. Neither of these building types is expected to be susceptible to visual cracking in the event of slight differential ground settlement.

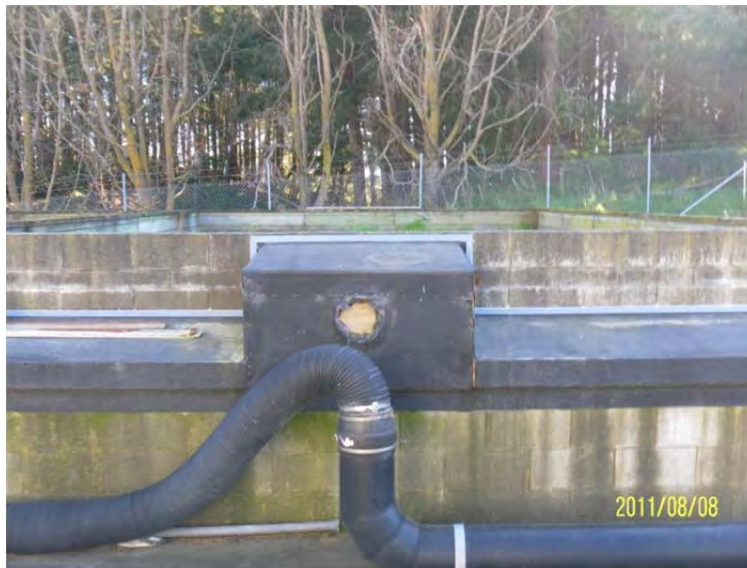
2.6 Organic Filters

This low structure is of concrete block and timber construction and due to the concrete blocks it is expected to be susceptible to visual cracking in the event of slight differential ground settlement.

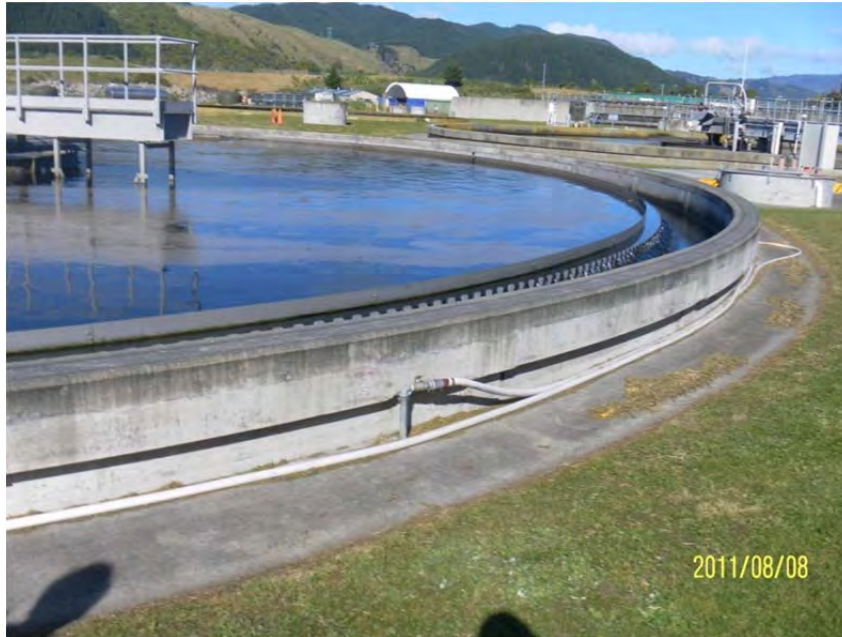
2.7 Mixing tanks

Each of the three mixing tanks is of similar construction. They consist of reinforced concrete and protrude approximately 5m into the ground. They are not expected to be susceptible to visual cracking in the event of slight differential ground settlement.

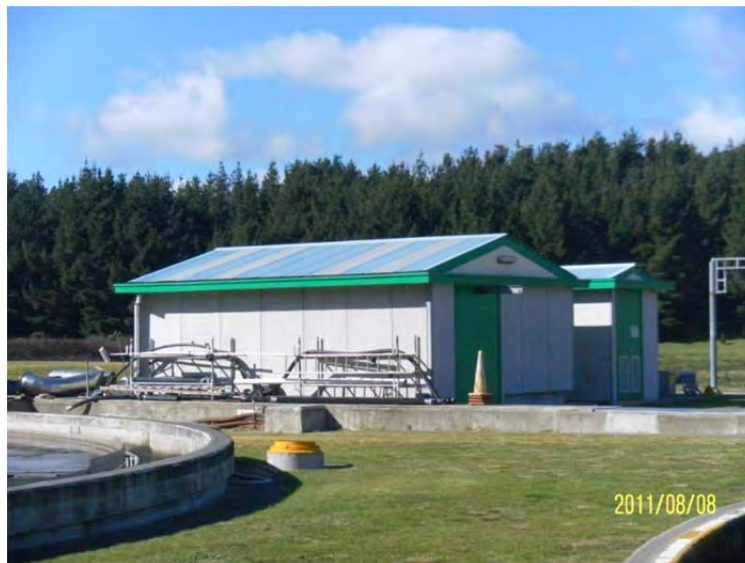
2.8 UV treatment shed

This 1-storey building consists of precast concrete panel facades. It is not expected to be susceptible to visual cracking in the event of differential ground settlement.

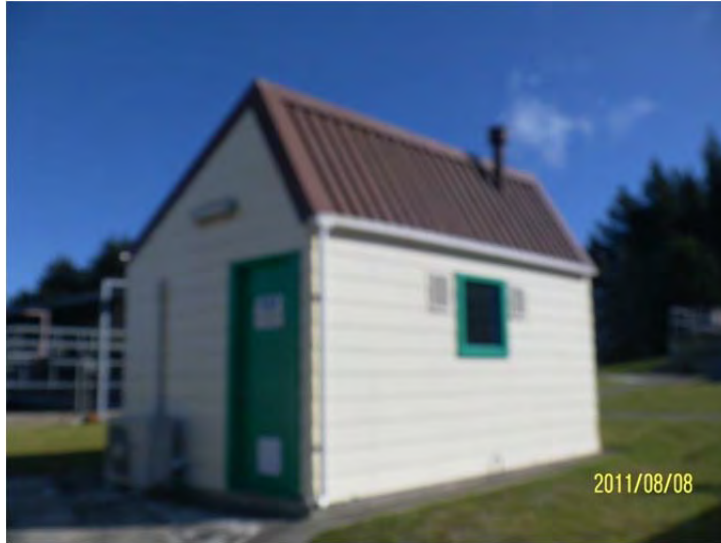
2.9 Small timber shed

This small 1–storey timber structure is not expected to be susceptible to visual cracking in the event of slight differential ground settlement.

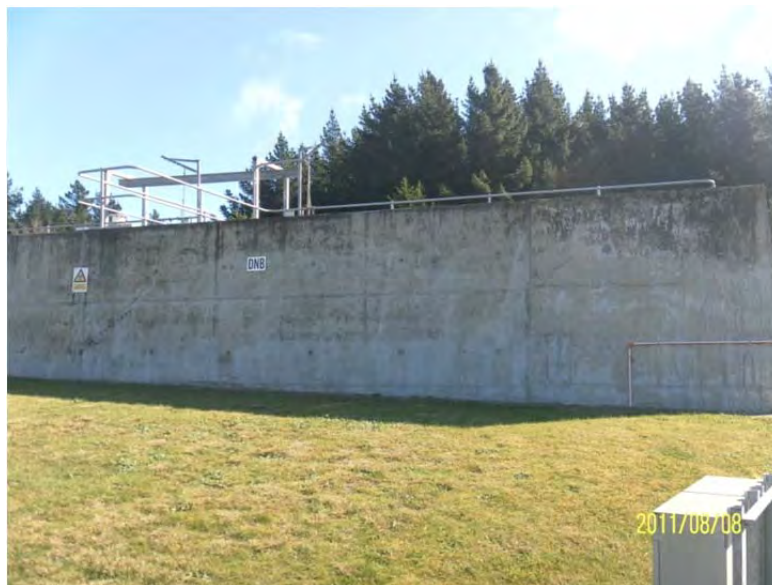
2.10 Concrete tanks

These two large tanks are of similar construction and the main structure consists of reinforced concrete. They are not expected to be susceptible to visual cracking in the event of slight differential ground settlement.

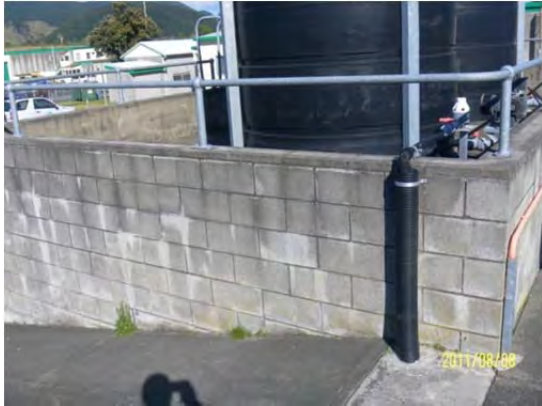
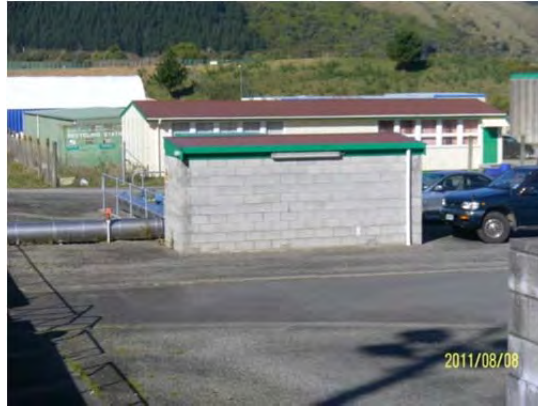
2.11 Small Concrete Block Structures

These two concrete block structures are likely to be susceptible to visual cracking in the event of slight differential ground settlement. Especially 11a (pictured on the left) which has no bracing at the top and is likely to feel a greater effect from any differential ground movement.

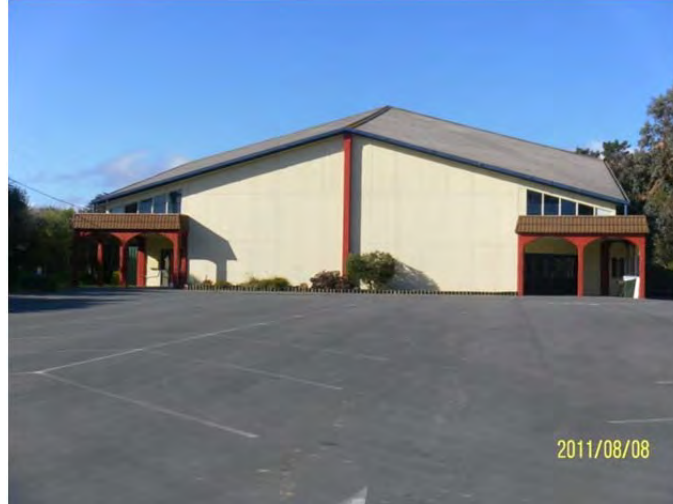
3.1 Kauri Hall

Kauri Hall appears to be a timber or steel portal frame building. Each façade is constructed of a board material that appeared flexible. The entrances that can be seen on the left and right of the above photo consist of columns that have a plaster surface. Due to the slender nature of these columns they are not expected to be susceptible to visual cracking in the event of slight differential ground settlement. The rest of the structure is not expected to be susceptible due to construction type.

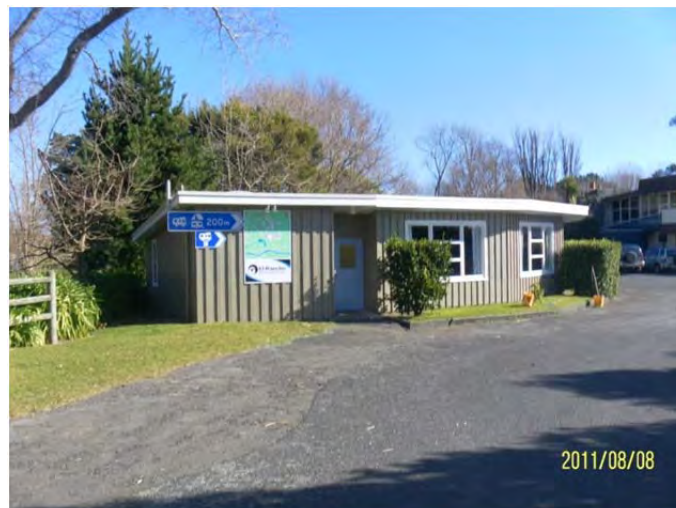
3.2 Poplar Lodge

Poplar Lodge is a 1 storey timber building with timber facades. Due to this construction type it is unexpected to be susceptible to visual cracking in the event of slight differential ground settlement.

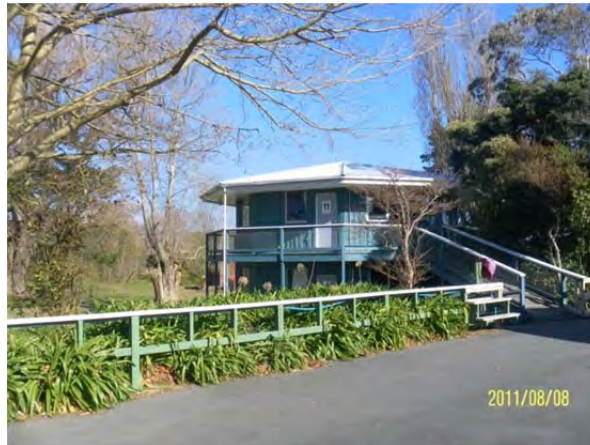
3.3 Oregon Lodge

Oregon Lodge is a 2-storey timber building with timber facades. Due to this construction type it is unexpected to be susceptible to visual cracking in the event of slight differential ground settlement.

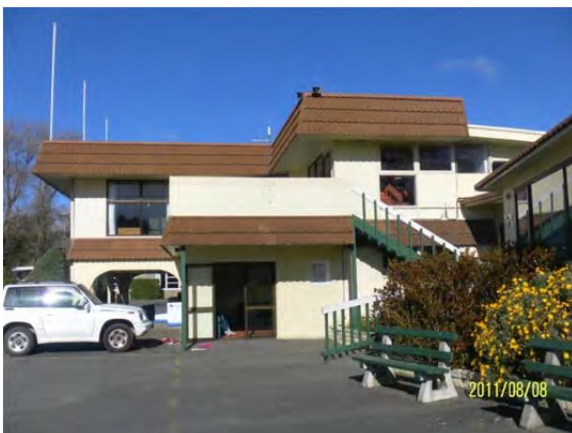
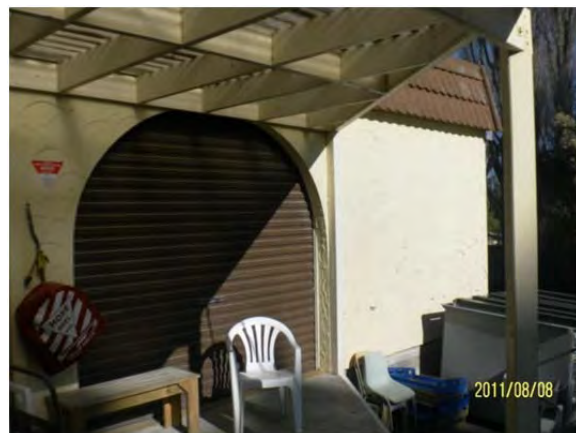
3.5 Redwood Hall/Dining Room

This 2-storey structure is constructed from various materials consisting of timber, brick and plaster facades with sections of concrete blocks at the base. Due to the brick, plaster and concrete blocks this structure is expected to be susceptible to visual cracking in the event of slight differential ground settlement.

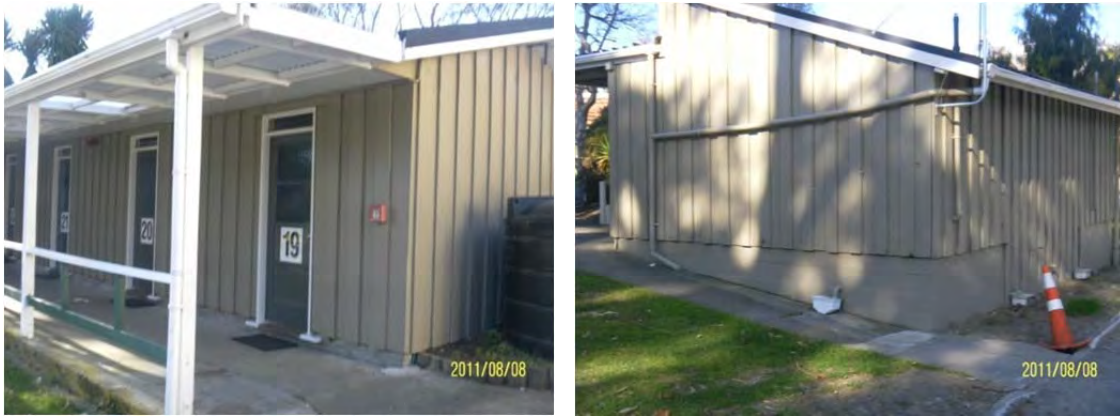
3.6 Rata Lodge, Rimu Lodge and Toilet Block

These buildings are of timber construction on a concrete slab foundation. They are not expected to be susceptible to visual cracking in the event of slight differential ground settlement.

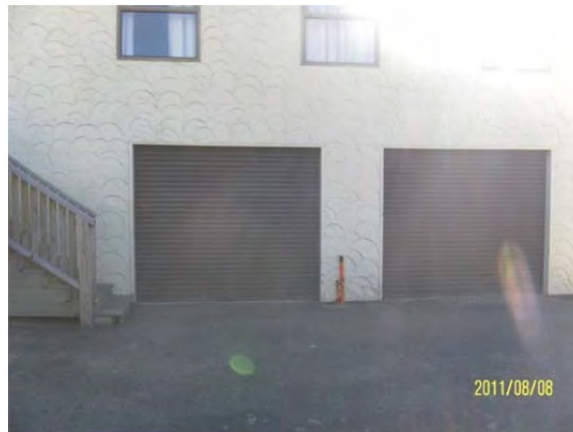
3.7 Office

The office building has a plaster façade with the rest of the building being clad in a board/timber material. Due to the plaster façade this building is expected to be susceptible to visual cracking in the event of slight differential ground settlement.

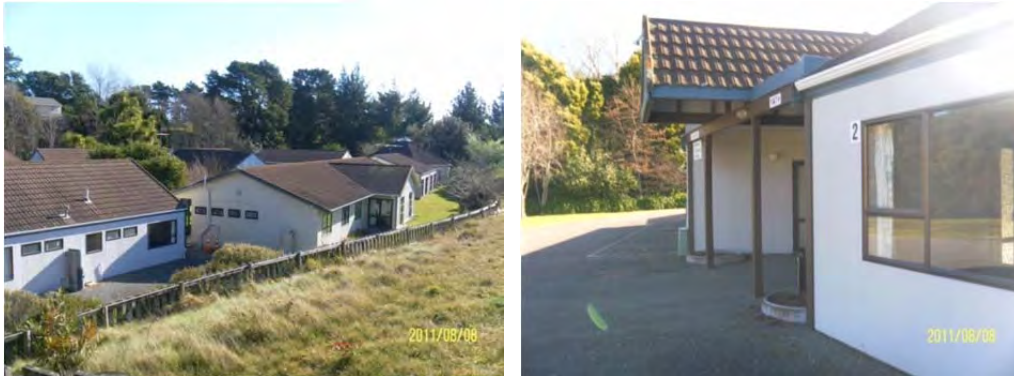
3.8 Elm Court

Elm Court is a series of buildings of timber/board construction. It is not expected to be susceptible to visual cracking in the event of slight differential ground settlement.

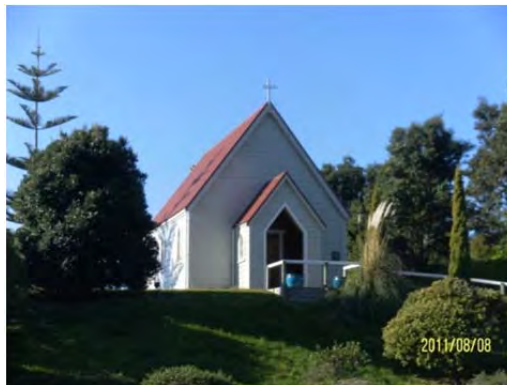
3.9 Apiti Chapel

This building is of timber construction and is not expected to be susceptible to visual cracking in the event of slight differential ground settlement.

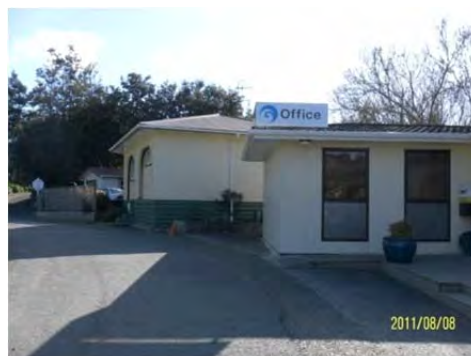
3.10 Staff #2

This building is constructed from both timber and plaster facades. Due to the plaster façade it is expected this building will be susceptible to visual cracking in the event of slight differential ground settlement.

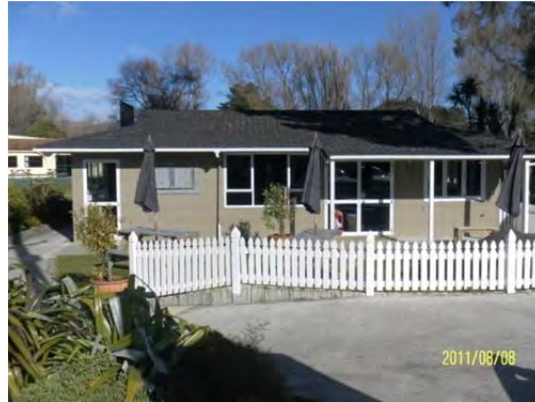
3.11 Cafe

This building is constructed from timber and is not expected to be susceptible to visual cracking in the event of slight differential ground settlement.

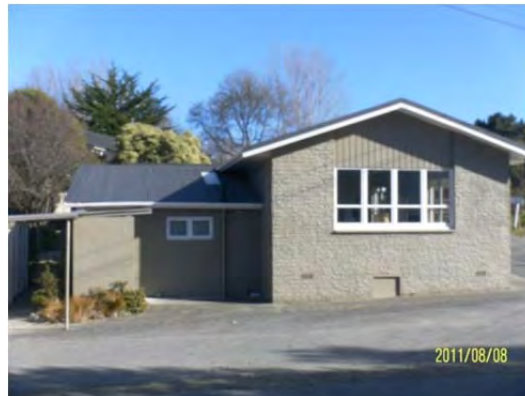
3.12 Pinewood Dining and Pinewood Hall

Pinewood Dining and Pinewood Hall both have facades constructed from both brick and concrete block. Due to this these buildings are both expected to be susceptible to visual cracking in the event of slight differential ground settlement.

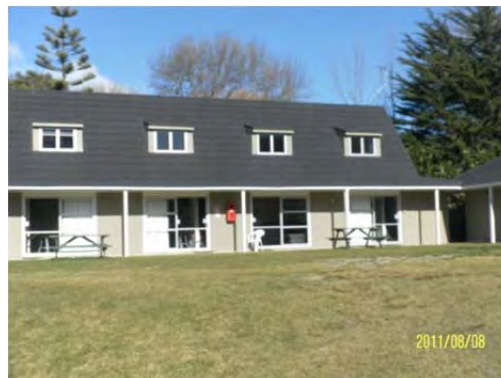
3.13 Villas

This 2-storey building is of timber construction and therefore is not expected to be susceptible to visual cracking in the event of slight differential ground settlement.
