Memorandum

| Subject | Transmission Gully - Post Construction Inspections Summary | | |
| File/Ref No. | | Date | 27-Feb-2023 |

1.0 Introduction

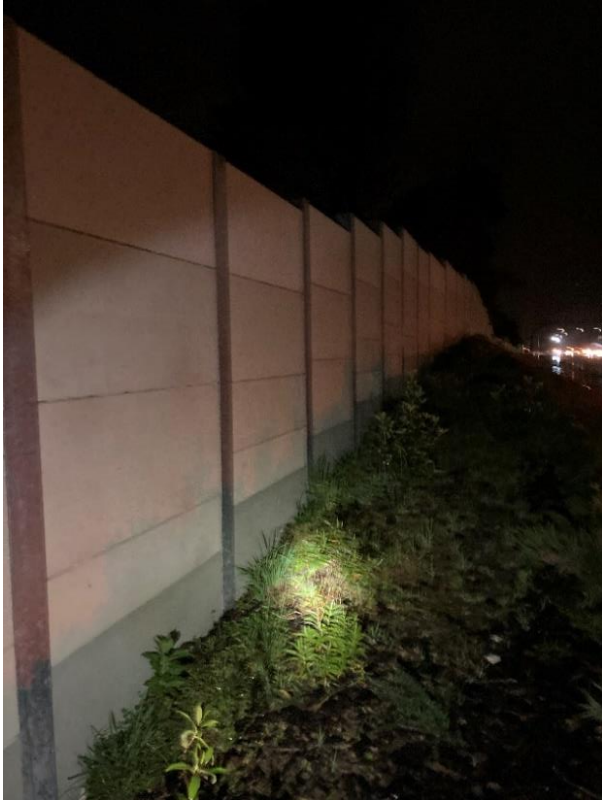
The height of the noise wall was recorded along its length and was generally found to be consistent with the noise model; The length of noise wall where the lower height was measured was approximately 10m out of the 470m length inspected. The as-built geometry of the noise wall was

Figure 1 Typical picture of noise wall N4

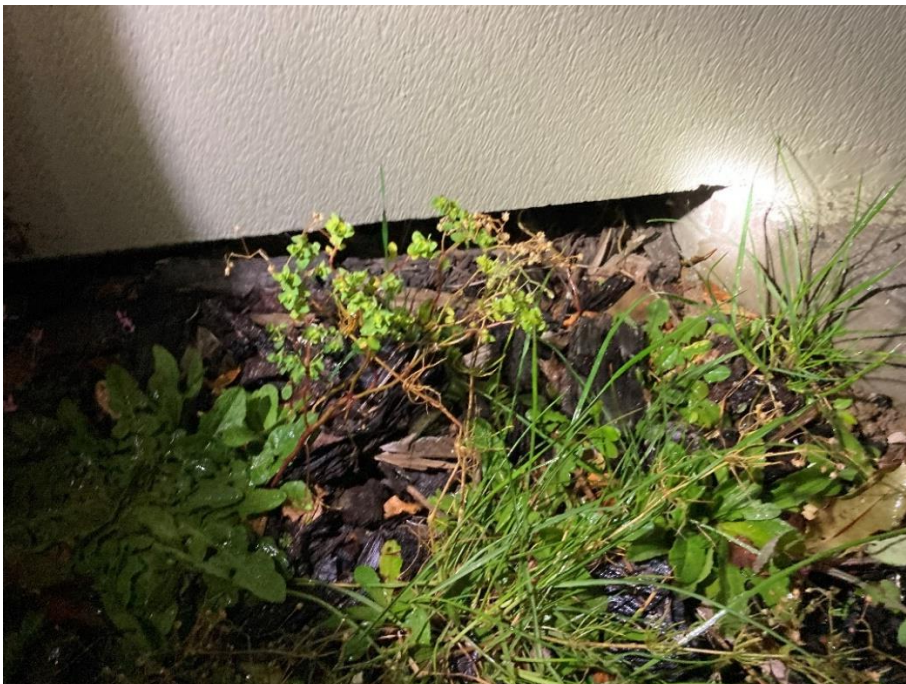
These noise walls were inspected and found to have gaps in some locations running under the wall. These gaps were notified to CPB HEB JV and were subsequently backfilled.

Figure 2 Typical picture of gap under noise wall

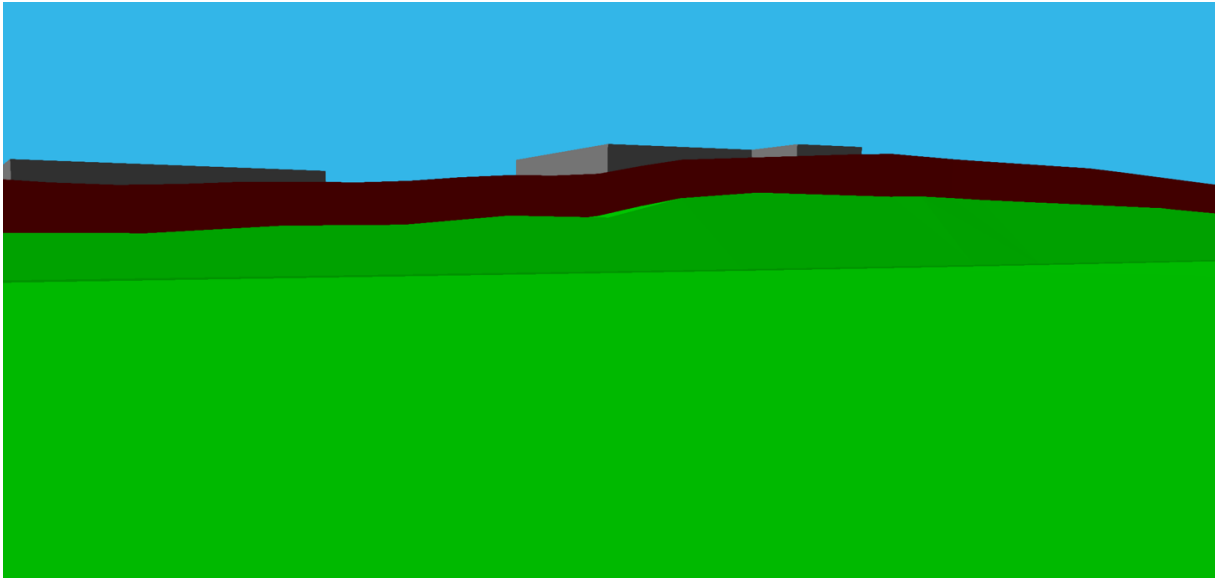
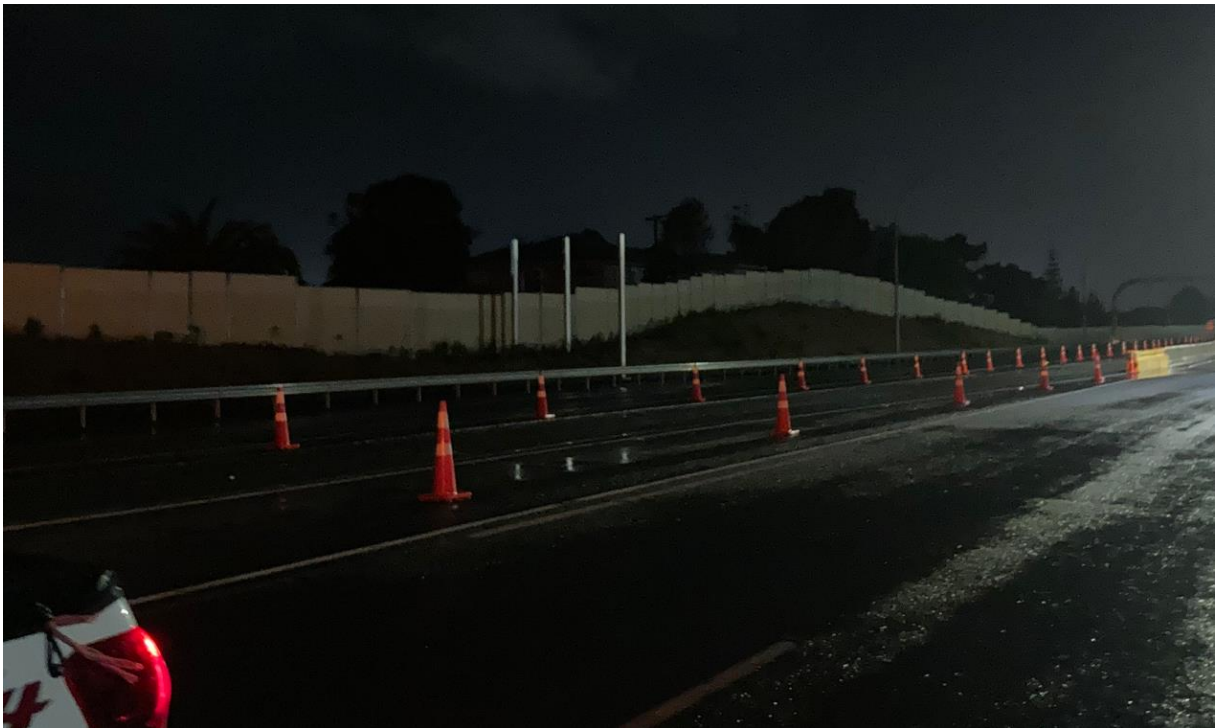
A visual comparison was made of the noise wall compared to the noise model and was found to be generally consistent as seen when comparing Figure 3 and Figure 4.

Figure 3 Image of noise wall N4 from noise model

Figure 4 Image of noise wall N4 from site inspection

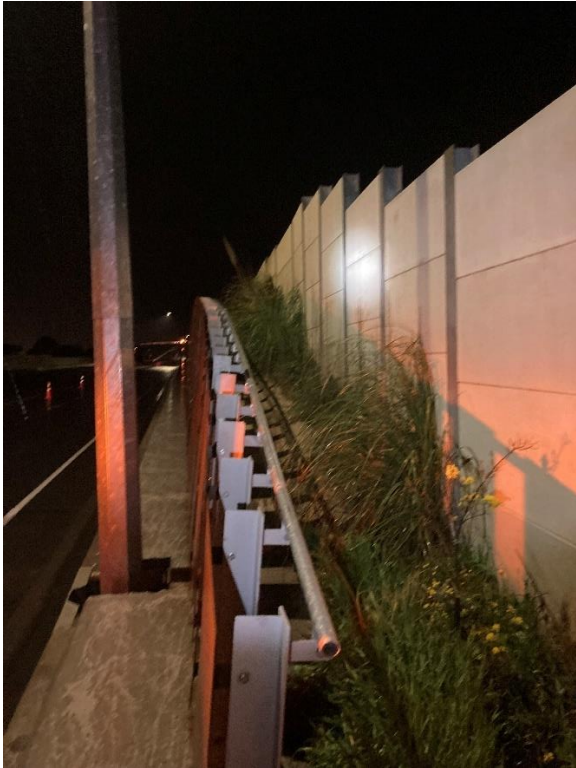
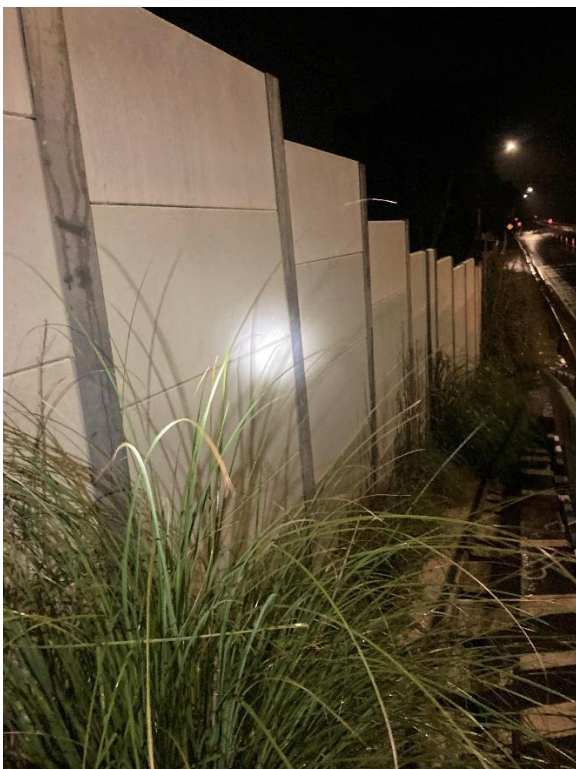
This noise wall was constructed along mostly steep ground with dense vegetation planted in front, and due to safety concerns at the time of the inspection, the noise wall was not physically measured along most of its length. Where the noise wall was measured, its height was found to be lower than the design height by up to 0.8m. The length of noise wall where the lower height was measured was approximately 17m out of the full 376m length of the wall.

found to be less than 1 dB and would not have changed the NZS 6806 Category of any PPFs behind the noise wall. The full memo summarising the outcome of this is provided in Appendix C of the full post-construction monitoring and noise model validation report. The as-built height of the noise wall was also included in the Post-Construction noise model.

Figure 5 Typical picture of noise wall N3

Figure 6 Typical picture of noise wall N3

CPB HEB JV was notified of the height discrepancy found for this noise wall. Additional noise modelling was undertaken at the time, and the change in noise level due to the lower barrier was

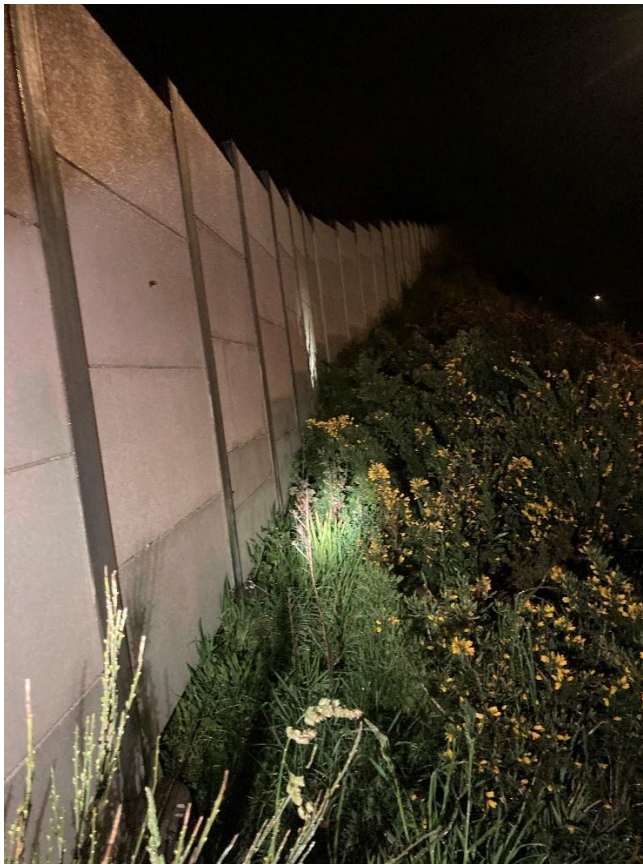
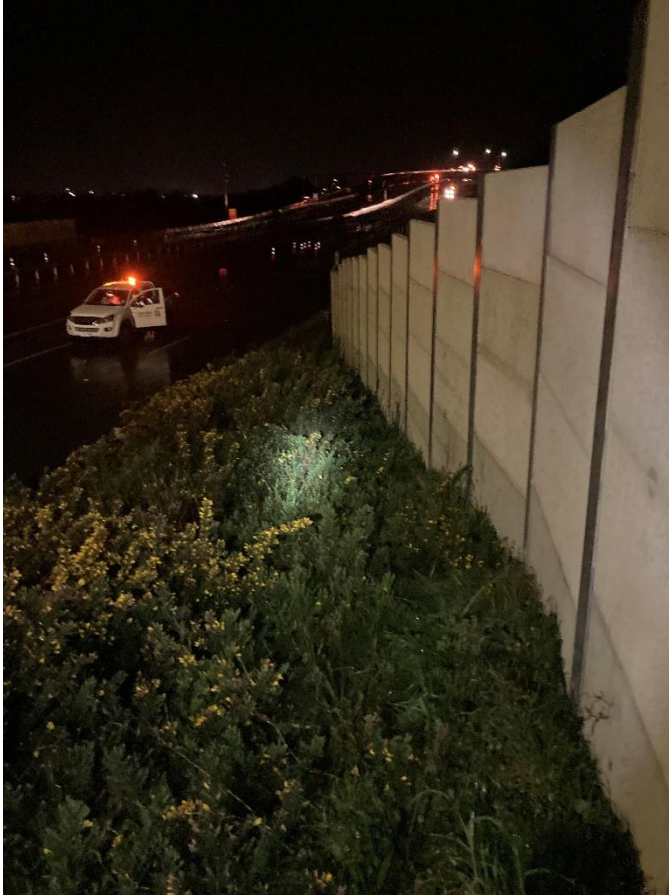
This noise wall was constructed along mostly steep ground, and due to safety concerns at the time of the inspection, the noise wall was not physically measured along approximately half of its length. Gaps were found along some parts of this noise wall during the inspection and were reported to CPB HEB JV, which were later rectified by the contractor.

The height of the noise wall was recorded along its length and was generally found to be consistent with the noise model; the height of the noise wall was recorded to be below the design height for a total length of 3m out of the 25m that was inspected. The as-built geometry of the noise wall was included in the post-completion noise model, and noise predictions at nearby PPFs were found to be consistent with the predictions undertaken for the Detailed Design phase.

Figure 7 Typical picture of noise wall N2

Figure 8 Typical picture of noise wall N2

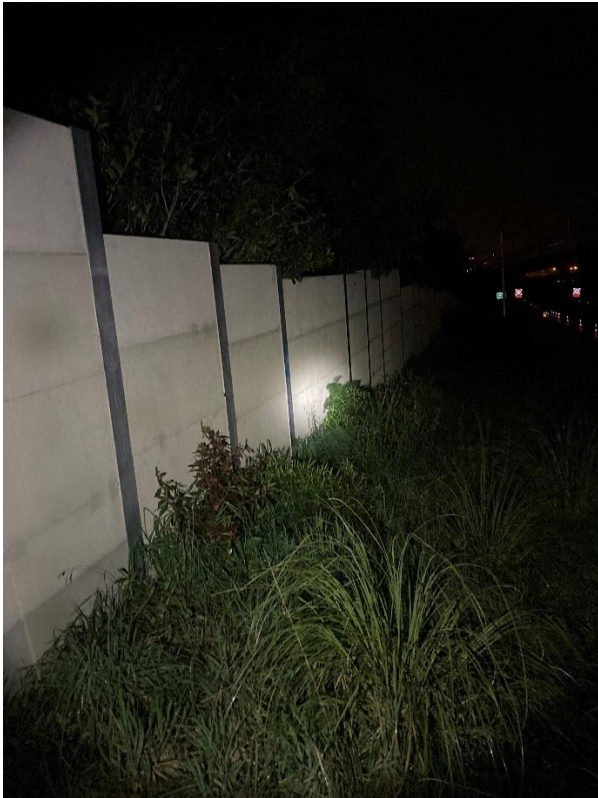
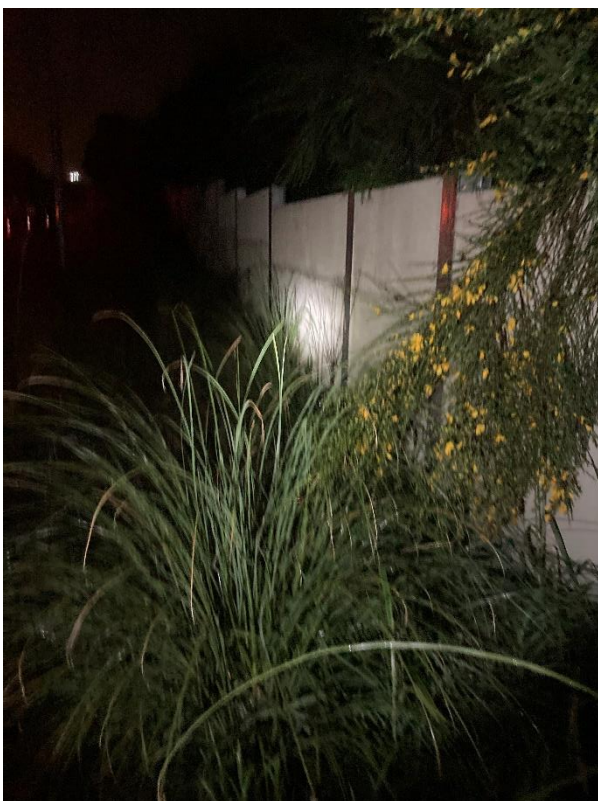
This noise wall was inspected and found to have gaps in some locations running under the wall. These gaps were notified to CPB HEB JV and were subsequently backfilled.

The height of the noise wall was recorded along its length and was generally found to be consistent with the noise model; the length of noise wall where the lower height was measured was approximately 9m out of the 85m length of the wall that was inspected. The as-built geometry of the noise wall was included in the post-completion noise model, and noise predictions at nearby PPFs were found to be consistent with the predictions undertaken for the Detailed Design phase.

Figure 9 Typical picture of noise wall N6

Figure 10 Typical picture of noise wall N6

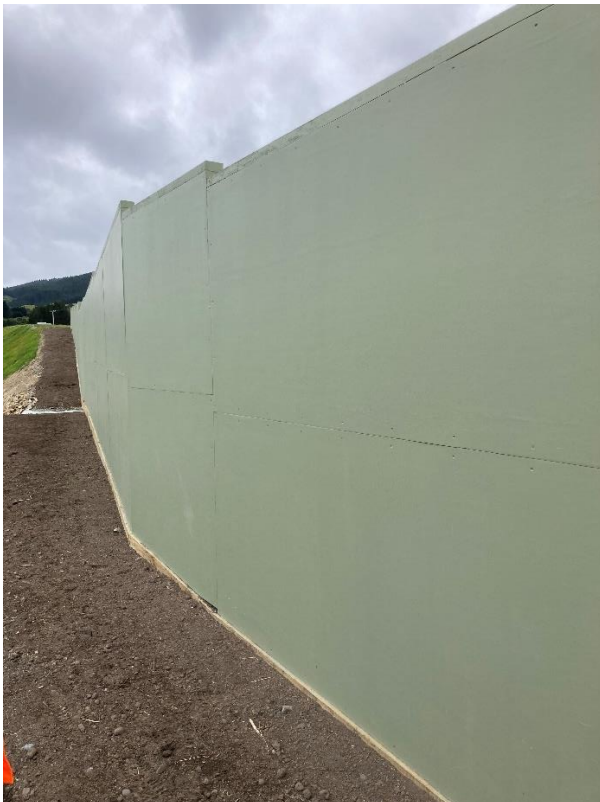
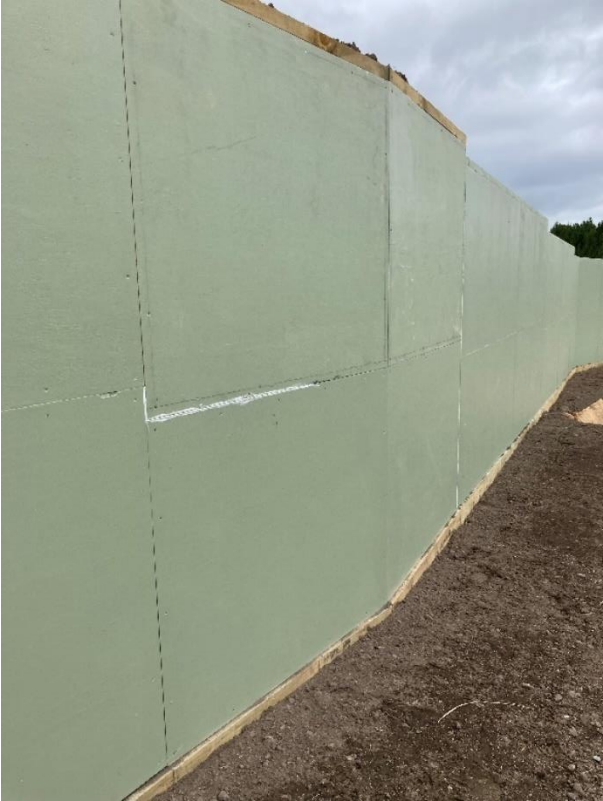
This noise wall was inspected and found to have gaps in several locations running under the wall. These gaps were notified to CPB HEB JV and were subsequently backfilled.

The height of the noise wall was recorded along its length and was generally found to be consistent with the noise model. The as-built geometry of the noise wall was included in the post-completion noise model, and noise predictions at nearby PPFs were found to be consistent with the predictions undertaken for the Detailed Design phase.

Figure 11 Typical picture of noise wall N2A

Figure 12 Typical picture of noise wall N2A

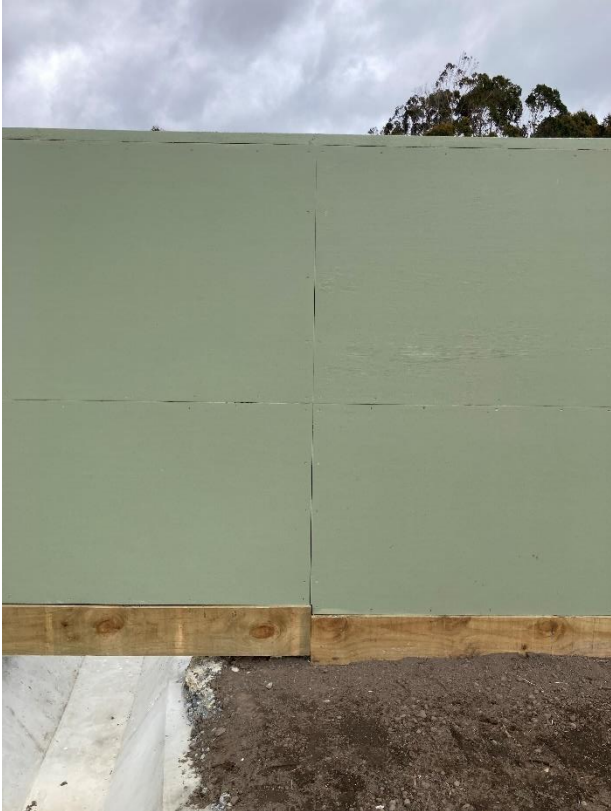
We note that a culvert was constructed in one location under the noise wall. This culvert was not included in the Detailed Design noise model, therefore it was included in the Post-Construction noise model in order to account for any noise leakage under the noise wall. Upon running the model, it was found that inclusion of the culvert in under the noise wall did not change the predicted noise levels at any of the PPFs in the local area.

Figure 13 Picture of culvert under noise wall N2A

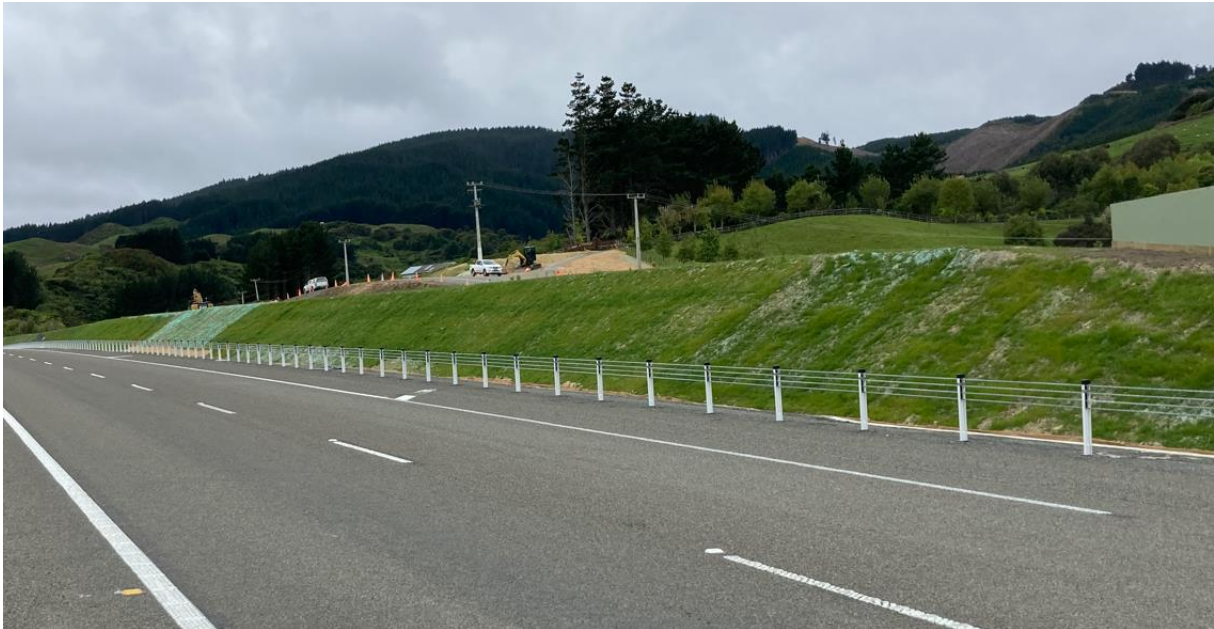
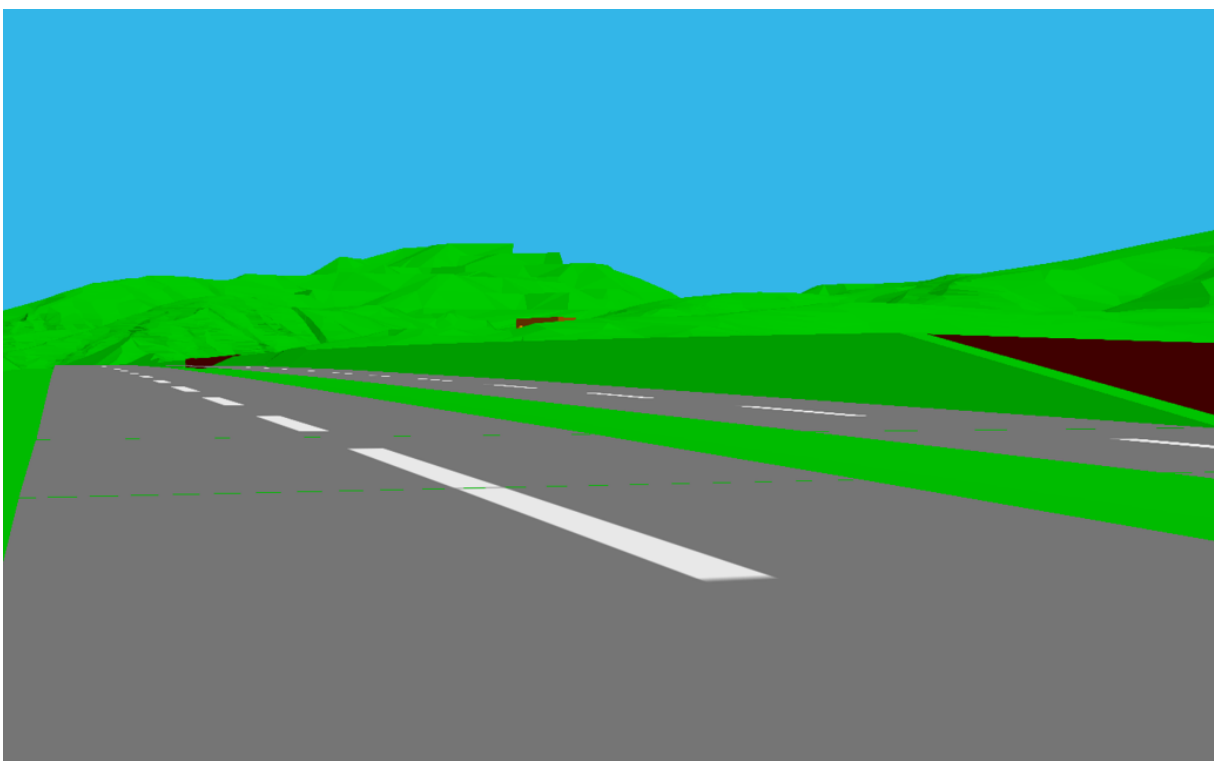
CPB/HEB JV advised that the constructed height of the bund was 0.5m higher than designed. This bund was inspected, and its height and extents were observed to be consistent with the images from the Detailed Design noise model through visual comparison. A typical image of the bund from the inspection and from the Detailed Design model are presented in Figure 14 and Figure 15 respectively as an example.

Figure 14 Picture of bund B1/N1A from site inspection

Figure 15 Picture of bund B1 from Detailed Design noise model

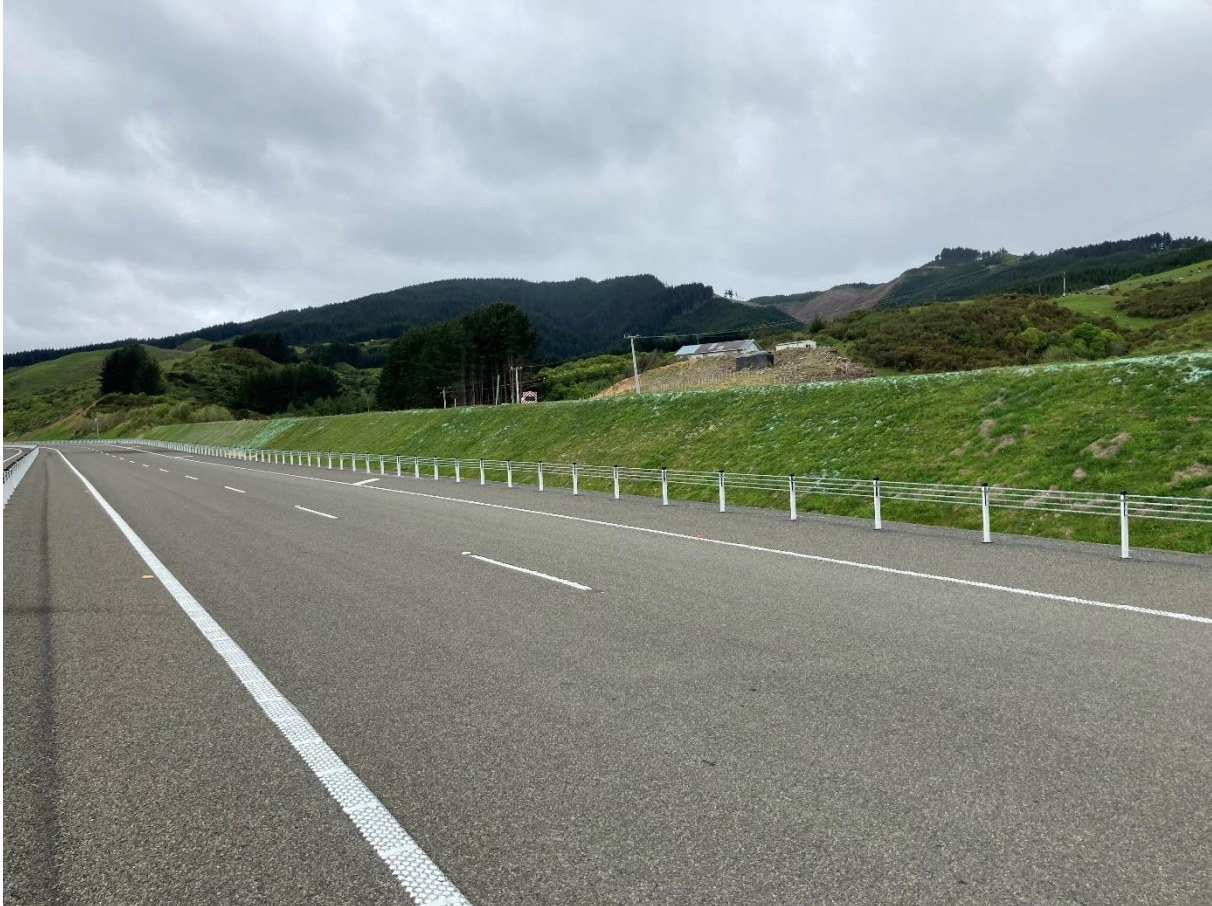
We note that during construction, noise wall N1A was replaced by extending bund B1 to cover the same extent as the noise wall. This design change was incorporated in the Post-Construction noise model. The extent of the constructed bund where the noise wall was formerly included in the Detailed Design model is shown in Figure 16.

Figure 16 Extent of bund B1 covering location of previous noise wall N1A
