# **Pavement maintenance patch trials December 2017**

Arnold, G, G Mudgway and O Dickin (2017) Pavement maintenance patch trials. *NZ Transport Agency research report 635*. 103pp.

**Keywords:** maintenance, patches, potholes

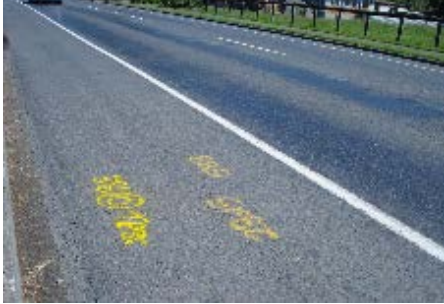
SH24 – RS0	
3% cement stabilisation	RP = 1405 – 1465 inc Rut = 5 mm Roughness (NAASRA counts per km) = 151 Deformation, shoving, minor rutting with high speed data showing only 5 mm ruts and flushing

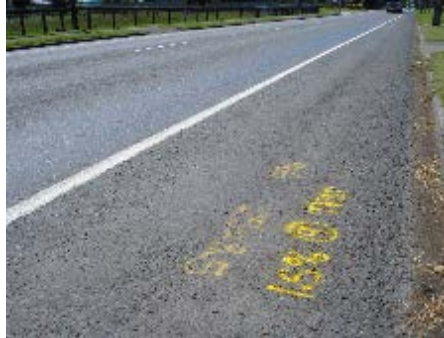
1.5% cement stabilisation	RP = 1465 – 1485 inc Rut = 5 mm Roughness (NAASRA counts per km) = 58 Deformation, shoving, minor rutting and flushing

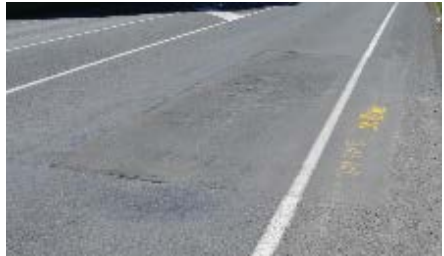
Full depth granular reconstruction	RP = 1975 – 1994 inc Rut = 10 mm Roughness (NAASRA counts per km) = 101 Shear failure of the old AC mill and fill has cracked

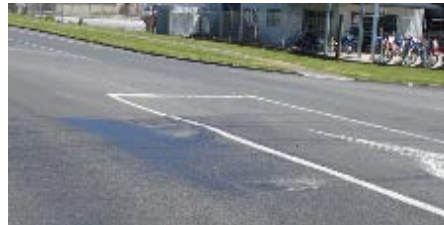
Mill and AC inlay	RP = 2102–2122 inc Rut = 14 mm Roughness (NAASRA counts per km) = 170 Shear failure

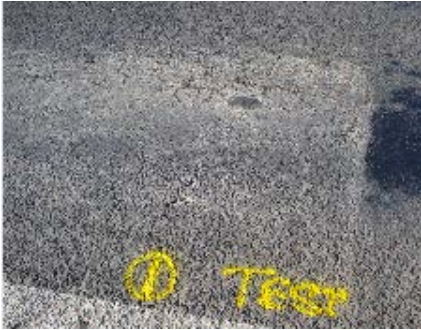
SH26 – RS80	
3% cement stabilisation	RP = 13612 – 13642 dec Rut = 18 mm Roughness (NAASRA counts per km) = 131  Shear failure and cracking

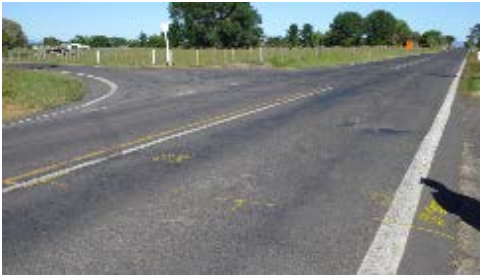
1.5% cement stabilisation	RP 13304 – 13364 dec Rut = 11 mm Roughness (NAASRA counts per km) = 124  Shear failure

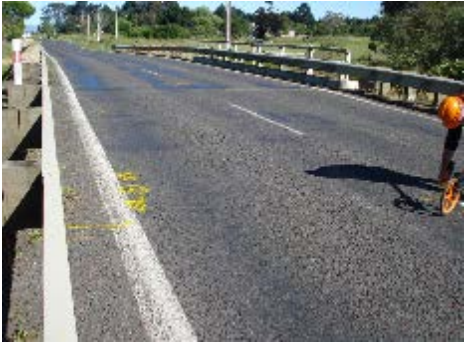
Mill and AC inlay	RP 13582 – 13592 dec Rut = 6 mm Roughness (NAASRA counts per km) = 162  Deformation in bridge approach

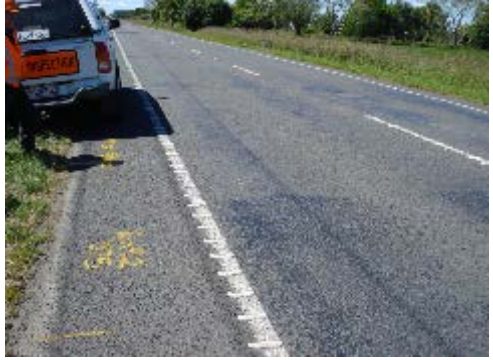
SH27 – RS46	
3% cement stabilisation	<p>RP 17825 – 17839 dec Rut = 6 mm Roughness (NAASRA counts per km) = 148</p> <p>Shear failure with cracking, pumping and shoving</p>

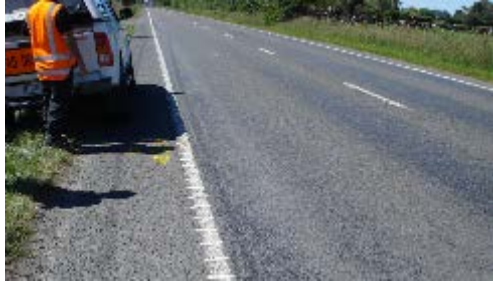
1.5% cement stabilisation	<p>RP 17430 – 17466 dec Rut = 13 mm Roughness (NAASRA counts per km) = 39</p> <p>Deformation, shoving, rutting and flushing</p>

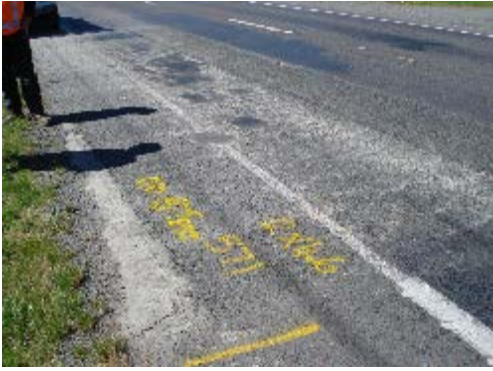
Full depth granular reconstruction	<p>RP 17965 – 17980 inc Rut = 7mm Roughness (NAASRA counts per km) = 90</p> <p>Deformation, block cracking and potholes repaired before</p>

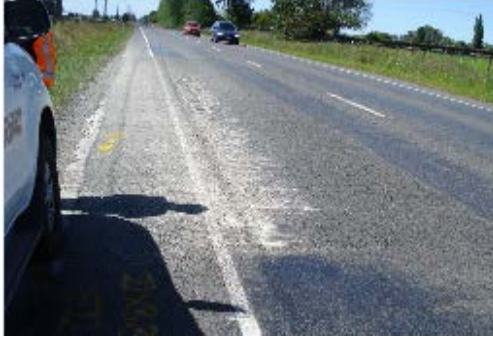
Mill and AC inlay	<p>RP 17455 – 17471 dec Rut = 14 mm Roughness (NAASRA counts per km) = 40</p> <p>Deformation, block cracking and potholes repaired before</p>

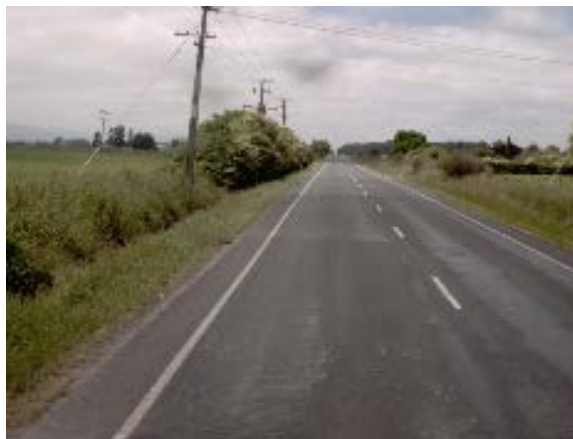
**Figure 5.1 Rutting and cracking after 16 months in the SH27 full depth granular reconstruction site which was also stabilised with 1.5% cement**

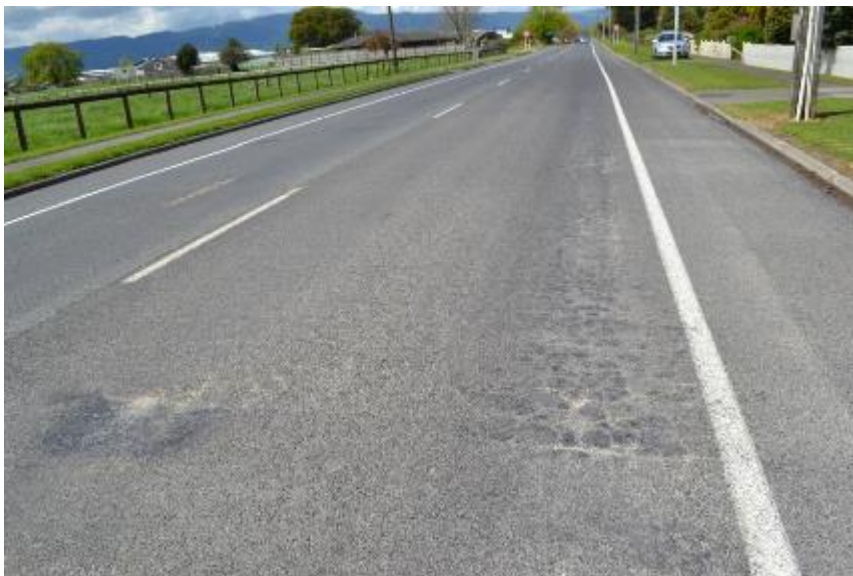
**Figure C.1 3% in-situ stabilisation – SH24–RS0–1417–1440 – three month inspection**

Maintenance patch type	Trial location	Traffic in ESA (when failure occurred)	Performance
3% cement in-situ stabilisation to a depth of 150 mm	SH24-RS0-1405-1465 (increasing side)	88,000 ESA – 3 months	Site started cracking within 3 months and at 16 months complete failure rutting and cracking.
	SH26-RS80-13612-13642 (decreasing side)	Site not failed after 16 months with 148,000 ESA. (Cracking started so estimate life of 2.5 years or 300,000 ESA).	At 16 months small area with minor alligator cracking and rutting <10 mm.
	SH27-RS46-17825-17839 (decreasing side)	Site not failed after 16 months with 500,000 ESA. (Cracking started in inside wheel path only so estimate life of 2.5 years for this inside wheel path or 1 MESA.)	At 16 months small area with minor alligator cracking and rutting <10 mm.

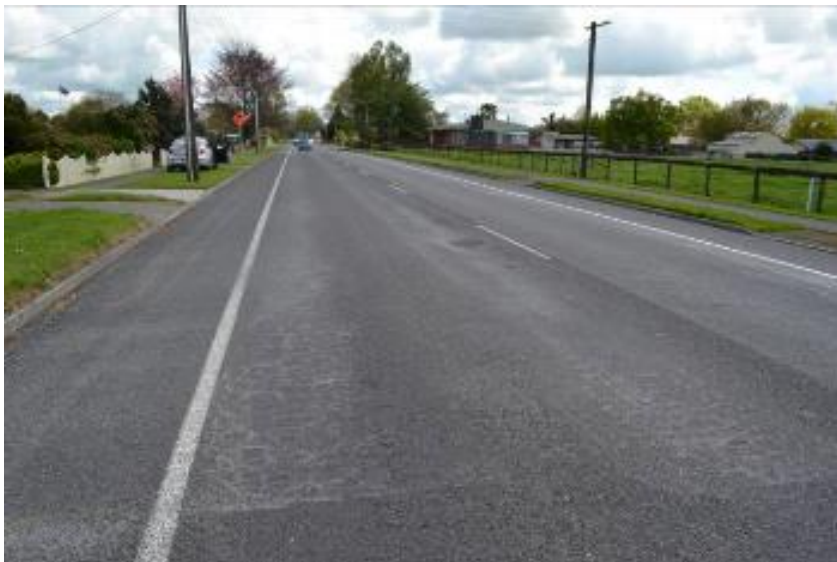
Figure C.5 1.5% in- situ stabilisation – SH24-RS0-1465-1485 – 3- month inspection

1.5% cement in-situ stabilisation to a depth of 150 mm	SH24-RS0-1465-1485 (increasing side)	88,000 ESA – 3 months	At 3 months, the site had extensive alligator cracking and rutting. At 16 months cracks were coming through thin asphalt repair.
	SH26-RS80-13304-13364 (decreasing side)	Not failed after 16 months or after 148,000 ESA, life estimated at 10 years or 1.5 MESA.	At 16 months, there was no pavement distress and rutting was less than 5 mm.
	SH27-RS46-17430-17466 (decreasing side)	100,000 ESA – 3 months	At 3 months, extensive alligator cracking and by 16 months complete failure repaired by asphalt patches which were also failing – rutting was 15 mm.

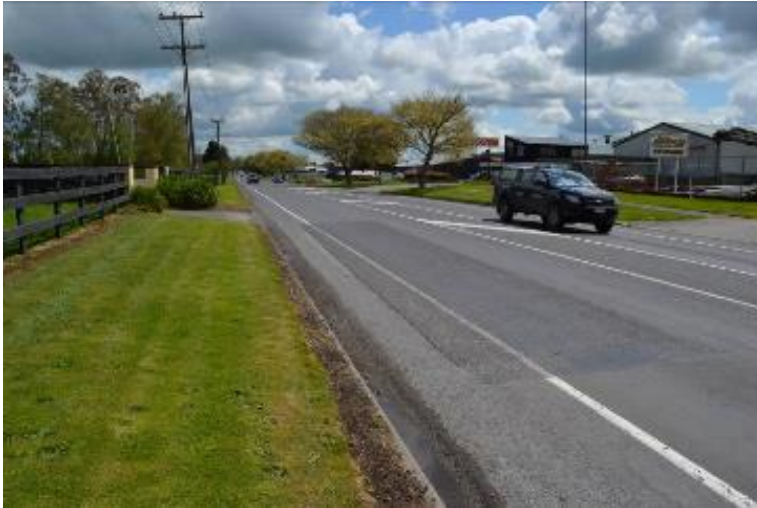
**Figure C.8 Full depth granular reconstruction – SH24-RS0-1975-1994-3- month inspection**

Maintenance patch type	Trial location	Traffic in ESA (when failure occurred)	Performance
Full depth granular reconstruction (dig-out and replace)	SH24-RS0-1975-1994 (increasing side)	Site not failed after 16 months with 479,000 ESA. (Life 25 years? Or 10 MESA?)	At 16 months pavement not failed although rutting around 8 mm.
	SH26-RS80-13394-13434 (decreasing side)	Site not failed after 16 months with 148,000 ESA. (Life 25 years? Or 10 MESA?)	At 16 months pavement had not failed although rutting was 15 mm in beginning of half of patch and in second half of patch only 3 mm. <i>(Note visual inspection with straight edge needed to confirm this).</i>
	SH27-RS46-17965-17980 (increasing side)	500,000 ESA - 16 months	At 3 months cracking had started and by 16 months all wheel paths had cracked and rutted from 15 to 23 mm. (Note cracking as top 150 mm was cement stabilised). The sub-contractor considered it was too risky not to stabilise on this site.

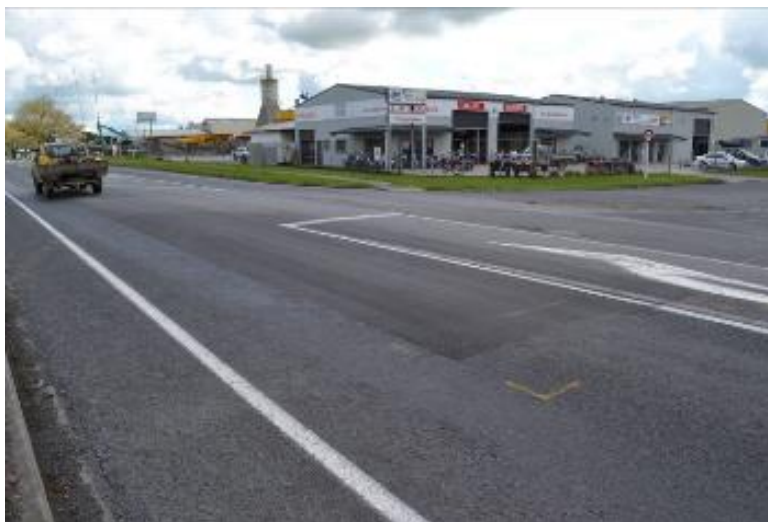
**Figure C.11** Mill and AC inlay – SH24-RS0-2093-2112 – 3- month inspection

Mill and AC inlay	SH24-RS0-2093-2112	Only minor damage on edges at 479,000 ESA - 16 months. Life estimated 3 years or 1.5 MESA (perhaps higher).	At 16 months some cracking and edge failure with rutting <5 mm.
	SH26-RS80-13582-13592 (decreasing side)	Not failed after 150,000 ESA - 16 months	At 16 months the site had not failed but the Hawkeye survey showed high rutting up to 18 mm which needed confirmation.
	SH27-46-17455-17471 (decreasing side)	Not failed after 500,000 ESA - 16 months	At 16 months the site had not failed but rutting was as high as 13 mm on either end of patch from the Hawkeye survey. This needed confirmation with a straight edge.
