Additional Waitemata Harbour Crossing

Historic Heritage Assessment

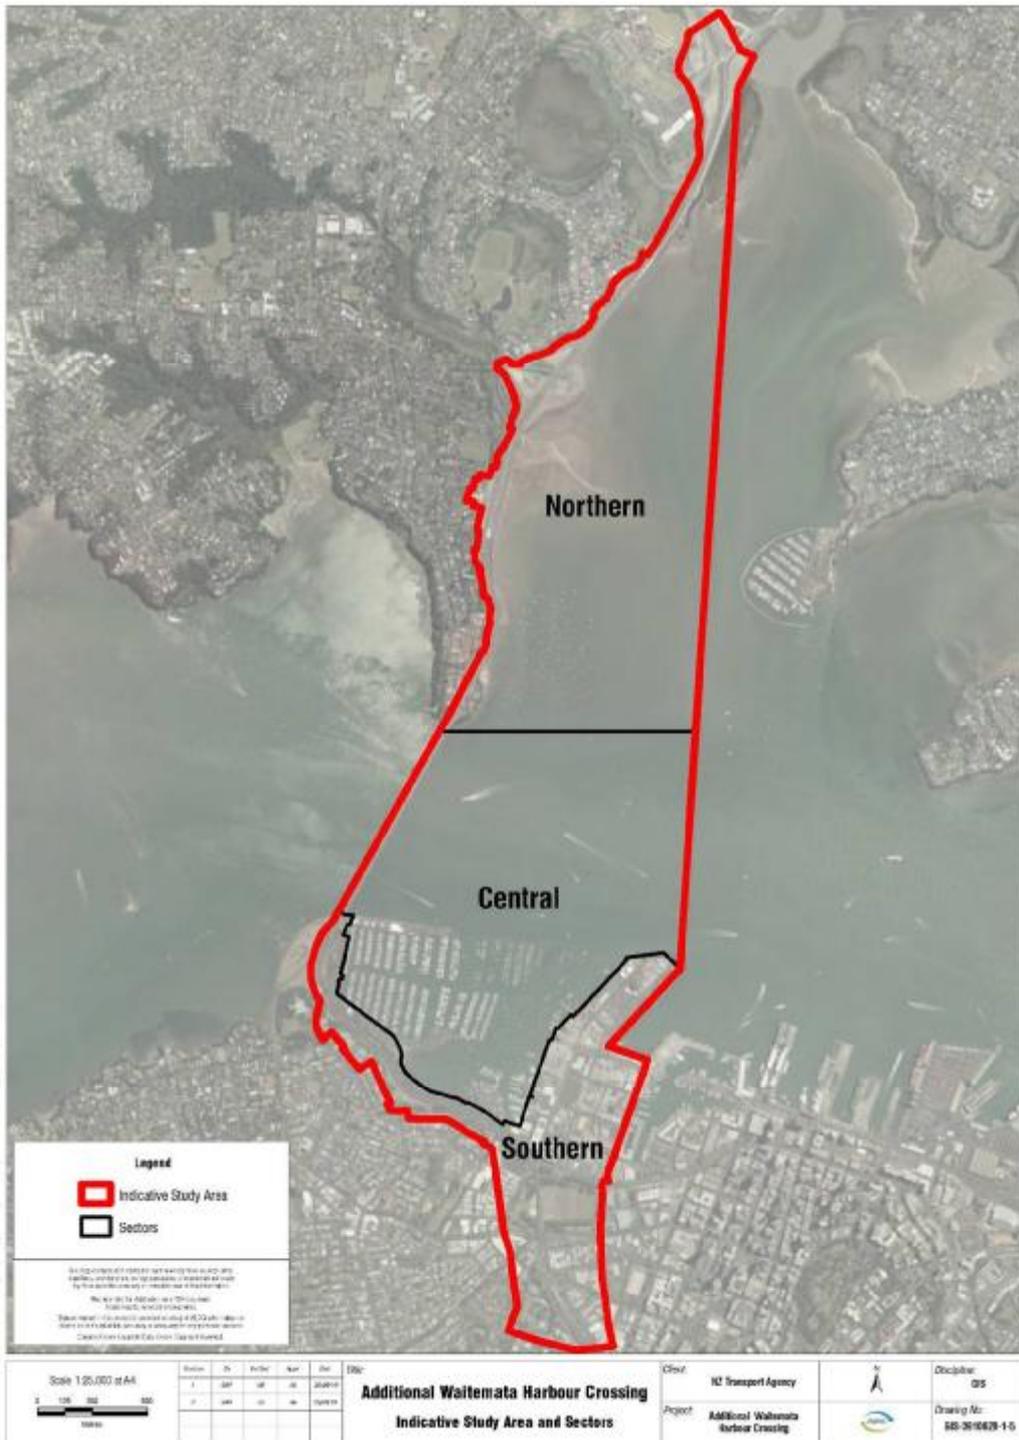
Figure 2.1: Study area, showing sectors

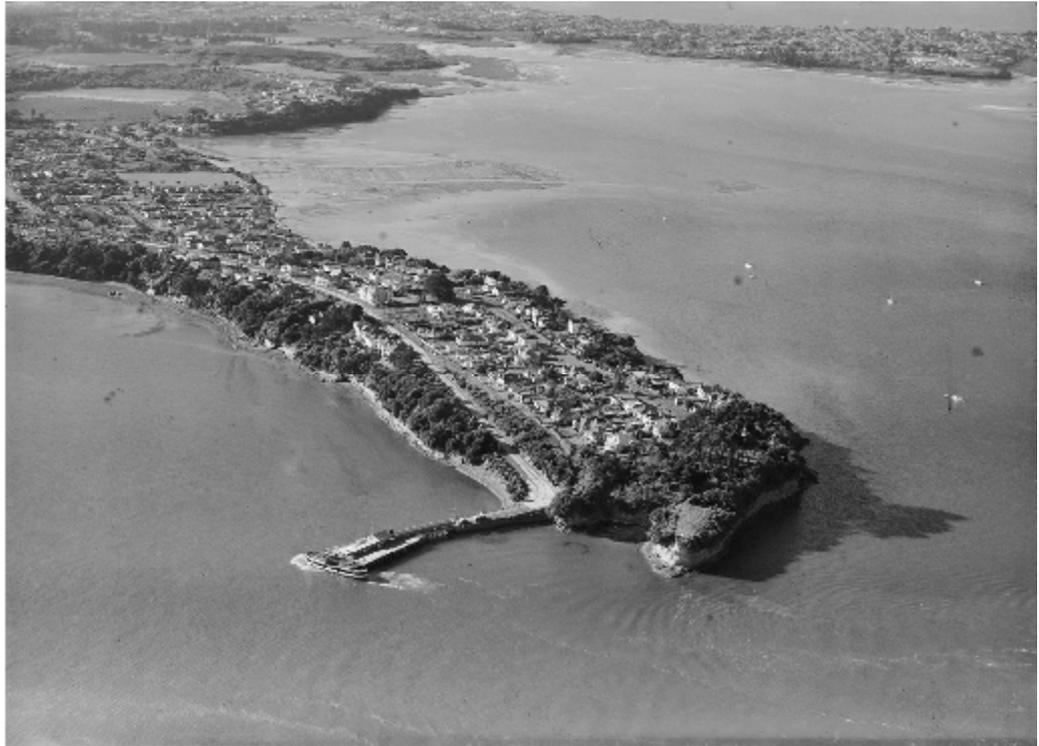
Figure 2.3: Stokes Point and the Northcote Peninsula prior to bridge and motorway construction, 24 May 1954 (source: Whites Aviation Collection, Alexander Turnbull Library, WA-35781)

During the 1950s, the Auckland Harbour Bridge (AHB) was constructed, opening in 1959, and the land and mudflats around what is now Heath Reserve and the lagoon to the north were significantly modified in preparation for the construction of the Northern Motorway. Figure 2.3 shows the study area prior to the construction of the motorway and AHB, and Figure 2.4 to Figure 2.6 show the works in progress (taken from the Heath Reserve).

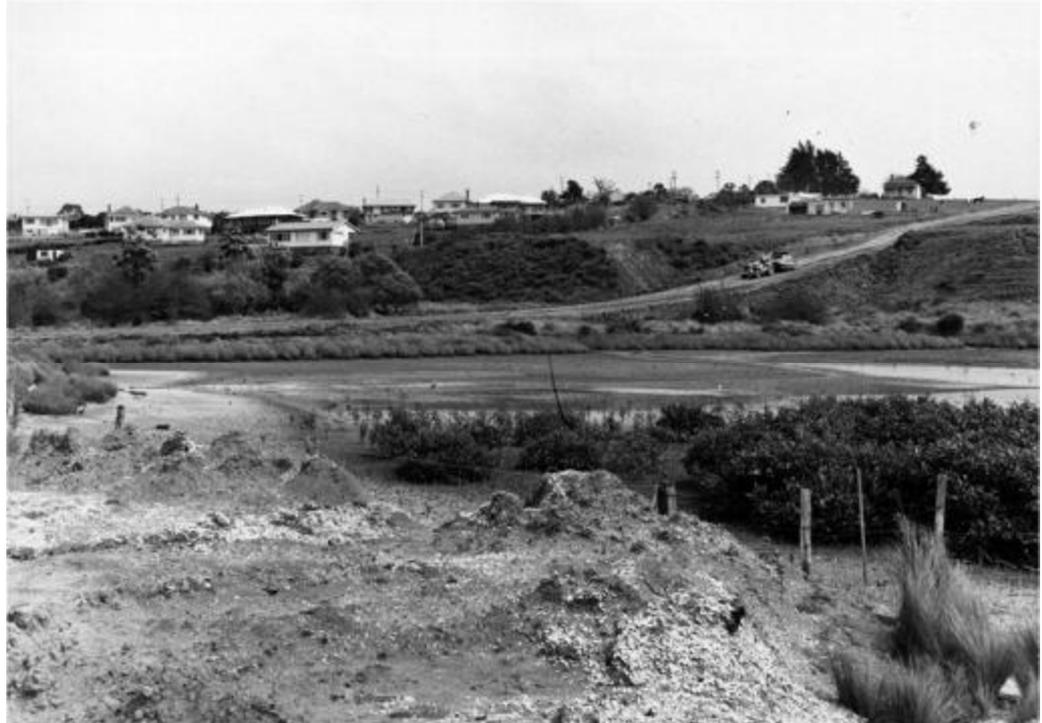
Figure 2.4: 'Earthworks at Exmouth Road' (La Vie c.1950s). Taken from Heaths Farm (Heath Reserve), looking across to the landfill earthworks (Image ID N0116047, North Shore Libraries Image Collection)

The low lying land which is now Heath Reserve has been substantially modified in the past, particularly through earthworks associated with the formation of the existing motorway in the 1950s (refer Figure 2.4 to Figure 2.6). More recent activities associated with the development of the Reserve – including the installation of the pedestrian bridge, installation of lighting, digging of open drainage channels and planting of trees – have further modified the area (Figure 2.11, Figure 2.12).

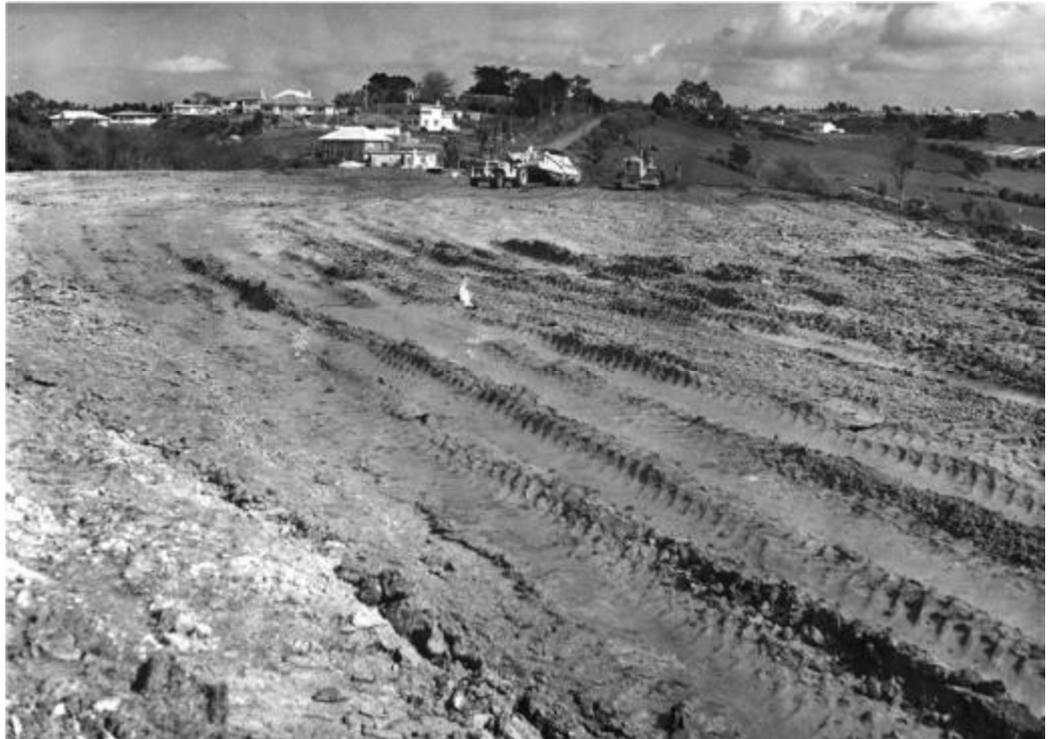
Figure 2.5:
 'Construction of
 Motorway' (La Vie
 1958). Earthworks
 across Heath Farm
 (now Heath
 Reserve), 3 October
 1958 (Image ID
 NO116041, North
 Shore Libraries
 Image Collection)

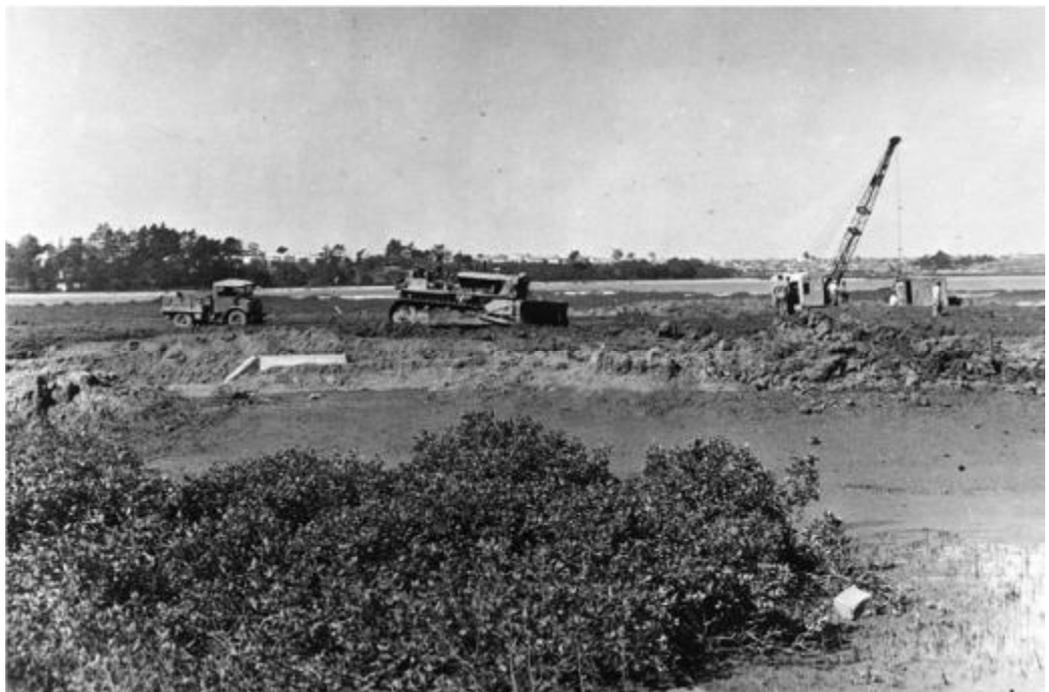
Figure 2.6.:
 'Earthworks at City
 of Cork Beach' (La
 Vie c.1950s).
 Earthworks along
 the City of Cork
 Beach during
 construction of the
 motorway between
 Northcote and
 Takapuna (Image
 ID NO116046,
 North Shore
 Libraries Image
 Collection)

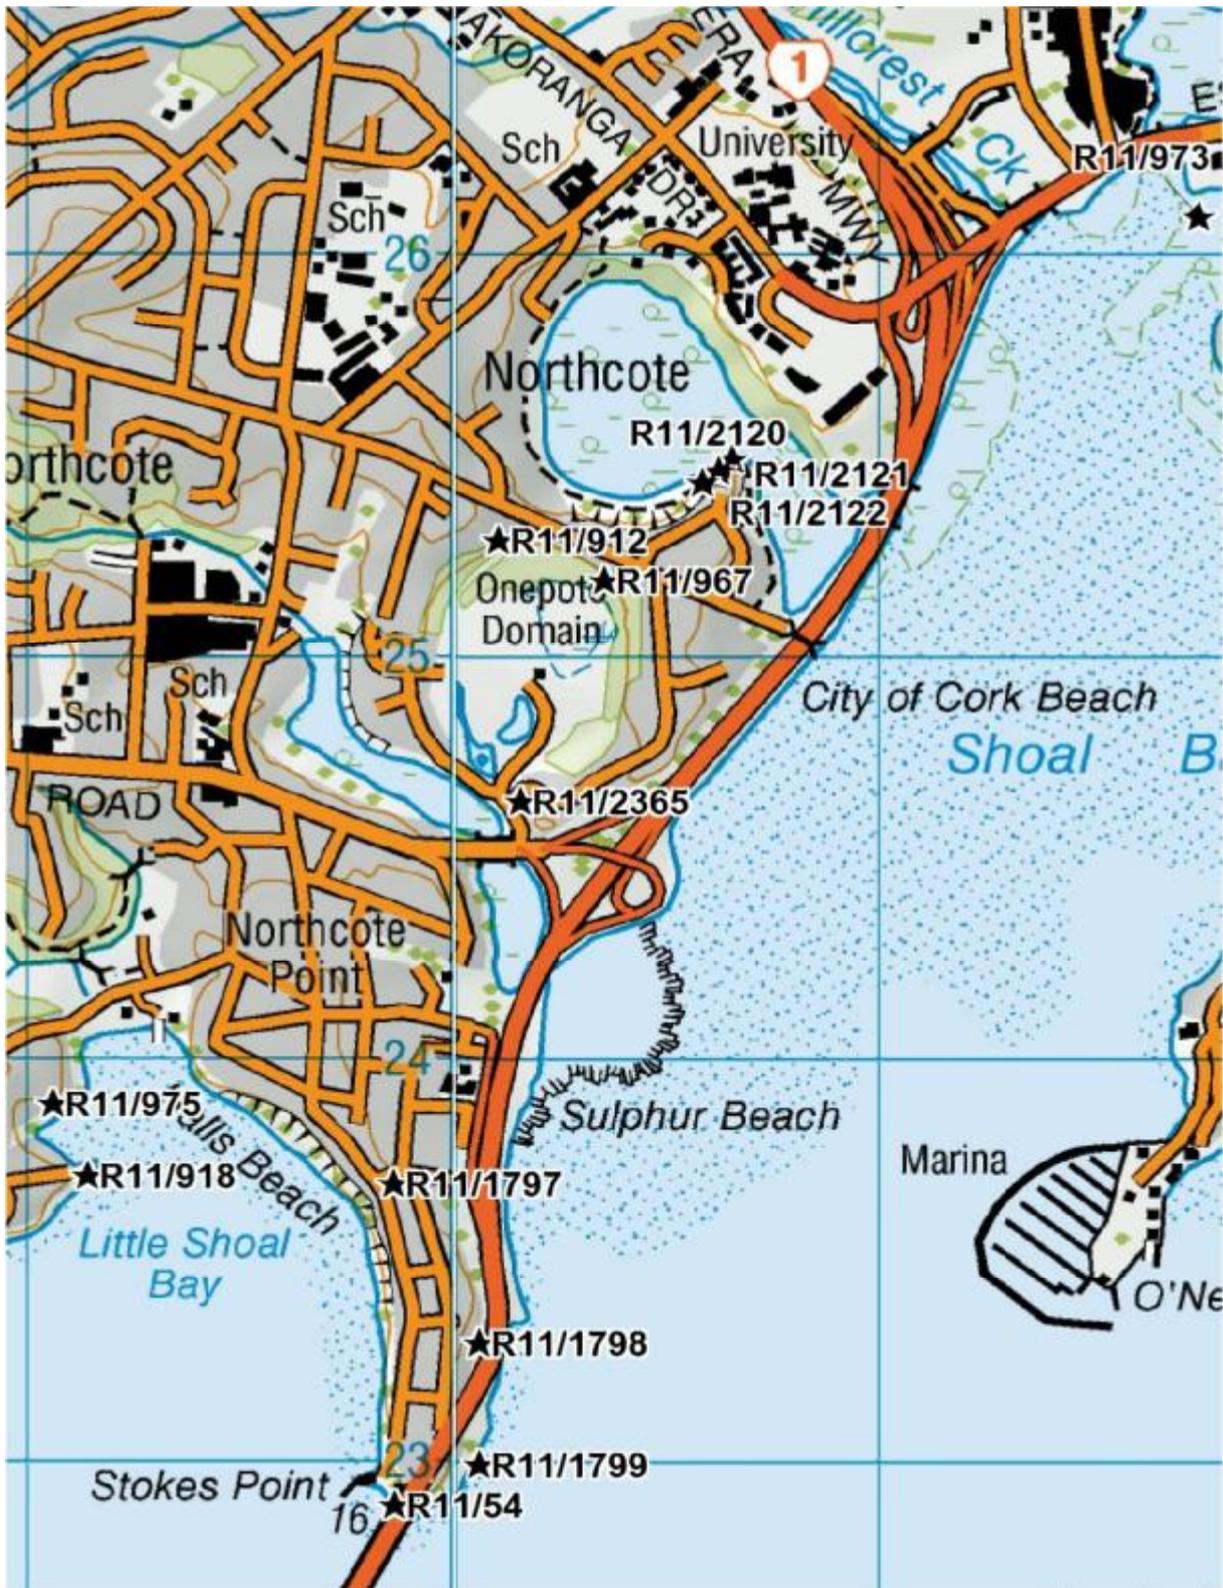
Figure 2.7: Recorded archaeological sites in/near the Northern Sector (note that locations shown are only accurate to within c.100m). Source: NZAA ArchSite

Table 2.1: Recorded archaeological sites in the Northern Sector (refer Figure 2.7. Source: NZAA ArchSite and ARC CHI

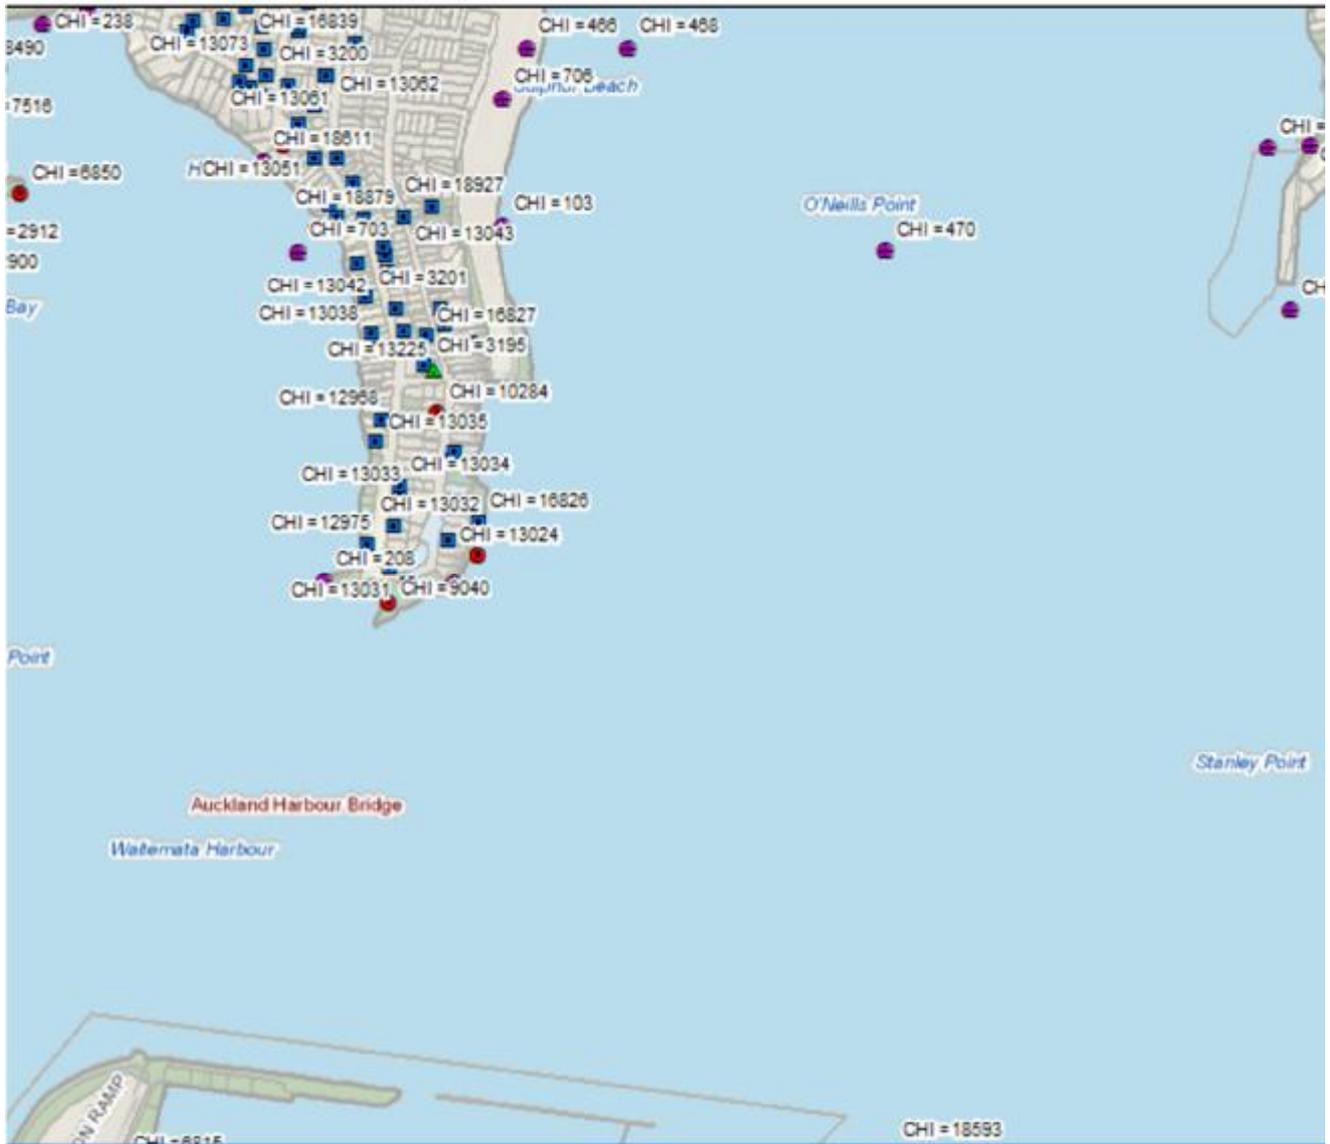
Figure 2.9: Heritage sites recorded on the ARC CHI (red dots = archaeological sites; purple = maritime sites; blue = buildings; green = botanical)

A number of other heritage sites have also been recorded in the ARC CHI (Figure 2.8, Table 2.1). Most of these are maritime sites such as hulks, wharves and jetties, shipwrecks, shipyards, sulphur works, and a careening area which have been destroyed or whose condition is unknown (numbers 103, 221,466, 468, 470, 475, 625, 706, and 967). However, they also include the Northcote Point seawall (no. 16826), the Onewa Road Bridge (no. 240), a slipway and posts in the intertidal zone (no. 15124), and a house at 7 Princes Street in Northcote, which are still present.

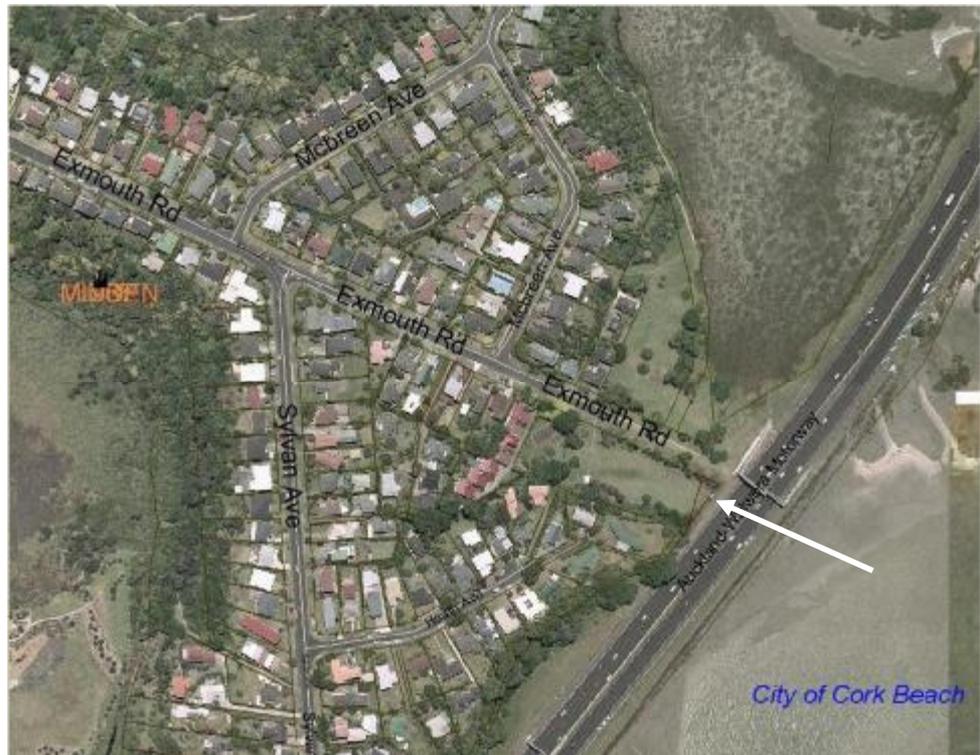
Figure 2.10: Aerial showing general area around Exmouth Road, with Heath Reserve area (arrow) relatively unmodified (source: QuickMap and NZAA ArchSite)

The only part of the AWHC study area close proposed works that appeared not to have been extensively modified or reclaimed was in the Exmouth Road area at the eastern, coastal end of Heath Reserve and the eastern end of a headland that forms the southern boundary of the reserve (Figure 2.10). This area was therefore surveyed and a number of small test pits dug to assess the nature of subsurface deposits.

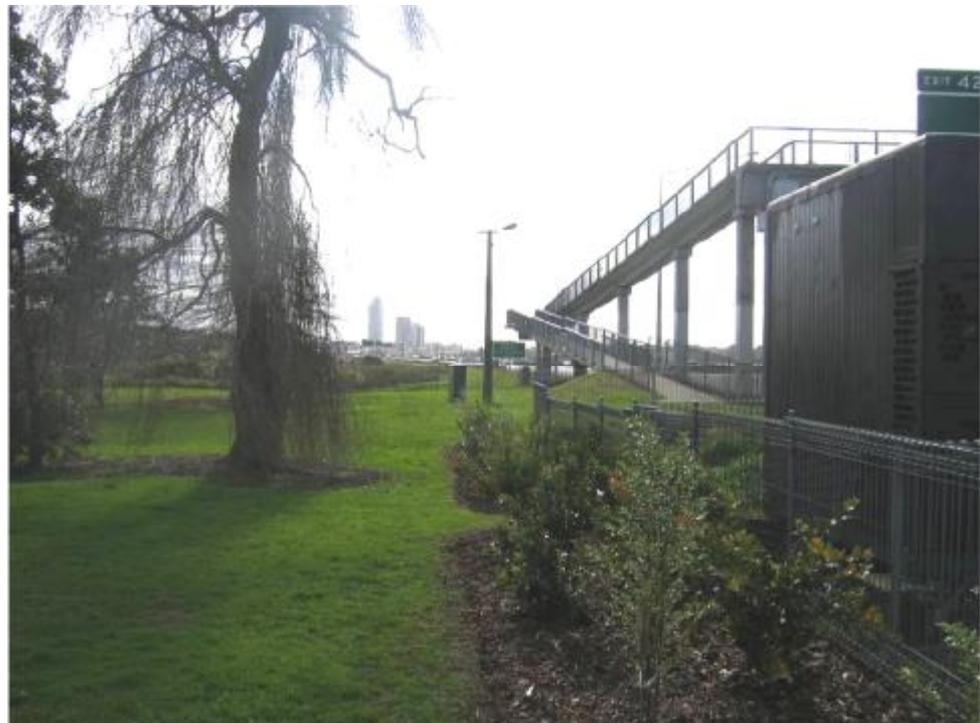
Figure 2.11: Looking north along the eastern edge of Heath Reserve

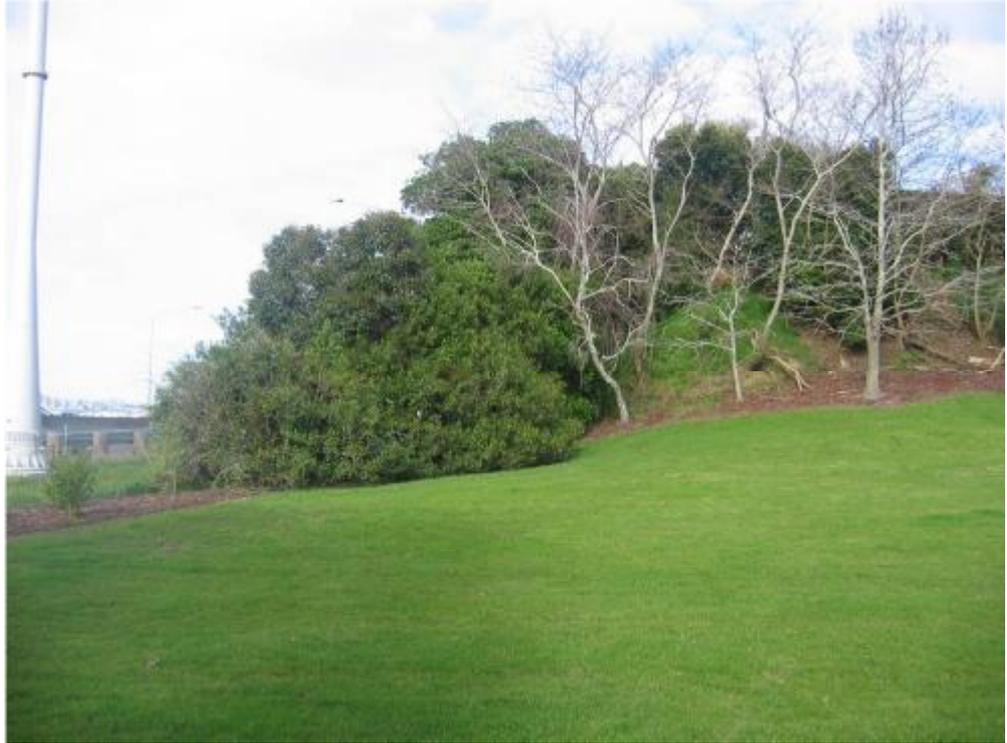
Figure 2.12: Looking south towards ridge

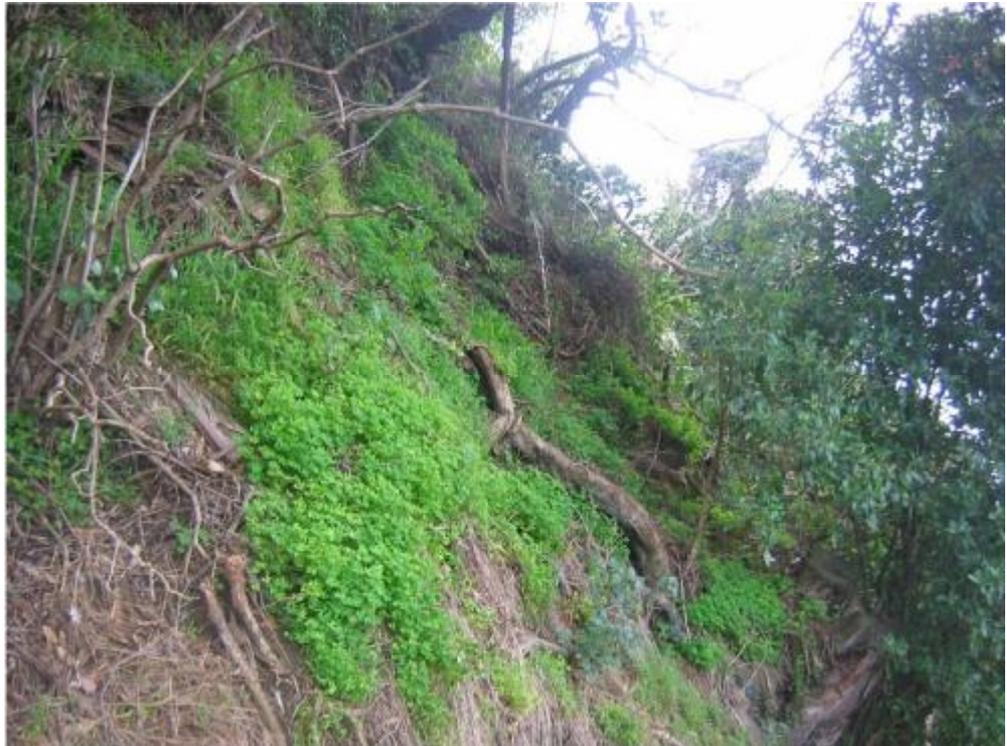
Figure 2.13: Vegetation cover over the eastern scarp of the ridge restricted visibility in most areas

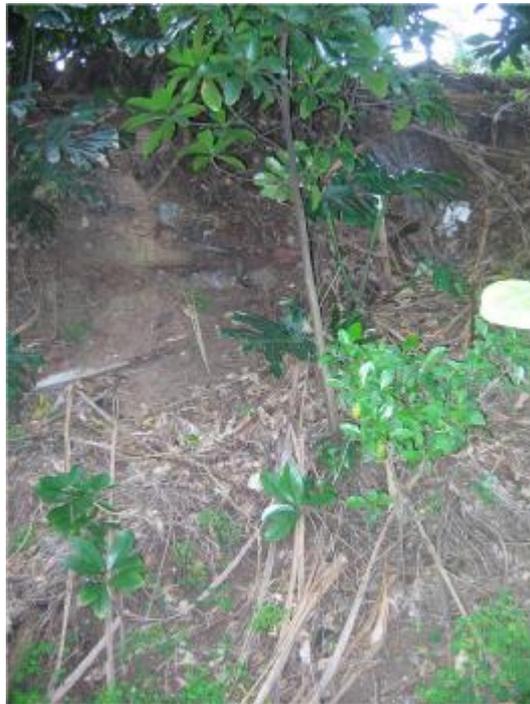
Figure 2.14:
Scattered cockle
visible eroding down
the steep east facing
scarp

The steep east facing scarp of the headland that runs along the southern boundary of the Heath Reserve is currently covered in thick scrub and large areas of dense bamboo, restricting visibility in most areas (Figure 2.13). Some scattered cockle shell was, however, noted in an exposed section of the scarp at the southern end at E2667207 N6486680 (Figure 2.14). No intact deposits or culturally modified soils were identified at the top of the exposed scarp. However, the private property on top of the ridge (27 Heath Ave, Lot 12 DP40320) was not accessible during the survey, and it is possible that the cockle scattered down the scarp derives from an intact site within the private property above.

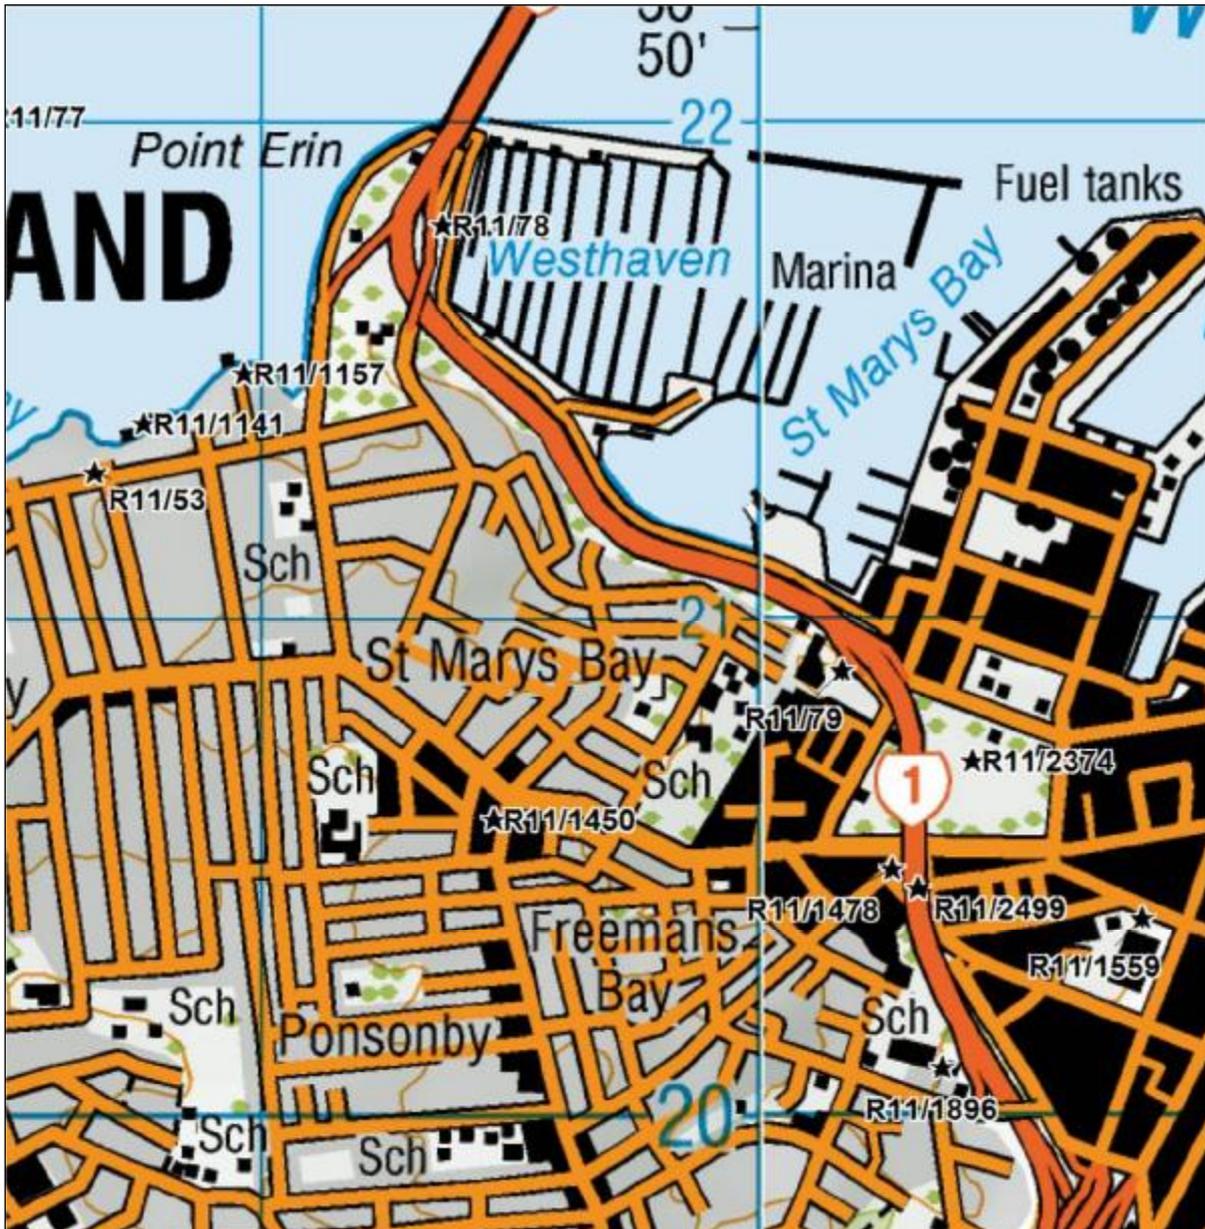
Figure 2.15: Recorded archaeological sites in the Southern Sector (note that locations shown are only accurate to within c.100m). Source: NZAA ArchSite

Table 2.2: Recorded archaeological and other heritage sites in the Southern Sector, excluding the Wynyard Quarter (refer Figure 2.15 and Figure 2.16). Source: NZAA ArchSite and ARC CHI

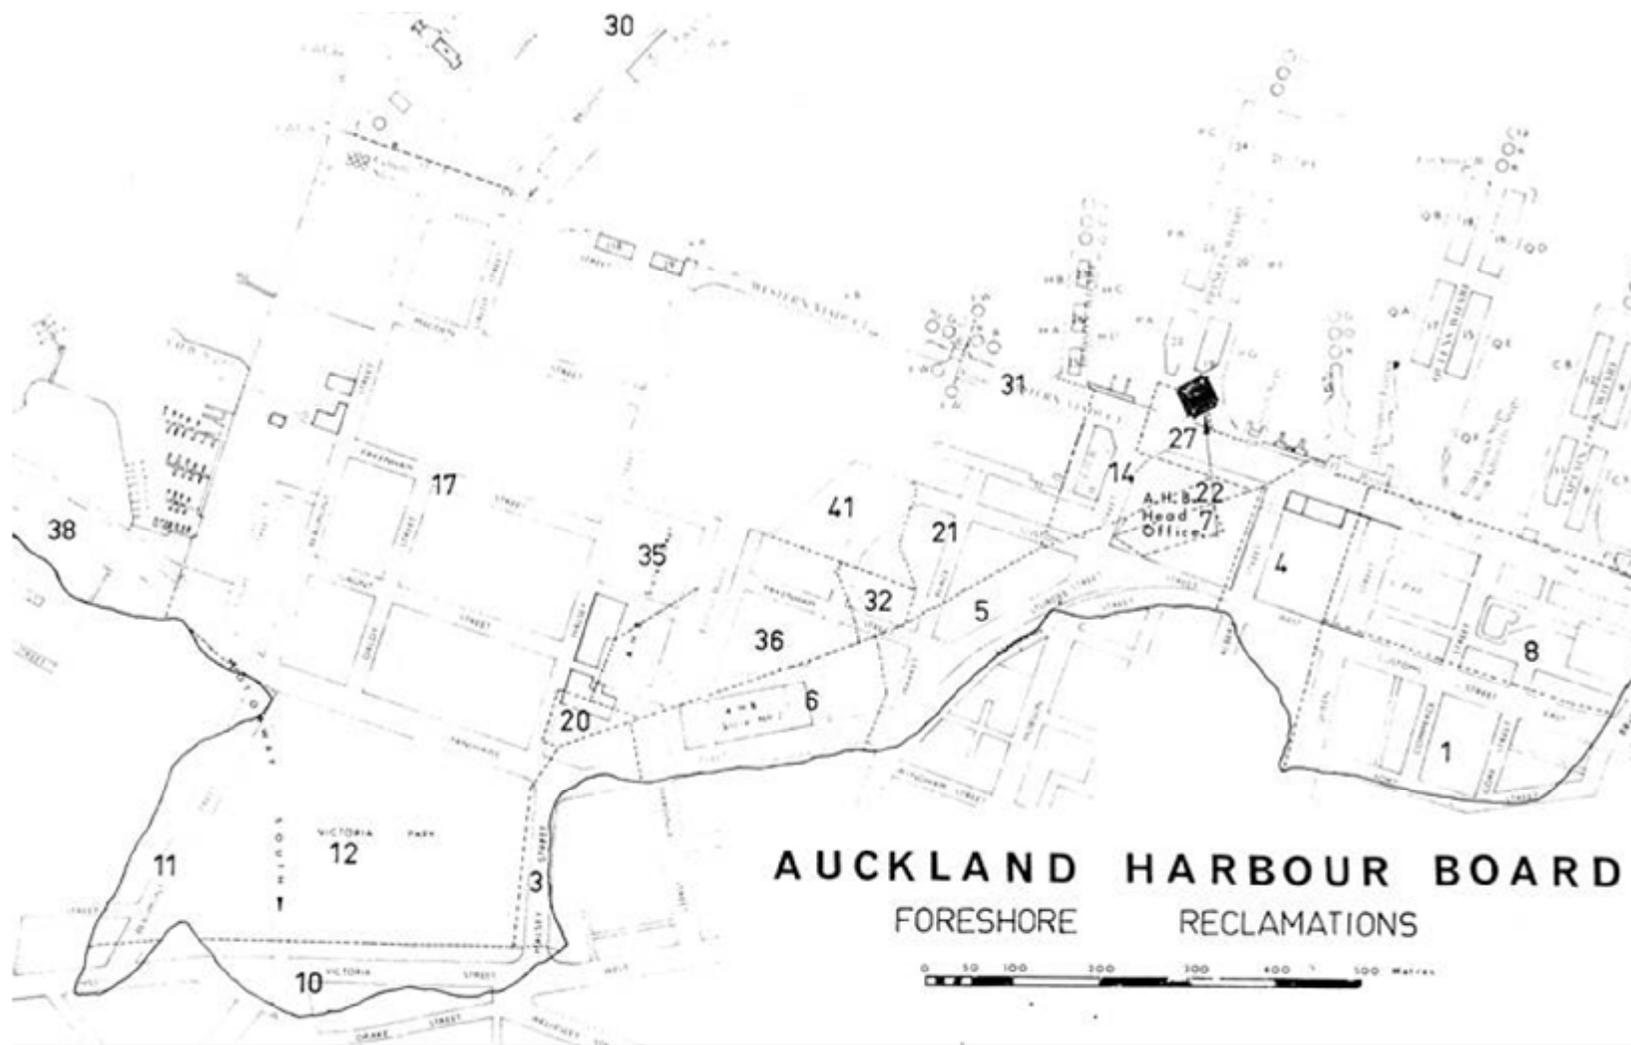
Figure 2.17: Location of the early shoreline, with areas of reclamation numbered (Auckland Harbour Board)

5	1876-77	ALBERT ST. TO NELSON ST.	4.55	"
6	1875-77	NELSON ST. TO HARDINGE ST.	2.13	"
7	1878-79	AUCKLAND GRAYING DOCK.	0.41	"
8	1879-86	RAILWAY STATION	7.59	"
9	1886	NZ FROZEN MEAT CO.	2.73	"
10	"	FREEMANS BAY : DRAKE ST. TO PATTESON ST.	2.53	"
11	1885-88	" : AUCKLAND GAS CO. (BEAUMONT ST.)	1.21	"
12	1886-1901	" : VICTORIA PARK ETC.	9.41	"
13	1901-10	MECHANICS BAY FROM RAILWAY EMBANKMENT TO OLD KINGS DRIVE	6.79	"
14	1902-08	HOBSON ST INCLUDING SOLID PART OF HOBSON ST WHARF.	1.52	"
15	1904	ST GEORGES BAY (SECTION)	0.91	"
16	1909-10	NORTHERN WHARF AND APPROACH THERETO	1.42	"
17	1905-17	FREEMANS BAY NORTH OF VICTORIA PARK.	28.03	"
18	1911-12	ST GEORGES BAY FROM ST GEORGES BAY RD.	0.82	"
19	1912-15	MECHANICS BAY FROM THE OLD TO THE NEW KINGS DRIVE.	13.05	"
20	1913-14	FANSHAWE ST.	0.41	"
21	1913-14	HOBSON ST (MARKET AREA)	1.72	"
22	1915	AUCKLAND GRAYING DOCK SITE.	0.41	"
23	1915-1916	ST GEORGES BAY FROM CAMPBELLS PT.	9.71	"

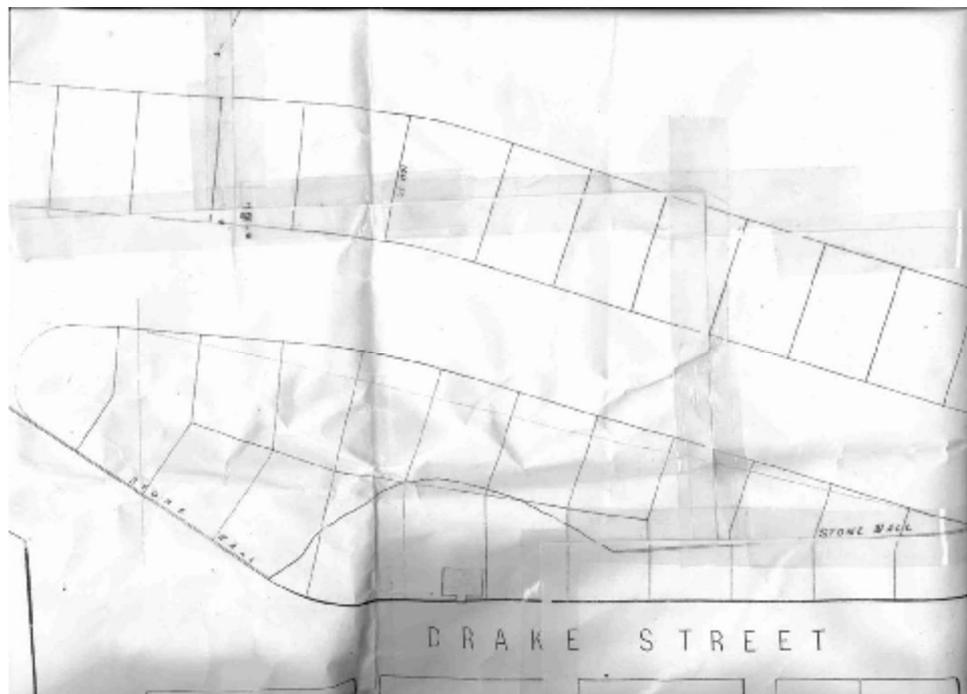
Figure 2.19. 'Plan of Proposed Reclamation Freemans Bay' Dec 4th 1873 (Auckland Public Library (APL) Special Collections NZ Maps 4818), showing blockhouse and stone seawalls

Archaeologically, the Victoria Park Markets have the potential to contain buried remains relating to the various small businesses occupying the Victoria Park Market site in the 19th century. It is also possible that remains relating to the earlier stone walls beside the 1860s blockhouse shown on plans dated to the 1870s in and adjacent to the Victoria Park Market would also have survived (stone blocks apparently relating to the wall were exposed in the VPT excavations). Reclamation deposits would also be encountered in the northern part of the Markets.

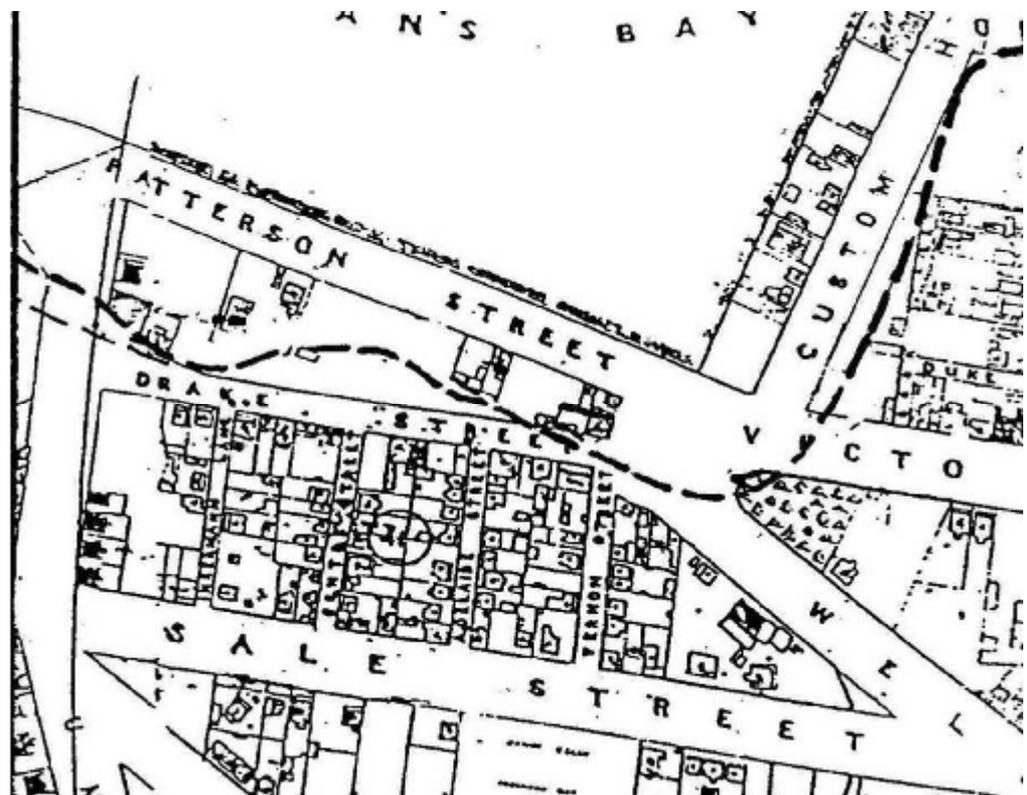
Figure 2.21: Detail from 1882 city plan by Hickson (APL NZ Maps 60), with original shoreline approximately superimposed. Patterson Street later became Victoria Street West

Although the first lease agreements were dated 1880, Wisers Street Directory did not record any residences or businesses on this block until 1883-1884. A map compiled in 1882 (Figure 2.21) shows buildings on part of the block, but most of the block was still undeveloped. Four years later a 'bird's eye view' (Figure 2.22) shows several more buildings, all allotments by now containing at least one building. On the central lots (Lots 9 and 10) is a large building with tall chimneys on the site of what became the Destructor (built in 1905). Further research is required to establish exactly what this building was, but it may have belonged to Michael Cook & Son glass manufacturers, recorded in street directories in approximately this location from 1885 onwards.

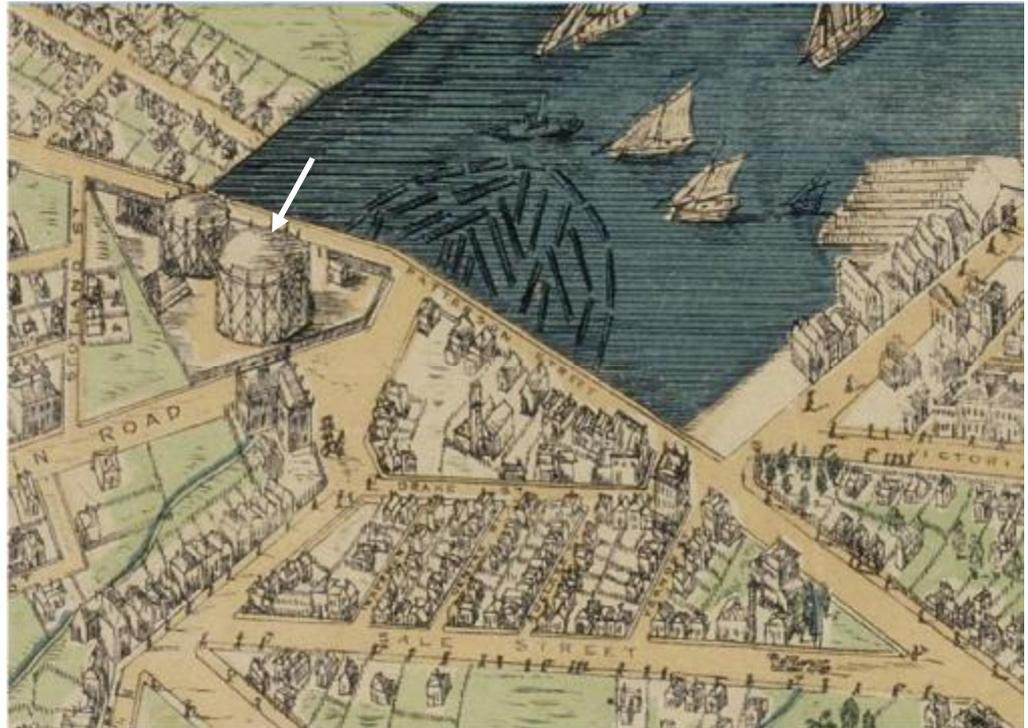
Figure 2.22: 1886 'Bird's Eye View' city map by G.T. Stevens (APL NZ maps 374). Note Gasometer site (arrowed)

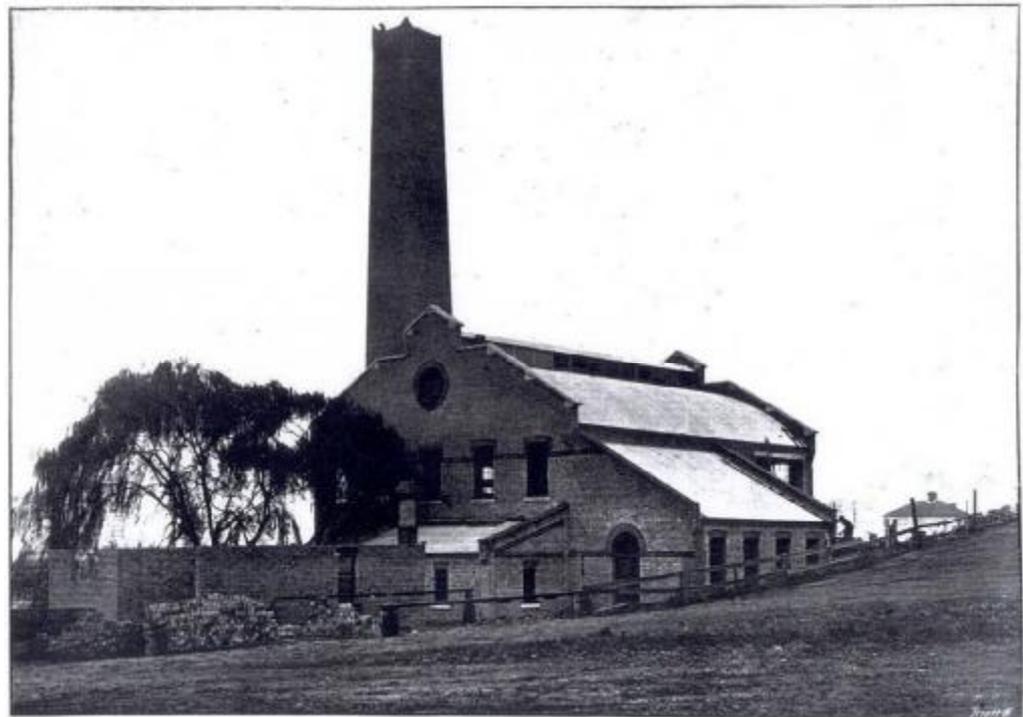
Figure 2.23: The rubbish and refuse destructor nearing completion, Freemans Bay (taken from the *NZ Graphic*, June 17, 1905, p34] Auckland Public Library Negative # A14442)

The number of businesses and residences rapidly declined in 1906 (probably beginning in 1905) with the construction of the City Council Refuse Destructor (Figure 2.23, Figure 2.24). ‘Beginning as a courtyard enclosed by timber buildings housing blacksmiths, carpenters’ shops and stables, the brick complex was completed in 1915’ (Palmer 2002:55). These businesses were probably established after 1910 or associated with the Destructor complex, as they do not appear in street directories prior to this date. Palmer (2002:55) further states, ‘Steam from furnaces generated some of Auckland’s first electricity. The boilers provided hot showers for the homeless, supervised by Sewing Machine Joe, who offered clothing repairs “while you wash”’.

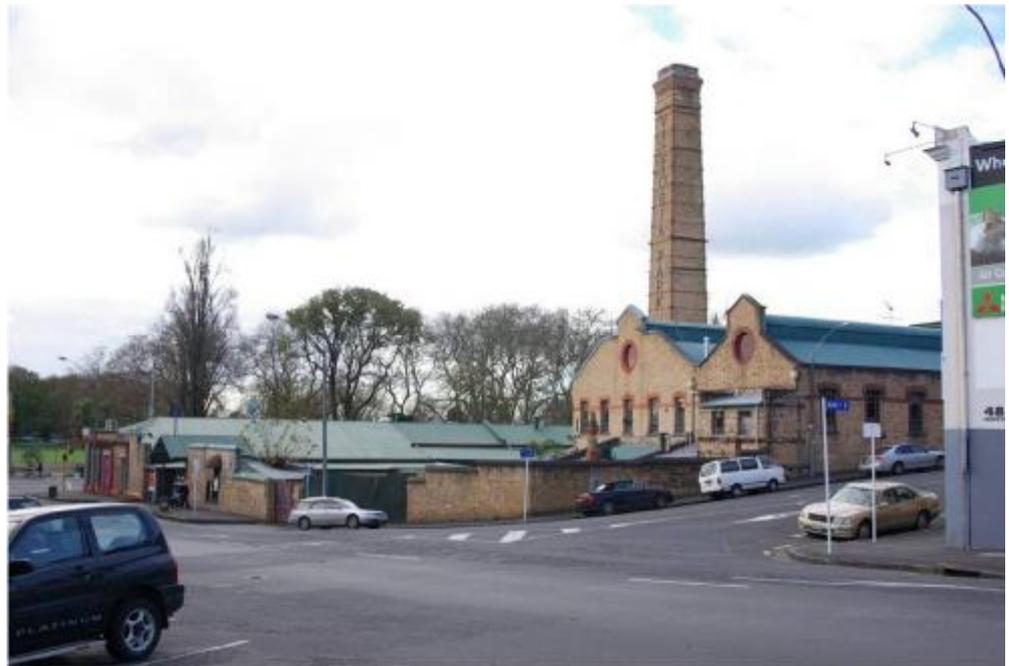
Figure 2.24: Victoria Park Markets from Union Street showing Destructor buildings and chimney (2007)

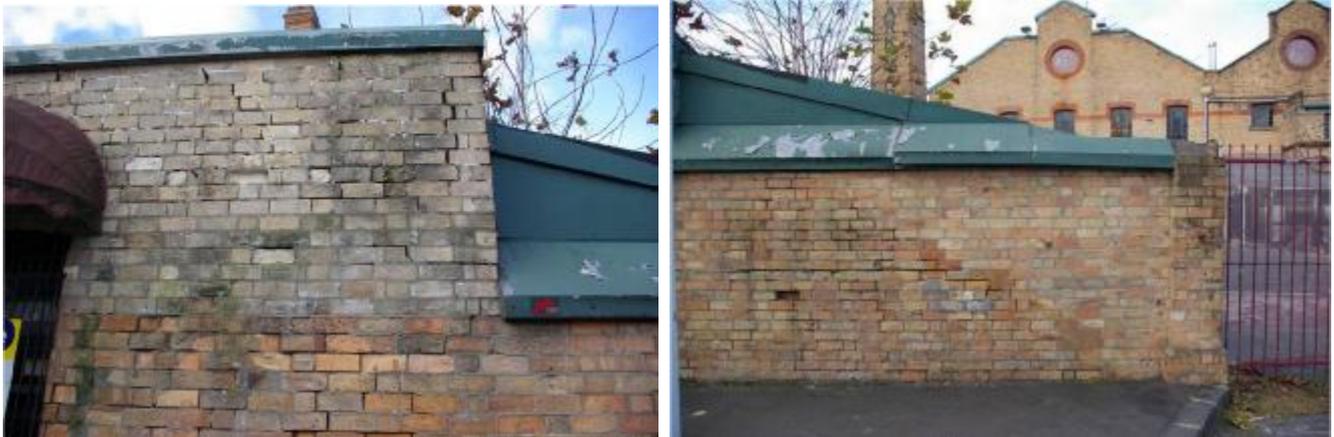
Figure 2.26: The western wall of Victoria Park Markets, showing patching and repairs

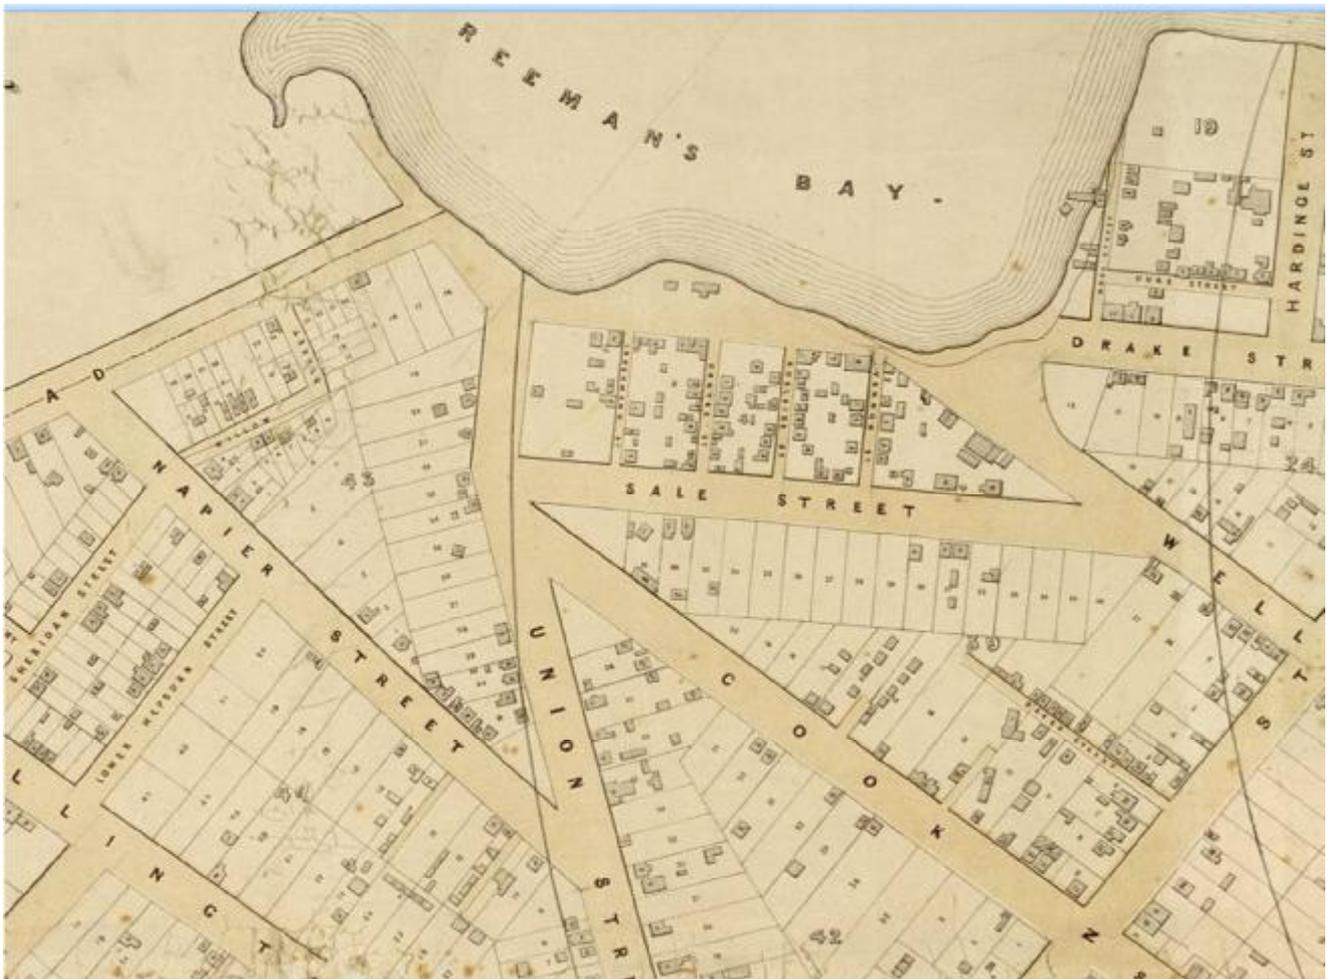
Figure 2.27: 1866 Vercoe & Harding map, showing buildings along Cook and Union Streets. Drake Street has not yet been formed and the 1860s blockhouse is still in place (APL NZ Maps 2591)

Figure 2.27 and Figure 2.28 show various buildings along Union and Cook Streets in 1866 (prior to reclamation) and 1886 (when reclamation had proceeded as far as Patterson Street – now Victoria Street West). Only one building is shown fronting Union Street between Drake Street and Sale Street in 1866. This building seems to have disappeared by 1886, but a few buildings are shown clustered together on the street frontage close to Sale Street. The corner lot at the junction of Sale and Cook Streets was held as reserve and not developed. Along the northern end of the Cook Street frontage (within the designation) a few buildings are shown. None of these have survived to the present day, and the area has been considerably altered by roading and 20th century development. No further research was carried out into the history of these properties as it was considered unlikely that any 19th century remains have survived within the areas affected by the alignment.
