Additional Waitemata Harbour Crossing

Historic Heritage Assessment

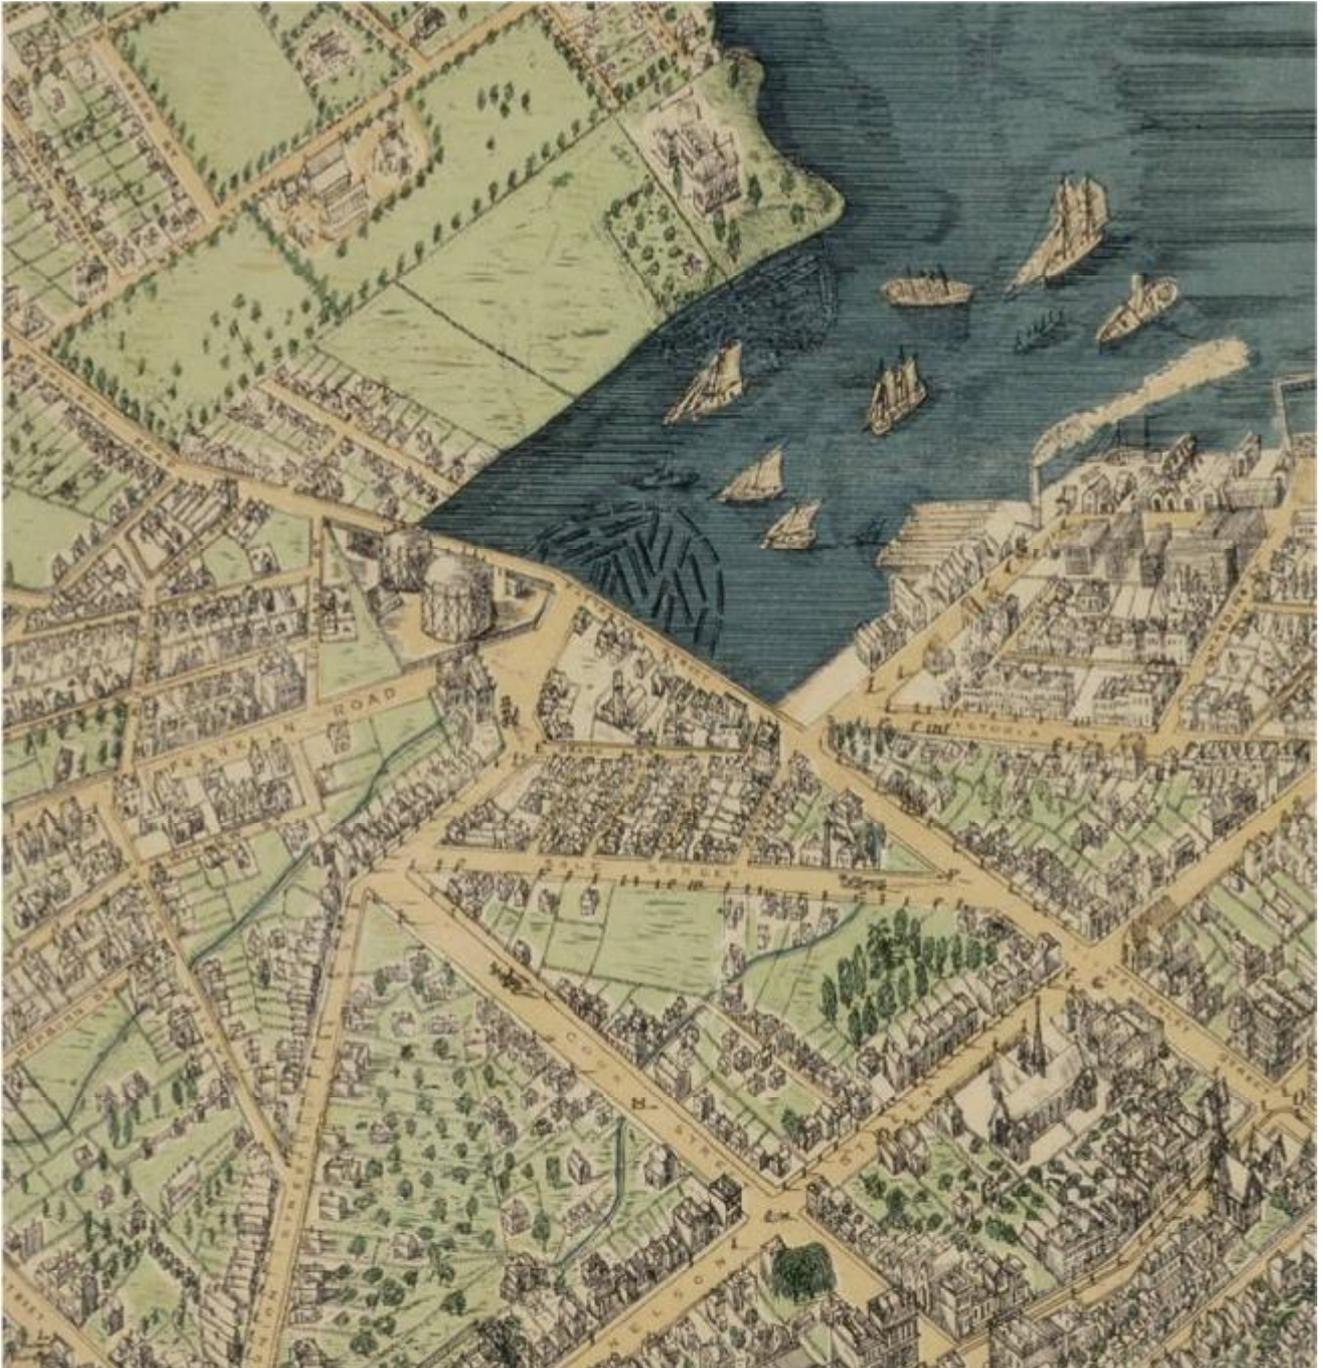
Figure 2.28: 1886 'Bird's Eye View' city map by G.T. Stevens (APL NZ maps 374) showing buildings along Cook and Union Streets

Figure 2.27 and Figure 2.28 show various buildings along Union and Cook Streets in 1866 (prior to reclamation) and 1886 (when reclamation had proceeded as far as Patterson Street – now Victoria Street West). Only one building is shown fronting Union Street between Drake Street and Sale Street in 1866. This building seems to have disappeared by 1886, but a few buildings are shown clustered together on the street frontage close to Sale Street. The corner lot at the junction of Sale and Cook Streets was held as reserve and not developed. Along the northern end of the Cook Street frontage (within the designation) a few buildings are shown. None of these have survived to the present day, and the area has been considerably altered by roading and 20th century development. No further research was carried out into the history of these properties as it was considered unlikely that any 19th century remains have survived within the areas affected by the alignment.

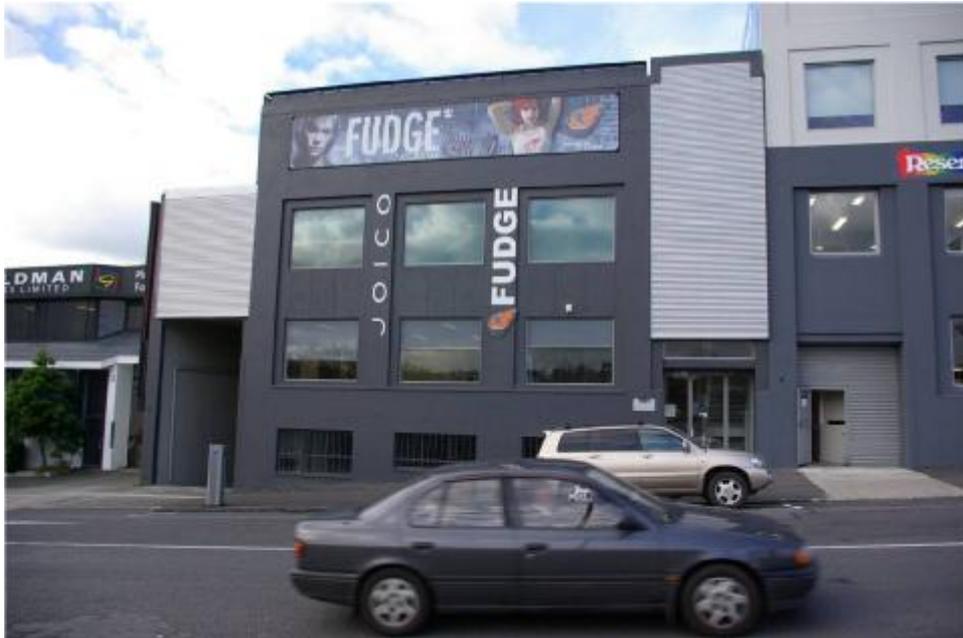
Figure 2.31:
Modern concrete
block buildings
benched into slope
of Cook Street
between Drake and
Sale Streets (2007)

Later development has almost certainly removed all traces of the 19th century buildings once present along the frontages of Cook and Union Street along the alignment. Later development has included road widening and a number of modern buildings of concrete block construction which have been benched in between Drake and Sale Streets, probably removing all traces of earlier remains (Figure 2.29 to Figure 2.31). If any archaeological remains have survived they would be deeper features, such as well bases. The north-western end of Cook Street is occupied by parking areas and modern buildings (Figure 2.32, Figure 2.33), with a few older buildings on the northern side further down the street (Figure 2.34). The latter appear to have been benched in slightly, and if any pre-1900 archaeological remains have survived in this area they are likely to be at the rear of these buildings.

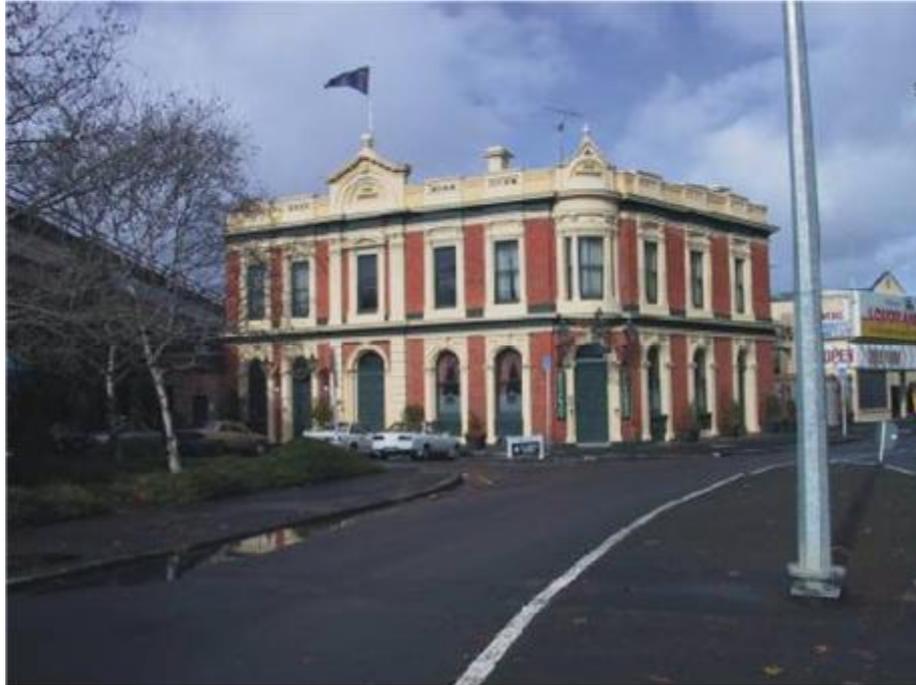
Figure 2.35: The Birdcage Tavern (from the north) (2005)

The Birdcage Tavern is located to the west of the Victoria Park Markets, on the opposite side of Union Street (Figure 2.35). It was originally known as the Rob Roy Hotel. An earlier Rob Roy Hotel, built in 1865, was located closer to Victoria Street West, and was operated to begin with by James Rosie. Patrons could come to the hotel by road or water as the property was close to the original Freemans Bay shoreline. In 1881 the licensee was teetotaler William Regan, who would operate the business for the rest of the 19th century (APL 1986; Matthews & Matthews 2003).

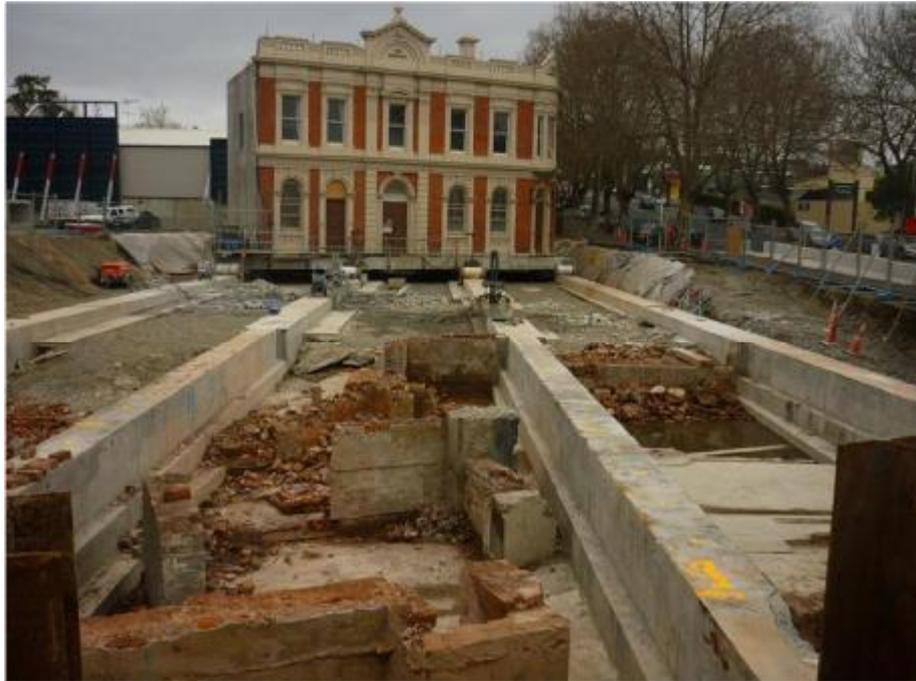
Figure 2.36: The Birdcage Tavern following the move to its temporary location (photo 7 September 2010)

The basement and the surrounding site of the Birdcage Tavern are in the process of being removed as part of the VPT project, and site R11/2499 will have no further archaeological value.

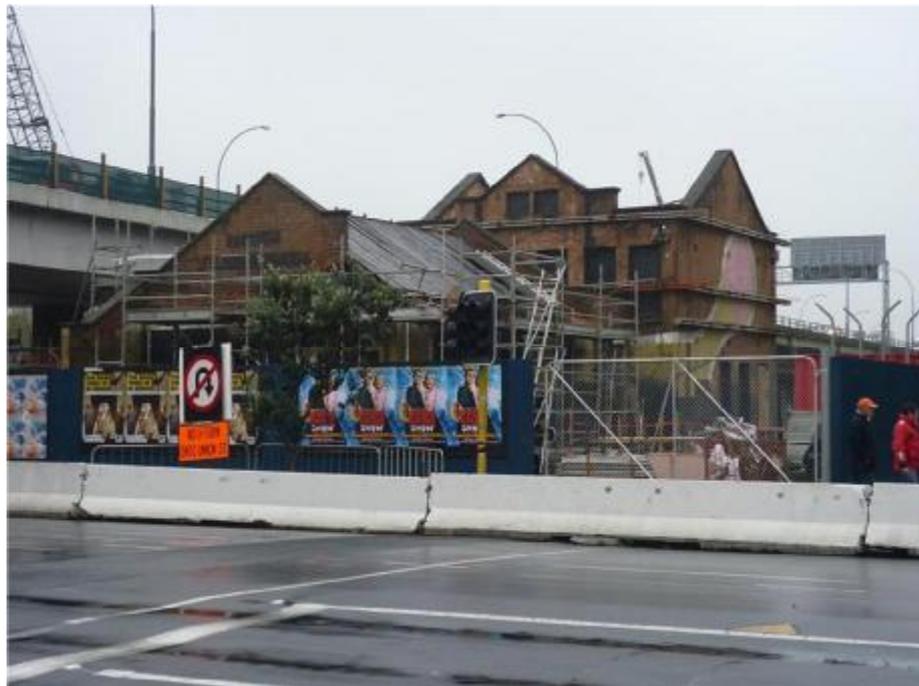
Figure 2.39: Campbell
Free Kindergarten
undergoing
weatherproofing and
stabilisation works
(September 2010).
Looking northwest

The building is at present unused and has been allowed to fall into a state of disrepair. As part of the VPT project, the Campbell Free Kindergarten will be stabilized and made weatherproof, and electrical and communications equipment for the project will be located within part of the building.

The building is in a disused and neglected condition, but is currently being stabilised and weatherproofed as part of the VPT project. As it would be directly affected by construction of an AWHC, it is recommended that the building is preserved by moving it to another location within the park. This is likely to be considered an acceptable mitigation proposal, as a similar solution was applied to the Birdcage Tavern in the VPT project. It

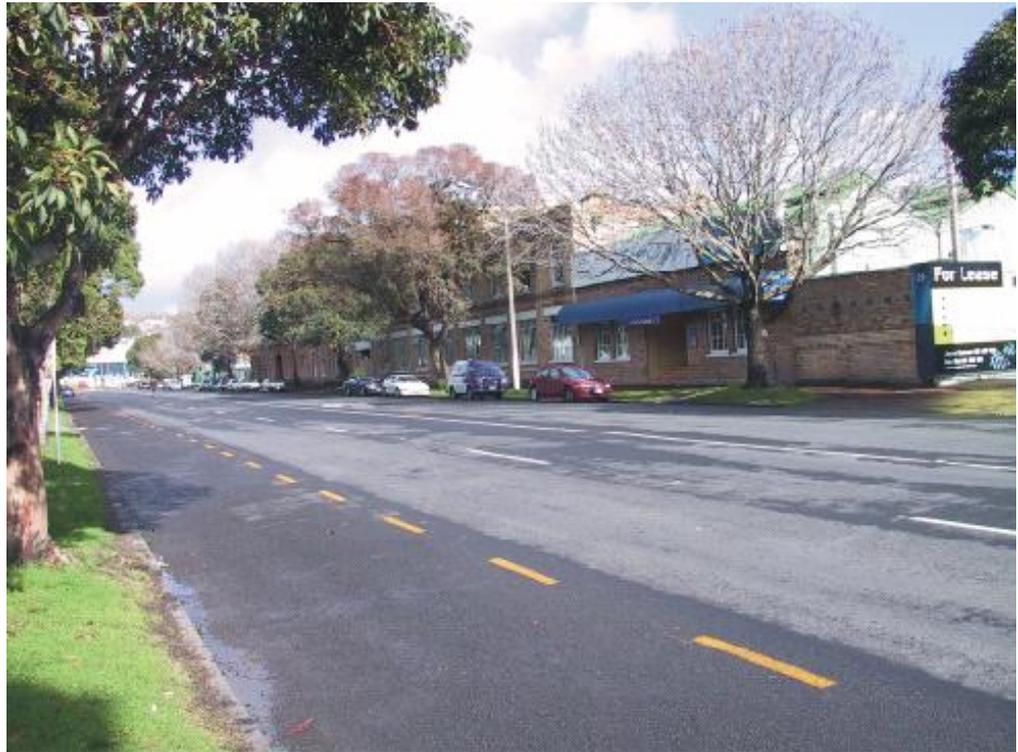
Figure 2.40:
Refurbished Beaumont
Street Gasworks
offices

The main administration and workshop building remain, along with part of the purifier house. Some smaller structures have also survived. They have recently been refurbished and adapted to commercial and residential uses and the original exterior of the buildings has been retained, with most of the alterations carried out to the building being internal. ACC has listed the buildings in Category B (no. B07-68).
