TECHNICAL REPORT 14

SETTLEMENT EFFECTS ASSESSMENT

NOVEMBER 2016

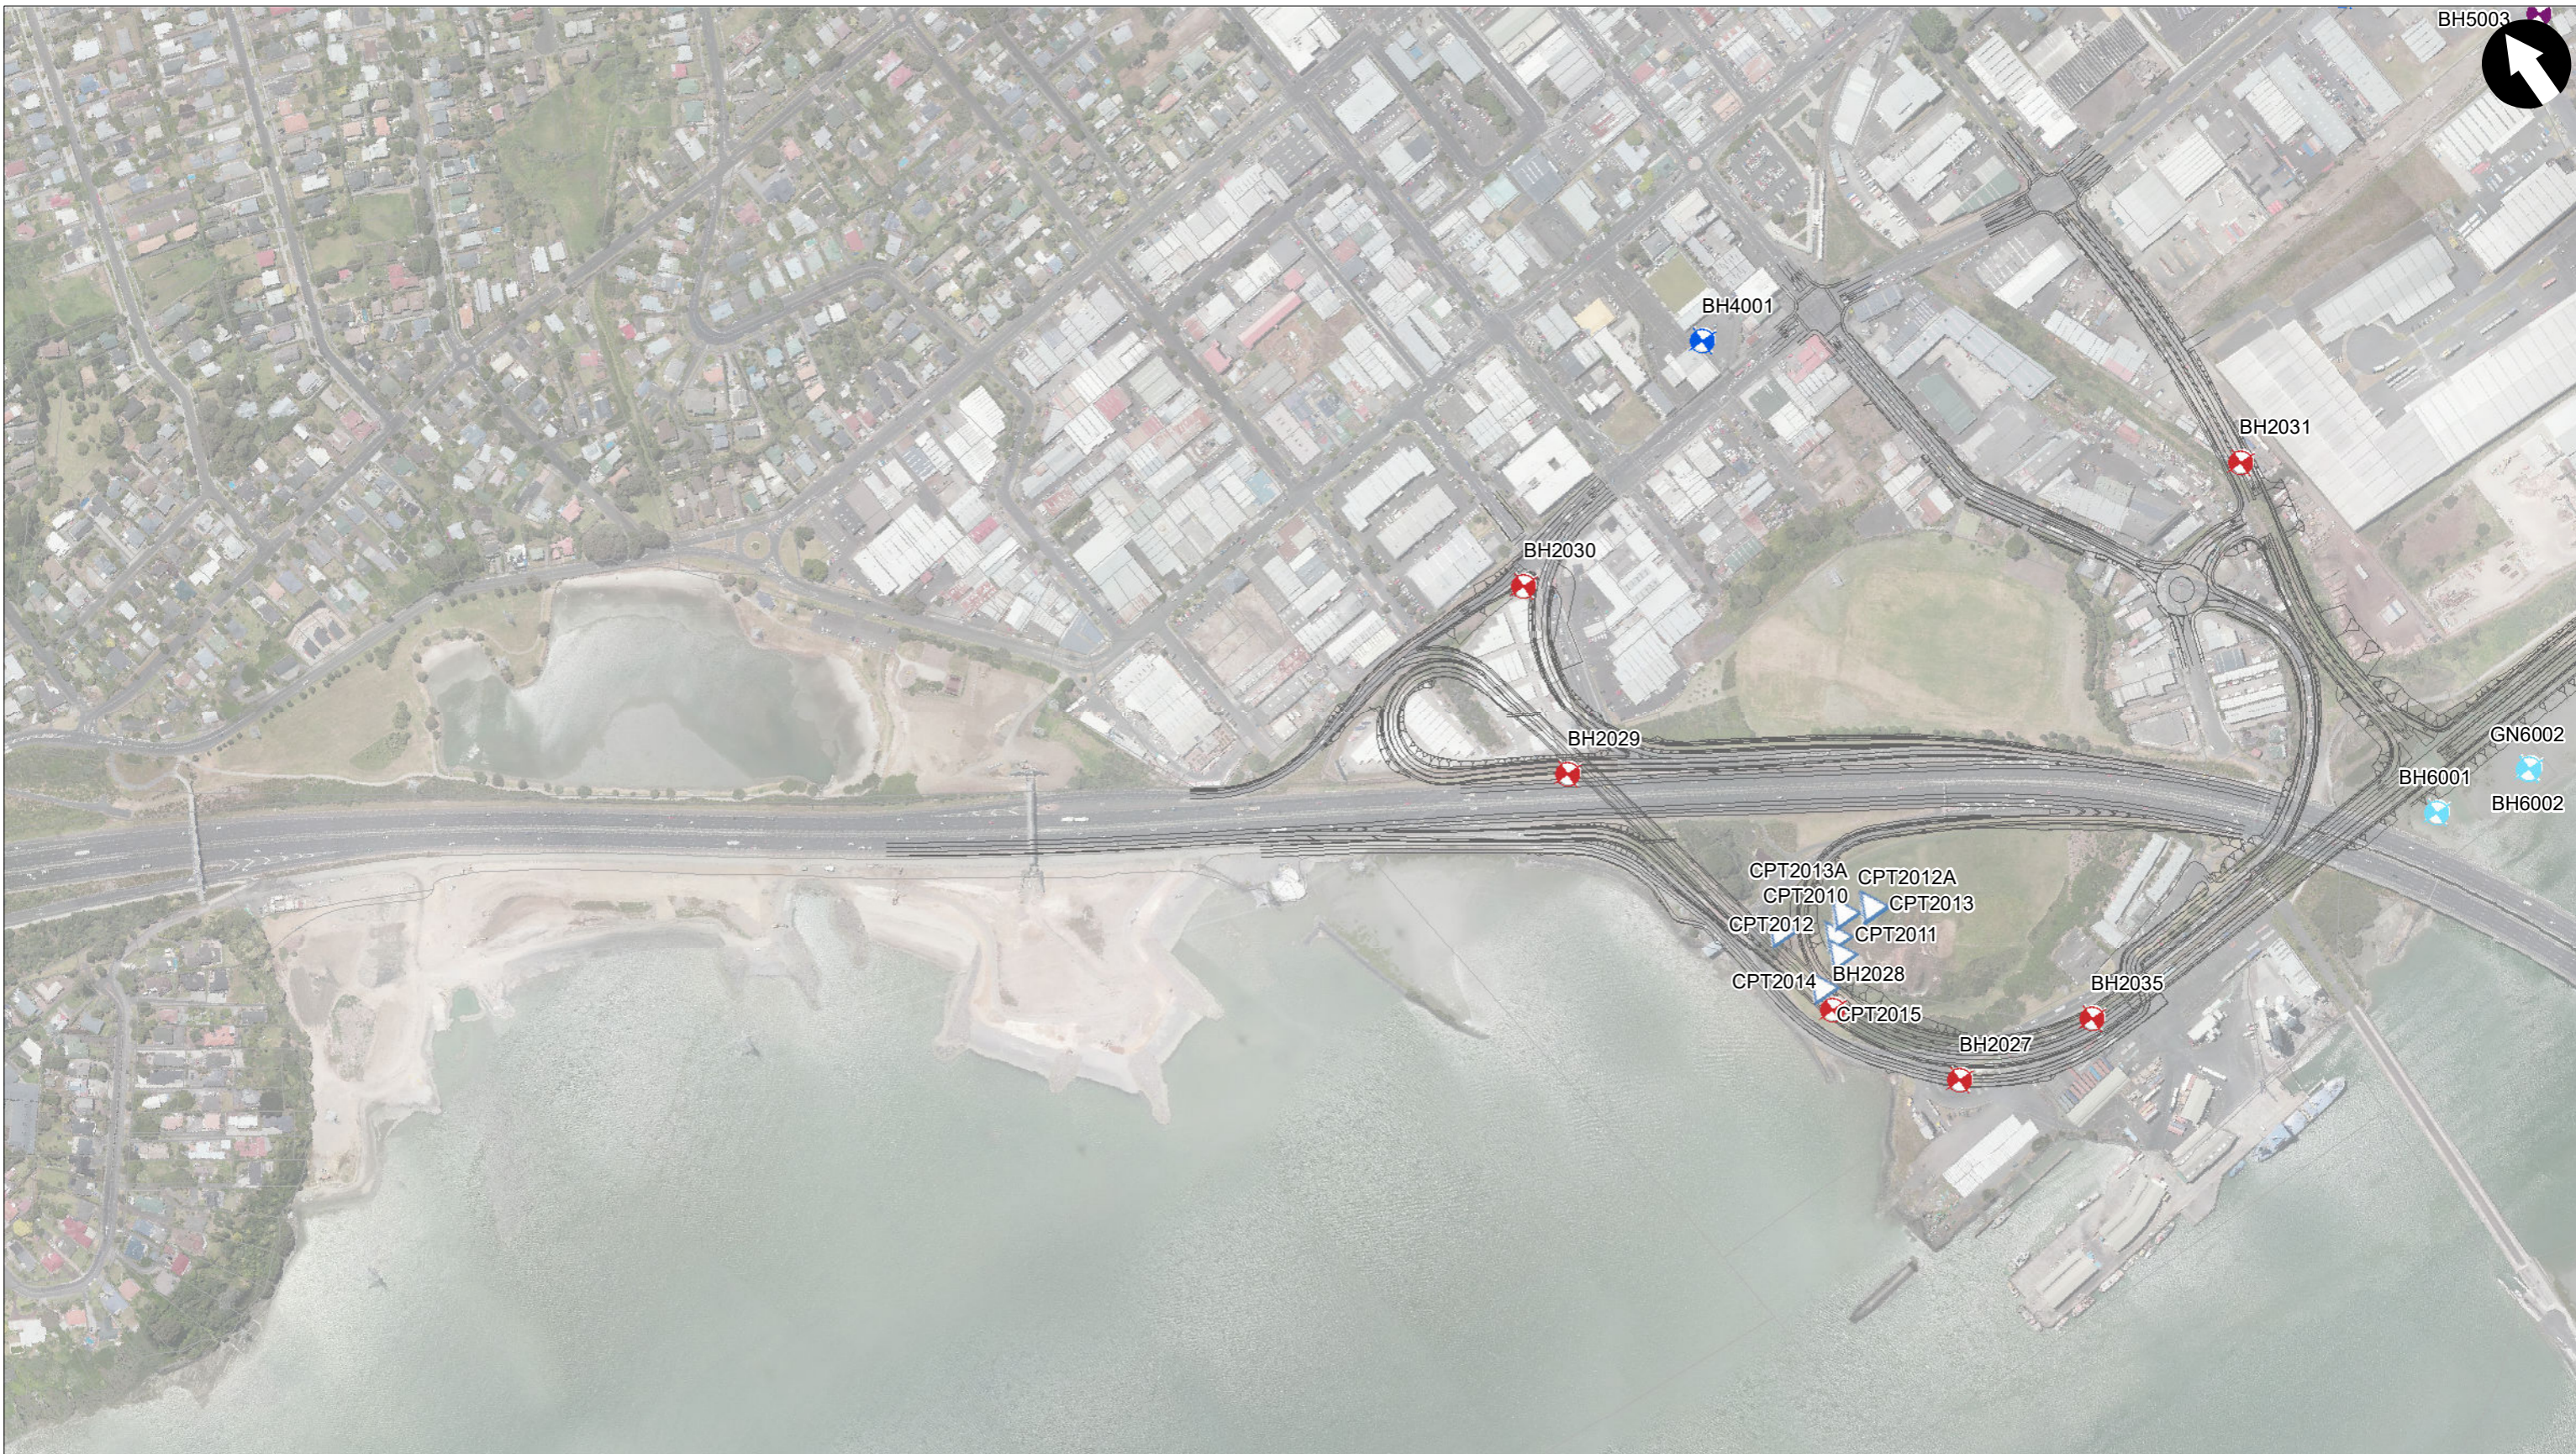
Drawing Title	GEOTECHNICAL 2016 Ground Investigations	
Drawing Number	GIS-Q-AEE-001	Rev No. A

Geotechnical Boreholes over water (BH) and In-situ Geonor Vane Test (GN)		Environmental Boreholes (BH)		Test Pits (TP)		EWL Alignment
	Geotechnical Boreholes (BH)		Groundwater Boreholes (BH)		Cone Penetration Test (CPT)

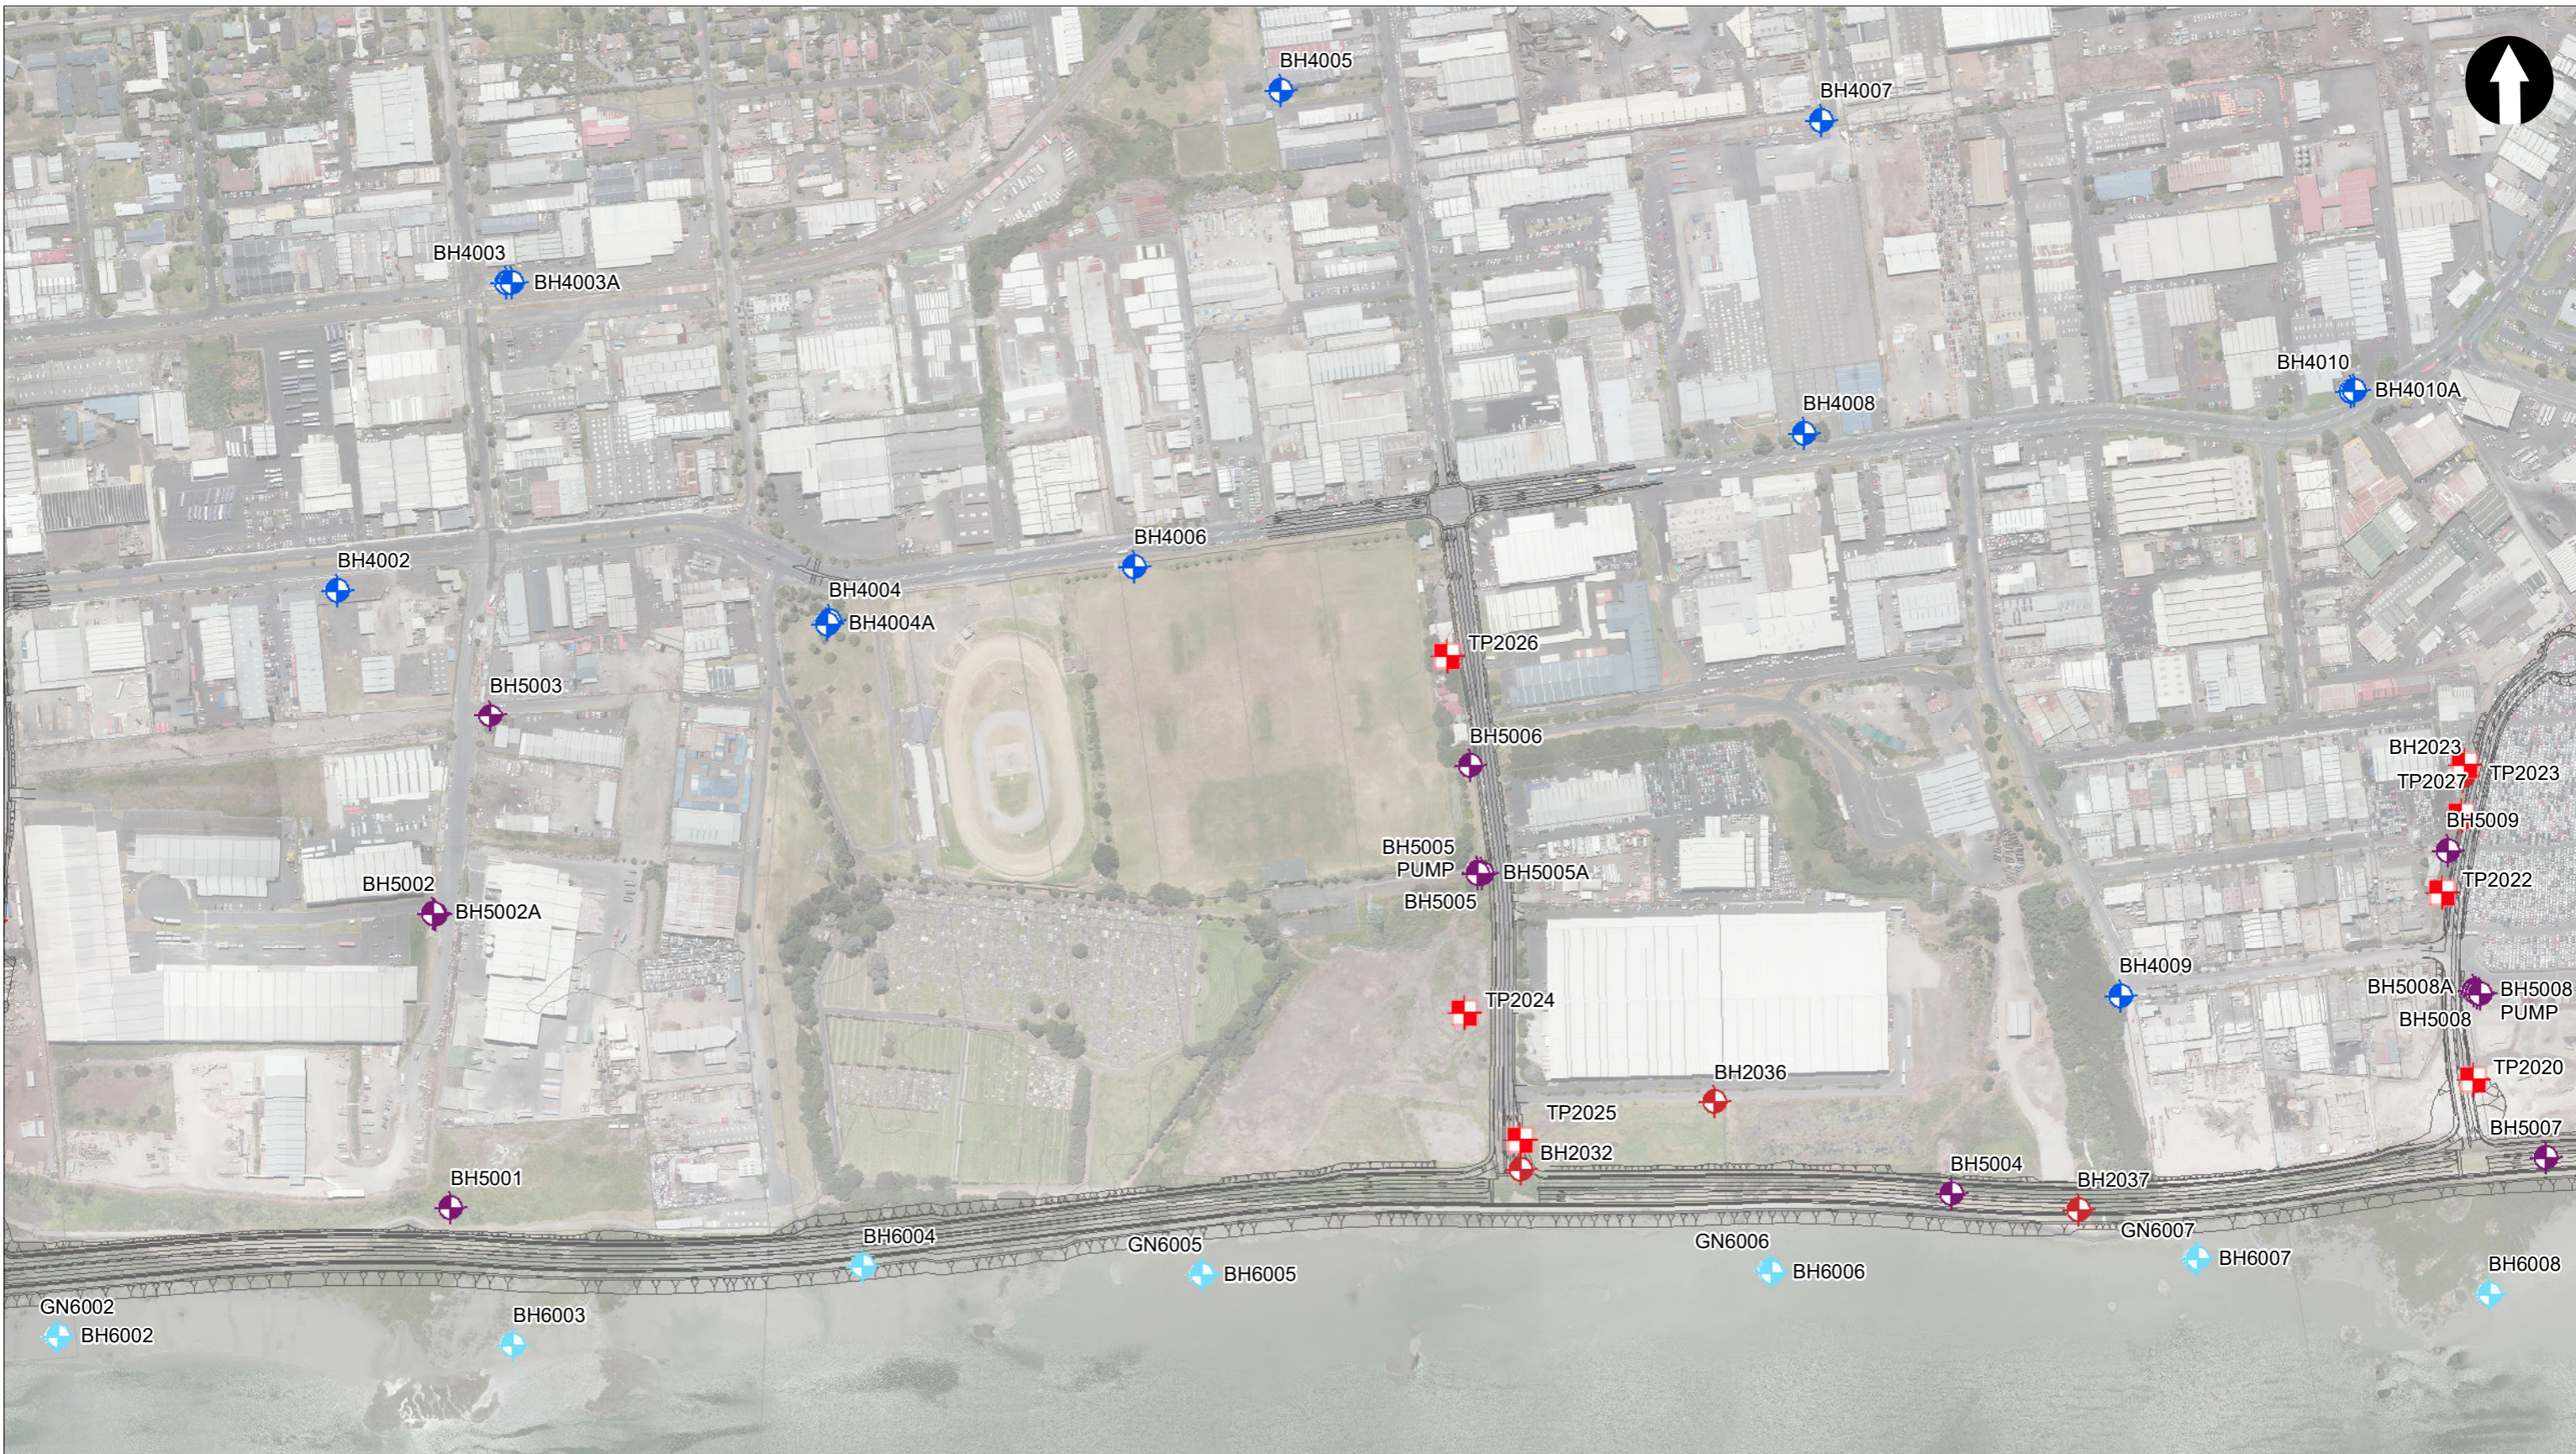
Drawing Title	GEOTECHNICAL 2016 Ground Investigations	
Drawing Number	GIS-Q-AEE-002	Rev No. A

- Geotechnical Boreholes over water (BH) and In-situ Geonor Vane Test (GN)
- Environmental Boreholes (BH)
- Test Pits (TP)
- EWL Alignment
- Geotechnical Boreholes (BH)
- Groundwater Boreholes (BH)
- Cone Penetration Test (CPT)

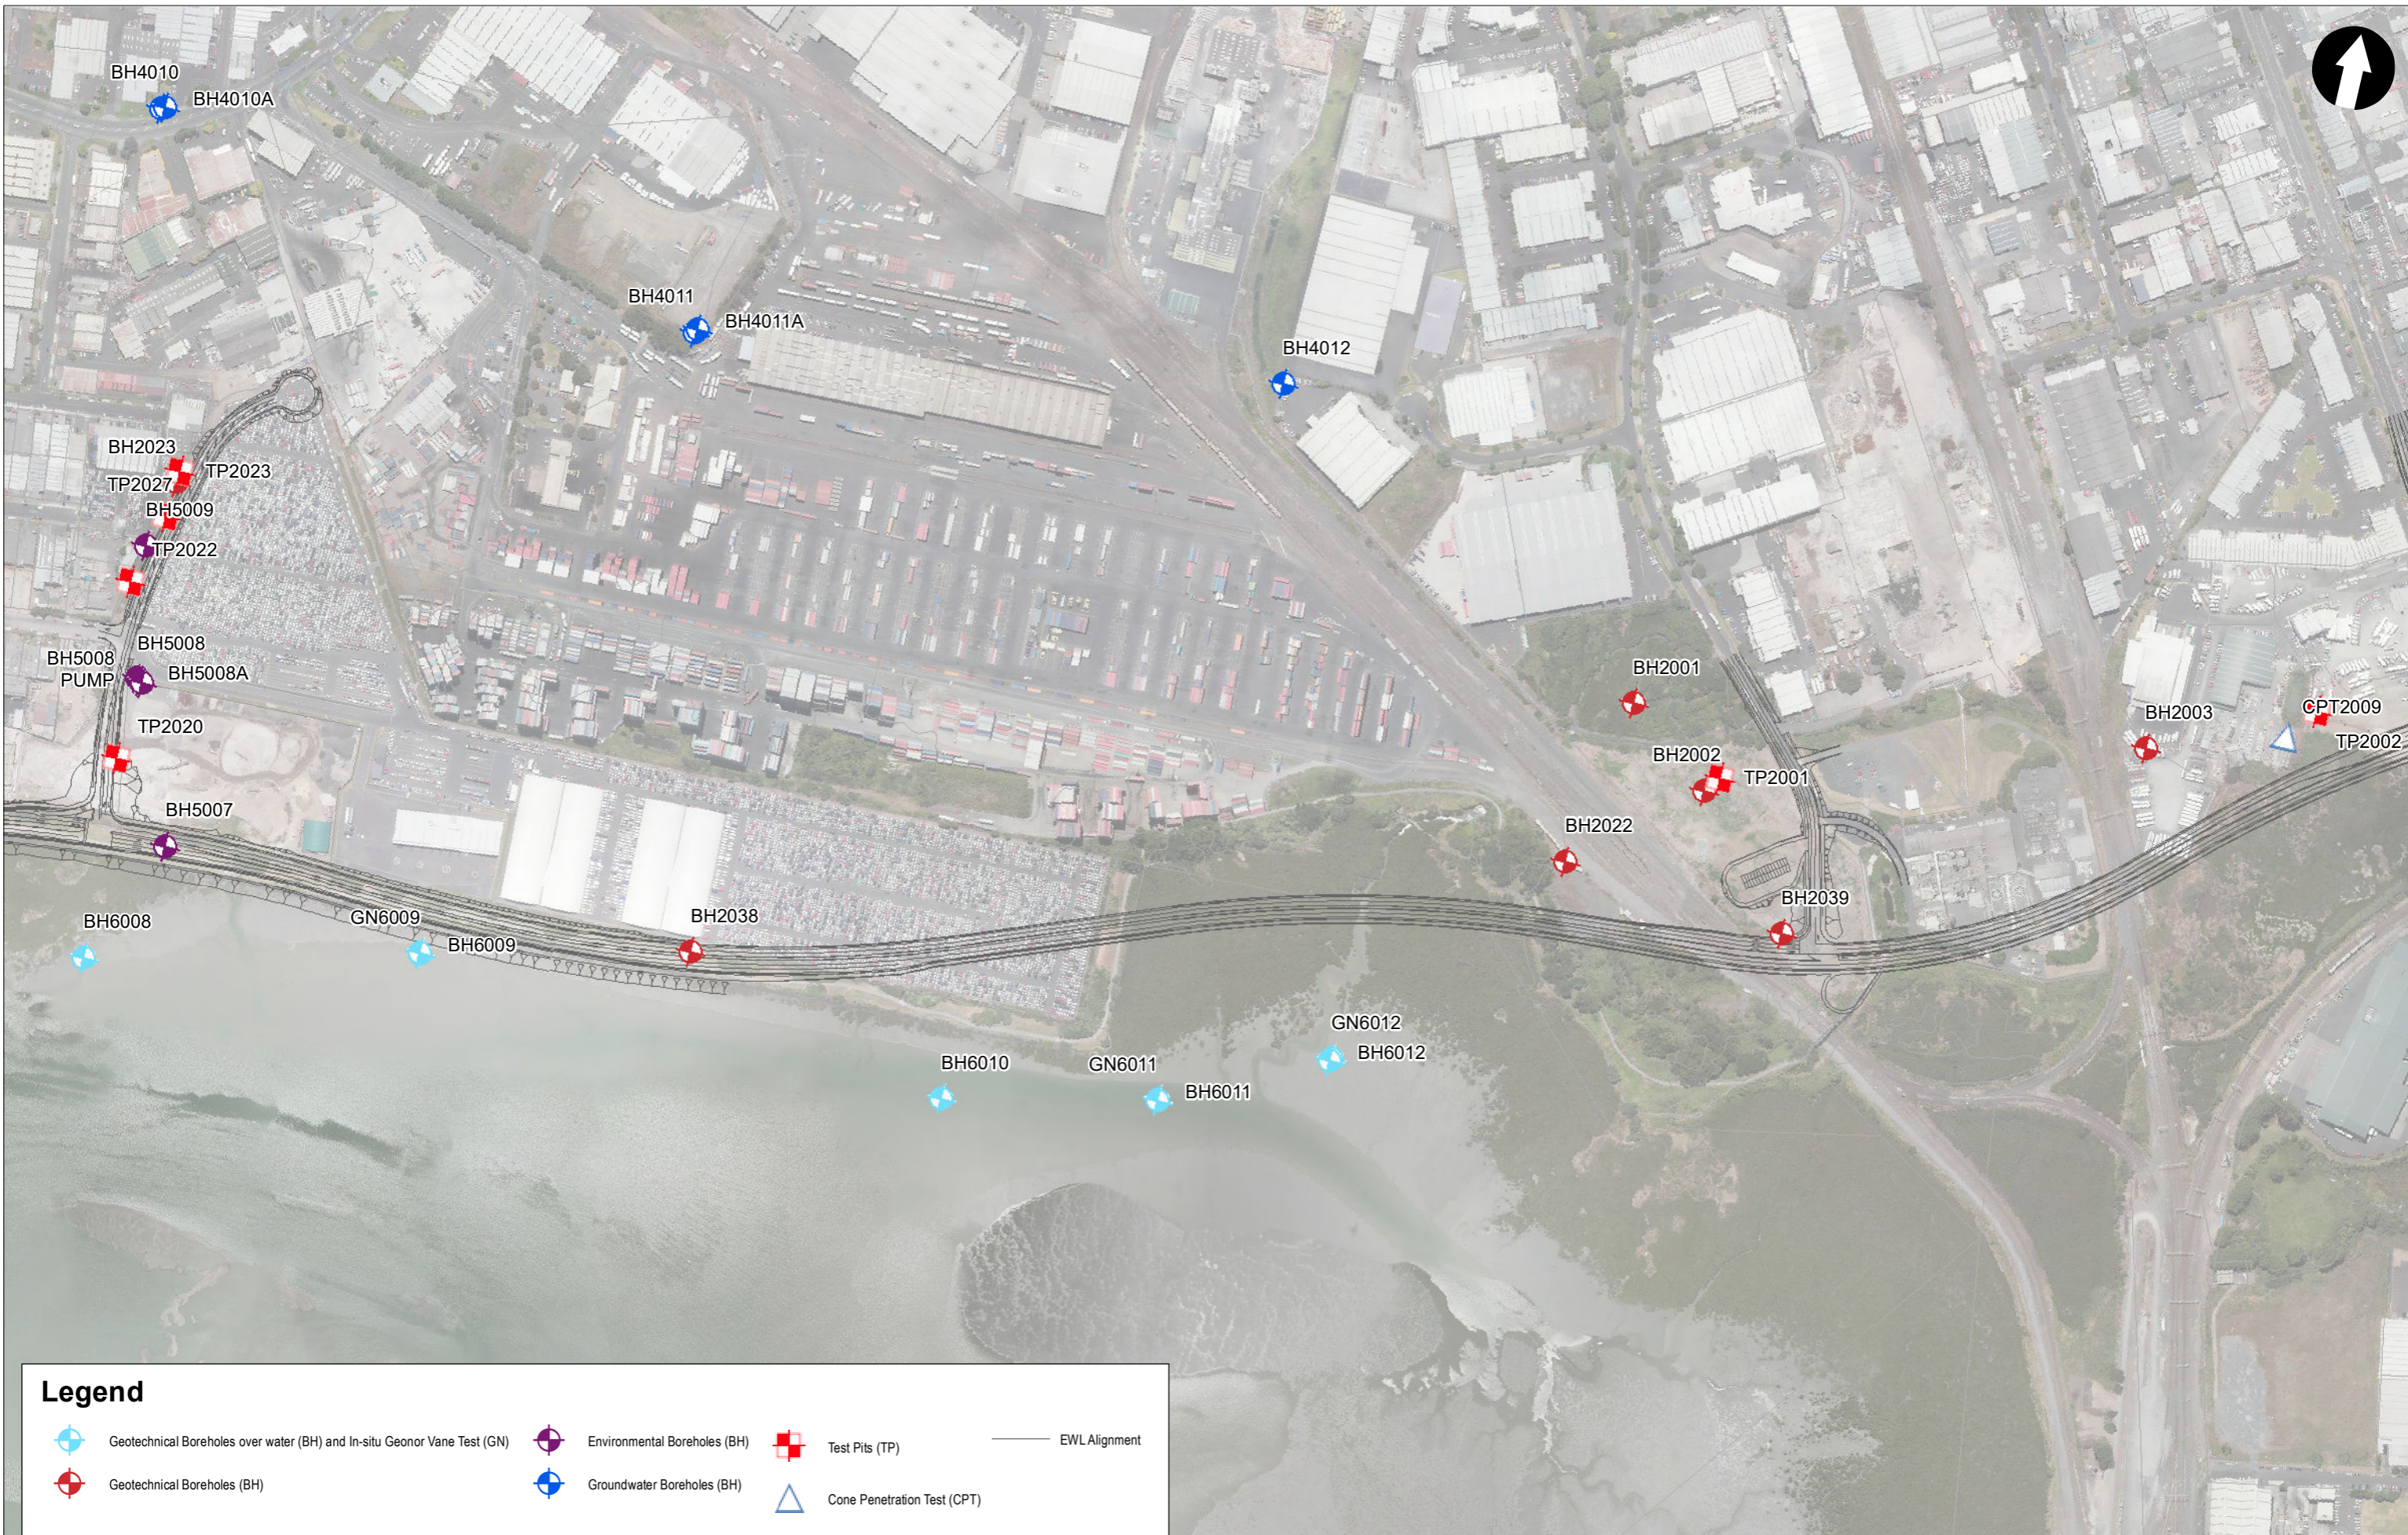
Drawing Title	GEOTECHNICAL 2016 Ground Investigations	
Drawing Number	GIS-Q-AEE-003	Rev No. A

- Geotechnical Boreholes over water (BH) and In-situ Geonor Vane Test (GN)
- Environmental Boreholes (BH)
- Test Pits (TP)
- EWL Alignment
- Geotechnical Boreholes (BH)
- Groundwater Boreholes (BH)
- Cone Penetration Test (CPT)

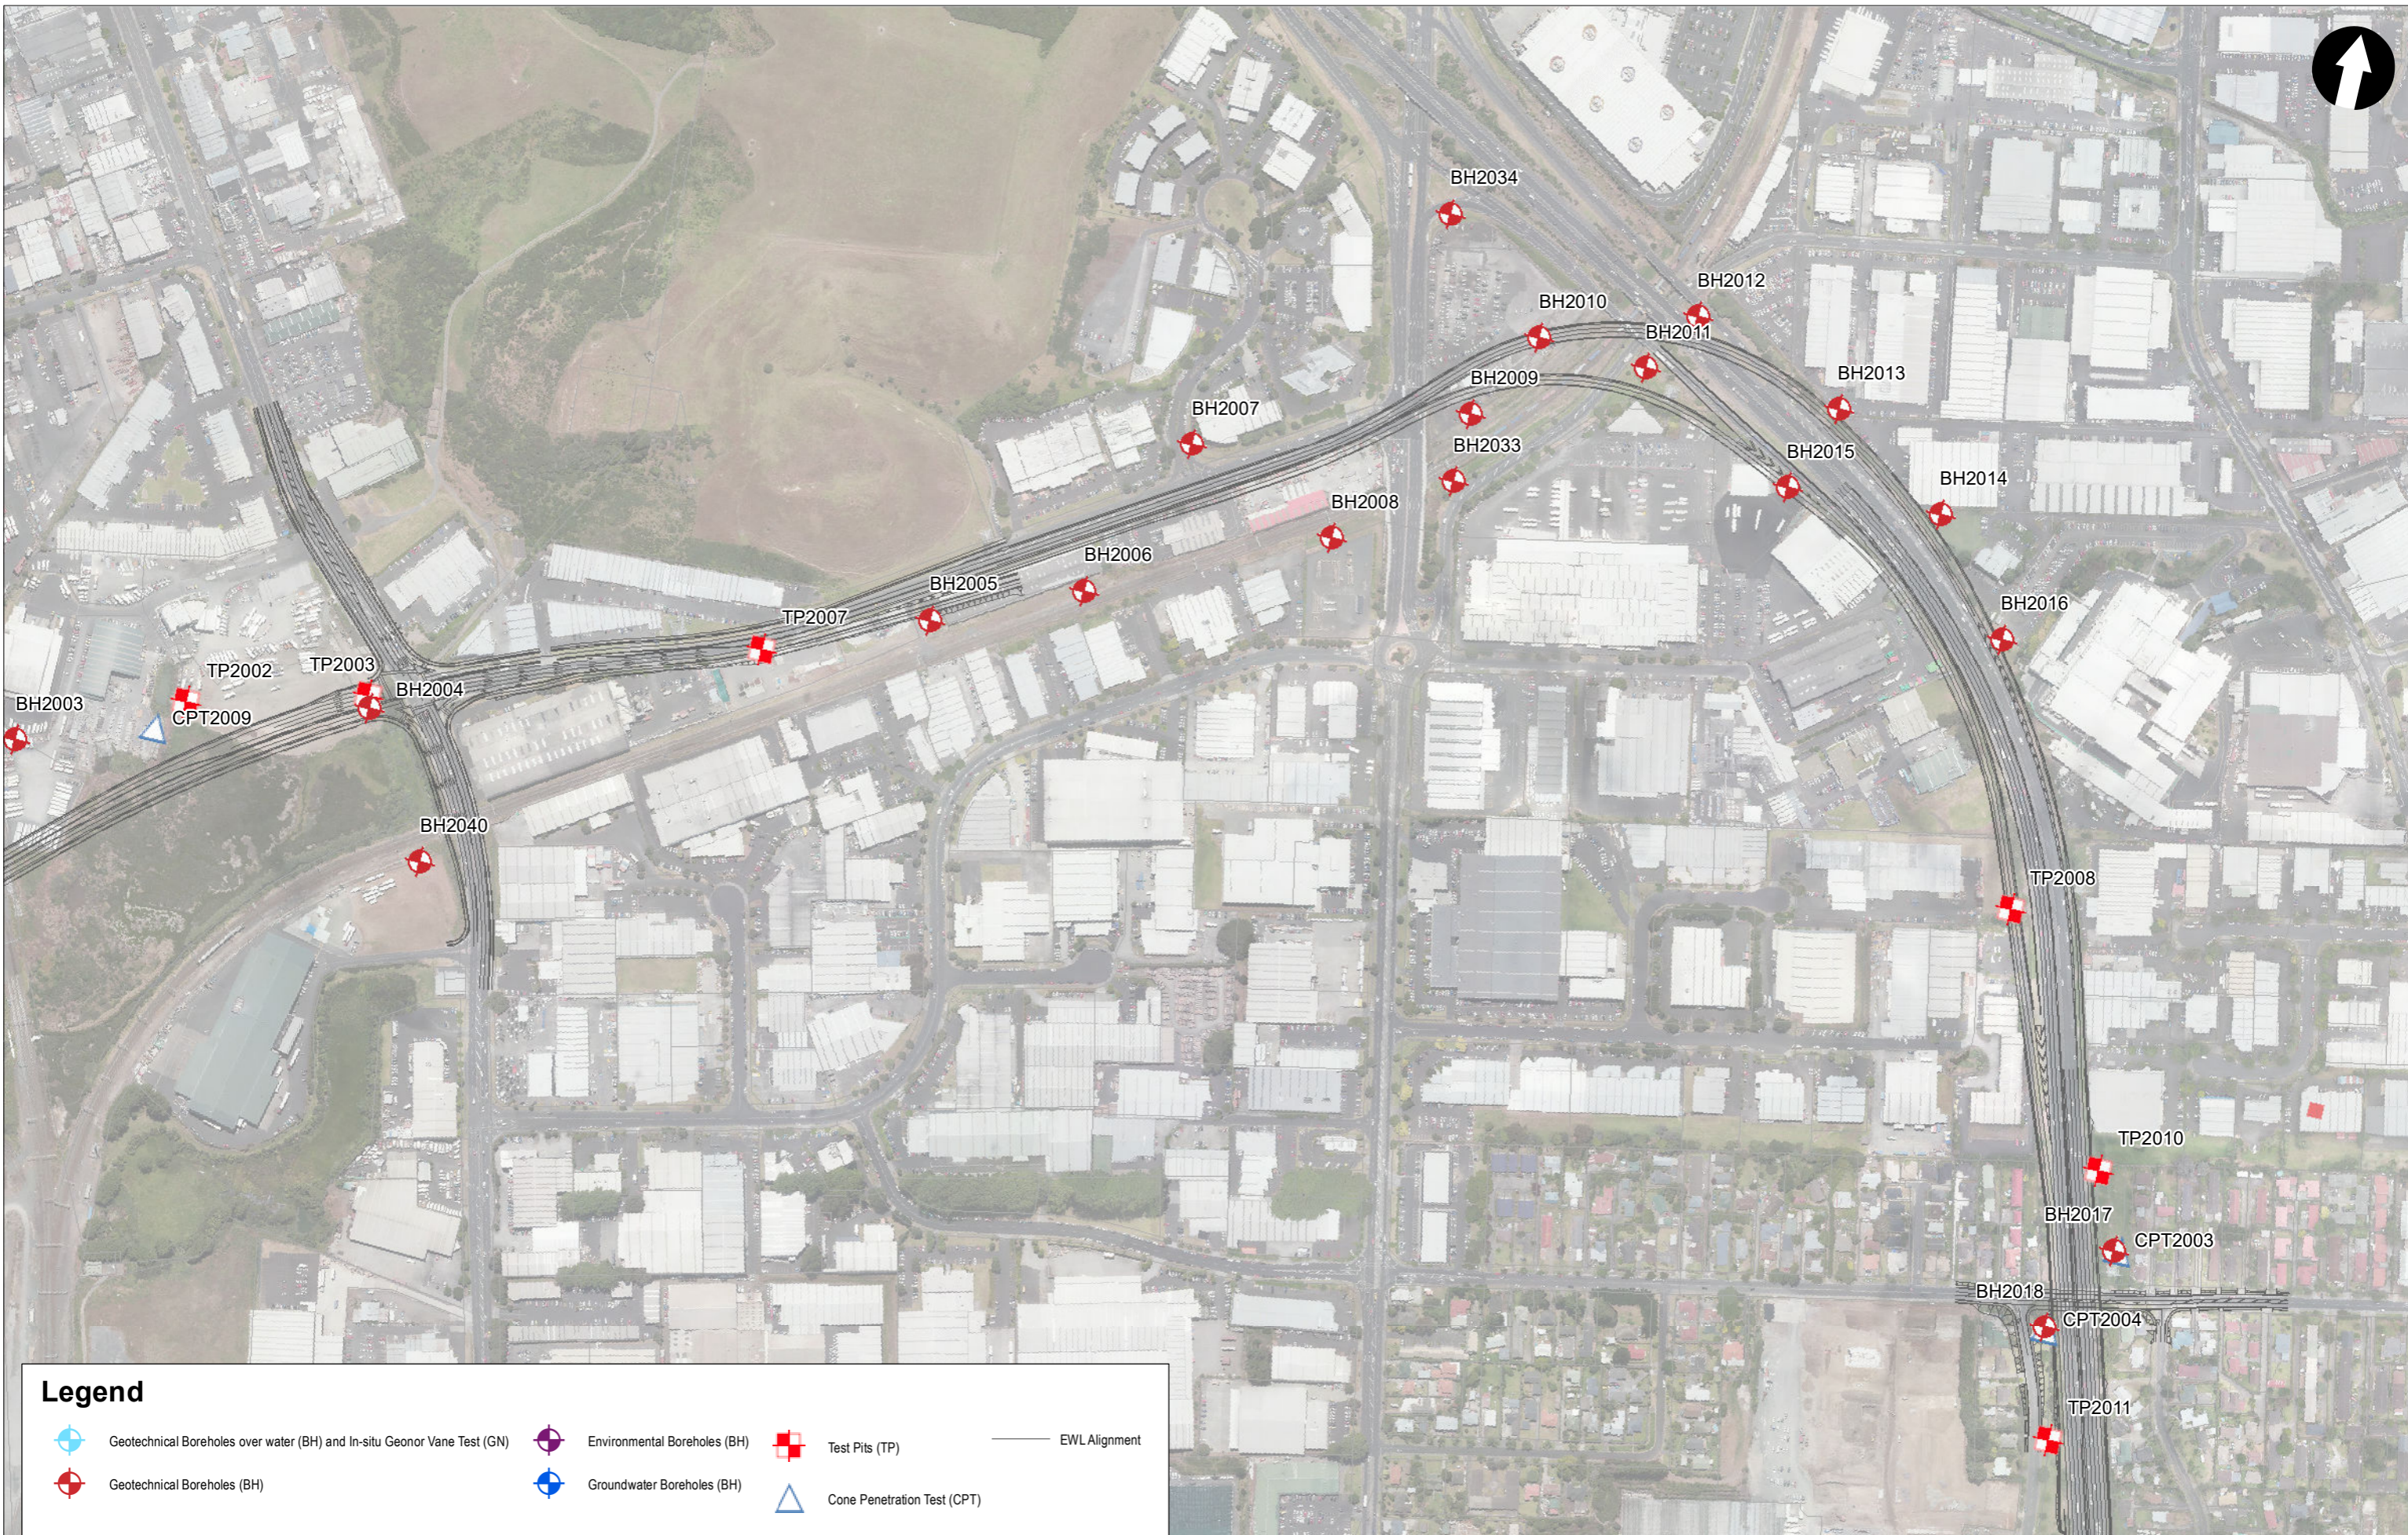
Drawing Title	GEOTECHNICAL 2016 Ground Investigations	
Drawing Number	GIS-Q-AEE-004	
Rev No.	A

- Geotechnical Boreholes over water (BH) and In-situ Geonor Vane Test (GN)
- Environmental Boreholes (BH)
- Test Pits (TP)
- EWL Alignment
- Geotechnical Boreholes (BH)
- Groundwater Boreholes (BH)
- Cone Penetration Test (CPT)

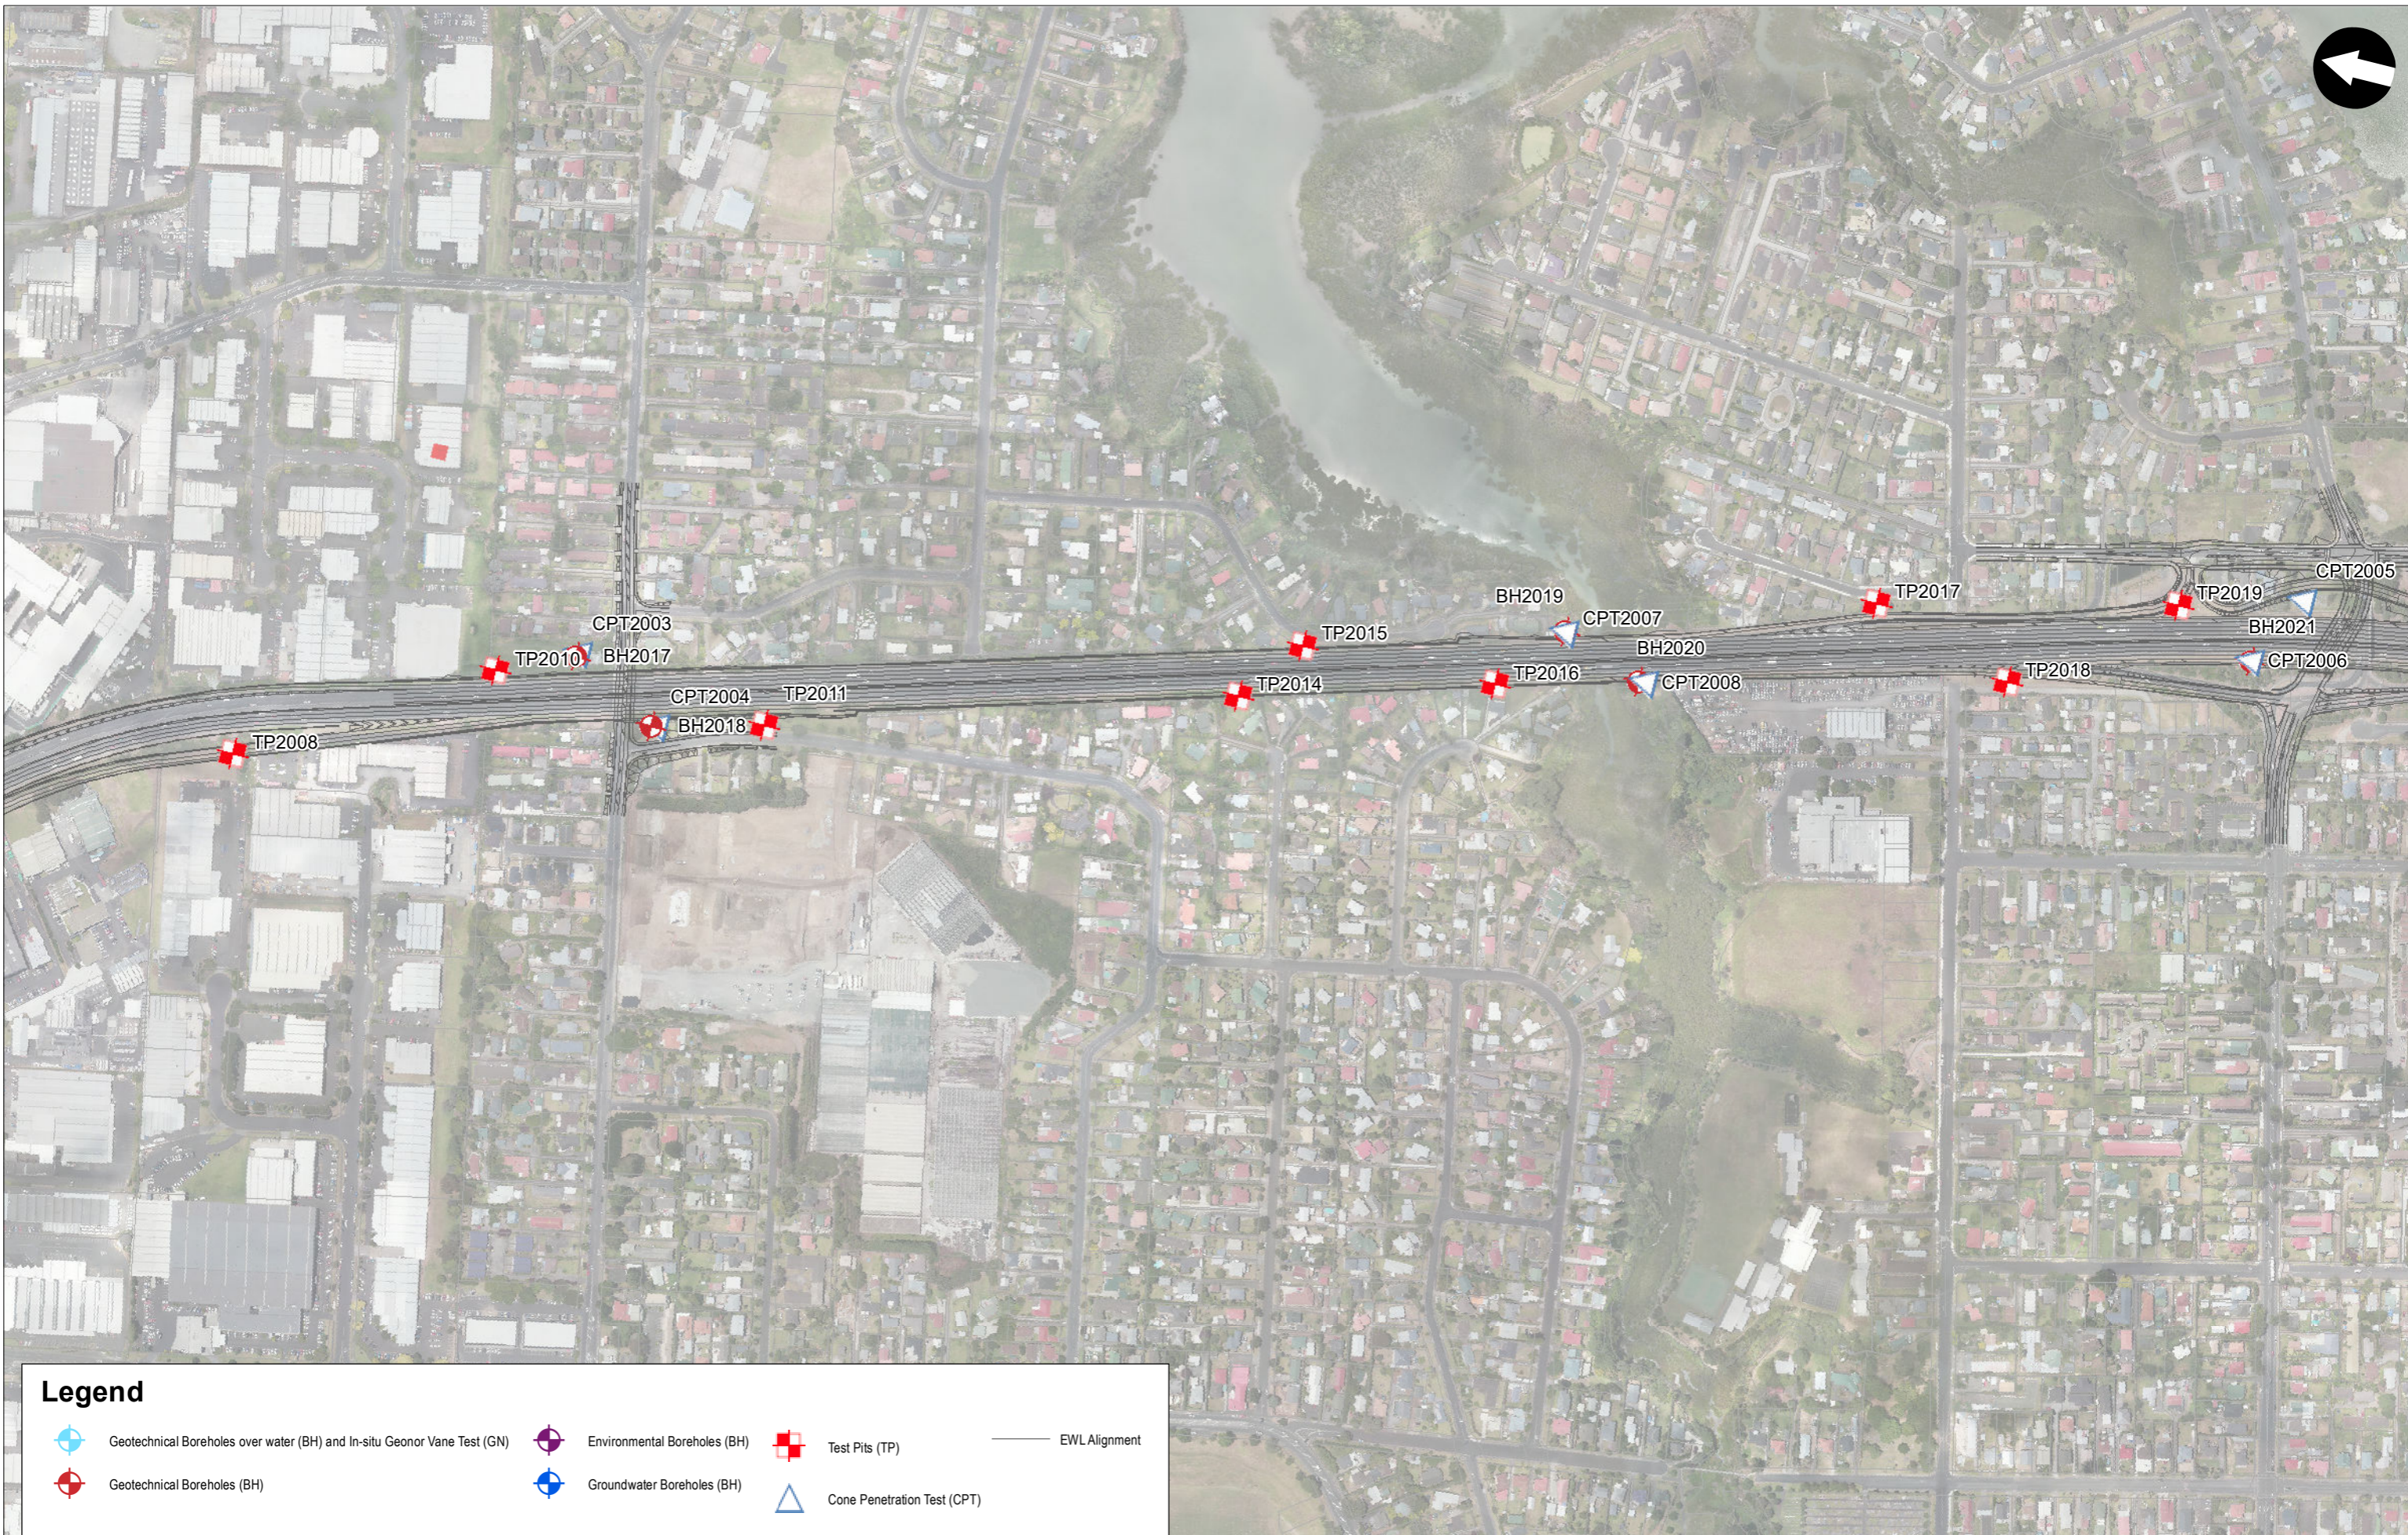
Drawing Title	GEOTECHNICAL 2016 Ground Investigations	
Drawing Number	GIS-Q-AEE-005	Rev No. A

Geotechnical Boreholes over water (BH) and In-situ Geonor Vane Test (GN)		Environmental Boreholes (BH)		Test Pits (TP)		EWL Alignment
	Geotechnical Boreholes (BH)		Groundwater Boreholes (BH)		Cone Penetration Test (CPT)

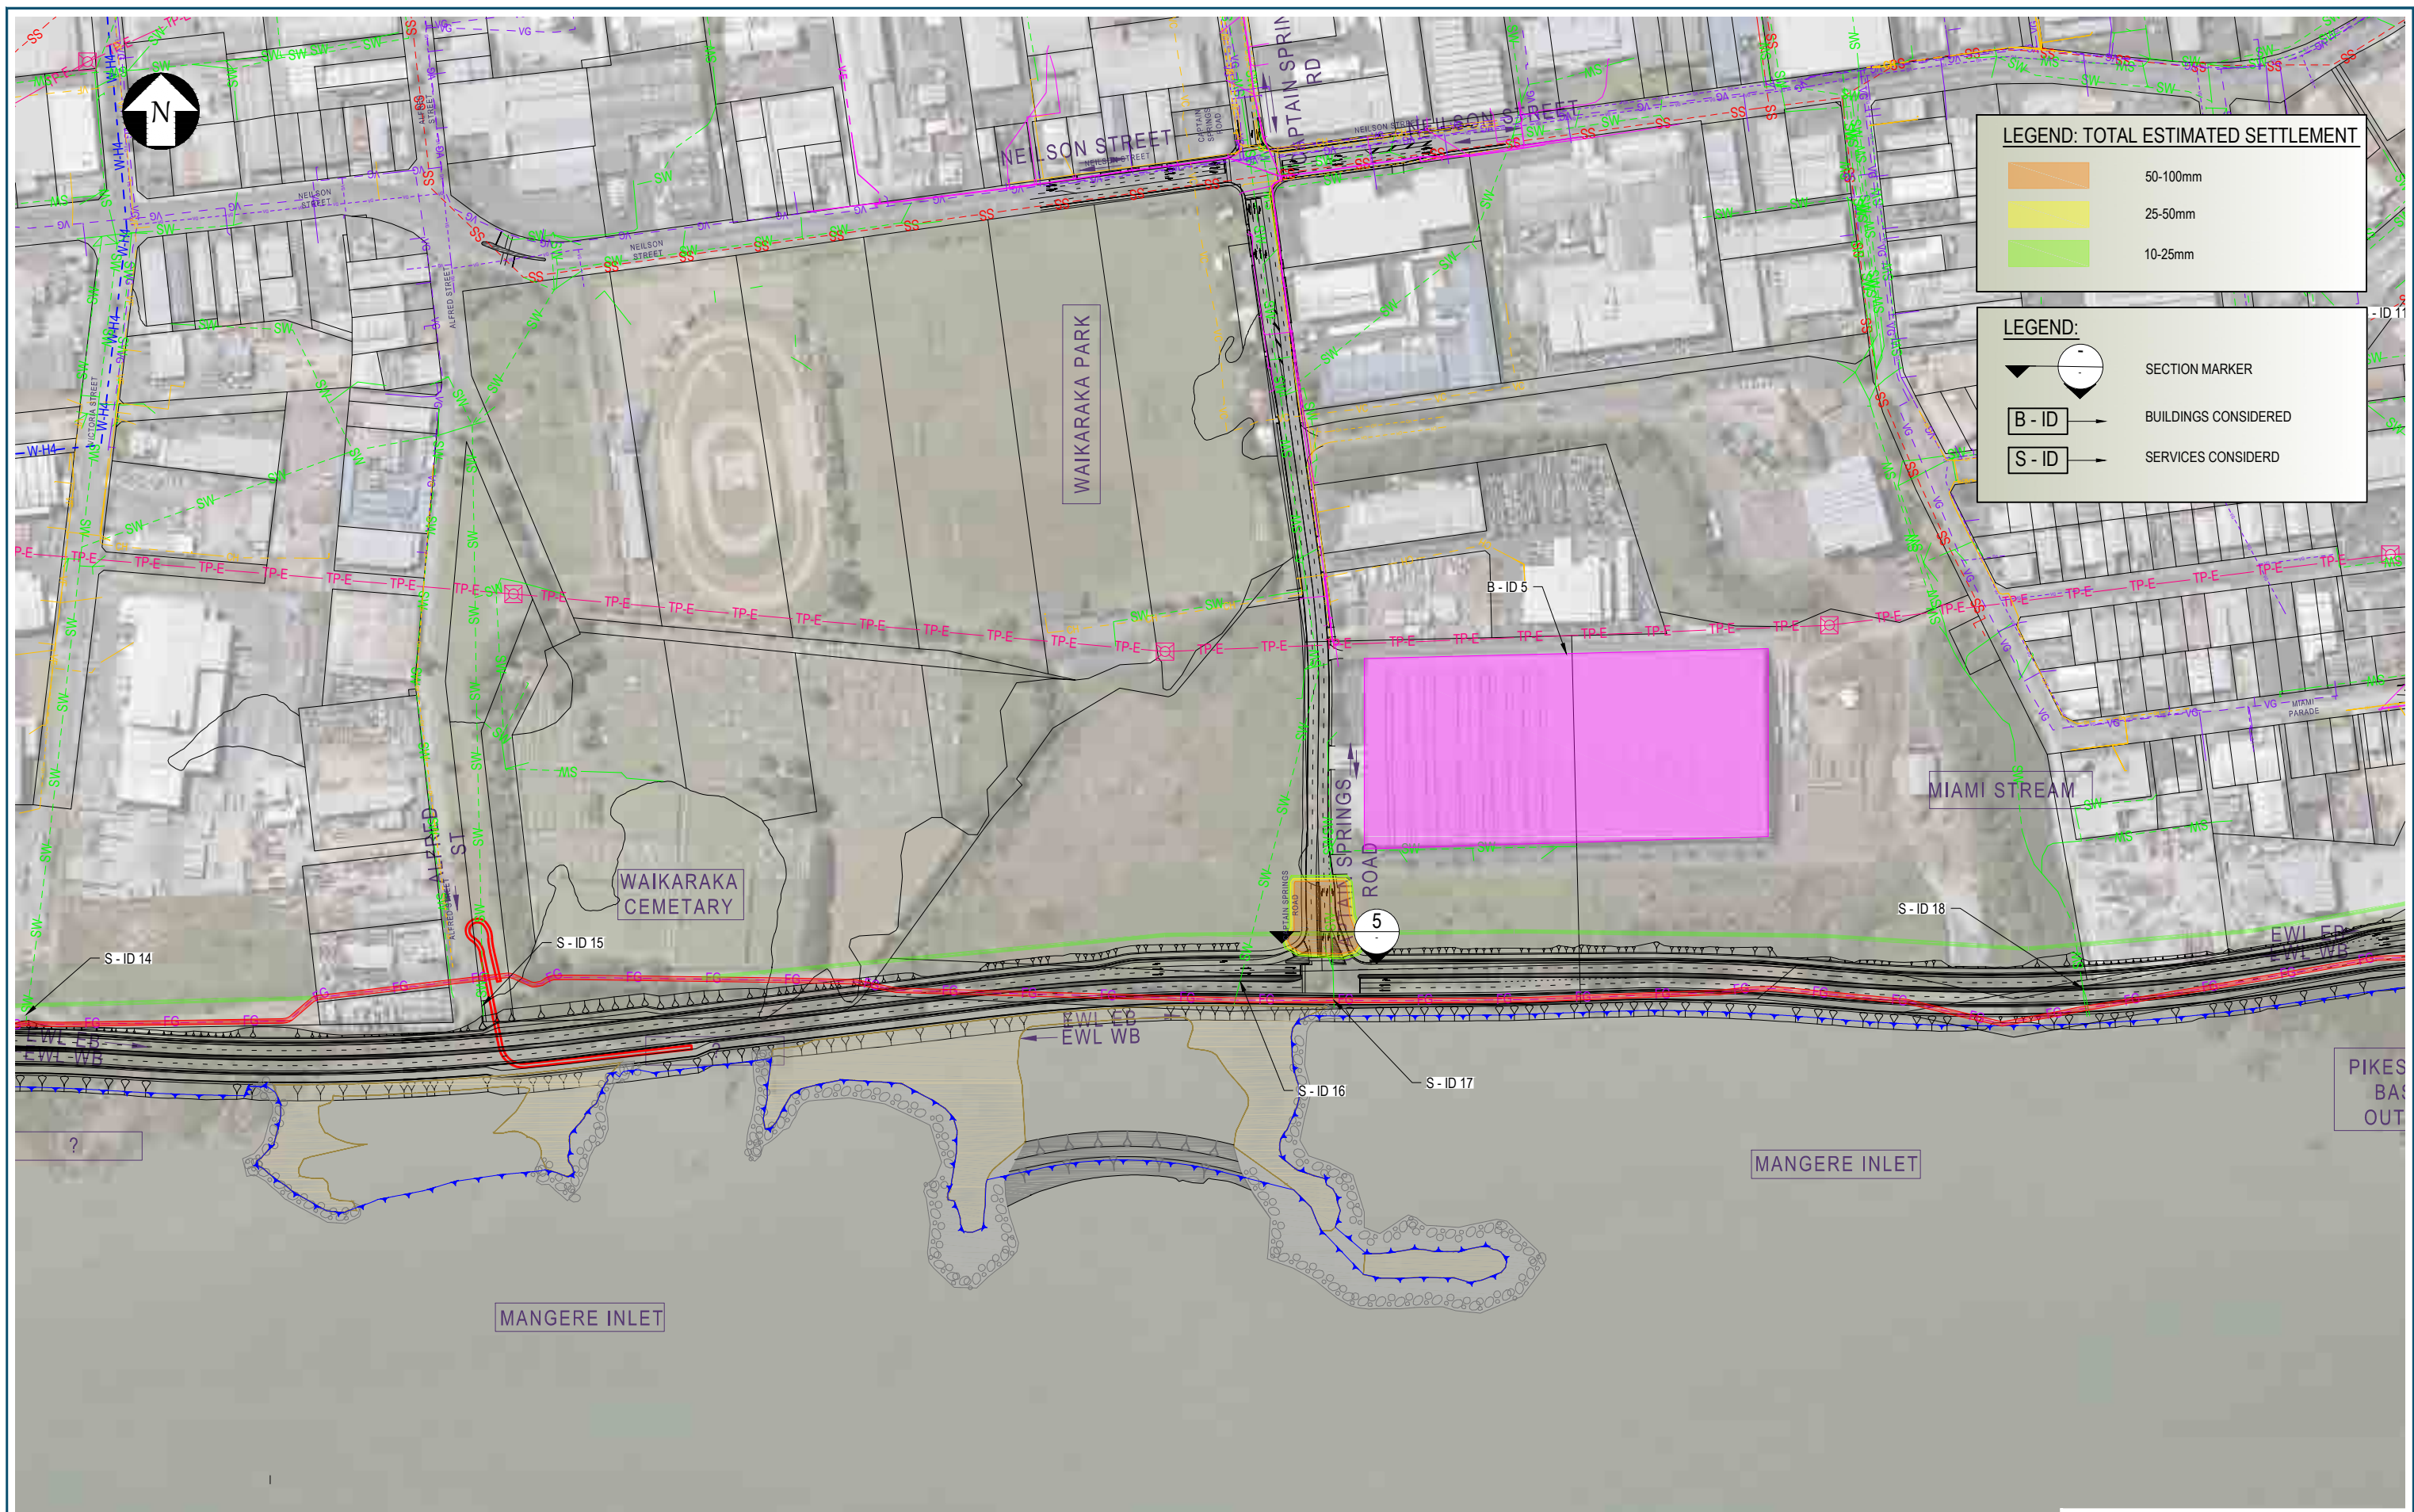
Drawing Title	GEOTECHNICAL TOTAL SETTLEMENT CONTOURS EMBANKMENT - SHEET 2	
Drawing Number	Z-EF-022	Rev No. B

- 50-100mm
- 25-50mm
- 10-25mm
