TECHNICAL REPORT 14

SETTLEMENT EFFECTS ASSESSMENT

NOVEMBER 2016

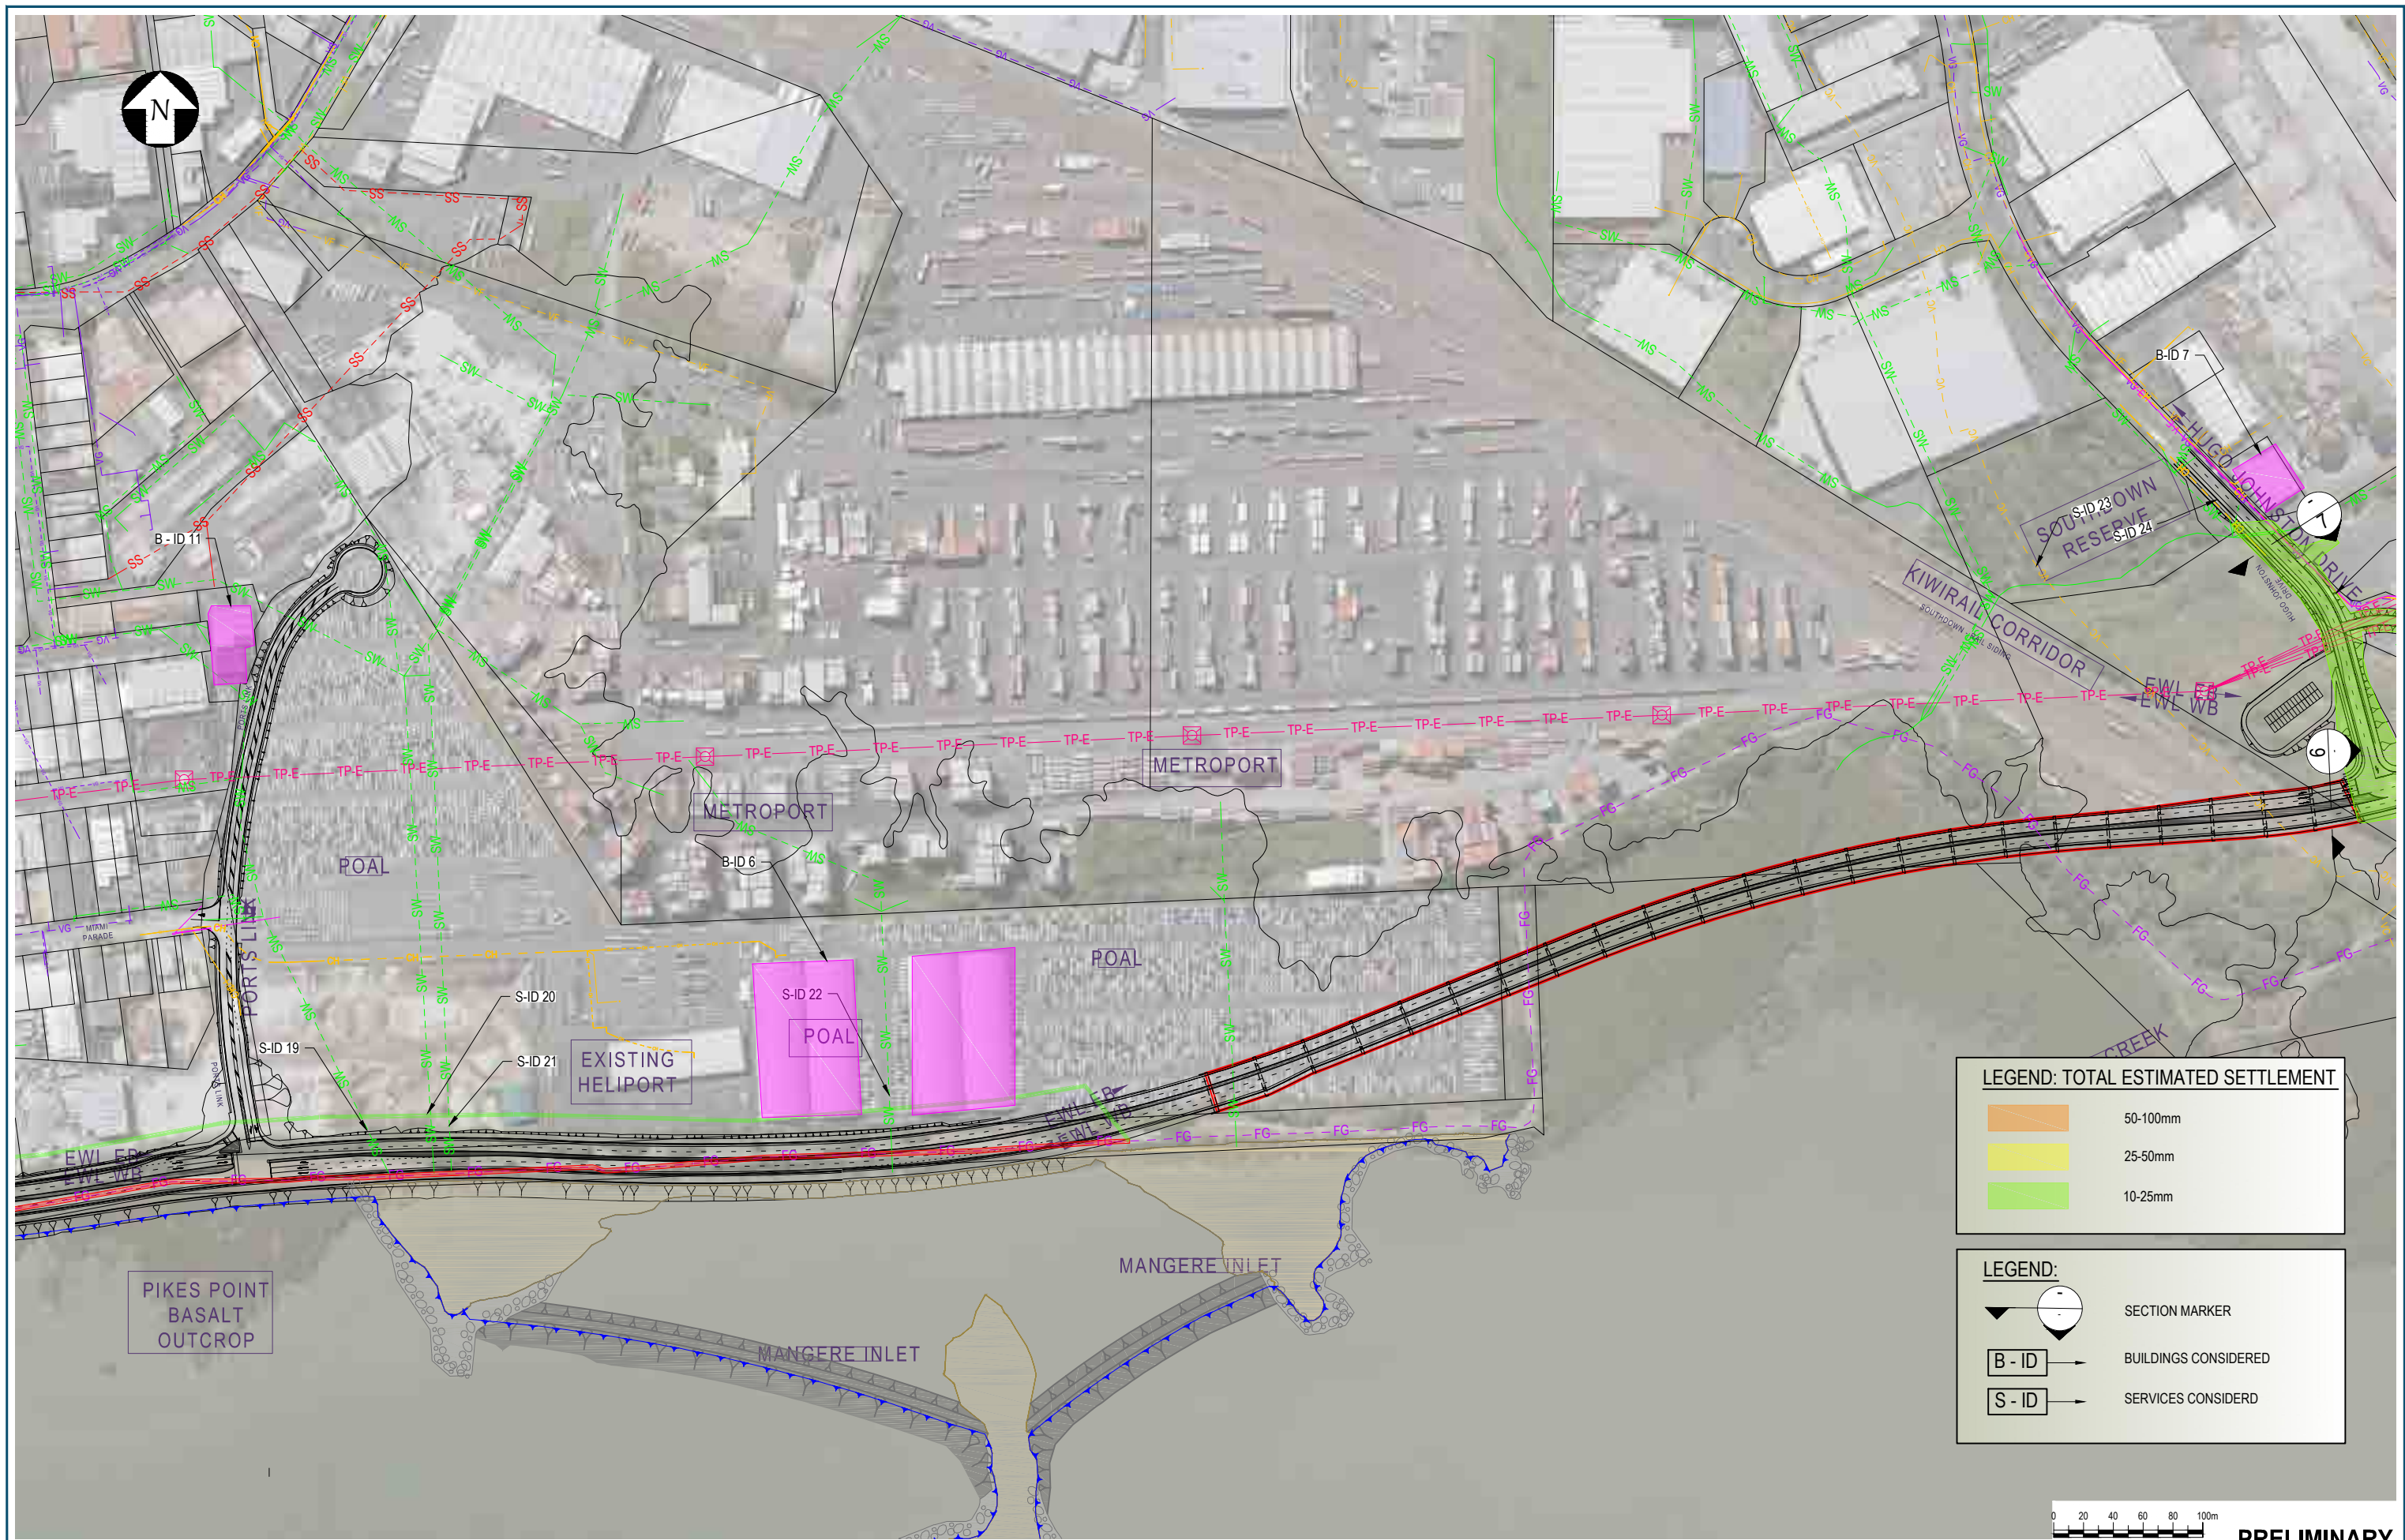
Drawing Title	GEOTECHNICAL TOTAL SETTLEMENT CONTOURS EMBANKMENT/ ANNS CREEK - SHEET 3	
Drawing Number	Z-EF-023	Rev No. B

50-100mm
	25-50mm
	10-25mm

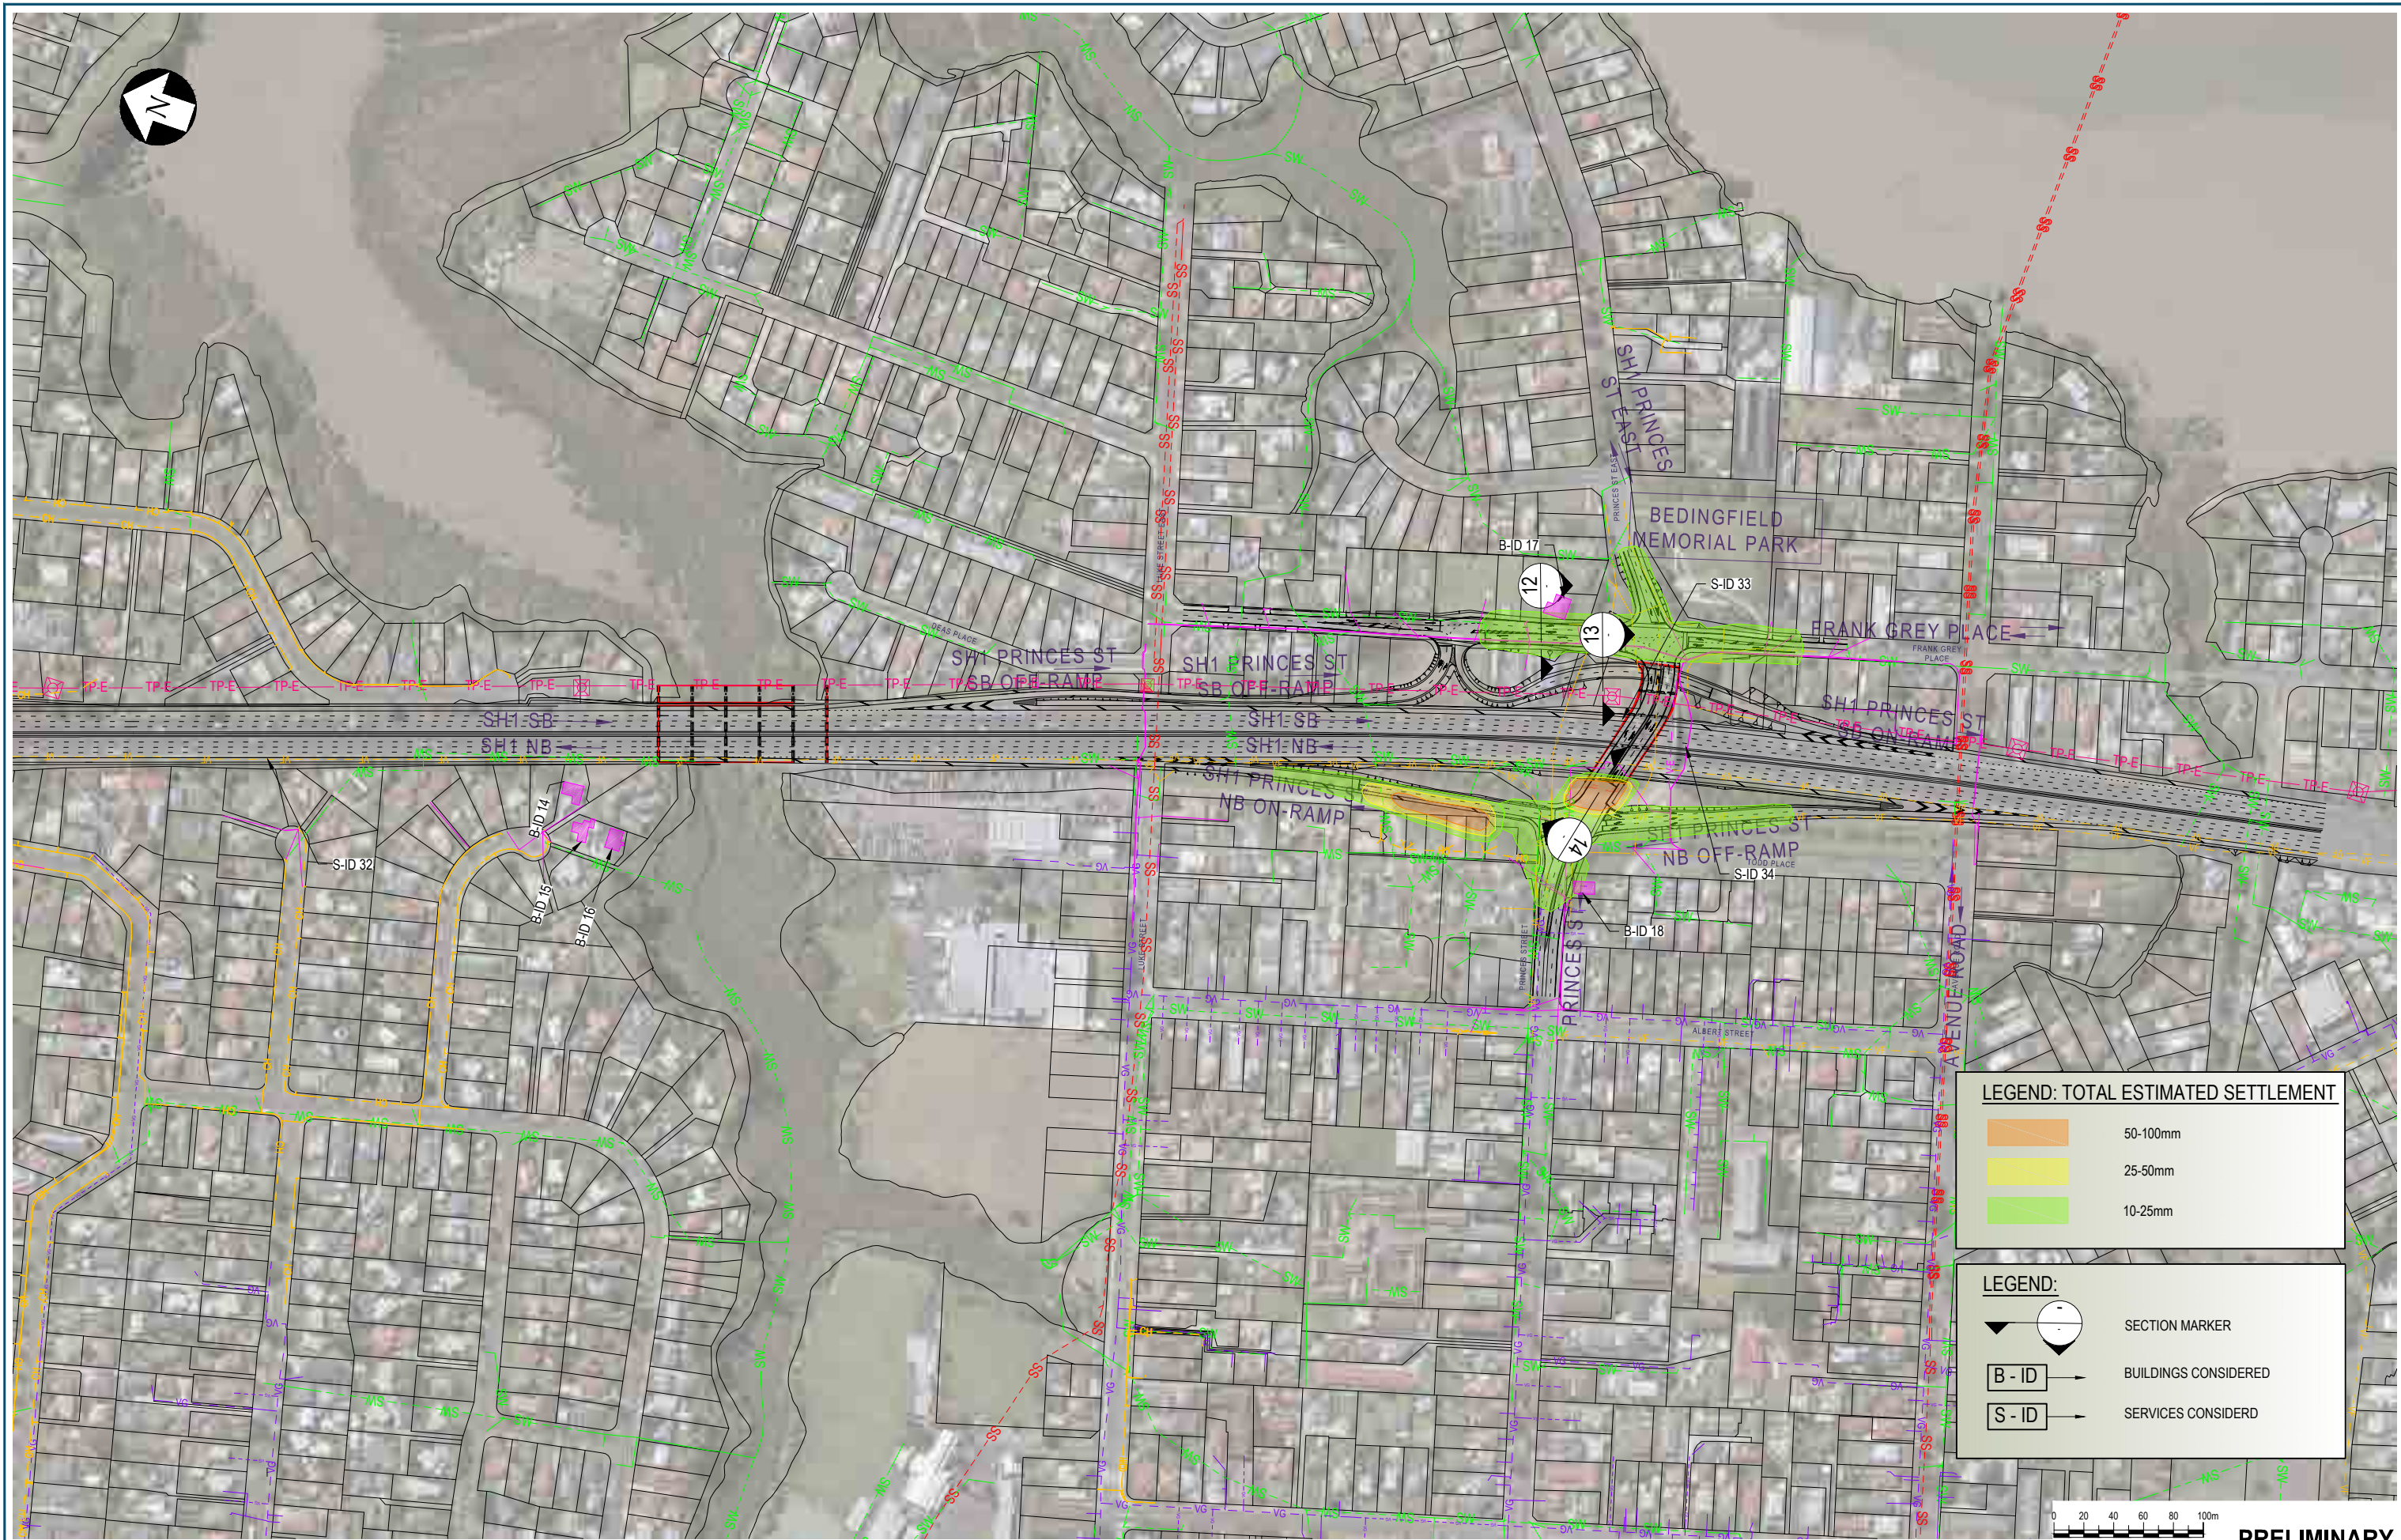
Drawing Title	GEOTECHNICAL TOTAL SETTLEMENT CONTOURS SH1/SYLVIA PARK RAMPS - SHEET 5	
Drawing Number	Z-EF-025	Rev No. B

LEGEND: TOTAL ESTIMATED SETTLEMENT

- 50-100mm
- 25-50mm
- 10-25mm

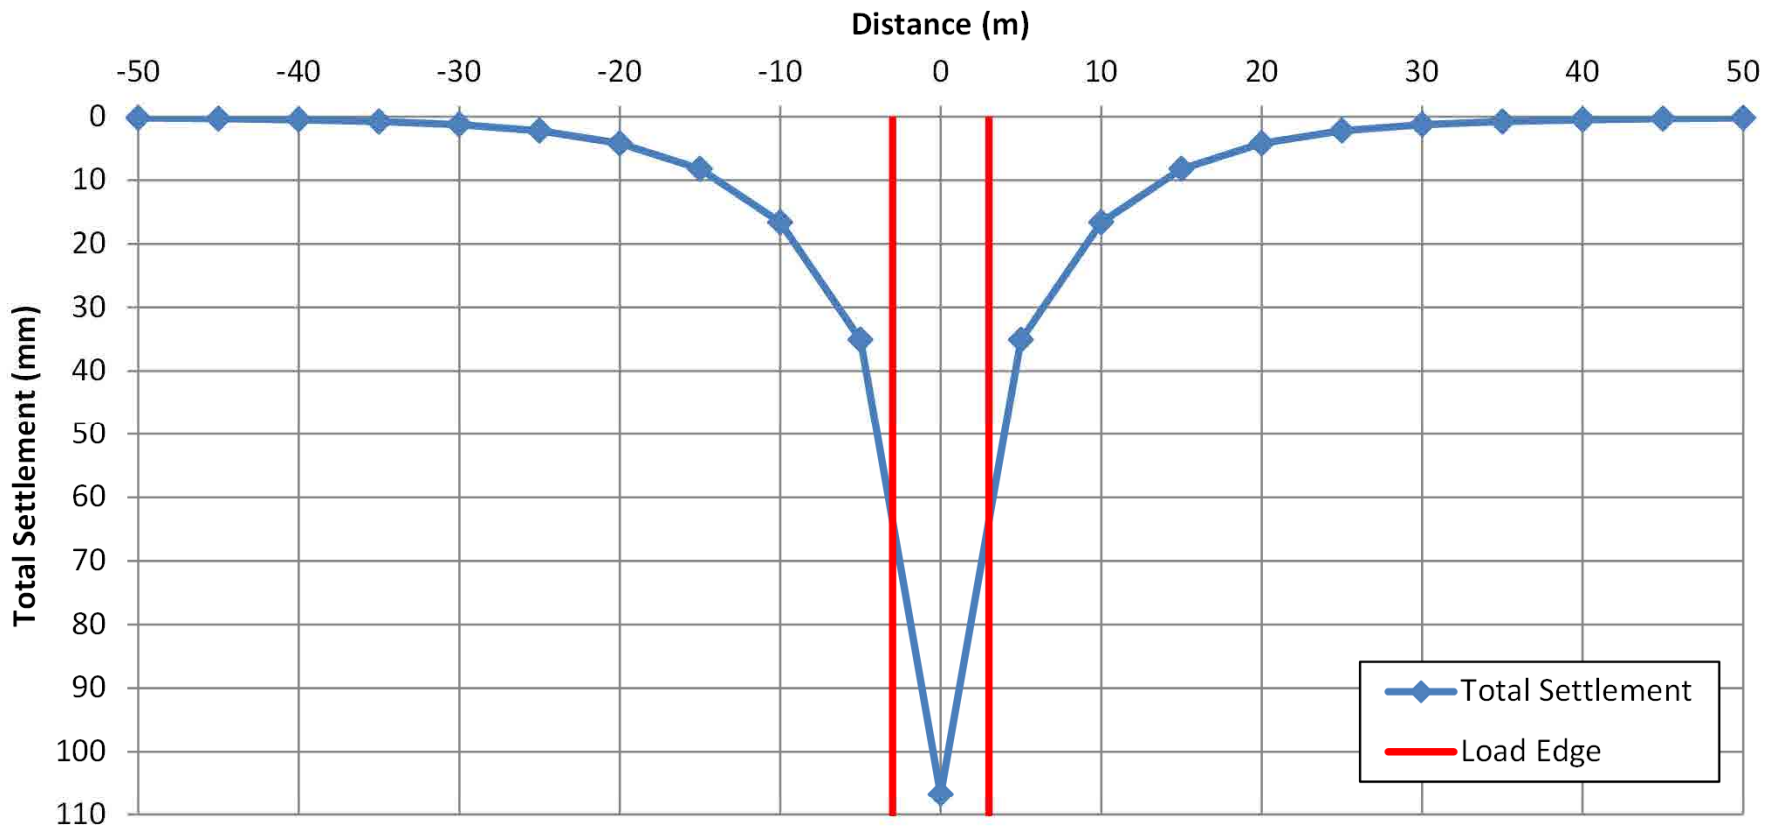
CH475 Section 3 - Distance vs. Total Settlement

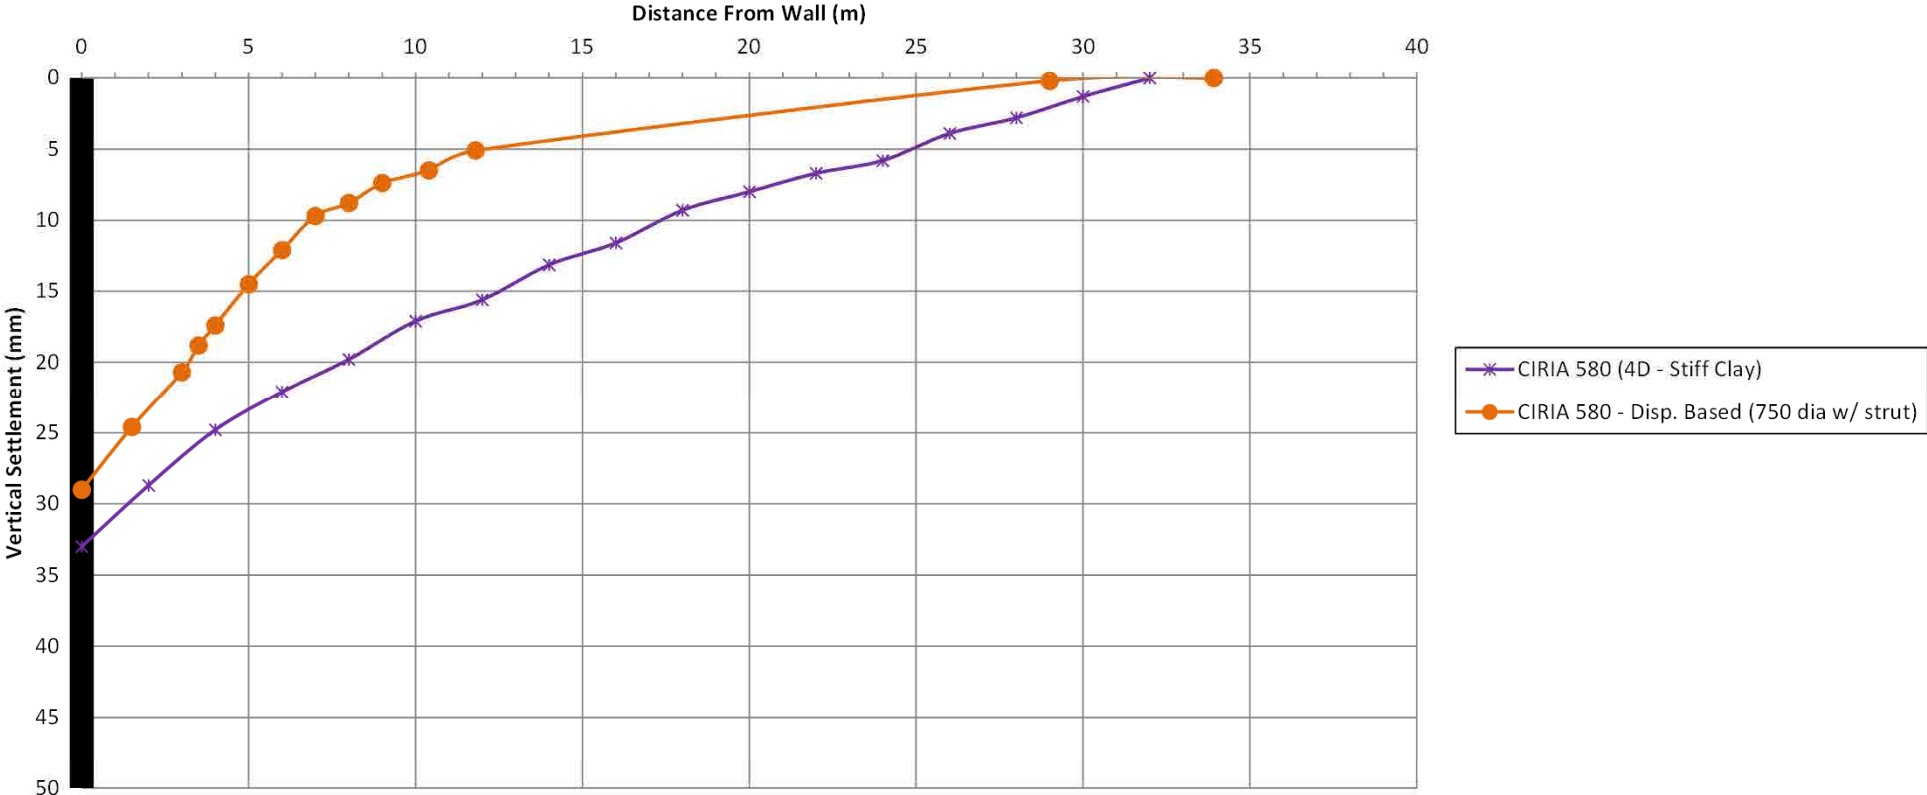
CH720 Section 4_Vertical Settlement behind Secant Pile Wall + GW drawdown settlement

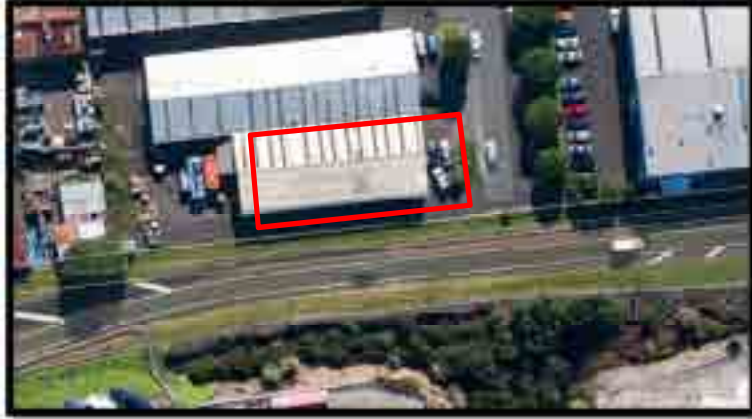
Figure 1: 2 to 2a Hill Street. Satellite view.

This is a portal frame building with concrete blockwork walls situated on the boundary of the construction designation and shown in Figures 1, 2 and 3. The walls are unlikely to be reinforced and are locally clad with steel. Due to the construction type this building is expected to be susceptible to visual cracking in the event of slight differential ground movement.

Building ID	Location	Calculated Settlement at closest point (mm)	Building Damage Category
B-ID 1	2–2a Hill St	<<10	Negligible
B-ID 2	3–5 Gloucester Park Rd	<<10	Negligible
B-ID 3	2–6 Onehunga Harbour Road	<<10	Negligible
B-ID 4	40 Victoria St	Nil	Negligible

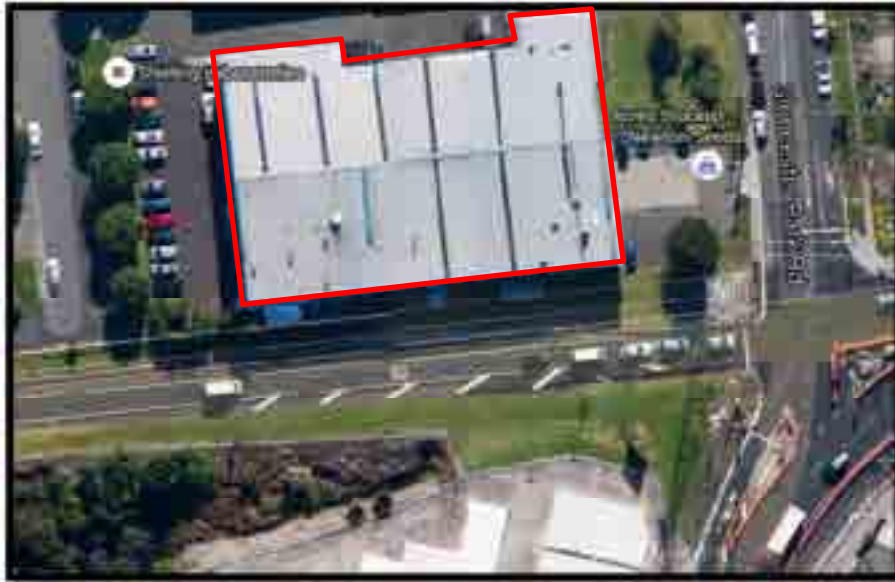
Figure 4: 3-5 Gloucester Park Road. Satellite view.

This is a reinforced concrete building with steel cladding situated on the boundary of the construction designation and shown in Figure 4 and Figure 5. The concrete walls are likely to be reinforced and are locally clad with corrugated steel. Due to the construction type this building is not expected to be susceptible to visual cracking in the event of slight differential ground movement.

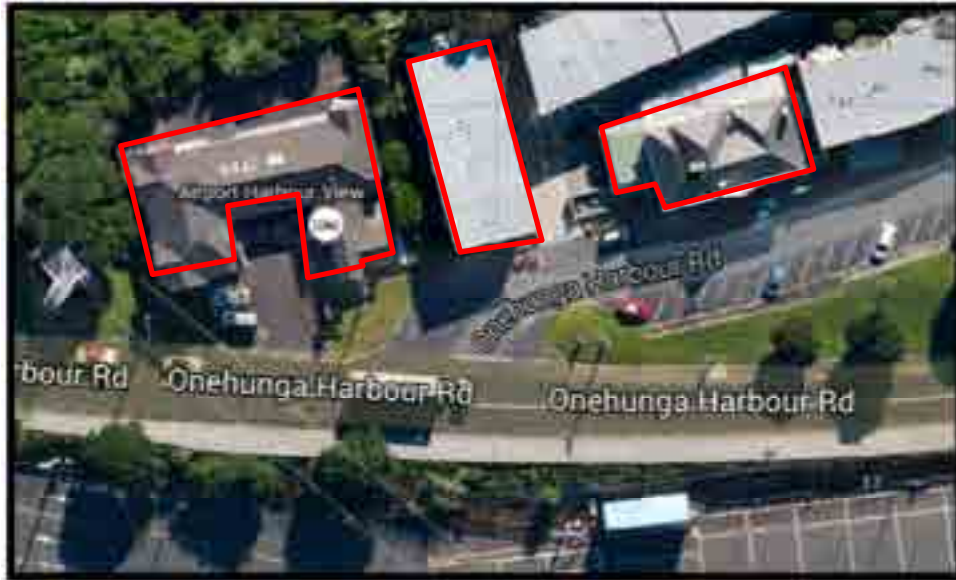
Figure 6: 2-6 Onehunga Harbour Road. Satellite view.

The three potentially affected buildings on this site comprise: a timber and plasterboard building (western most); plasterboard clad building (central building); and a concrete building (eastern most), which are all situated on the boundary of the construction designation and shown in Figures 6, 7 and 8. The western and central buildings (the motel and apartments) are likely timber frame with mainly plasterboard cladding. The eastern building (The Landing Restaurant and Bar) is a historic concrete building, surrounded by a basalt block wall, and is unlikely to be reinforced. Due to the construction type of these buildings, they are expected to be susceptible to visual cracking in the event of slight differential ground movement.

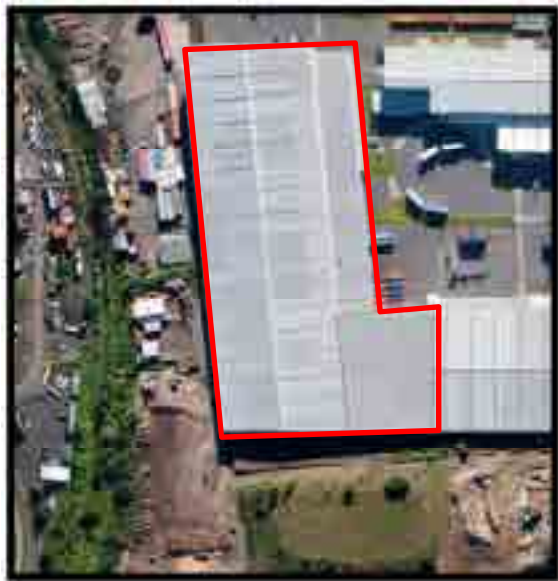
Figure 9: 40 Victoria Street. Satellite view.

This is a reinforced concrete panel building on the boundary of the construction designation and shown in Figures 9 and 10. This large scale distribution warehouse has a 10m high stud. The concrete walls are likely to be reinforced and there are steel clad portal frames on the northern side of the building footprint. Due to the construction type this building is not expected to be susceptible to visual cracking in the event of slight differential ground movement

The buildings outlined in Table 5-1 are assessed to have a “negligible” building damage category, as the calculated settlement arising from the Project is less than 10mm. The effects on building B-ID4 have been assessed as negligible as the cut is above the existing groundwater table and no drawdown and hence consolidation settlement is expected.

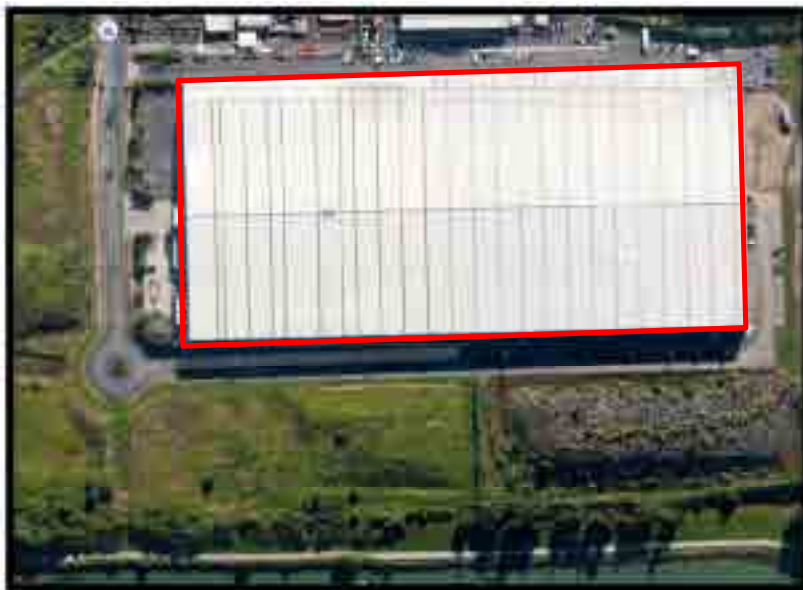
Figure 11: 69 Captain Springs Road (Seamount Building). Satellite view.

The Seamount building has a reinforced concrete base supporting steel cladding and roof, and is on the boundary of the construction designation. The building is shown in Figures 11 and 12. The concrete walls are likely to be reinforced and the building contains significant storage of, amongst other things, glass items. Due to the construction type this building is not expected to be susceptible to visual cracking in the event of slight differential ground movement.

Building ID	Location	Calculated Settlement at closest point (mm)	Building Damage Category
B-ID 5	69 Captain Springs Road	<10	Negligible
B-ID 11	63 Angle Street	<10	Negligible

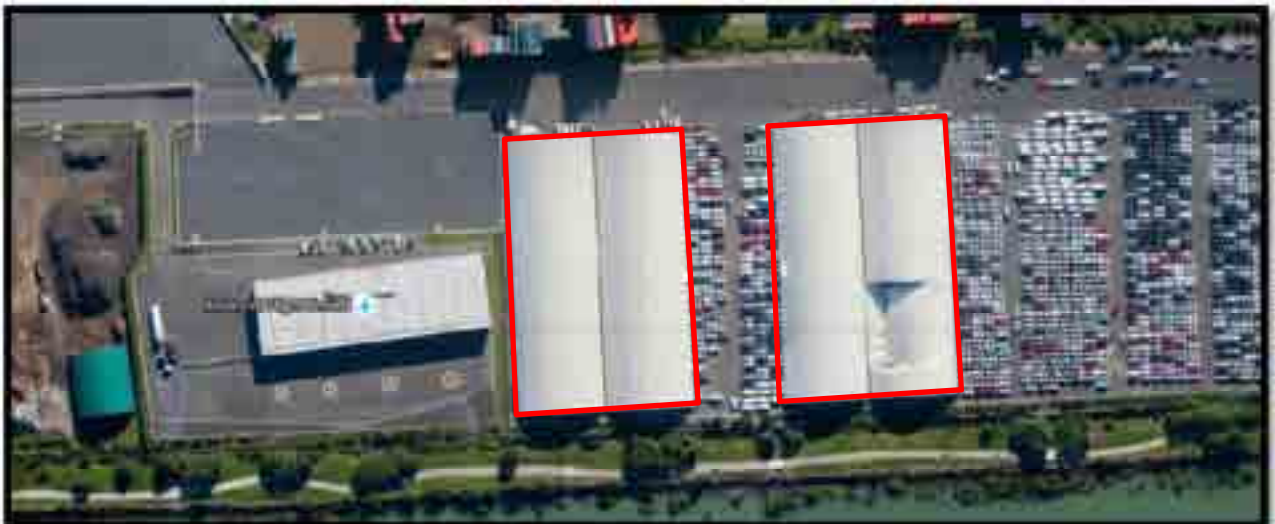
Figure 13: 59 Miami Parade (Car Distribution Group). Satellite view.

These are portal frame buildings with steel cladding on the boundary of the construction designation and shown in Figures 13 and 14. The walls are unlikely to be reinforced and are clad with steel. Due to the construction type this building is not expected to be susceptible to visual cracking in the event of slight differential ground movement.

Building ID	Location	Calculated Settlement at closest point (mm)	Building Damage Category
B-ID 6	59 Miami Parade	<10	Negligible

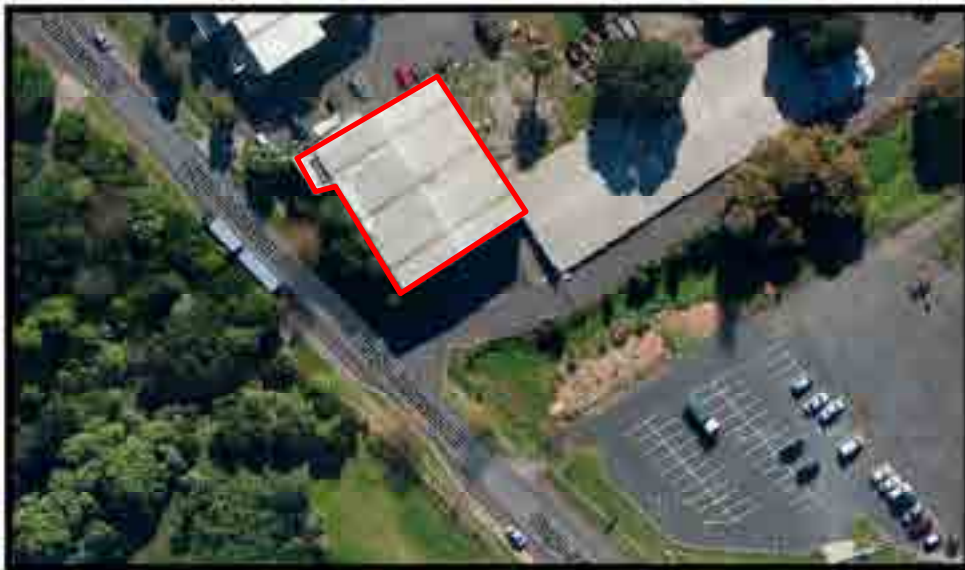
Figure 15: 140 Hugo Johnston Drive (Anton’s Seafoods). Satellite view.

This is a reinforced concrete building on the boundary of the construction designation and shown in Figures 15 and 16. The concrete walls are likely to be reinforced and the building has a localised glass

panel façade at its north-western end. Due to the construction type this building is expected to be susceptible to visual cracking in the event of slight differential ground movement

Building ID	Location	Calculated Settlement at closest point (mm)	Building Damage Category
B-ID 7	138 Hugo Johnston Drive	<<10	Negligible

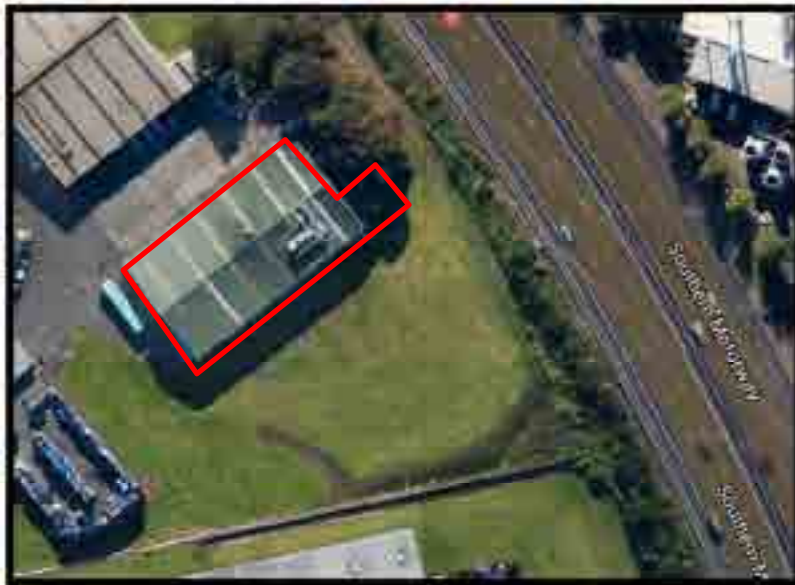
Figure 17: 5 Monahan Road (PPG Industries). Satellite view.

This is a concrete block building with steel cladding on the boundary of the construction designation and shown in Figures 17 and 18. The concrete blocks are likely to be reinforced. There is a small shed, assumed to be of steel construction, adjacent to the main building. Due to the construction type the buildings are not expected to be susceptible to visual cracking but the small block building is expected to be susceptible to visual cracking in the event of slight differential ground movement.

Building ID	Location	Calculated Settlement at closest point (mm)	Building Damage Category
B-ID 8	5 Monahan Road	Nil	Negligible
B-ID 9	7 Carmont Place	Nil	Negligible
B-ID 10	11 George Bourke Drive	Nil	Negligible
B-ID 12	112 Hillside Road	<<10	Negligible

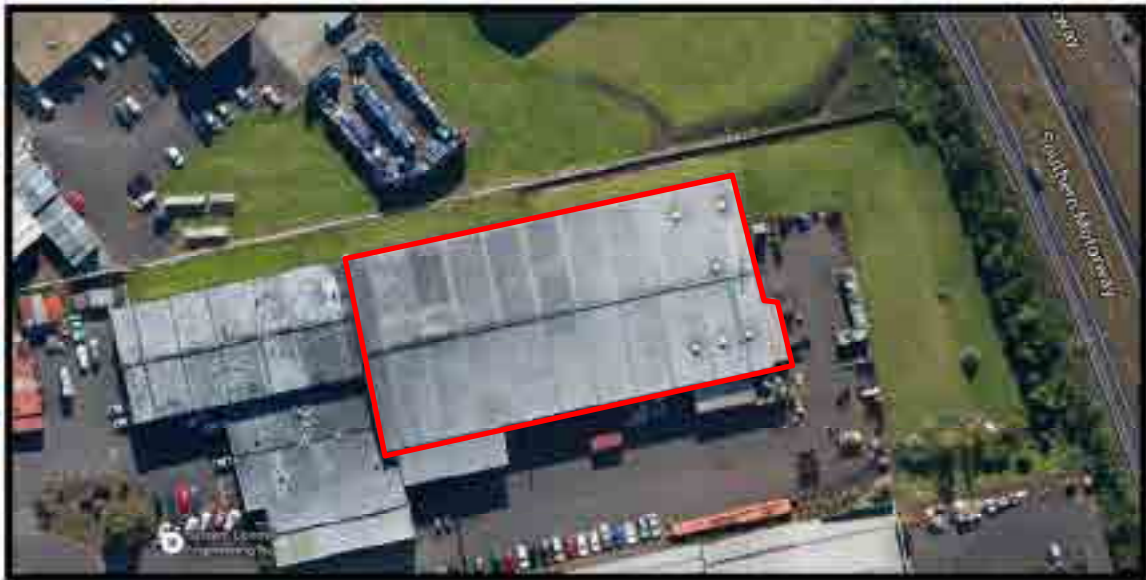
Figure 19: 7 Carmont Place. Satellite view.

This is a concrete panel building with steel cladding on the boundary of the construction designation and shown in Figures 19 and 20. The concrete panels are likely to be reinforced. Due to the construction type the main building is not expected to be susceptible to visual cracking in the event of slight differential ground movement.

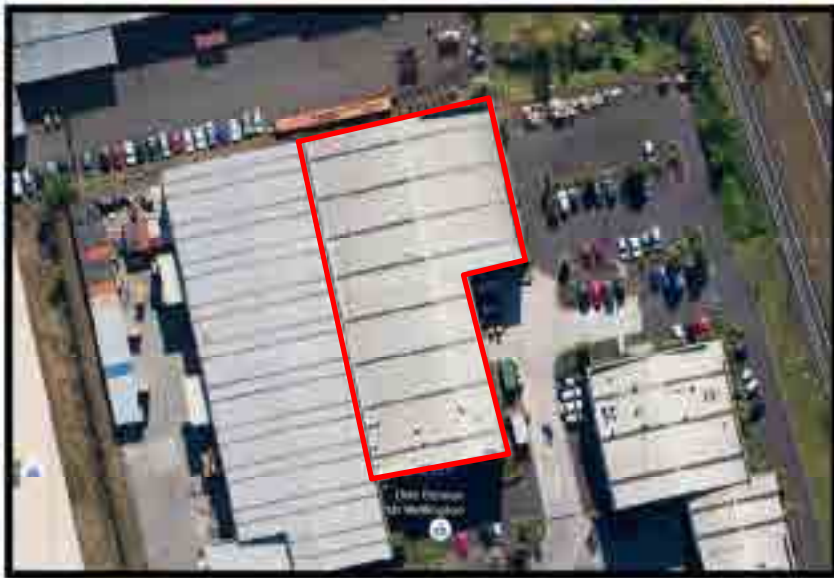
Figure 21: 11 George Bourke Drive. Satellite view

This is a reinforced concrete panel building on the boundary of the construction designation and shown in Figures 21 and 22. Due to the construction type the main building is not expected to be susceptible to visual cracking in the event of slight differential ground movement.

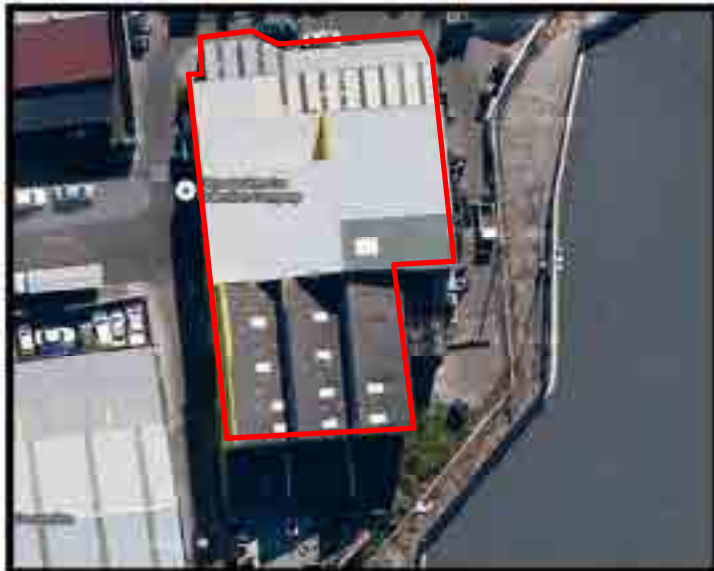
Figure 23: 63 Angle Street (Zebra Broken Car Collection Company). Satellite view

This is likely a concrete block building with steel cladding on the boundary of the construction designation and shown in Figures 23 and 24. The concrete panels are unlikely to be reinforced. Due to the construction type the main building is expected to be susceptible to visual cracking in the event of slight differential ground movement.

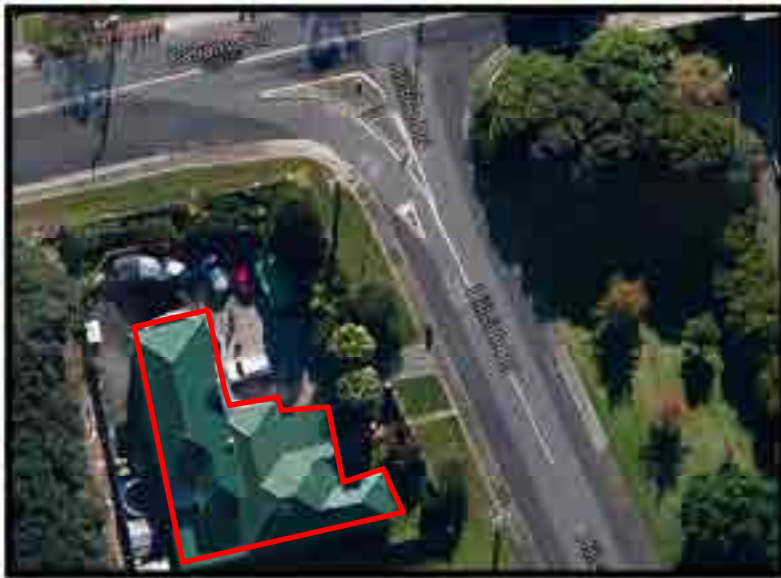
Figure 25: 112 Hillside Road. Satellite view.

This is a two storey plasterboard building constructed on shallow foundations situated on the boundary of the construction designation and shown in Figures 25 and 26. Due to the construction type, this building is expected to be susceptible to visual cracking in the event of slight differential ground movement.

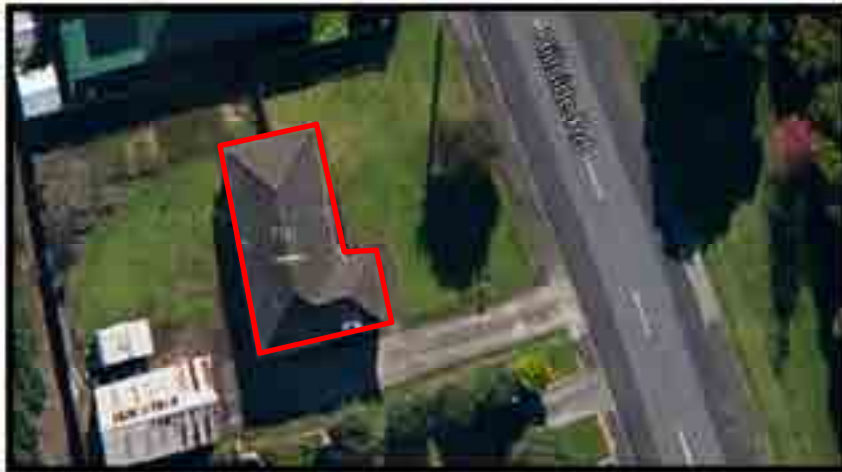
Figure 27: 110 Hillside Road. Satellite view

This is a single storey weatherboard building constructed on shallow foundations situated on the boundary of the construction designation and shown in Figures 27 and Figure 28. Due to the construction type, this building is not expected to be susceptible to visual cracking in the event of slight differential ground movement.

Building ID	Location	Calculated Settlement at closest point (mm)	Building Damage Category
B-ID 13	110 Hillside Road	<<10	Negligible
B-ID 14	16 Coppins Road	Nil	Negligible
B-ID 15	14 Coppins Road	Nil	Negligible
B-ID 16	14a Coppins Road	Nil	Negligible
B-ID 17	31/31a Frank Grey Place	<10	Negligible
B-ID 18	95 Princes Street	<10	Negligible

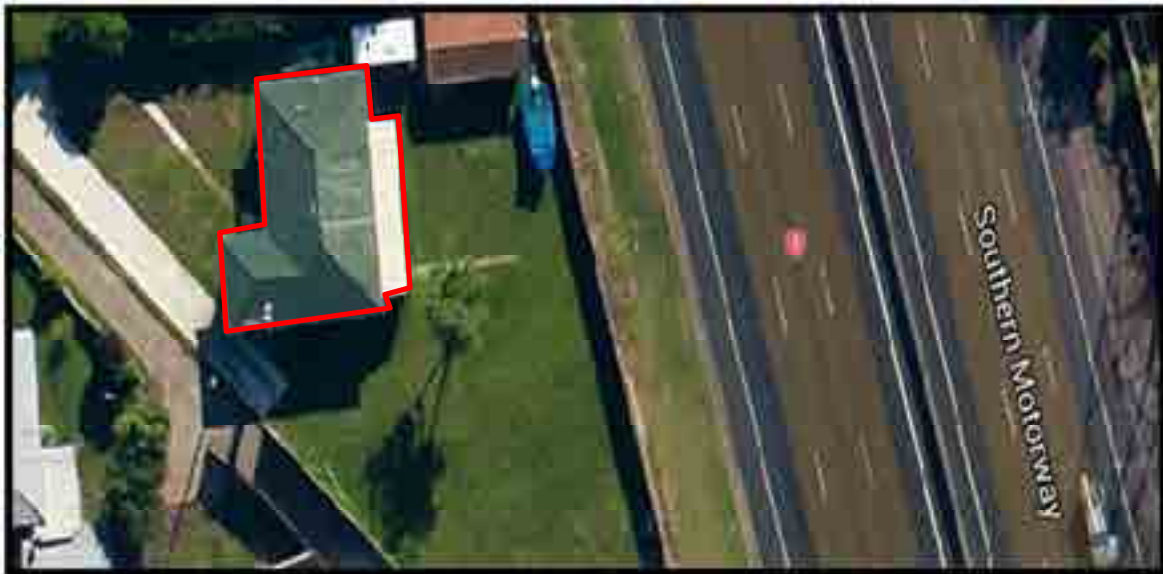
Figure 29: 16 Coppins Road. Satellite view

This is a single storey weatherboard building constructed on shallow foundations situated on the boundary of the construction designation and shown in Figure 26 and Figure 27. Due to the construction type, this building is not expected to be susceptible to visual cracking in the event of slight differential ground movement.

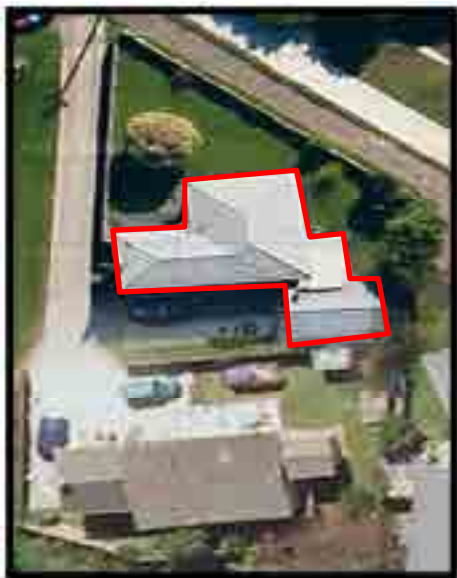
Figure 31: 14 Coppins Road. Satellite view.

This is a single storey weatherboard building constructed on shallow foundations situated on the boundary of the construction designation and shown in Figures 31 and 32. Due to the construction type, this building is not expected to be susceptible to visual cracking in the event of slight differential ground movement.

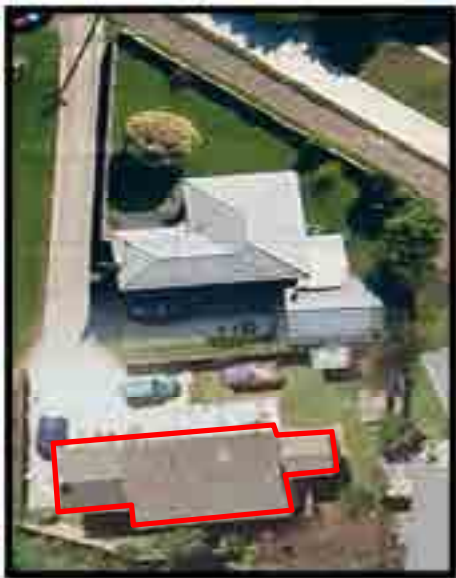
Figure 33: 14a Coppins Road. Satellite view.

This is a single storey weatherboard building constructed on shallow foundations situated on the boundary of the construction designation and shown in Figure 33 and Figure 34. Due to the construction type, this building is not expected to be susceptible to visual cracking in the event of slight differential ground movement.

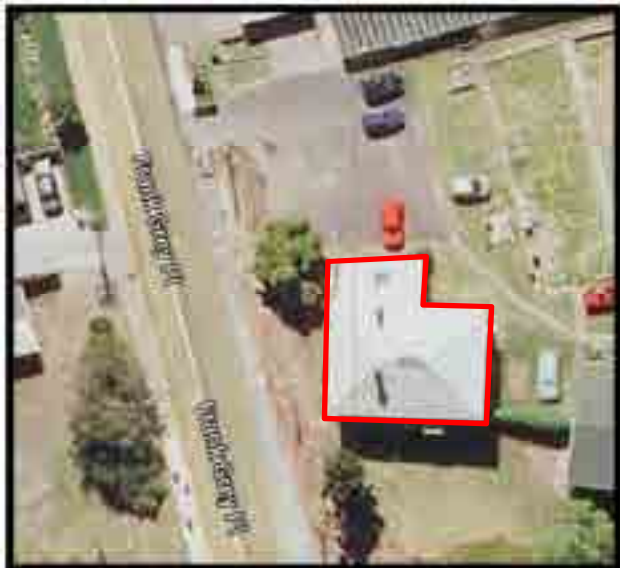
Figure 35: 31-31a Frank Grey Place. Satellite view.

This is a single storey weatherboard building constructed on shallow foundations situated on the boundary of the construction designation and shown in Figures 35 and 36. Due to the construction type, this building is not expected to be susceptible to visual cracking in the event of slight differential ground movement.

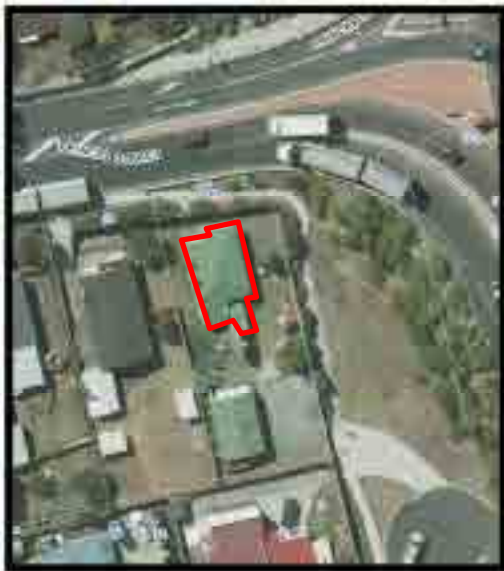
Figure 37: 95 Princes Street. Satellite view.

This is a single storey weatherboard building constructed on shallow foundations situated on the boundary of the construction designation and shown in Figures 37 and 38. Due to the construction type, this building is not expected to be susceptible to visual cracking in the event of slight differential ground movement.
