- 1. The purpose of this assessment is to determine as far as possible potential archaeological effects of the Project, and to develop recommendations to address any such effects. It is noted that some recommendations developed are subject either to approval under other legislation, most notably the HNZPTA 2014, or are constrained by other legislation. The Protected Objects Act (POA 1975) provides a legal process regarding discoveries of protected objects including Tāonga Tuturu, and the Coroners act (CA 2006) specifies additional required procedure in the event of discovery of Kōiwi (historical human remains) or any human remains. The NZ Transport Agency have also developed an Accidental Archaeological Discovery Specification, and the decision version of the Auckland Unitary Plan has additional specification of Accidental Discovery Protocols for Archaeological Sites.

Figure 1-1: The archaeological study area, sectors 1-3 and Sector 6

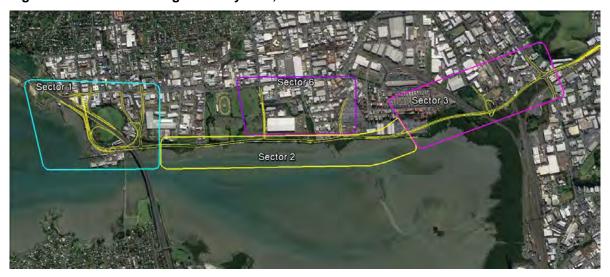
The study area for this assessment comprises principally the footprint of works, in regard to assessing effects. Full details of temporary construction areas, services trenching etc. are not yet available. It is also in the nature of archaeological assessments, which necessarily take a landscape approach to developing archaeological formation theory for a project area, to look beyond the immediate footprint of works and to understand broader landscape patterns of archaeological formation processes, where these are of relevance to the Project, including the patterns of human occupation in both pre-European times and after the arrival of European settlers. The study area, and sector divisions used in discussion, are defined as shown in Figure 1-1 and Figure 1-2, with the footprint of works shown in yellow.

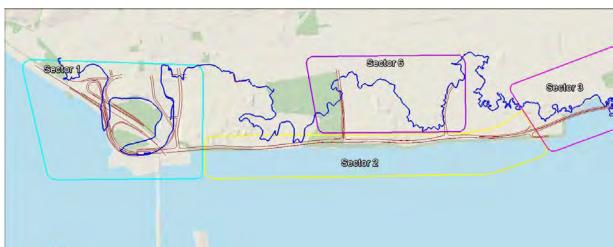
Figure 5-1: Digital terrain information for the western part of the Project (source Auckland Council GIS)

This data provides overview of modern altered terrain details and current shorelines. The vast majority of the study area has been subject to various cut or fill landscape modifications. The details of such modifications need to be considered in assessing archaeological values or potential for these to be present, and in assessing potential archaeological effects. Places that are the transition from cut to fill, and places that have been filled but where deep excavation earthworks are planned, are those where *in-situ* traces of earlier times may be discovered and/or affected.

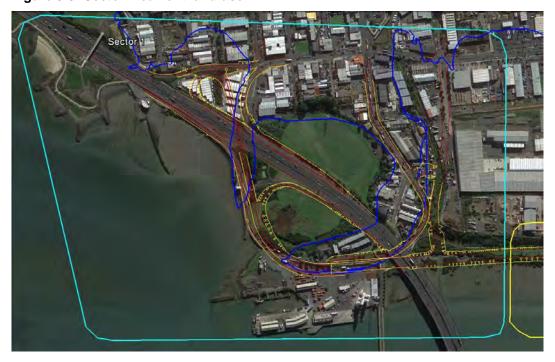
Figure 5-3: Sector 1 current land use

Sector 1 current land use (Figure 5-3) includes road and motorway, port facilities, town allotments with buildings, a railway line, and one historic structure (the rail overbridge to the north of the Old Māngere Bridge). The latter may incorporate older pre-1900 archaeological remains of the earlier rail overbridge

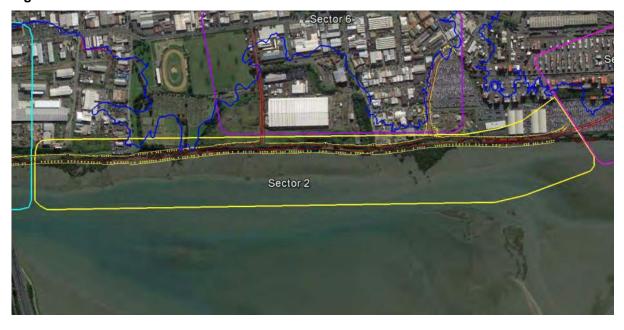
Figure 5-4: Sector 2 current land use

Sector 2 comprises almost exclusively harbour areas, but includes some reclaimed land (Figure 5-4).

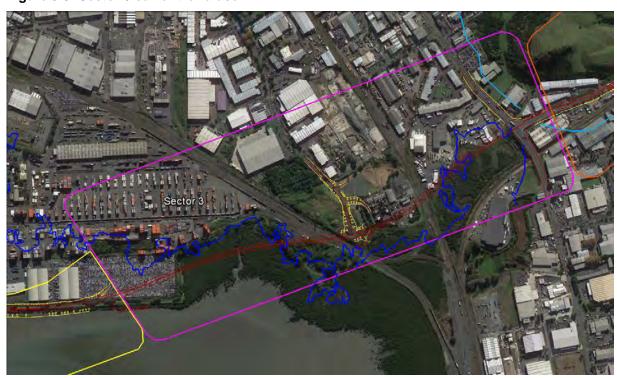
Figure 5-5: Sector 3 current land use

Sector 3 proposed works are principally raised structure for the main arterial road, with an embanked feeder road. Sector 3 current land use (Figure 5-5) includes reclaimed land, harbour and foreshore areas, but no areas that were formerly 19th century land are to be affected by the current proposed Sector 3 works, with the possible exception of areas destined for structural foundations for the elevated structure. These latter areas are discussed in more detail in the effects section of this report.

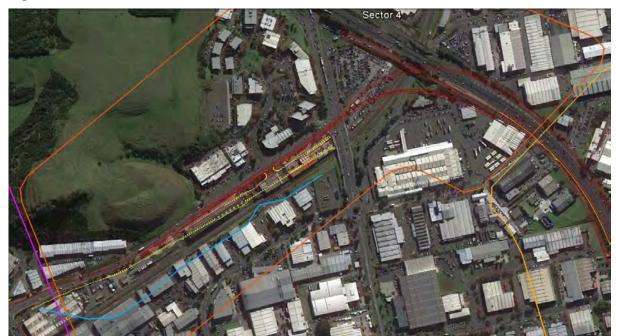
Figure 5-6: Sector 4 current land use

Sector 4 land use within the study area (Figure 5-6) was mostly paved roadway. An area of grassed road berm along the southern edge of Mutukāroa-Hamlins Hill, within the footprint of proposed works, was, at the time of writing, a smooth battered slope of grass, part of a large-scale cut-and-fill commercial development area. The road verge was grassed, with evidence of services present. The land to the south of Sylvia Park Road falls away to former rail yards to the north of the railway line. Works in this area would comprise added fill on the approaches to the Mt Wellington Highway, to provide a new intersection approach ramp.

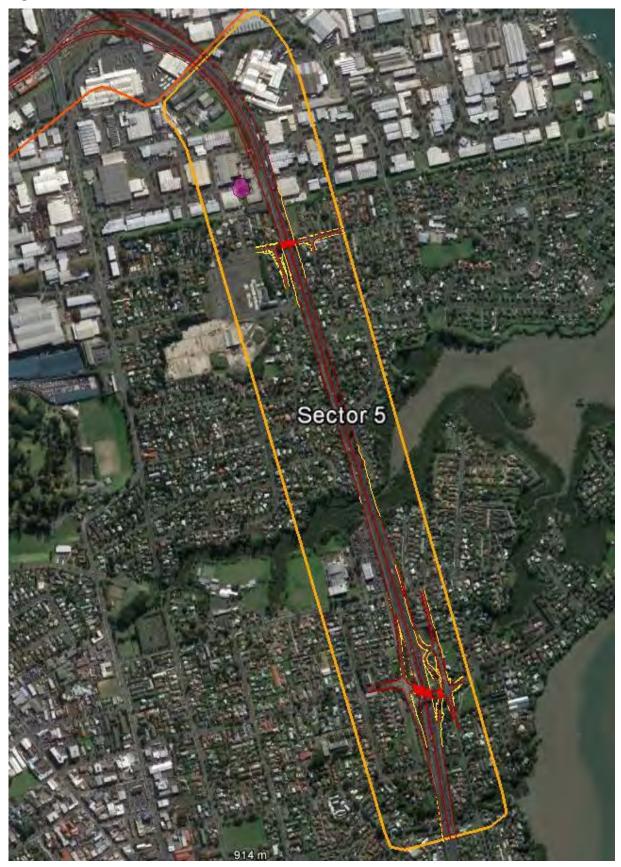
Figure 5-7: Sector 5 current land use

Sector 5 study area (Figure 5-7) includes motorway shoulders/berms, intersection upgrade areas at Panama Road. and Princes Street, and reclamation areas where SH1 crosses the Ōtāhuhu Creek. These land uses precluded any systematic physical assessment of archaeological values or effects. Consideration was given to seeking an arrangement with the Auckland Motorway Alliance to carry out spade or probe prospection but this was deemed impractical, given the scale of the motorway system and the expectation based on preliminary assessment that archaeological remains are likely to be very restricted in geographic scale and thus difficult to locate without significant scale of subsurface prospection.

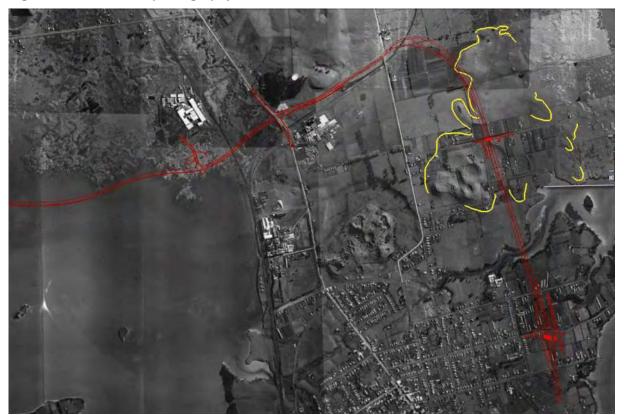
Figure 5-9: 1940 aerial photography sourced from the Auckland Council GIS Viewer

The 1940 air photograph series, accessed via the Auckland Council online GIS viewer, provides additional insight into ancient Māori Settlement in Sectors 3-5 (Figure 5-9 provides an overview, but he detail can only be seen by referring to the information in the Auckland Council online GIS). Sector 1 had been quite modified from its ancient landscape by 1940. Sector 3 includes the Southdown early 20th century industrial complex, which does not, however, obscure any large area of existing landforms etc. at that time. Reference to the 1940 photographs in more detail does not show any obvious signs of Māori settlement in the area of proposed works in Sector 3. Sectors 4 and 5 had been modified by swamp drainage and agriculture by 1940, but landforms and traces of former Māori settlement were still plentiful in Sectors 4 and 5 1940, and are informative. The data from these is discussed more fully in sections reviewing previous archaeological work. The yellow lines in Figure 5-9 indicates areas where conspicuous archaeological evidence relating to the Te Apunga o Tainui area is identifiable with reference to the 1940 air photograph coverage in Auckland Council's online GIS viewer.

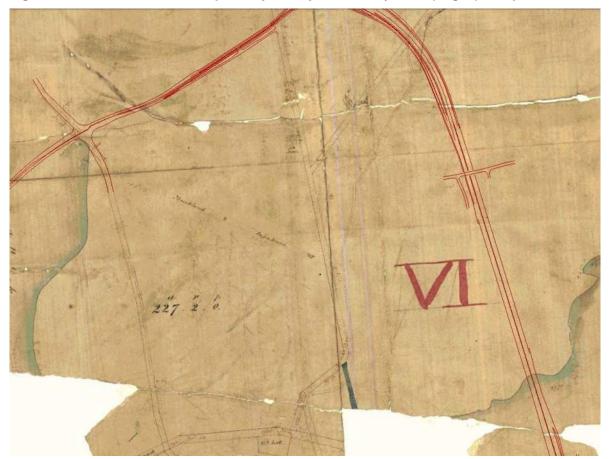
Figure 5-11: Detail from SO 672, possibly surveyed 1840s by John (Logan) Campbell

In 1838 another CMS missionary, James Hamlin, brought the land adjoining Fairburn's grant (Claim 904, OLC 62 and Figure 5-11). Historic Survey Plan SO 672 (Figure 5-11) was surveyed by John Campbell, so was probably an early 1840s survey plan, or a plan prepared for land commission hearings some years later. The road layout shown may well postdate the original survey, and may be the road layout of the Fencibles years. It shows a "Church Lot" bordering the south side of Portage Road, and what is either a cart track or a foot track linking the portage with the Tāmaki in the vicinity of Mokoia headland Pā, from where deeper-draft trading vessels such as cutters maintained water trade with Auckland. The track skirts the hill at Tip Top corner (Sector 5). Roads shown on the plan probably postdate 1849, because the street Anne's Bridge is thought to have been built as a road link from Ōtāhuhu north about then.

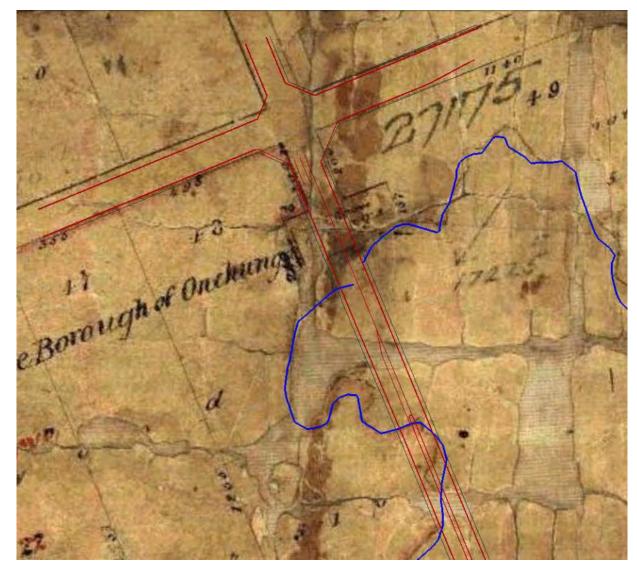
Figure 5-16: Proposed works at Captain Springs Road and Nielson Street intersection in relation to detail from SO 683

A former landing reserve is shown on what is now Captain Springs Road on SO 683. This area would have been the focus of some level of activity by the Fencibles military pensioner settlers, and was also a refugee area in the 1860s.

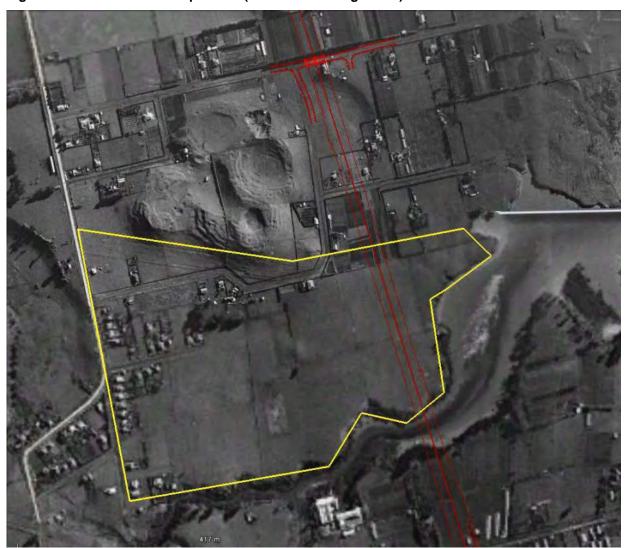
Figure 5-19: Extents of "Camp Farm" (after CFG Heritage 2012)

The lands to the south of the Te Apunga o Tainui volcanic cone settlement complex were used as the site of one of largest military encampments associated with the Land Wars of the 1860s. By May 1861 2,000 soldiers were camped at Ōtāhuhu (see for example The Aucklander, 16/5/1861, p. 3, col. 2), with Auckland commentators at the time confident that the government was planning to invade the Waikato. Sector 5 of the Project crosses the land formerly known as "Camp Farm" (Campbell, 2013)(Figure 5-19).

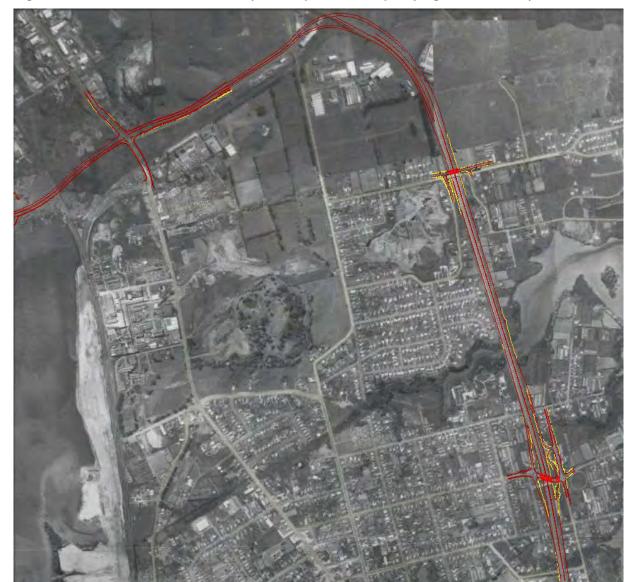
By 1959 the southern motorway had been constructed, amid a landscape drastically changed from that of 1940 (Figure 5-23). Camp Farm had been developed for housing, along with other large blocks of land, with more land under development at that time. The terraced volcanic cone component of the Te Apunga o Tainui complex was by this time largely destroyed as an archaeological site. The southern motorway had been cut and filled through this landscape to a greater degree than the modifications which had occurred for housing.

Figure 5-23: Residential and motorway development, and quarrying, in Sector 5 by 1959

The lands adjacent to SH1, although developed for housing, were visibly subject to a much lesser degree of modification than the motorway itself. This means that land to be affected by installation of retaining walls etc. for Sector 5 widening and addition of extra lanes may be relatively unmodified in places, although these are expected to be very limited in extent. Some specific areas would thus warrant careful monitoring for archaeological remains.

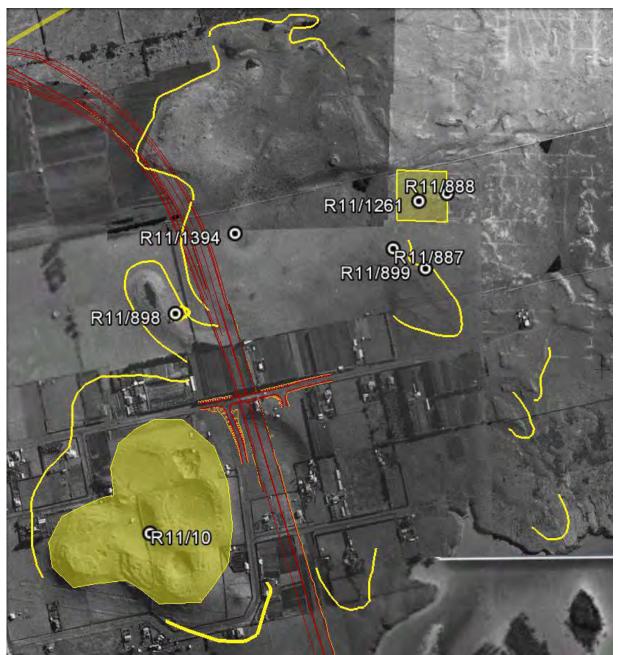
Sector 5 works are proposed in what was formerly an extensive archaeological complex, of which small-scale traces may well be encountered during proposed works. This archaeological complex has been recorded as a variety of NZAA records, with the most conspicuous, and formerly rich, record being R11/10, pertaining to settlement on the major volcanic cone component of the complex. A summary of these, overlain of the 1940 Air Photograph to illustrate the former landscape, is shown in Figure 5-32. The yellow linework added indicates areas of the landscape particularly suited to Māori settlement and gardening, on which traces of settlement can be seen on the 1940 air photograph when viewed in detail in the Auckland Council online GIS viewer.

Figure 5-32: Te Apunga o Tainui archaeological landscape interpretation from 1940 Air photographs

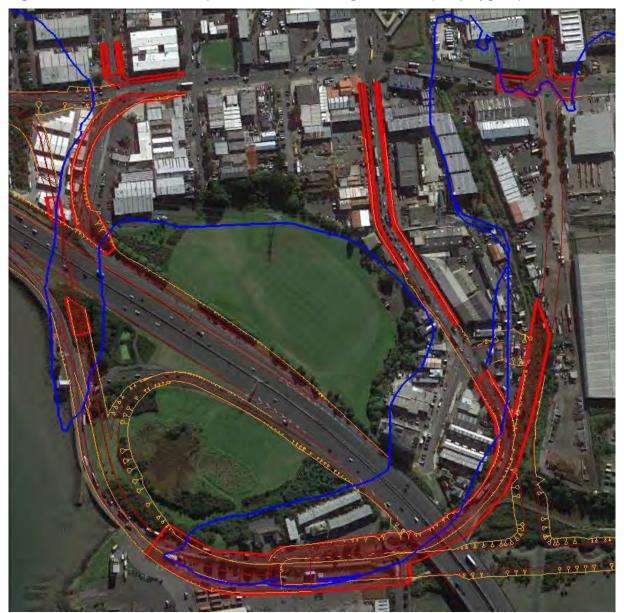
Figure 7-1: Sector 1 areas with potential for archaeological effects (red polygons)

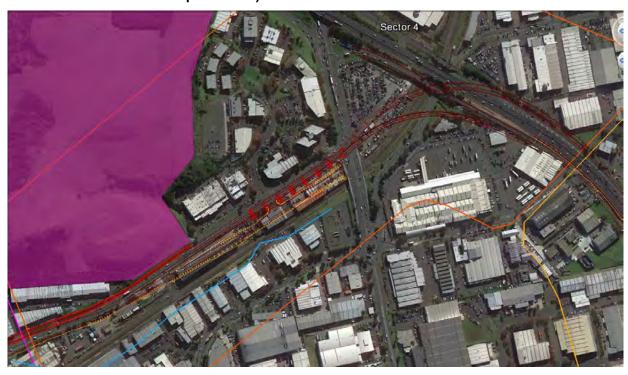
Figure 7-3: Sector 4 areas with potential for archaeological effects (structural column foundations in former swamp excluded)

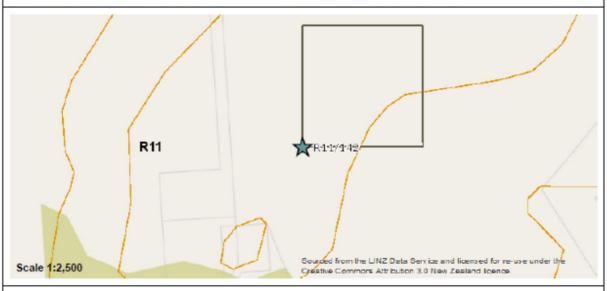
IMPERIAL SITE NUMBER: N42/137 METRIC SITE NUMBER: R11/142

There are at least three occupation areas - the spur, southern section of main ridge and northern end of main ridge.

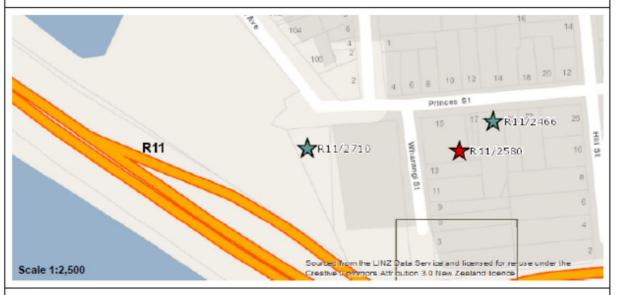
Western end of Princes Street, Onehunga.

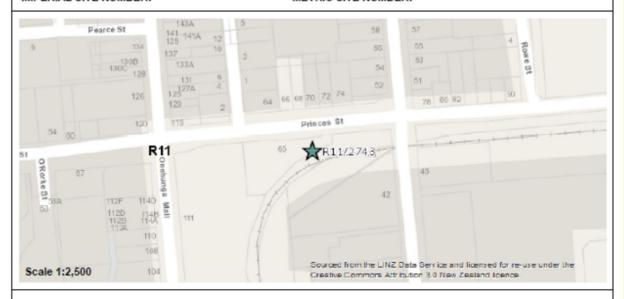
The Onehunga Branch Line (OBL) originally ran from the Penrose Junction at the Penrose Railway Station to the Onehunga Wharf. The original Onehunga Railway Station was located at 65 Princes Street, Onehunga, Auckland.

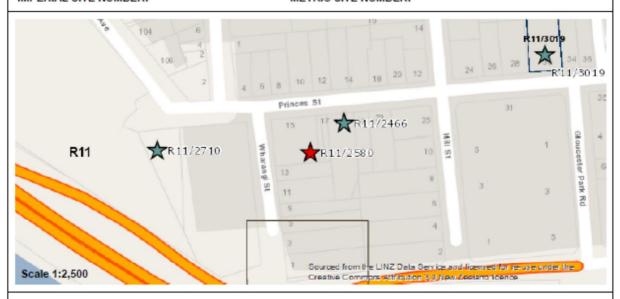
13 - 17 Princes Street and 9 - 13 Wharangi Street, Onehunga. Adjacent to the Onehunga Bluestone Store (R11/2466).
