KAIKOURA EARTHQUAKE UPDATE

WEEKLY BULLETIN – no. 5

24 February 2017

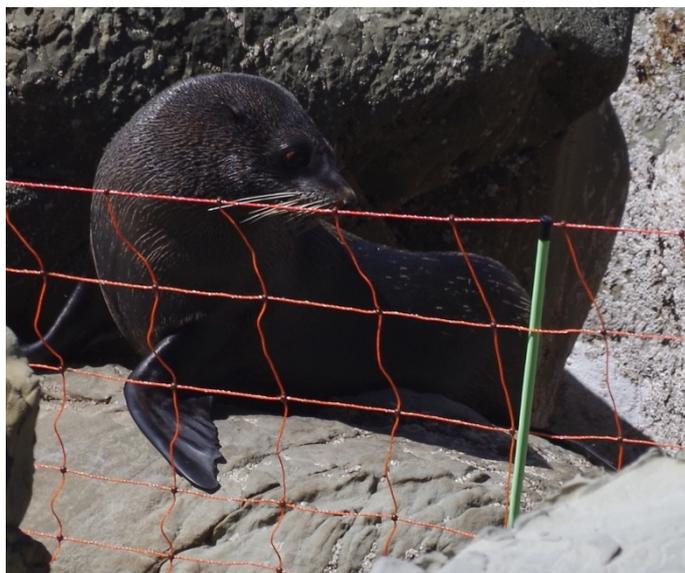
The first phase of this work is two-week trial, which is now underway at Site 7, a 20,000 cubic metre slip 300m north of Ohau Point. The trial is using seal-proof fencing (pictured above) and on-site seal herding to keep seals and their pups away from the immediate base of the slip site, clear of falling rocks and debris while helicopter sluicing and slip clearance work is carried out. The fencing is working well.

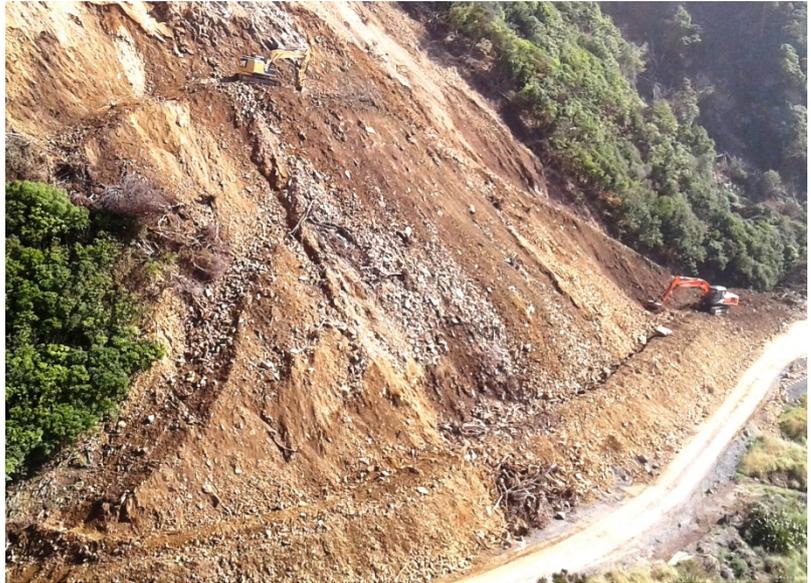
- This week our crews have installed rockfall safety bunds along the bottom of the slips at Sites 1A (pictured right), Site 1B and Irongate (Site 2), about 1km north of Blue Duck Road. These bunds help protect our construction crews from falling rocks, enabling work to carry on on the slip face while other crews travel past the site to access slips further to the north.

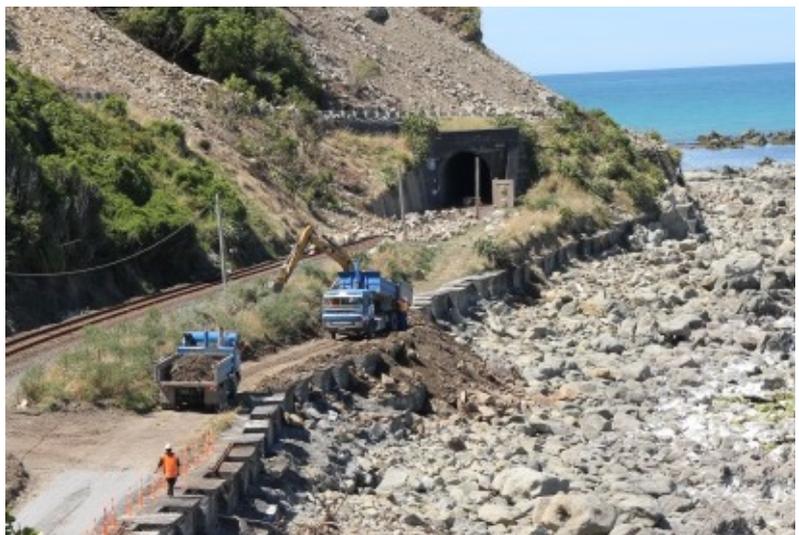
- Four minor slips near Irongate have been cleared this week, the material from these being used to build the construction access track (pictured below, right) around Site 2. This track is expected to be completed by the end of next week.

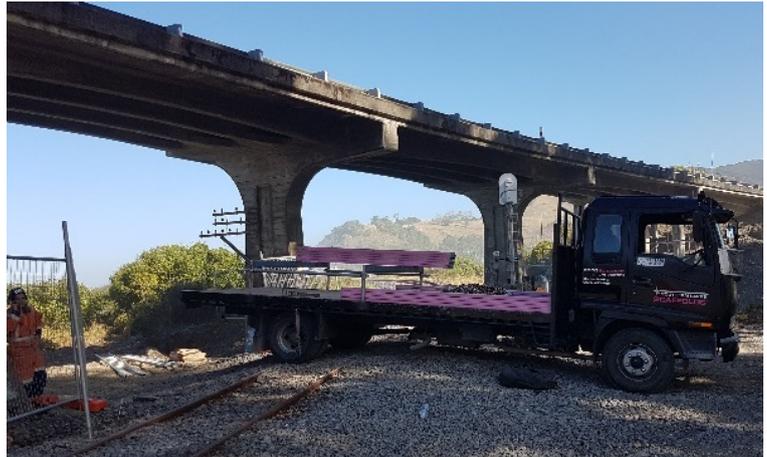
Strengthening of the Oaro overbridge (right) is progressing well. Debris from under the bridge have now been removed, exposing the concrete columns and bridge foundation. Crews have already moved on site to begin removing the minor crack damage. Once completed, the bridge foundations, beams and abutments will be strengthened with structural steel bracing. This will enable the bridge to carry heavy freight vehicles. The work is scheduled to take several months and traffic will continue to be detoured around the bridge until the work is completed.

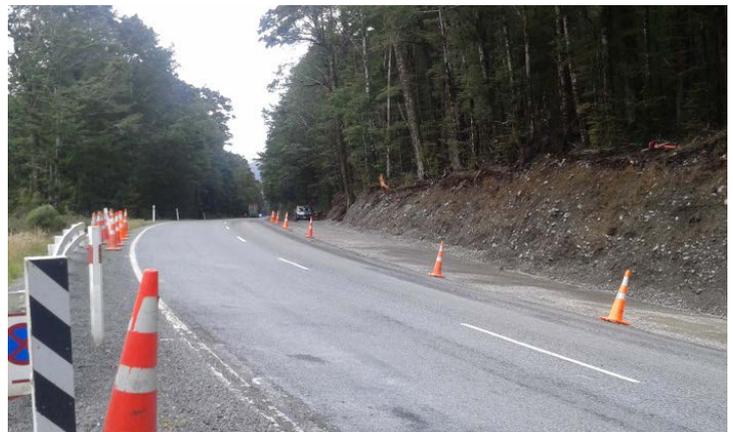
- All the work along this route is to improve the condition of the road and make it safer before winter.
 - 4.6kms of new guardrail is being installed along various areas of the route to increase safety by help prevent vehicles running off the road
 - Other sections of the highway are being rebuilt to strengthen the road to cope with the extra volumes of vehicles
 - 20km of the planned 35km pre-winter road resealing is now completed to ensure the road can better cope with weather conditions and the extra traffic

- Protection works are being installed along SH7 where erosion issues have been identified
- SH7 is to be realigned at Silvia Flats (previous page), near Lewis Pass, to protect the road from erosion and slumping. This work will get underway within the next few weeks.
- We're also identifying areas to install slow vehicle bays and improve traffic flow

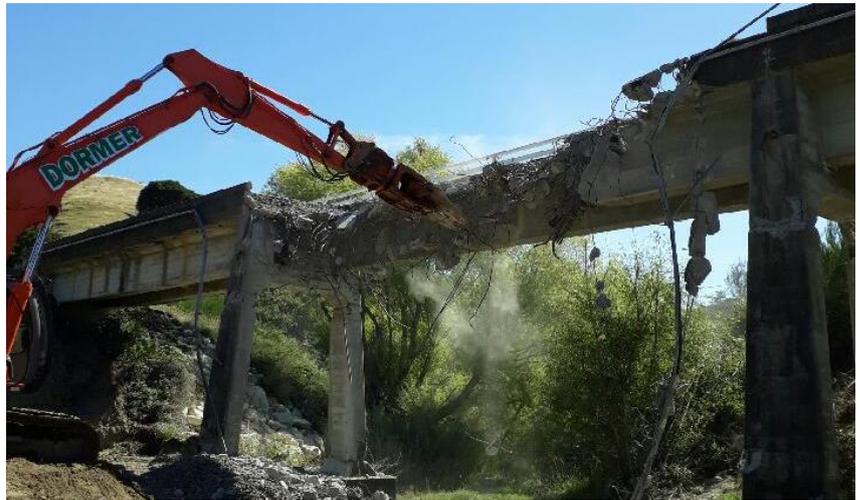
- Demolition of the rail bridge at Ferniehurst (Bridge 90), south of the Hundalee, is well underway (right). This is a major project in the programme to restore the Main North Line between Picton and Christchurch. The bridge will be demolished and temporary bridging spans installed across this section of the line to get it re-opened as quickly as possible. More than 1 million tonnes of freight is moved on the Main North Line each year.

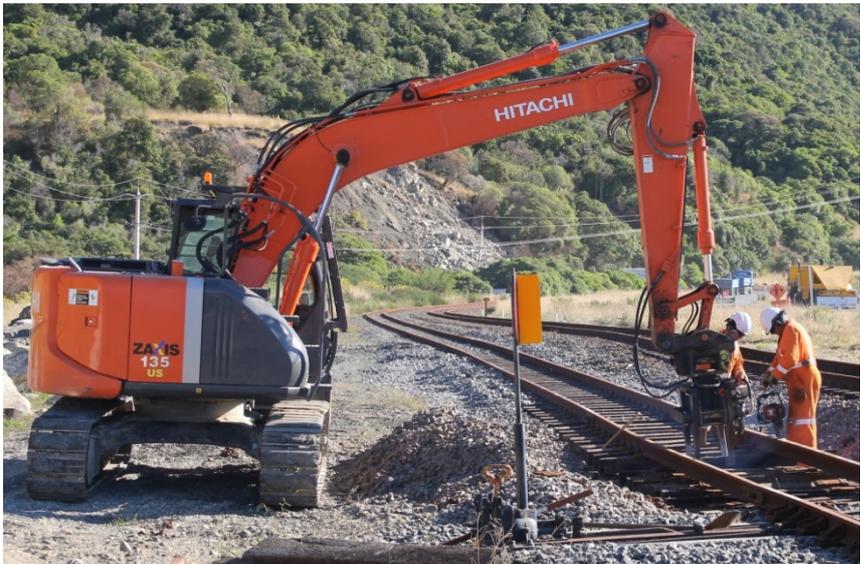
- Near Hawkswood, just north of Parnassus, work got underway this week repairing more than 200m of track, including culverts and retaining walls, which have slumped. This is a big job that is critical to the overall repair programme for the rail network. This will enable the line to be used for the movement of equipment further north. Several crews are working at this site.
- Ballast trains are bringing stones along the rail line to the sites where the sleepers have slumped. The ballast is laid on the ground and the rails on top. The earthquake caused the ballast to slump at many locations.
- With access tracks being built around the slips to the north of Kaikoura, KiwiRail teams can now begin detailed assessments of the tracks in this area to help finalise the design and construction timetable. Like the highway, the rail tracks have been badly damaged.

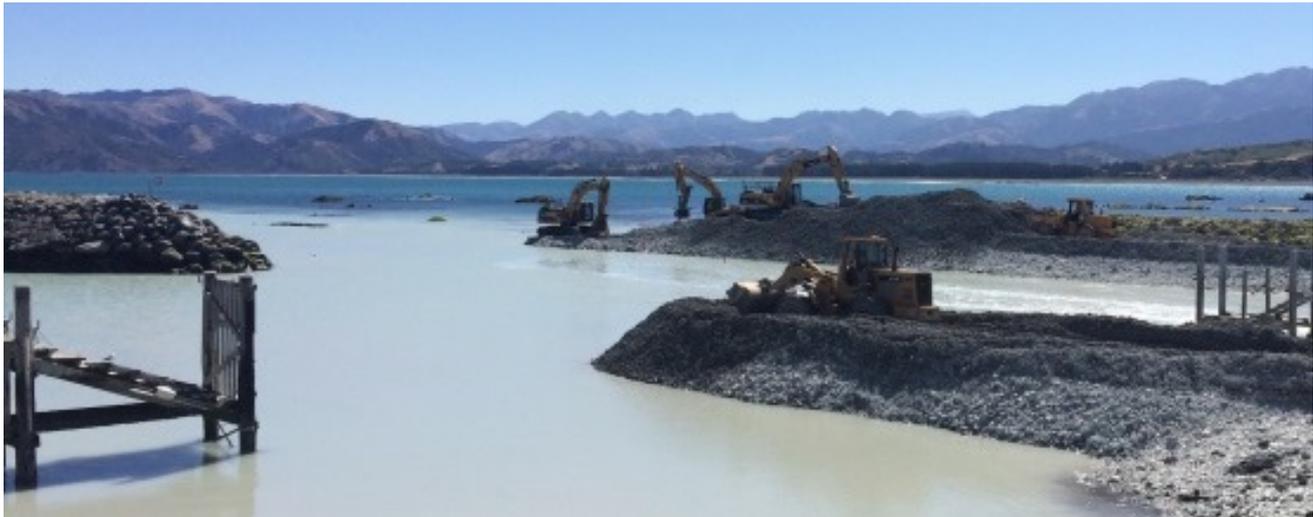
- More than 10,000 cubic metres of material has now been dredged from the main marina channel. This is being used to construct a cofferdam across the marina basin: a watertight enclosure pumped dry area that will enable construction work can get underway to deepen the marina basin below the waterline within the harbour.
- We're investigating barge options to excavate the outer channel of the harbour - 200m beyond the harbour wall. This area is too deep to excavate from the land.
