KAIKOURA EARTHQUAKE UPDATE - no. 15

5 May 2017

MILESTONE: SEAWALL FOUNDATIONS LAID

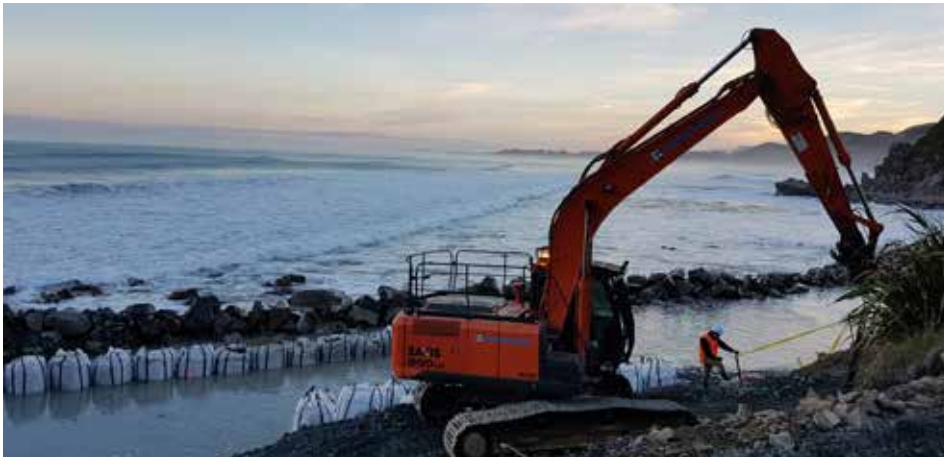
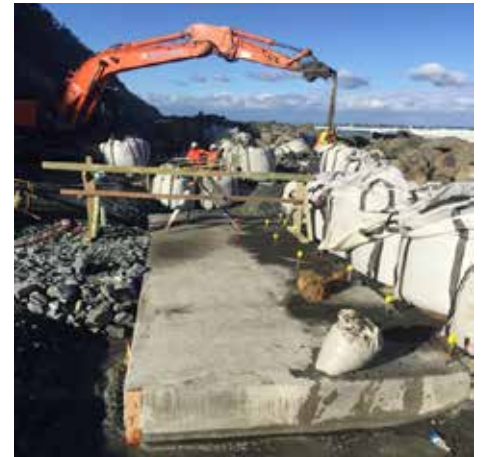
Building seawalls requires careful planning: the construction crews must work when the tides allow. The crews use excavators to place 15 to 20 huge sandbags – each weighing more than two tonnes – so the worksite stays dry while the concrete foundation is poured. When the foundations are set, pre-cast concrete blocks (2m wide, 1m high) are placed on top and tied together to form the seawall.

The completed seawalls will eventually stretch along about 2.5km of the coastal transport corridor. These photos show the very first section of seawall being built last week, just north of Kaikoura.

The construction of new seawalls on the Kaikoura coast is underway – this work will allow the North Canterbury Transport Infrastructure Recovery alliance to reinstate State Highway 1 and the railway.

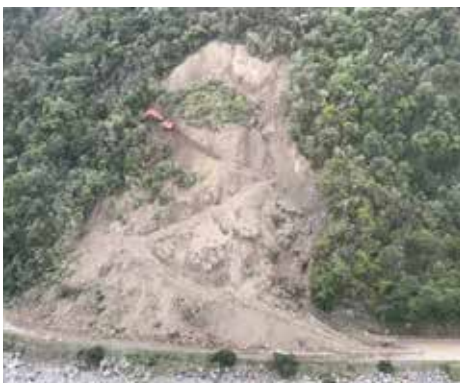
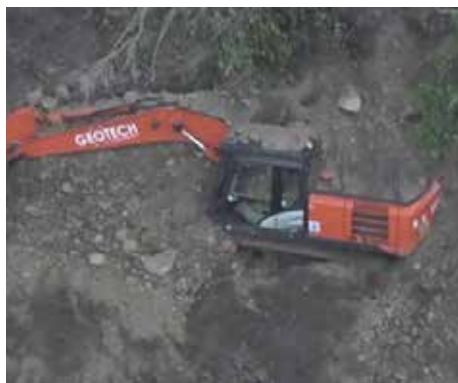
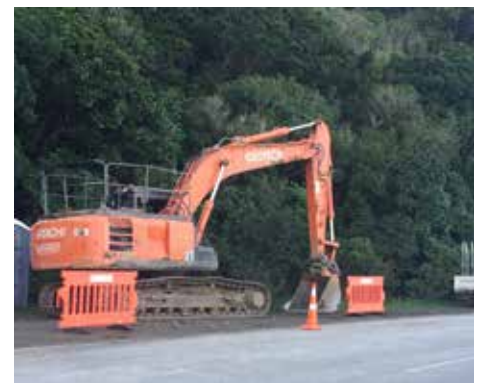
Meanwhile, the digger that was last week partially buried during the night on the large landslip near Rosy Morn, south of Kaikoura, has been recovered. Damage to the digger was minimal. The digger had been parked on the face of the slip.

Using diggers to clear landslides is part of the normal recovery process. After engineers have assessed the safety of the landslide, excavators carefully built a path to the top of the slip, zig-zagging across the slip's face. When they reach the top of the landslide, they create a flat bench area and undertake slope stabilisation by removing fallen stone, dirt and vegetation. For some landslides, small excavators are used as they are more agile and lighter for the delicate works.

On the inland road, the scaling of the slip at the Whales Back saddle is now complete and rock bolting is well underway to mitigate rock fall along this route – as of this week about half of the bolts had been installed. This work is expected to finish this month. The temporary road that was built to carry traffic around that slip remains in use.

SH1 south of Kaikoura – between Peketa and Goose Bay – remains closed so crews can clear the landslide blocking the highway and continue slope stabilisation work. The Waiiau/Mt Lyford inland road to Kaikoura (Route 70) is open; if travelling from Cheviot, the Leader Road connects with Route 70 at Waiiau

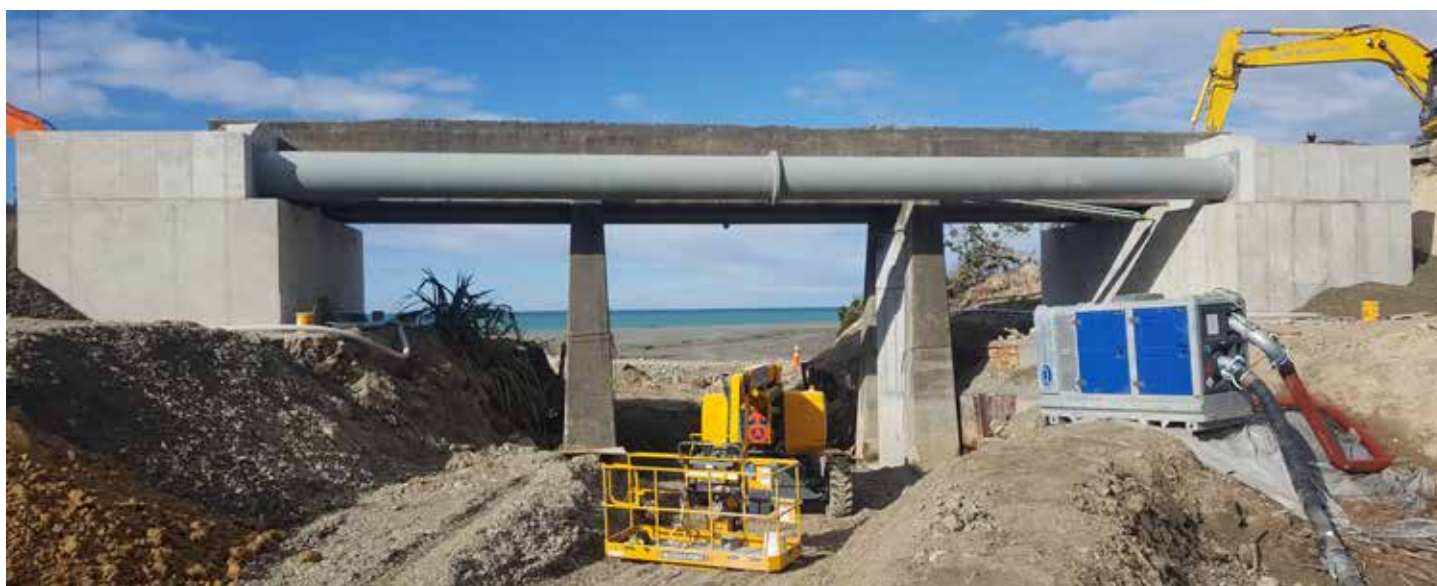
KiwiRail has completed numerous minor track repairs between Spotswood and Kaikoura, while work continues on bridges and tunnels. In North Canterbury, work trains are progressing north out of Spotswood, working their way towards Claverley on the coast. These work trains are laying ballast as they go and are then followed by regulator machines which smooth out the ballast. Tampers then undertake the fine adjustments of the track alignment.

Where the railway crosses the Old Claverley Creek on Bridge 95 – work has been underway to strengthen the bridge, built in 1938, and reinstate its approaches. Piling and abutment concreting is now complete.

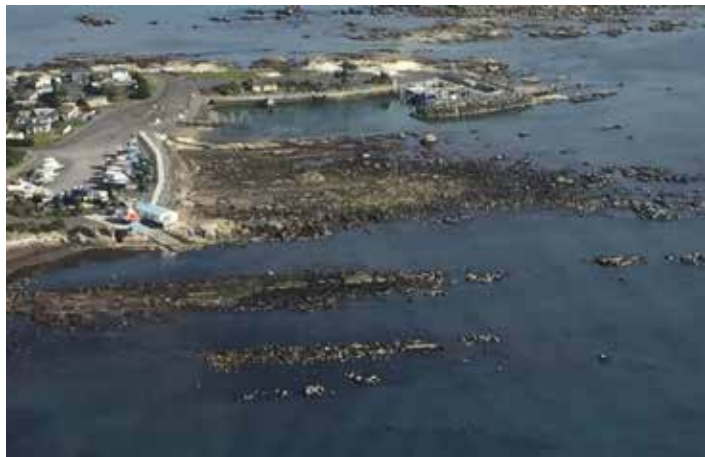
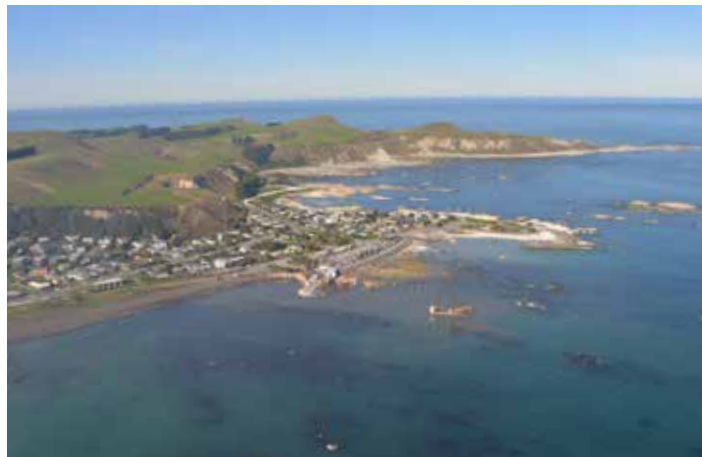
Solid progress continues in the harbour with a new Coast Guard ramp completed at the new seabed level, and around half of the inner harbour seabed dredging now done.

November's earthquake raised the seabed under the harbour; these photos show the harbour after the quake and now. In the outer harbour, seabed dredging is also progressing well, with around a month's worth of work left. The next step is to dredge the main channel boat ramp used by commercial operators.

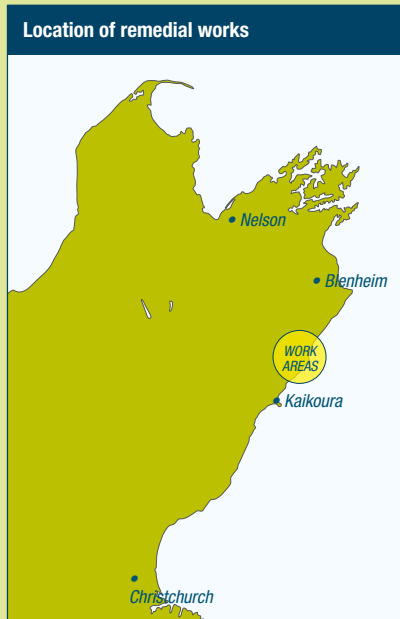
SITE 9: 3,000m³ of slip material

SITE 8: 41,000m³ of slip material

SITE 7: 20,000m³ of slip material

SITE 6: 110,000m³ of slip material

SITE 5: 6,000m³ of slip material

SITE 3: 5,000m³ of slip material

SITE 4: 44,000m³ of slip material

SITE 2: 10,000m³ of slip material

SITE 1B: 112,000m³ of slip material

SITE 1A: 23,000m³ of slip material

There are 27 excavators, 25 truck and trailer units, 14 dump trucks, 5 bulldozers, 3 loaders, 2 rollers and 1 crane currently working to clear the 10 largest landslides. This army of machinery is working long hours to clear landslide material and rebuild the road and rail corridor. They remove and stockpile the slip material, some of which is being used for repairs within the transport corridor.
