The Bulletin Kaikōura earthquake update

This bulletin provides the latest information about the rebuild of road and rail networks damaged by the Kaikōura earthquake in November 2016. The bulletin is produced by the North Canterbury Transport Infrastructure Recovery (NCTIR) - an alliance representing the NZ Transport Agency and KiwiRail, on behalf of Government.

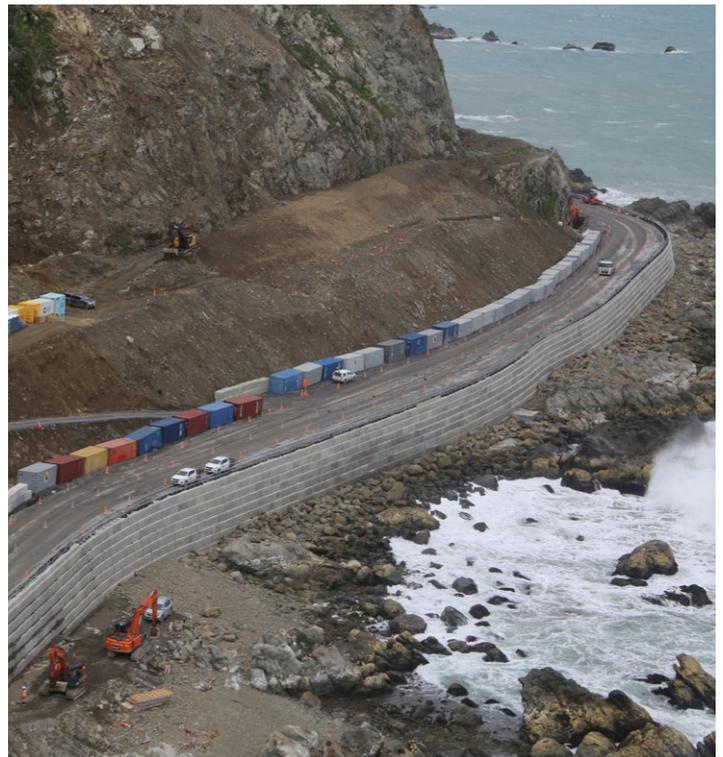
UP TO HEIGHT AT ŌHAU POINT

The site 6 seawall around Ōhau Point is up to full height, as of 15 March 2018 - a massive achievement for everyone involved. Work on this seawall began in June 2017, and the footings at this site were the most challenging of all the seawalls.

When the alignment was dug for the seawall, the bedrock was found to have very uneven ridges throughout it. 'We needed to get it level and to a certain height for our foundations,' says project manager Clark Butcher. 'The uneven bedrock meant that pours for each 12 metres length of footing ranged from 160 metres cubed to 800 metres cubed.'

Another major obstacle was the footings, which were located right on the tideline in places - so the works were constantly being flooded with seawater, even while the crews were working between tides. The job had to be done though, and the team proved they were up to the challenge. 'The full blocks are all in and we are now placing facing panels on top of the seawall,' Clark explains.

A facing panel is a narrow concrete block, which is connected along the entire wall length by pouring a reinforced concrete beam on the back of it. This allows the team to secure the capping beam on top, which locks it on to the wall with reinforcing steel. 'Getting the seawall up to height was a significant milestone, there was a real sense of achievement, the crew felt they'd finally achieved what they had worked so hard for,' says Clark.

There is still a lot of work to be completed at site 6. Along with the capping system, the road has to come up about 700 millimetres and a protection fence needs to be installed around Ōhau Point between the road and the slope.

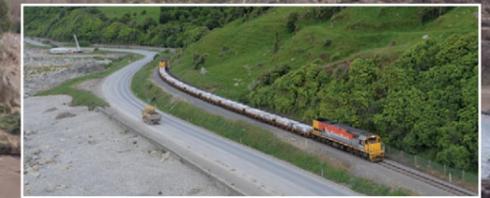
We're protecting the rail network by installing rockfall protection to stop rock or other material falling onto the tracks. We have installed in some areas detection fences, which automatically let train control know if any material has fallen on the track so we can respond as quickly as possible.

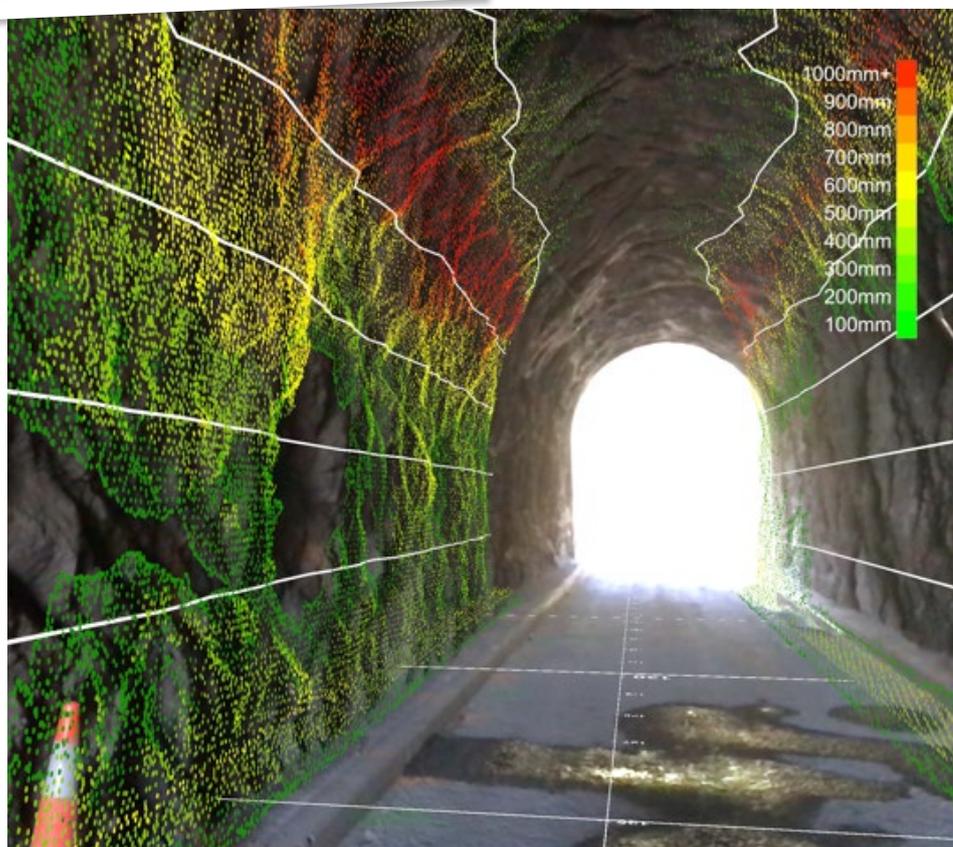
Pictured is Chris Souter, viewing the app in the Raramai South tunnel. The colours represent the amount of material, which needs to be removed from the existing tunnel surface to reach the desired 'new' designed dimensions (ranging from no colour, which is already wide enough, through a range all the way to red - which is more than a metre to remove).

The NCTIR visualisation team has recently trialled a new app to assist construction teams with pre-planning and visualisation. The augmented reality app has been used for a tunnel-widening project at Raramai South, a road tunnel on State Highway 1 south of Kaikōura. The tunnel is being enlarged to improve clearance and safety for compliant vehicles.

Digital visualisation lead Kat Salm says 'the visualisation tool is another way technology can support the engineered designs'. 'It can help with context and project discussions and for briefing crew. The app brings designs to life in front of clients or other interested people, without the need to be on-site. 'It's an actively engaging, simple to use app and can be viewed on iPads.'

This innovative tool is a great example of 'safety in design' as teams can plan works in more detail well before getting to site. The risks can be fully outlined and tweaks of design can be made having all the methodologies sorted beforehand. 'We hope this also means a quicker, more efficient and better value project as the team can understand the risks fully before being on site,' says Kat. It was created using information from surveying, design and analysis. A heat map is then formed from the analysis.

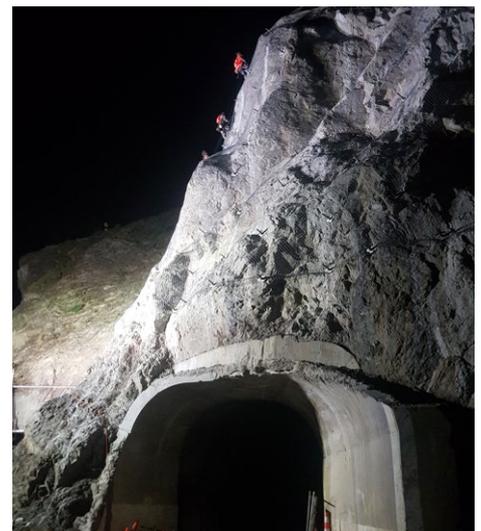
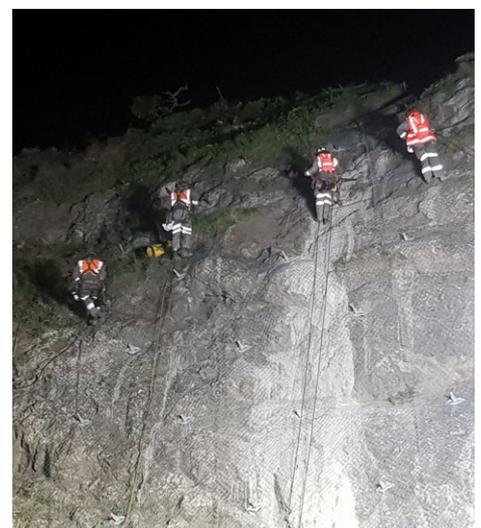
UNDER THE MOONLIGHT

The 70 high and 30 metre wide site originally came down during the 2016 earthquake and has required strengthening. 'A lot of work was completed last year; we installed more than 300 rock bolts into the hillside and secured steel mesh to the rock face,' he says.

The alternative was to get clearance to work at night. With strict health and safety conditions met, the crew recently spent two nights working 40 metres above the road. 'Working at night was only possible because of the huge amount of work we had already put in strengthening the site,' says Chris.

The crew worked under floodlights to carry out final pieces of work on the site, checking the last 70 rock bolts, which had recently been installed. 'It's relaxing working at night - you don't need to worry about traffic movements, other contractors or helicopters. It's just you, your gear and the ocean,' Chris explains. 'And, it's soothing hearing the sounds of the ocean as you go about your work.'

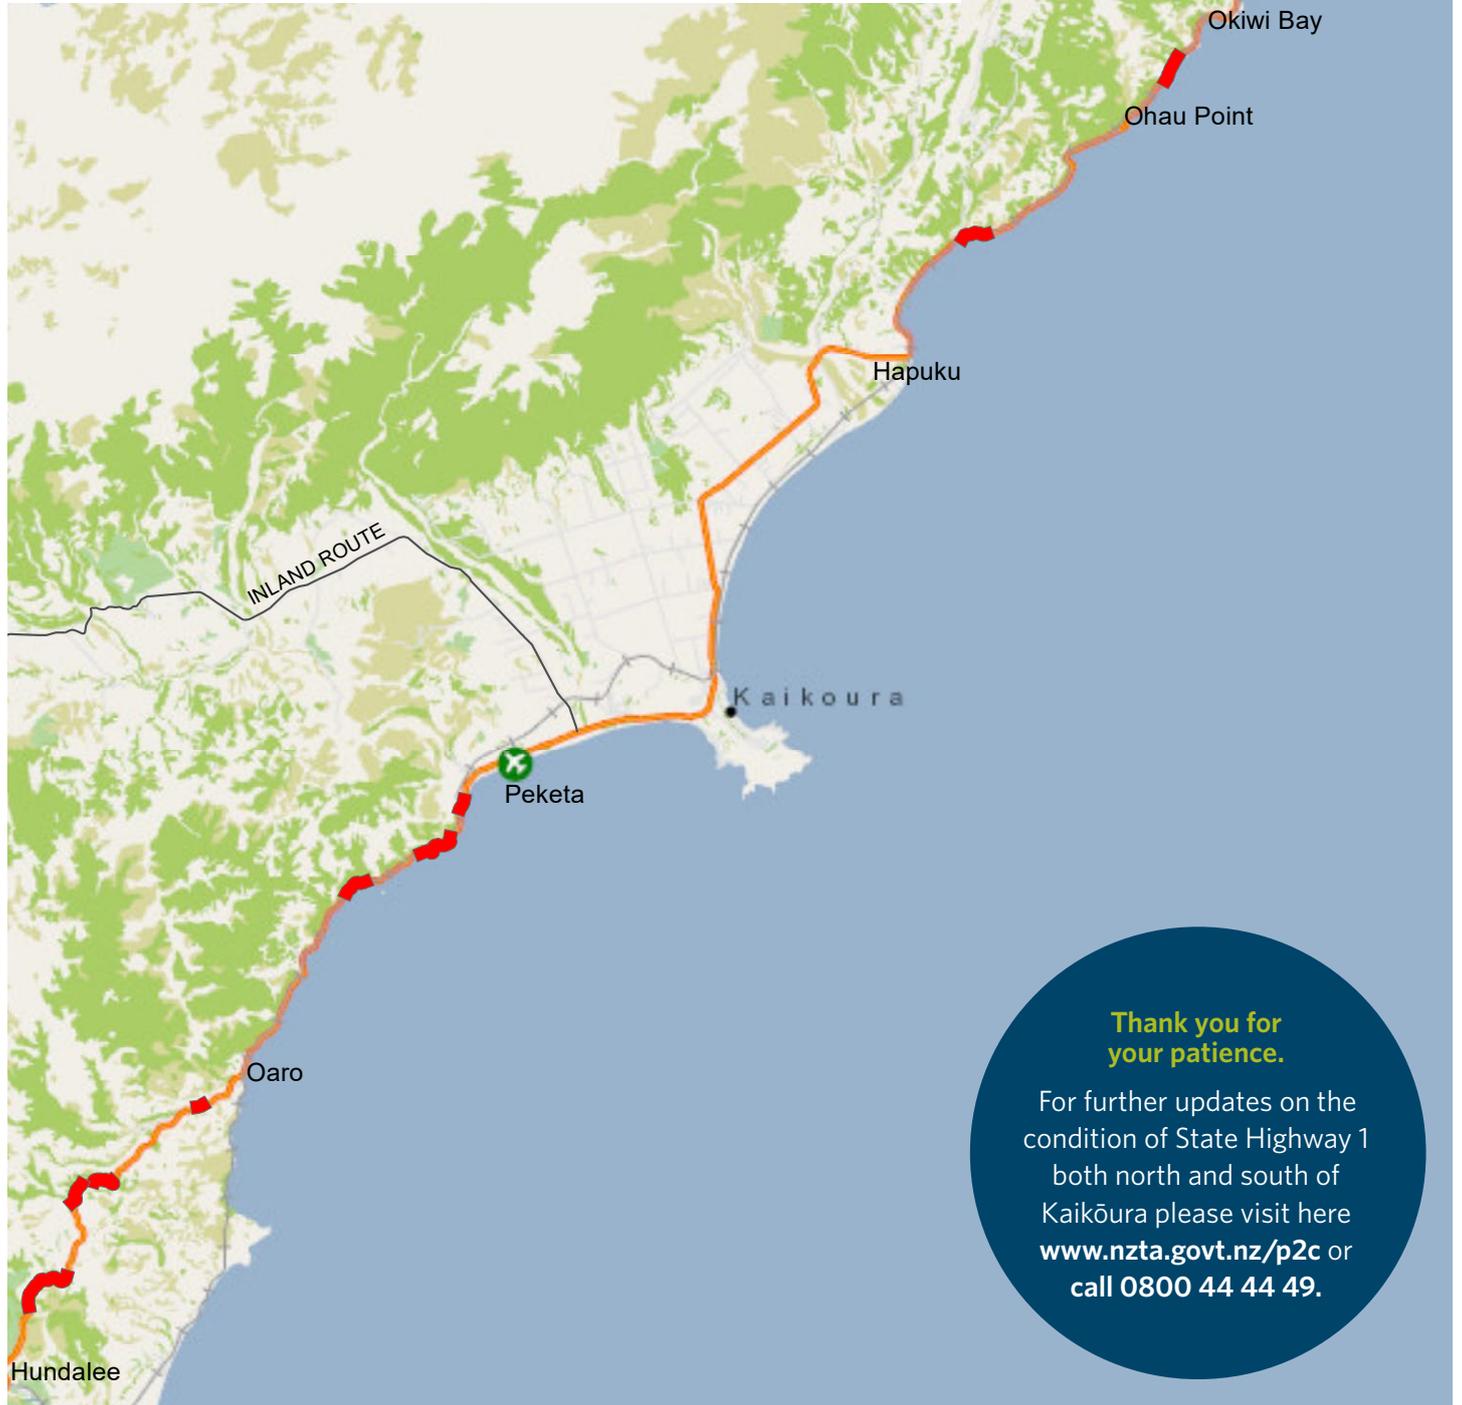
WHERE TO EXPECT DELAYS ALONG THE CORRIDOR

In the red on the map below are delay hotspots along State Highway 1. Please drive safely through these areas - some of which are single lane. The closure point for 7.30pm to 7.30am in the south will remain at Leader Road/State Highway 1 as repair work continues in the Hundalee Hills because of damage caused by ex-cyclone Gita.
