The Bulletin Kaikōura earthquake update

PILING UP

This bulletin provides the latest information about the rebuild of road and rail networks damaged by the Kaikōura earthquake in November 2016. The bulletin is produced by the North Canterbury Transport Infrastructure Recovery (NCTIR) - an alliance representing the NZ Transport Agency and KiwiRail, on behalf of Government.

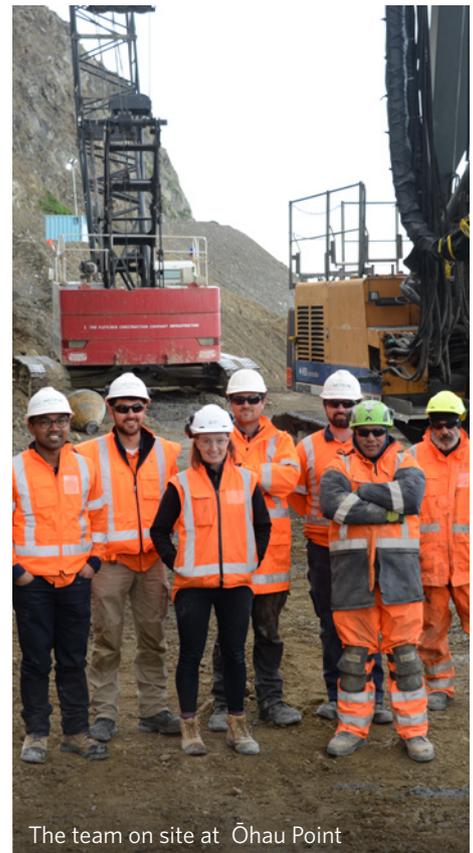
Just south of Ōhau Point, our crews, piling rigs and cranes are constructing a 300-metre-long retaining wall to realign the Main North Line railway.

Material captured inside the casings is then bored out, round steel cages inserted into each of them, concrete poured in and the casings extracted. Then once a reinforced concrete beam is built on top of the piles, the ground in front is excavated and the end result is a bored pile retaining wall.

The team on site at Ōhau Point

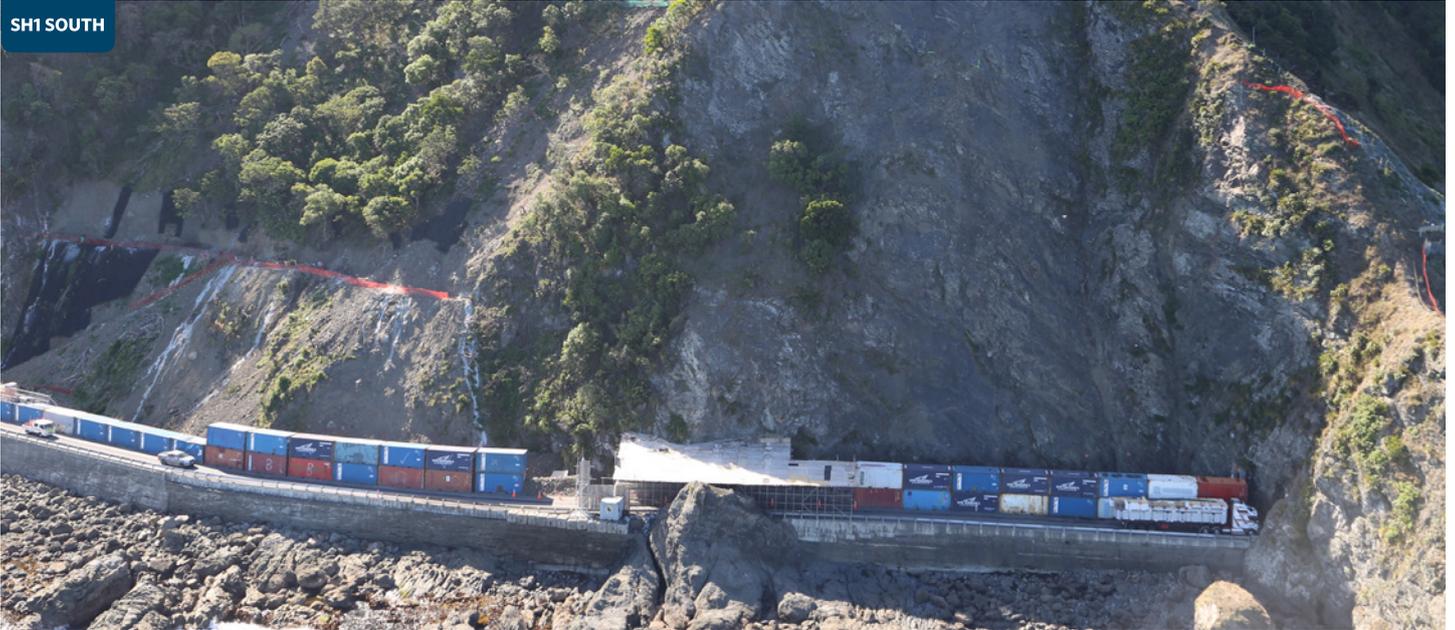
A section of State Highway 1 south of Kaikōura between Peketa and SH1/Leader Road was closed this week for the removal of 16 shipping containers. The move took place on Monday and Tuesday from 10pm to 6.30am.

The containers had been in place since the early stages of earthquake recovery to protect the road from rockfall. They had to be removed for the tunnels team to complete the widening of the Parititahi tunnel portals, allowing the switching of traffic between north and south-bound lanes.

During the night, Hiab trucks and a 25-tonne crane moved the 16 containers from the north-bound lane south of the Parititahi Tunnels. Reflectors were also fixed on the scaffold around the tunnel.

‘In the week before the closure we installed new protection of a 5.5 metre high meshed scaffold fence at the toe of the slope and a MacMat geomat mesh drape that hangs within 20 metres of the road.’

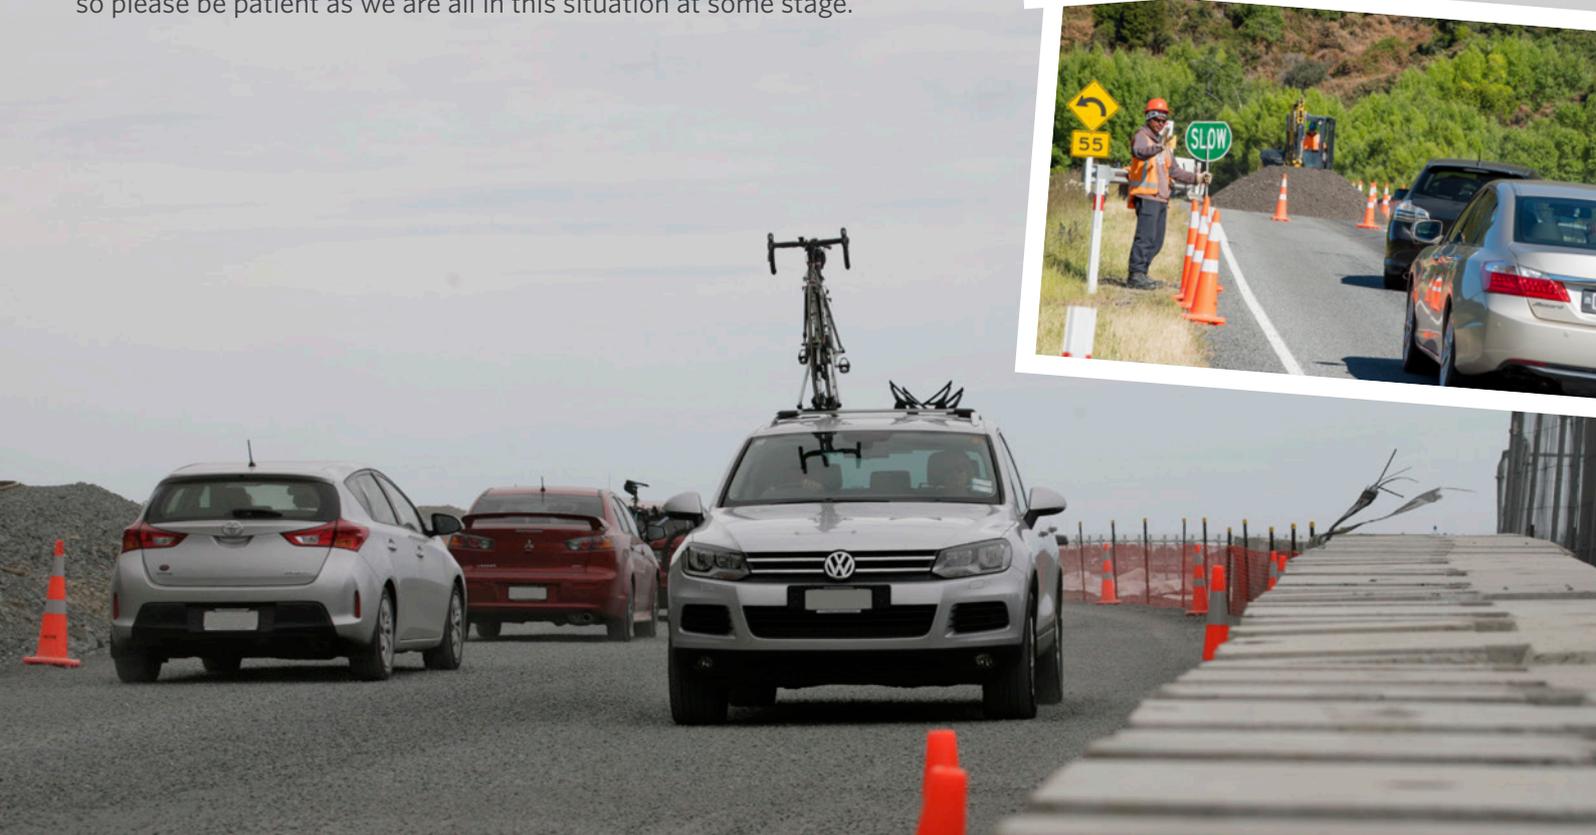
WIDENING TUNNELS

The Raramai and Parititahi Road Tunnels to the south of Peketa were built over a century ago. These road tunnels were not significantly damaged in the November 2016 earthquake, but were in need of improvements. The NZ Transport Agency's plans to upgrade and enlarge this row of tunnels is now underway.

'The upgrades require the use of special equipment, including milling heads, which are double-barrel rotators that reshape the surface of the tunnel, and a shotcreting robot. This milling and shotcreting of walls, shoulders and crown [100mm] of the existing tunnels will complete Stage 1,' says tunnels manager Rafael Ballen.

'Stage 2 will include a further 150mm layer of concrete to finish the walls and 150mm of shotcrete to finish the shoulders and crown, which will complete full ground support. These processes will bring the Raramai and Parititahi Tunnels up to their new specifications. In order to achieve this amount of work by the set deadline, the tunnels teams are working both day and night shifts,' says Rafael.

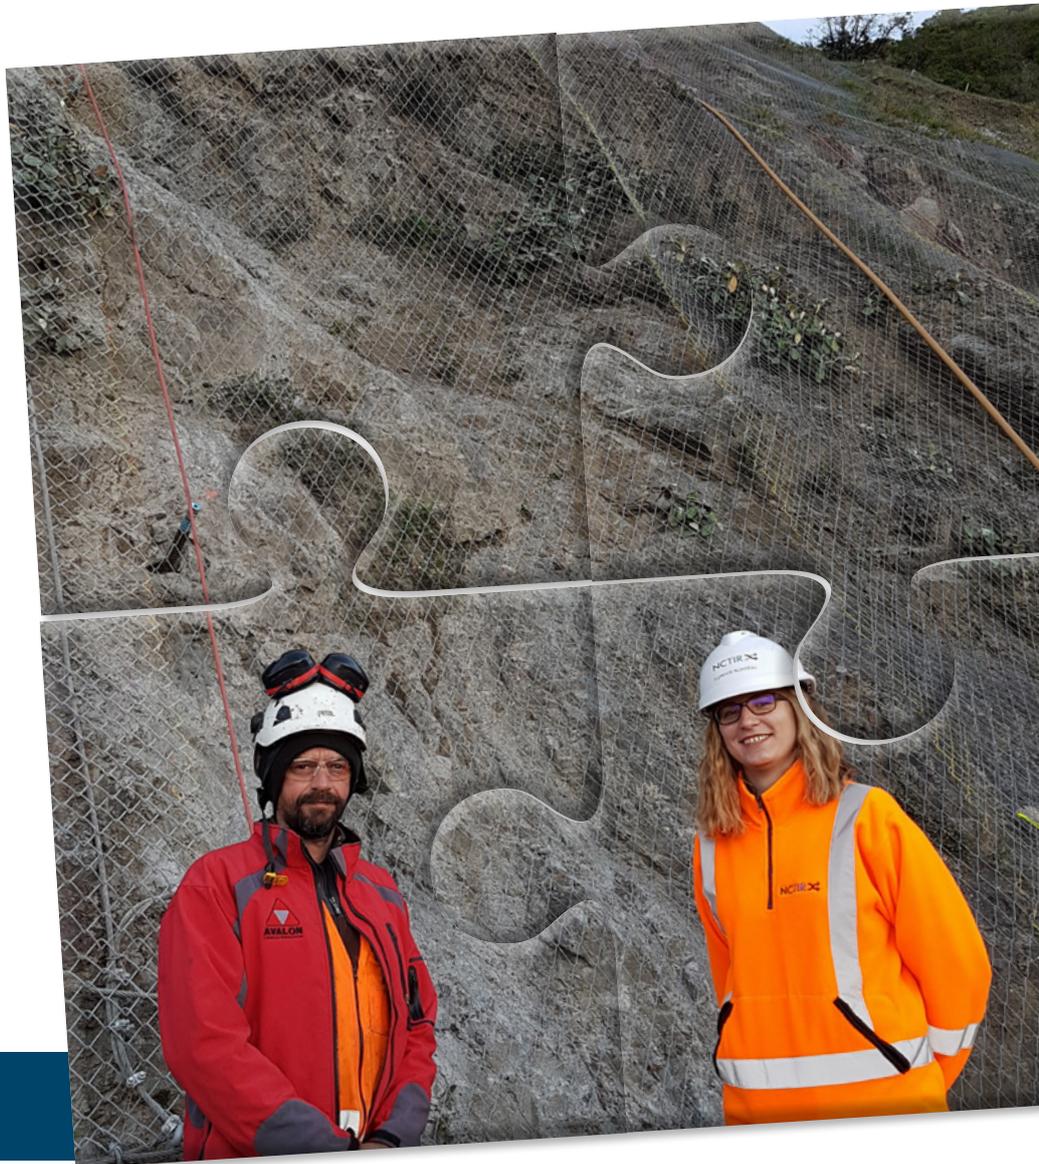
Drivers can expect a smoother ride through Jacob's Ladder, which was damaged by 200,000 cubic metres of material coming down off the neighbouring hillside during the intensity of ex-cyclone Gita in February this year.

Our crews, with their high-vis winter layers, were out on the road last week laying down 100mm of roading gravel. Once the team had distributed the gravel across the road a roller soon followed compressing it tightly to create a smooth top layer.

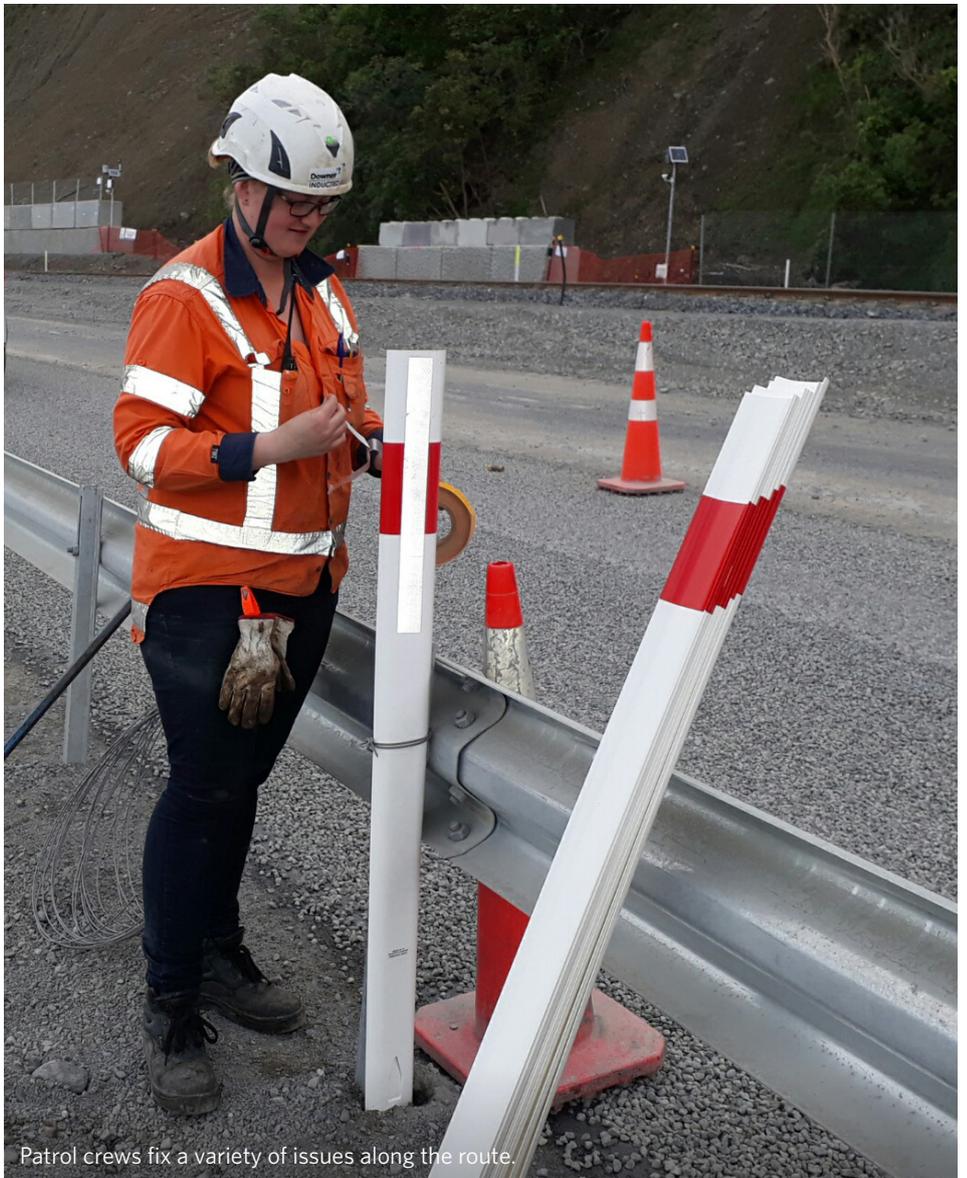
These patrol trucks are the 'eyes and ears' undertaking a variety of jobs including pothole repairs, maintaining culverts, attending to traffic incidents, cleaning traffic signage and clearing roadkill off the road.

Patrol crews fix a variety of issues along the route.

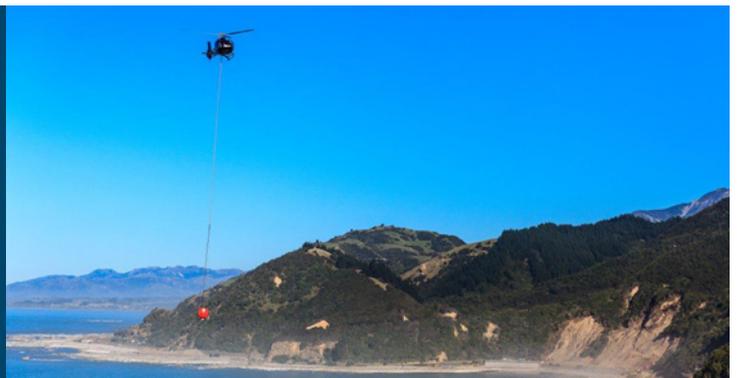
Abseilers work down the sides of the damaged mountain to install anchors using drill rigs, then apply mesh netting lowered down in pieces by helicopters, and finally, nuts and plates secure the mesh to the anchors so any material which might be prone to come loose is secured to the cliff face. While completing the work, quality checks on the cables and all of the components are ongoing, to ensure the work will last.

'The site includes the largest area we've meshed south of Kaikōura, about 8900 metre squared,' says Florence.

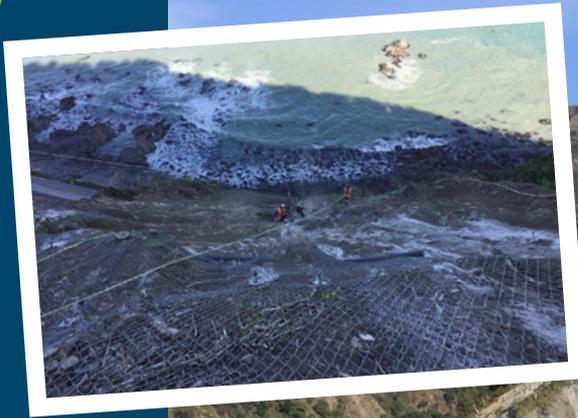
Looking up from the passenger seat driving south of Rosy Morn, it is impossible to see the top of one of the largest sites on State Highway 1 south of Kaikōura; Site 30. From the road, only the lower section is visible, but above, there is a bigger slip area, where the works are mostly happening.
