Muldoon's Corner Easing Project

Project progress

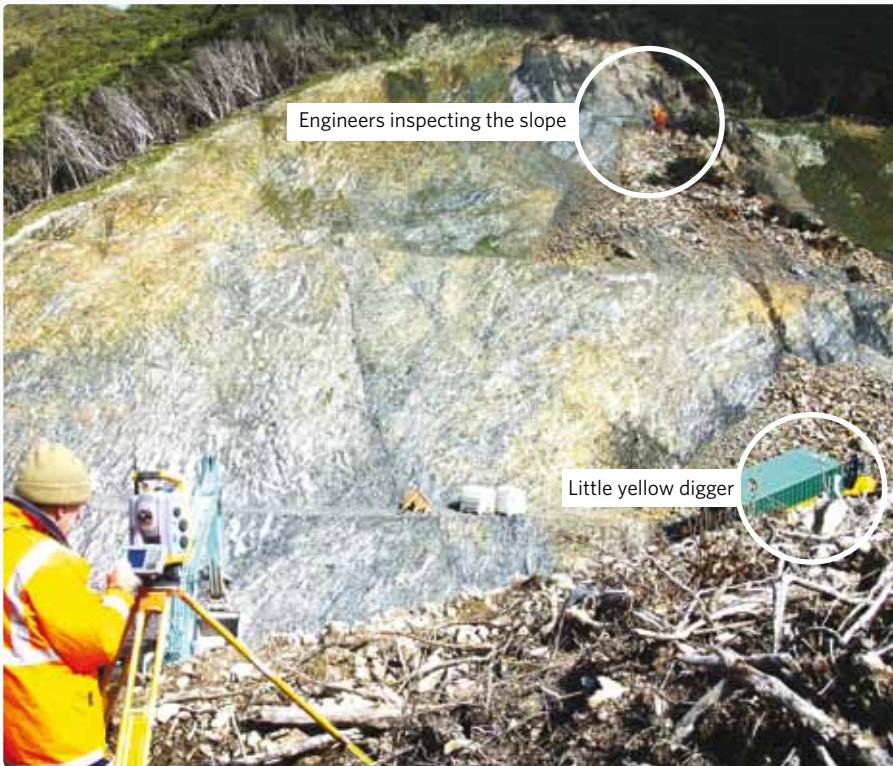
Opus geotechnical engineers scrambling up the hill like mountain goats were safely anchored by ropes as they directed professional absailers across the slip.

The photograph shows a slip at Cut Site A, which happened overnight in late August, after a period of heavy rain. No-one was injured but a large shipping container used as storage was shunted aside, and, in scenes a bit like the children's picture book, the little yellow digger got stuck and the team used a bigger digger to rescue it.

Investigations indicate that water built up behind a shear plane in the hill, where blocks of rock join, which caused it to slip. This photograph shows just how tricky it is to carry out those investigations too.
