Aotea Sea Scouts Building

Conservation Plan

**AOTEA SEA SCOUTS BUILDING
CONSERVATION PLAN**

**19 FEBURARY 2007
REVISION: FINAL DRAFT
MHX REF: X025**

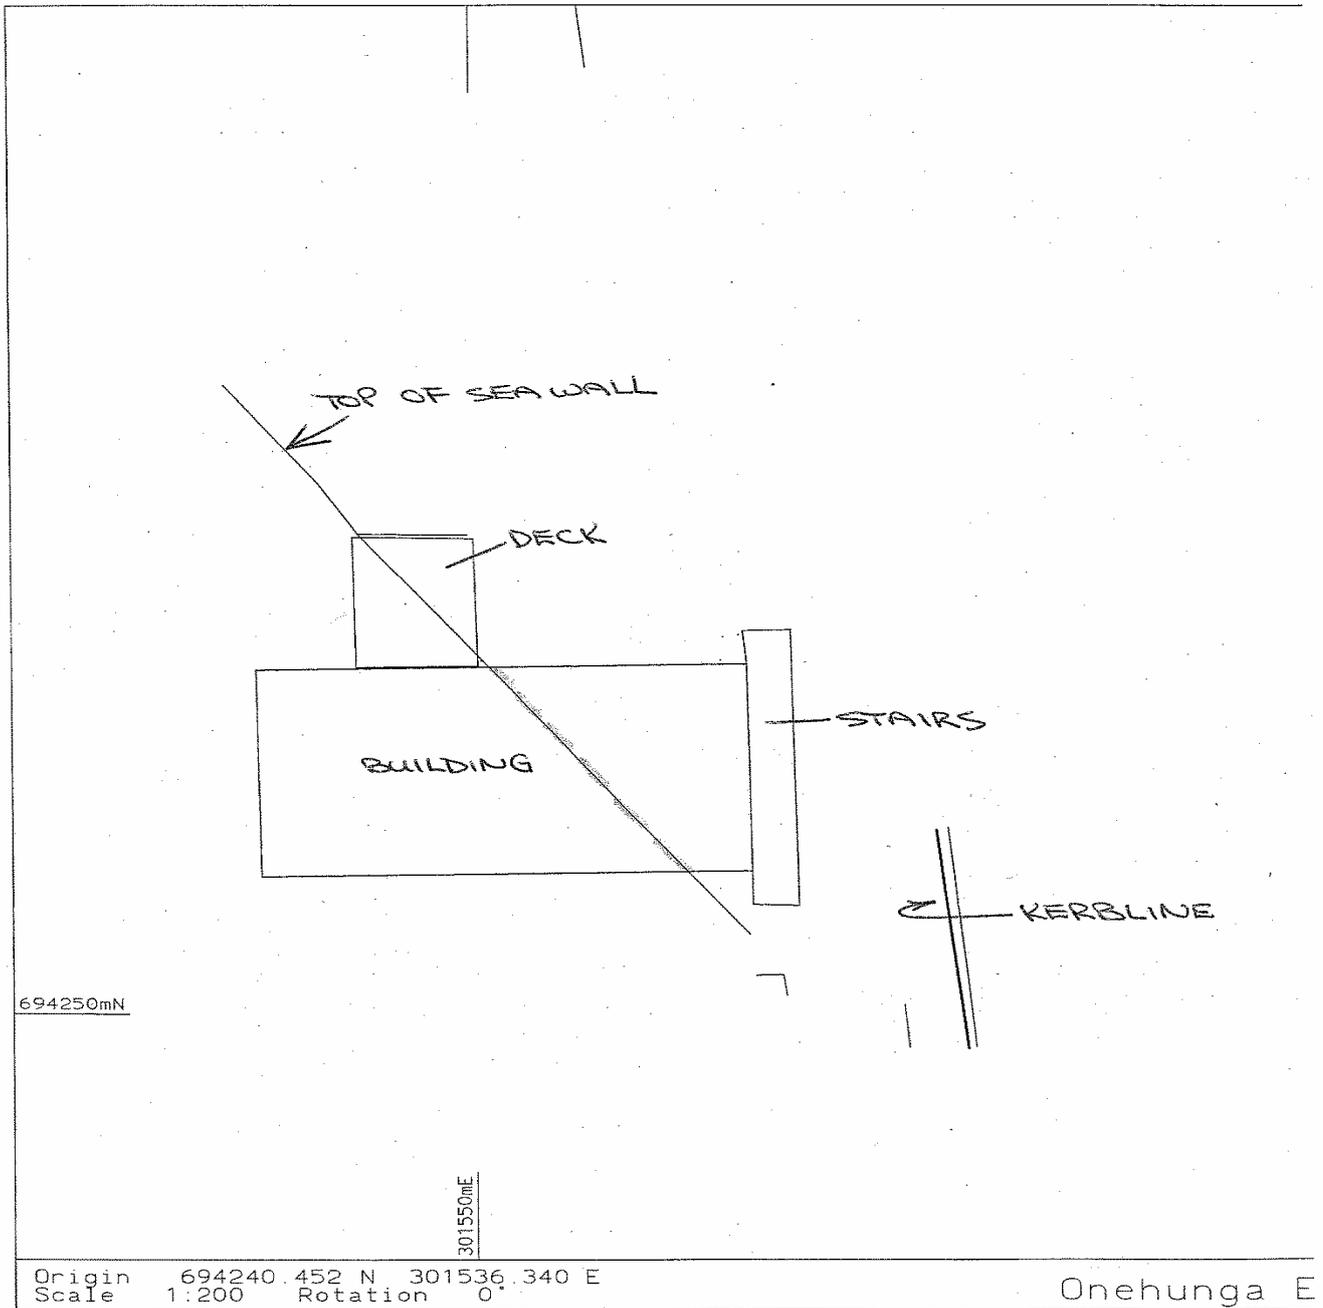
Figure 1: Part of Plan showing position of building

In August 1967 a title was issued to the Auckland Harbour Board pursuant to the Manukau Harbour Control Act 1911 in the tidal lands set out as defined by the Harbours Act 1950. This certificate of title is 9B/1172. In 1999 all the land in this title below mean high water springs was reinvested in the Crown under section 5 of the Foreshore and Seabed Endowment Reinvesting Act 1991, to be administered by the Department of Conservation. A caveat was placed on this title by the Crown in September 1999. A severance of land above mean high water springs at this point continues to be held as tidal lands. This indicates that the building is sited over the boundary between two parcels of land. A 1981 survey of adjoining parcels of land to be taken for road and motorway shows the location of the building overlapping the boundaries of the Crown Land and the shows the location of the building overlapping the boundaries of the Crown land and that of the Auckland Harbour Board up to the front face of that building.

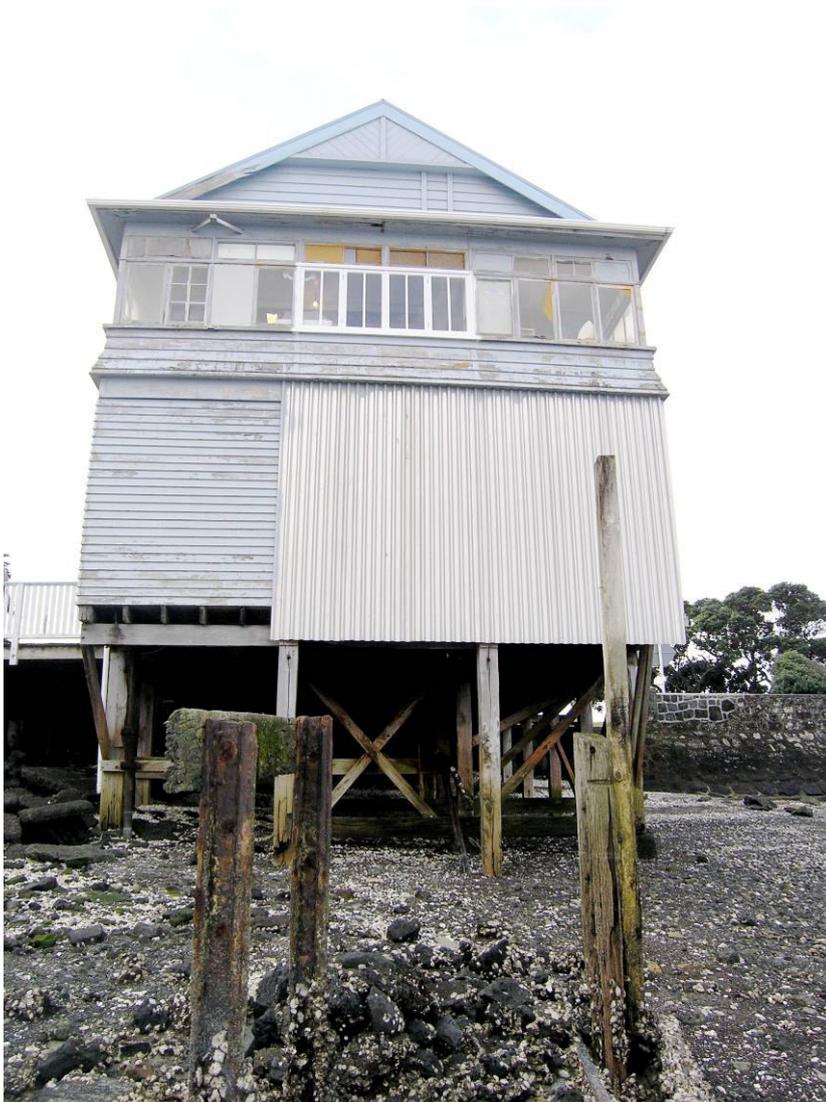
Fabric	Space	Architecture	History	Environment	Heritage values	
					Usability	Integrity
West elevation		H	H	H	H	S
<p>Painted timber shingles to gable (hf), painted timber corbels (hf), painted timber shiplap weatherboards (hf), painted timber fixed 8 and 12 pane windows (hf and rf), painted timber chamfered architraves to windows (hf), painted timber hoods over windows (hf), painted timber fixed casement and top lights to south (hf), painted timber cover-boards (hf), painted fibre cement baseboard (nhf), aluminium cladding to south (nhf), roller shutter door (nhf), lights (nhf), painted timber louvres (hf)</p>

Figure 2: West elevation Ian Bowman photograph, 2/8/06

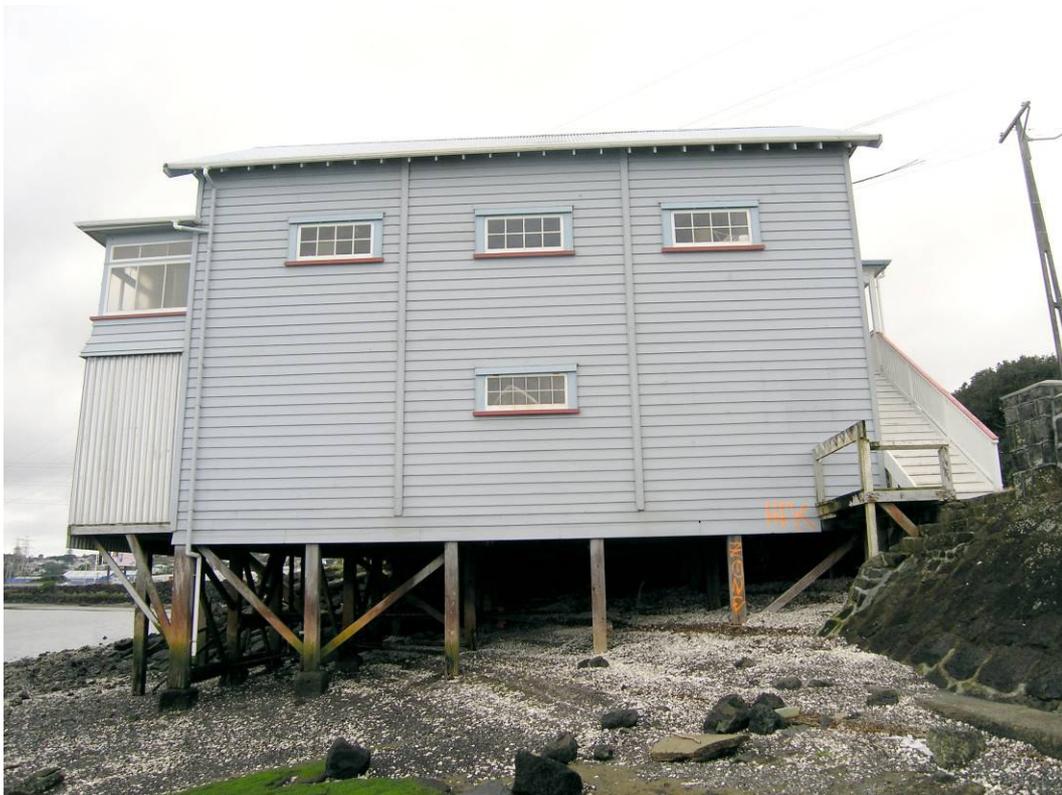
Fabric	Space	Heritage values				
		Architecture	History	Environment	Usability	Integrity
South elevation		H	H	H	H	S
Painted timber shingles to gable (hf), painted timber corbels (hf), painted timber shiplap weatherboards (hf), painted timber fixed, sliding and side hung casements with top lights (hf), aluminium cladding (nhf), painted timber diagonal boarded gable screen (hf), painted timber cover-boards (hf)

Figure 3: South Elevation, Ian Bowman photograph, 2/8/06

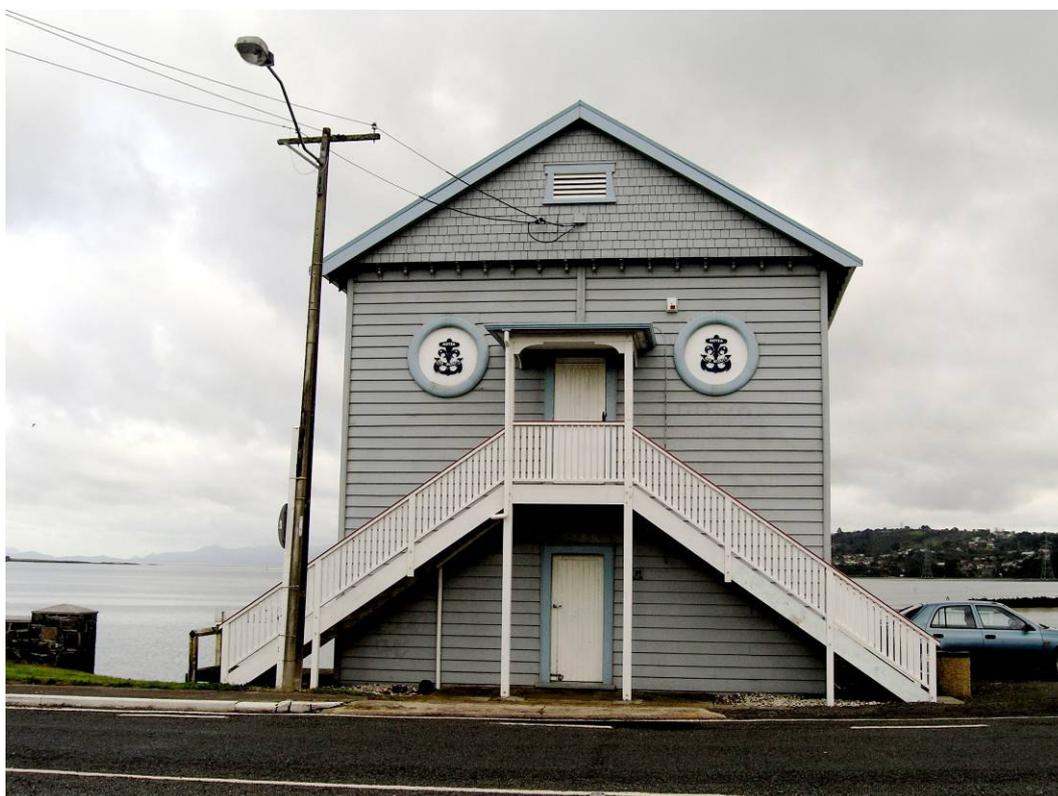
Painted timber shiplap weatherboards (hf), painted timber fixed 8 and 12 pane windows (hf and rf), painted timber fixed casement and top lights to south (hf), painted timber chamfered architraves to windows (hf), painted timber hoods over windows (hf), painted timber cover-boards (hf), painted fibre cement baseboard (nhf), aluminium cladding to south (nhf), uncoated timber part deck with handrail – there was a walkway along elevation (hf), note adjacent stone steps

Figure 4: East Elevation Ian Bowman 2/8/06.

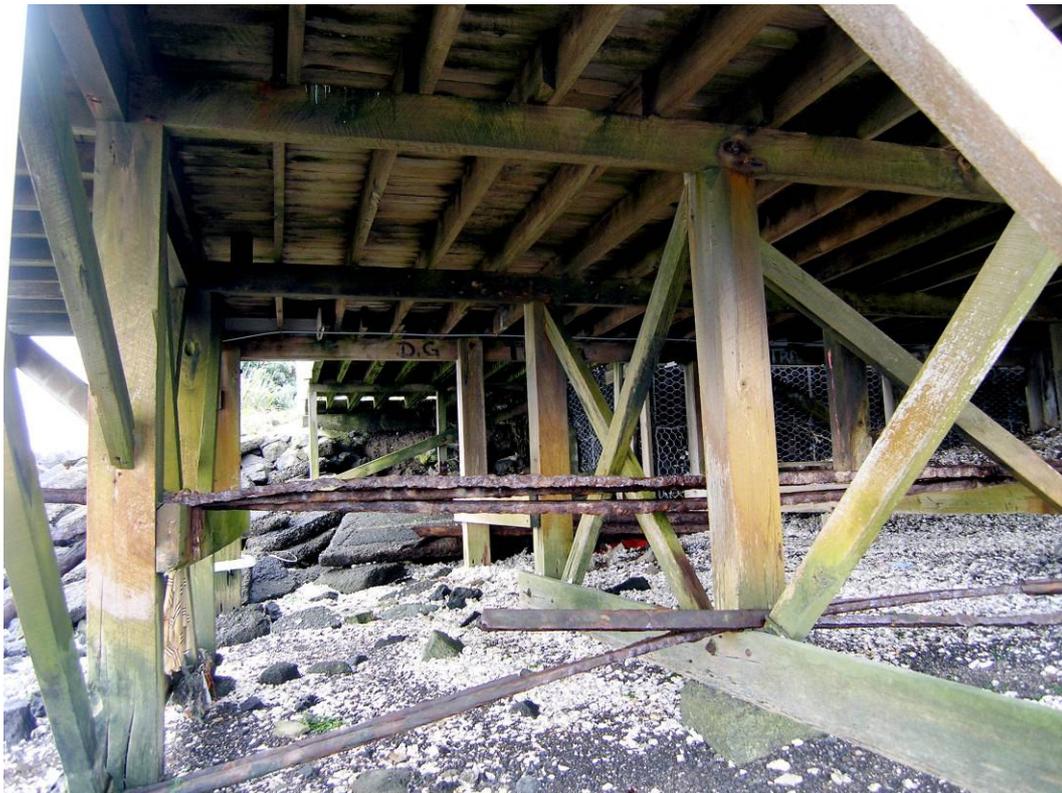
Fabric	Space	Heritage values				
		Architecture	History	Environment	Usability	Integrity
Sub floor frame		S	S	H	S	S
Timber floor joists (hf), timber flooring (hf), timber bearers (hf), timber piles and cross bracing (hf?), cast iron pipe to south (hf), steel/cast iron/wrought iron fixings (hf)

Figure 6: Sub floor, Ian Bowman Photograph, 2/8/06.

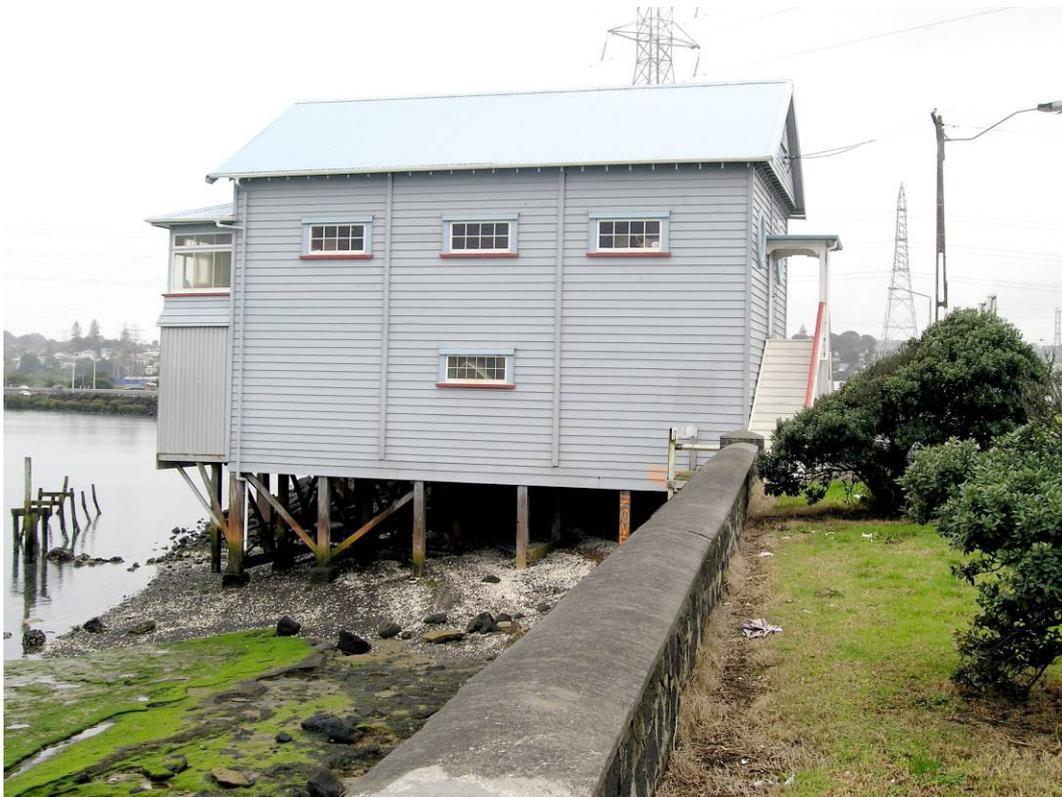
Fabric	Space	Heritage values				
		Architecture	History	Environment	Usability	Integrity
Setting		H	H	H	H	H
Basalt rock walls (hf), basalt footings/foundations to previous structure (hf), steel and timber structure to south (hf), worked basalt in tide (hf), basalt steps to east (hf), timber deck to west (nhf), gabions to west (nhf)

Figure 7: Setting, Ian Bowman photograph, 2/8/06.
