NZ TRANSPORT AGENCY
WAKA KOTAHI

WATERVIEW CONNECTION PROJECT Environmental Overview – Te Atatu

WATERVIEW CONNECTION TEAM

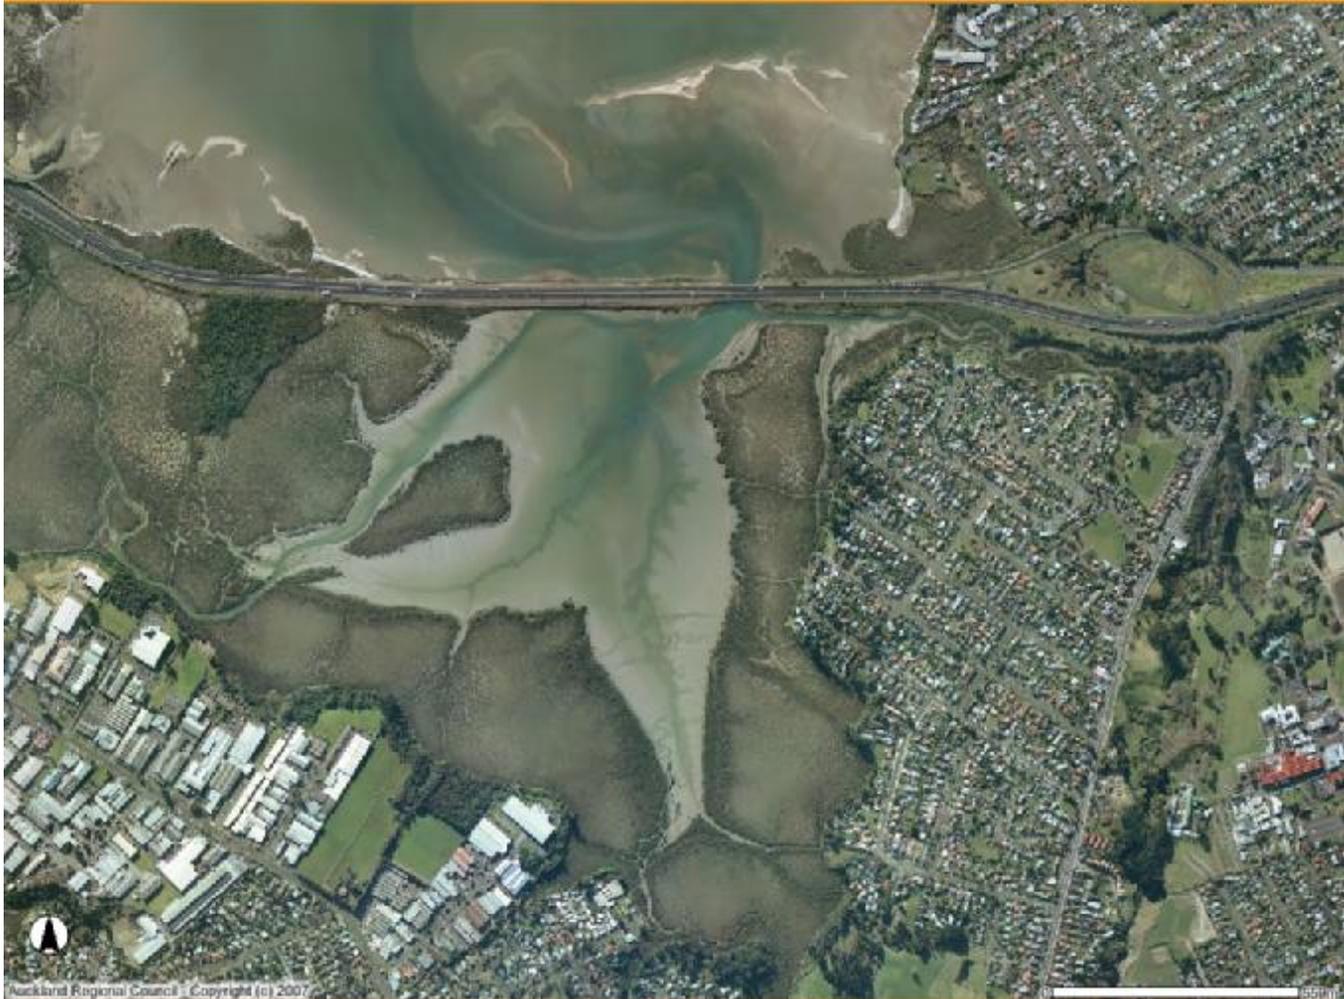
Coastal Processes- change in Waterview Inlet: 1940 to present

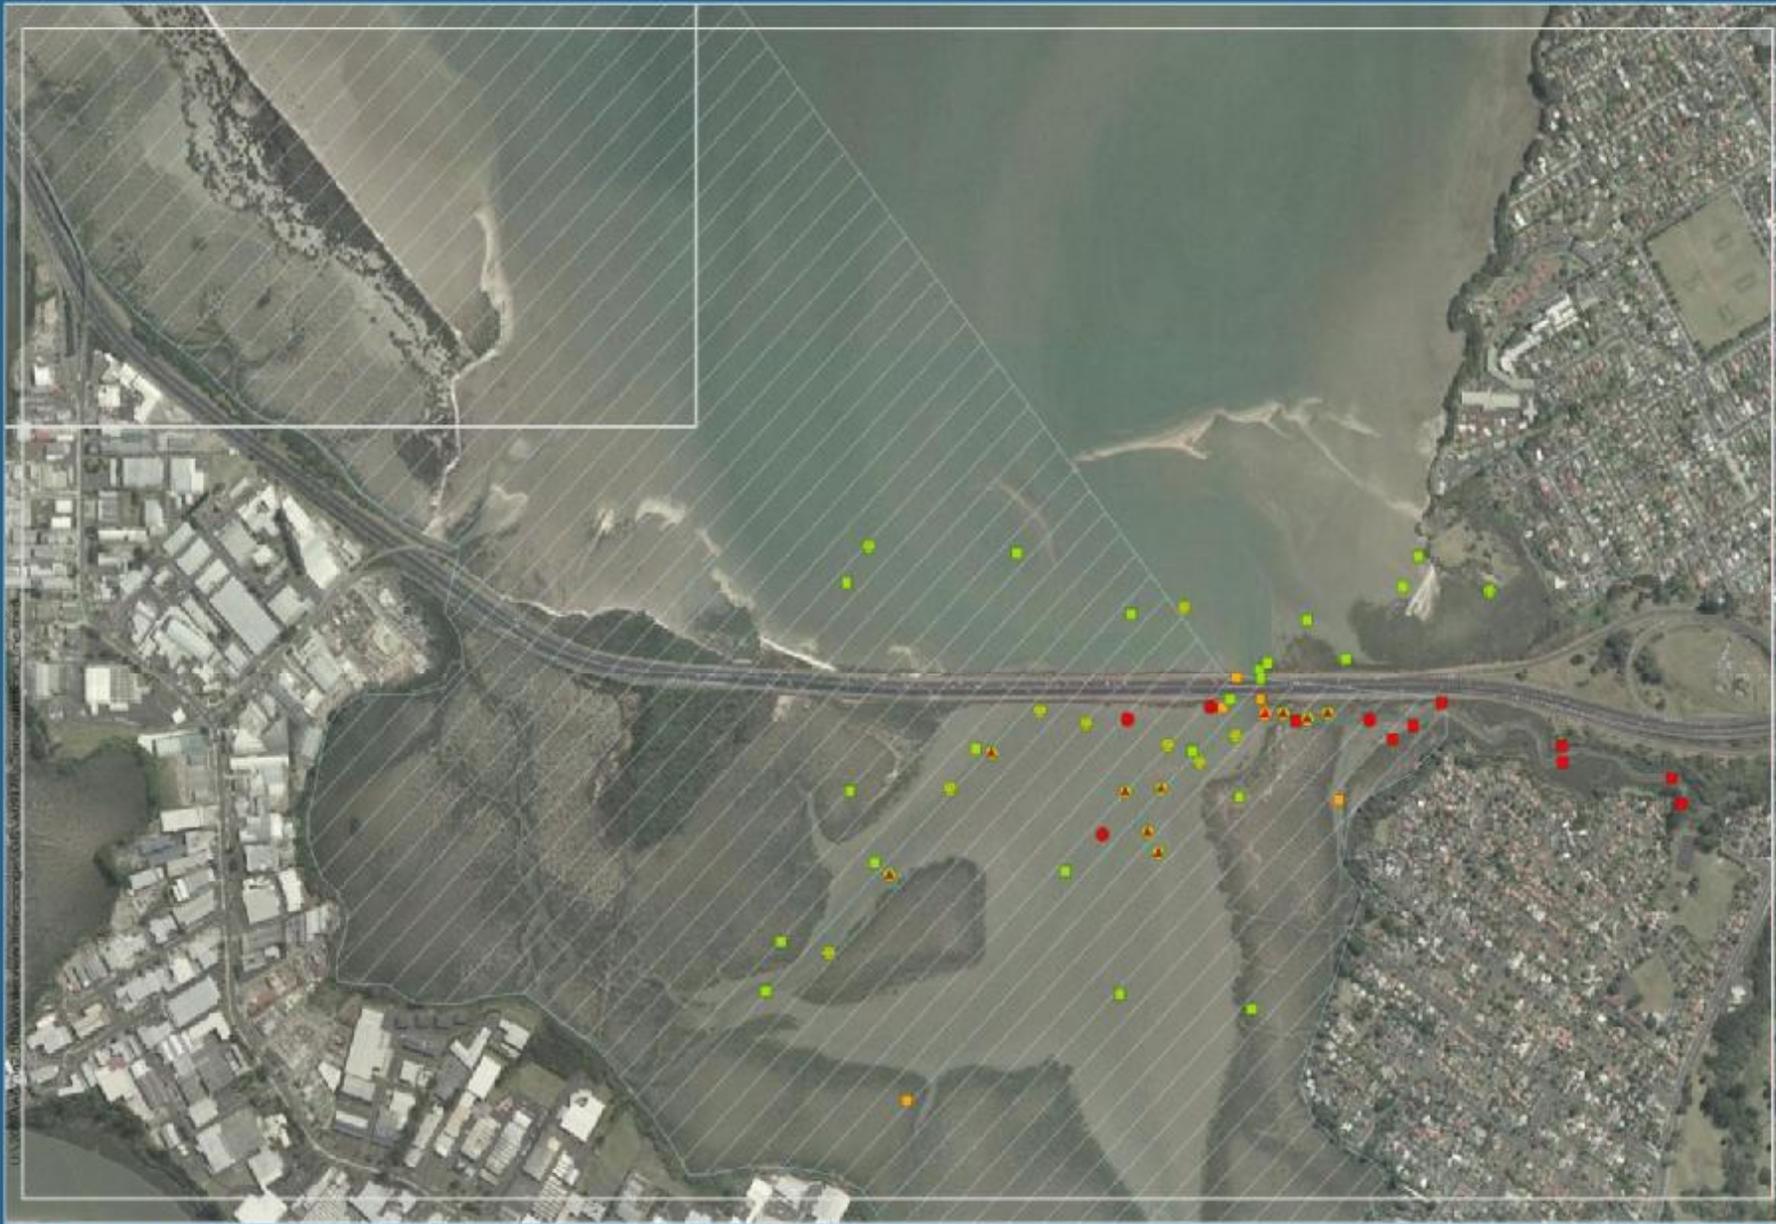
Marine Ecology - Sediment

- Past and present landuse/ discharges have impacted sediment quality.
- Sediment predominantly very fine silt and clay fraction.
- Constriction of tidal exchange, stormwater and contaminant discharges has resulted in elevated contaminant concentrations in sediment.
- Contaminants often exceed ARC criteria

Concentration in sediment
Zinc
Waterview

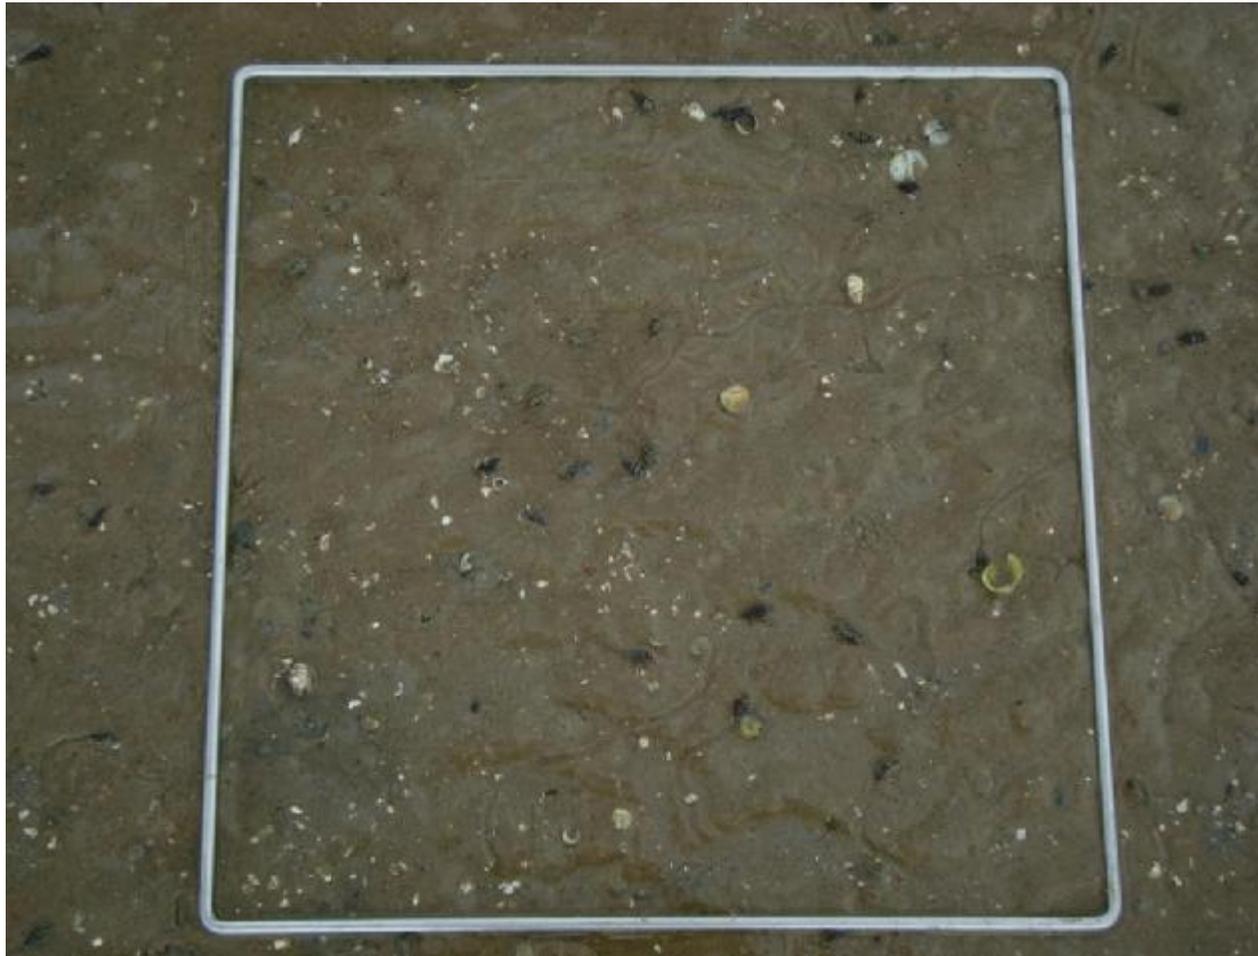
Marine Ecology - North of Waterview Causeway (firm, coarse sediment)

- **Invertebrate composition related to sediment grain size and hydrodynamic environment.**
- **Waterview Inlet has fine sediment (gloopy mud) with low diversity.**
- **Outer sites had more diversity of sediment grain size and invertebrates.**

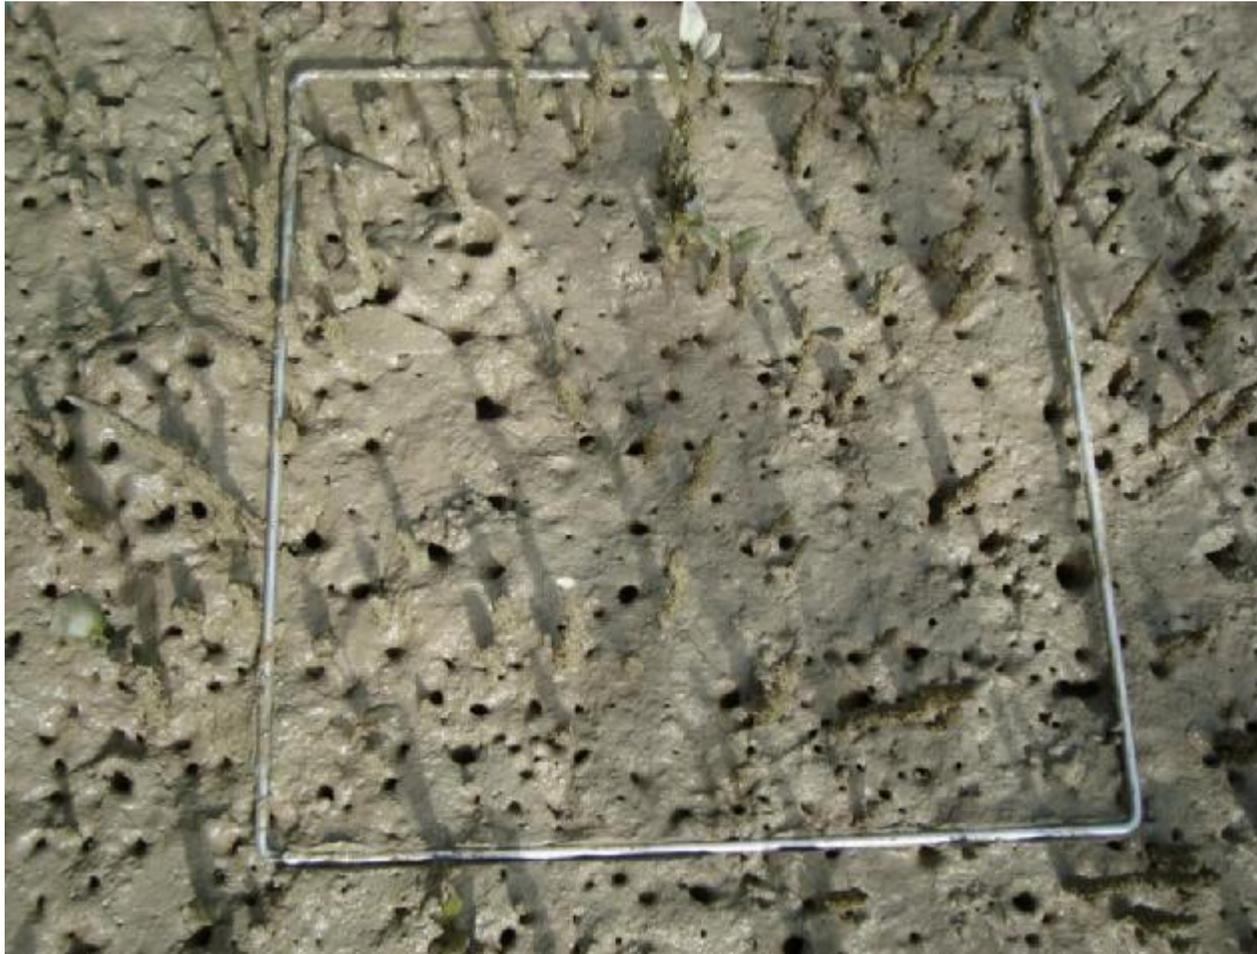
Marine Ecology- Within Waterview Inlet (soft deep gloopy mud)

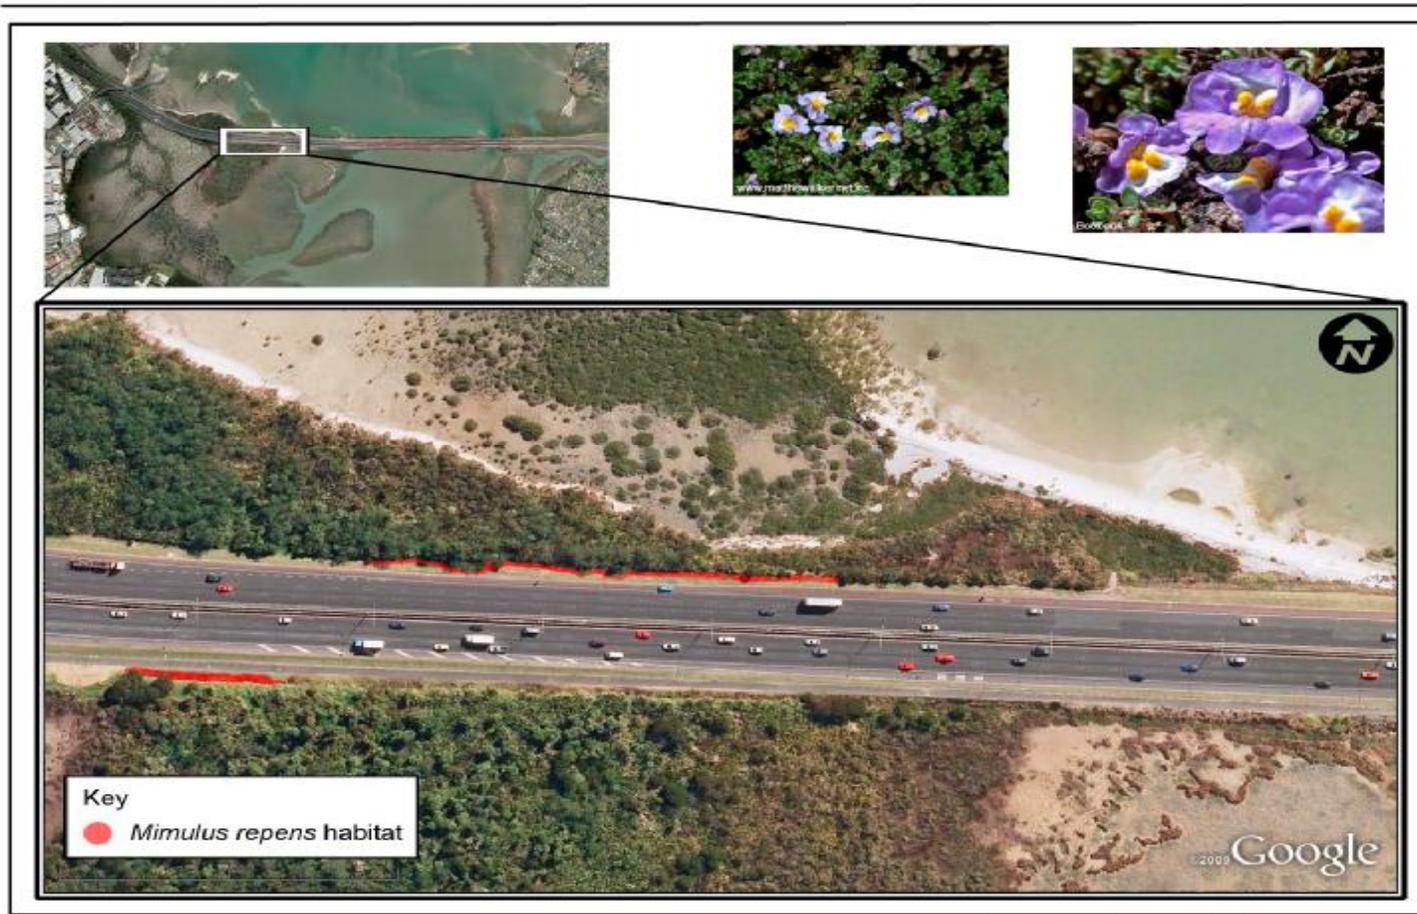
Waterview Connection Project - Location of *Mimulus repens* (Maori musk)

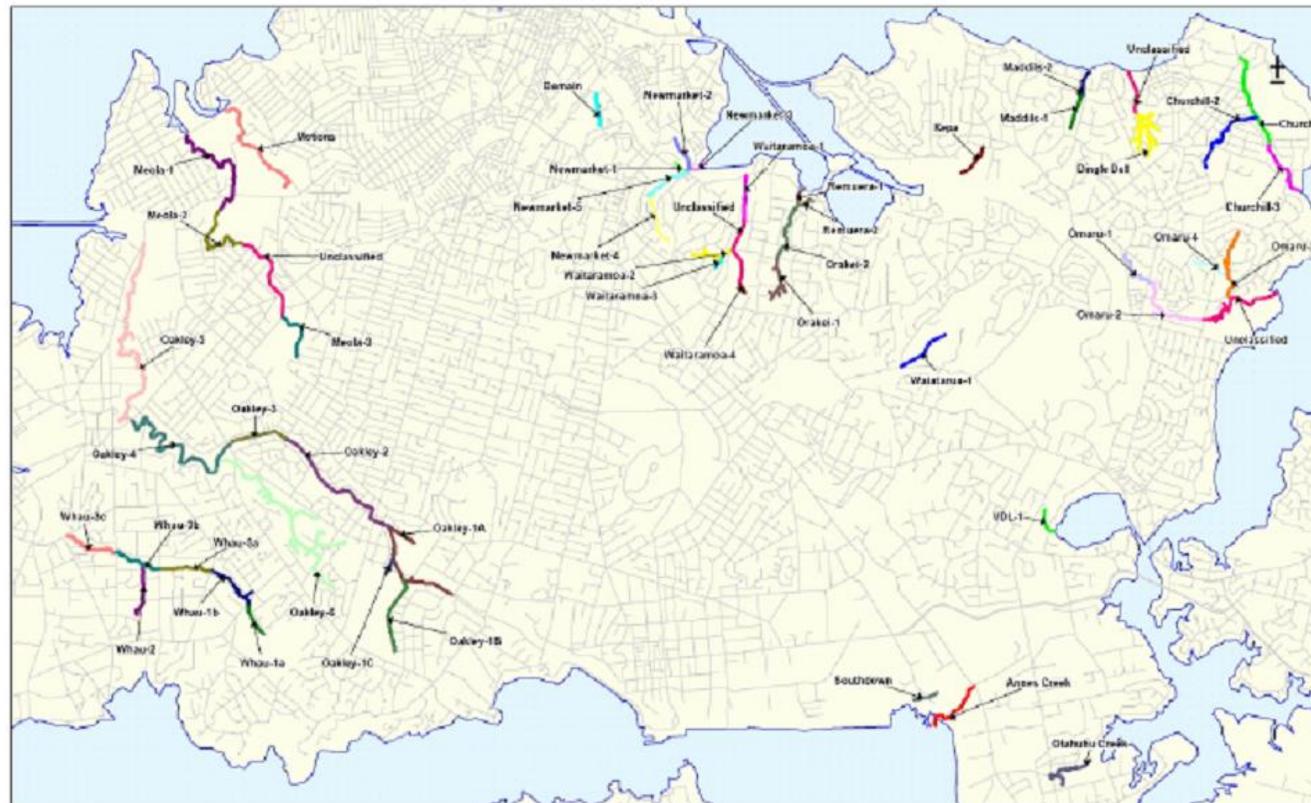
Figure 3 – NIWA stream reaches, produced by KMA and Beca

Freshwater Ecology- Auckland's Streams

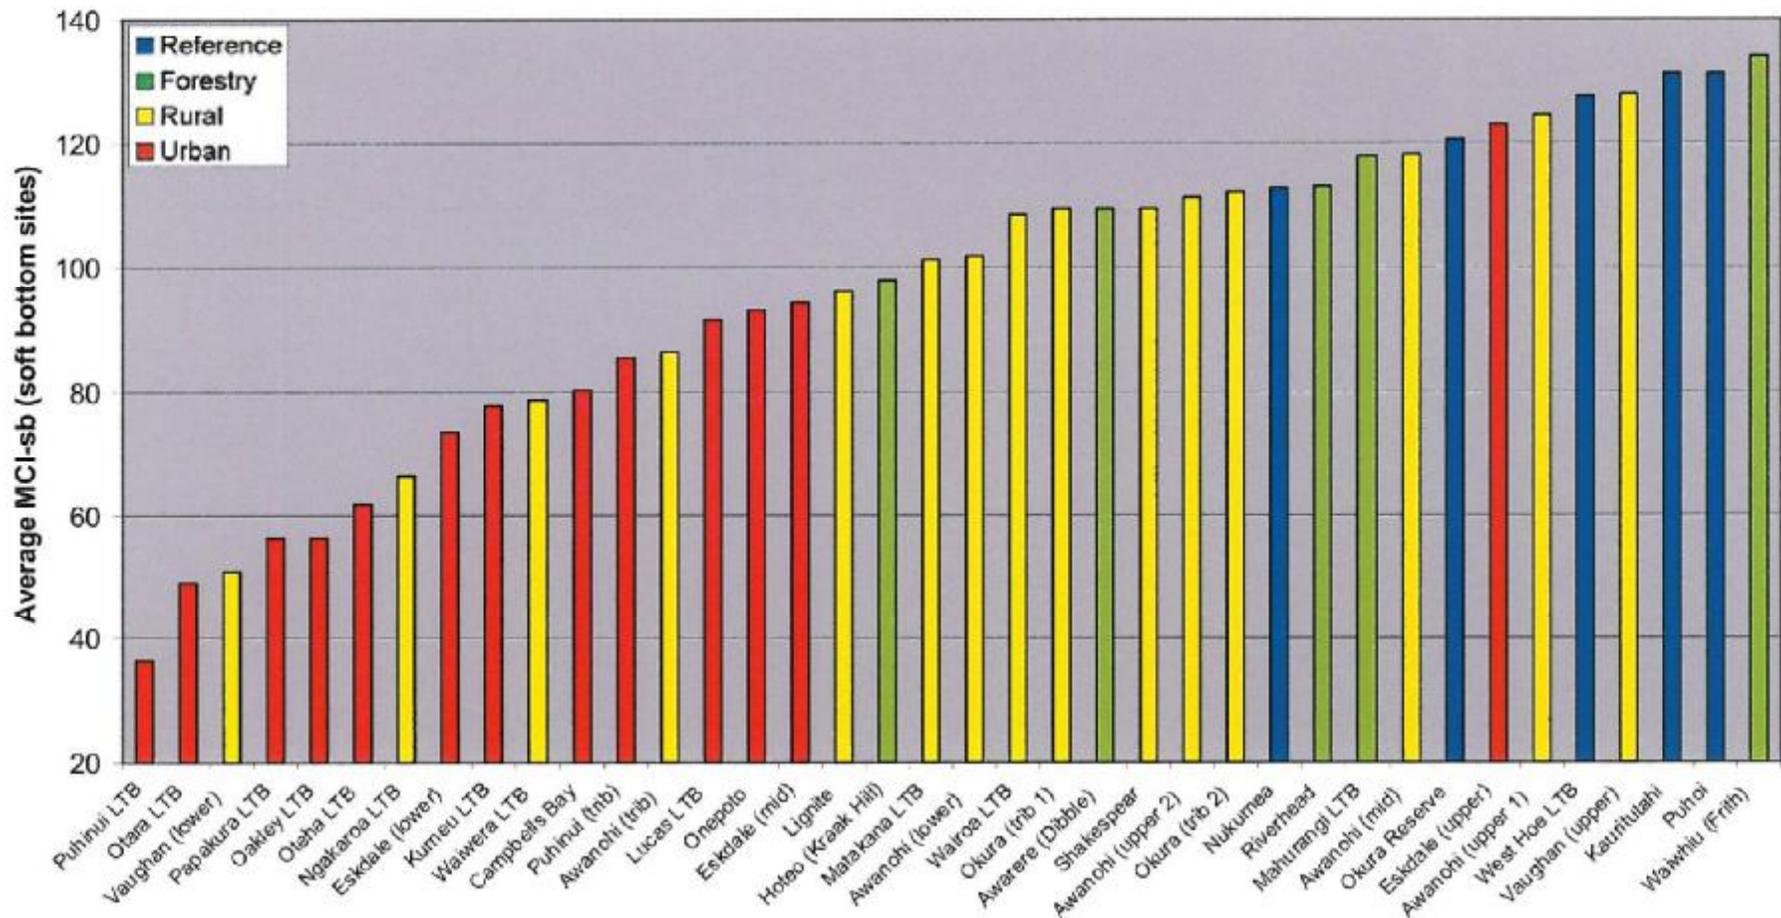
Freshwater Ecology - Regional Invertebrate Data

- **Three streams affected, the most significant being Oakley Creek.**
- **Receives stormwater/sewer overflows typical of urban environments.**
- **Macroinvertebrate communities indicate polluted conditions.**
- **Native fish diversity limited by waterfall.**
- **Rehabilitation guidelines prepared to detail how this will be achieved.**

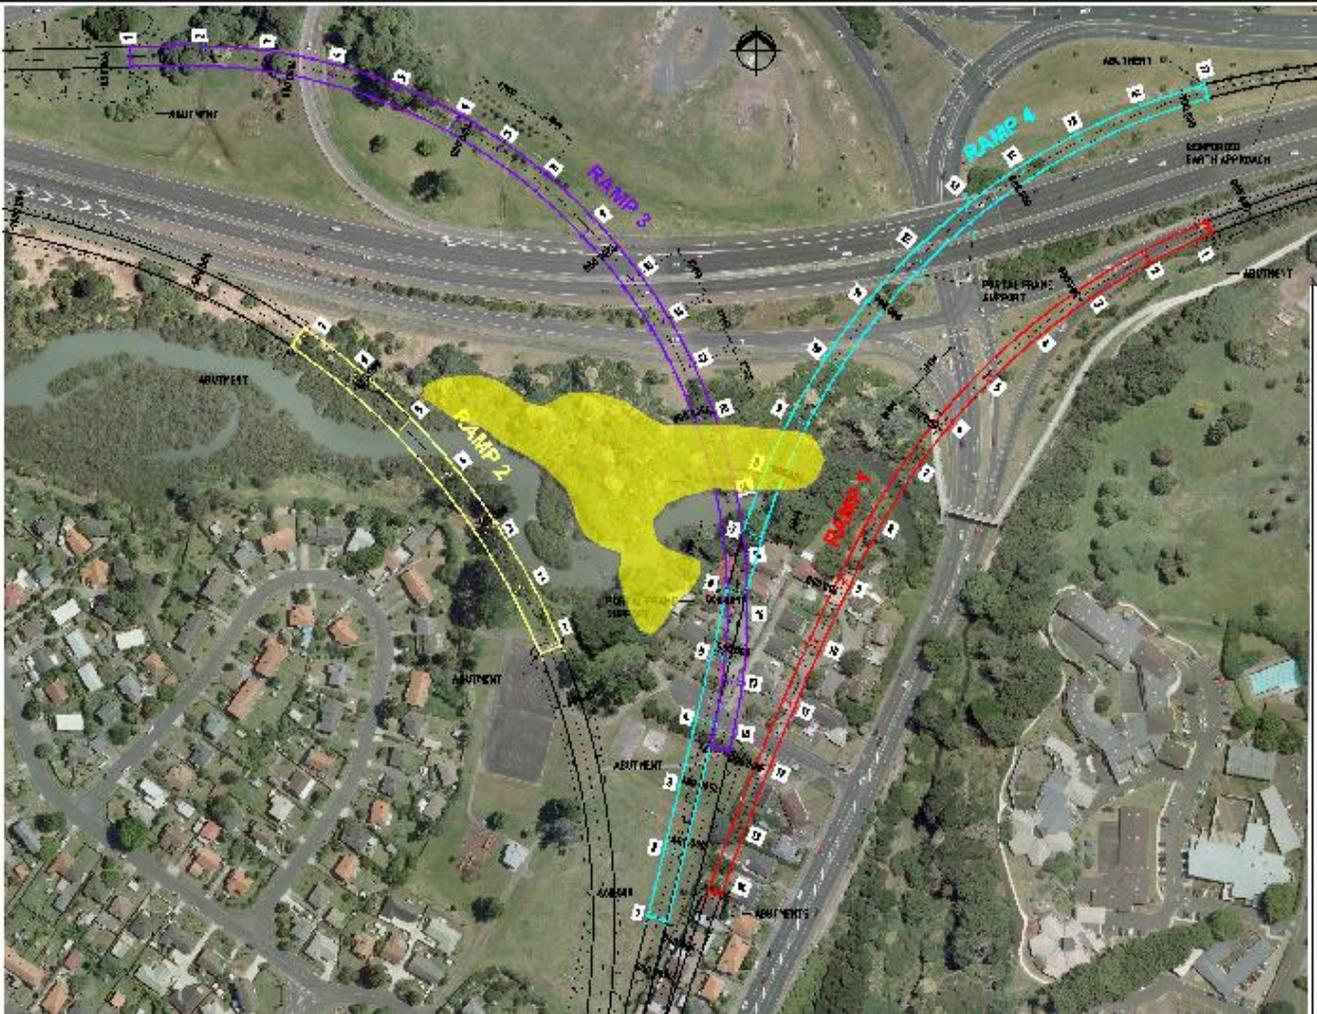
Archaeology - Sites around the Great North Road Interchange

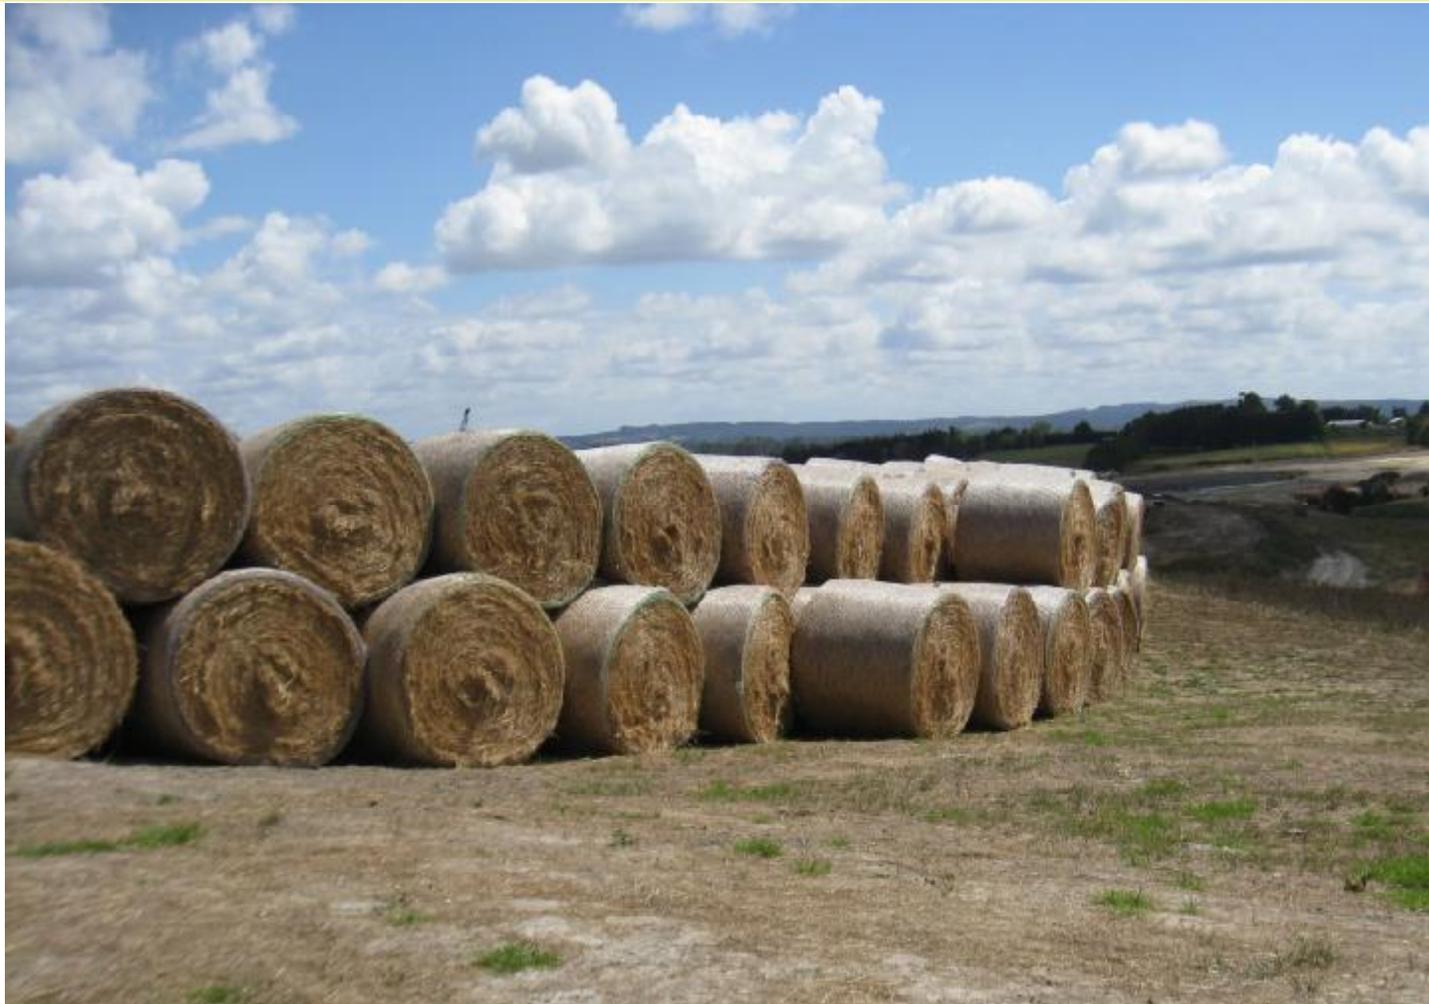
Erosion Protection - Mulch

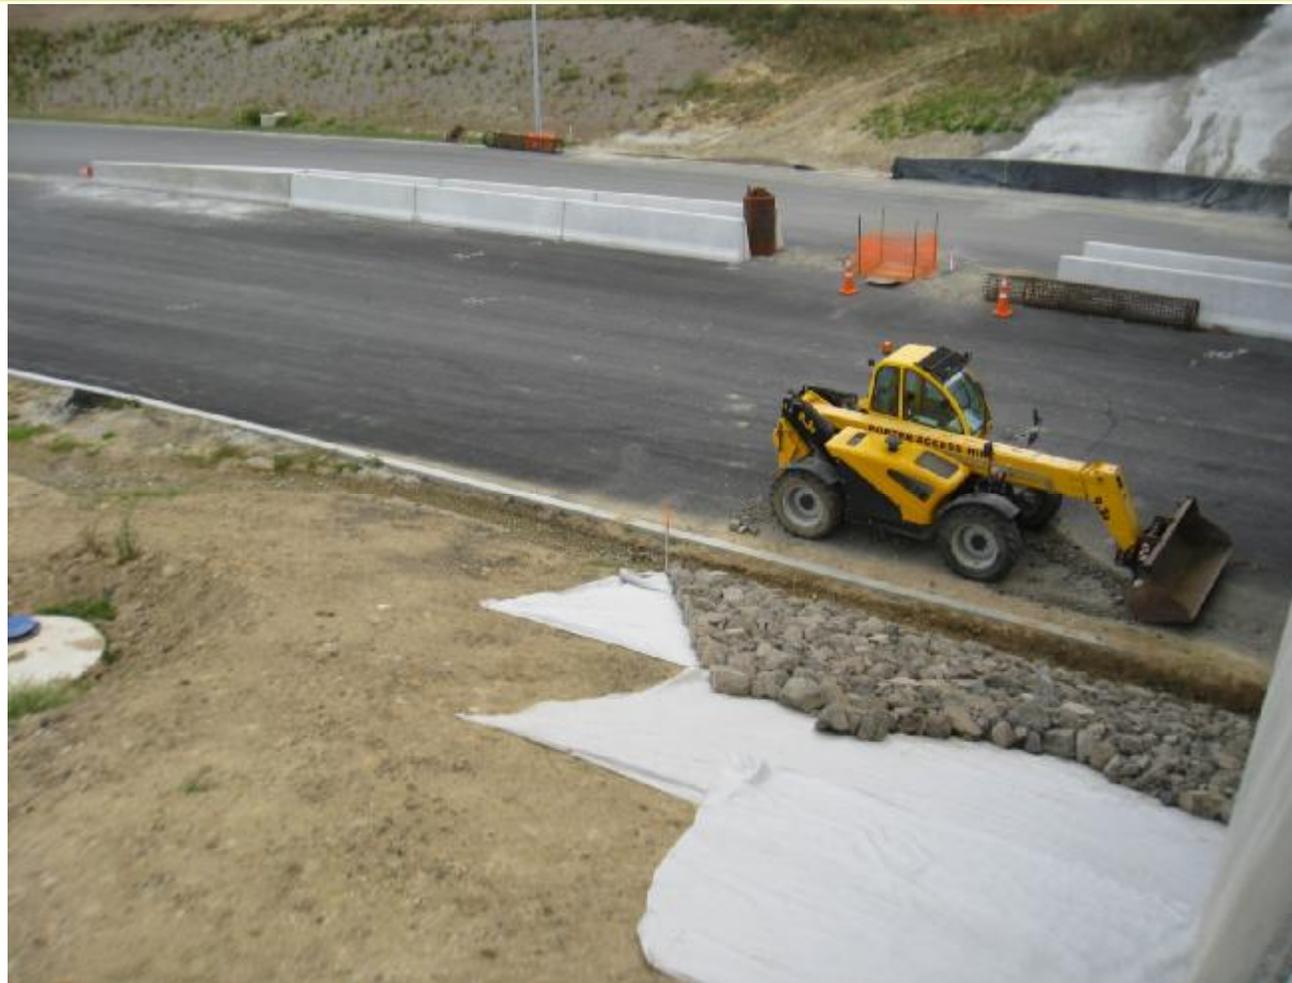
Erosion protection- Stabilisation

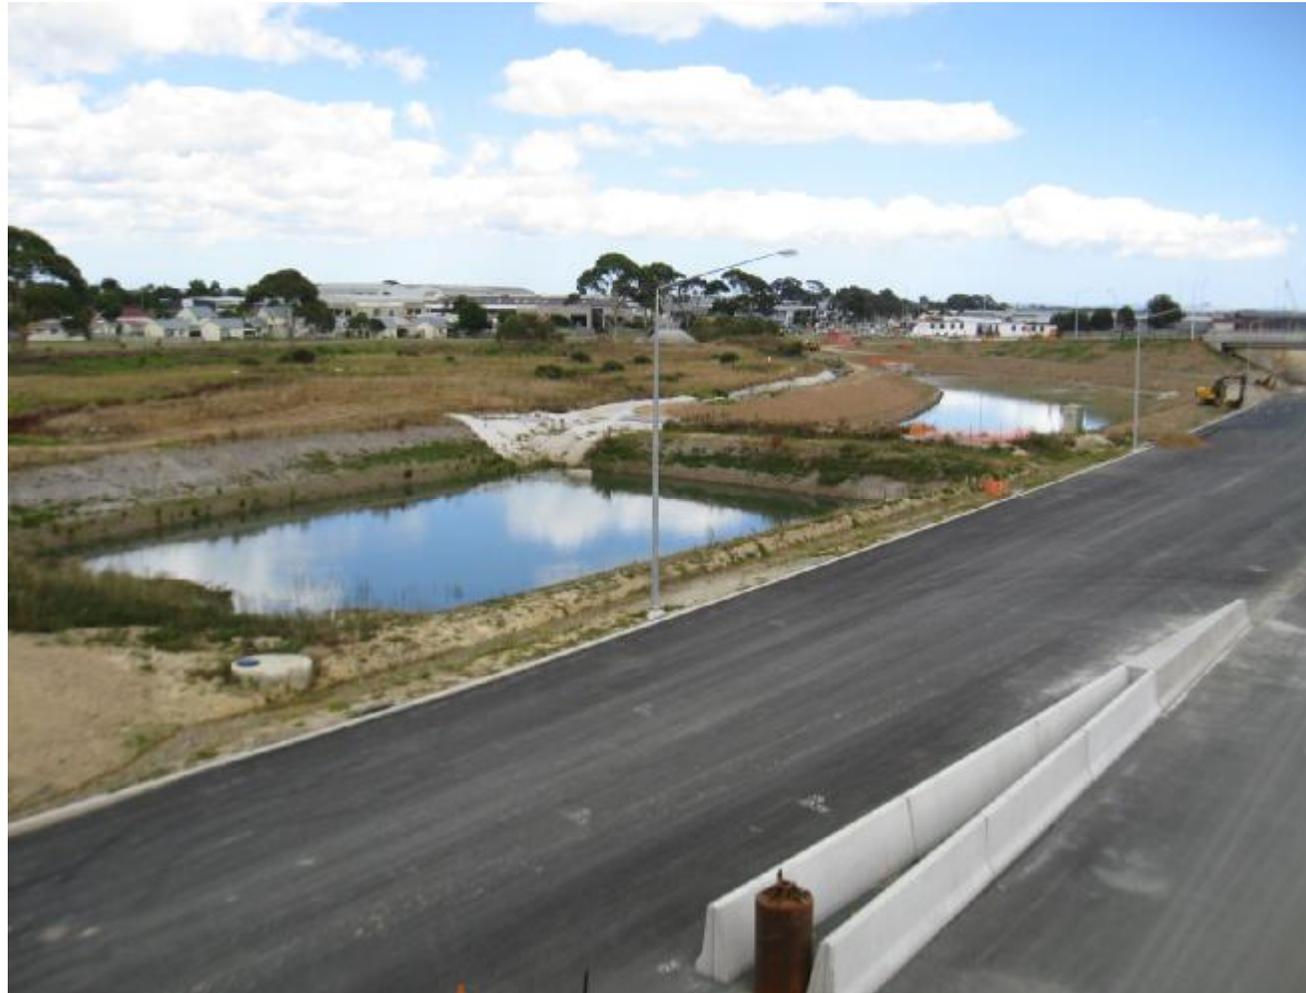
Sediment Retention Pond

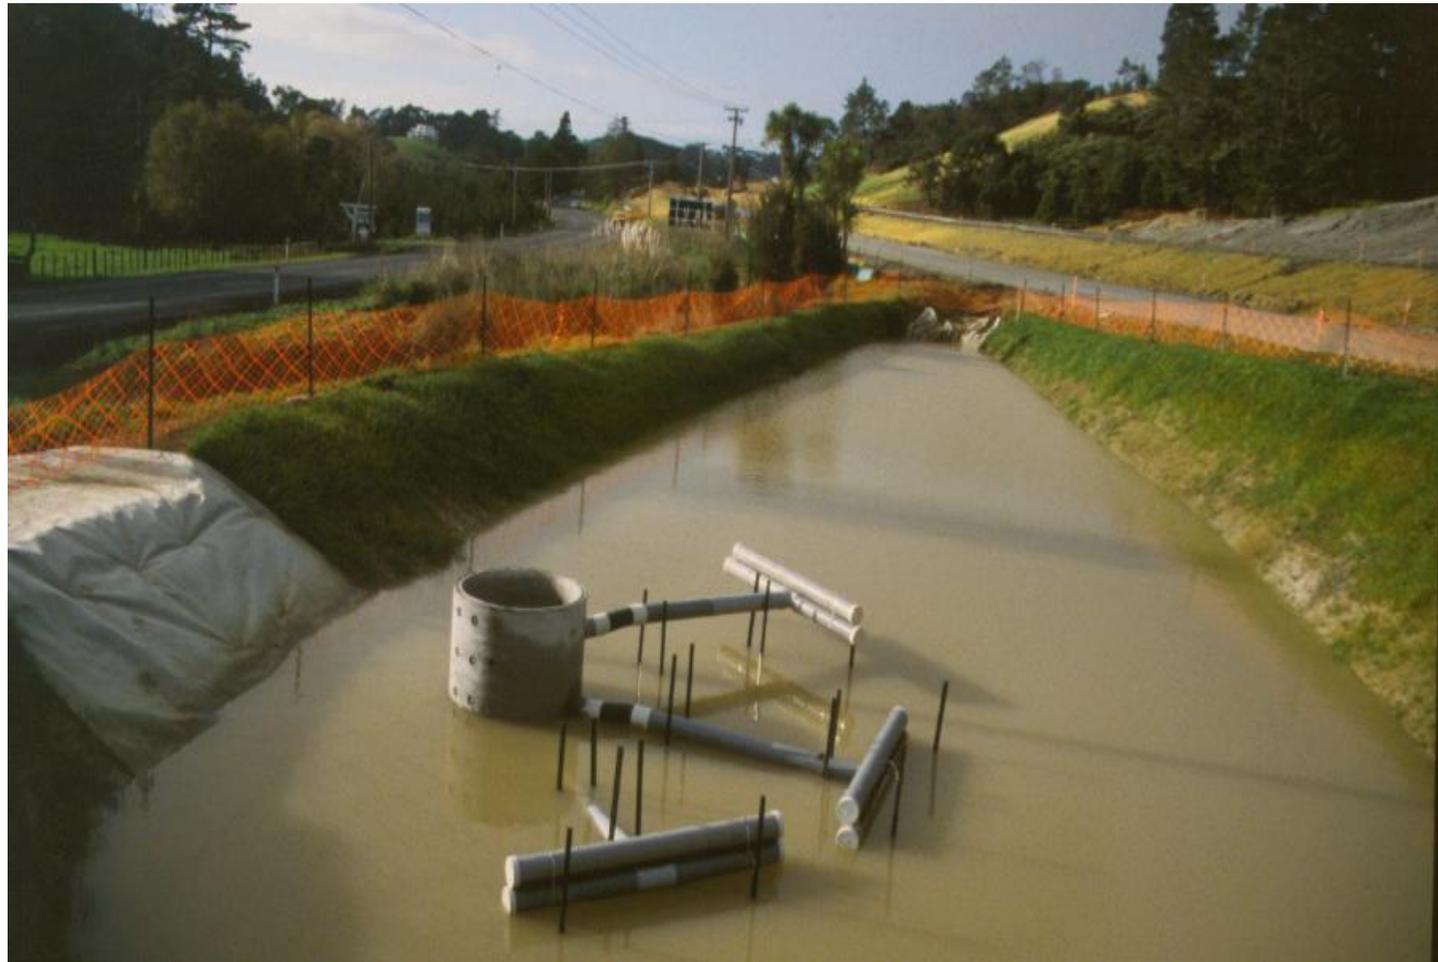
Sediment Retention Pond

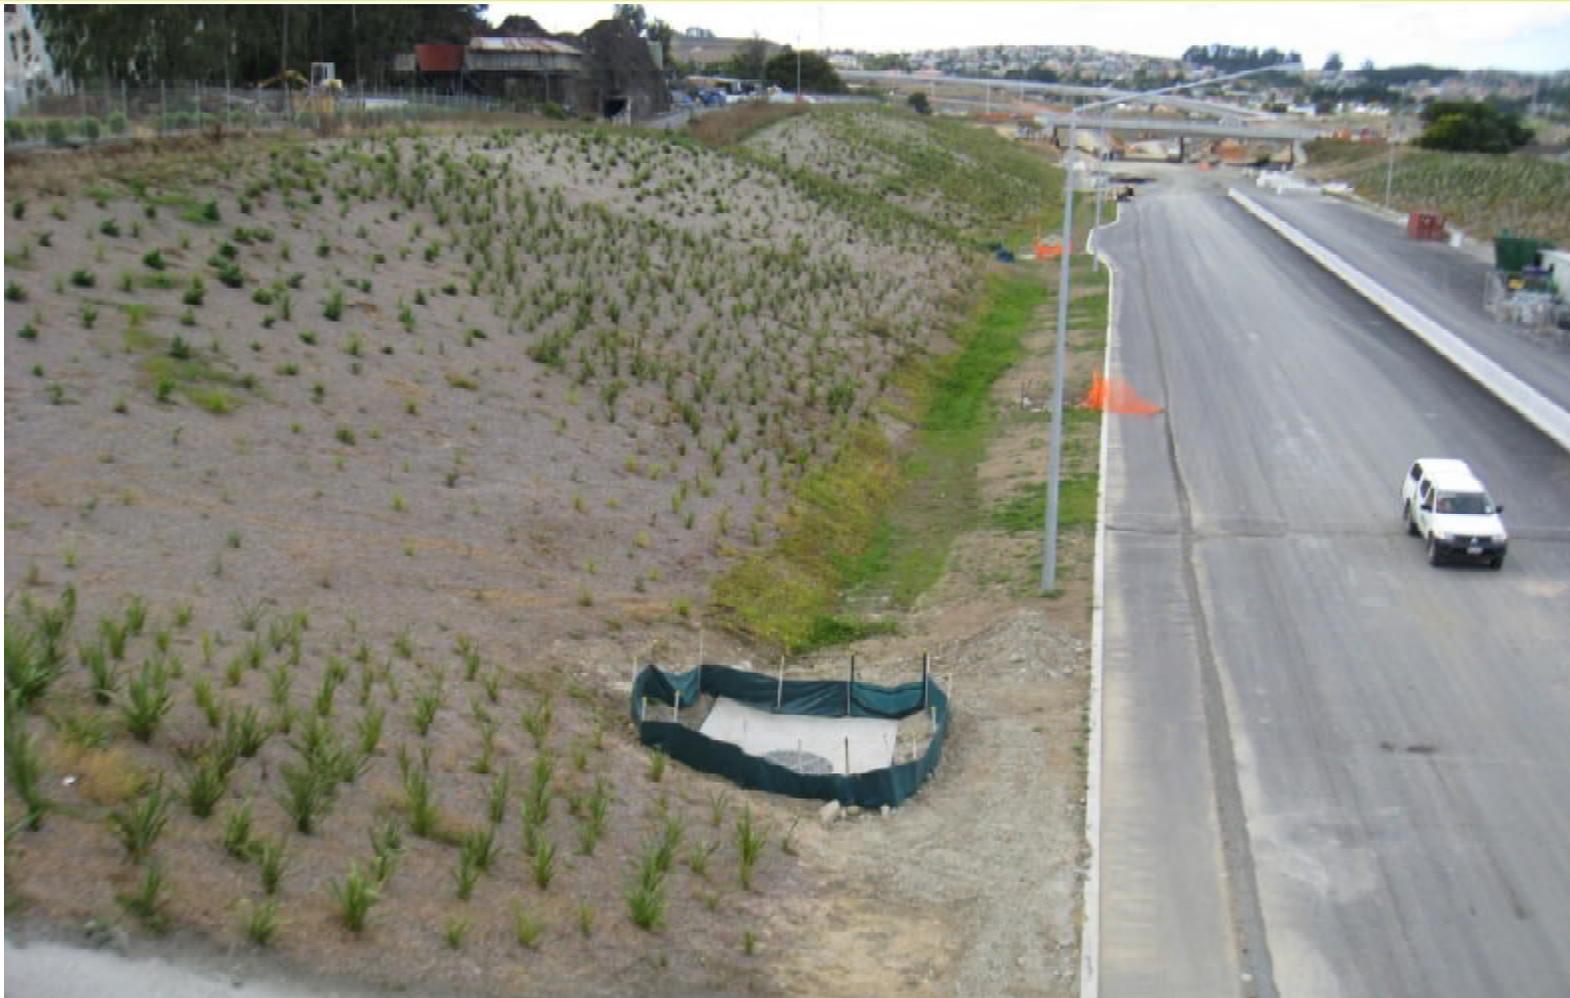
Sediment control

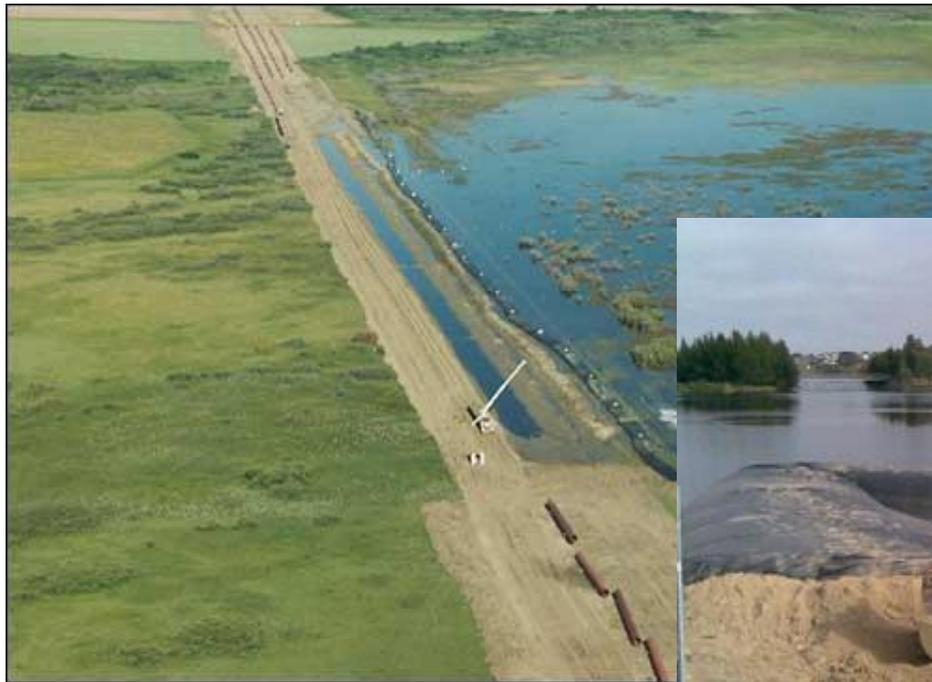
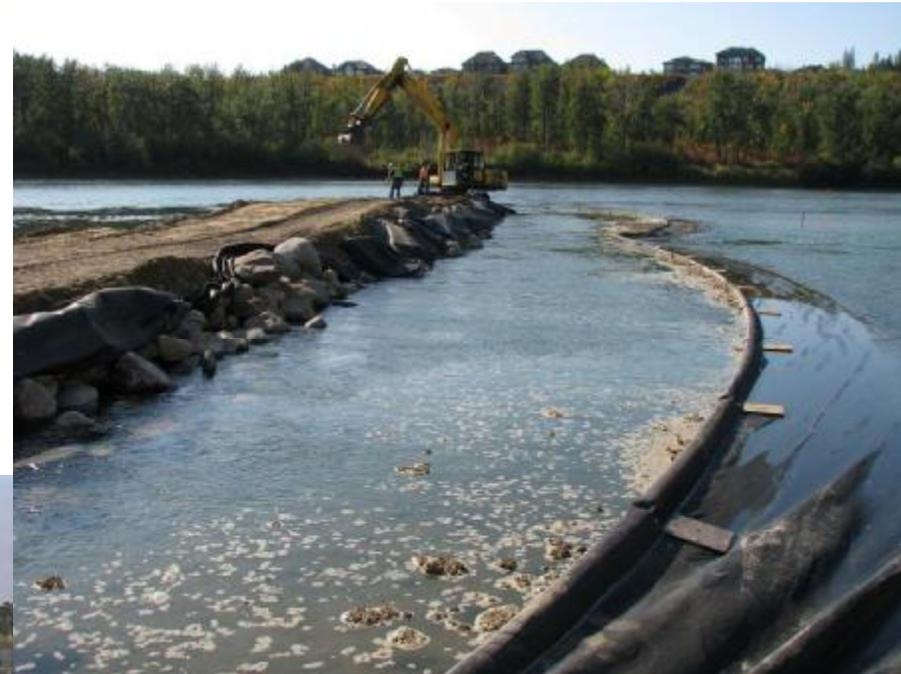
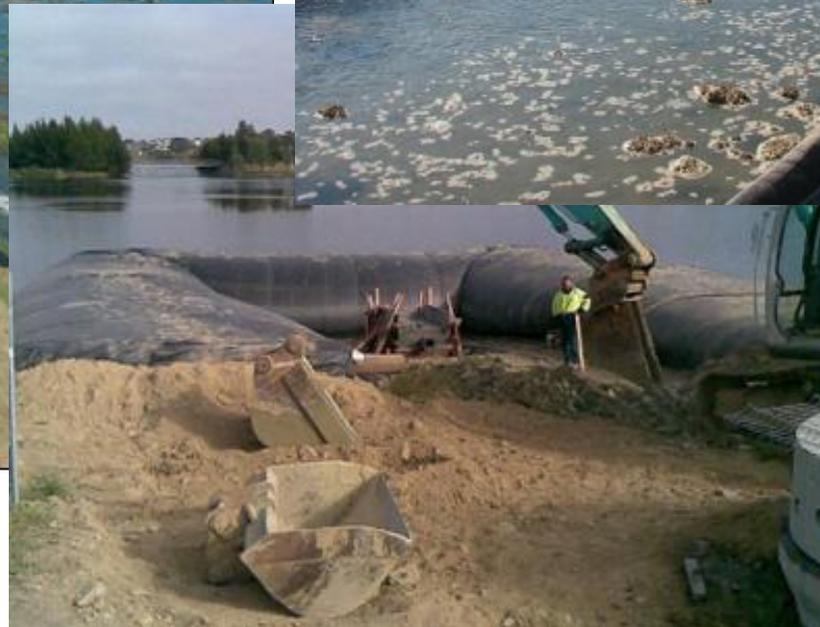
Erosion and Sediment Control Measures

- **Works still ongoing:**
 - Current possibilities include
 - Aquadam (or similar)
 - Silt curtain

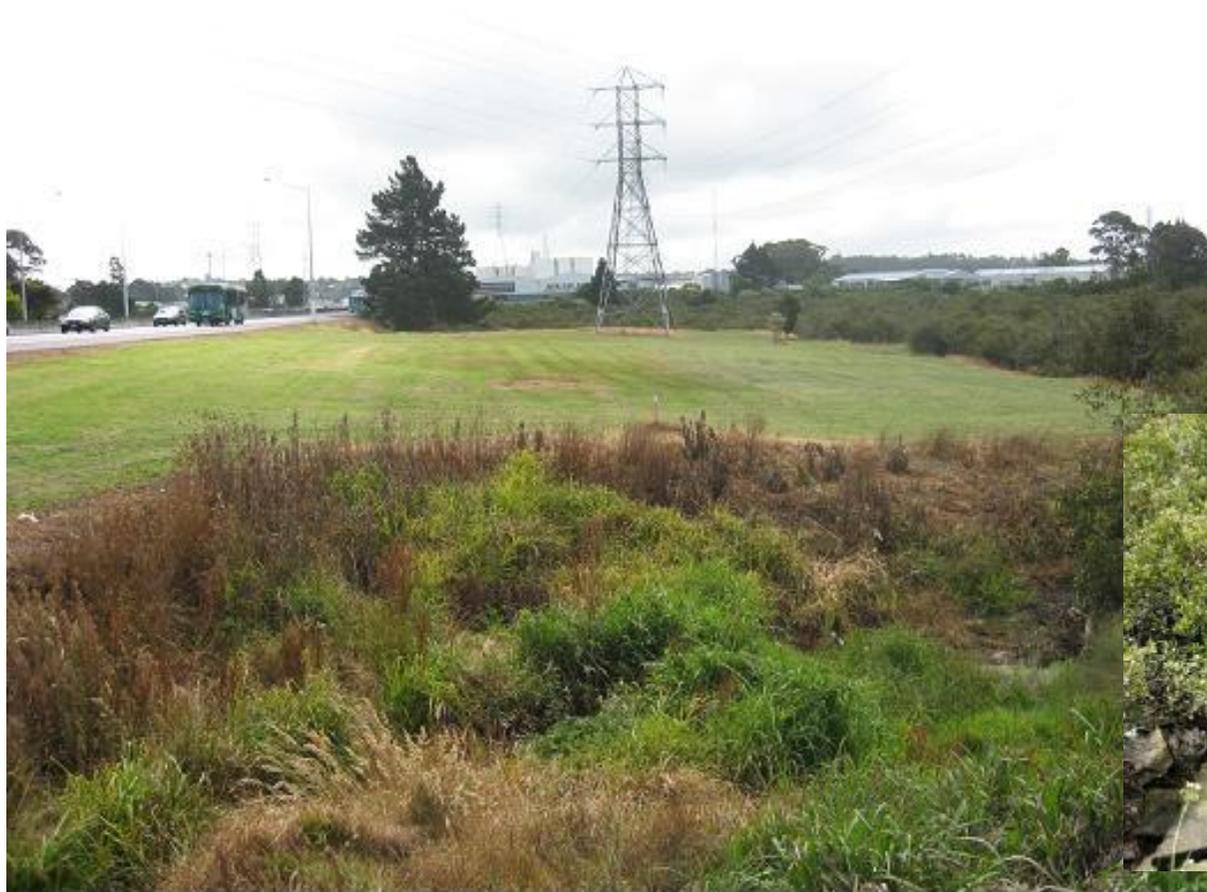
Stormwater Management –Te Atatu

Stormwater - Design Philosophy

Stormwater treatment provided for

- all new impervious surfaces
- for existing impervious surfaces where practicable

Sediment removal achieved by :

- q Wetlands
- q Grassed swales
- q Grassed filter strips
- q Proprietary cartridge filters

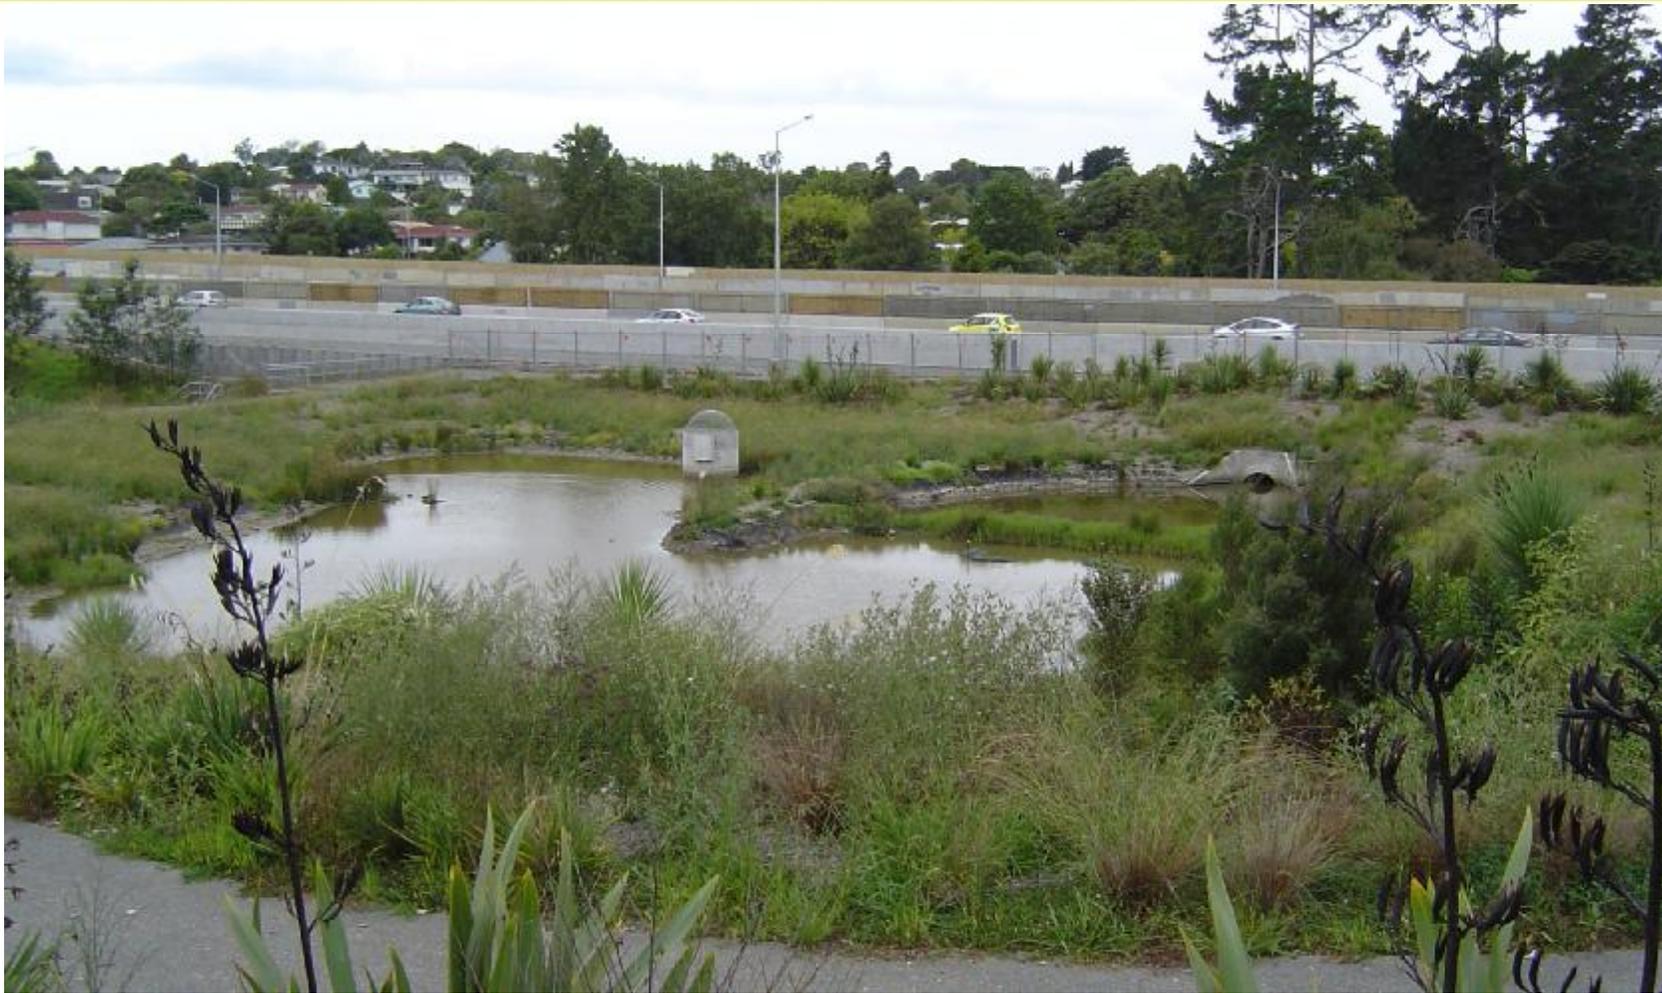
Stormwater pond
