# Chipseal Failures and Repairs

## Chapter 12 Chipseal Failures and Repairs

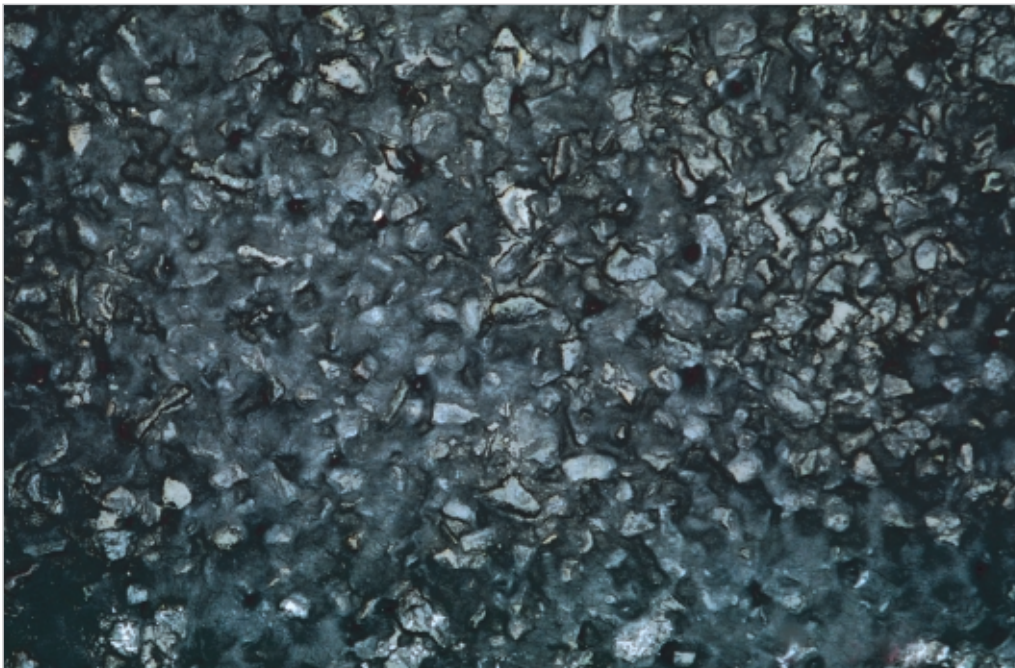
Figure 12-1 Small holes are evidence of binder rise through the action of vapour venting (volcanoes) (see also Figure 4-20).

Binder rise is a natural action which occurs over the life of a chipseal and can cause flushing and bleeding (Figure 12-1). Some researchers believe that the chips are pushed into the binder rather than the binder rises over the chips. In fact both can happen.

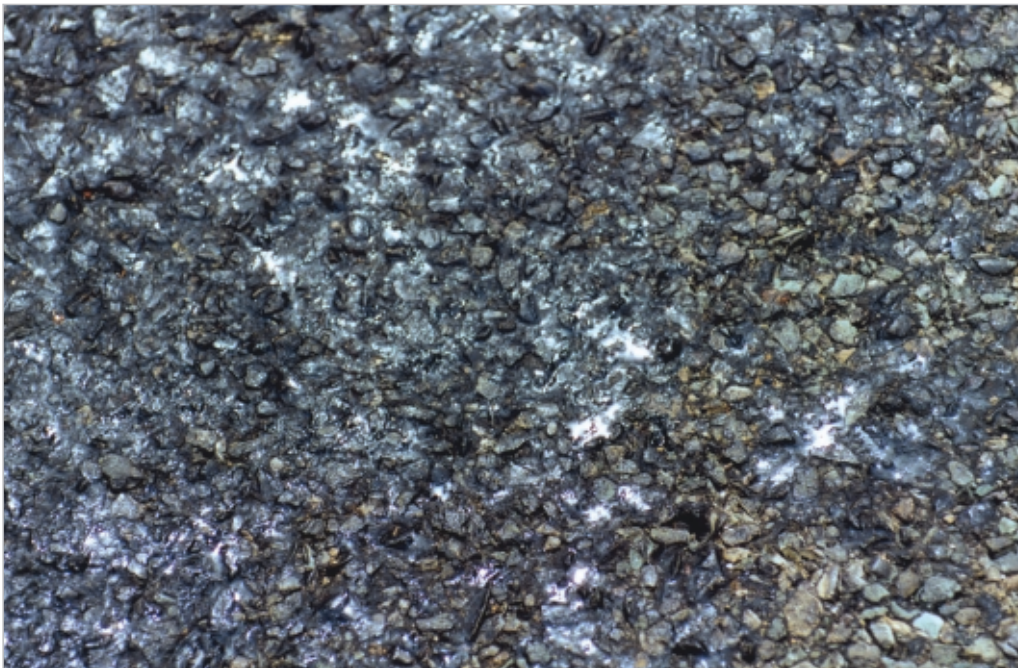
Figure 12-2 Bleeding in progress.

As mentioned above, and discussed in Section 3.11.7, binder rise can result in bleeding (Figure 12-2) which occurs when the surface tension of the binder is broken and tracking can occur (Figure 12-3).

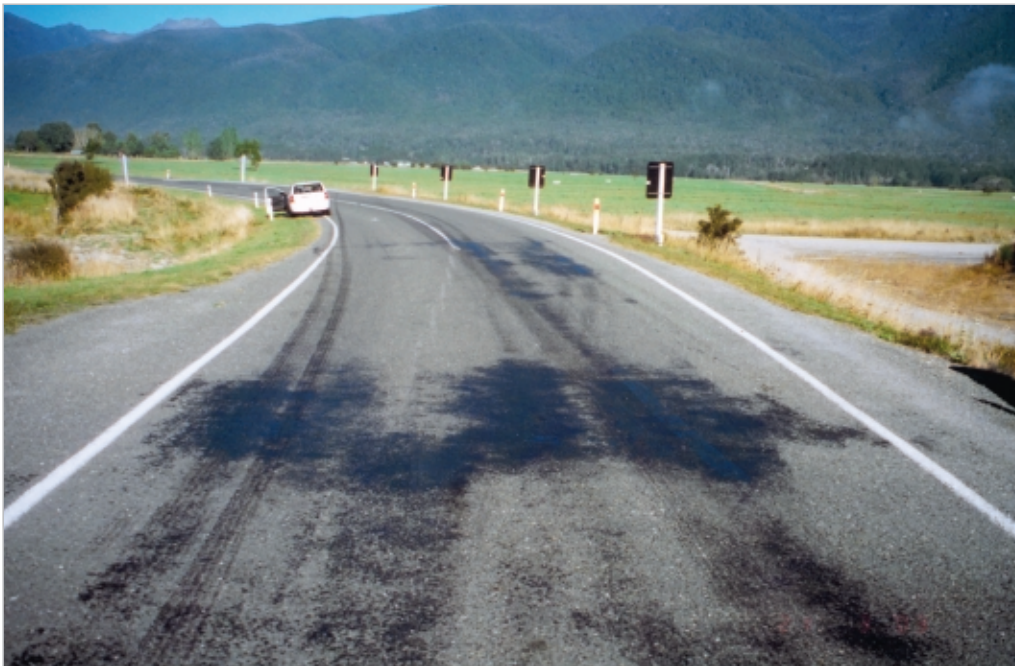
Figure 12-3 A surface showing both bleeding and tracking on a hot summer day, possibly caused by an old repair patch. This has caused the current chipseal to flush and bleed.

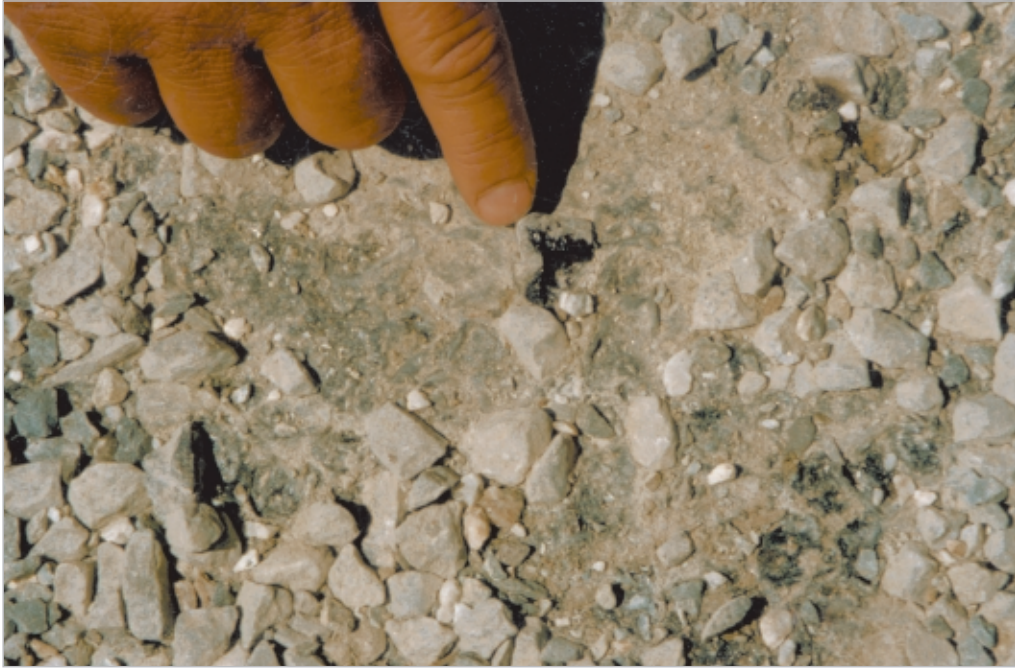
Figure 12-4 Chip loss caused by dirty chip in the seal.

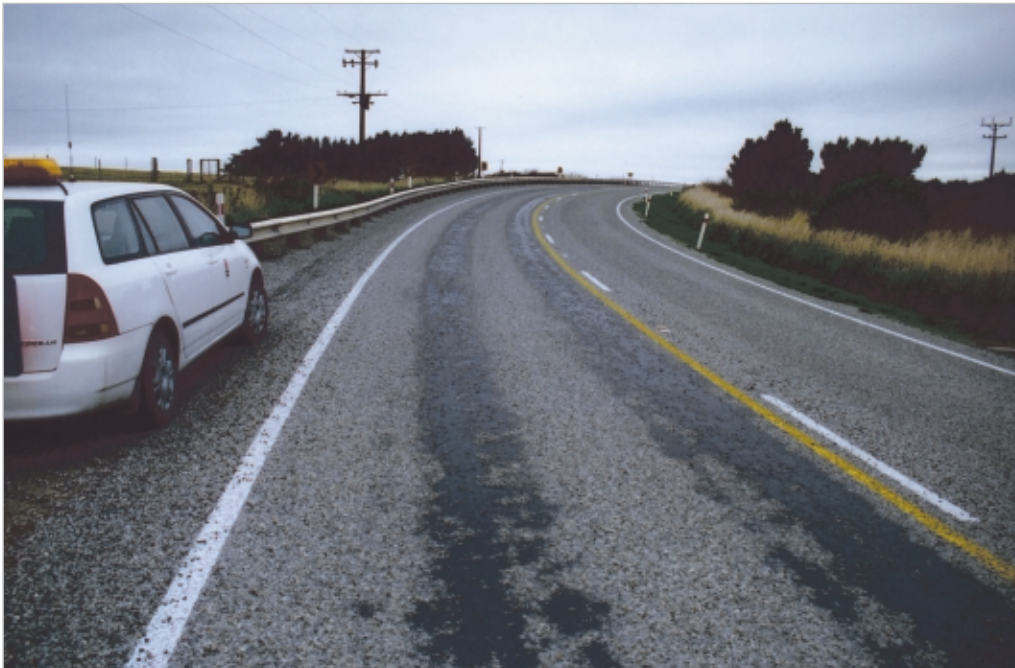
Figure 12-5 Chip loss can occur within 48 hours after chipsealing. Photo courtesy of Les McKenzie, Opus

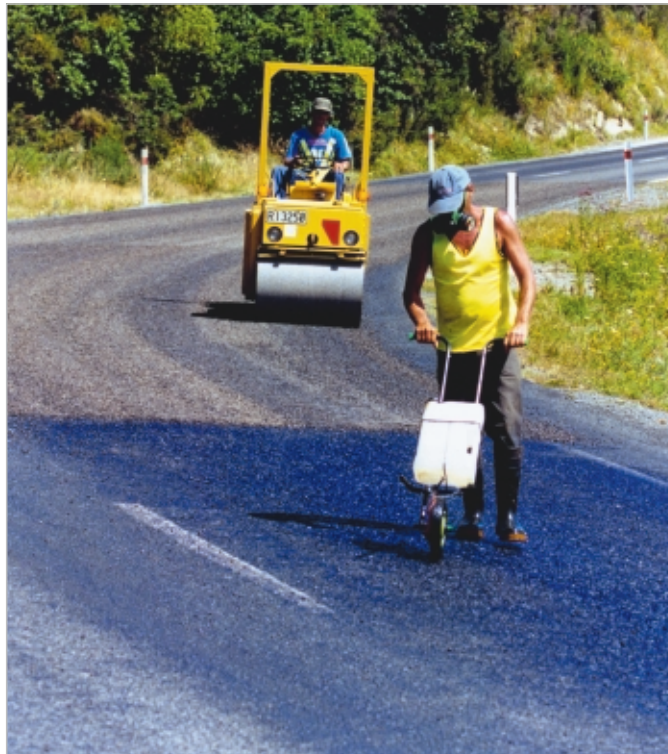
Figure 12-6 Solvent (e.g. kerosene) being applied before it is covered with chip.

The application of a solvent to a flushed seal or to a seal that is showing chip loss, and then applying chip, is a technique that has been widely used in New Zealand as a localised treatment. The choice of solvent has often been kerosene, as mineral turpentine has a lower flash point and is thus a greater safety hazard. The application rate of the solvent is usually between about 0.1-0.3 ℓ/m<sup>2</sup>, and can be applied with a sprayer (Figure 12-6). Adhesion agent may also be required in the solvent mix.

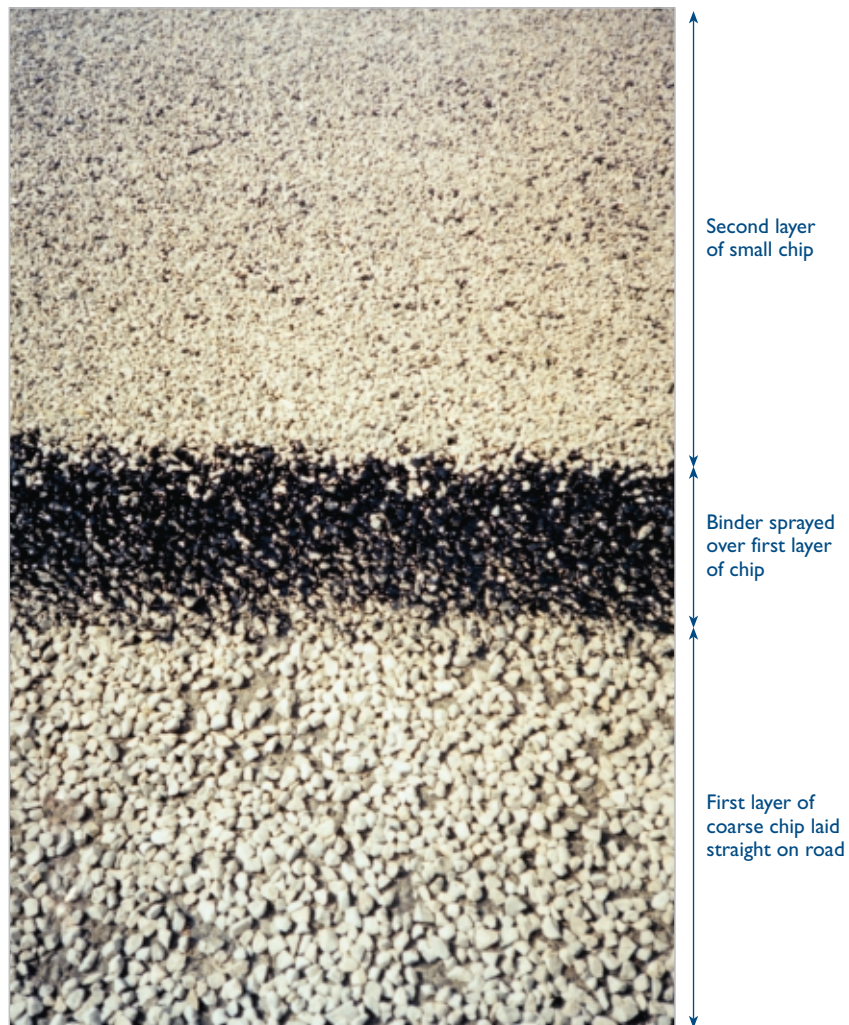
Figure 12-8 The three layers of a sandwich seal are shown part way through construction.

The sandwich seal technique originated in France and has been used in New Zealand (especially the Napier region) since 1995. It essentially consists of the following construction sequence:

1. large chip (lowest layer);
2. binder;
3. small chip (in surface layer).

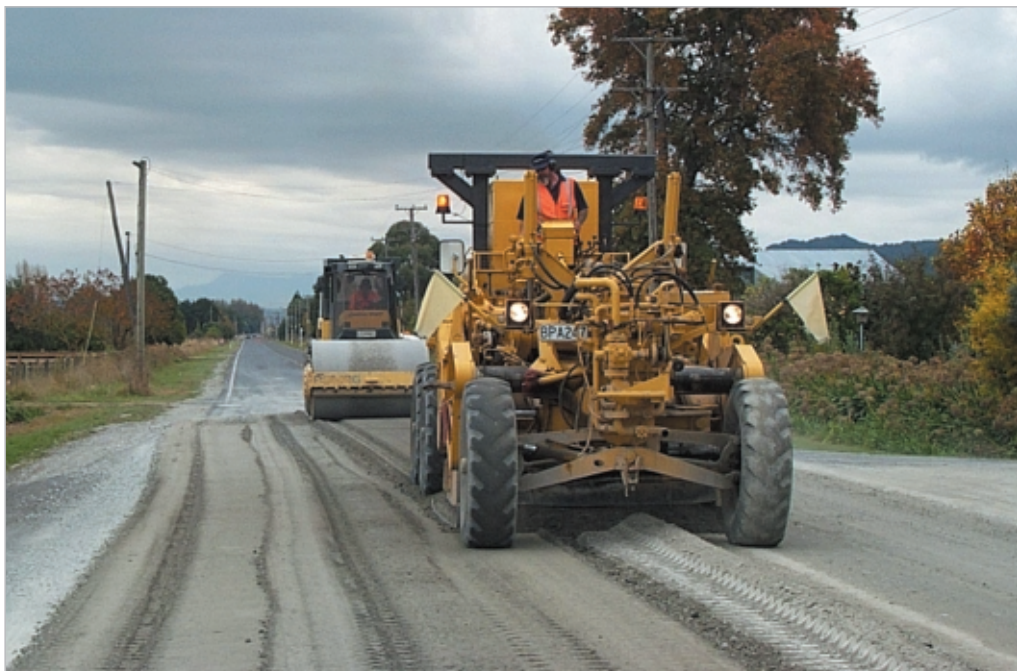
Figure 12-9 Recycling a multiple chipseal that has developed layer instability.

This technique has been developed in the Hawke's Bay region and is advocated for use as an area treatment where multiple seal coats have developed layer instability (Figure 12-9). The Hawke's Bay experience suggests that, where the volume of bitumen in multiple seal layers is >12% and the build-up of seals exceeds 40 mm thickness, then the pavement can have low shear strength and shallow shear can be experienced.
