Road and traffic guidelines

RTS 14

Guidelines for facilities for blind and vision-impaired pedestrians

Consultation document

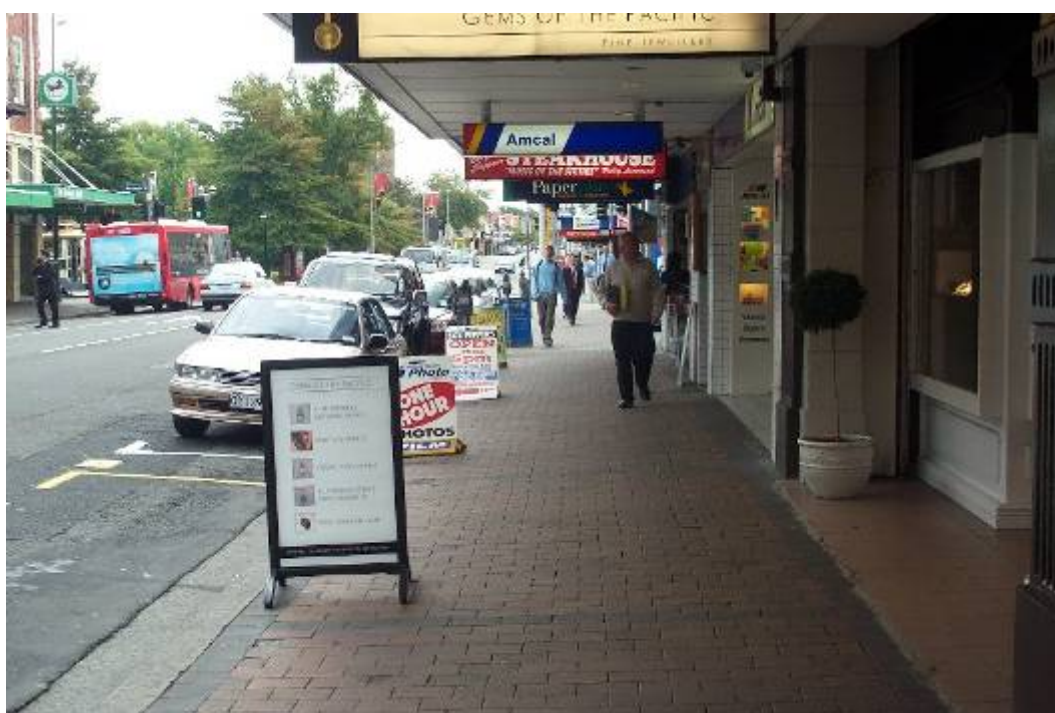
Photo 1: While no footpath obstacles would be preferable, these advertising signs are located on the kerb edge, outside the continuous accessible path of travel.

Advertising signs on the footpath should be avoided if possible. Where advertising is permitted, signs shall be located away from the continuous accessible path of travel, ie, on the kerb edge, as shown in Photo 1, and always placed consistently in the same location.

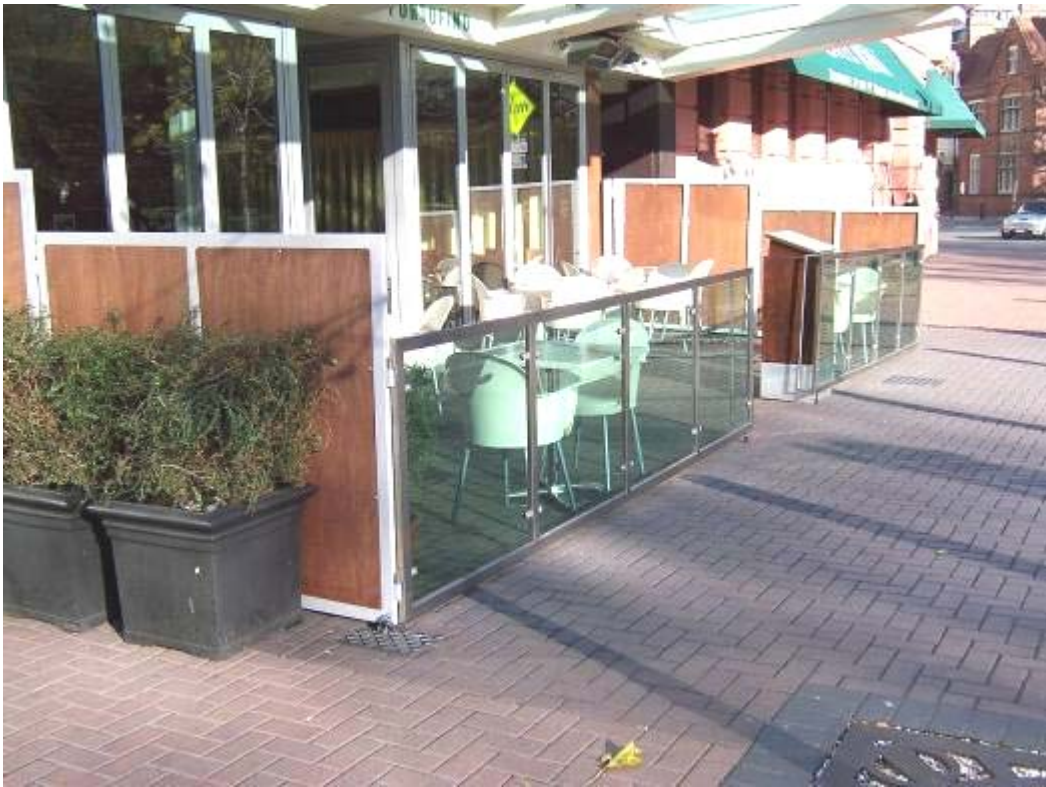
Photo 2: Good practice – street furniture is located in an enclosed area which can readily be detected by the use of a long cane.

Photo 2 below is an example of good practice with seating outside a restaurant that is enclosed by a structure that meets the aforementioned requirements of NZS 4121: 2001. On the other hand, Photo 3 shows seating and signage outside a bar that encroaches on the continuous accessible path of travel with the table in particular being a nasty obstacle for vision-impaired pedestrians.

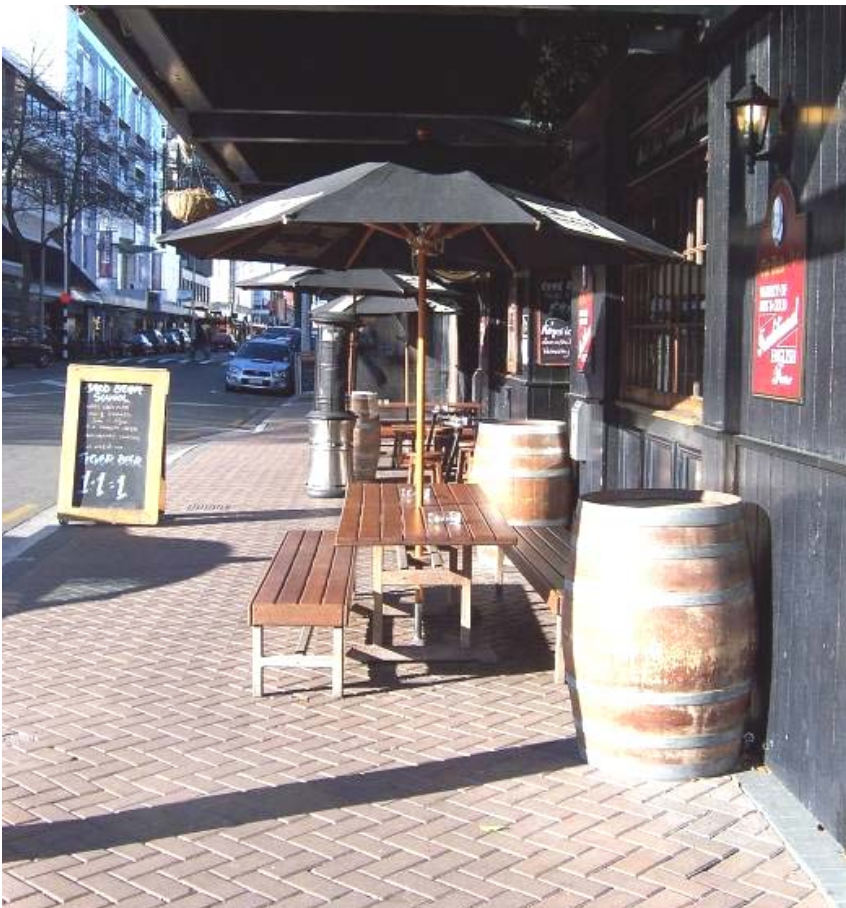
Photo 3: Poor practice – street furniture that sprawls out onto the footpath is a hazard for all pedestrians.

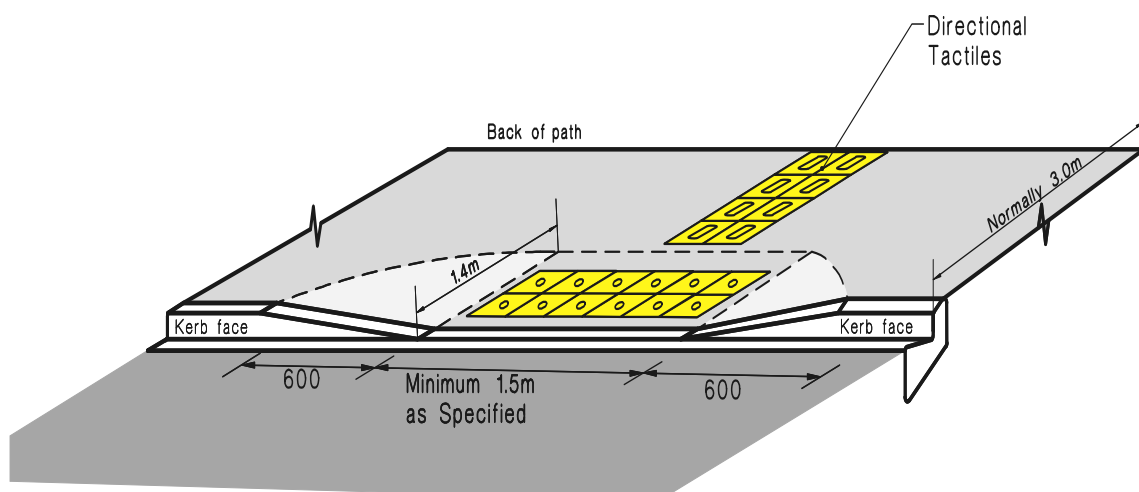
Figure 1: Standard kerb ramp design, assuming a full kerb height of 100mm.

Figure 1 shows a typical kerb ramp design next to a kerb that is 100mm high. It shows the maximum slope of haunching of 1:6. If the crossfall on the footpath is 1%, a kerb ramp depth of at least 1.4 metres is required to keep the slope below 1:12. For a footpath

crossfall of 2%, a kerb ramp depth of at least 1.6 metres would be necessary.

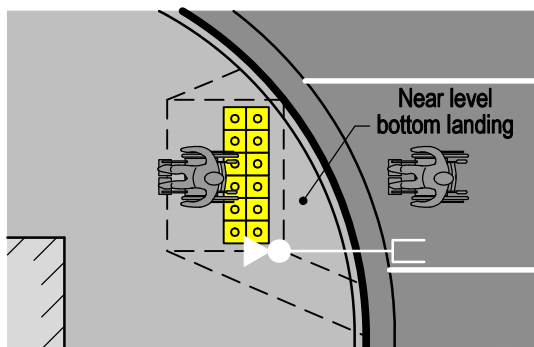
Figure 2. Correct bottom landing arrangement.

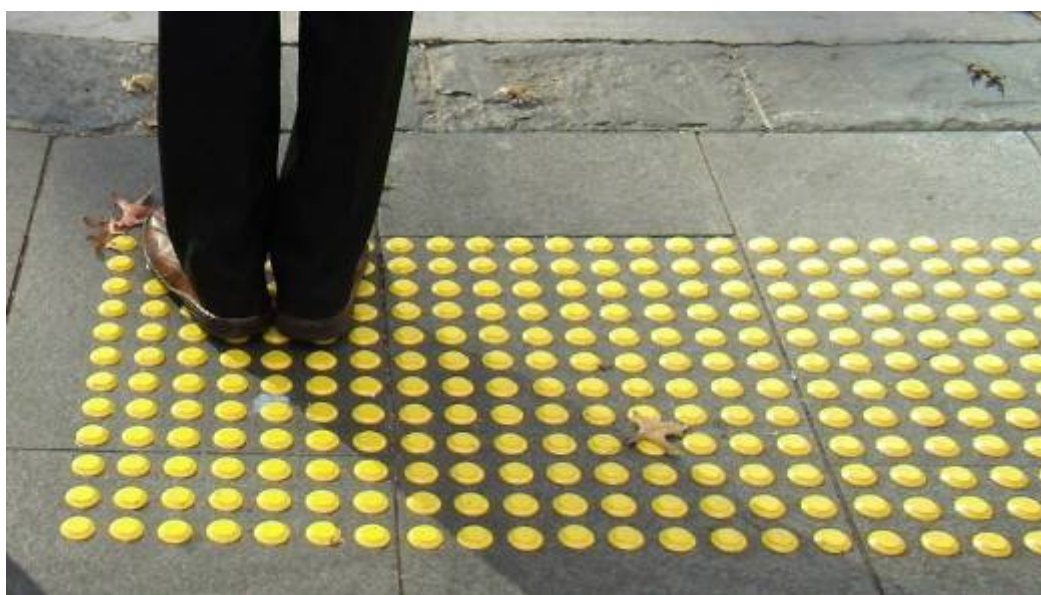
Photo 5: View of warning indicators. Note how the domes have been located to maintain equal spacing between domes across the entire warning indicator surface.

Photo 5 shows a typical arrangement of warning indicators.

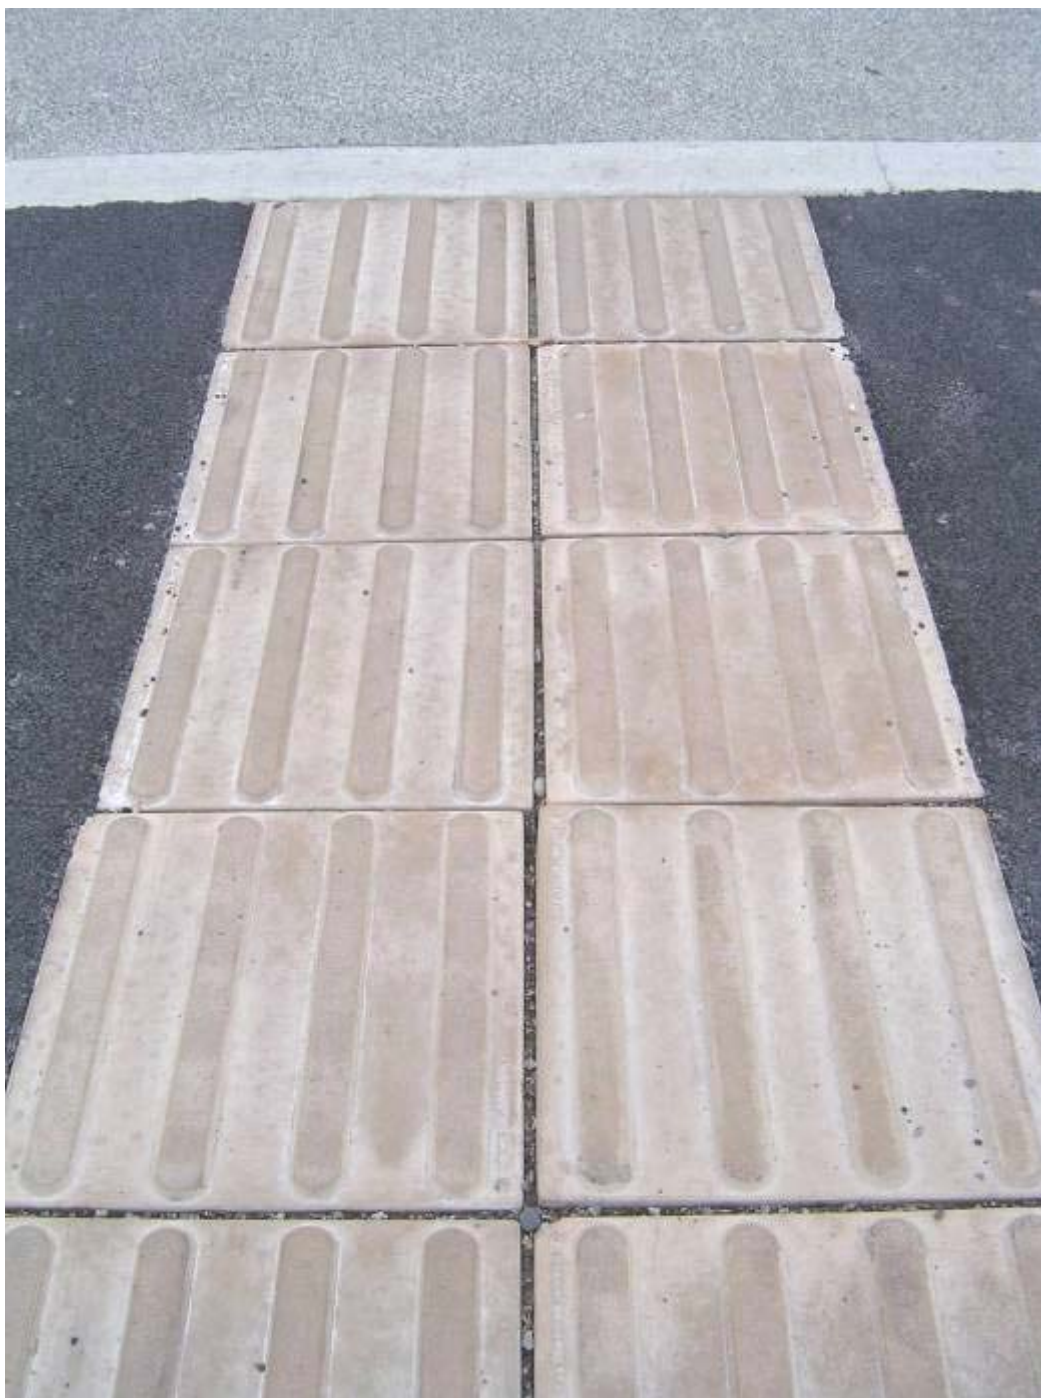
Photo 6: View of directional indicators.

Photo 6 shows a typical arrangement of directional indicators.

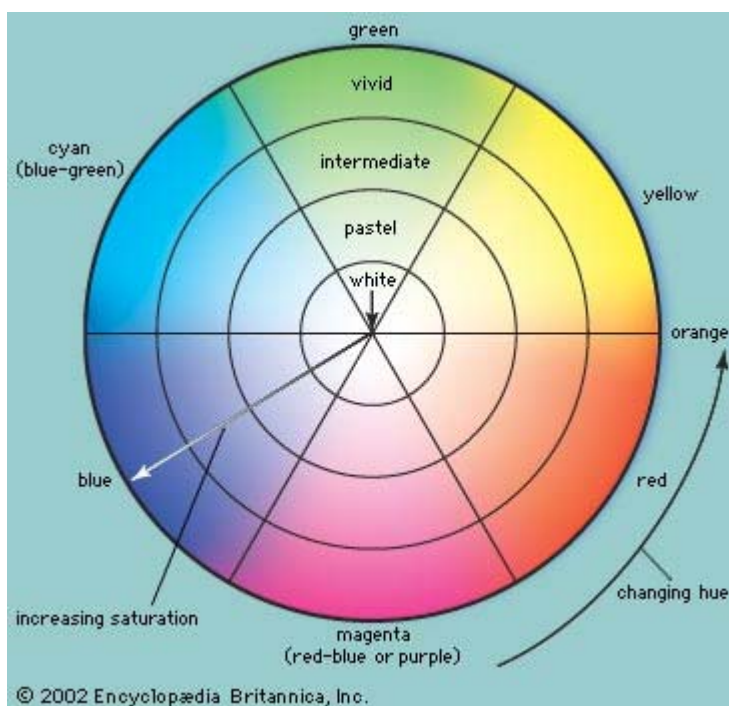
Avoid using the same or adjacent parts of the colour wheel. If the aesthetics of the design dictate that TGSIs are to be of similar hue to the adjoining footpath surface, then an increase in the contrast should be sought by greater differences in brightness and saturation.

The greatest contrast is provided by colours on opposite sides of the colour wheel.

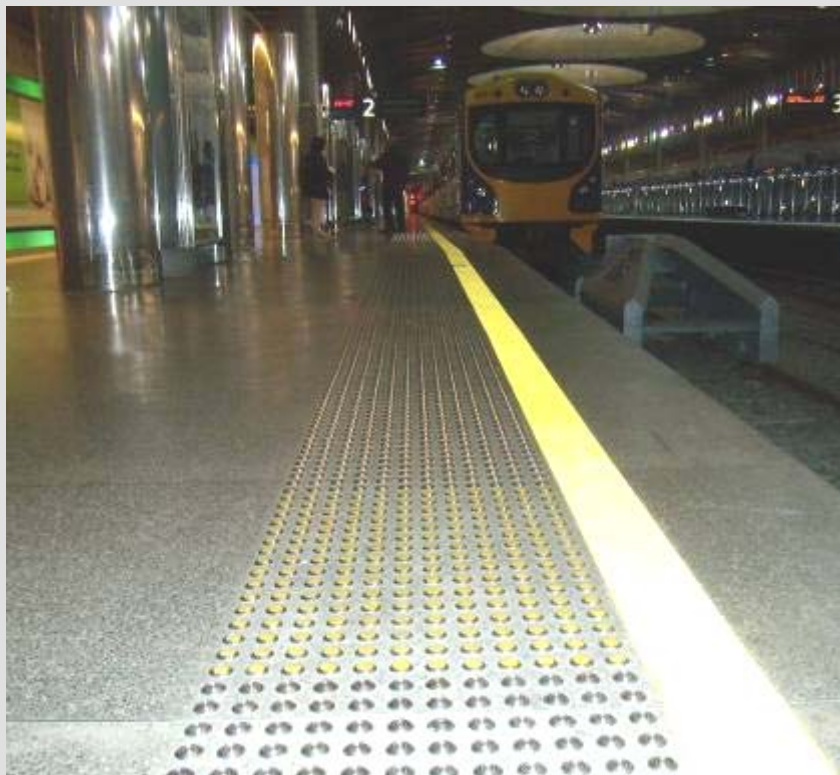
Photo 7: The warning indicators at this railway station are 600mm deep and set 600mm back from the platform edge. A better photo is to be sourced because the contrast is marginal and not uniform.

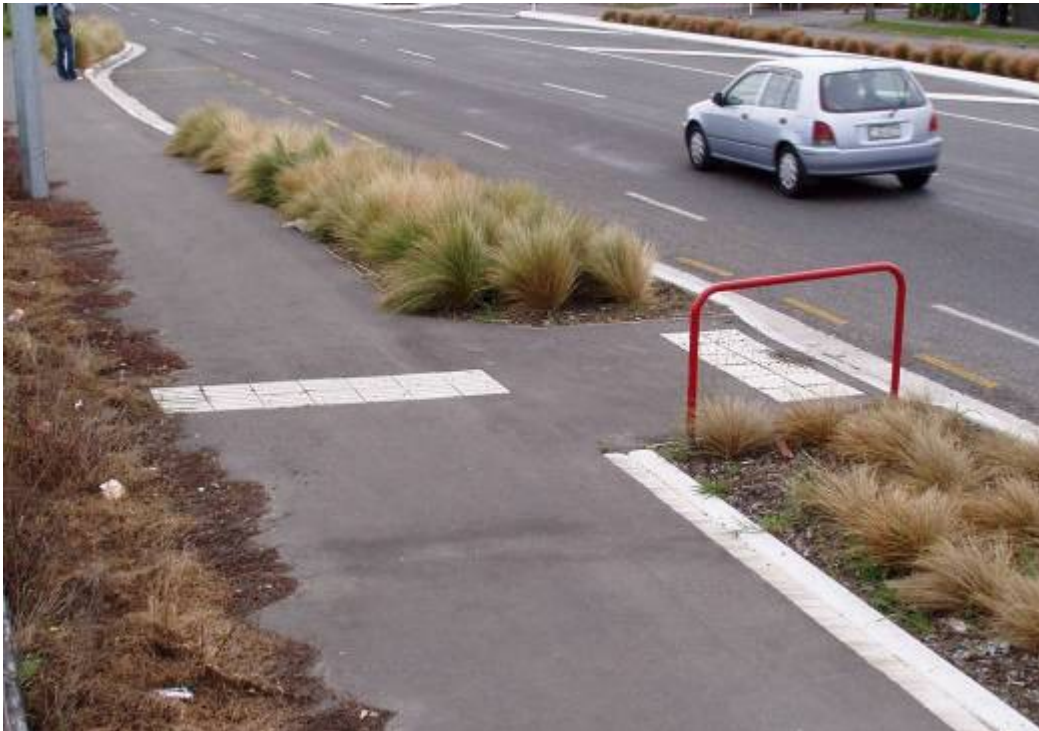
Photo 8: The directional indicators shown in this installation cover the full width of the path while other features, including the planting and a handrail provide tactile cues to the road crossing point.

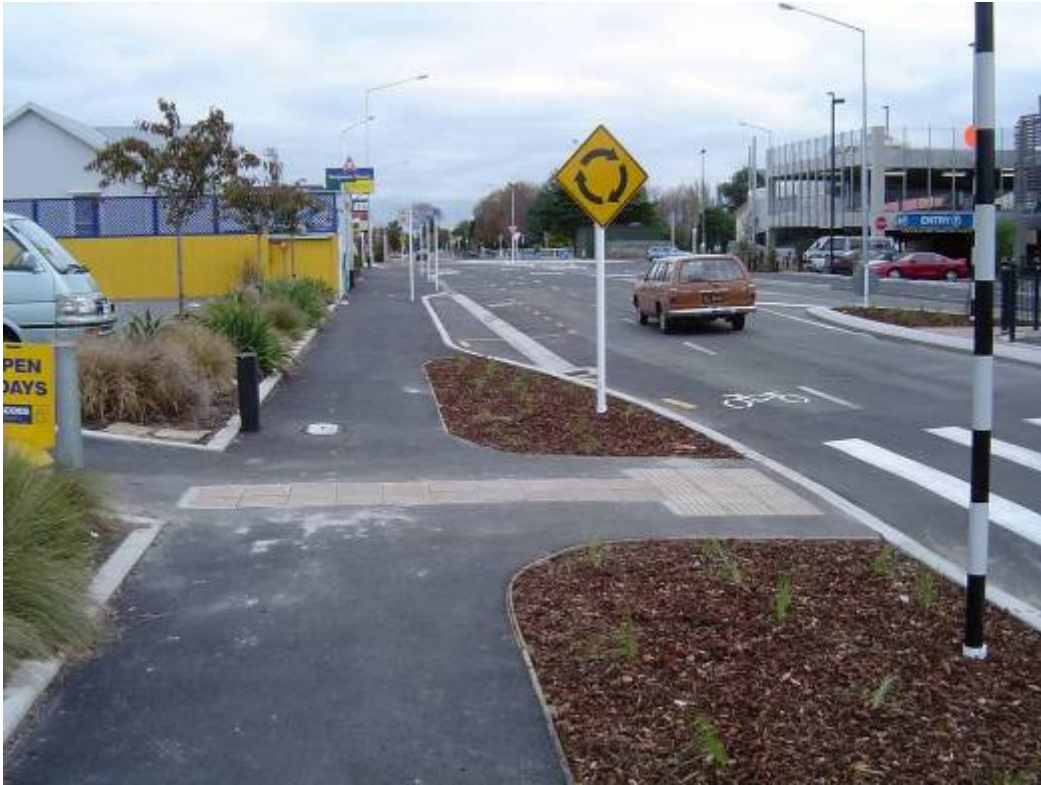
Photo 9: These directional indicators intercept all pedestrians on the continuous accessible path of travel. They lead directly to the warning indicators, which are aligned with the centre of the pedestrian crossing (but unfortunately not the full width of the crossing point).

In most cases, the footpath will run parallel to the roadway and thus the crossing point will not be on the continuous accessible path of travel (Photo 9).

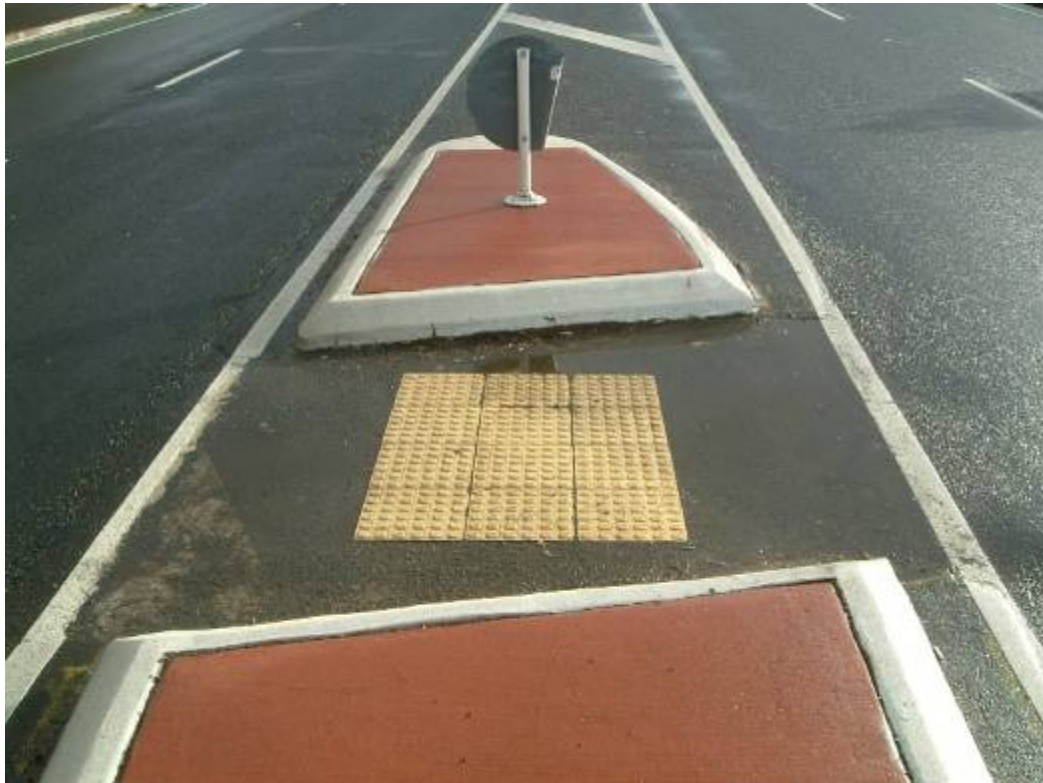
Photo 10: Warning indicators correctly installed across the full depth of this pedestrian median island (1.2 - 1.8m deep). Note: Warning indicators should cover full width of cut through. This one could be bypassed.

Where the median is from 1.2 metres to 1.8m deep, warning indicators shall be installed across the full depth, set back at least 300mm from the roadway (Photo 10).

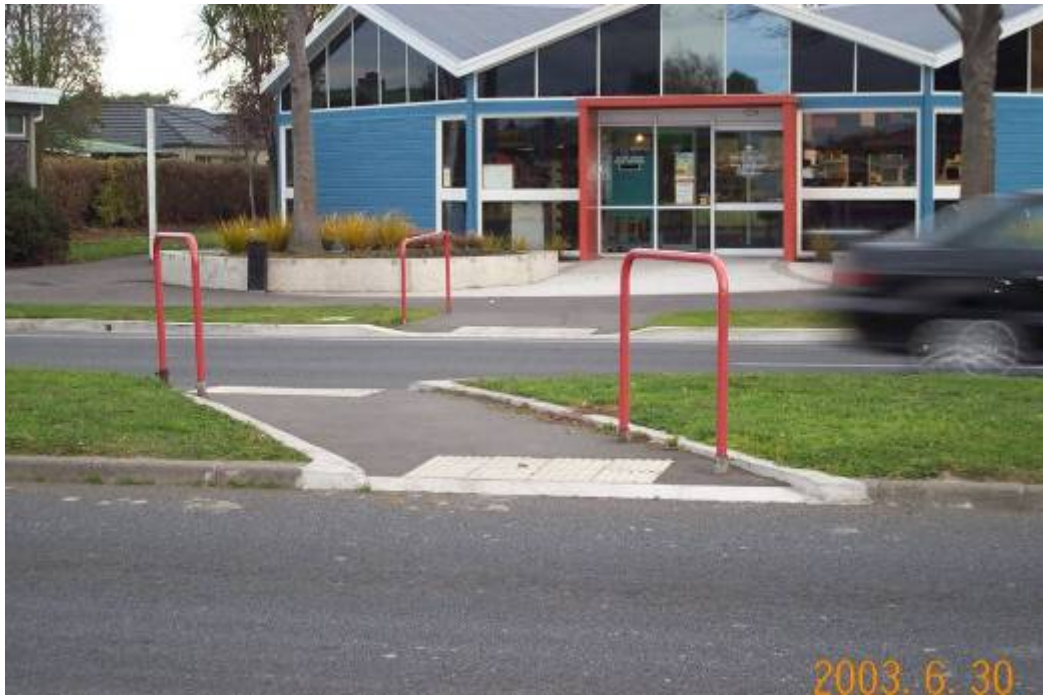
Photo 11: On deep medians, two sets of warning indicators are installed. (Note: again not quite full width.)

Where the median is more than 1.8 m deep, two sets of warning indicators each 600mm deep, shall be installed, set back 300mm from the roadway (Photo 11).

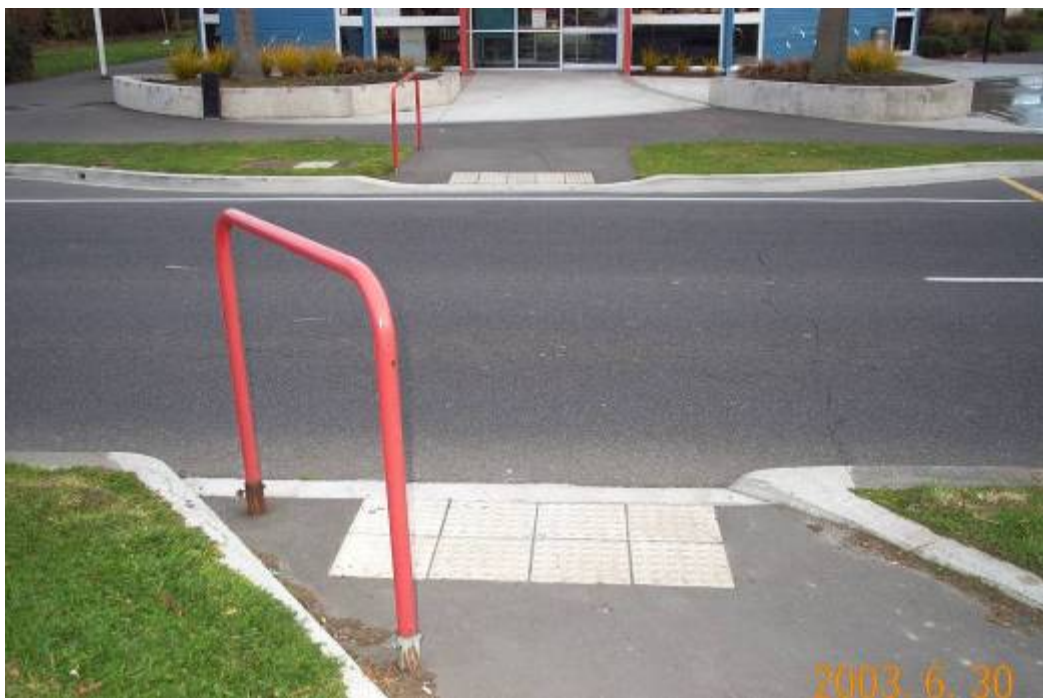
Photo 12: The warning indicators are aligned with the road crossing direction. (Note again: not quite full width)

Where the cut through of a median is angled, the warning indicators must be installed so that they are aligned with the direct road crossing line (Photo 12).

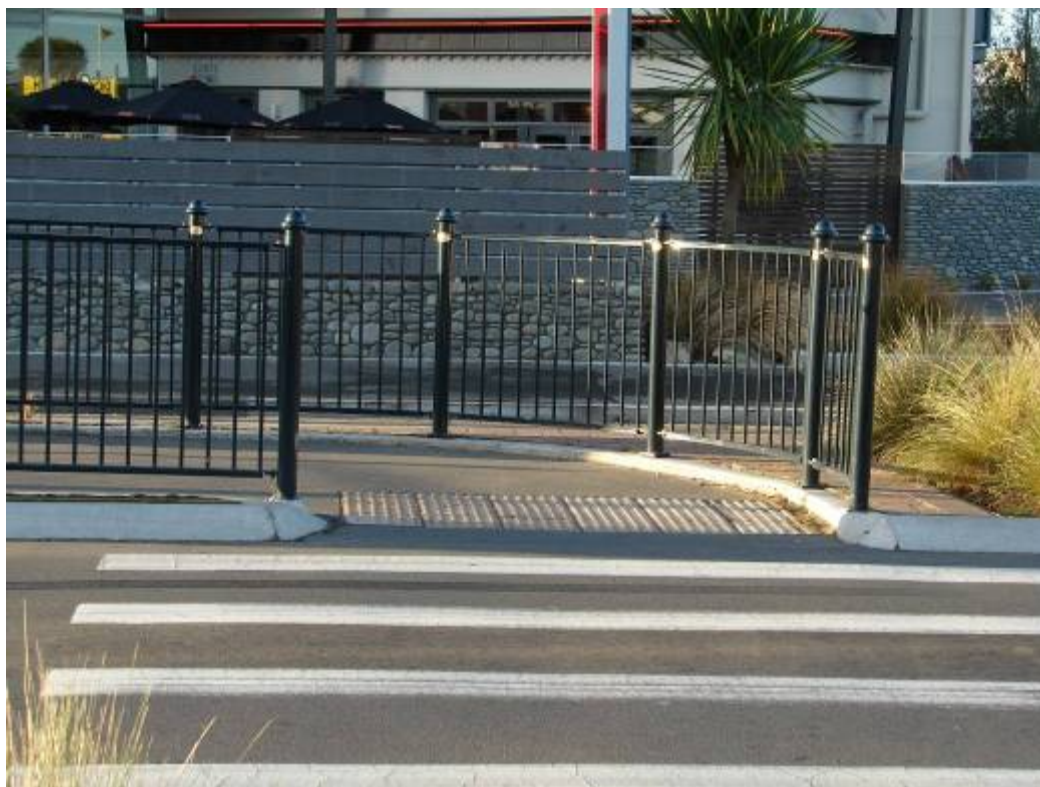
Photo 13: Example of a staggered median crossing with marked pedestrian crossing over the traffic lanes.

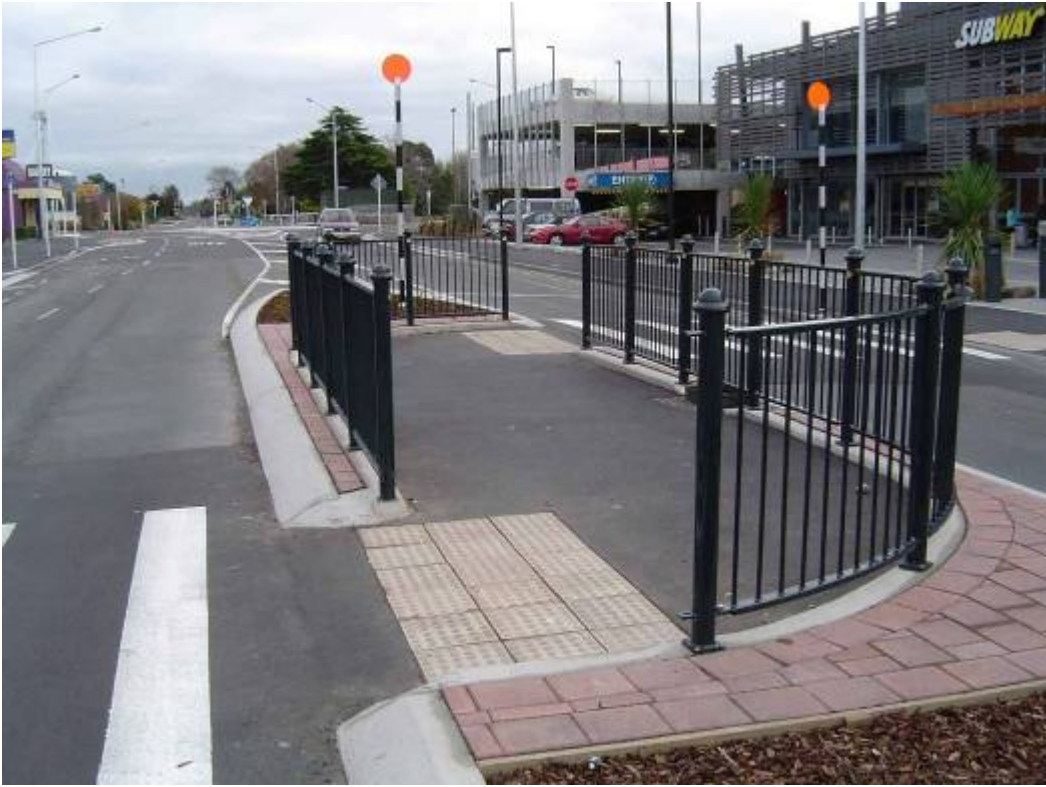
Photo 14: The kerb and fencing provides tactile cues within the staggered median to assist vision-impaired pedestrians.

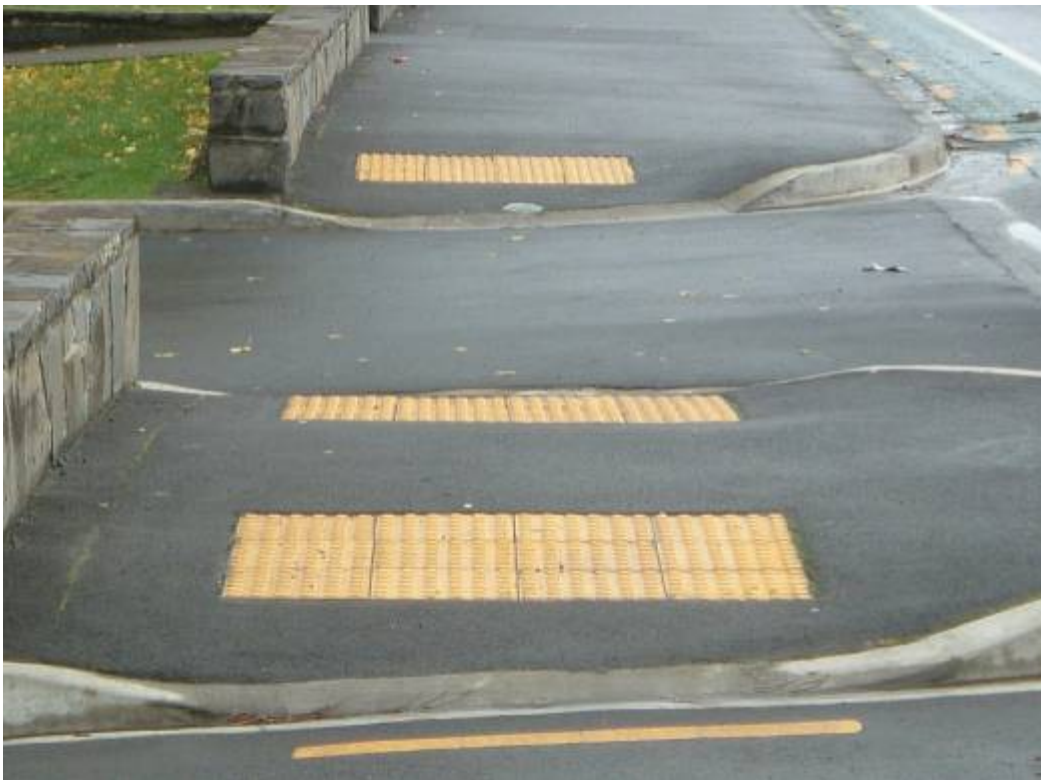
Photo 15: Warning indicators should be installed at all intersections, no matter how minor.

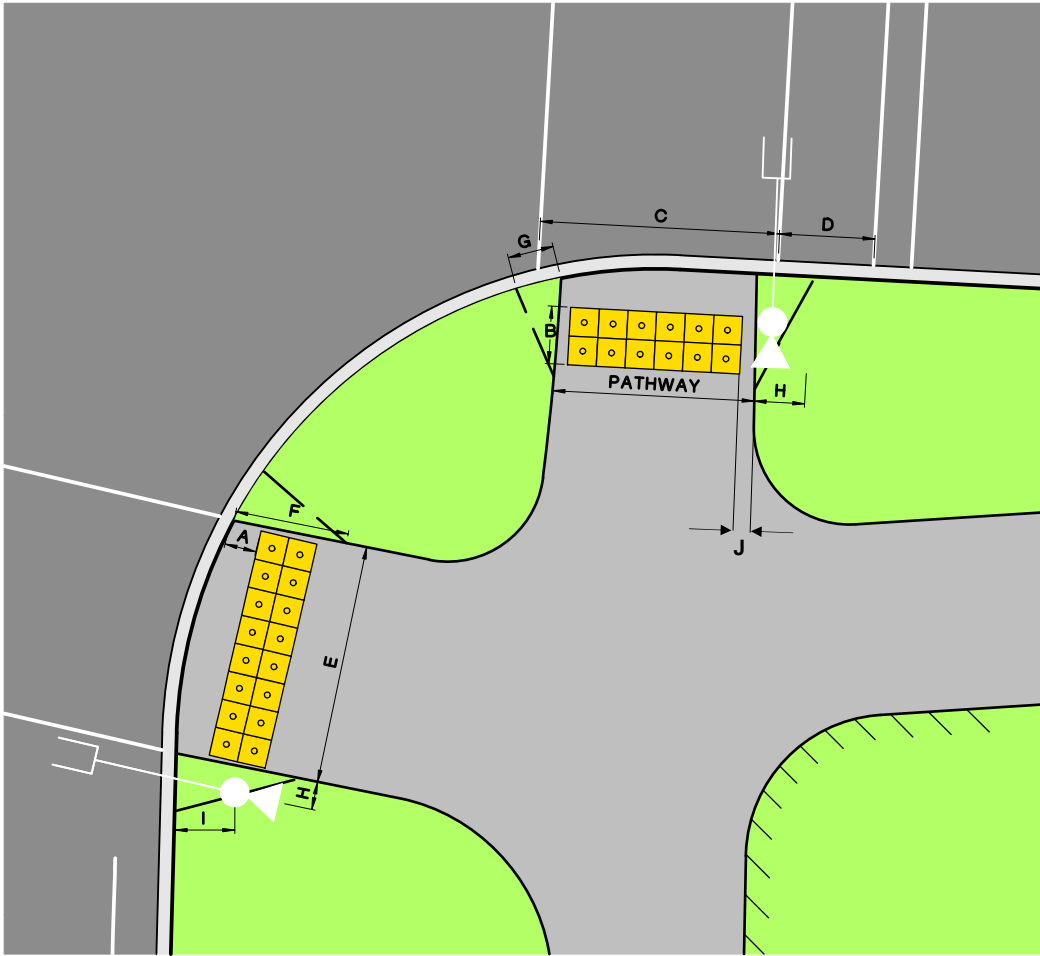
Figure 3: Correct design and orientation of kerb ramps, location of push button pole and installation of warning indicators at a signalised intersection (key below).

Figure 3 illustrates the correct layout of warning indicators at a signalised intersection. The layout dimensions also refer to recommended kerb ramp design (Section 3.4) and location of pedestrian push button poles in relation to kerb ramps and crosswalk lines (Section 5.5).

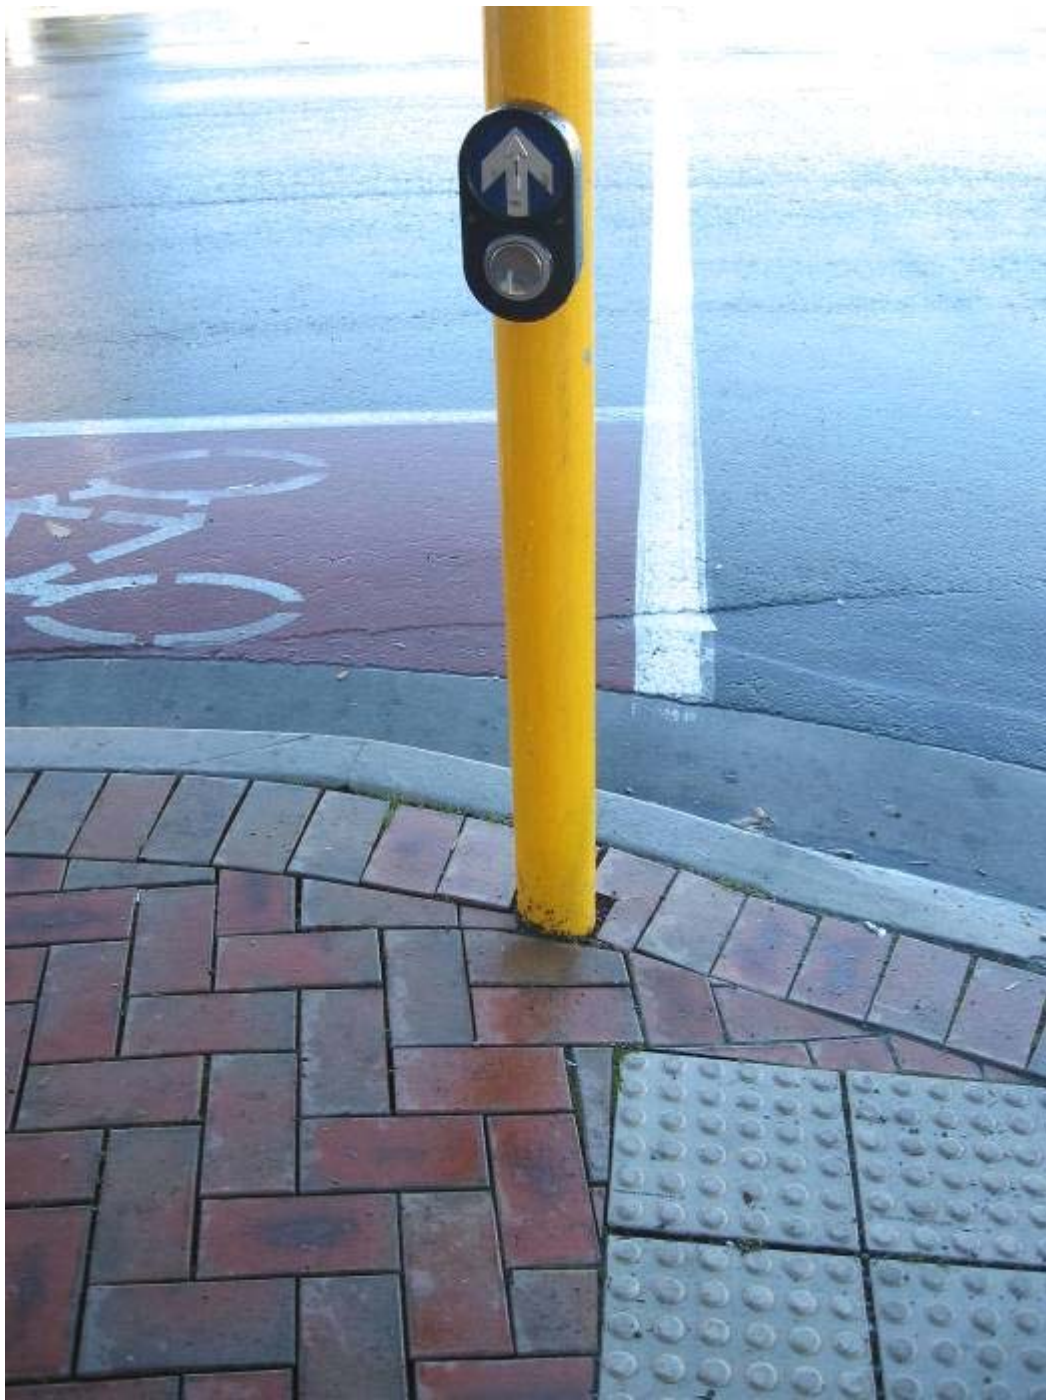
Photo 16. This installation is an example of best practice with the warning TGS and pedestrian call box both aligned with the crossing direction. The gap between the TGS and signal pole is so small that a person cannot inadvertently enter the road without receiving tactile warning.

Photo 16 below shows an example of warning TGSi and the pedestrian push-button correctly aligned with the pedestrian crosswalk.

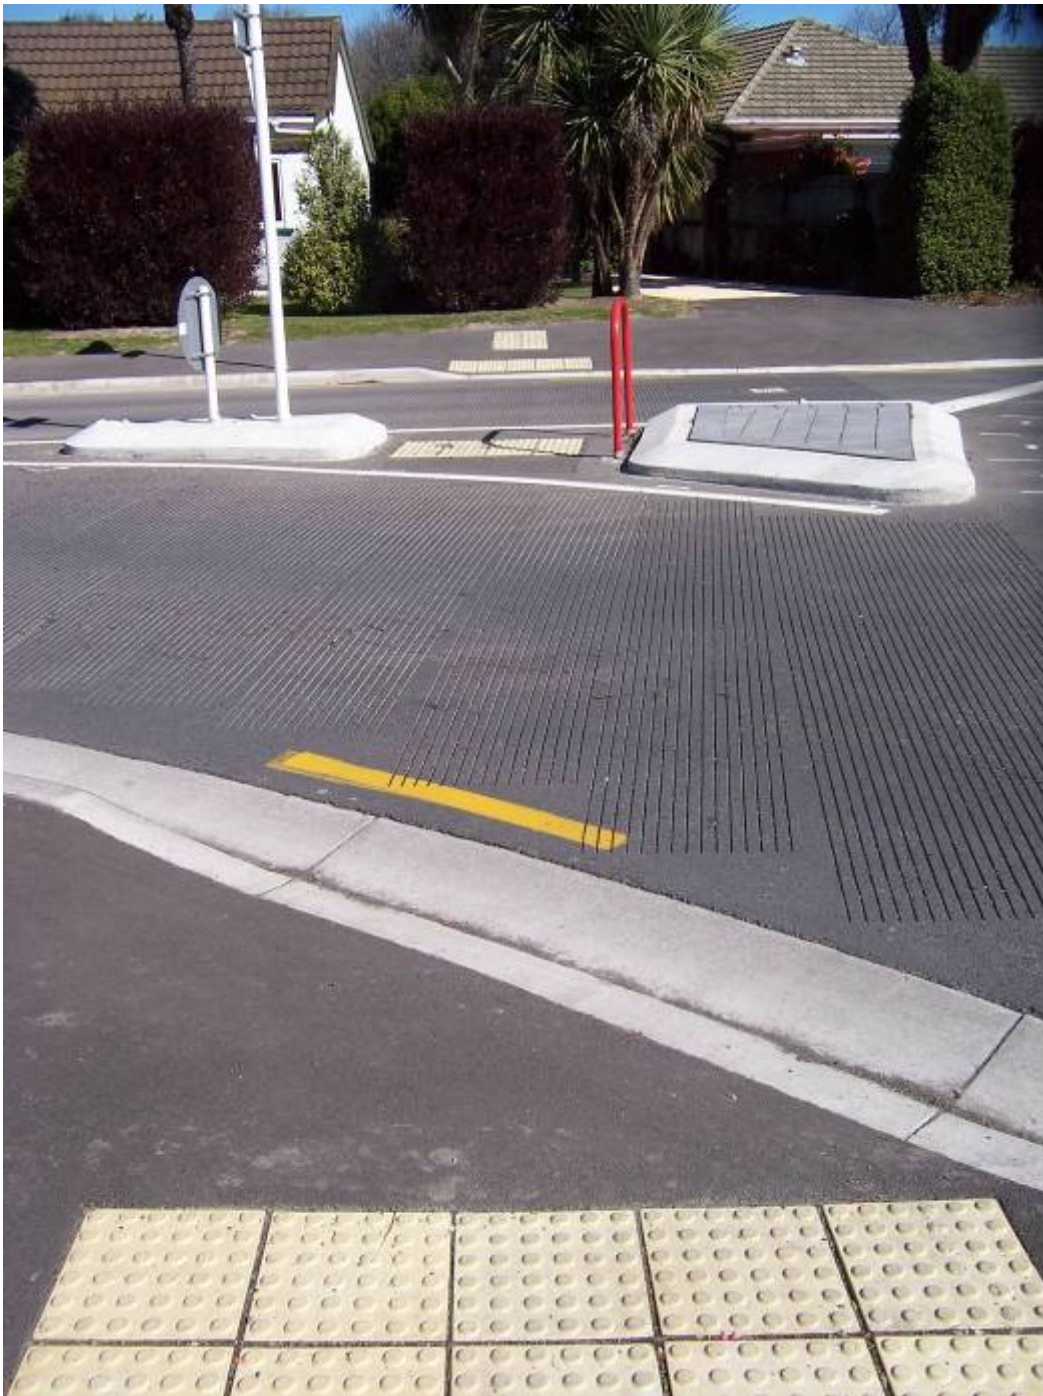
Photo 17. Actual example of the TGSi layout shown in Figure 4.

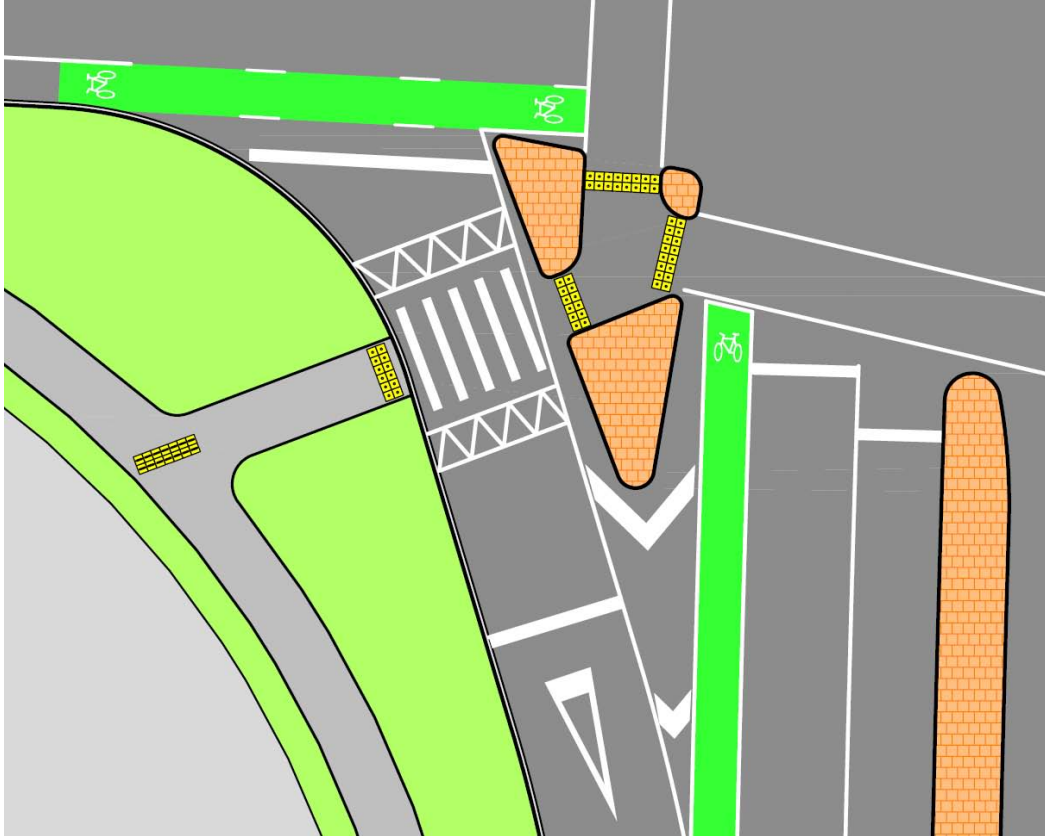
Figure 5: Warning indicators correctly shown in a slip lane island. Note how the warning indicators are orientated perpendicular to the crossing direction.

On most slip lane islands there will be three crossing places: Across the left turn slip lane, across the through and right turning traffic, and across the intersecting road.

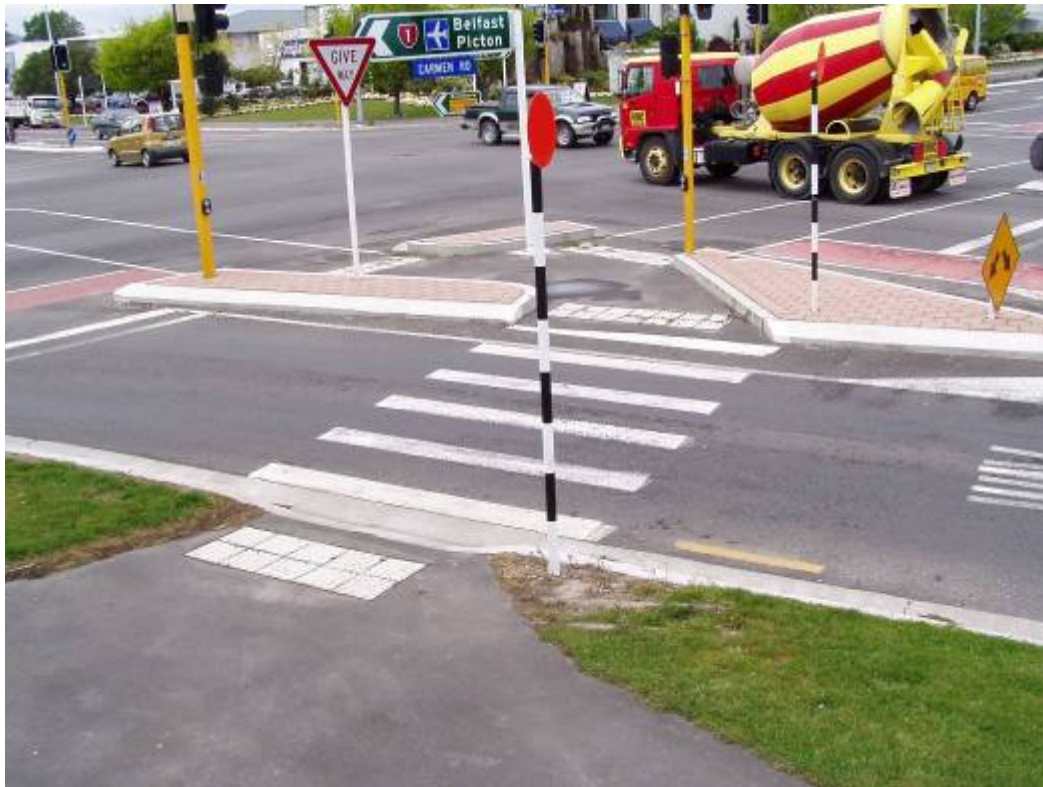
Photo 18. Actual example of the TGSi layout shown in Figure 5.

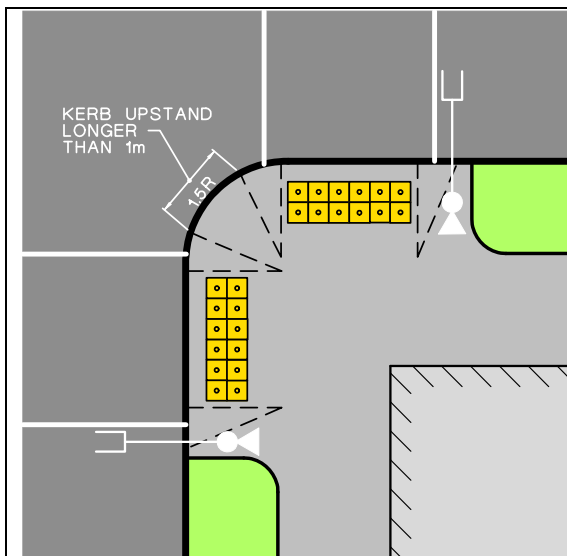
Figure 5a Two kerb crossings

With a small kerb radius like 1.5 metres, satisfactory solution.

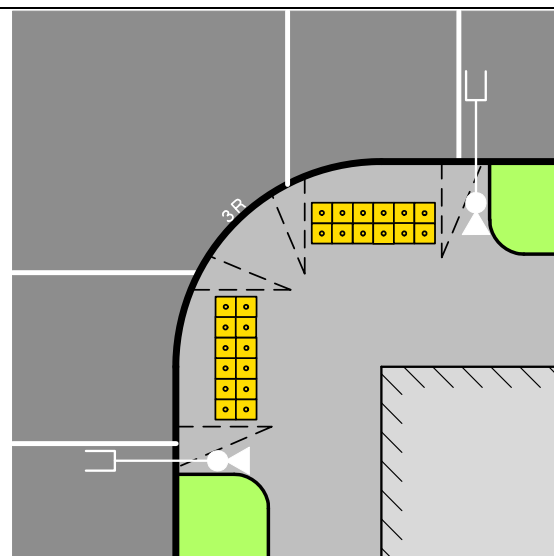
Figure 5b Two kerb crossings

3 metre kerb radius, design somewhat compromised

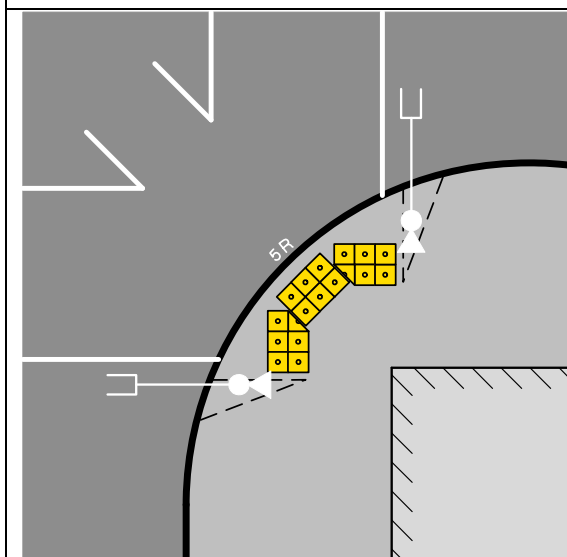
Figure 5c Full quadrant kerb crossing scramble phase/Barnes dance.

TGSI intercept full path and provide information for all directions of crossing.

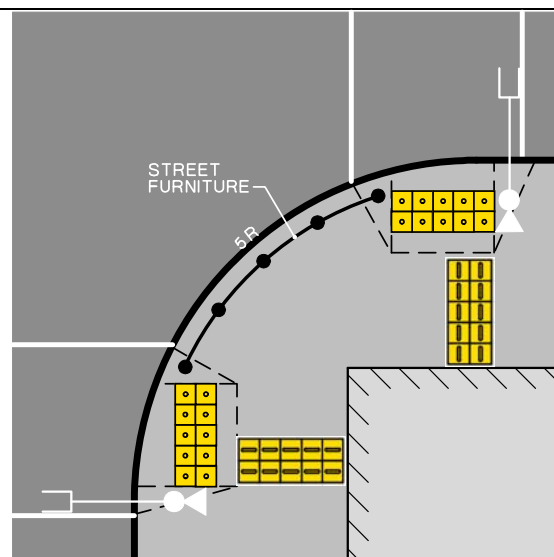
Figure 5d Two crossings, 5m kerb radius

Greater separation reduces kerb crossing angles. Kerb and warning TGSI provide more consistent guidance. Crossings are outside continuous accessible path of travel. Directional TGSI desirable.

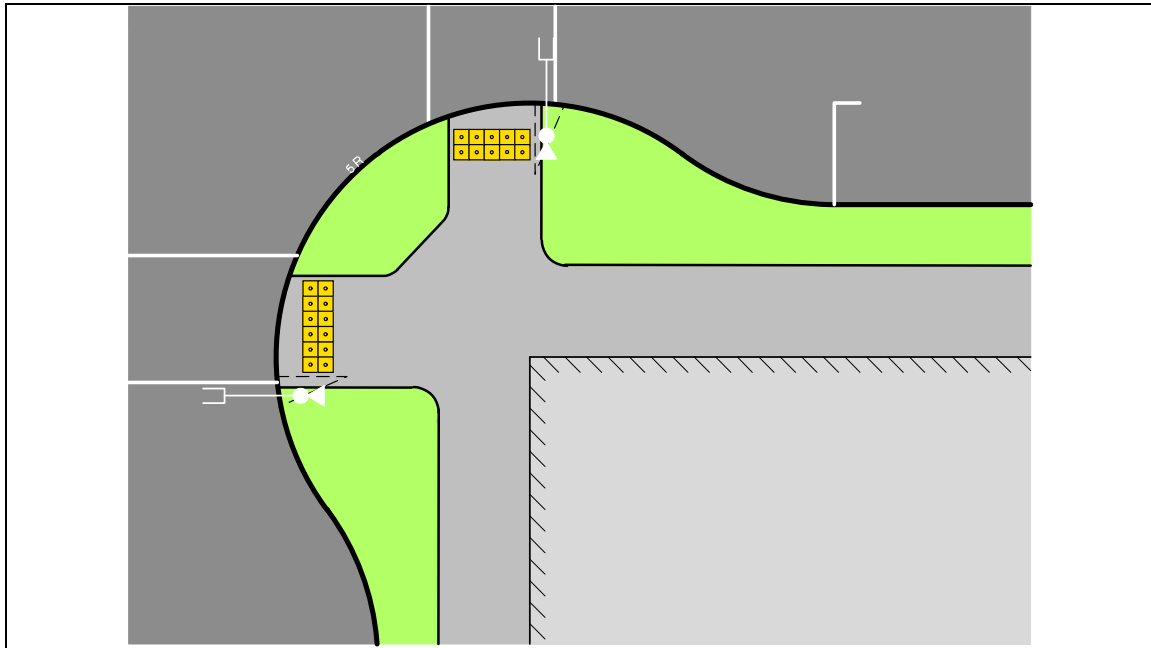
Figure 5e Two kerb crossings with kerb build out

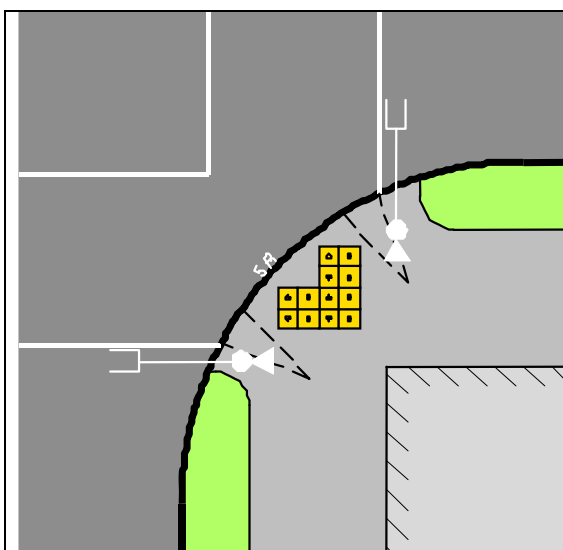
Figure 5f Single angled crossing
Kerb ramp design not recommended
 This TGSIs arrangement gives the least confusing crossing information for this situation, and intercepts a higher proportion of the approach path.

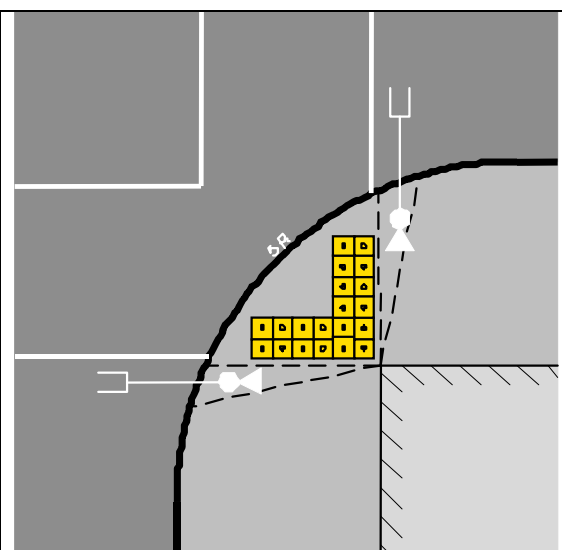
Figure 5g Full quadrant kerb crossing
Kerb crossing layout not recommended
 Warning TGSIs at entry intercept all users, and guide to crossing point.
 (Warning TGSIs only around kerb would confuse).

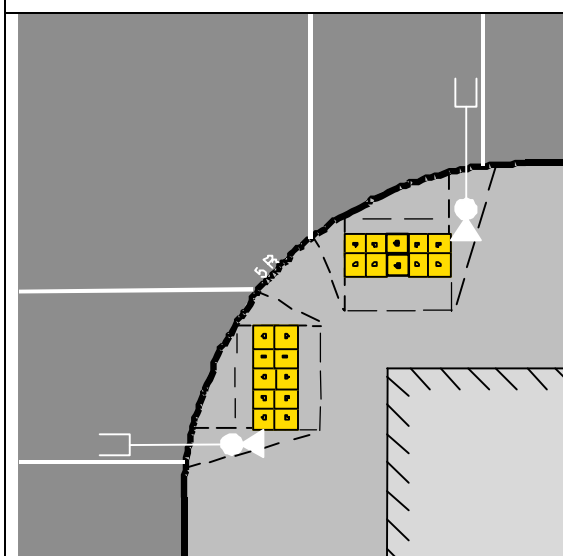
Figure 5h Two crossings 5m kerb radius
 Minimum separation between kerbs (1m of full height kerb, plus haunchings). Highly angled kerb crossings are offset from the continuous accessible path of travel.
