Road and traffic guidelines

RTS 14

Guidelines for facilities for blind and vision-impaired pedestrians

Consultation document

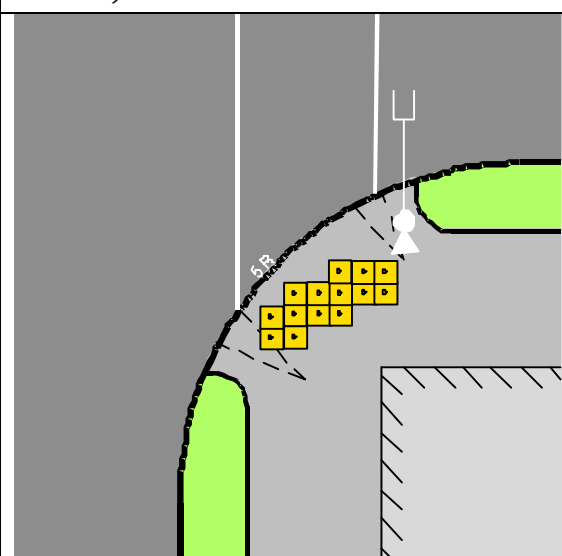
Figure 5i Staggered TGSIs arrangement for single direction kerb crossing
 TGSIs arrangement indicates crossing direction and intercepts all pedestrians.
 Kerb ramp design not recommended.

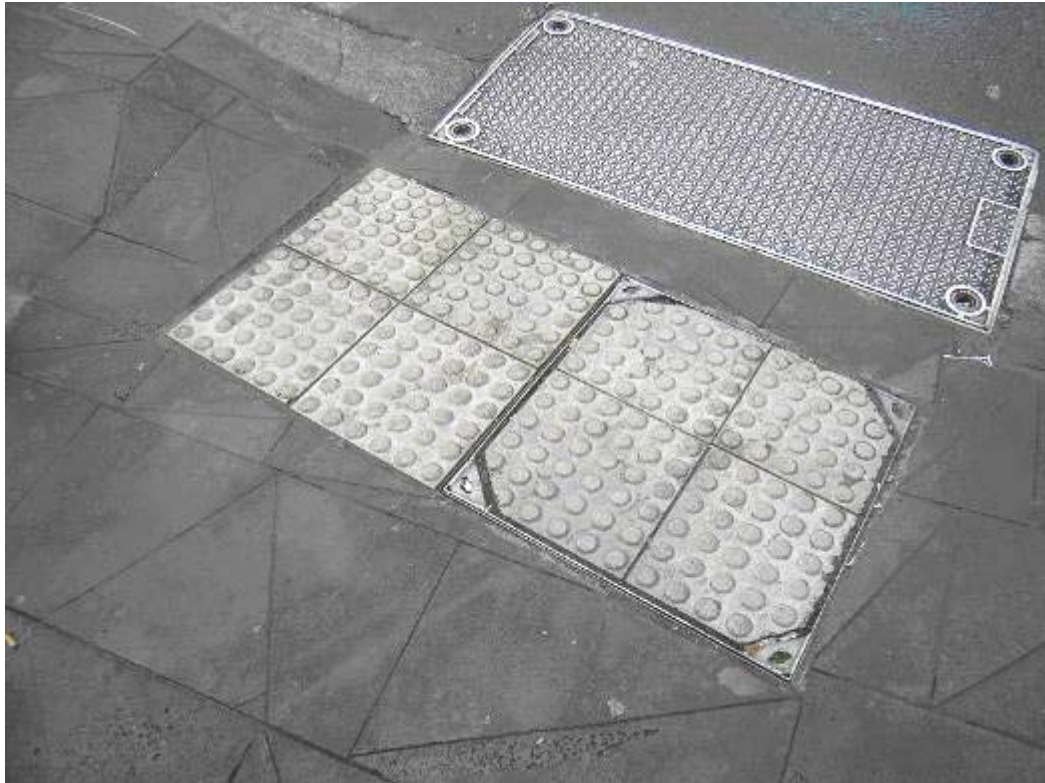
Photo 20: An example of how warning TSGI can be integrated into the design of utility service cover.

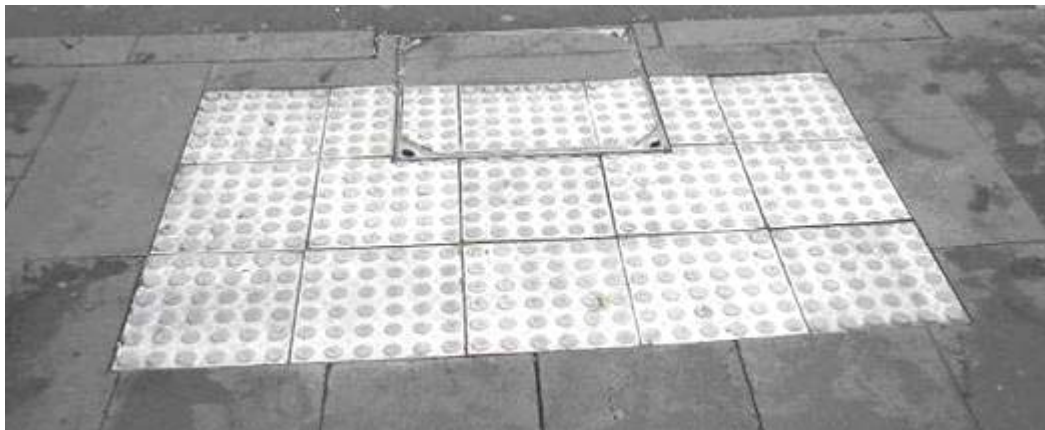
Photo 21: An example of how warning TSGI can be integrated into the design of utility service cover.

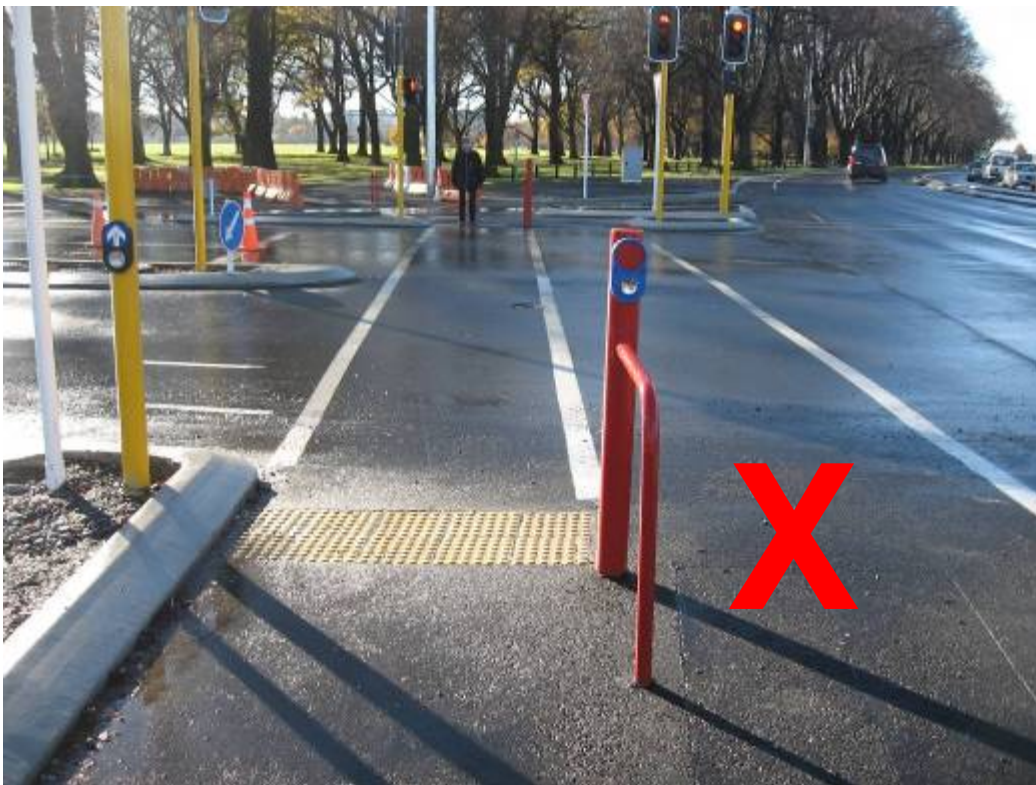
Photo 22: The TGSI at this signalised pedestrian and cyclist crossing are installed across the pedestrian area only. The TGSI should extend across the entire facility to ensure that a vision-impaired person receives tactile warning if they mistakenly enter the cyclist crossing area.

Where pedestrian and/or cycle volumes are high, paint marking can be used to indicate that pedestrians are to use one side of the crossing and cyclists the other to avoid conflict between these users. In such circumstances, **warning indicators shall be installed across the entire width of the shared crossing**, including the area allocated for cyclists. This will ensure that any blind or vision-impaired person that is walking in the area allocated to cyclists will receive a tactile warning prior to entering the road. The inconvenience to cyclists will be minimal.

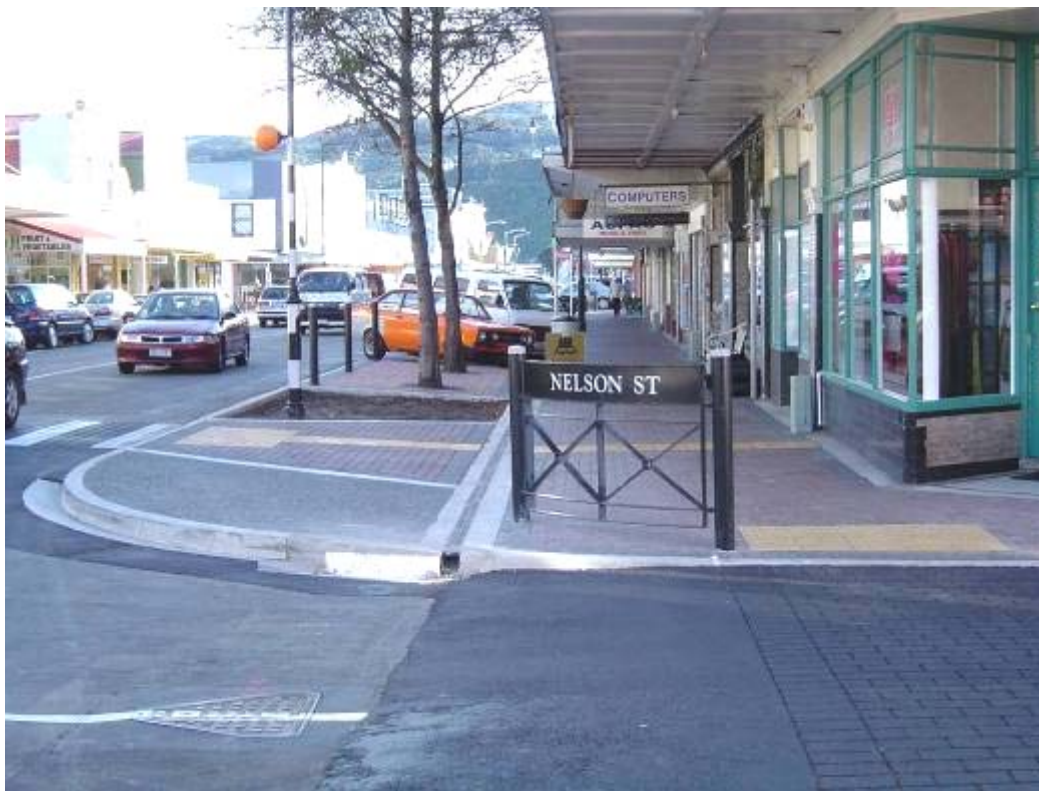
Photo 22: This installation shows a textured and raised crossing surface to inform blind and vision-impaired pedestrians of the boundaries of the crossing point. Note also how street furniture (in this case fencing – with a compliant low level horizontal bar) has been used to divert pedestrians to the crossing point away from the trip hazard at the ramp up to the crossing point.

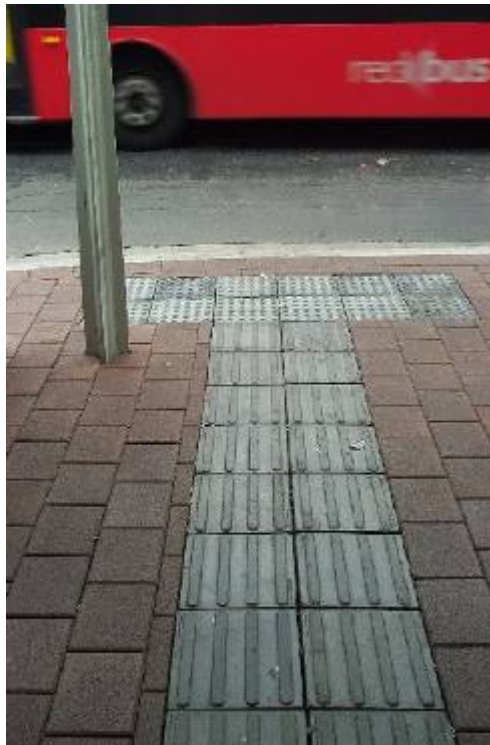
Photo 23: Directional indicators lead to warning indicators at a bus stop.

Photo 23 shows directional and warning indicators installed correctly at a bus stop.

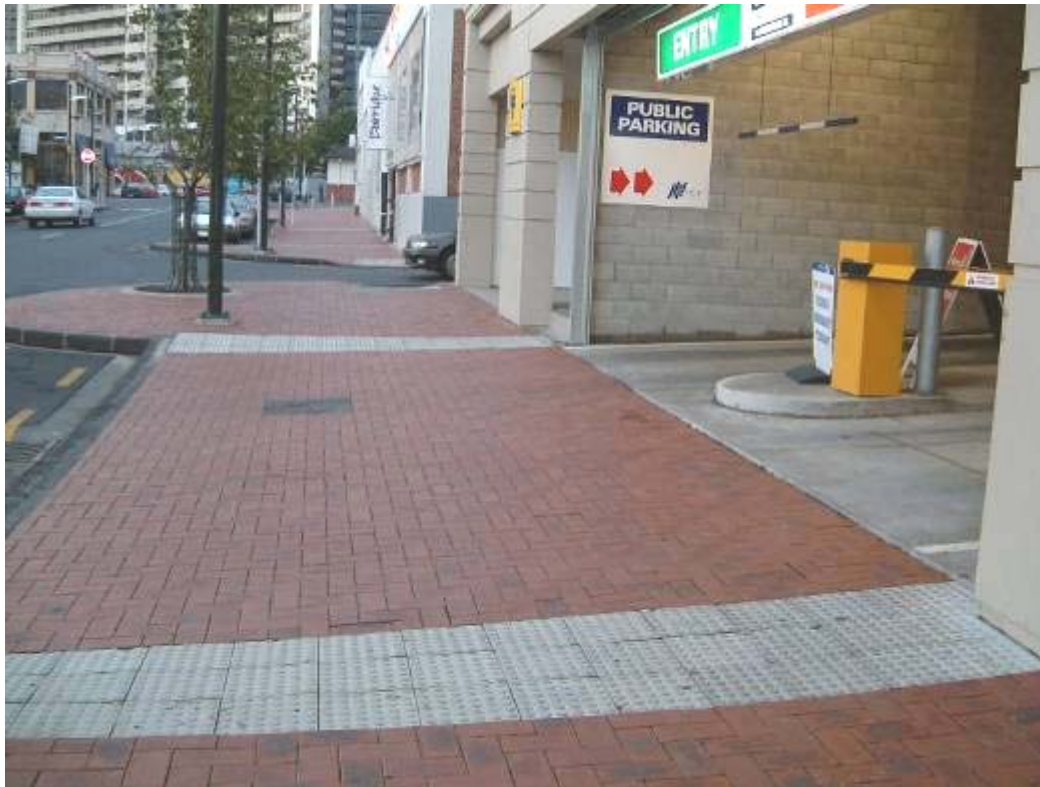
Photo 24: Warning indicators extend across the full width of the footpath outside a car park building.

- have a depth of 600mm and extend across the full width of the footpath, and
- be set back at least 300mm from the expected travel path of a large vehicle turning to enter or leave the vehicle crossing point.

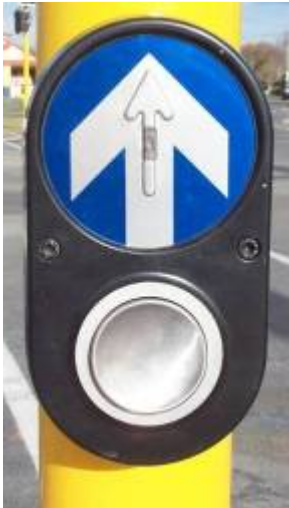
Photo 19: Pedestrian push-button assembly.

The standard pedestrian push-button assembly layout is shown in Photo 19 and Figure 6. It has an arrow above the push button. The main function of the arrow on the call box is to provide blind and vision-impaired pedestrians with directional orientation.

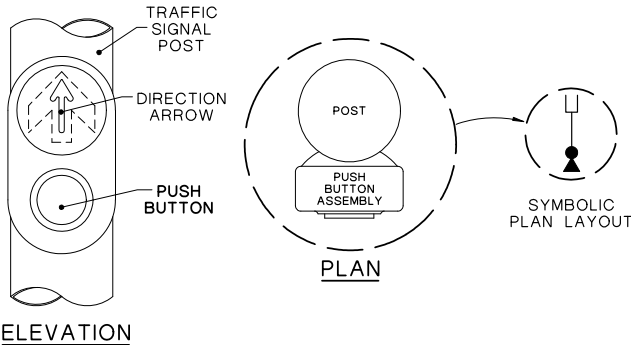
Figure 6: Diagram of pedestrian push-button assembly.

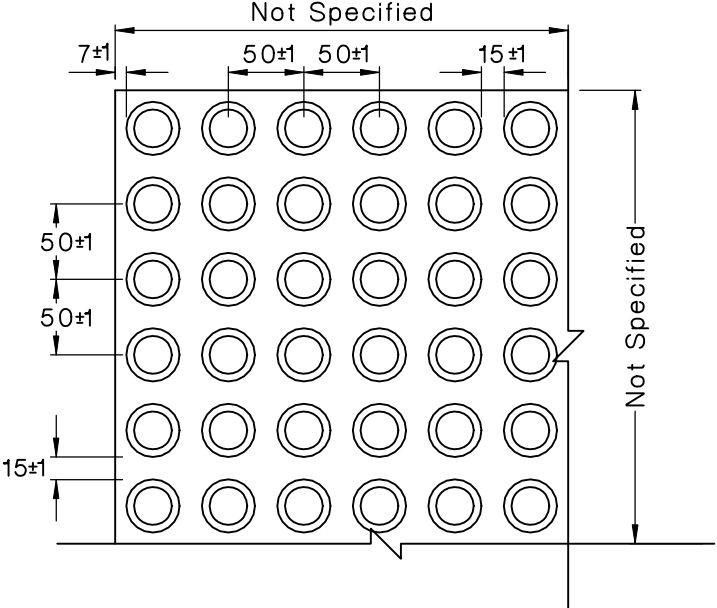
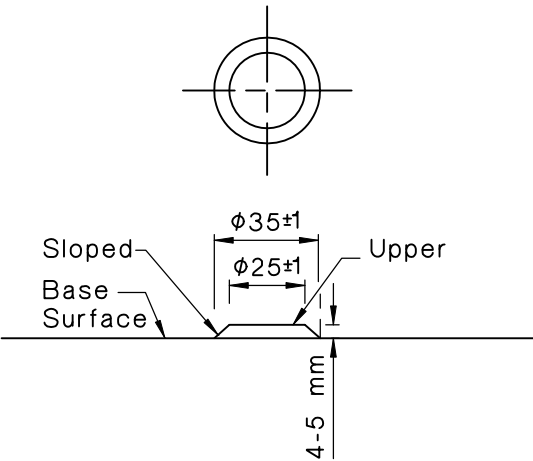
Warning indicators

Sourced from AS/NZS 1428.4: 2002

Detailed specifications of these TGSI can be found in AS/NZS 1428.4: 2002 Section 2. For convenience the diagrams are reproduced in Appendix B.

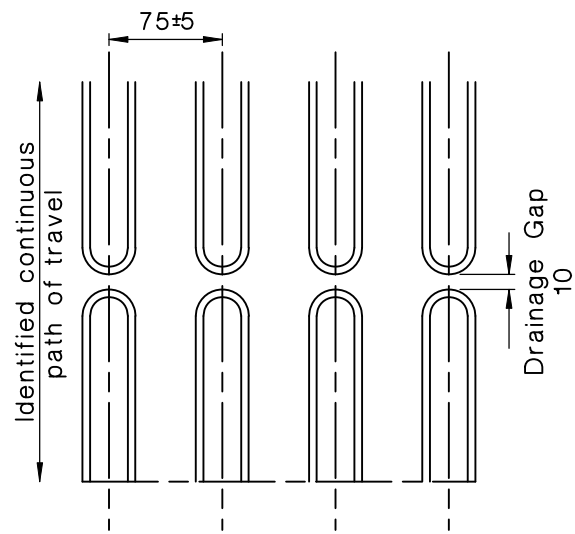
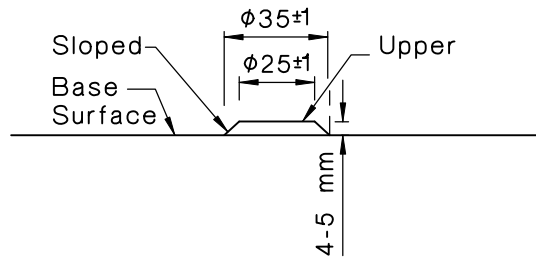
Directional indicators

Sourced from AS/NZS 1428.4: 2002
