MEASURING PAVEMENT CONDITION DATA FOR THE ESTABLISHMENT OF A LONG-TERM PAVEMENT PERFORMANCE STUDY ON NEW ZEALAND ROADS

D.N.Brown

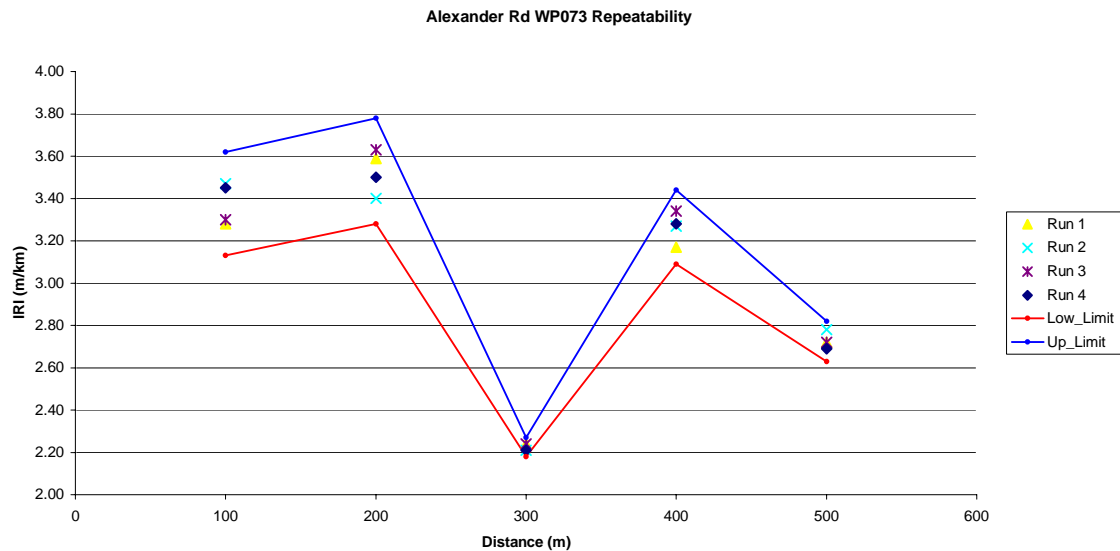
Figure 3 below shows the distribution of the data within the TOR specified limits at Alexander Rd. Clearly all measurements meet the TOR specification.

Figure 3: Repeatability of Walking Profiler 073 (Alexander Road)

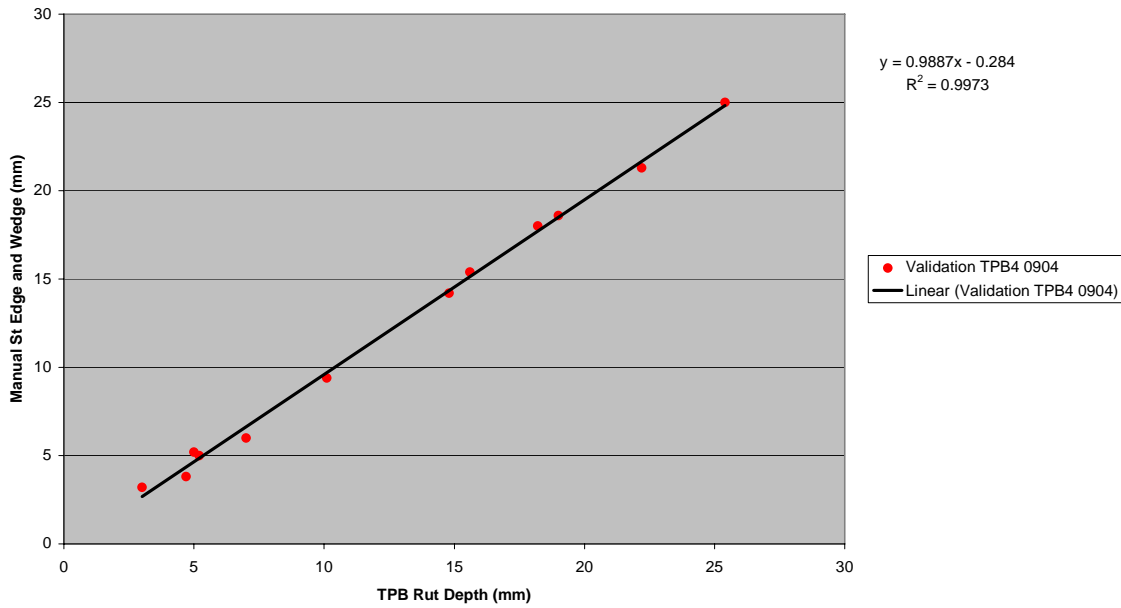
From this data it is clear that rut depth measured by TPB4 is consistent with the data measured by the straight edge and wedge. The correlation (0.9887 – 0.2) further demonstrates the accuracy of this measurement system.

Figure 4: TPB4 Vs Manual Rut Depth August 2004

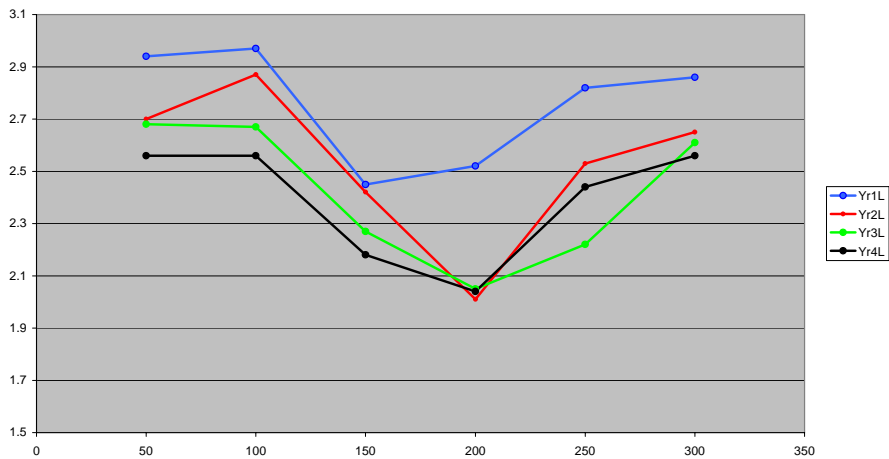
Figures 6 to 9 below show the progression of roughness on the four characteristic pavement types found in New Zealand. The most significant factor here is that on all but one pavement (machine laid asphalt) the roughness reduces with time. It is also possible that this trend may occur on the open grade asphalt example as this pavement was several years old when first surveyed. The most dramatic change being observed on the locked grade 3-5 chip seal.

Figure 8: Grade 3 Chip Seal Roughness Progression

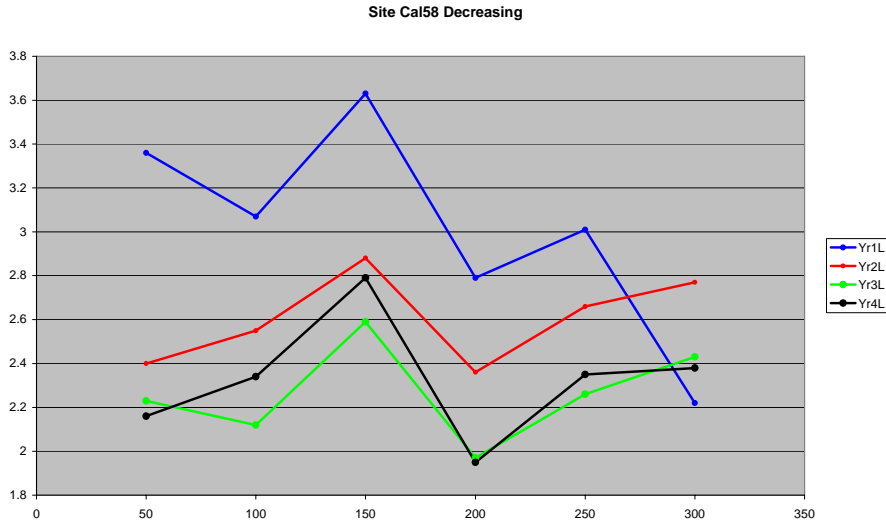
Figure 9: Grade 3/5 Locked Chip Seal Roughness Progression.

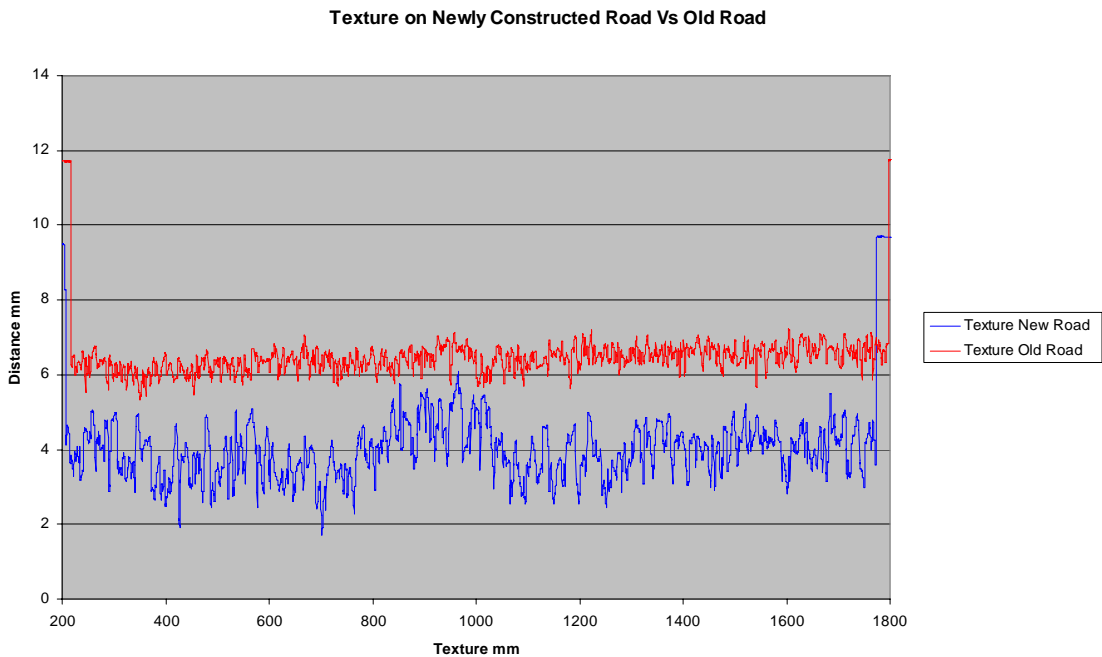
Our initial impression was that the texture was the most likely reason for this phenomenon, as the sites having the highest texture showed the largest reduction in roughness. These sites also affected the operation of the Walking Profiler and the repeatability of both roughness and rutting measurements. However if we compare the texture profile of a newly constructed road with high texture to that of an older road, it is clear that one of the wavelengths most prevalent in the new road is not present on the old road. Significantly the wavelength corresponds to that overlap between what is classified as texture and what is considered roughness, the 0.2 to 0.8m wavelength, and it is therefore understandable why the repeatability of the measuring equipment is affected. Figure 10 shows the profile obtained from a newly constructed locked grade 3 - 5 chip seal and that obtained from an older road section. Clearly the old surface has very little of the 0.2 to 0.8m roughness (appears flat), while the new surface has significant variation over the wavelength in question. It is therefore possible that the smoothing of the surface as a result of the normal wear and tear resulting from the daily traffic reduces this short wavelength variation and as a result reduces the pavement roughness. Clearly there is insufficient evidence to date to categorically deem this as fact but it seems a logical assumption.

Figure 10: Texture profile on new and old pavement.

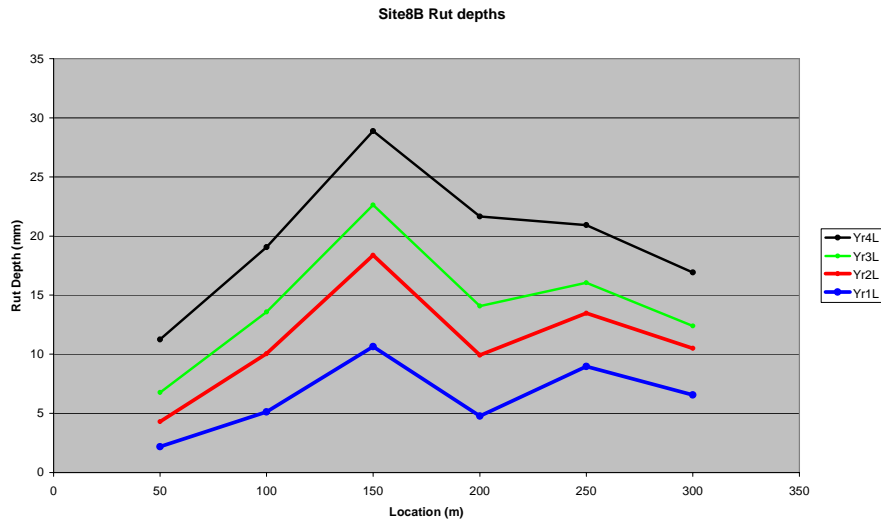
Figure 12: 50m Average Rut Depth Change
