# **Wellington Urban Motorway**

## **Bridge Safety Barrier Assessment**

Date: 10/09/2015  
Reference: 5c3008.01 / 5110  
Status: Draft for NZTA comment

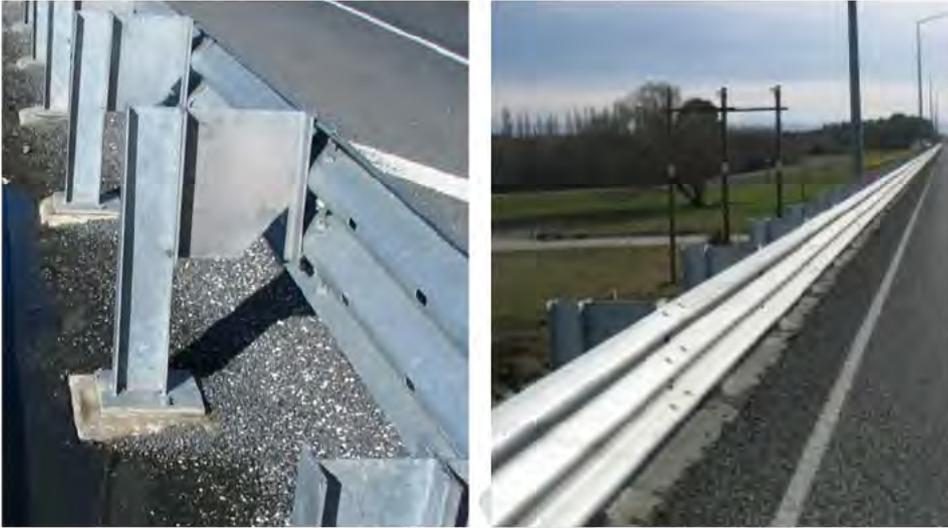
**Figure 3.3:** TL-4 Thrie-beam (with Modified Blockout) Barrier System

The Bridge Manual specifies a performance level 4 (TL-4) barrier is the minimum standard acceptable on state highway structures. For this reason we will primarily compare the existing barrier systems to a TL-4 (Modified Thrie-beam) barrier (if a semi-rigid system) or a TL-4 (F-shape) concrete barrier (if a rigid system). Figure 3.3 shows a TL-4 Thrie-beam (with modified blockout) barrier system.

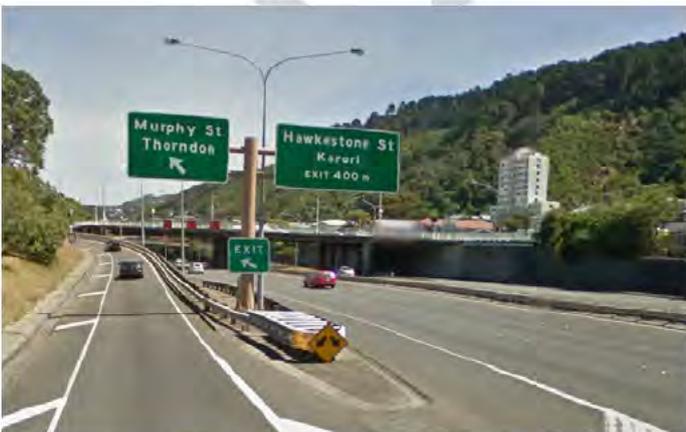
**Figure 4.1:** Murphy Street Off-Ramp – Crash Cushion

The road safety barriers on the Murphy Street Off-Ramp (BSN 10718) are shown in Figures 4.1 and 4.2. As shown in Figure 4.1, there is a crash cushion protecting Flag Sign #6 (BSN 10717) located in the median area between the off-ramp and the motorway. Along the off-ramp (on the motorway side), there is a strong post (timber) with w-section guardrail system, as shown in Figure 4.2. This barrier system manages the risk of a potentially errant vehicle falling onto the three-lane motorway below, which carries approximately 24,000 vpd.

The crash cushion appears to be in a satisfactory condition.

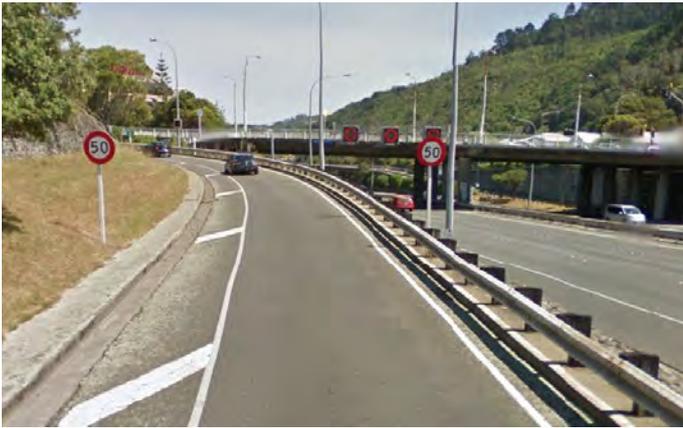
**Figure 4.2:** Murphy Street Off-Ramp – Edge Barrier

Although this barrier system is approved in M/23, there are a couple of construction defects with the existing system. In accordance with Transport Agency Technical Memorandum (TM-2005), issued December 2011, timber guardrail posts are not permitted to be embedded into hard surfaces such as concrete footpaths (as shown in Figure 4.2). The hard surface limits the performance of the barrier system as the impacted post will not be able to properly rotate backwards before shearing. This issue increases the stiffness of the barrier which could lead to wheel snagging or vehicle pocketing, and ultimately rupture or override of the barrier.

The timber posts, timber blockouts, steel rail and steel bolts are in satisfactory condition and there are no significant areas of impact damage, as observed during the principal bridge inspection in 2014. Note, some early signs of corrosion is still considered acceptable and will need to be monitored to ensure the performance of the barrier is not severely impaired.

The performance level (TL-3) of the existing barrier meets the current compliance standards by the Transport Agency. Although noting the two issues discussed in Section 4.3, we consider the existing barrier system is adequate for this location and fit for purpose given it is maintained in a satisfactory condition.

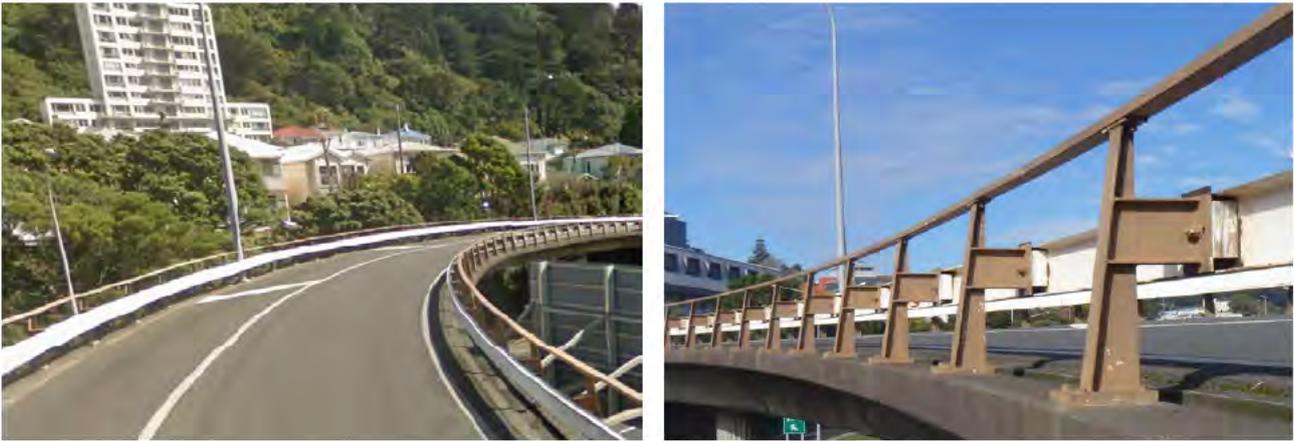
**Figure 5.1:** May Street On-Ramp – Barrier System

The road safety barriers on the May Street On-Ramp (BSN 10720), which was constructed in 1968, are shown in Figures 5.1 to 5.5. The barrier along the on-ramp is an out-dated system consisting of steel channel bridge rail on steel posts which are top mounted to the kerb upstand on the bridge deck (refer to Figure 5.1). There is a top handrail along the entire length and on both sides. The length of the barrier system on the bridge structure is approximately 100m on each side (200m total).

The height of the existing barrier is however a major concern as there is a high risk that a TL-4 vehicle (higher centre of mass) could over-ride the barrier system. The construction drawings show the rail height to be 533mm to the rail centre, and 660mm to the top of the rail. However due to several resurfacings of the bridge since construction, these heights are now expected to be less. Therefore, the height of the barrier is significantly lower than the TL-4 Thrie-beam system at 610mm (rail centre) and 865mm (top of rail). It should be noted that these heights are even less than a TL-3 W-beam system at 550mm (rail centre) and 710mm (top of rail). Although there is a top handrail at 941mm, the welded connection at the post/baseplate is expected to fracture before the vehicle would engage with the handrail, due to the stiffness of the rail. Therefore the handrail is not expected to provide any resistance to a vehicle over-riding the barrier.

If the existing barrier system is retained, the Transport Agency will need to accept the risk of the non-compliant (and potentially deficient) barrier system. Additionally, ongoing difficulties, and high costs, of maintaining the non-standard barrier system will continue, especially when damaged sections are replaced after a vehicle collision.

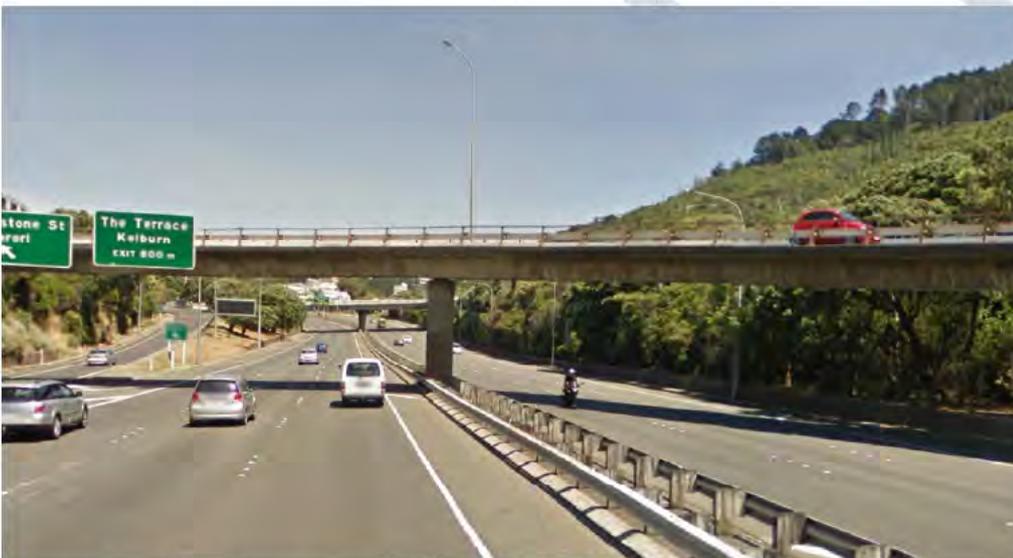
**Figure 5.2:** May Street On-Ramp – Bridge Structure and WUM

This barrier system manages the risk of a potentially errant vehicle falling onto the six-lane motorway (three in each direction) beneath the structure, which carries approximately 21,000 vpd northbound and 24,000 vpd southbound. Refer to Figure 5.2

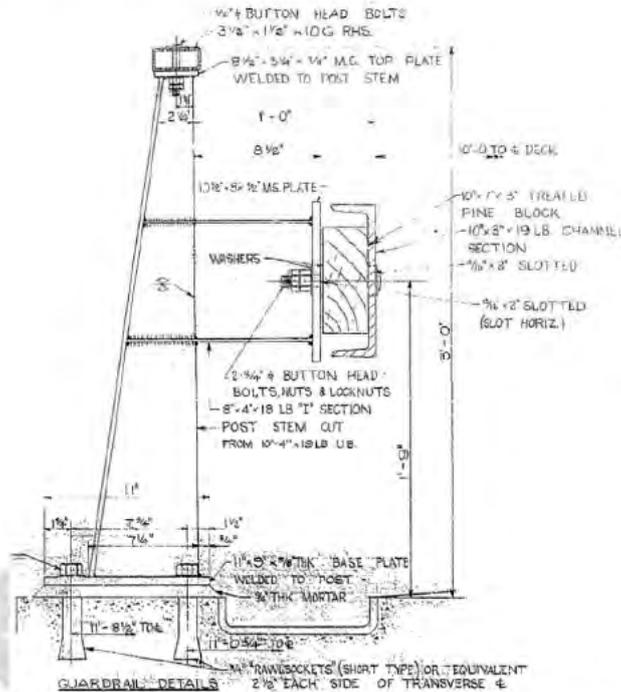
**Figure 5.3:** Post Detail from Construction Drawings (Designed in 1968)

The centreline of the rail was 1'-9" (533mm) from the road surfacing, and the handrail was to be 3'-0" (914mm) from the road surfacing. Given the bridge would have likely been resurfaced several times over the years, it is reasonable to expect that this height will most likely be less than these values. Additionally, the front face of the rail was 1'-0" (305mm) from the post face and 2'-0" (610mm) from the back edge of the concrete kerb upstand.

The lateral rotational resistance of the post is governed by the particular load which causes the post/baseplate assembly to be frangible. Current compliant deck mounted barrier systems include 'necked' hold down bolts, fixing the post baseplate to the bridge deck, which provide resistance against impact forces. These bolts are weakened to fracture and release the post at a particular design load. For example, the TL-4 Thrie-beam system includes two M20 Class 4.6 hold-down bolts, fixing the post baseplate into the bridge deck, which have a 20mm 'necked' length in alignment with the baseplate in order to fail in tension at a load of 90kN. In comparison, the lateral rotational resistance of the existing barrier would probably be governed by the welded connection between the post and baseplate, given that the 3/4" (18mm) diameter hold-down bolts are not 'necked'. Although the failure mechanism of the existing barrier is slightly different to the TL-4 Thrie-beam system, in principal it is the same with the post/baseplate connection expected to be frangible at a comparable loading. Therefore, we predict the existing barrier posts will dislodge from the bridge deck at a loading roughly similar to the modern TL-4 Thrie-beam system, and the barrier system will behave in a similar manner.

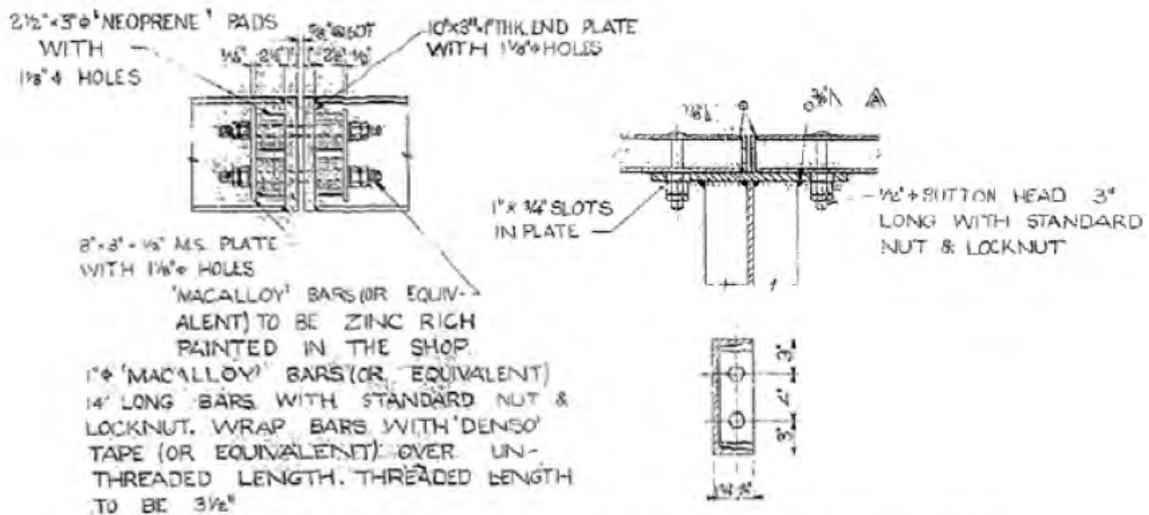
**Figure 5.4** Rail Detail from Construction Drawings (Designed in 1968)

The rail sections vary between 82 and 109 inches (25-33m) long, typically spanning approximately 12 posts. As shown in Figure 5.4, the rail sections were fixed together at each end with two 1" Macalloy bolts.

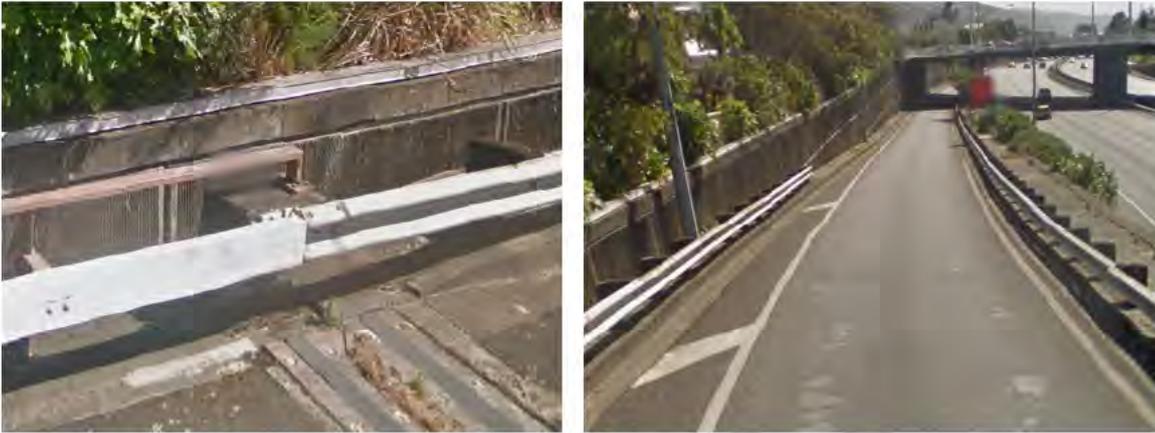
**Figure 5.5:** May Street On-Ramp – Trailing Transition and Barrier System

At the bottom of the on-ramp, the barrier changes to a strong post (timber post and blackout) system with w-beam guardrail. Refer to Figure 5.5.

The strong post (timber) system with w-beam guardrail, at the bottom of the on-ramp, appears to be in a satisfactory condition.

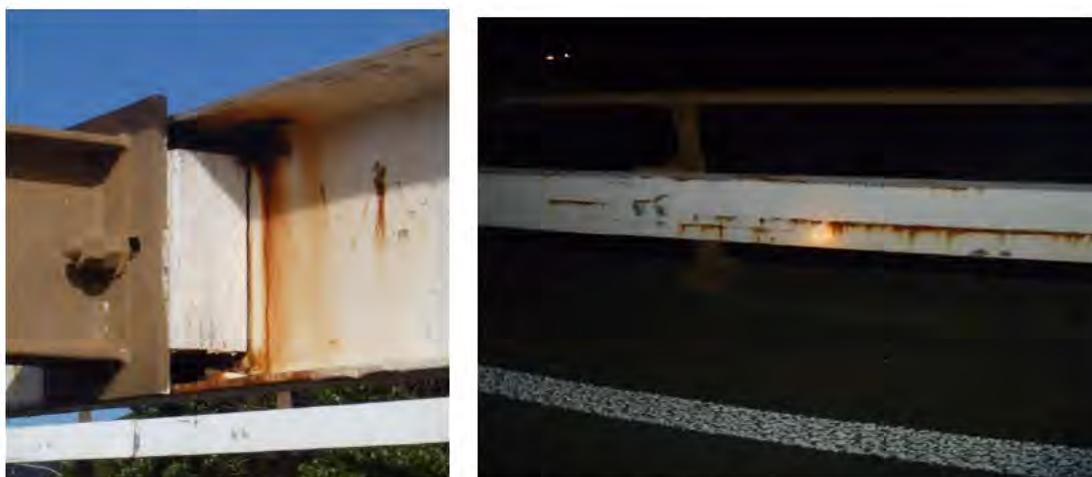
**Figure 5.6:** Corrosion on the Steel Channel Rail

As observed during the principal bridge inspection in 2014, there are various stages of corrosion on several parts of the barrier system (posts, rail and bolts). This corrosion is not surprising given the barrier was installed around 40 years ago. Refer to Figure 5.6 for some example of the corrosion observed.

Although early signs of corrosion is not expected to severely weaken the barrier system, critical elements of the barrier (hold-down bolts, rail bolts and welded connections between rail sections)

should be regularly checked for corrosion and repaired/replaced if necessary. If the condition of these critical elements is neglected then the performance of the barrier could be compromised.

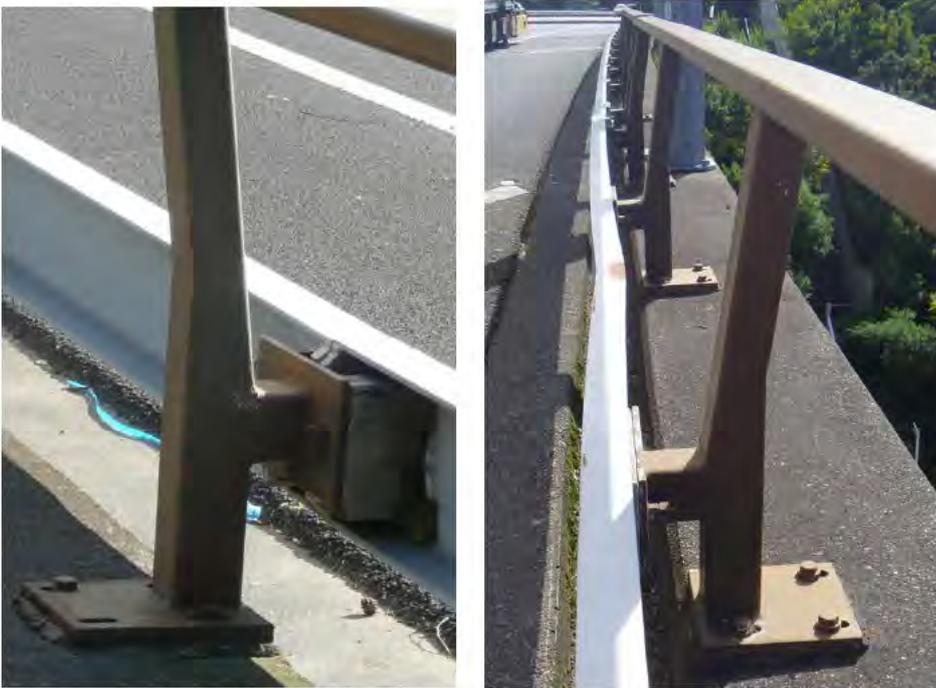
**Figure 6.1:** Bowen Street Overpass (Southbound) – Edge Barrier Post

The road safety barriers on the Bowen Street Overpass - Southbound (BSN 10727), constructed in 1972, are shown in Figures 6.1 to 6.6. This is also an out-dated system consisting of steel channel bridge rail mounted on steel posts. The length of the barrier system on the bridge structure is approximately 100m on each side (200m total). Although the rail section (and height) is identical to that on the May Street On-Ramp, the steel post is a 4"×4"×1/4" rectangular hollow section (RHS), as shown in Figure 6.1.

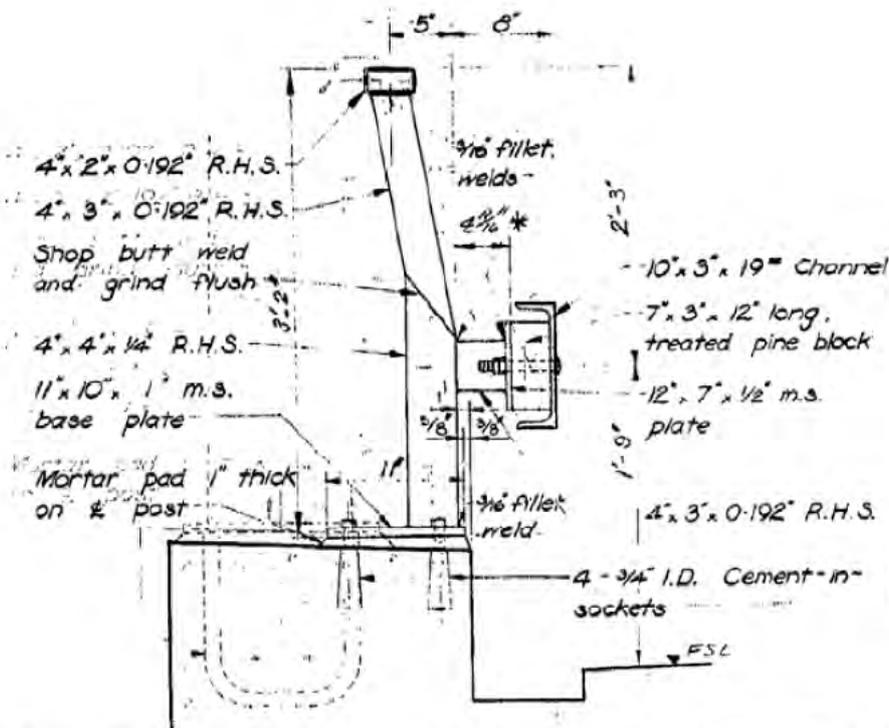
- The height of the top handrail is 4'-0" (1219mm) from the road surfacing (at construction).
- Post spacing of 7'- 6" (2.3m).
- Steel posts were positioned at the front edge of the 11"×10"×3/4" mild steel baseplate.
- The steel post was comprised of two sections. The bottom half was a 4"×4"×0.25" RHS which was shop butt welded to a 4"×3"×0.192" RHS above.
- Steel blockout was a 4"×3"×0.192" RHS and there was a 7"×3"×12" treated pine block between the rail and steel plate on the blockout.
- Steel was mild steel according to BS15 and welds were 3/16" fillet welds (all around).
- The posts are mounted on a concrete kerb upstand which is 200mm above the surfacing.

Figure 6.2: Bowen Street Overpass - Barrier Detail from Construction Drawings (Designed in 1971)

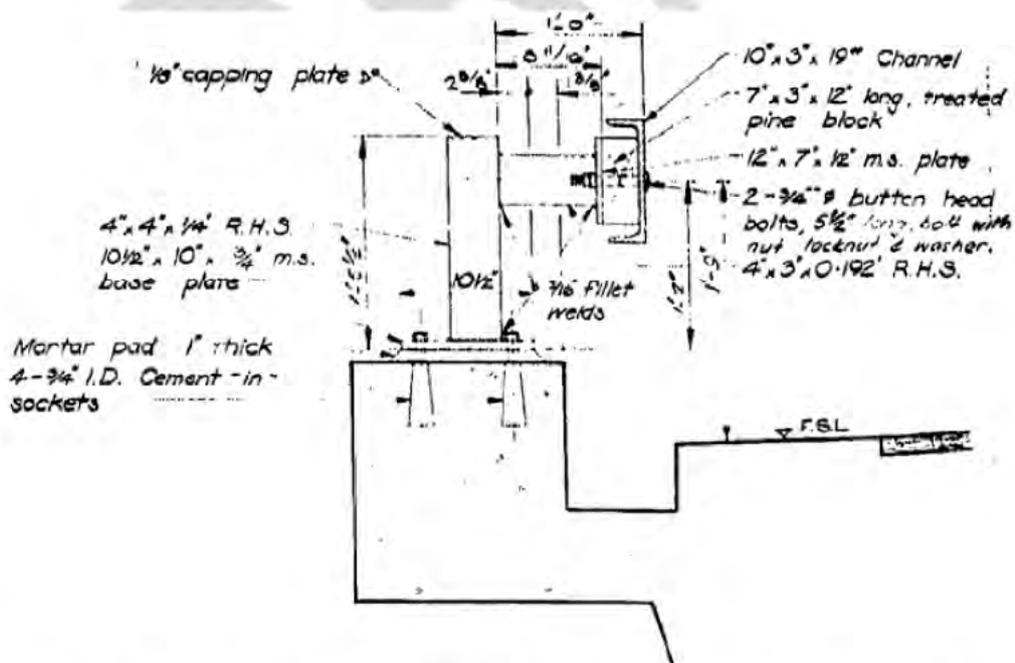
- Steel posts were positioned behind the front bolts in the 10.5"×10"×3/4" mild steel baseplate.
- To account for the positioning of the post further back on the baseplate, the blockout is longer to ensure the rail in front of the concrete kerb.

Figure 6.3: Bowen Street Overpass - Barrier Detail from Construction Drawings (Designed in 1971)

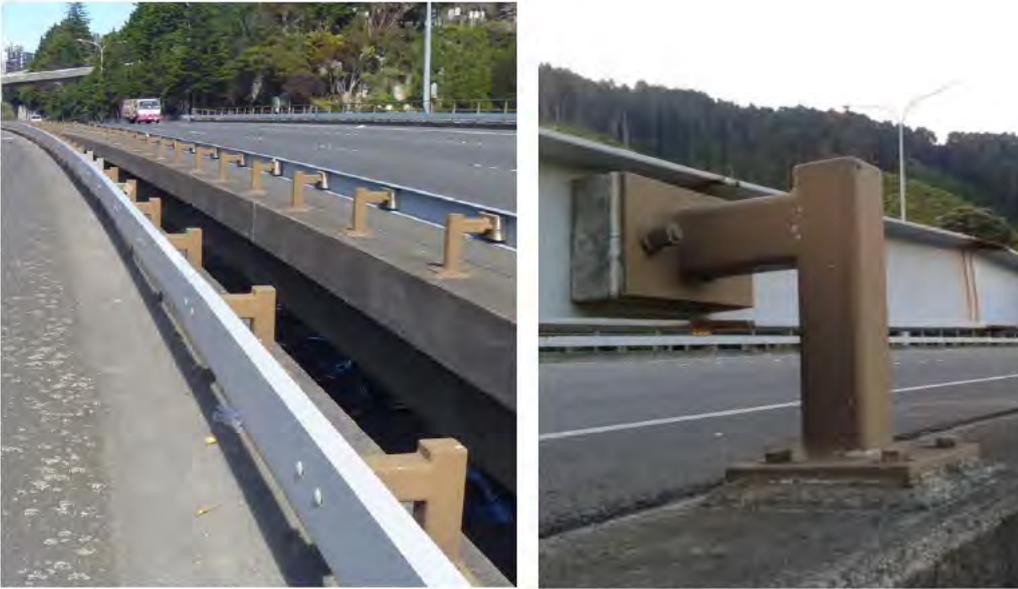
**Figure 6.4:** Bowen Street Overpass (Southbound) – Median Barrier System

The edge barrier system adjacent to the bridge (refer to Figure 6.5), on both the leading and trailing sides, is the same as the median barrier system shown in Figure 6.4. The length of the leading transition barrier is approximately 30m and the length of the trailing transition barrier is approximately 20m.

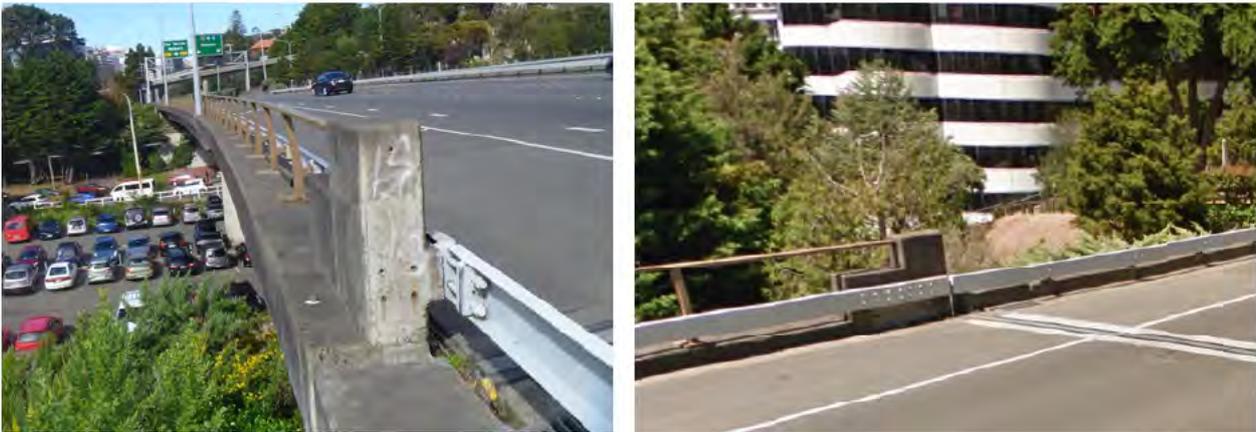
**Figure 6.6:** Bowen Street Overpass (Southbound) – Concrete Anchor Block

Additionally, there is a concrete anchor block at each end of the bridge structure where the handrail terminates, as shown in Figure 6.6. This anchor block is 3'-3" (991mm) high, 12" (305mm) thick and 6'-0" (1.83m) long.

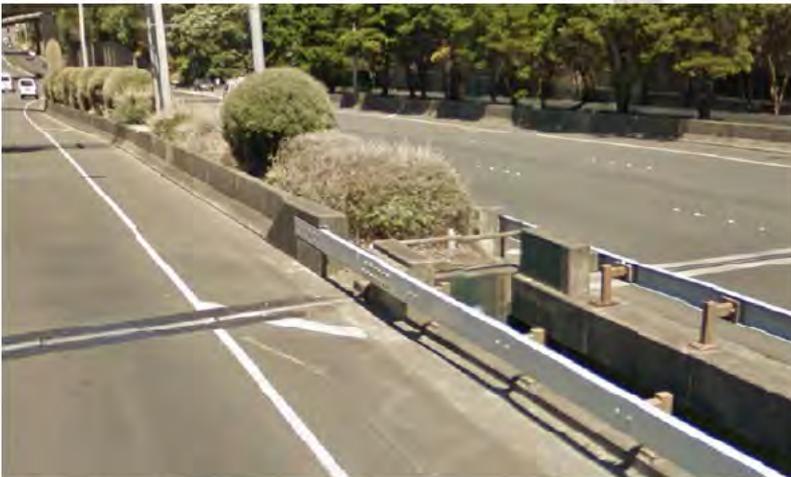
**Figure 6.7:** Bowen Street Overpass (Southbound) – Median Barrier Trailing Transition System

The median barrier has different transition systems before and after the bridge. The trailing end involves a TL-4 ‘New Jersey’ concrete (rigid) barrier connecting to the steel channel rail system along the bridge, as shown in Figure 6.7.

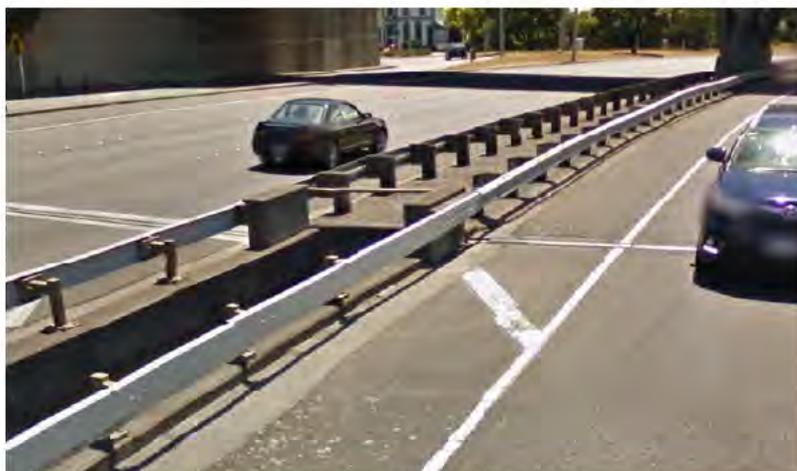
**Figure 6.8:** Bowen Street Overpass (Southbound) – Median Barrier Leading Transition Approach

At the leading end, the steel channel rail system on the bridge connects to a TL-3 w-beam guardrail system. Note that there is no appropriate transition section between the two systems to account for the significant increase in stiffness, especially with the rigid concrete anchor block terminal (as mentioned above for the outer edge barrier). Refer to Figure 6.8.

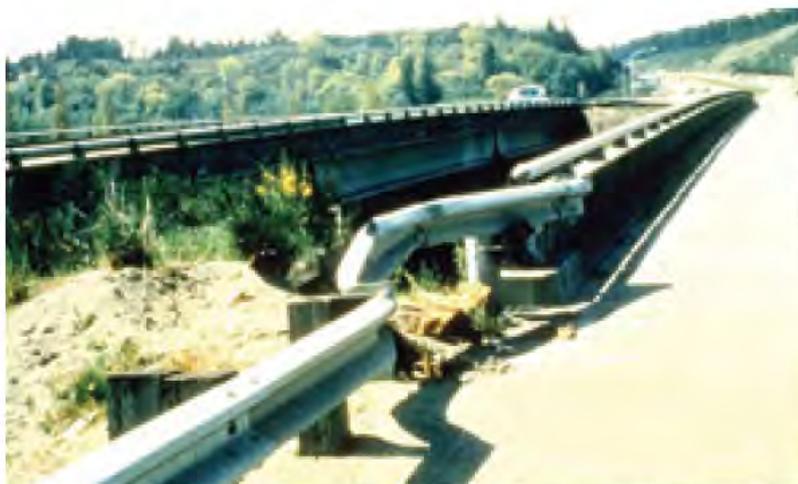
**Figure 6.9:** Example of Vehicle Pocketing (source – US Department of Transportation)

timber posts incorrectly installed in the concrete footpath). Although the timber posts are embedded into the concrete footpath, the deflection of the timber post with w-beam guardrail system is expected to be much greater than the steel channel rail system (especially at the location of the concrete anchor block terminal). Given this differential in stiffness (and deflection) between the two barrier systems, we expect there is potential for vehicle pocketing which is a significant concern. An example of vehicle pocketing is shown in Figure 6.9.

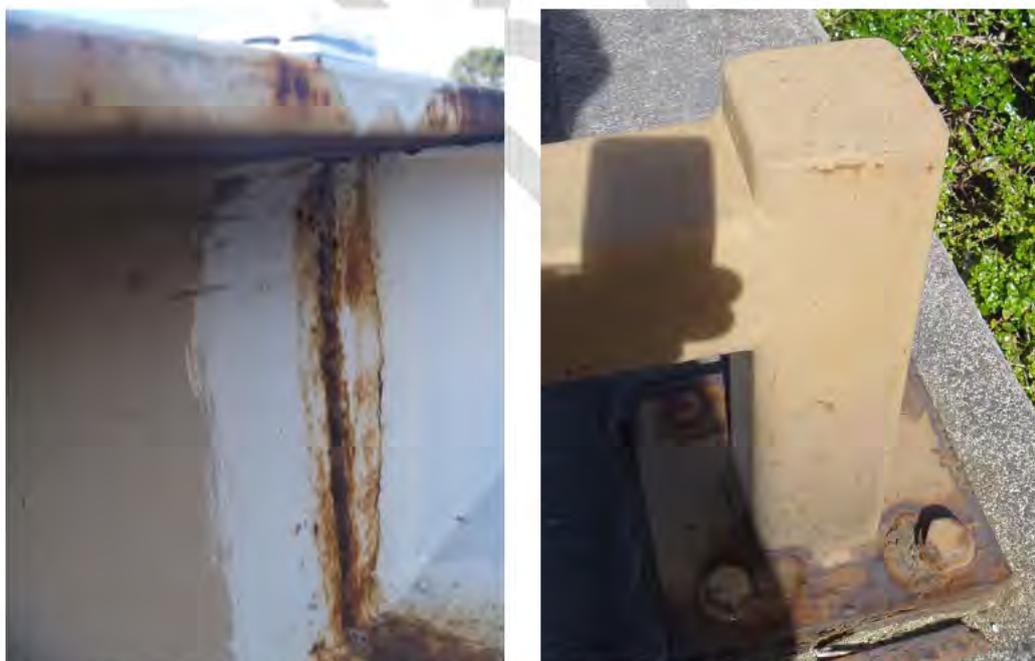
**Figure 6.10:** Corrosion at Welded Connection in the Rail and around Post Baseplate

As observed during the general bridge inspection in 2014, there are various stages of corrosion on several parts of the barrier system (posts, rail and bolts). Refer to Figure 6.10 for some typical examples of the corrosion observed.

Although early signs of corrosion is not expected to severely weaken the barrier system, critical elements of the barrier (hold-down bolts, rail bolts and welded connections between rail sections) should be regularly checked for corrosion and repaired/replaced if necessary. Should the condition of these critical elements be neglected then the performance of the barrier could be compromised.

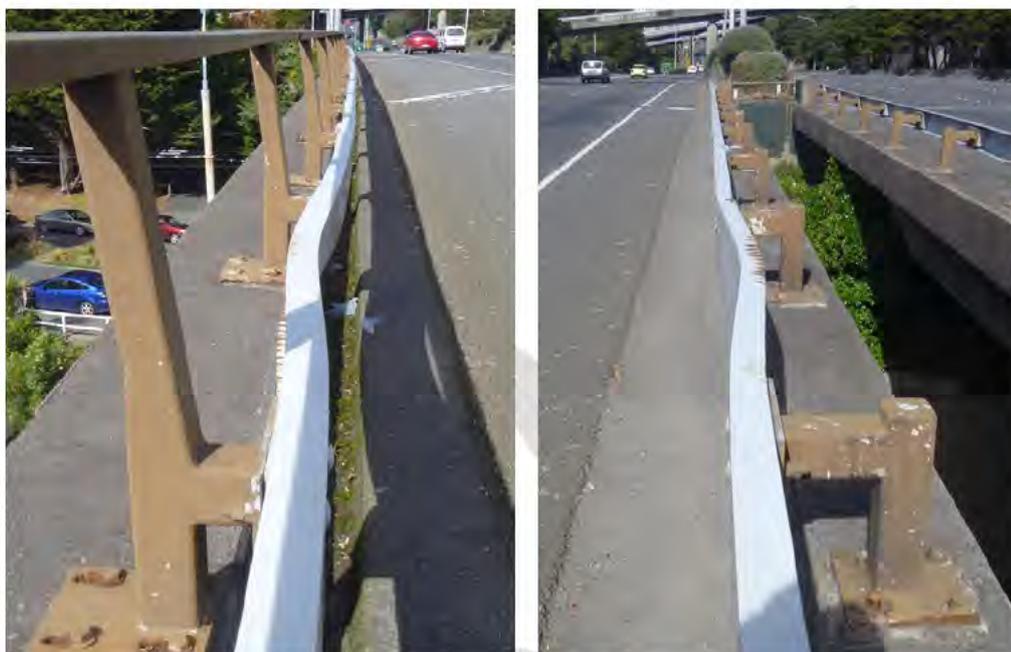
**Figure 6.11:** Examples of Barrier Damage from Vehicle Impacts

Additionally, the existing barrier does have a few localised areas of impact damage (eg slightly bent rail and/or posts), however these appear to have been sideswipe collisions given the damage is only minor. As there is no substantial damage (eg tears in rail, deformed posts/blockouts, fractured bolts, etc), we don't expect the performance of the barrier system to have been dangerously impaired. Refer to Figure 6.11 for some examples of barrier damage due to vehicle impacts.

If the existing barrier system is retained, the Transport Agency will need to accept the risk of the non-compliant (and potentially deficient) barrier system. Additionally, ongoing difficulties, and high costs, of maintaining the non-standard barrier system will continue, especially when damaged sections are replaced after a vehicle collision.

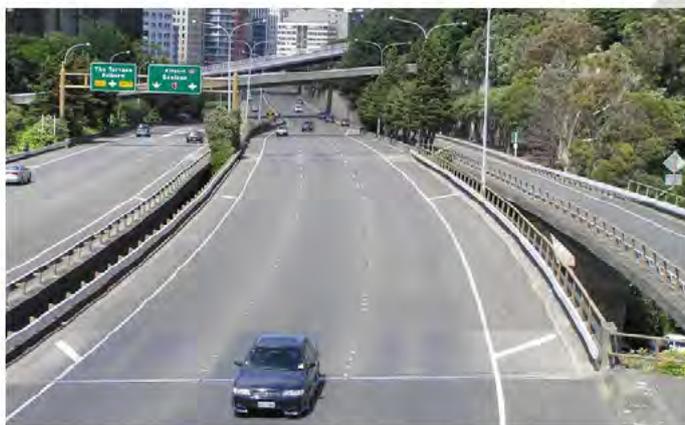
**Figure 7.1:** Bowen Street Overpass (Northbound) – Barrier System

The road safety barriers on the Bowen Street Overpass - Northbound (BSN 10728), constructed in 1972, are shown in Figures 7.1 to 7.5. The barriers are identical to those on the Bowen Street (Southbound) Overbridge, with a top handrail on the outer edge barrier but no handrail on the median barrier. The length of the barrier system on the bridge structure is approximately 100m on each side (200m total).

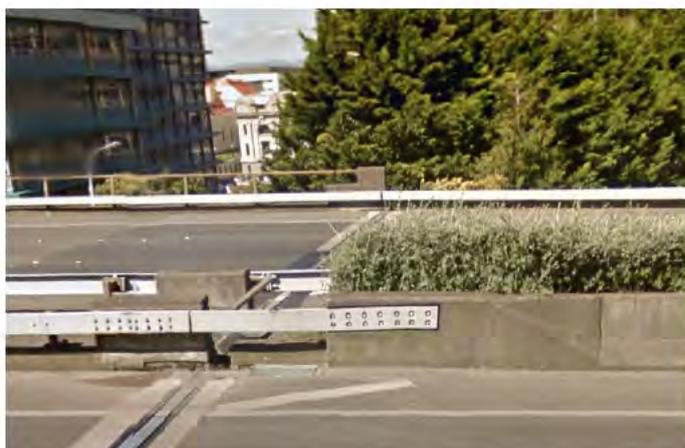
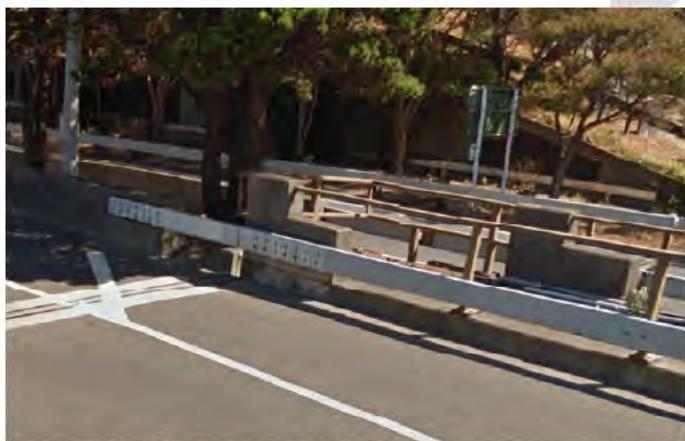
However, this detail can't be seen from the photos. The transition from the steel channel bridge rail system on the bridge to the rigid barrier is shown Figures 7.3 - 7.4.

**Figure 7.3:** Bowen Street Overpass (Northbound) – Median Barrier Leading Approach

**Figure 7.4:** Bowen Street Overpass (Northbound) – Edge Barrier Leading Approach

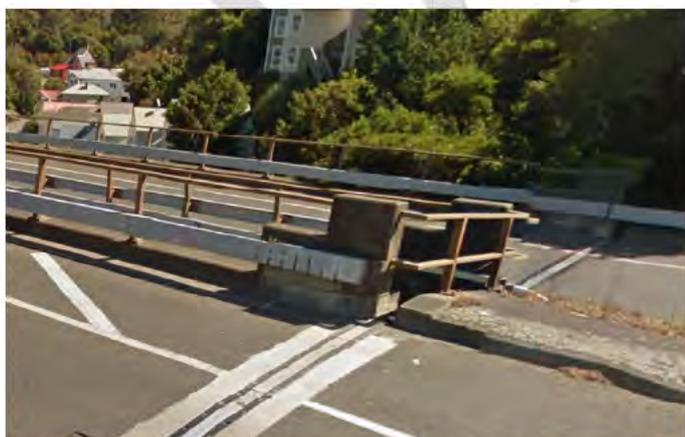
**Figure 7.5:** Bowen Street Overpass (Northbound) – Barrier System Trailing Terminal

The trailing end terminal of the edge barrier system is shown in Figure 7.5. The trailing approach system for the median barrier was shown previously in Figure 6.6.

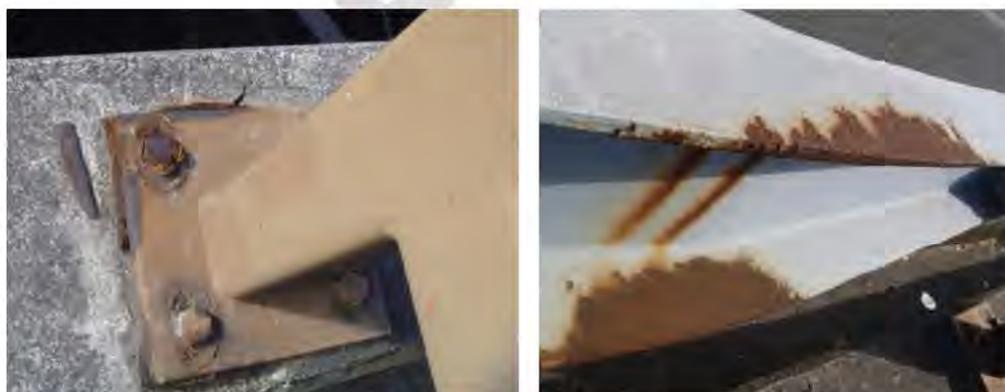
Similar to Bowen Street Overpass (Southbound), there various stages of corrosion on several parts of the barrier system (posts, rail and bolts), as observed during bridge inspection (principal) in 2014. Refer Figure 7.6 and 7.7 for typical examples of corrosion on the barrier system.

**Figure 7.6:** Examples of Corrosion on Baseplate Hold-down Bolts and Rail

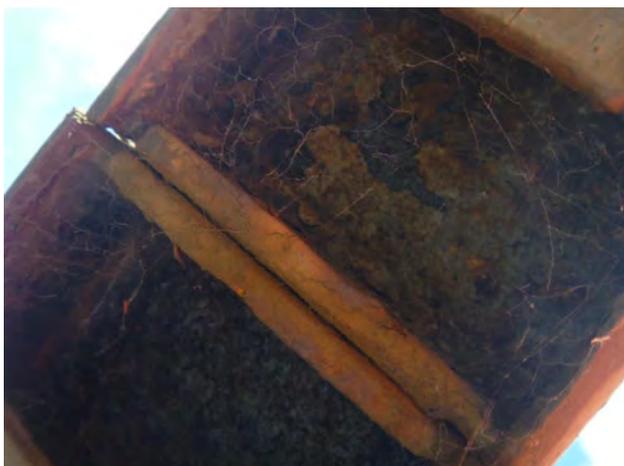
**Figure 7.7:** Corrosion on the Underside of the Top Handrail

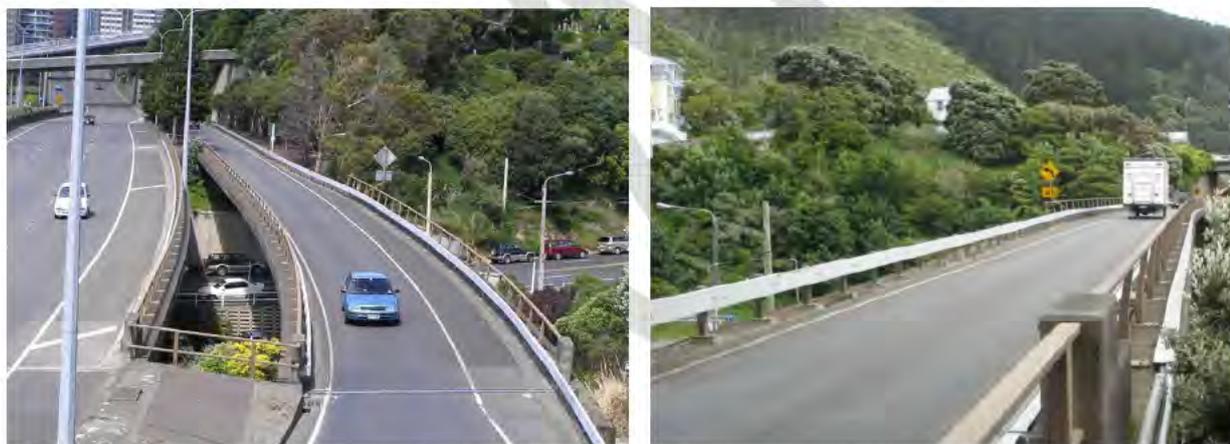
**Figure 8.1:** Tinakori Road Off-Ramp Bridge – Barrier Systems

The road safety barriers on the Tinakori Road Off-Ramp (BSN 10728), constructed in 1972, are shown in Figures 8.1 - 8.4. As shown in Figure 8.1, the characteristics of the existing barrier systems are generally identical to those on the Bowen Street Overpass structures, as outlined in Section 6.1. The length of the barrier system on the bridge structure is approximately 100m on each side (200m total).

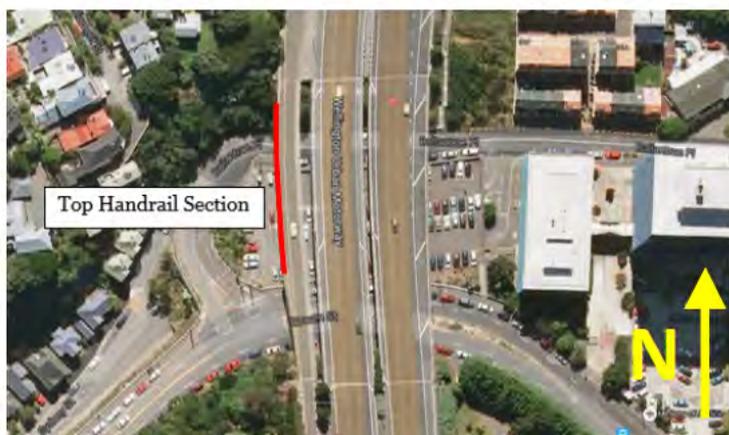
**Figure 8.2:** Tinakori Road Off-Ramp Bridge – Top Handrail Section

The only difference is that the barrier on the motorway side has the top handrail along the entire length, but on the Tinakori Road side the handrail only extends along two-thirds of the off-ramp. The section without the top handrail is above Bowen Street, whereas the section with the handrail is above a carpark, as shown in Figure 8.2.

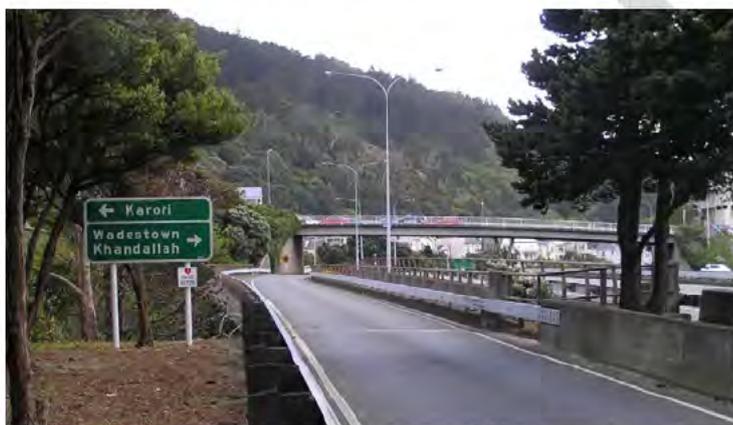
**Figure 8.3:** Tinakori Road Off-Ramp Bridge – Leading Approach Barriers

The leading approach barrier on the western side is a strong post (timber) with steel channel rail system, which originates approximately 80m before the bridge. Whereas the approach barrier on the motorway side is a TL-4 rigid concrete system. Refer to Figure 8.3.

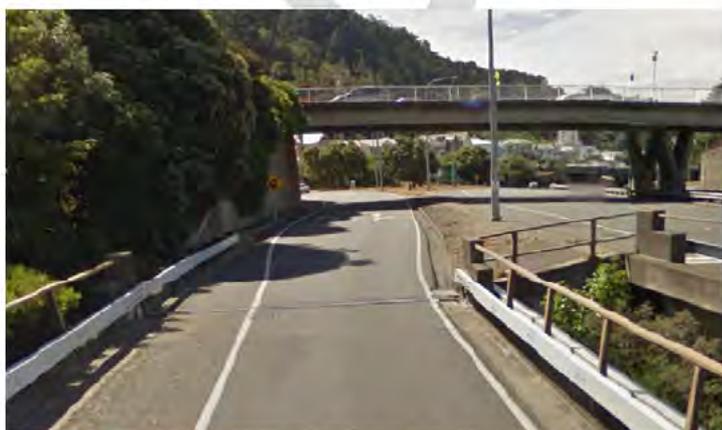
**Figure 8.4:** Tinakori Road Off-Ramp Bridge – Trailing Approach Barriers and End Terminals

The trailing approach barrier, on the western side, is the same steel channel rail system as on the bridge but without the top handrail. This approach barrier extends approximately 20m past the bridge and has no appropriate end terminal. On the motorway side there is no barrier system after the bridge, as shown in Figure 8.4.

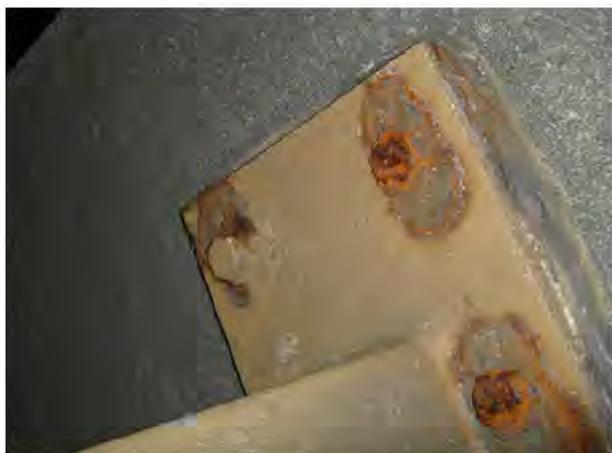
As with Bowen Street Overbridge, there are early signs of corrosion on various parts of the barrier system (posts, rail and bolts), as observed during the bridge inspection (general) in 2014. Refer to Figure 8.5. The issues with this corrosion and the maintenance of the barrier hardware was discussed in Section 6.5.

**Figure 8.5:** Corrosion of Baseplate Hold-down Bolts

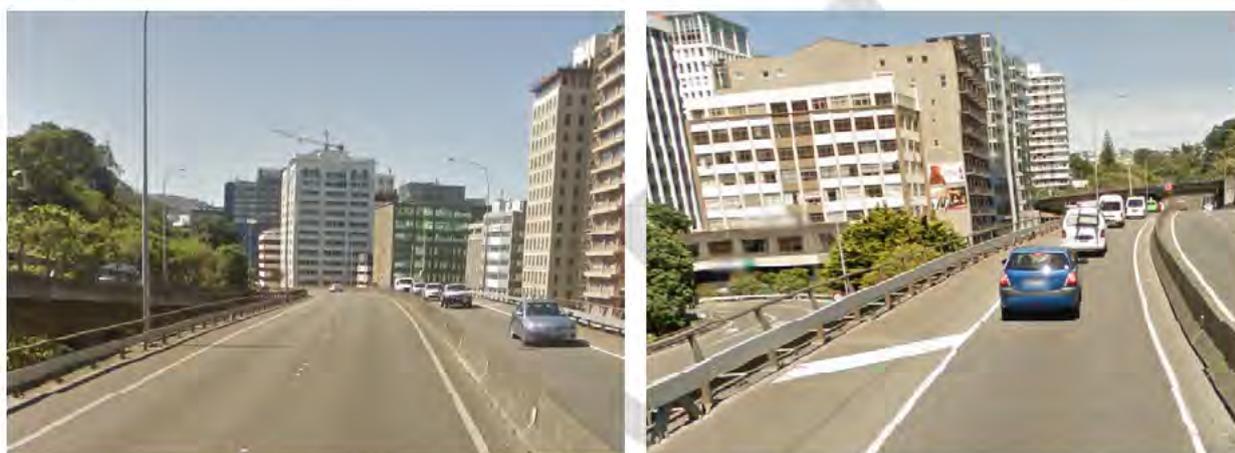
**Figure 9.1:** Shell Gully Overbridge – Edge Barrier and Median Barrier

The road safety barriers on the Shell Gully Overbridge - Northbound (BSN 10731) and Southbound (BSN 10732), constructed in 1980, are shown in Figures 9.1 - 9.6. The length of the barrier system on the bridge structure is approximately 370m on each side and 370 along the median (1,100m total).

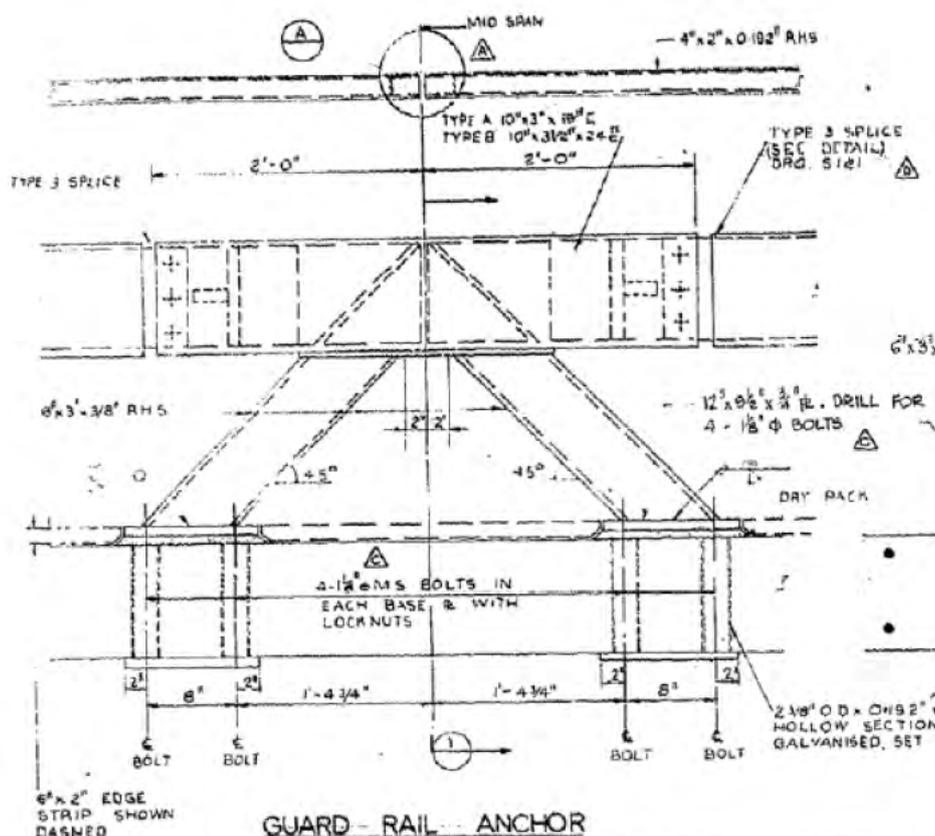
However, one key difference was the anchoring of the rail to the bridge deck, as shown in Figure 9.2 and 9.3. The rail was anchored at spacings of no more than 200'-0" (61m).

Figure 9.2: Shell Gully Overbridge - Anchorage Detail from Construction Drawings (Designed in 1974)

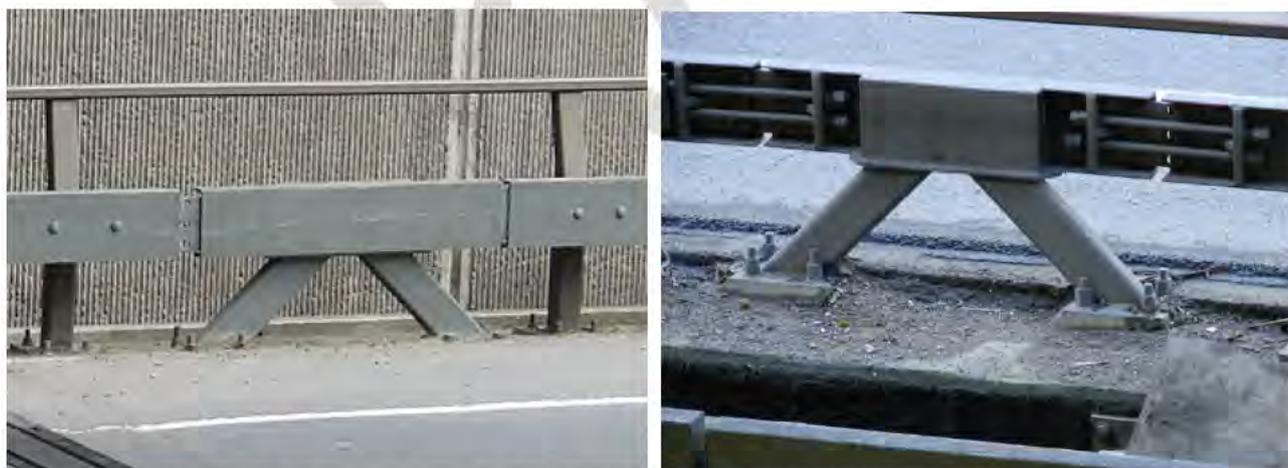
Figure 9.3: Shell Gully Overbridge – Rail Anchorage to Bridge Deck

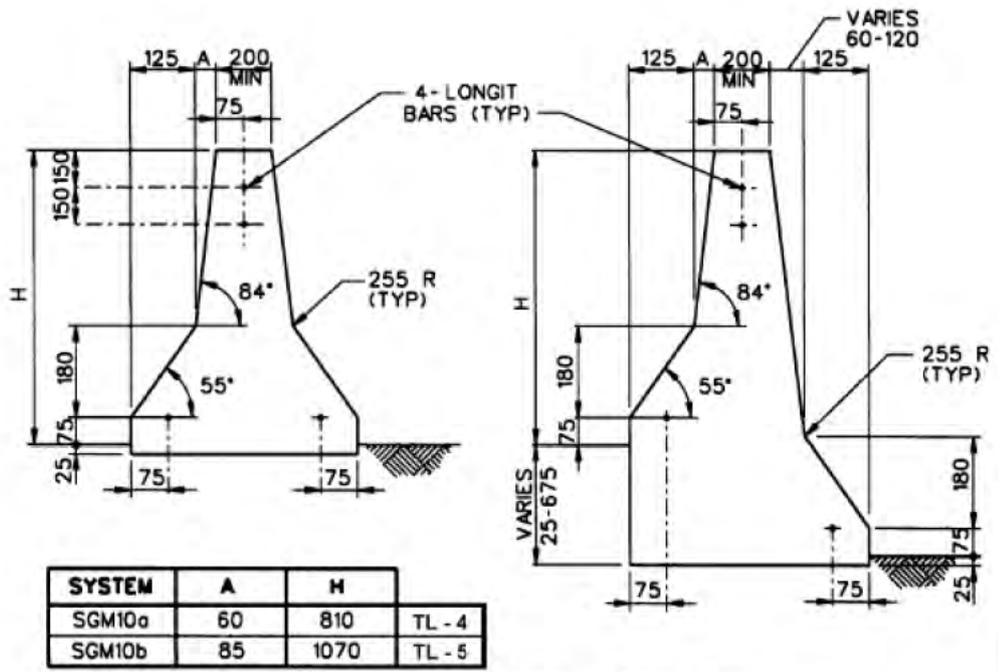
The median barrier along the entire length of the bridge is a concrete (New Jersey Type) barrier, consisting of 6m long segmental units. The height of the concrete barrier seems to be approximately 800mm, which according to the Transport Agency Specification M23 (Specification for Road Safety Barrier Systems), corresponds to a TL-4 level of protection. Figure 9.4 is the F-Shape concrete barrier detail from Section 1.2 in Appendix A of NZTA M23. The F-Shape barrier is the preferred system by the Transport Agency for a TL-4 concrete (rigid) barrier.

Figure 9.4: F-Shape Concrete Barrier Detail from NZTA M23A

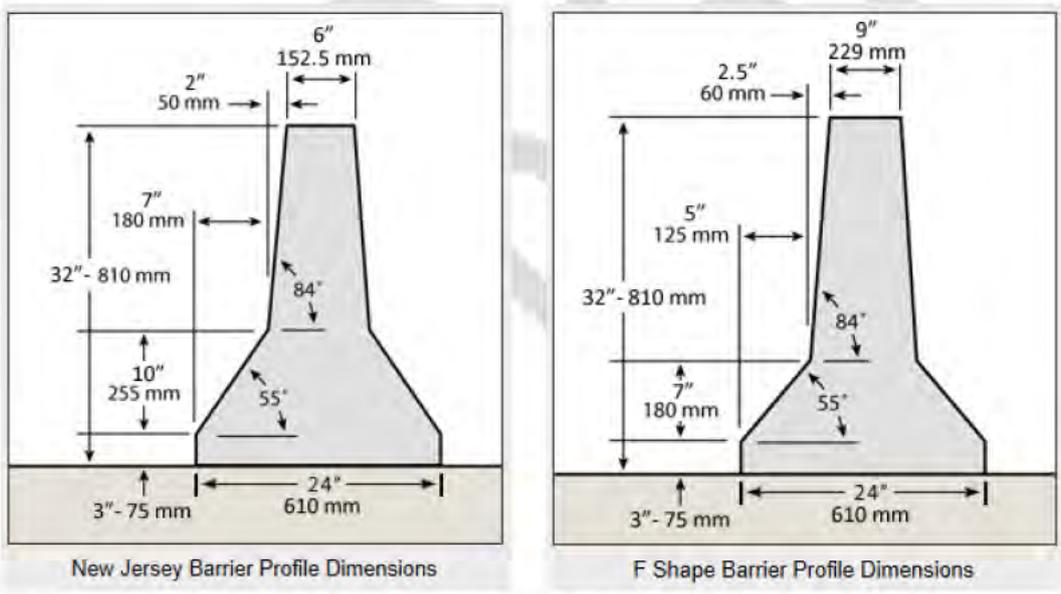
The New Jersey shape median barrier is similar to the F-Shape (specified in NZTA M23) but the breakpoint, distance from the ground level to the slope deviation point, is 3" or 75mm higher. This profile difference is illustrated in Figure 9.5.

Figure 9.5: New Jersey Type Concrete Barrier v F-Shape Concrete Barrier

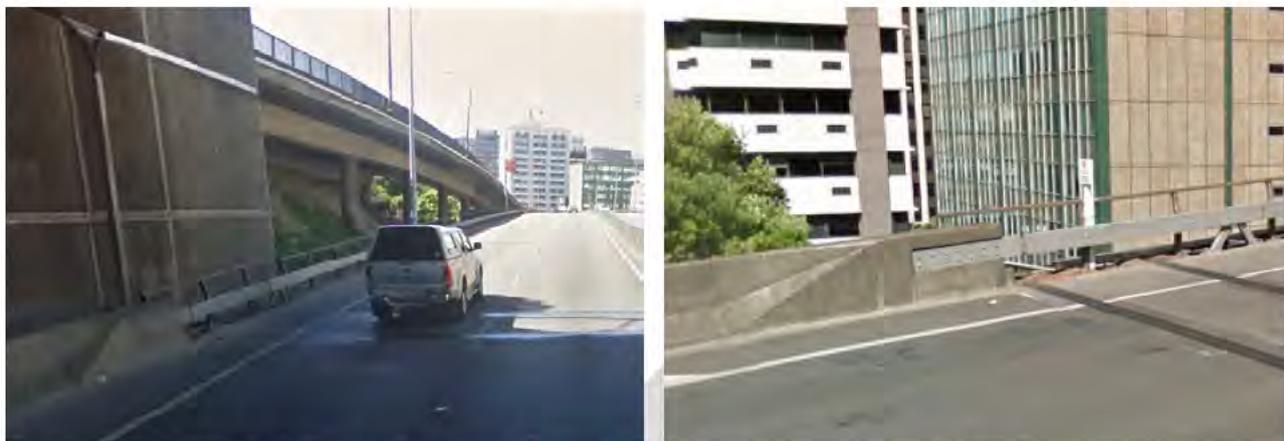
**Figure 9.6:** Shell Gully Overbridge (Northbound) – Leading Approach Barriers

On either approach to the bridge, at the outer edge, there is this same 'New Jersey' concrete barrier which then connects into the steel channel rail barrier on the bridge structure (refer Figure 9.6).
