# **Wellington Urban Motorway**

## **Bridge Safety Barrier Assessment**

Date: 10/09/2015  
Reference: 5c3008.01 / 5110  
Status: Draft for NZTA comment

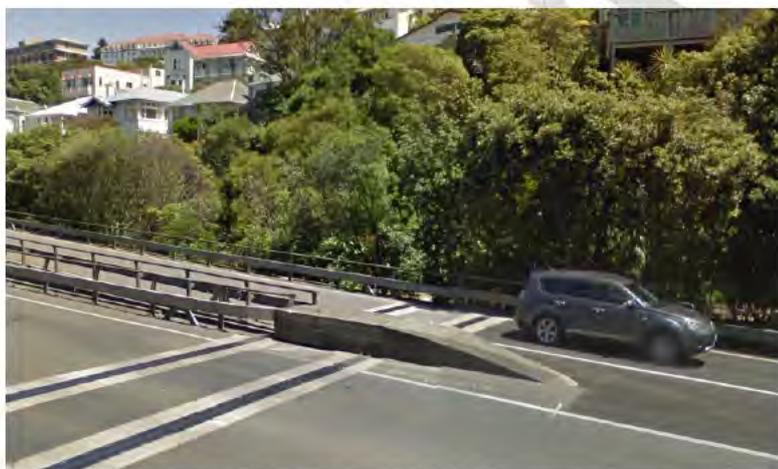
**Figure 9.7:** Shell Gully Overbridge (Northbound) – Edge Barrier Trailing End Terminal

As the bridge meets the Clifton Terrace On-ramp structure, there is a concrete end terminal. Refer to Figure 9.7.

At the bottom of the on-ramp, at the outer edge, the steel channel rail system connects to a TL-4 rigid concrete barrier (see Figure 11.3). Additionally, there is a non-compliant concrete end terminal where the on-ramp merges with the motorway, as shown previously in Figure 9.7.

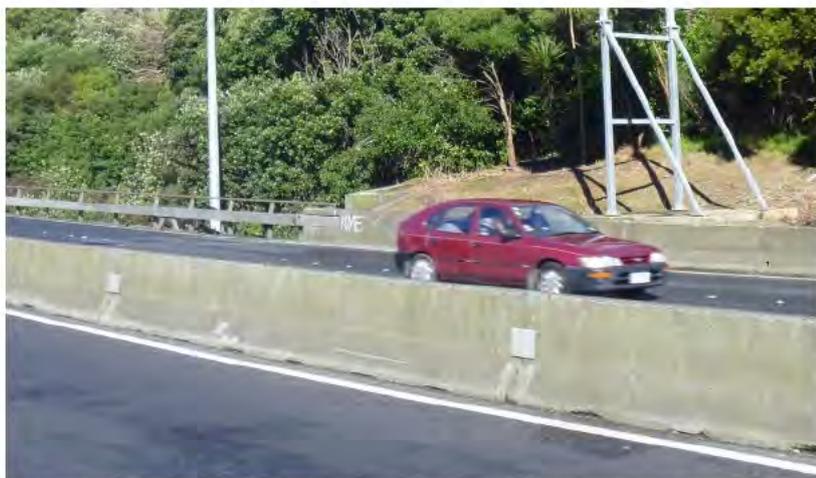
Figure 8.7: Shell Gully Overbridge (Northbound) – Median Concrete Barrier

Following discussions with Engineers from the former Ministry of Works who were involved with the installation of the 'New Jersey' concrete (rigid) median barrier, the 6m long concrete units were not pinned together, which nowadays is current practice for permanent rigid barriers. Although, the concrete units are to some extent held together with steel plate clamp, as shown in Figure 8.7.

Additionally, the concrete units are not fixed to the pavement or bridge deck, therefore the barrier does not meet the criteria for a NCHRP-350 TL-4 system. Given the absence of a fixing detail to the bridge deck, the concrete median barrier can be displaced up to 1.5m during a vehicle impact. The only resistance provided against the impact loadings is the self-weight of the 6m long concrete units. This deflection of the concrete barrier is a major concern as concrete units could be displaced into the path of an oncoming vehicle travelling at 100km/h.

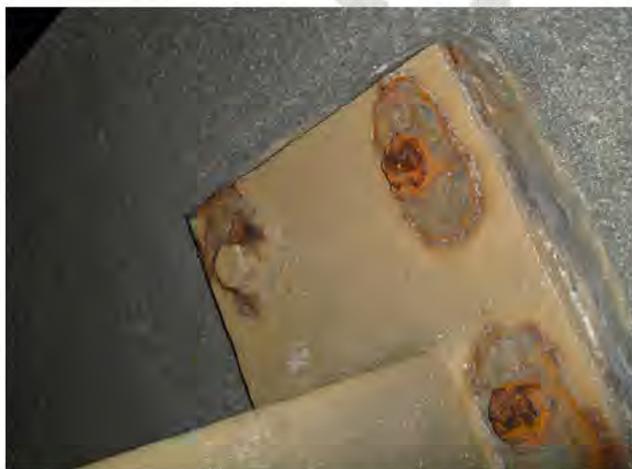
Figure 8.5: Corrosion of Baseplate Hold-down Bolts

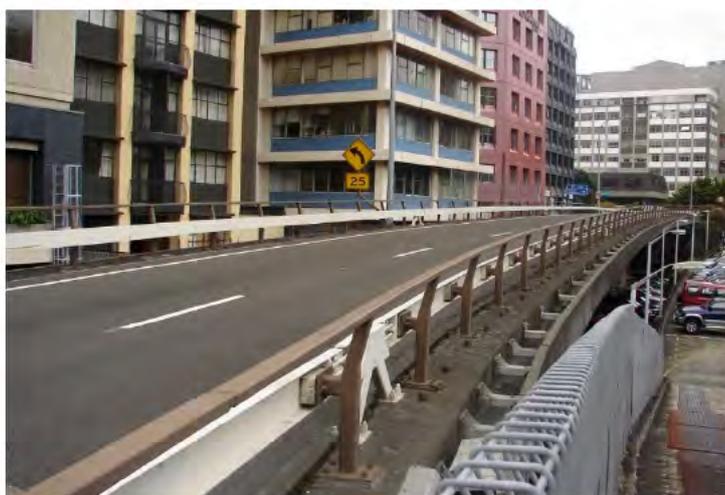
**Figure 10.1:** Terrace Off-Ramp Bridge – Barrier Post and Rail

The road safety barriers on the Terrace Off-Ramp Bridge (BSN 10733), constructed in 1980, are shown in Figures 10.1 - 10.3. The barrier system is generally identical to the outer edge barrier on Shell Gully Overbridge, as discussed in Section 9.1. The length of the barrier is approximately 260m on each side (520m total).

Figure 10.1 and 10.2 show the trailing terminals at the end of the bridge near the Terrace.

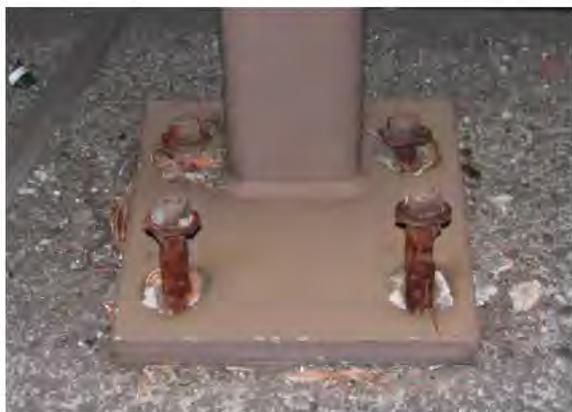
**Figure 10.4:** Corroded Hold-down Bolts

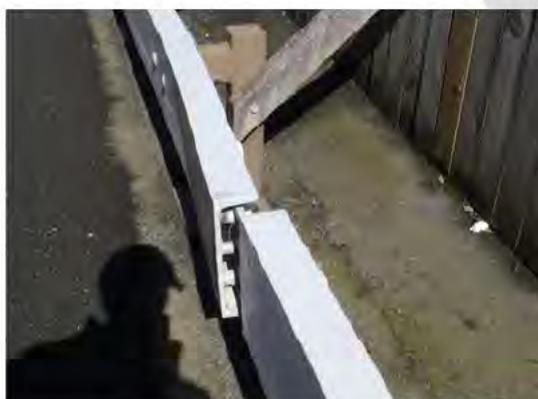
**Figure 10.5:** Misaligned Rail due to a Vehicle Impact

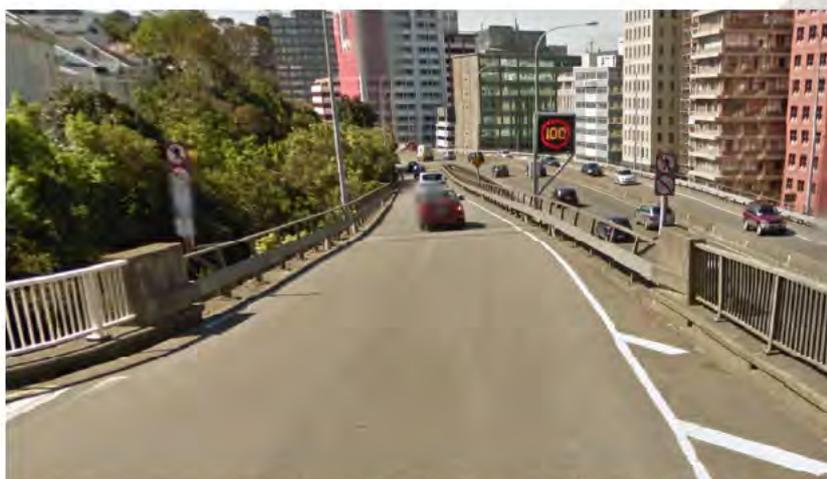
**Figure 11.1:** Clifton Terrace On-Ramp Bridge – Leading Approach Barriers

The leading approach barriers, on either side, are pedestrian barriers due to the 50km/hr speed environment before the on-ramp. Refer to Figure 11.1.

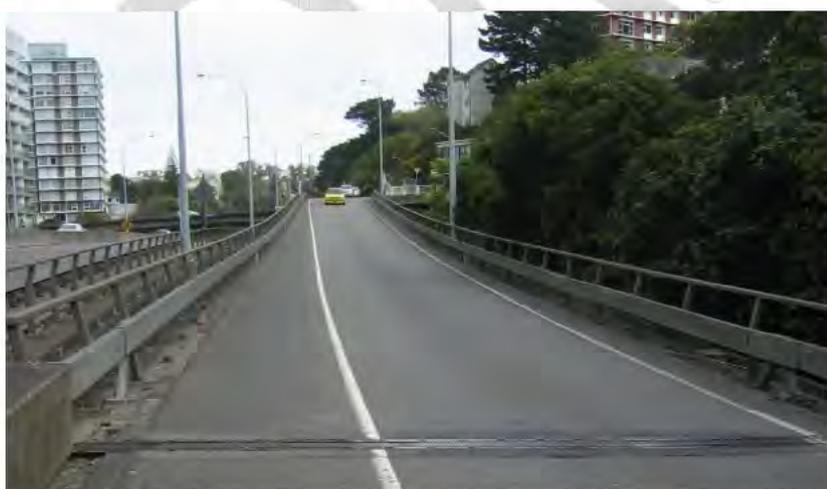
**Figure 11.2:** Clifton Terrace On-Ramp Bridge – Steel Channel Rail Barrier System

The barrier along the on-ramp is identical to the steel channel rail system on Shell Gully Overbridge, as shown in Figure 11.2.
