# Transport noise Visual screening

## NOISE BARRIER CASE STUDY 6

January 2012

## Kennedy Road Overbridge, Napier

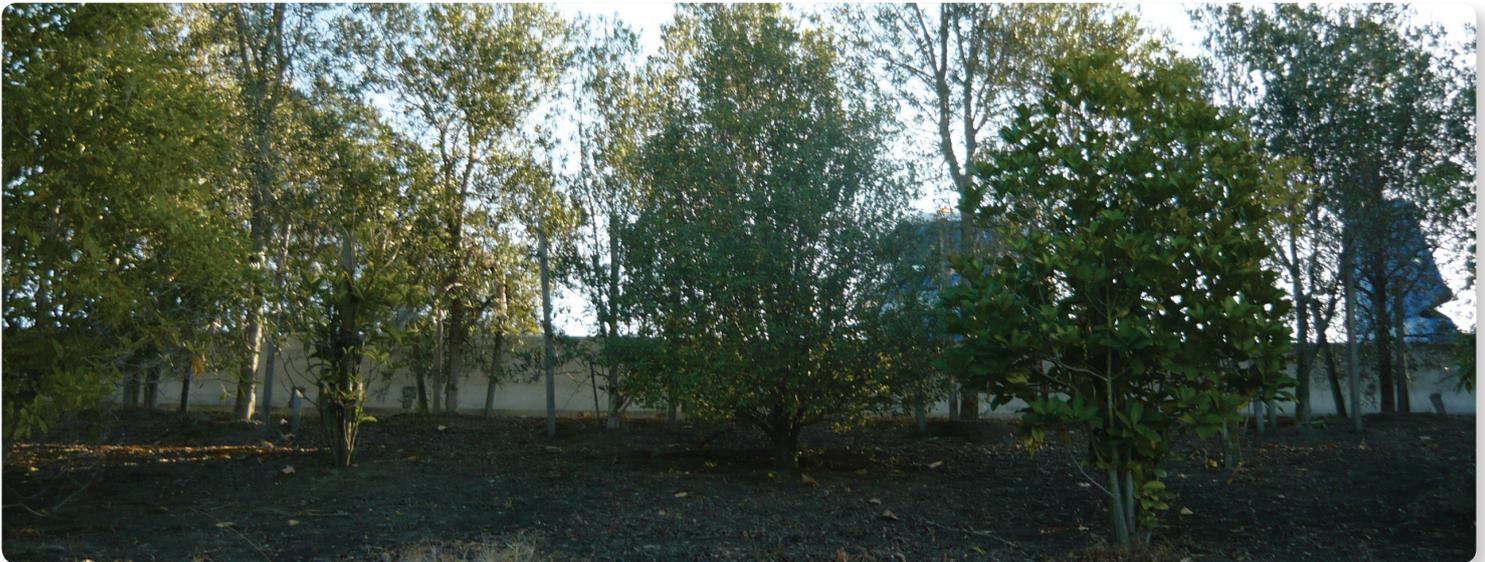
A truck on the expressway partly obscured from view at the neighbouring house by trees planted in the road reserve.

In this instance trees to form a visual screen were used rather than a noise barrier. Appropriate species were researched that would provide visual screening, grow fast and be compatible with the ground conditions. A variety of olive tree was found that met these criteria and was planted in the road reserve between the expressway and the neighbouring house. As can be seen from the photograph above and

overleaf, the olive trees (and other trees planted in front) only provide partial visual screening, but this was sufficient to alter the perception of the noise from trucks, and prevent the residents from becoming sensitised to road-traffic noise.

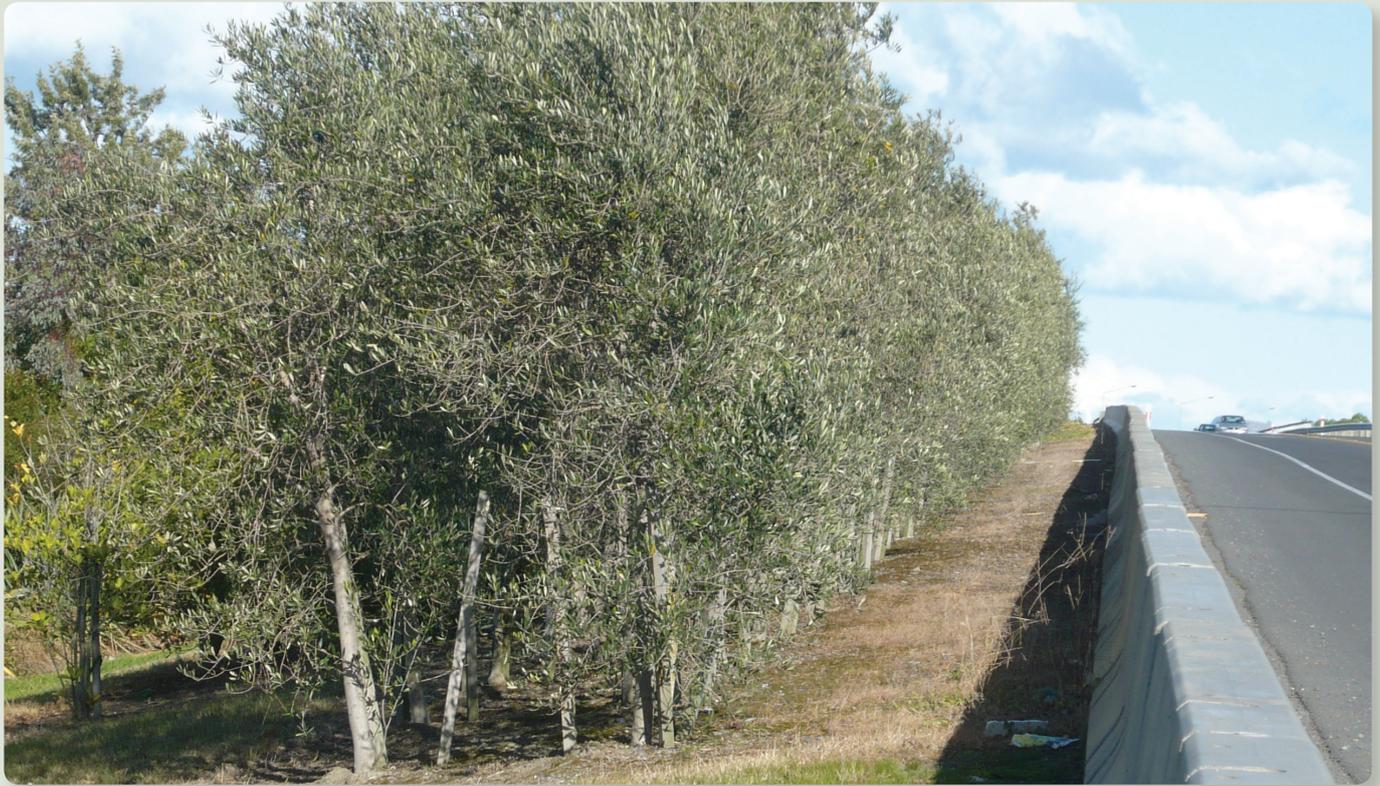
View approaching the overbridge looking along the line of olive trees and concrete safety barrier. The neighbouring house is to the left of the photograph.

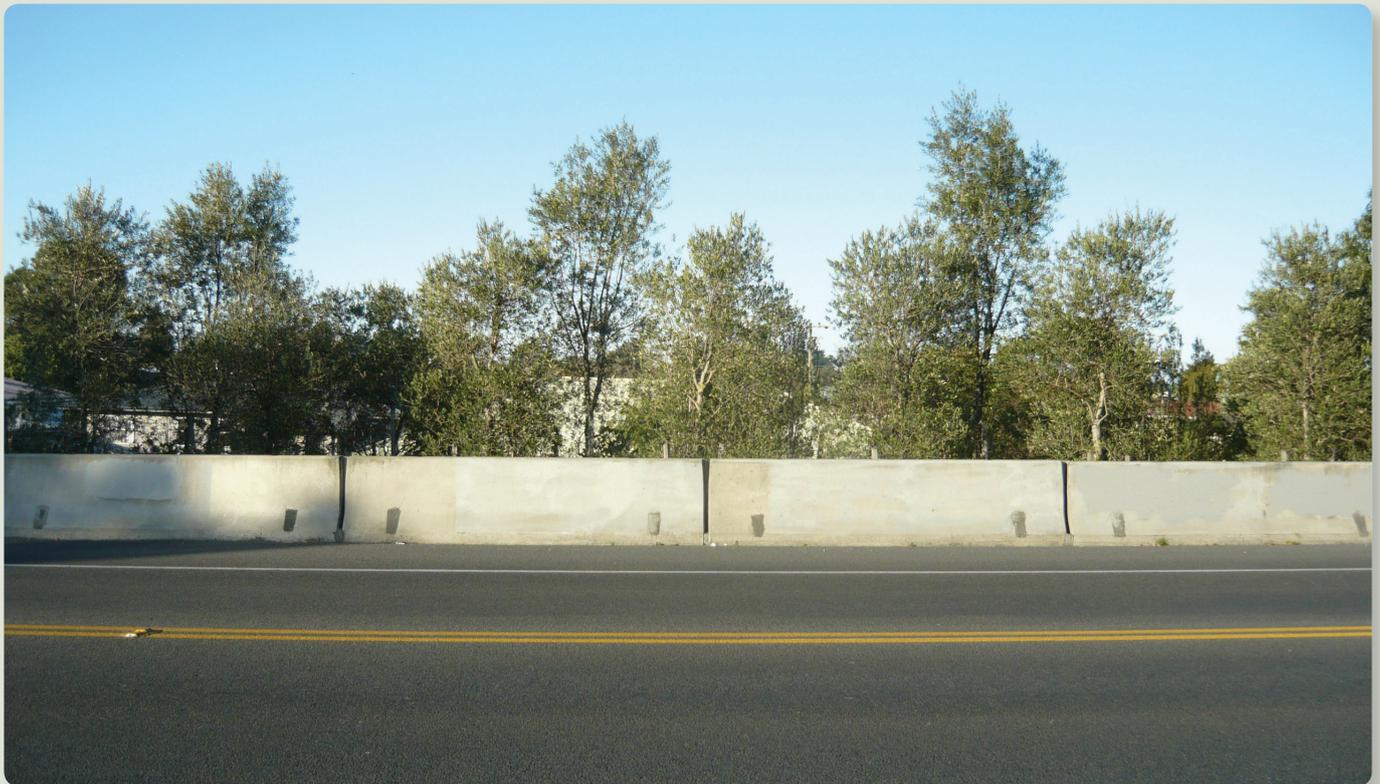
View across the expressway towards the olive trees and concrete safety barrier, with the neighbouring house behind. It can be seen that the view between the house and the road is only partly obscured.
