Low-Noise Road Surfaces Performance Monitoring

Prepared by John Patrick, Igor Kvatch
Reviewed by Vince Dravitzki

Opus International Consultants Limited
Opus Research, Petone
Telephone +64 4 587 0600

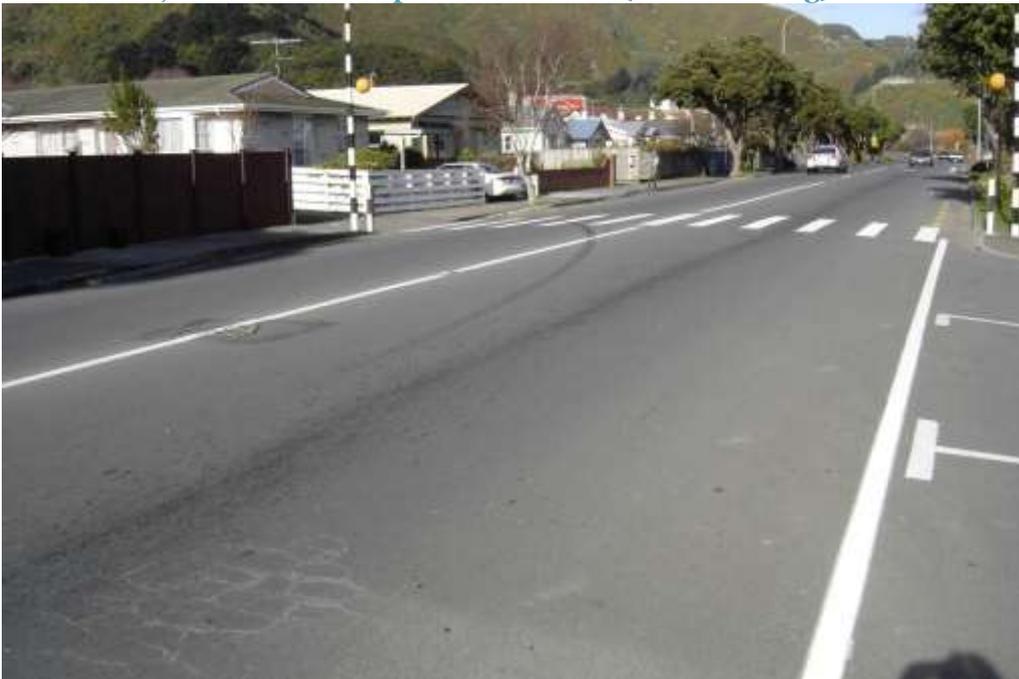
Lower Hutt, Wainui Road asphaltic concrete (note cracking)

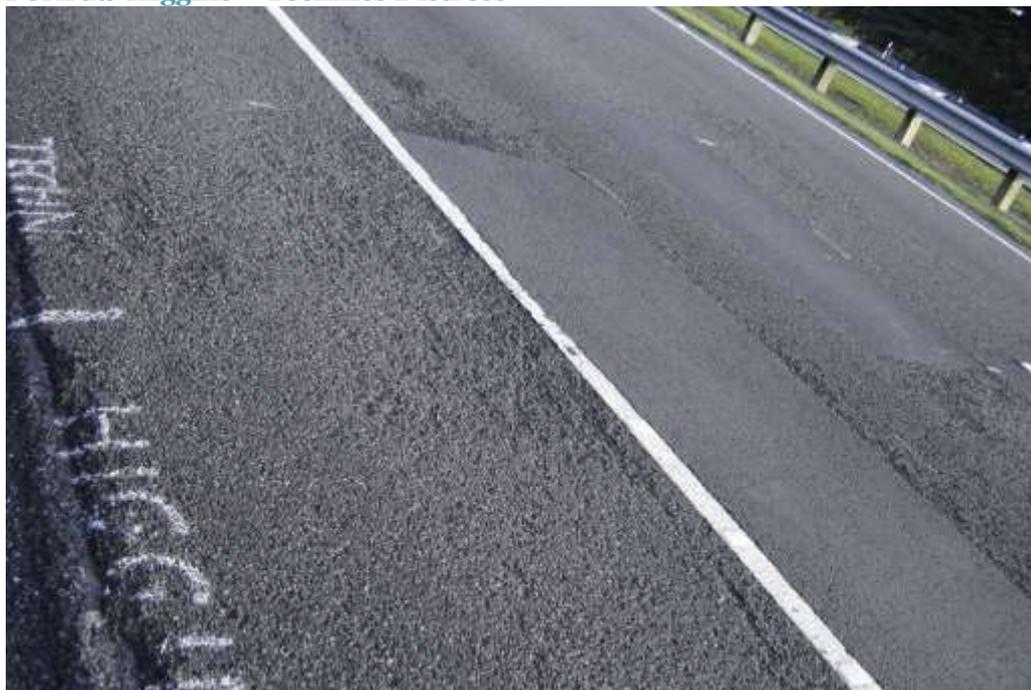
Porirua Higgins – Technics Distress

By 2007 the standard TNZ P11 mixes, Higgins Flexiphalt and Technics sites had cracking and pumping of fines at localised spots. The monitoring was stopped and the area resurfaced in 2008.
