Appendix 3 – Fundamentals and Inspection Assessments Site Summary

Fundamentals and Inspection Assessments Site Summary:

EXAMPLE OF A

State Highway 1, RS 273 RP 0.000, Maungakaramea Rd intersection

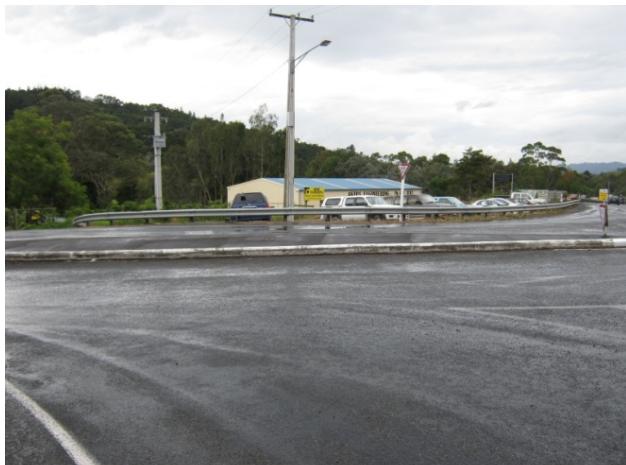
Photo 1

There are 3 hazards identified: car park (photo 1), traffic counter (permanent) and power pole (photo 2), steep batters up to 3m (photo 3). Based on the batter slope and height, figure 4.6 from Pt 6 AGRD suggests a barrier is warranted over much of the site.

- Consider removing the car parking spaces behind the curved rail to establish a Gating Clear Area.
- Install a compliant trailing end terminal
- Investigate changing the light pole behind the curved rail from a concrete pole to a frangible pole.

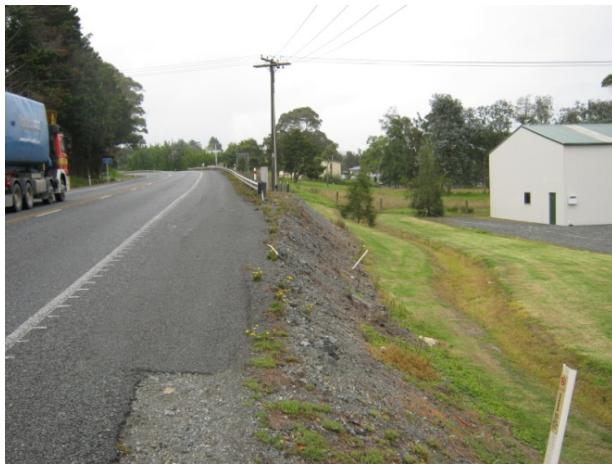
Photo 3

Referring to table 4.1 of Part 6 of the AUSTROADS Guide to Road Design (Pt 6 AGRD), we see that the clear zone requirements for fill slopes range from 10.0m to 13.5m, depending on the batter slope. Batter slopes 3h:1v and steeper are considered non-traversable and no clearzone is provided. On this site the batter slope at best is 3h:1v and therefore reliance on a clear zone is not recommended.

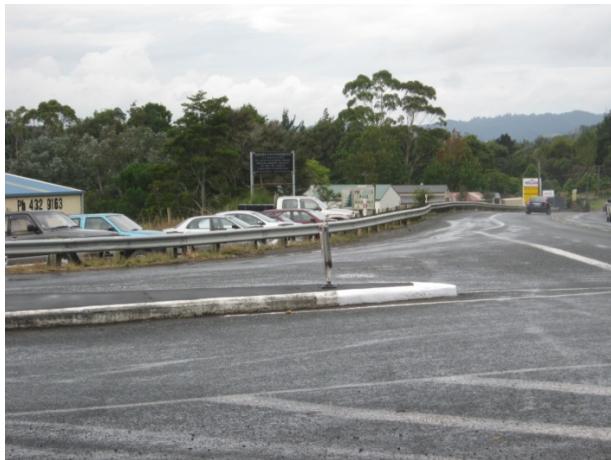
Curved Rail - looking north

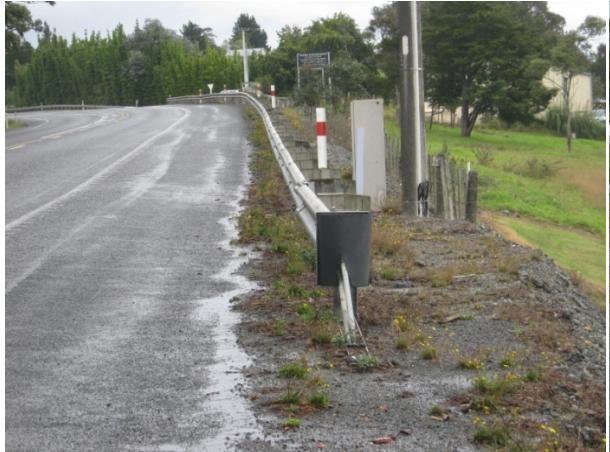
X-350 Terminal end - looking south

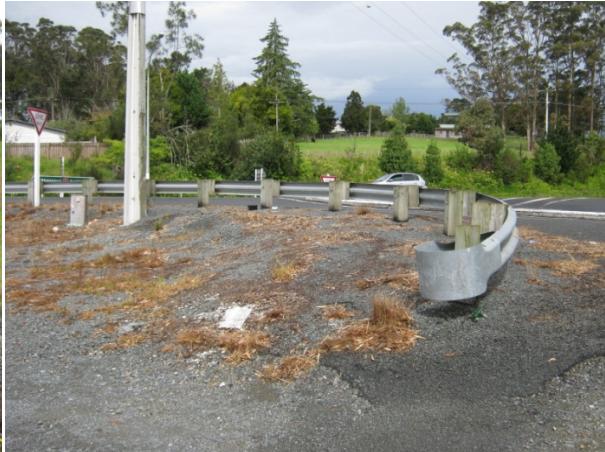
Curved Rail and Trailing End Terminal

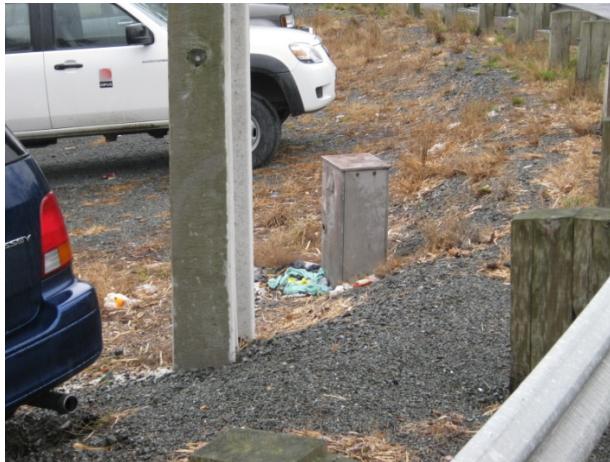
- The system is a *semi-rigid strong post timber*. It is a tangential barrier primarily.
- There are two types of end terminal selected; an X-350 and a curved trailing end; both of which comply with NZTA: M23A.
- Referring to Table 6.4 in Pt 6 AGRD, the shyline required is 2.4m from the near side traffic. This installation is compliant for highway traffic.
- A 'gating clear area' is required for each terminal end. This is not available to the X-350 due to the close proximity of the batter. It is also not available to the trailing end/curve section as it is compromised by the light pole and control box.

Trailing end/curve gating area compromised

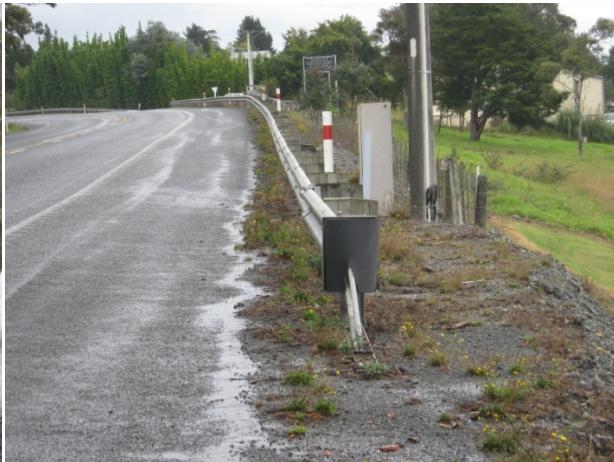
No clear gating area for X-350

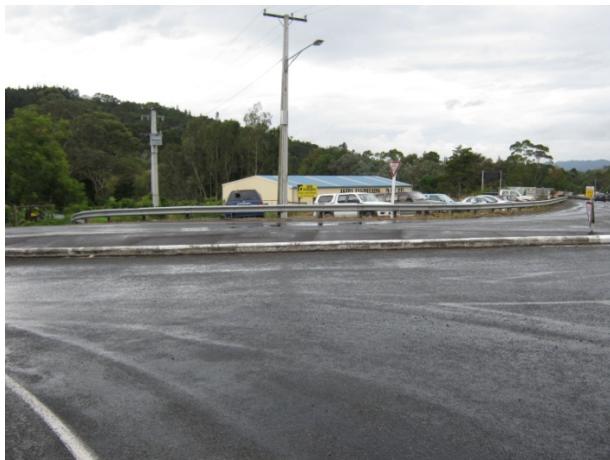
- A run out length to the hazard of 120m is required in this location. There is no run out length available on the north end (X-350) and only 65m available on the south end (car park).
- Length of Need (LoN) requirements is set out in Section 6 of Pt 6 AGRD. As stated above there are 3 hazards identified. The car park has the required LoN from errant vehicles because of the curved rail installation. The traffic counter also has the required LoN in both directions; it is 1m behind the rail (refer to sketch 2). The steep batter hazard is unprotected at the northern end from both directions.

Car park protected from errant vehicles

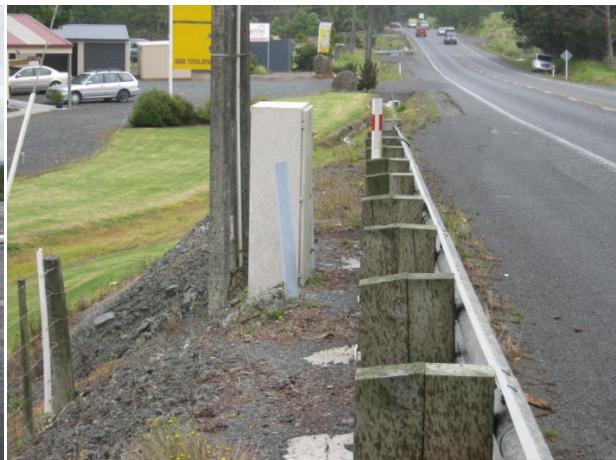
North end steep batter unprotected

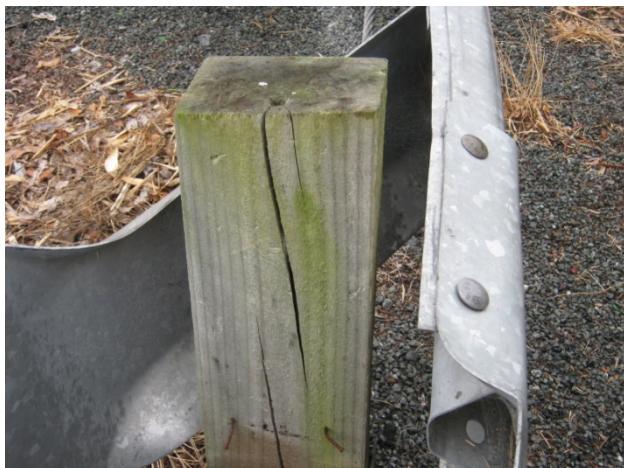
- rail not bolted to no. 1 post
- no shelf angles anywhere
- X350 shear bolts used for rail anchor fitting

Post 1 – not bolted

- Change the bolting pattern on the curved section so that correctly selected posts have rails sitting on shelf angles only
- Remove all detritus that compromises rail height
- Attach hazard and width markers
- Tighten X-350 cables
- Replace Trailing End Terminal anchor bolts with correct ones, install shelf angle and bolt at Post 1.

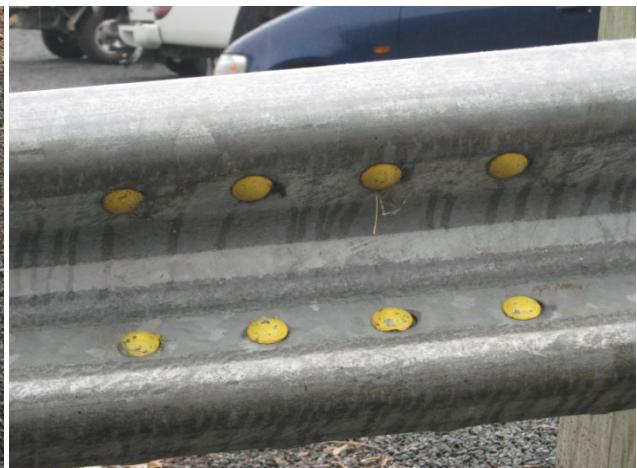
Rail anchor bolts

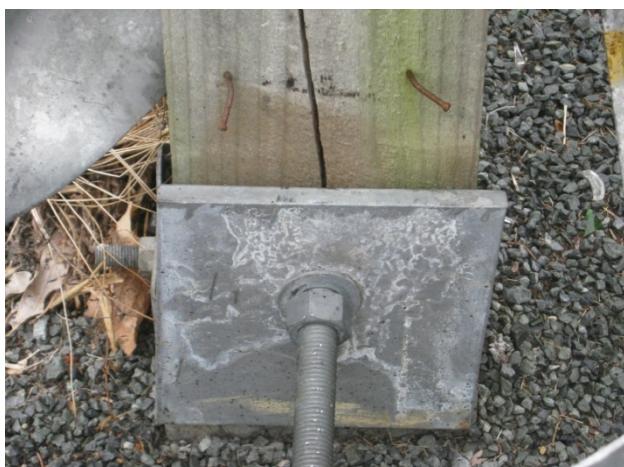
Bearing plate slipped around

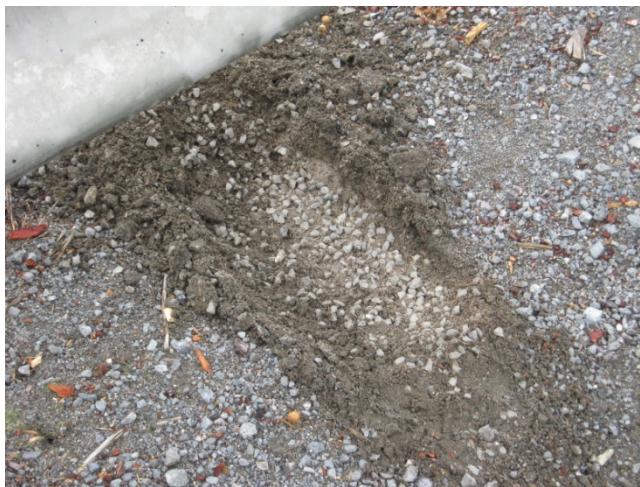
- Height of rail is good at 550mm to centre over the majority of length. The presence of detritus lets the remaining length down but if removed it would comply.

Detritus build up

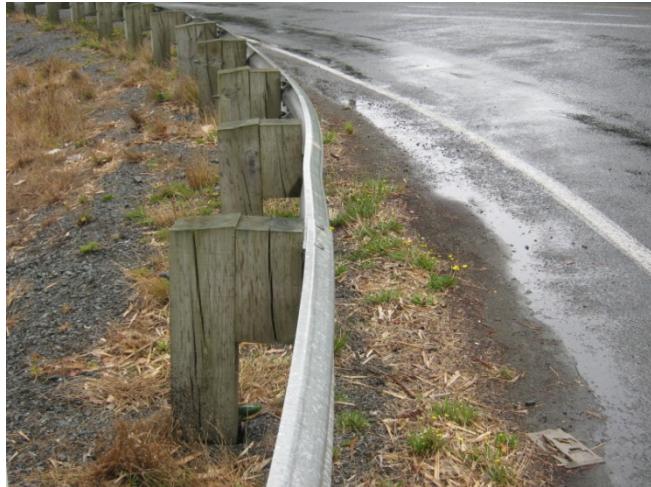
- Post condition is good.
- Blockouts have been toe nailed against rotation.
- Nesting of rail has not been required in this installation.
- Rail damage is minor and consists of 1 slightly dented rail.

Rail damage
