ALERT

UPDATED ALERT

Temporary Traffic Management and Level Crossing Interface

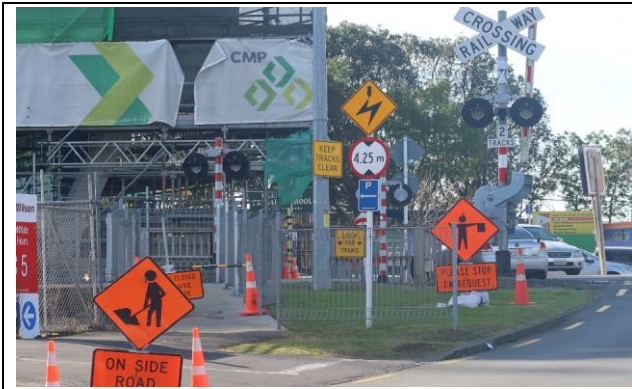
Example of confusing signage as approaching a level crossing.

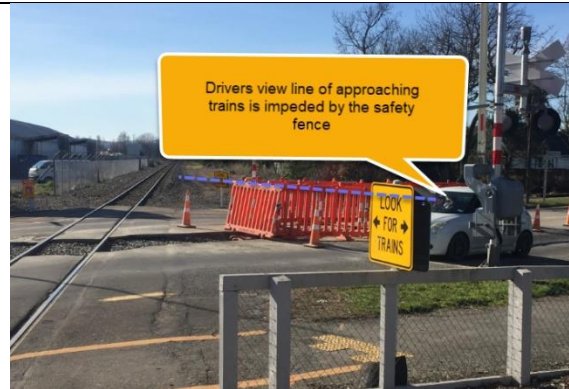
Example of driver view lines where fencing is used in proximity to the rail corridor

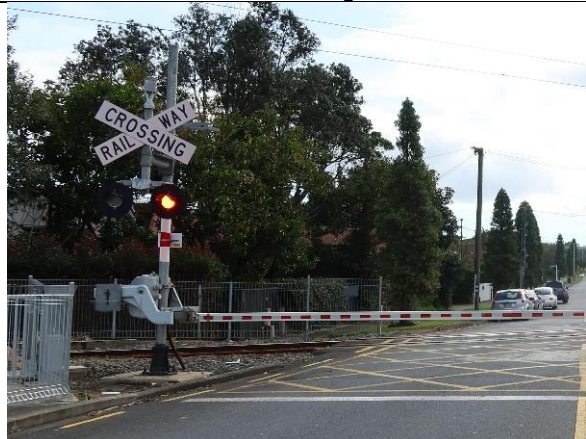
View of signalling when crossing is activated on the correct side of the road

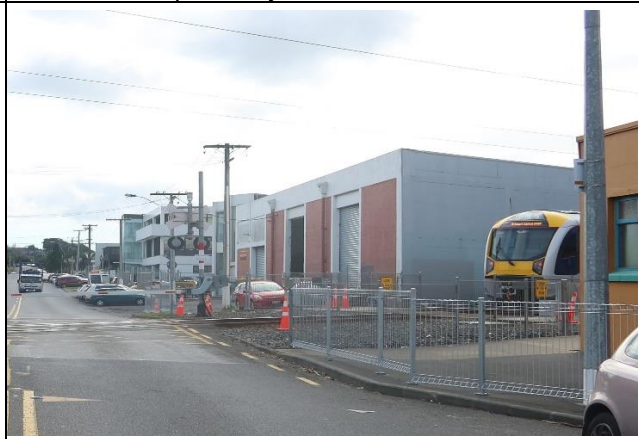
View of signalling when crossing is activated on the wrong side of the road (half-arm barrier has very low visibility and flashing lights are not observable)

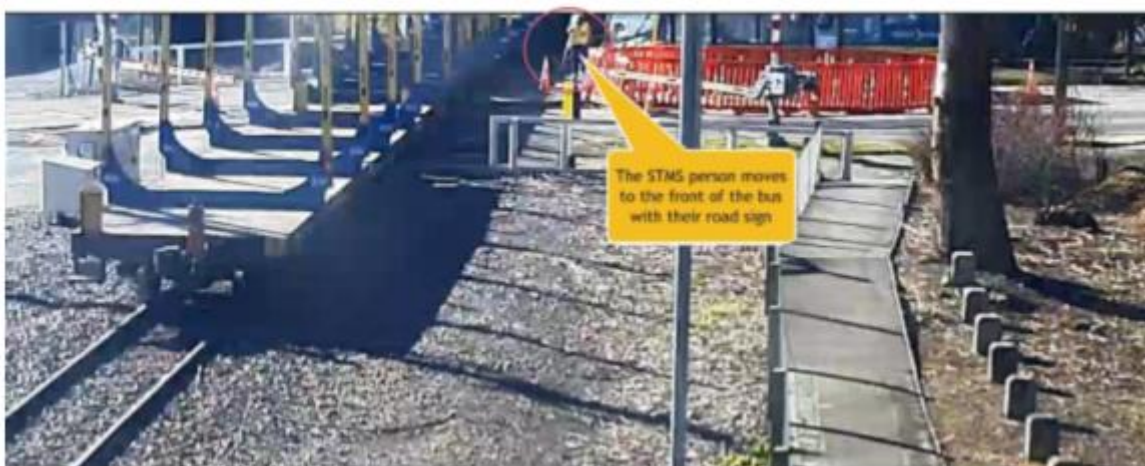
A temporary traffic management system had been established for excavation work being undertaken on Renall Street. The system diverted road users through side roads away from the crossing. A passenger bus service was granted special permission supported by the local council to travel through the worksite and over the wrong side of the crossing. A passenger bus approached the crossing as the half-arm barrier activated blocking the bus from exiting the crossing. The driver stopped the bus and reversed clear of the tracks. Less than 10 seconds later a freight train proceeded over the crossing. As the train is proceeding over the crossing the STMS placed themselves between the front of the bus and the passing train wagons shown in figure 10 below.

Figure 10: STMS person positioned near the front of the bus.

Rail protection and bulletins are required to protect people from rail movements where activity is underway within 5m of the track centre line.
