# SAFETY ALERT

2 February 2024

## Heavy full trailer drawbar hinge pin failures

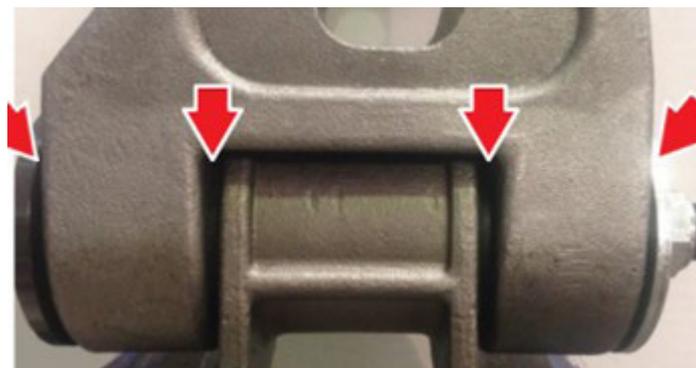
**Figure 1:** A rubber bead should be formed in each area the arrows are pointing to, separating the metal components. It should be complete around the circumference and not split.

- All components are in place - make sure rubber is present between the hinge components (Figure 1).
- The pin is securely in place - see Figure 2 for signs of an insecure pin assembly around the nut and washer.
- Hinge castings and weldings show no signs of cracks.

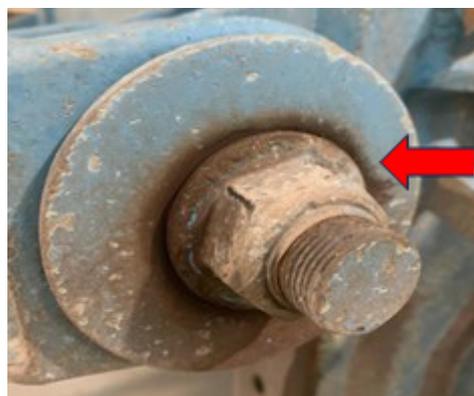
**Figure 2:** These black marks shouldn't be present on a secure connection. If they are, replace the pin kit and bushes.

The assembly should be repaired immediately and any faulty components replaced.

Once the original assembly is completed, further tightening of the bolt will not yield any further beneficial compression of the rubber into the spaces between the components. Therefore, if play is found, the pin and bushes must be replaced.

If the nut is to be checked for security, then a **torque of no more than 300Nm** should be applied. If a nut has come loose, then the reason for its insecurity must be found and faulty components replaced as required. An impact gun **must not** be used to check the security of the nut.
