Post Implementation Review

Kaingaroa Safety Improvements (State Highway 10)

December 2012

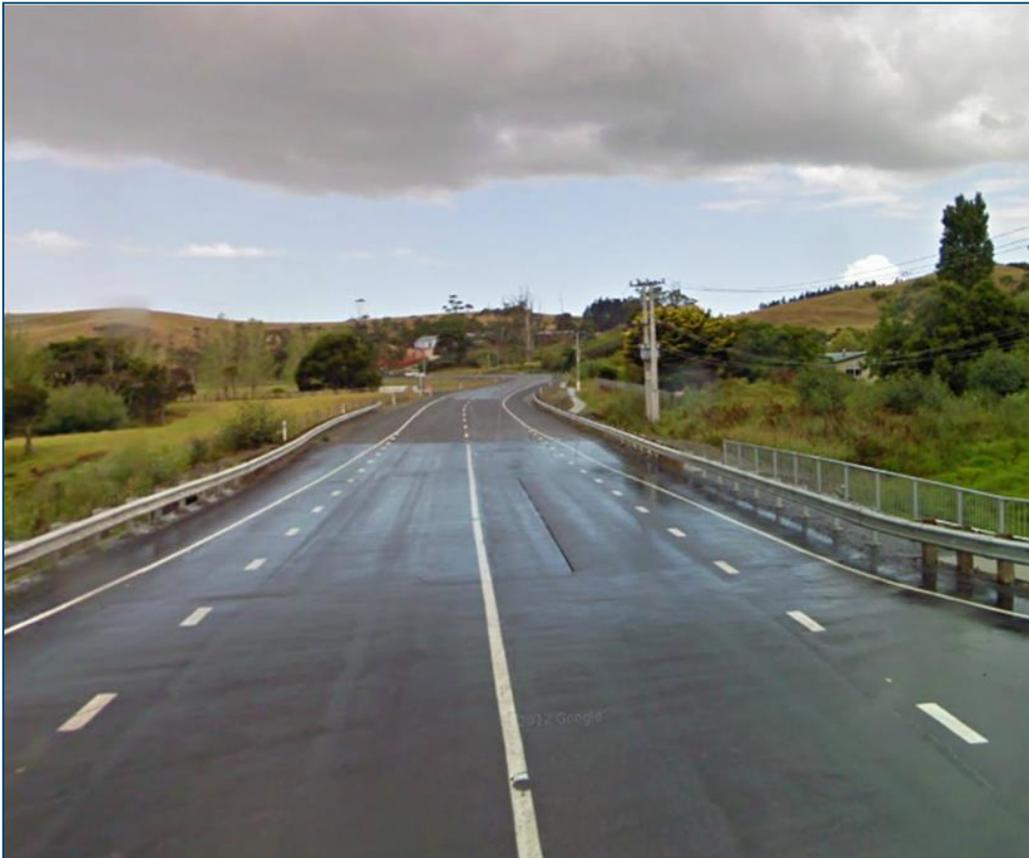
The widening of the Kaingaroa bridge involved constructing a new bridge next to the existing one. This has resulted in a visible crack between the two structures to allow them to contract and expand with temperature changes.³ We consider that this design detail has the potential to be a safety risk for motorcyclists, as it is positioned near the middle of one of the bridge lanes, and would not like to see it use on other projects.

³ This crack is evident from the bridge photo on the cover of this report

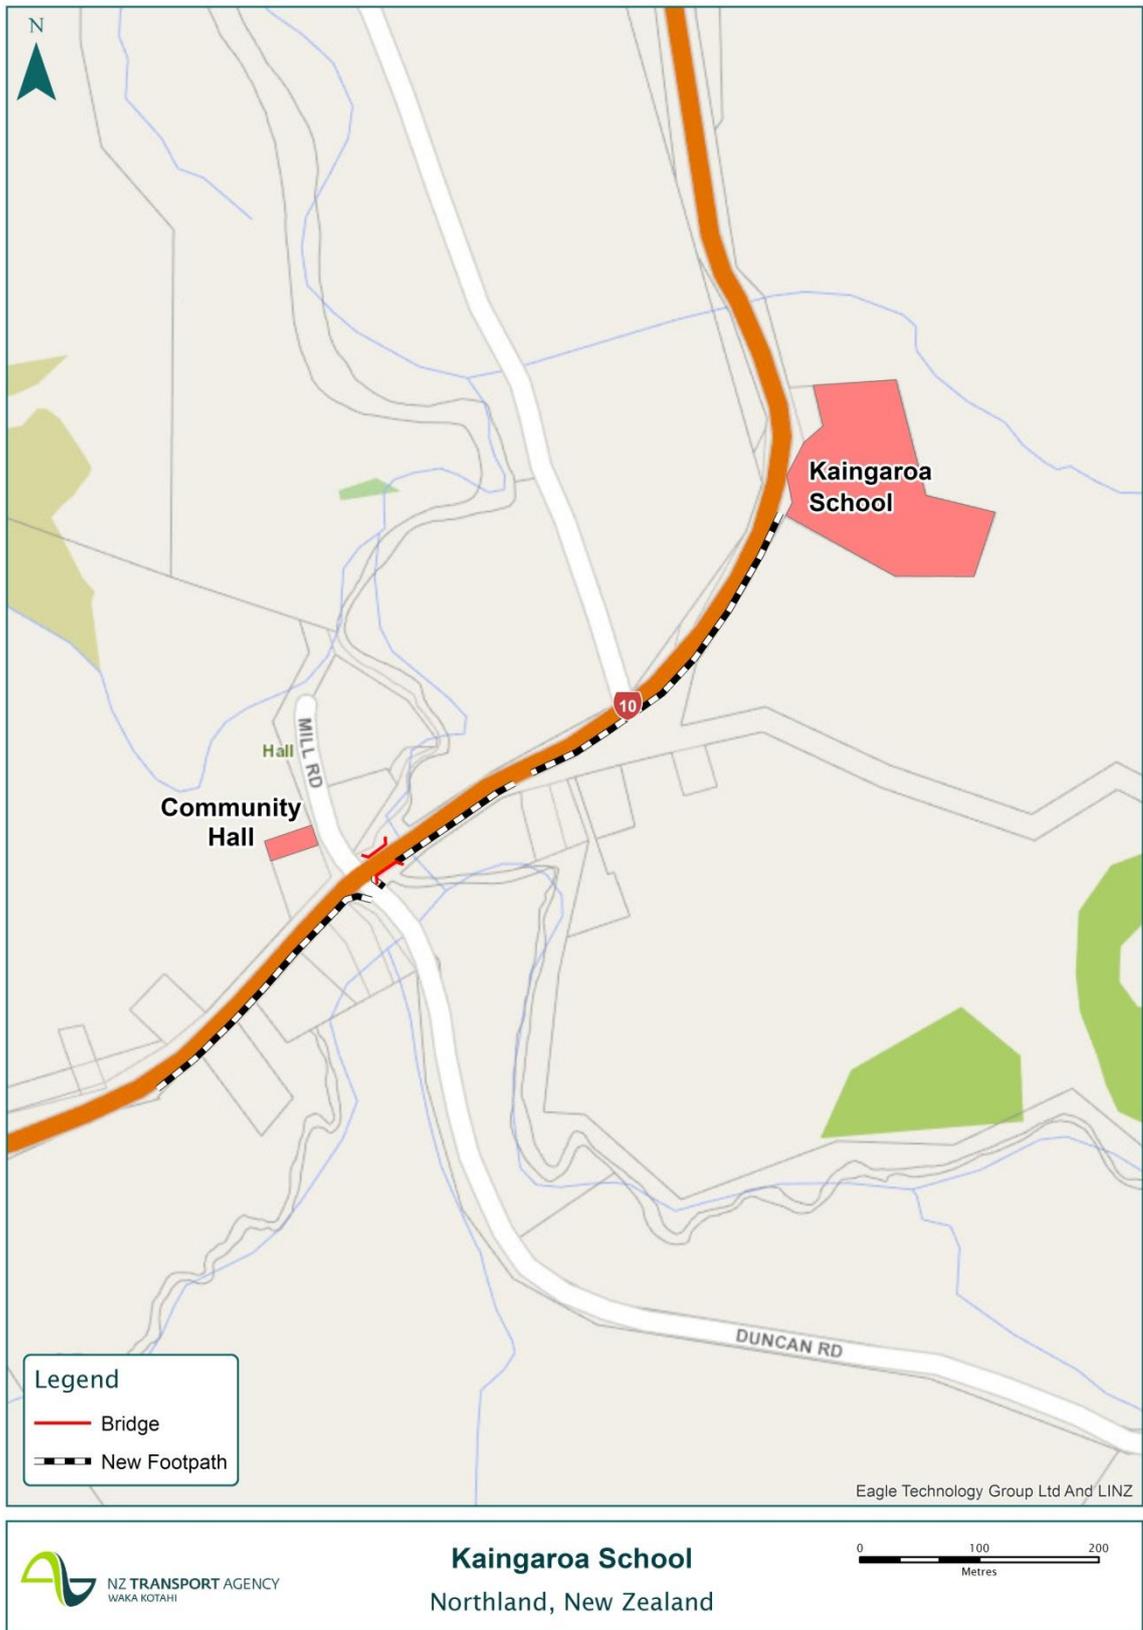
Figure 2: Kaingaroa safety improvements project site

Figure 2 on page 4 shows the location and main features of the project site.

Community concern for pedestrian safety related specifically to the occasional walking of the whole school population along the state highway to attend special occasions at the community hall (see Figure 2 for the location of the school and hall).

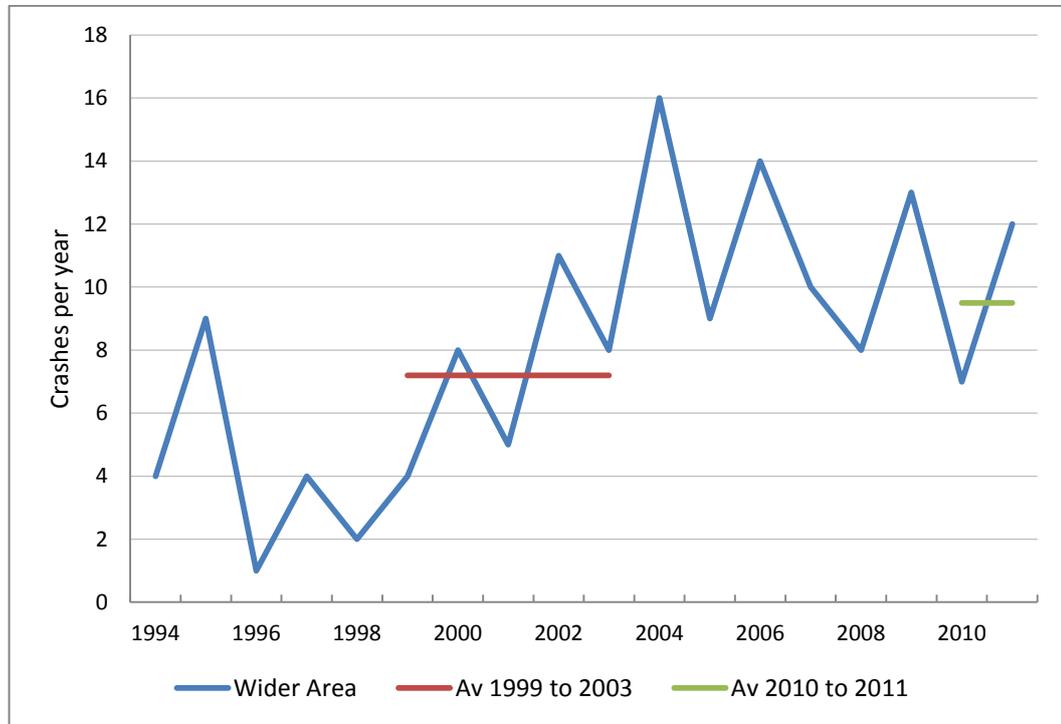
Figure 4: Reported injury crashes, network around Kaingaroa, 1994-2011

Given that between 1999 to 2003 and 2010 to 2011 there has been an almost 20% increase in both reported injury crashes and all reported crashes on the surrounding network (see Figures 4 and 5), we can be reasonably confident that an improvement in safety has occurred. However, given the lack of crashes following completion of the works, a longer after period should really be considered to determine the size of the improvement.
