Western Ring Route – Waterview Connection

Geotechnical Interpretive Report

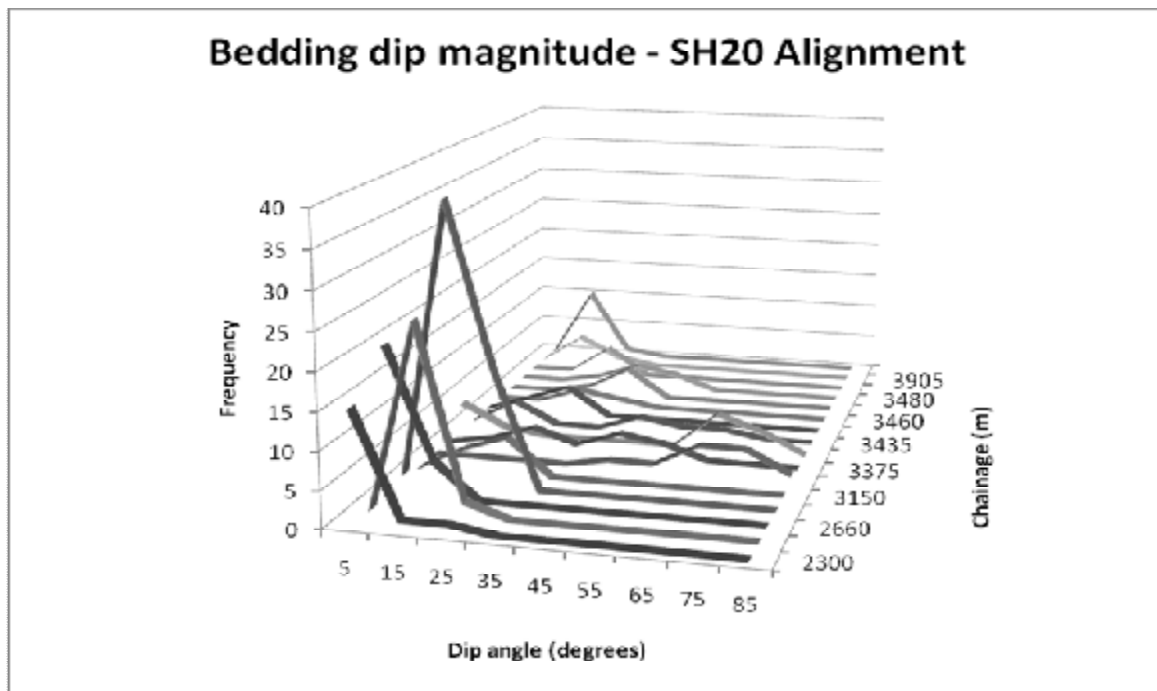
Figure 2.1: Dip magnitude of ECBF bedding along the SH20 tunnel alignment

Bedding is the most prominent and well developed defect within the ECBF. In general, average bedding dips in logged boreholes are around 0 to 20 degrees (average 5 to 10 degrees) from the Harbutt Reserve area towards the south along the alignment (approximate chainage 0-2900). To the north of New North Road the bedding becomes more inclined in some areas with recorded bedding dip magnitudes of up to 80 degrees (approximate chainage 2900-3600; Figure 2.1). It is possible that bedding may be locally disturbed around intra-formational slump features within the ECBF and the Parnell Grit deposits. Variable dips are noted particularly adjacent to Parnell Grit beds in the Phyllis Reserve/ Waterview Downs/ Oakley Creek area. Here bedding dips vary between 25 and 80 degrees (See Figure 2.1).

Bedding dip direction within outcrops in the northern reaches of Oakley Creek (around the waterfall) are approximately 20 to 25 degrees to the south-southwest. Further borehole investigations are scheduled for this area to identify and model the areas of the geological uncertainty. No orientated or inclined core drilling has been undertaken at this stage of the project. Bedding shear surfaces and partings have developed along some of the interbedded layers as a result of tectonic movement. Evidence of possible shear planes has been observed within several boreholes. These provide preferential planes of weakness for instability and structural defects.
