Progress so far

Drivers and residents would have noticed the changing landscape of the Maungatapu underpass project site. In this update, you will find information on the construction since starting in September 2015, the forward works programme, and what the various machines are doing on site.

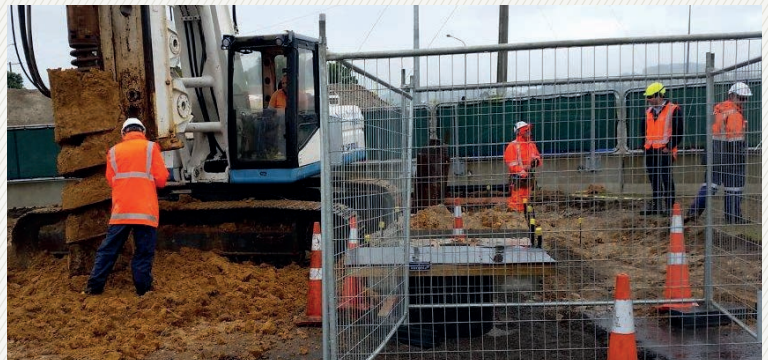
Piling at the Maungatapu roundabout has started. The drilling device used is an auger, which as it drills into the ground, removes the drilled out material. Steel cages are inserted after the auger is removed and concrete poured in, creating the pile which will support the bridges and the sides of the underpass. This is a fast efficient method of construction in stable soils. There will be 200 piles in total and the auger holes are 17.5 metres deep and 750mm wide.

Auger drilling at Maungatapu roundabout

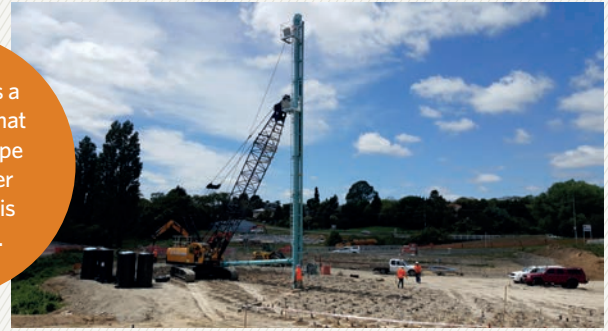
The team have had some questions about what these machines are doing. They are installing the 110,000 lineal metres of wick drains near Hammond Street.

Wick drains are made up of a synthetic material wrapped around a piece of grooved plastic. This is inserted vertically into the ground providing a path for water to flow and quickly escape once pre-load material is placed on top (see diagram opposite).

Installing wick drains near Hammond Street

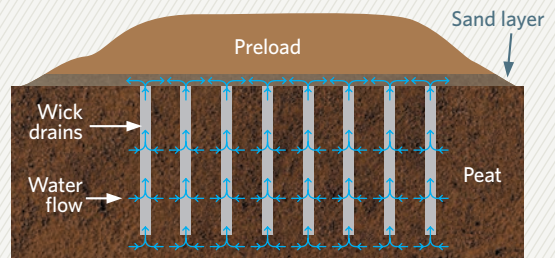
The wick drains speed up the rate at which the water can escape from the underlying water-logged soils, reducing the settlement time.

A wick drain is a vertical drain that allows an escape route for water when the soil is compressed.

Diagram showing how wick drains remove the water content from soft soils.
