The Bulletin Kaikōura earthquake update

This Bulletin provides the latest information about the rebuild of road and rail networks damaged by the Kaikōura earthquake in November 2016. The Bulletin is produced by the North Canterbury Transport Infrastructure Recovery (NCTIR) - an alliance representing the NZ Transport Agency and KiwiRail, on behalf of Government.

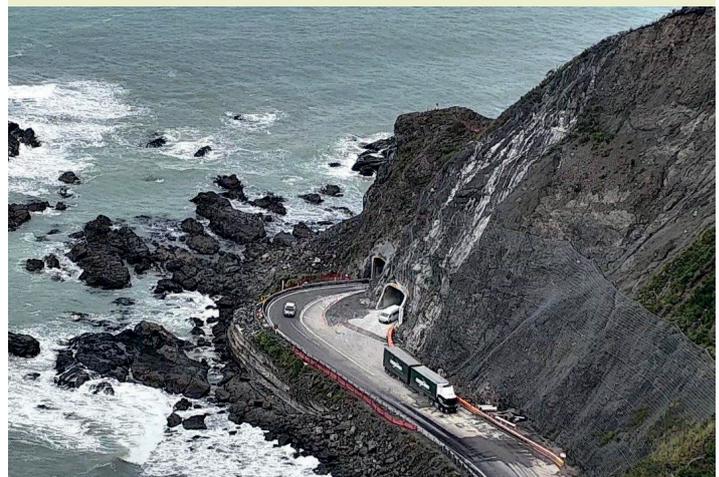
The Parititahi Tunnels

The December 2018 re-opening of both Parititahi Tunnels for the first time since the November 2016 earthquake was cause for celebration. The inland tunnel was completely buried by a landslide and both tunnels required repairs. Along with those repairs, the twin tunnels required widening to accommodate larger freight vehicles which will help to make State Highway 1 a more efficient freight route.

While repairing the tunnels the crew were able to mill out and provide extra height and side clearance for larger vehicles.

The new 4.6m height allows freight vehicles under the Vehicle Dimensions and Mass rules of 4.3m to travel the road. The original lane widths have not changed and remain as 3.6m.

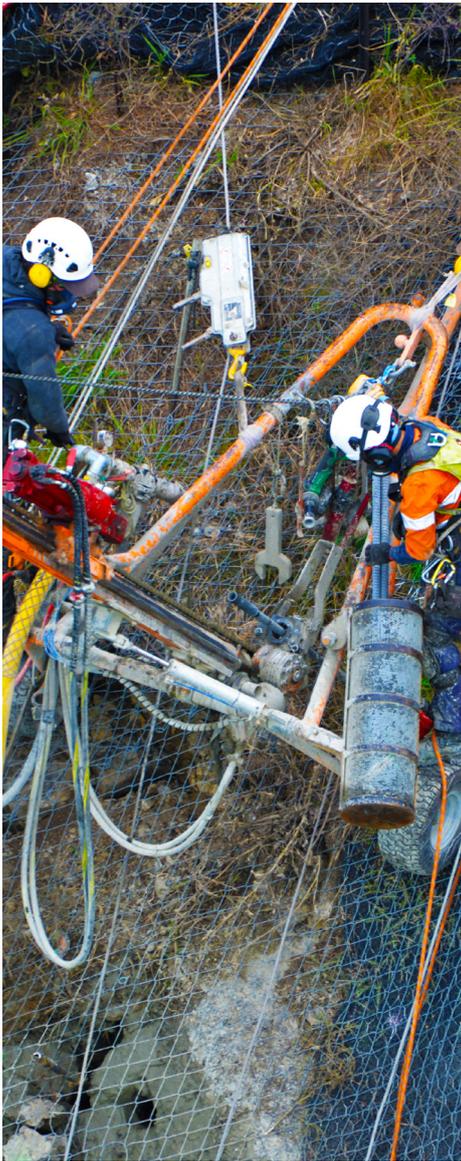
This awesome photo was taken from one of our helicopters at the end of last year, and shows abseilers hard at work drilling the final anchors just south of the Parititahi Tunnels. It was a one of the last steps needed for traffic to flow through both tunnels for the first time since the November 2016 earthquake.

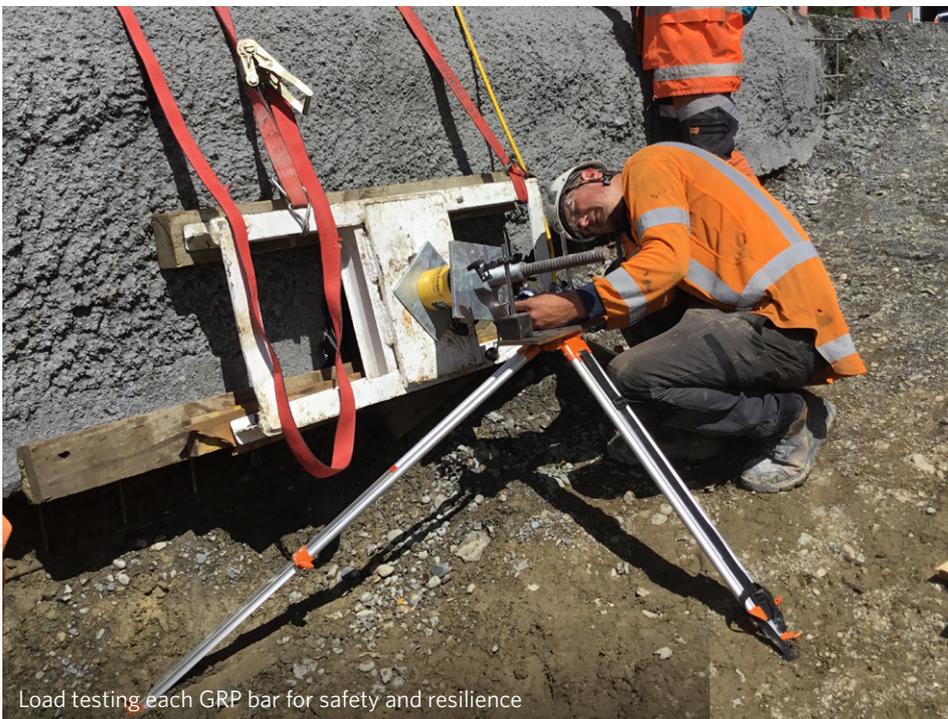
Load testing each GRP bar for safety and resilience

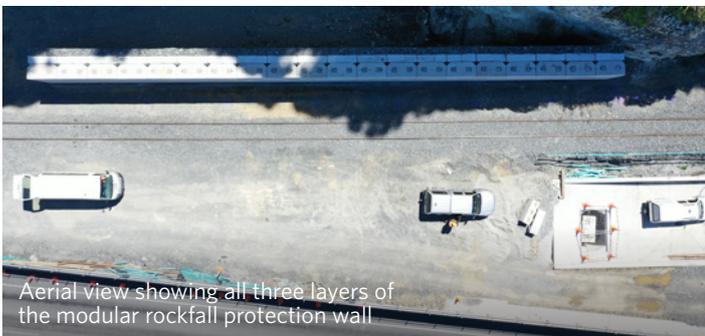
The three-metre-high section, closest to the hillside, is a gabion rock basket layer designed to reduce the impact of slips. The centre layer is comprised of sand and texcel-filled gabion baskets. These baskets absorb the initial impact, with the softer sand dispersing the force and allowing the final rock wall layer, closest to the rail, to be pushed out slightly without being damaged.

Aerial view showing all three layers of the modular rockfall protection wall

Each part of the 40-metre-long wall is connected with wire, steel rings and eye bolts to keep the structure together. Project engineer Tomislav Diklan says the wall works in a similar way to a concrete barrier for traffic, only much more flexible and compact.

A drainage system built into the bottom block-wall layer directs water into a swale, and then out to debris flow bridge 115C, to be carried underneath the rail and road and back out to the ocean.

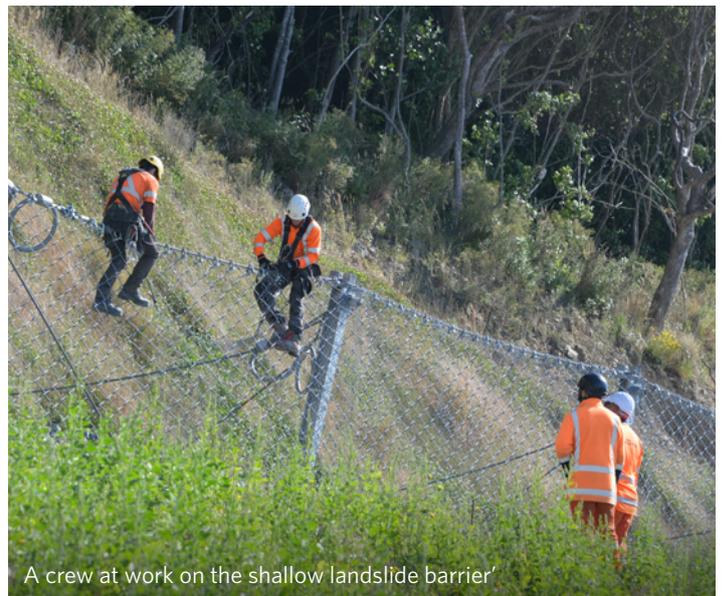
We have run the wire ropes through energy dissipating rings at the top, middle and bottom of the border posts. If debris hits the fence, the rings absorb much of the force and protect the wires. Hinges at the base of each post add further protection by allowing for back and forth movement while the middle wire rope, called a transmission rope, is anchored every 50 metres so it can bulge when filled with material, preventing it from reaching the rail. All of these solutions will protect the Main North Line and keep trains on schedule.

A crew at work on the shallow landslide barrier

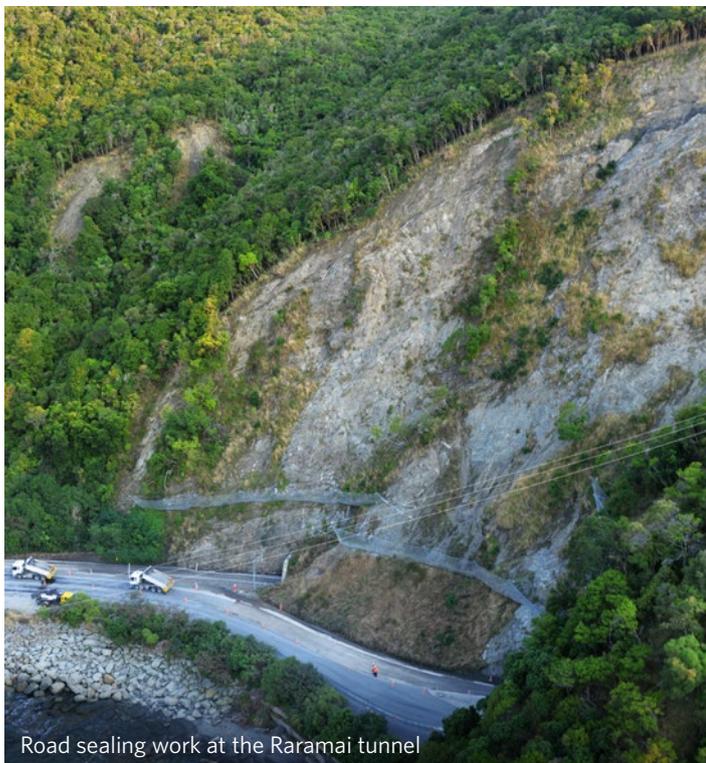
Road sealing work at the Raramai tunnel

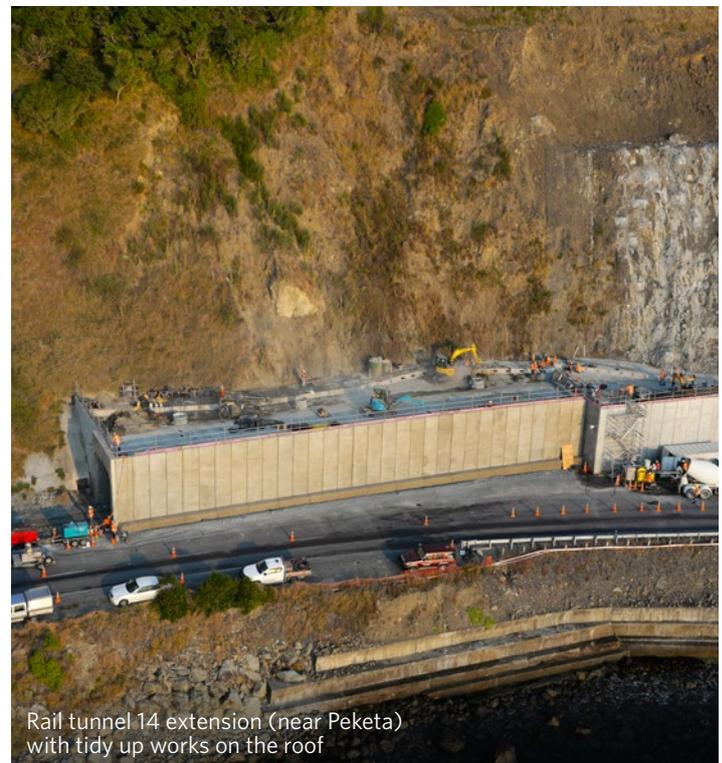
Rail tunnel 14 extension (near Peketa) with tidy up works on the roof

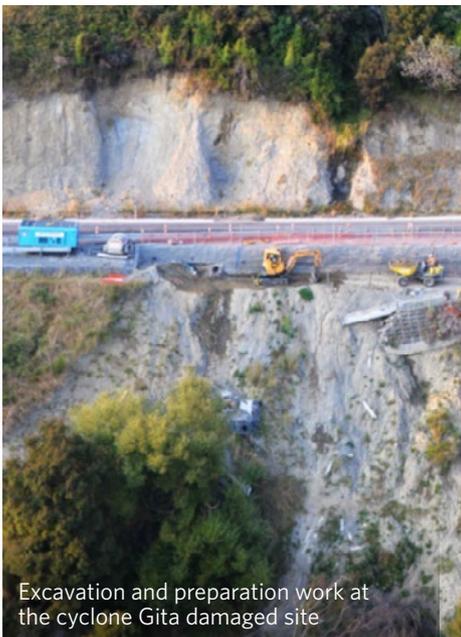
We are excavating and making it a safe work site before starting reconstruction of the washed-out road. The original crib retaining wall has collapsed and will be replaced with a new resilient retaining wall.

Excavation and preparation work at the cyclone Gita damaged site

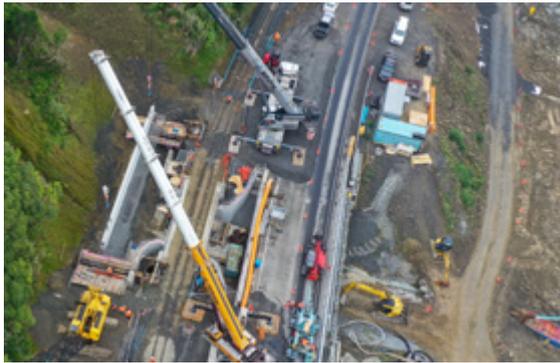
Half Moon Bay debris bridge work

Work is underway at a debris rail bridge near Half Moon Bay to further improve the resilience of the Main North Line. By installing a new, wider bridge the capacity of the channel will be increased. This work

will be completed in time for the Coastal Pacific passenger train to return at the end of September. Two 63 tonne precast beams, which form the sides of the bridge deck, were driven up from Christchurch and installed during two hour-long road closures. Now that these have been fitted, work can begin in 24-hour shifts to prepare the bridge deck for a concrete pour. After the concrete has cured, the main 'deck swap' will occur within a 54-hour window (old bridge will be lifted out, the new bridge desk slid into place), and the road and rail will be closed for a short period during this time in late September.

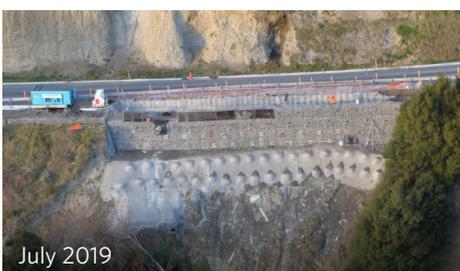
Repairing this section has been a major piece of work as the edge of the road had fallen off. To rebuild it, the NCTIR crew had to create a working platform on the side of the hill, six metres down, and then slowly build up the land to eventually reinstate the second lane. To do this the bank was stabilised by drilling in 37 six-metre-long soil nails. A retaining wall of 63 gabion baskets, four rows high, was built and this was secured with nine-metre-long rock anchors. All this work has been done out of sight of the travelling public down the side of the hillside.

This section of road is now back to two lanes, meaning a quicker trip through the Hundalees.

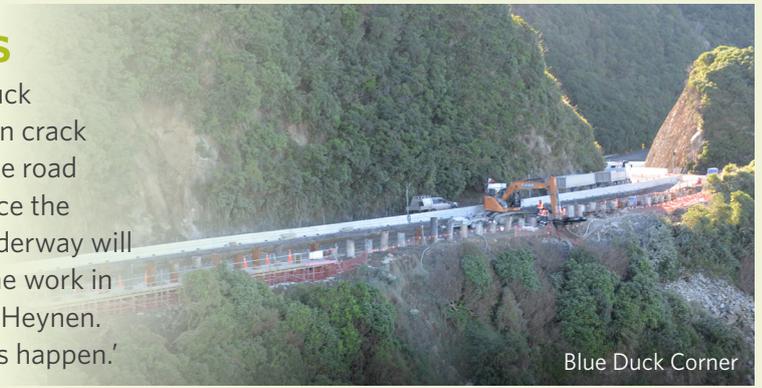
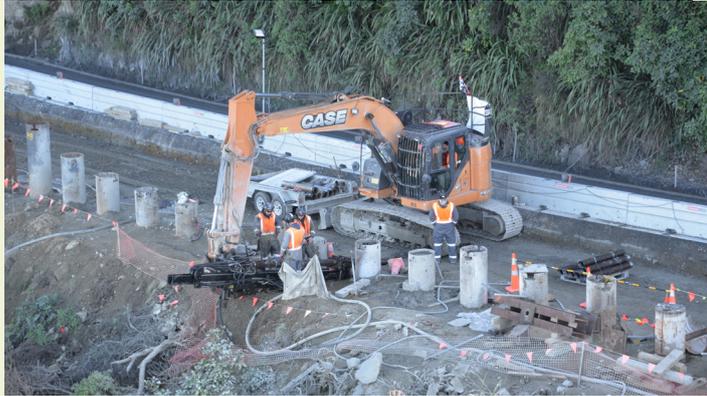
During the 2016 earthquake, the corner between Blue Duck Valley Road and Irongate Bridge developed a large tension crack that required serious ground stabilisation work. Before the road reopened in 2017, concrete piles were installed to reinforce the corner. The rock anchors and capping beam currently underway will complete the work required to stabilise the new road. 'The work in this location is unique,' explains Project Engineer Wendy Heynen. 'The team came up with innovative solutions to make this happen.'

Pre-drilling 18-metre rock anchor holes under the road, and into the rock bank, at angles of 15 and 30 degrees. A fine mist is sprayed to reduce dust.

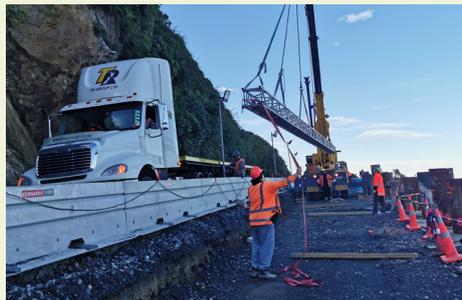
Rock anchors consist of a steel rod grouted inside a plastic tube. This ramp allows grout to be poured into the tubes at the correct 15 degree angle, to secure the rods at the same angle they will go into bank.

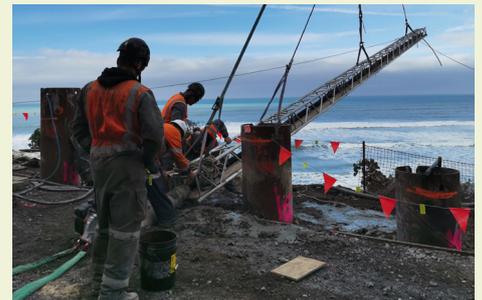
Before work started, a platform was built to hold the machinery, and a crane sourced that would fit the narrow corridor, but is large enough to manoeuvre a rock anchor around into the hillside.

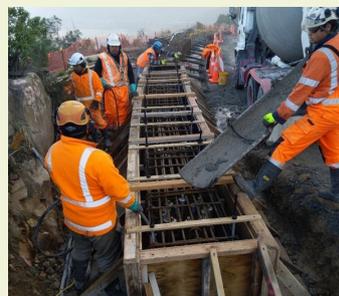
48 reinforced concrete piles were constructed to a depth of 13-22 metres. The concrete at the top of each pier is removed to expose the steel reinforcing rods. These rods, as well as the rock anchor ends, are then tied securely into a complex steel reinforcing cage that will form the skeleton inside the capping beam.

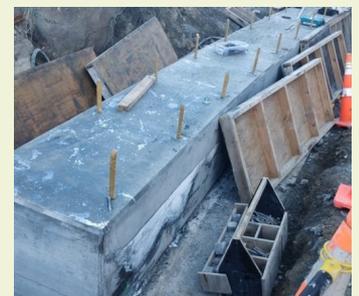
The concrete is poured in multiple sections, with a gap between each segment to allow for earth movement. Once complete, the road can be built up to finished level, and guardrails installed. Road sealing should take place in October, once weather conditions are suitable.

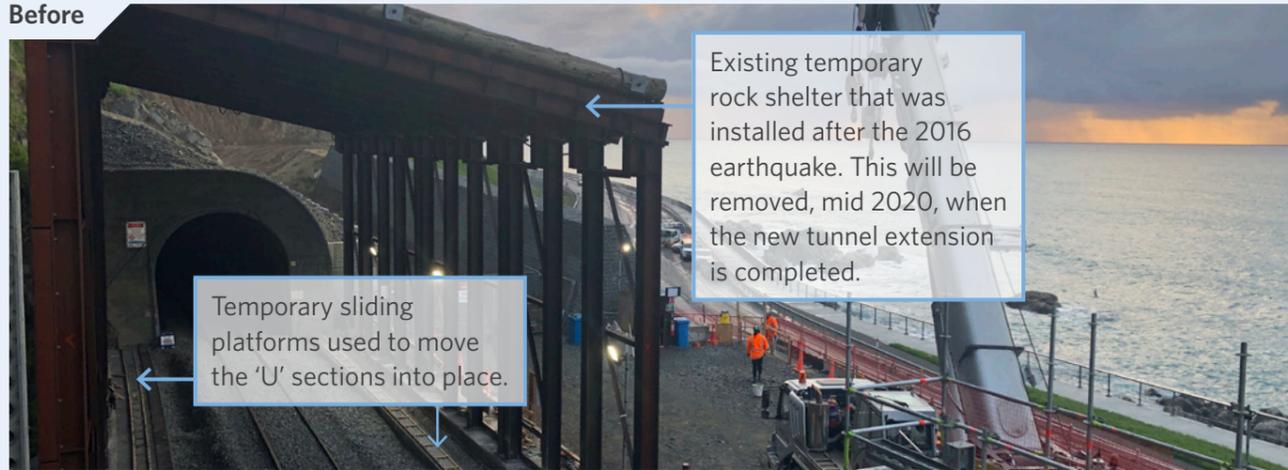
Before

Existing temporary rock shelter that was installed after the 2016 earthquake. This will be removed, mid 2020, when the new tunnel extension is completed.

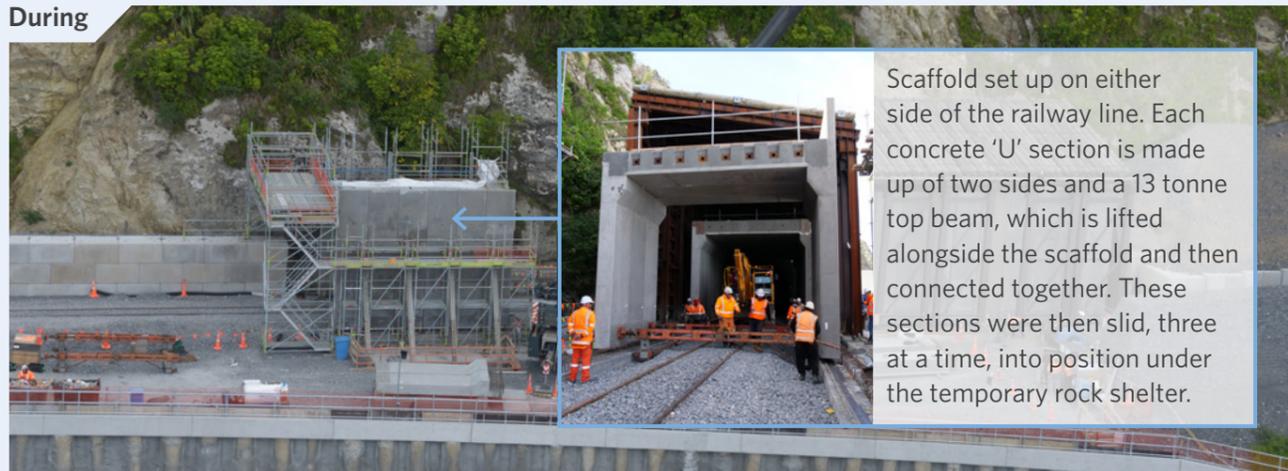
During

Scaffold set up on either side of the railway line. Each concrete 'U' section is made up of two sides and a 13 tonne top beam, which is lifted alongside the scaffold and then connected together. These sections were then slid, three at a time, into position under the temporary rock shelter.

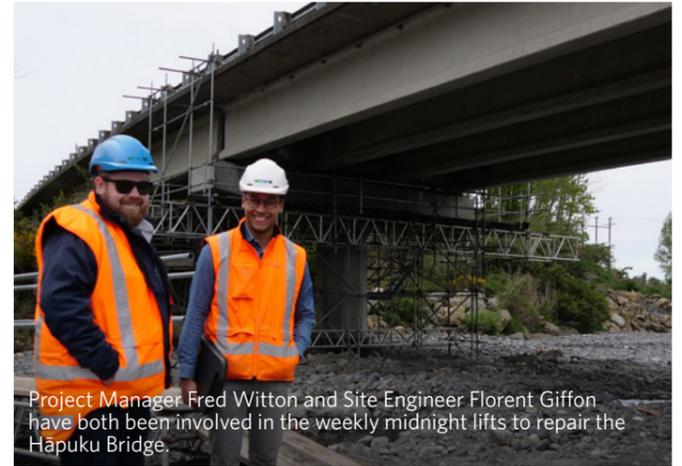
The main work involves jacking the bridge at each of the ten piers to remove and replace the bearing pads. The 30km speed restriction and one-way traffic lanes currently in place help to reduce the impact of the traffic loading on the bridge.

'We use four jacks at the same time - and the purpose is to jack the bridge evenly to prevent any damage. It's an old bridge that has been partially damaged by the earthquake so we need to take care of the weight,' says Florent.

'We are allowed to jack a maximum of 10mm of displacement, but most of the time we are only jacking the bridge to 6mm, which is enough to remove the bearing pad.'

The team raise the bridge slowly using a number of small lifts across each 100 tonne jack to ensure each is raising evenly in increments of about 5MPa (MPa stands for Megapascal, a unit of pressure) and no more than 2mm of displacement at a time.

A total of 88 mortar pads from ten piers and two abutments will be replaced. The work is expected to be complete by late December.

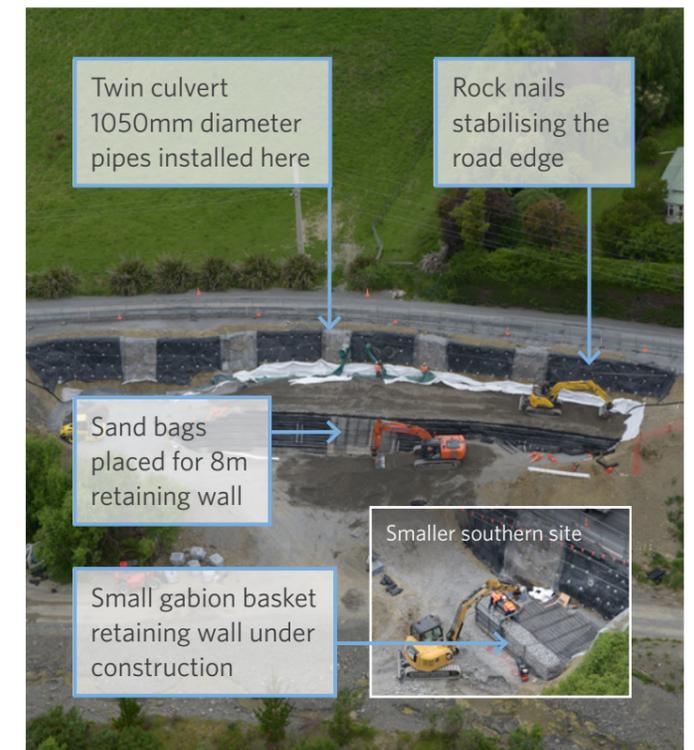
Twin culvert 1050mm diameter pipes installed here

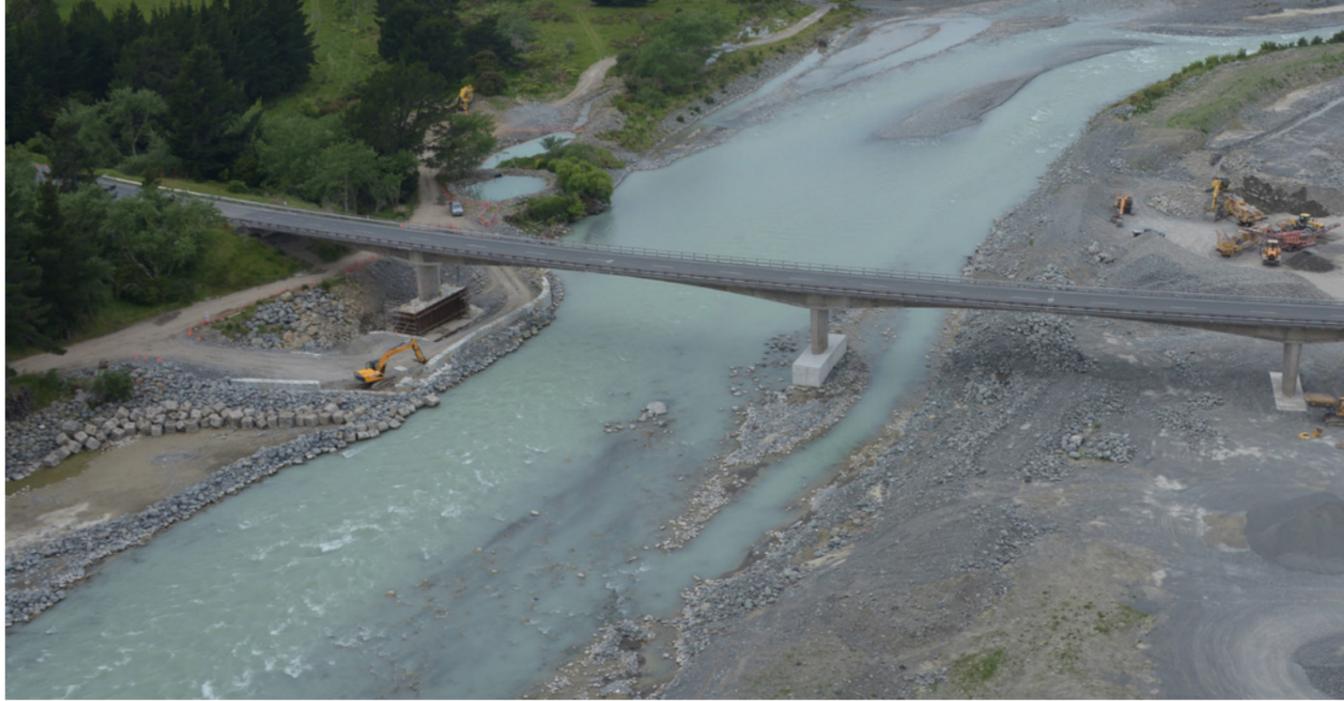
Crew at Clarence River Bridge recently hit a milestone, strengthening the last of the bridge's piers by pouring a 92m³ concrete 'jacket' around the existing Pier B structure. The pour lasted around six hours, with two 6m³ capacity concrete trucks taking turns to pour and then refill at an on-site concrete plant. Crews will now begin removing the river diversion, with work expected to wrap up before Christmas.

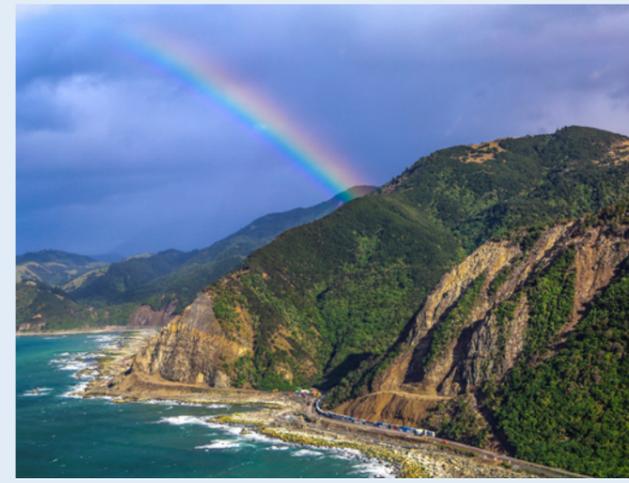
AUGUST At Ōhau Point a construction access platform was cut around the hillside allowing crews from both sides to work together for the first time

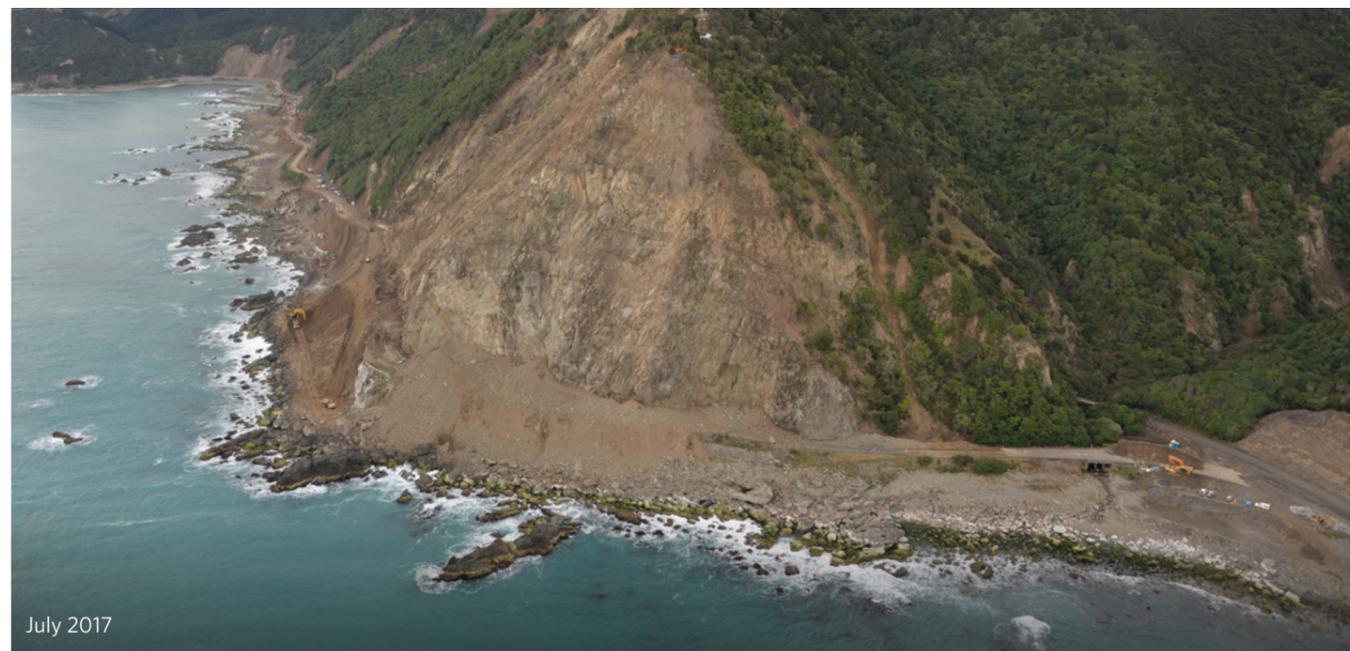
July 2017

The seawall has been constructed close to the maximum height possible, as to go higher meant that the wall would have needed to go further out into the sea. While there is a long term provision to increase the current wall by 1m, going any higher in the current location would make the wall too tall and skinny and it would not survive well in an earthquake.

For the majority of the 3.2km, the wall has matched the modelling - but there is a 50m section at Ōhau Point which has proven to be affected by strong 3D wave effects, generating the few 'overtopping' events that we have seen.

To mitigate the effects of waves coming over the road along that short section of seawall a number of measures are being taken. These include:

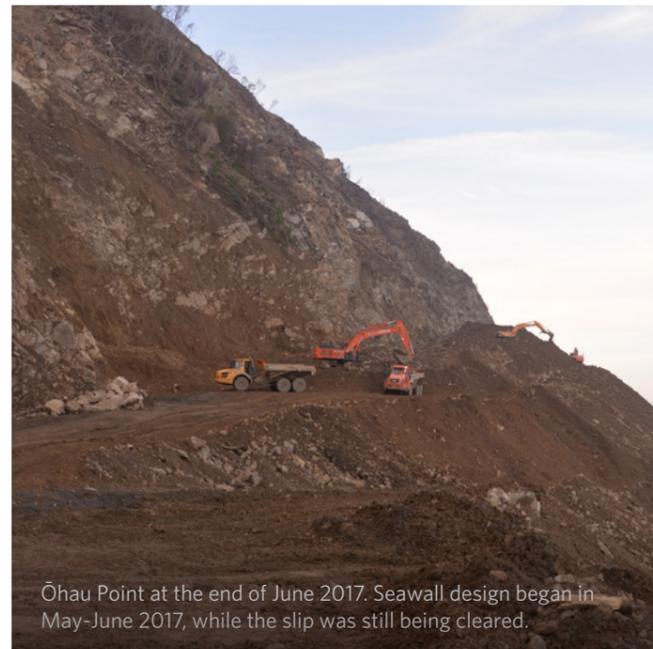
Ōhau Point at the end of June 2017. Seawall design began in May-June 2017, while the slip was still being cleared.

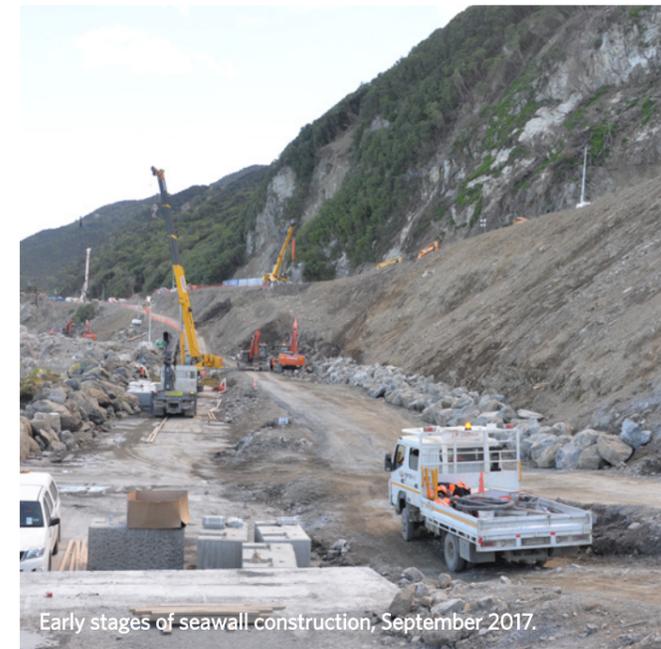
Early stages of seawall construction, September 2017.

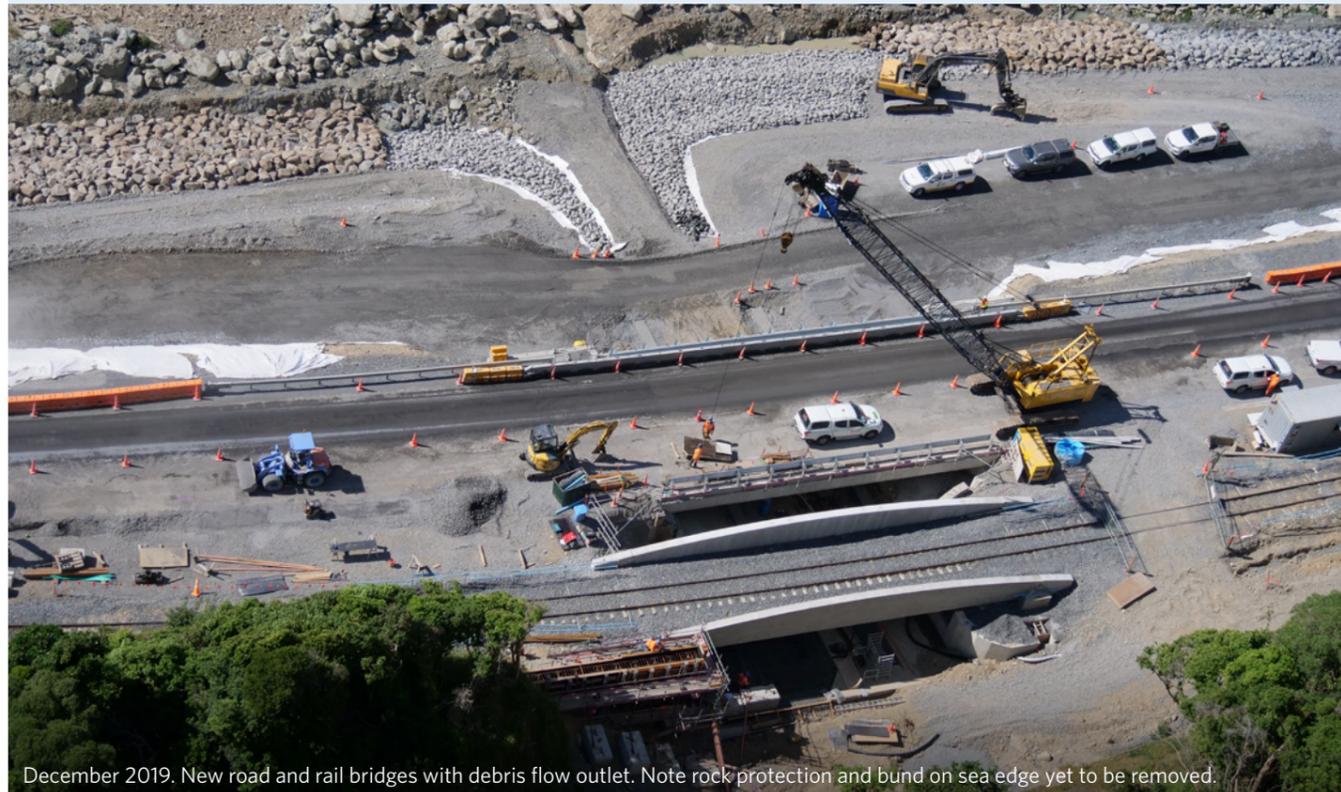
December 2019. New road and rail bridges with debris flow outlet. Note rock protection and bund on sea edge yet to be removed.
