KAIKOURA EARTHQUAKE UPDATE

KAIKOURA EARTHQUAKE UPDATE - no. 14

28 April 2017

MOVING MOUNTAINS TO OPEN BY DECEMBER

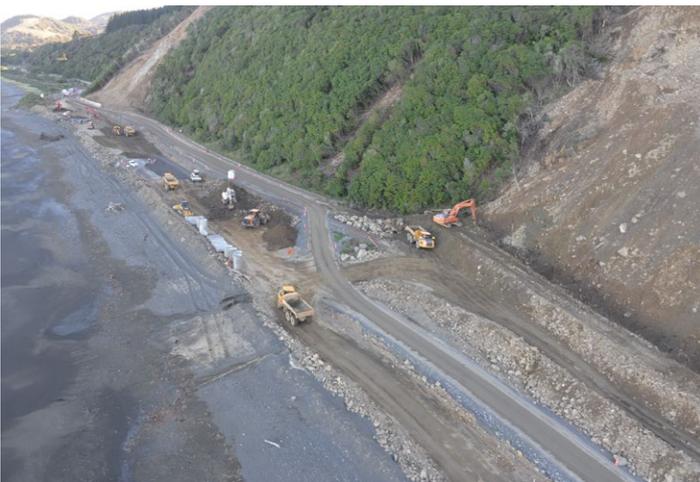
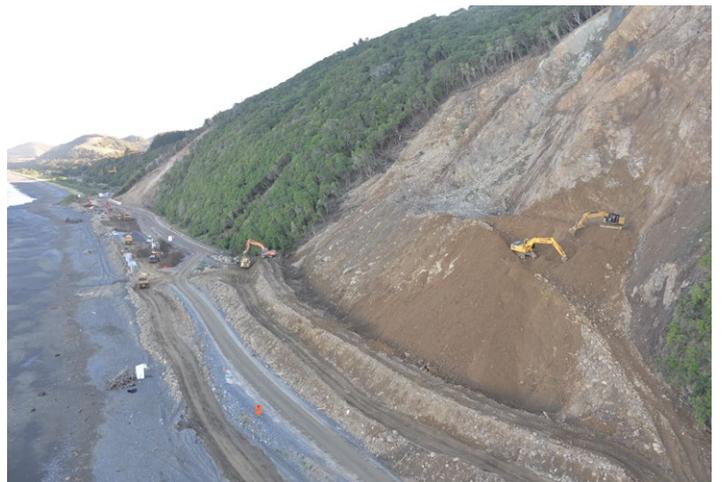
Work on the new rail and road alignment is progressing well at Site 1, near Maungamanu. The photographs below show how the transport corridor is taking shape; at this location, SH1 will be slightly more seaward than it was before the quake. Investigations are also underway for a new bridge site within a new alignment at Site 2.

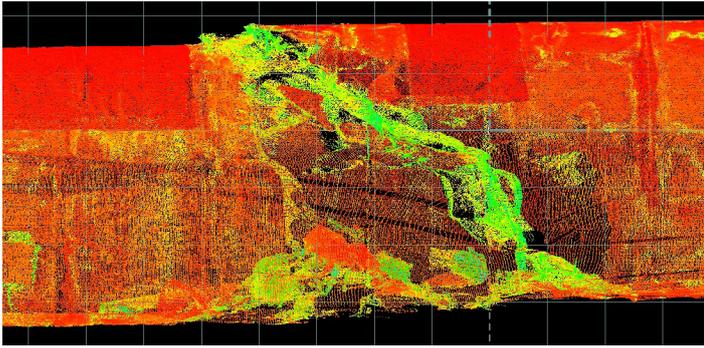
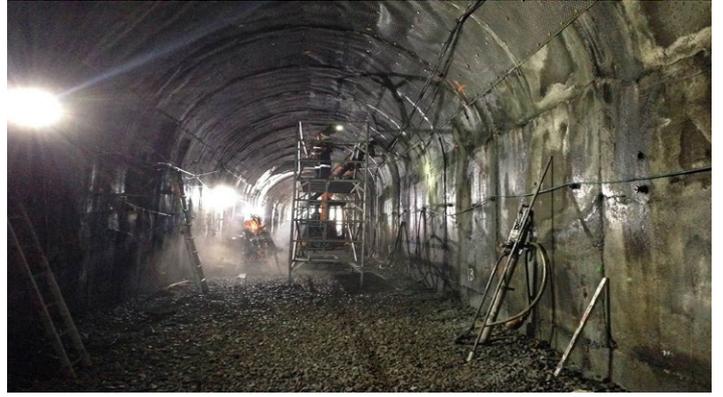
Four out of the damaged 20 rail tunnels on the line have now been repaired to the extent that work trains can pass through them, repairs are underway at a further eight tunnels, with the remainder to commence soon. Tunnel 18 (pictured right) suffered significant structural damage: it's effectively been cracked in two. The Hope fault is only 70m from the tunnel's northern portal. The reverse upward movement across the fault sheared the tunnel's concrete lining. In the laser image, the green lines show where the force from the jolting fault hit the tunnel, and you can see how part of the tunnel floor moved by 500mm. The second image shows the same crack in the tunnel's interior.

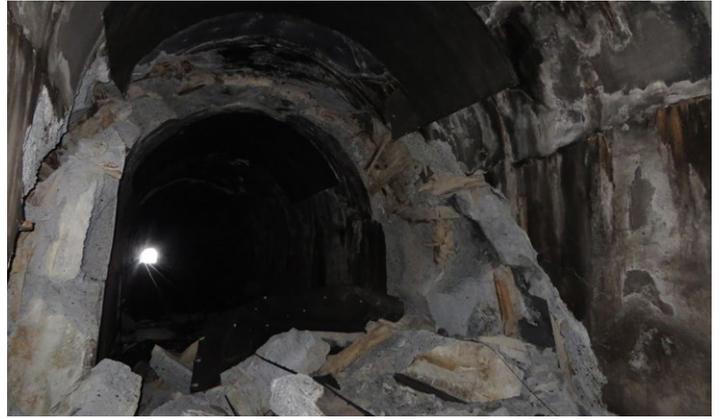
Tunnel 16 (pictured below) underwent 'squeezing' during the earthquake, leading to longitudinal tension and compression cracks. The picture below shows rock bolts being used to re-secure the tunnel's damaged concrete lining to surrounding rock.

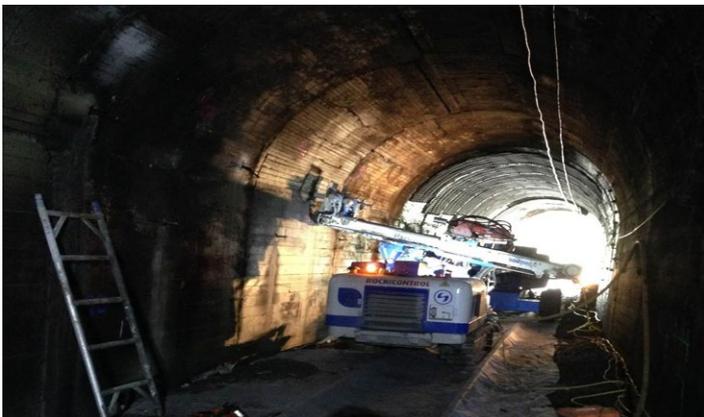
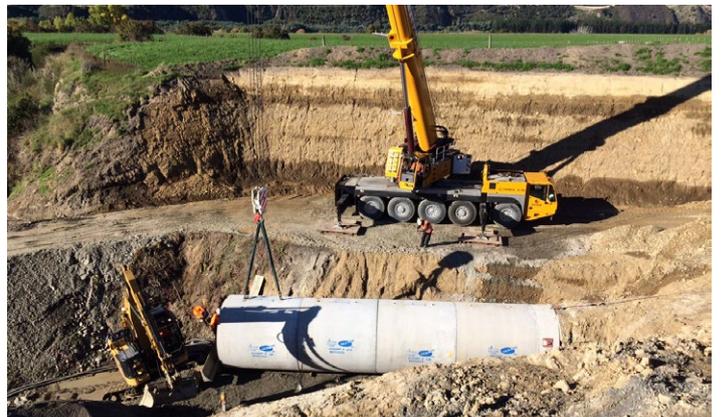
Repairs to an earthquake-damaged culvert near Ferniehurst are well underway (pictured). The crew have excavated the downstream face of a rail embankment to a 12m depth in order to expose a large (15m long, 2.5m high) concrete-lined tunnel that formed a culvert under the railway. The underground damage to the tunnel meant the crest of the embankment had slumped by up to a metre. After the culvert is repaired, the embankment will be reinstated to its full height.

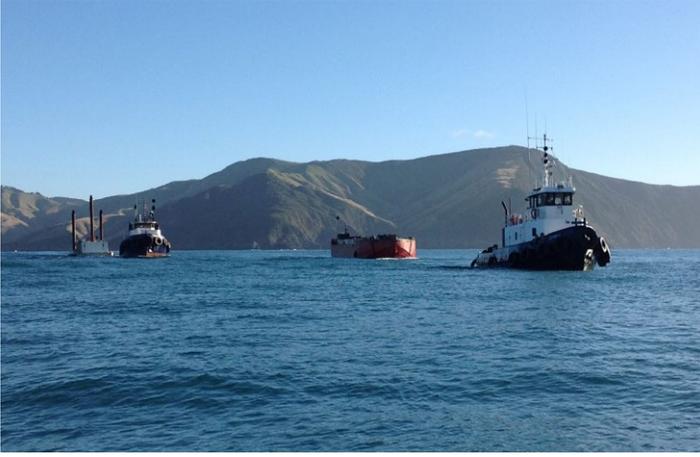
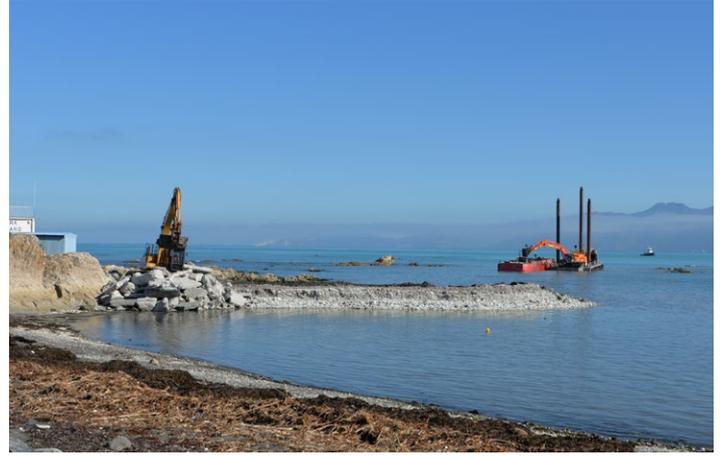
Kaikoura harbour repairs have reached a new milestone with the arrival of the dredging barges - one has a 47-tonne excavator aboard while the other is a hopper barge for carrying waste material. The two barges work in tandem: the excavator dredges up to 400 cubic metres a day from the seabed and deposits it onto the hopper. A tug boat then pulls the hopper out to sea, depositing the excess material approximately 2km from the shore. Dredging is required because the earthquake raised the seabed under the marina by about a metre; deepening of the harbour is ongoing work. These photographs show the trio of vessel as they left Picton last week and in Kaikoura yesterday.

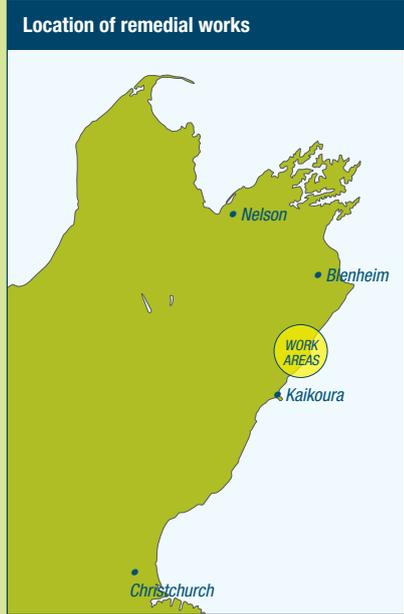
SITE 9: 3,000m³ of slip material

SITE 8: 41,000m³ of slip material

SITE 7: 20,000m³ of slip material

SITE 6: 110,000m³ of slip material

SITE 5: 6,000m³ of slip material

SITE 3: 5,000m³ of slip material

SITE 4: 44,000m³ of slip material

SITE 2: 10,000m³ of slip material

SITE 1B: 112,000m³ of slip material

SITE 1A: 23,000m³ of slip material
