KAIKOURA EARTHQUAKE UPDATE - no. 29

11 August 2017

MILESTONE: RAIL CONNECTED

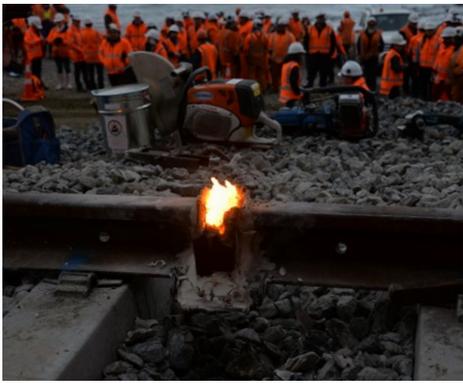
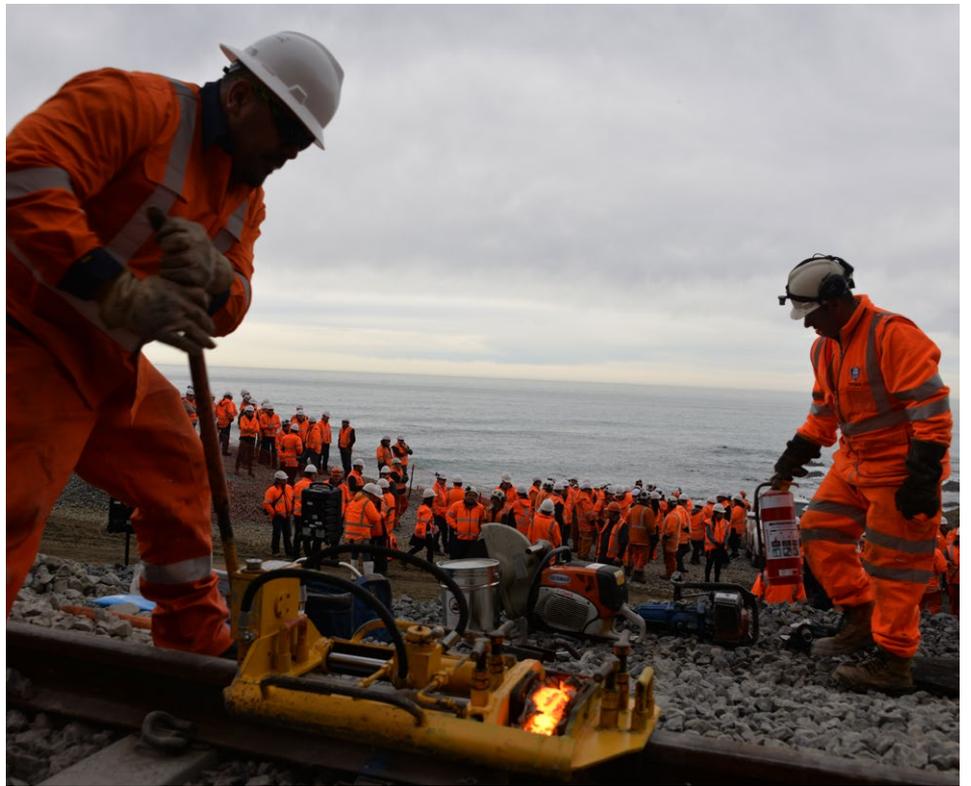
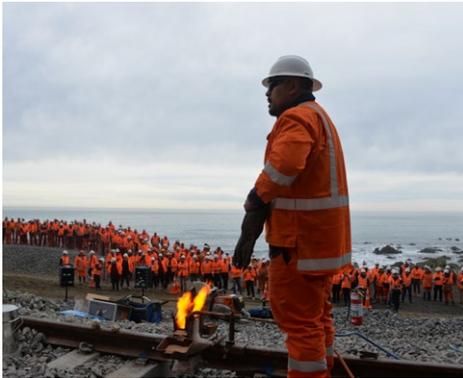
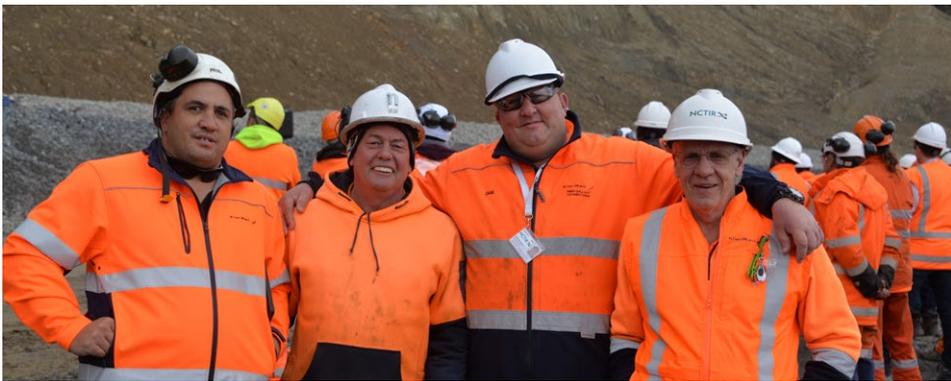
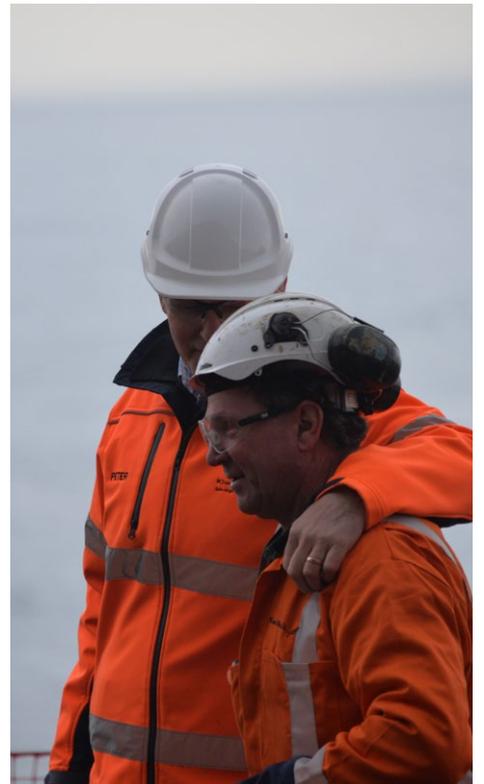
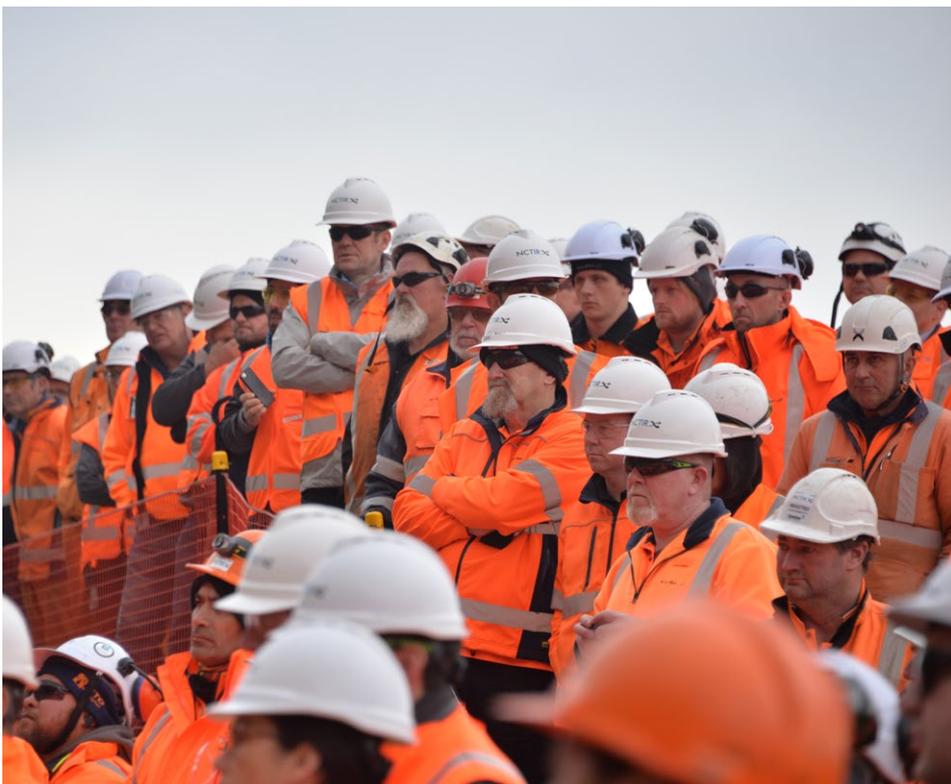
The weld was a hot process (2000 degrees celsius) that took about 90 minutes and involved installing a mould and then sealing the gaps with special putty. The rails were then preheated so that they could be fused together. A bucket of 'one shot thermic weld' was put on top of the mould and ignited starting a very hot chemical reaction. Flames spouted out the top of the bucket as the liquid metal got super-hot and then flowed into the mould. Once cooled the mould was then knocked off and the metal ground flush (see above and photos on the following page).

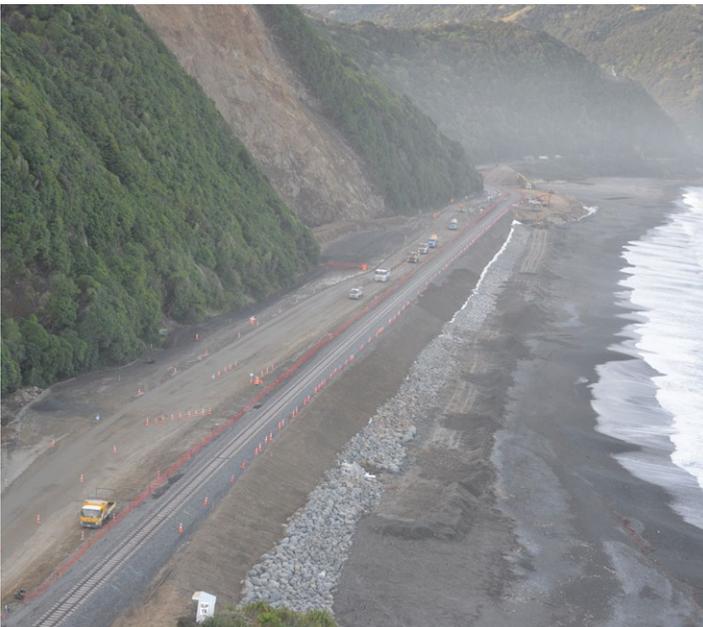
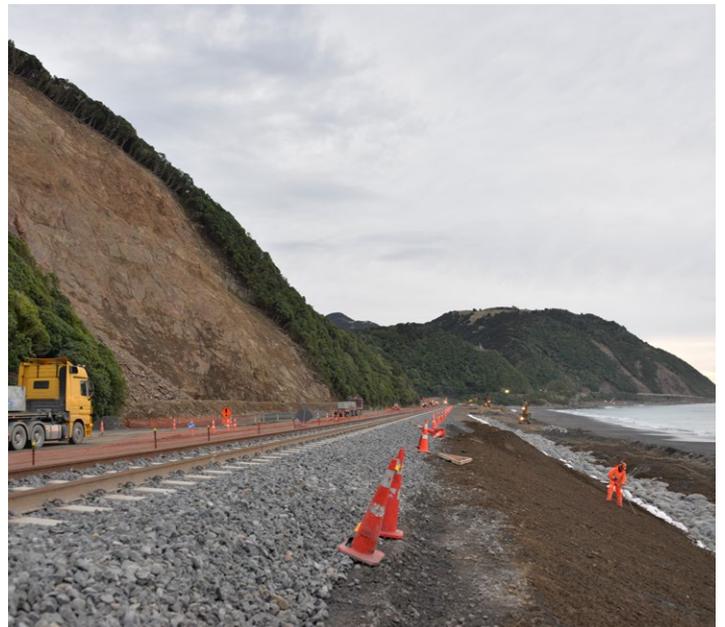
Both road and rail realignments have taken place at the site and in some areas realignment of the rail has had to be brought up by as much as four metres (see photos). This has created a large embankment, and for the last couple of months a crew has been building the coastal protection for this embankment.

Site engineer Josh Gardner says: 'the sea wall is made up of three layers; first a filter fabric that stops sediment coming out from underneath the railway which would undermine the embankment, then a layer of smaller rocks, and finally a layer of boulders.'

In the last month, 8000 cubic metres of boulders have been added to the embankment to prevent erosion. This layer of boulders is known as rock armour, and it protects the embankment, which provides coastal protection from wave action.

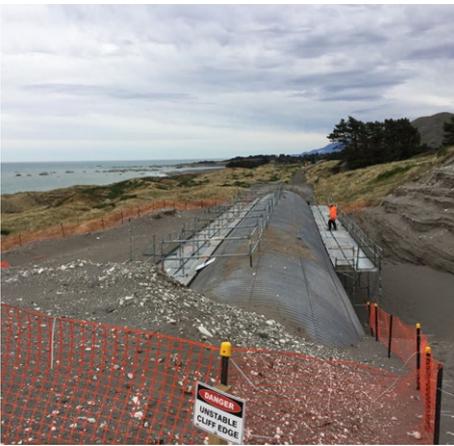
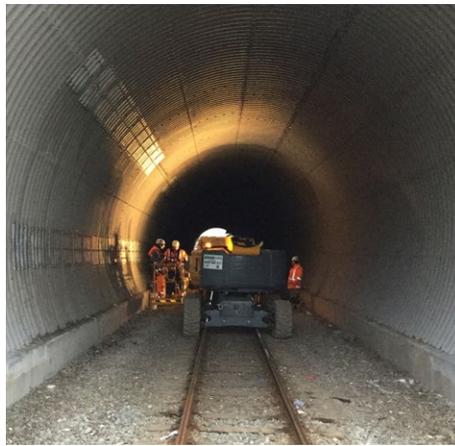
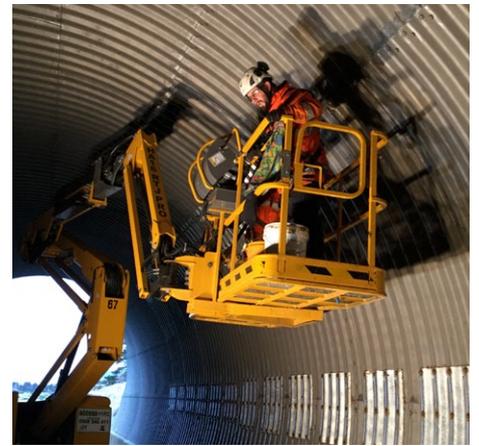
In the earthquake, the southern half of the multi-plate culvert that creates a road over rail overpass was pushed over, leading to significant kinks in the seams. Basically, it was bent badly out of shape, and the culvert repair required to fix the damage had never been done before.

Before plates could be bolted together to reform the culvert walls and arches, a lot of work had to be done to prepare the site. In the last month, work has really progressed and the crew have begun bolting plates up along the seams to provide additional strength and push it back into shape.

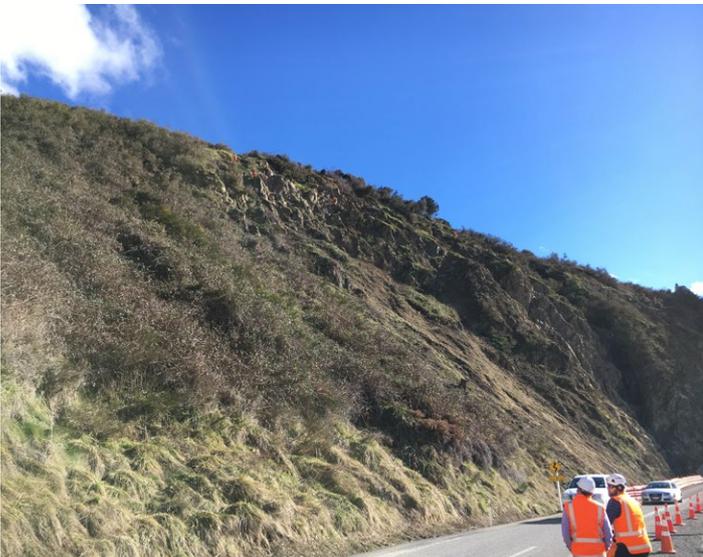
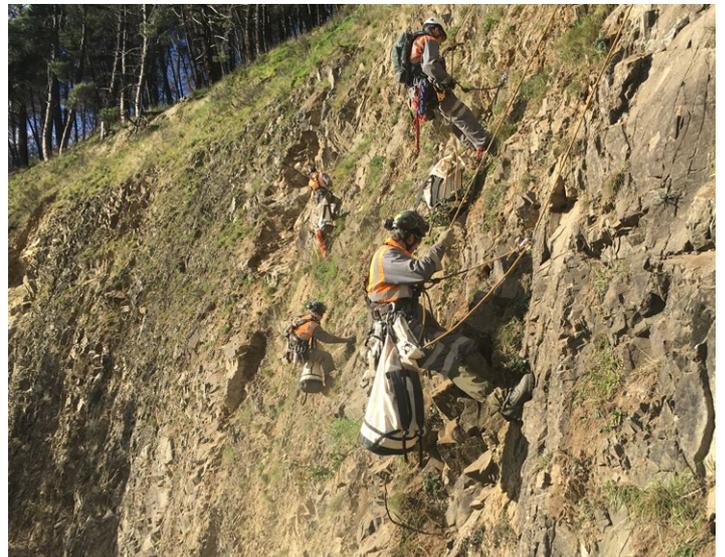
Three days worth of scaling and air-bagging work has been completed at Conway Bluff on the Inland Road (Route 70). This involved inflating a bag with a compressor to remove rocks where there were some bigger ridges between the rocks and the embankment, to make the rock shelf fall off. A further two weekends of work is planned.

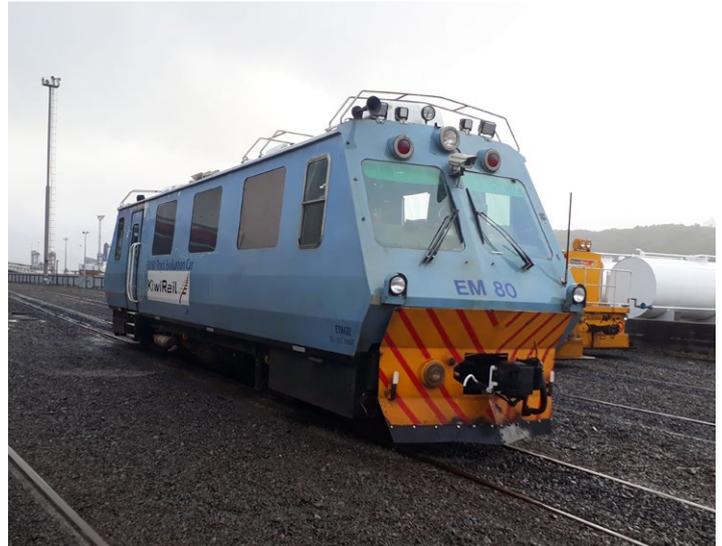
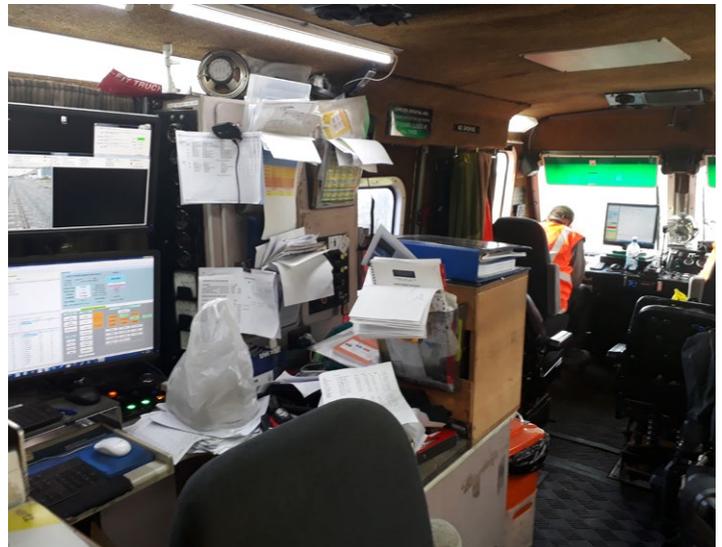
Officially called a Track Geometry Measuring Car, the EM80 is the only one in New Zealand and has recently been travelling along the Main North Line for engineering inspections of the track ahead of freight trains operating on the line.

The machine is a rail vehicle that applies a load onto the rail to create the effect of a train going over the track. By applying pressure it helps identify geometry faults and where the rail fasteners aren't holding well. It also takes a lot of data (13GB), measures track geometry, videos track conditions and marks spots requiring attention. This is something that a person on foot with a rail gauge would take a very long time to do.

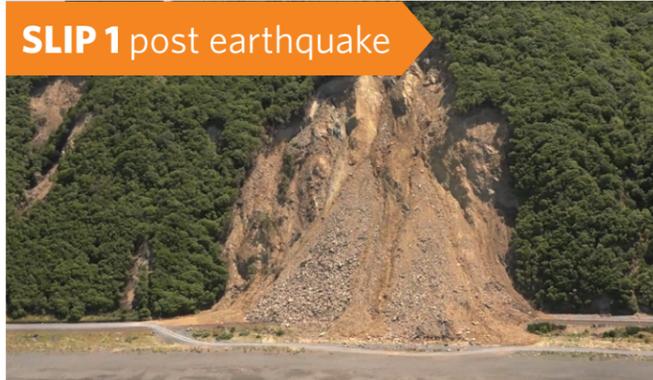
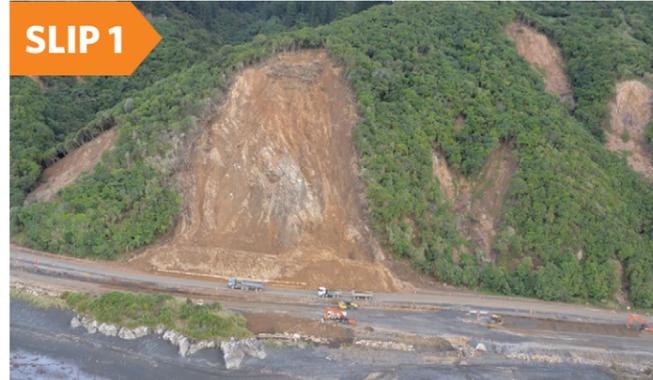
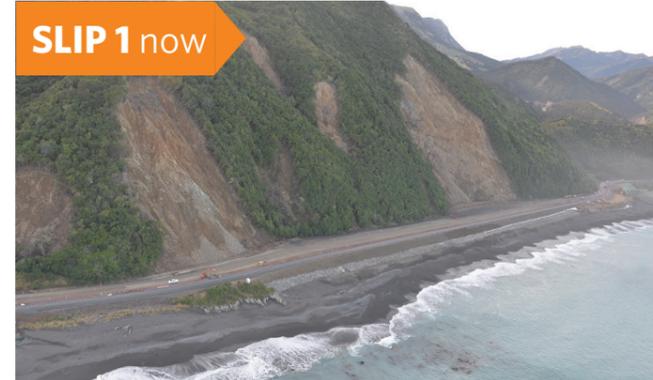
SLIP 1
This is located near Maungamanu.
An update on work being done at this site be found on page 3 of this issue the Bulletin

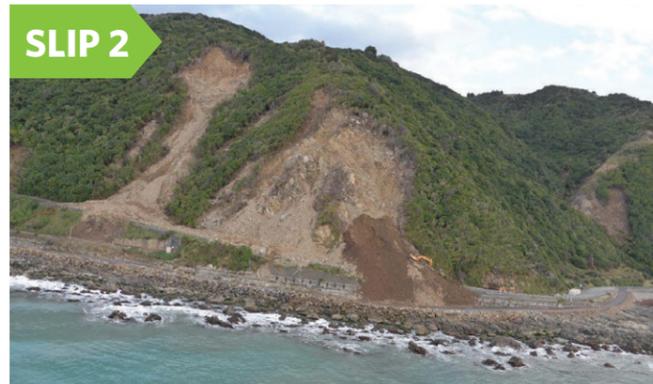
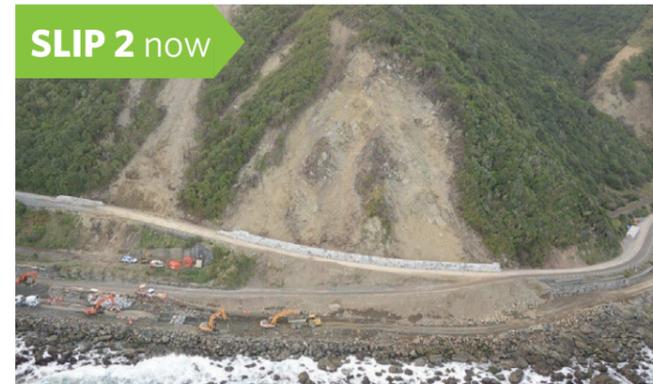
SLIP 2
This is located near Irongate.
An update on work currently being done at site can be found on page 3 of this issue of Bulletin.

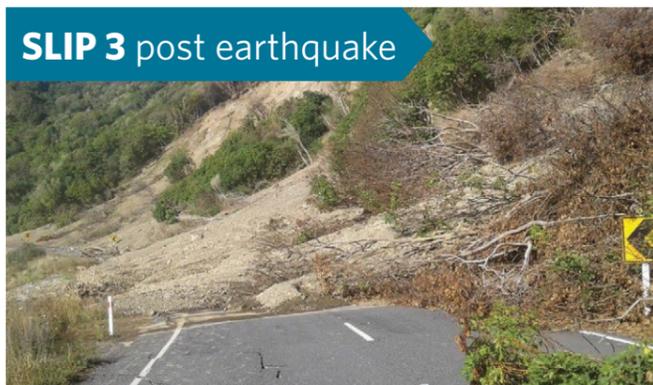
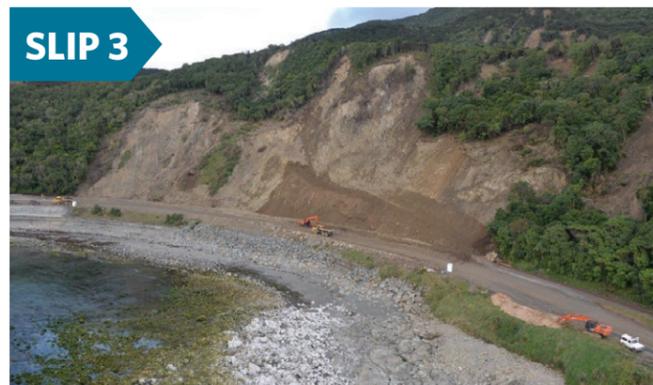
SLIP 3
This is one of three slips located in Half Moon Bay.
An update of work being done at this site will feature in next week's issue of the Bulletin.

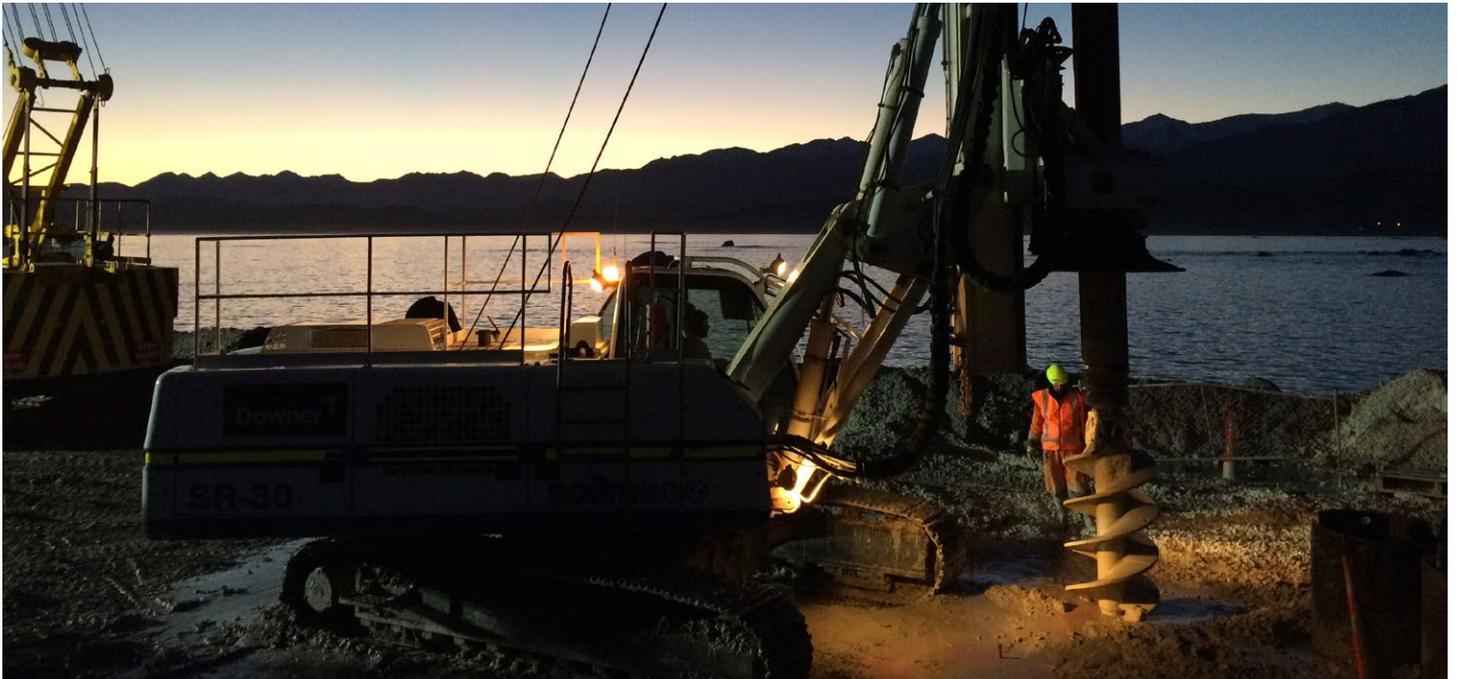
Now that the piling is complete, great progress is being made on the 10-metre sections in between the piles of the promenade wall. Workers are digging down to the bottom of the harbour and lowering in a mobile temporary protective steel barrier (trench shield). These areas will then be infilled with concrete.

Work is well underway, with a drill rig and piling crane on site and 8 of the 35 piles along the rock groyne now installed.

Six piles are now in place to which the prefabricated steel frame jetty will be attached. The next step will be to install the jetty walkway.

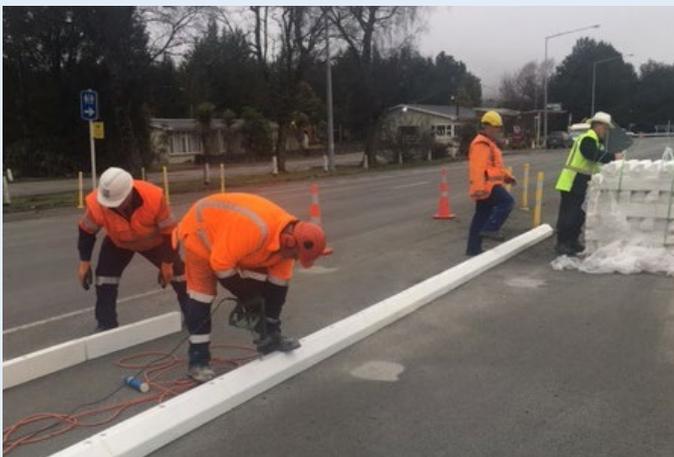
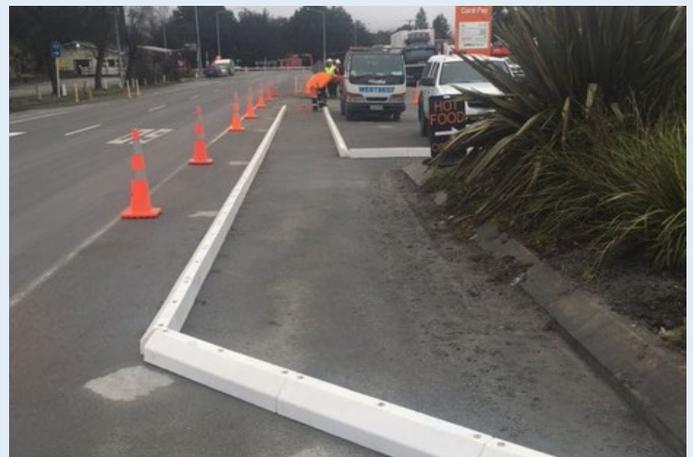
At Springs Junction where weary travellers often stop for fuel and a bite to eat work is underway on some safety improvements. Kerbing is being installed along the highway to provide vehicles and pedestrians with clearer guidance around where to drive, where to pull over and park, and for those on foot, where to cross the road safely. With up to four times the normal amount of traffic along parts of the alternate Picton to Christchurch route since the closure of State Highway 1, this latest piece of work will support a better overall flow of traffic and improve the safety of everyone moving through this area.

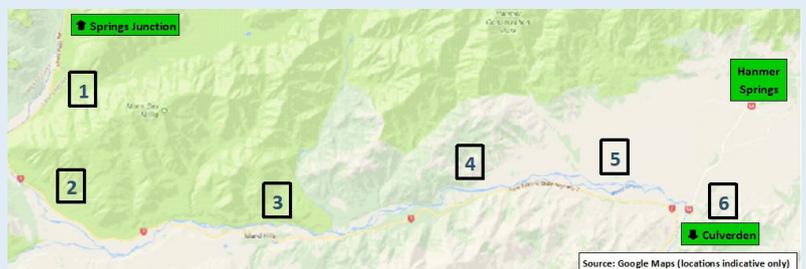
In North Canterbury alone, there is a variety of safety, resilience and maintenance work underway:

1. Boyle River Bridge - pavement repairs
2. West of Engineers Camp - road widening
3. Glynn Wye - retaining wall replacement
4. Dons Fan - drainage work
5. Lewis Pass Road, west of SH7a
Hanmer turnoff - tree felling
6. SH 7A Waiiau Bluffs - rock face stabilisation
