The Bulletin Kaikōura earthquake update

This Bulletin provides the latest information about the rebuild of road and rail networks damaged by the Kaikōura earthquake in November 2016. The Bulletin is produced by the North Canterbury Transport Infrastructure Recovery (NCTIR) - an alliance representing the NZ Transport Agency and KiwiRail, on behalf of Government. Please note the next edition of The Bulletin will be published on Wednesday, 24 October.

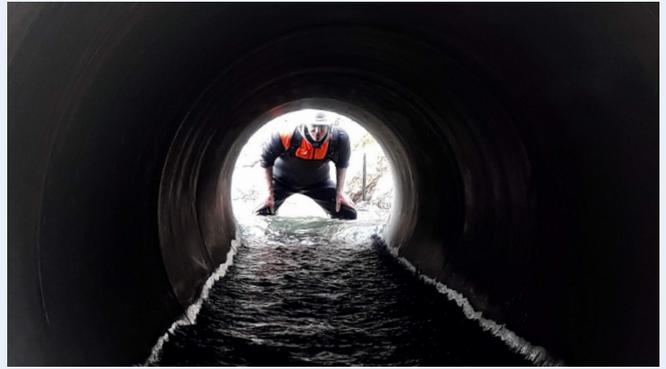
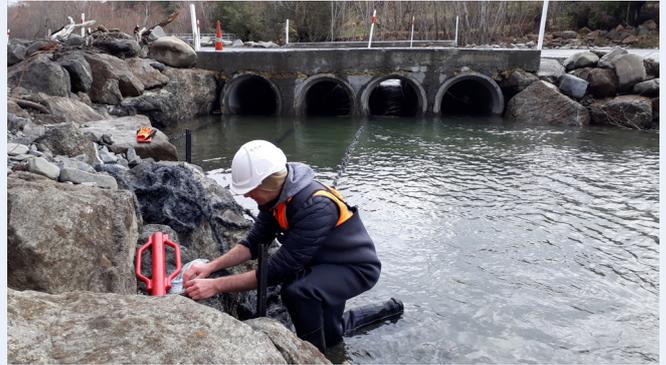
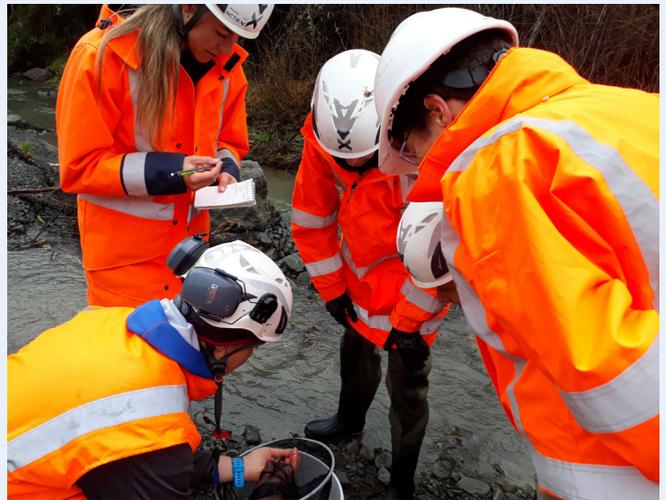
On the Electric Fishing Machine (EFM) is Greg Burrell, our intrepid new freshwater ecologist. His task as mission leader is to induce a current into the watercourse to promote the involuntary muscle movements of the target fish without causing undue harm to them (or his team members). The fish are collected and deposited to a safe part of the stream away from the works. The ecologists identify the species, measure, count, record and report the fish caught as part of our Ministry of Primary Industries permit requirements and monitoring programme. Other improvement work can include the placement of spat ropes within the temporary diversion road culverts and the construction of in stream pool and riffle steps. NCTIR's ecology team have saved or relocated over 3400 fish during the restoration of State Highway 1 and the Inland Road, many of them threatened and at risk species. Coastline and inland freshwater ecology has been a top priority during the repair works with fish recovery a routine occurrence on the NCTIR work programme.

Water works: The NCTIR team get their hands dirty finding fish at a culvert on the Inland Road. The team search waterways before culvert improvement work and relocate any fish found to ensure their safety.

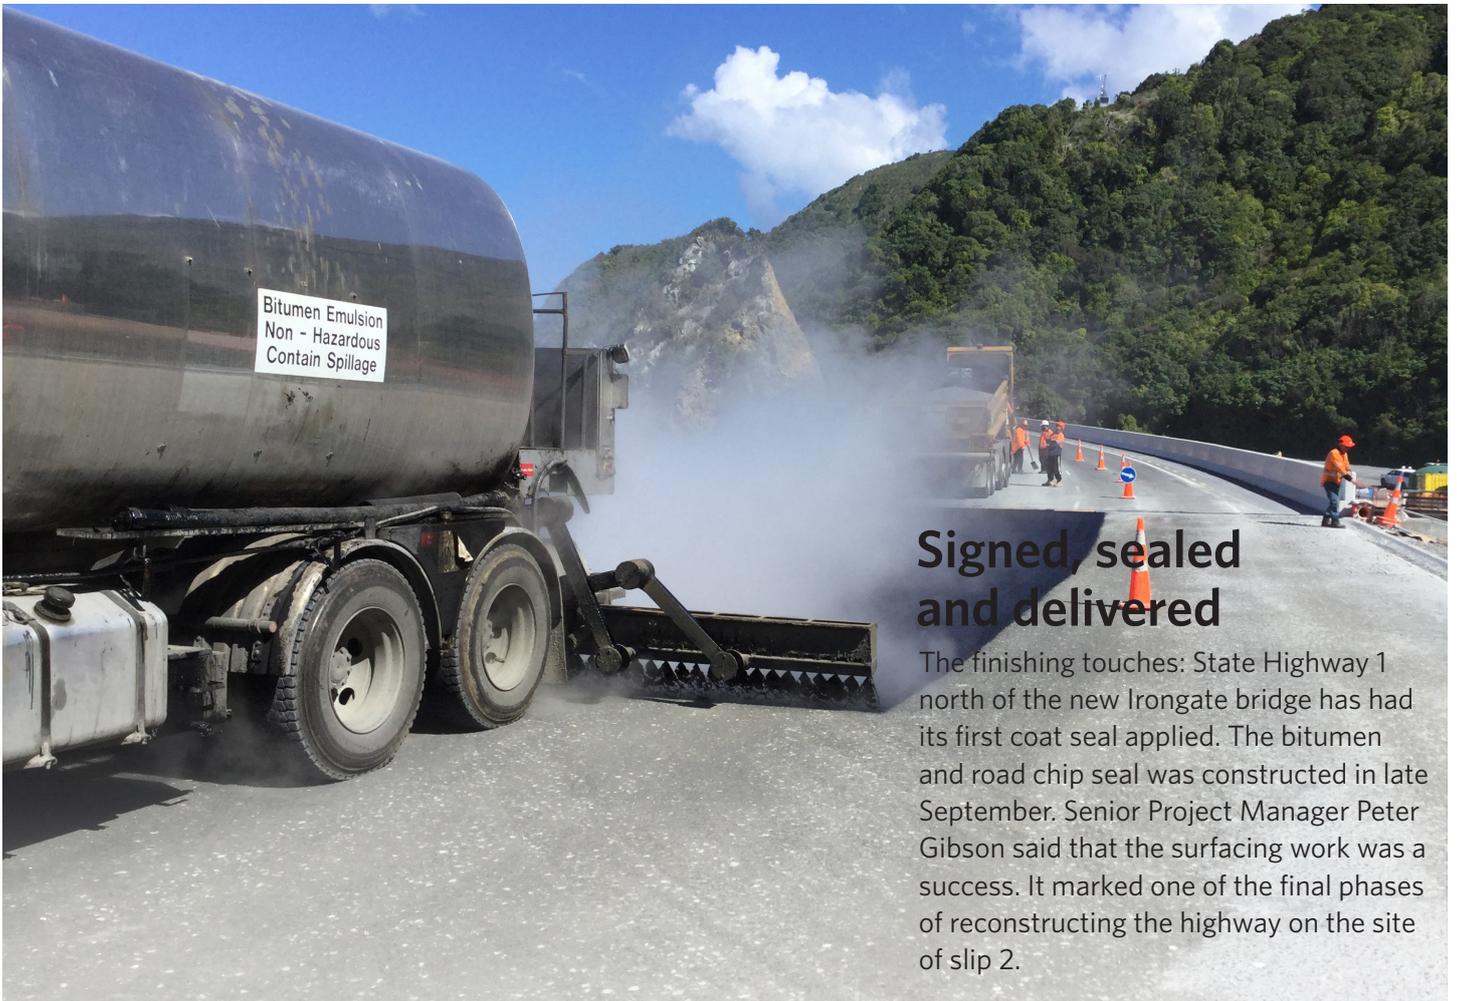
The finishing touches: State Highway 1 north of the new Inrongate bridge has had its first coat seal applied. The bitumen and road chip seal was constructed in late September. Senior Project Manager Peter Gibson said that the surfacing work was a success. It marked one of the final phases of reconstructing the highway on the site of slip 2.

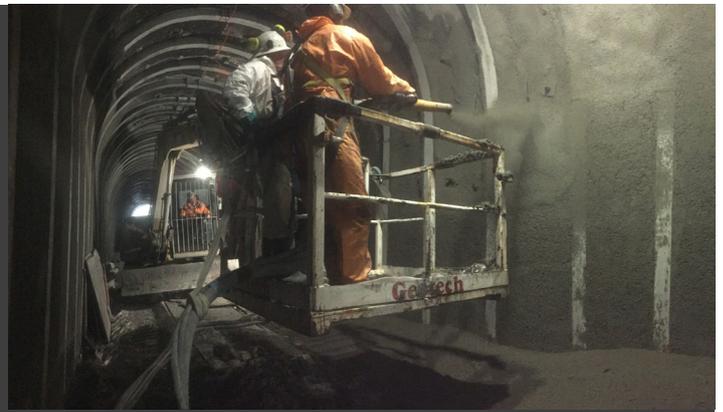
Welcome to the equivalent of a backstage pass to a construction site. The photo was taken deep inside tunnel 16, a 123m long rail tunnel near Irongate. It depicts a construction method known as shotcrete which is being sprayed onto the walls of the tunnel between steel ribs, to reinforce the 262 rock anchors that were installed during stage one of the tunnel project. Underway now is stage two, a process which strengthens the existing concrete lining and improves tunnel resilience in the event of future seismic activity. 'This project faced many challenges,' says Tunnels Manager, Rafael Ballen. Site engineer Cassandre Gatineau added: 'The ribs were retrofitted into the concrete linings left buckled by the 2016 earthquake

and the team now needs to spray approximately 180 cubic metres of shotcrete. This work needs to be done within tight windows of time to fit around train movements. The team has made great progress, but there is still work to be done.'

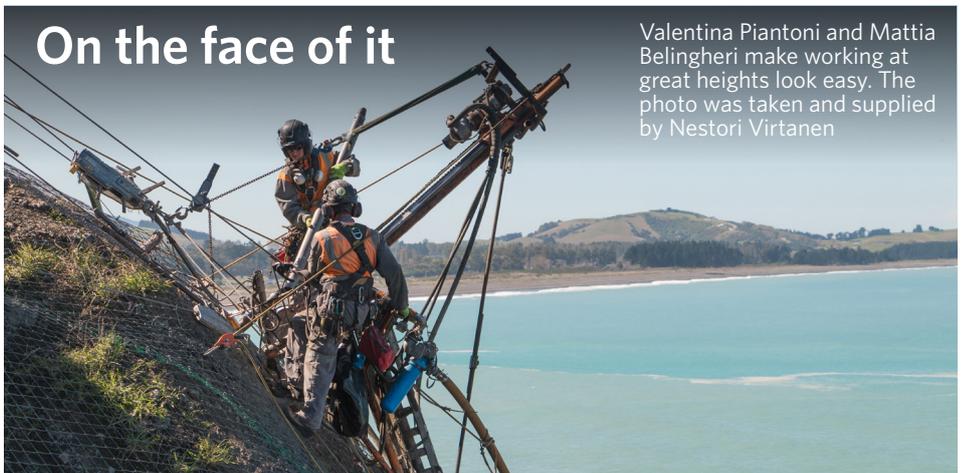
Valentina Piantoni and Mattia Belingheri make working at great heights look easy. The photo was taken and supplied by Nestori Virtanen

If you've noticed cliff-side abseilers working with an odd-looking piece of equipment and wondered what it was, wonder no more. Weighing in at 600kg, the large tripod is in fact a rock drill, and needs to be helicoptered into place due to its size. In this picture, the abseilers are working on slip 3 - just next door to Peketa - to drill up to six metres into the cliff face. A drill bit is attached to an epoxy-coated galvanised titan bar 40mm in diameter, so that the hole can be drilled and the bar inserted simultaneously. 300 bars like this have been inserted into the rock face at this site alone. Combined, the bolting and layers of mesh (also visible in the image) should stabilise the rock and prevent it from falling on passing traffic for at least 50 years. Handy!
