SH8 Beaumont Bridge

Report for Point of Entry

March 2016

Project		
NEW ZEALAND TRANSPORT AGENCY BEAUMONT, OTAGO SH8 BEAUMONT BRIDGE DETAILED BUSINESS CASE		
Sheet		
LONG LIST OPTIONS LAYOUT 1		
Project No.	Sheet No.	Revision
6-CT010.00	C01	A

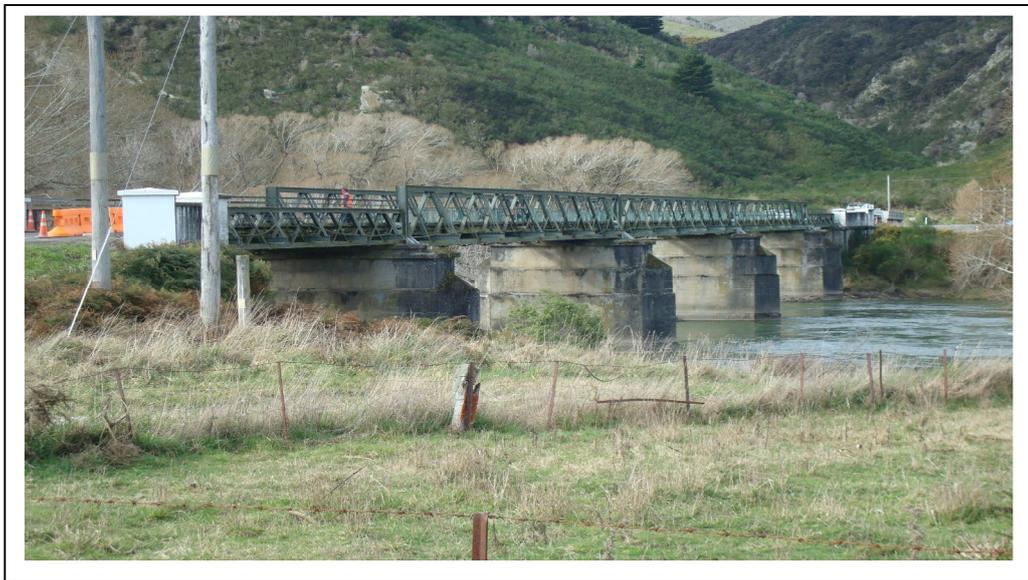
**SH8 Beaumont Bridge (Pre-scaffold)
Photo looking West (Alexandra end) to East
(towards Milton SH 1)**

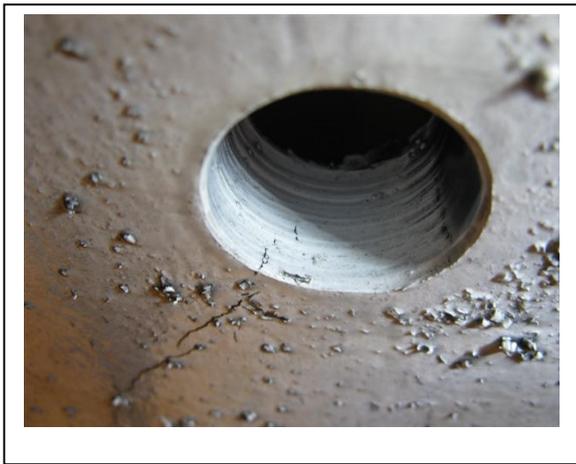
Plate Sample showing the delaminated plate acting as a natural crack arrestor

detectable by Non-Destructive testing (NDT) well into its fatigue life. Taking a cautious approach, the cracks only become visible to the eye nearing the end of the wrought iron's fatigue life. Because of the composite nature of wrought iron and its old age it is likely cracks are occurring within the wrought iron plate that can neither be seen nor able to be picked up by Non Destructive Testing.

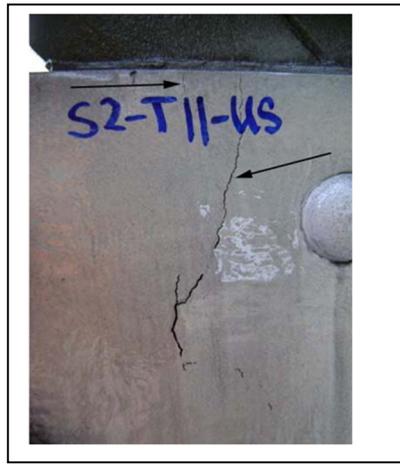
Example of a Surface Star Crack

- ii) Surface Star Cracks – cracks initiating on one side of a plate and propagating through part thickness of the plate (approximately 7mm). The laminations in the wrought iron act as a natural crack reliever and stop the crack propagating full thickness of the plate. Although we can see and monitor the surface cracks, we can't see the cracks occurring within the wrought iron plate. Nor can we see if cracks restart propagating from the relieved area.

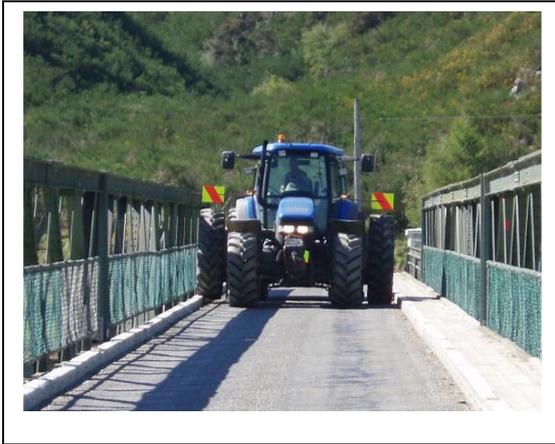
Single Lane shows the pedestrian walkway and timber kerb

- iii) Being a single lane structure means that as vehicles cross the bridge there is almost zero eccentricity of the load i.e. the load is symmetric to the bridge centreline, producing less transverse bending and generally uniform load distribution. This equates to less on-going demand on the fatigue life of the wrought iron.

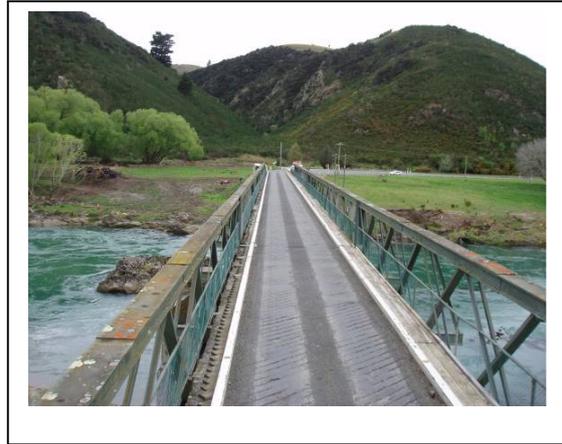
Looking towards Lawrence (East end of bridge)

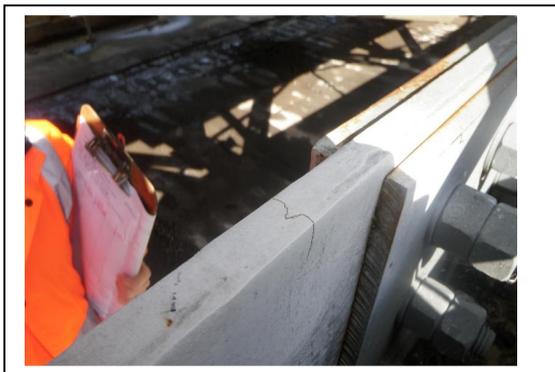
- i) Edge Notch Cracks – cracks initiating from the edge of a plate and propagating through the full thickness of the plate.

Edge Notch Crack

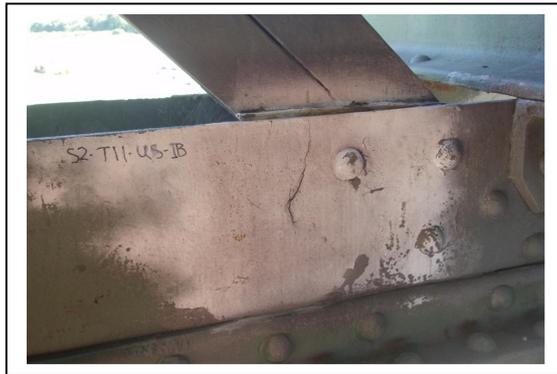
Surface Star Cracking

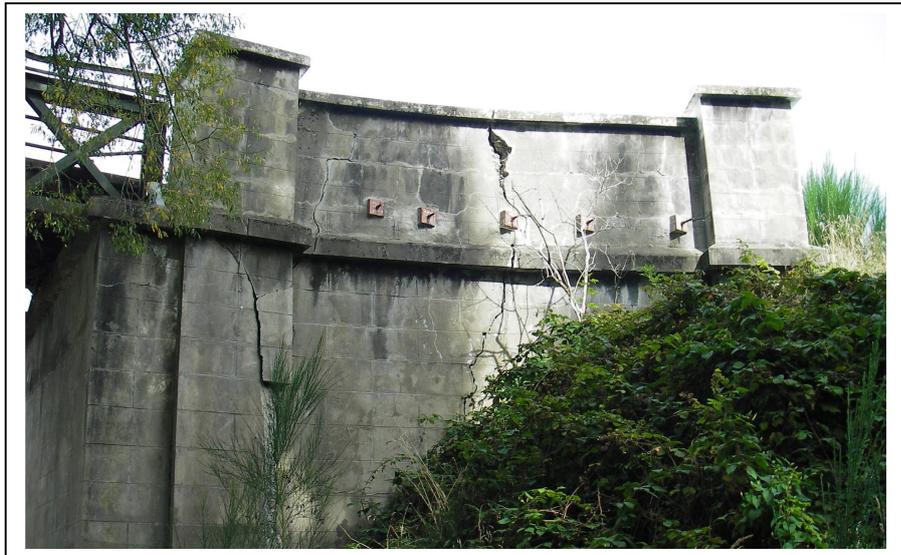
- The western abutment, that has settled and cracked, is founded on gravels whereas the piers are all founded on rock.

Western Abutment Settlement

- vi) The bridge piers are founded solidly on rock whereas the western end abutment is built on river bed materials and has settled and separated from the wing-walls. The abutment is leaning in towards the bridge. We haven't seen any significant deterioration since monitoring was started in 2009. Both the short span and the long span at the western end of the bridge have been shunted eastwards on the piers. The evidence can be seen in the 'closed' expansion joints. We have concluded this could be due to the combined effect of the abutment settlement and hard braking of heavy vehicles on the deck. Monitoring will

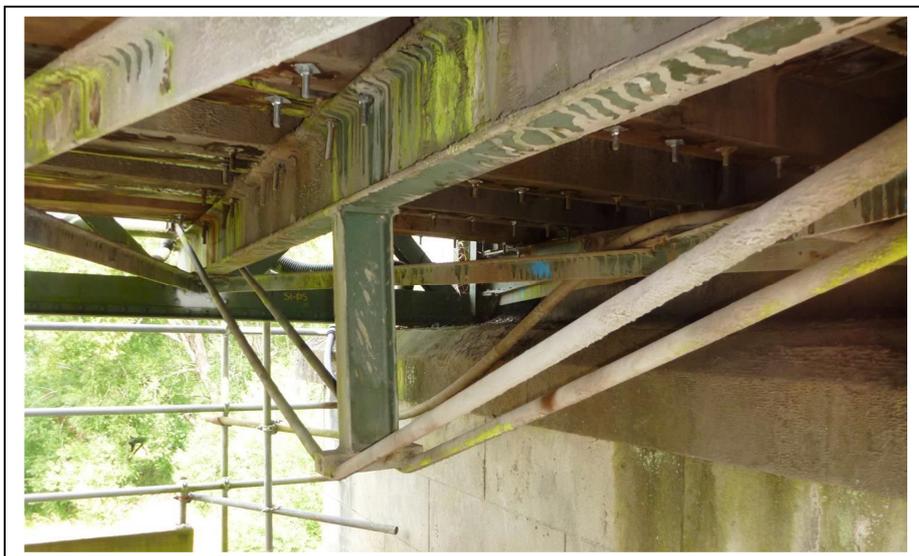
- The wrought iron transoms that have been strengthened using a king post/tie rod system which provides a degree of pre-tension, reducing the stresses in the transoms. Although not very well designed the system is reasonably effective. Maintenance includes replacement of the relatively lightly designed connections and ensuring the tie rods are in tension.

King Post/Tie Rod Transom Strengthening

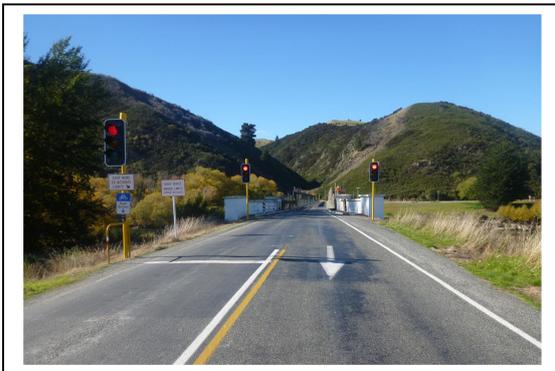
Traffic Signals to reduce dynamic load

Our monitoring records indicate **only minor** propagation of the surface star cracks and **no** propagation of the edge notch cracks, since the traffic signals were installed in 2009/2010.

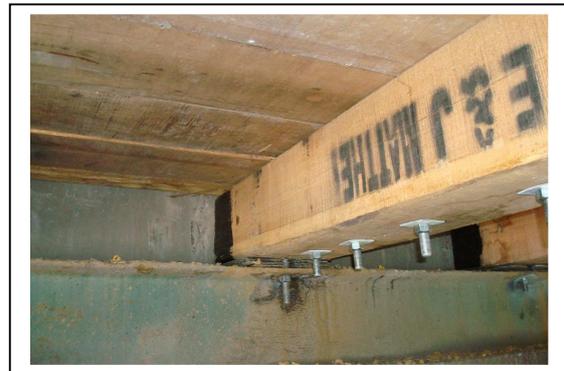
Stringer replacement

- ii) Annual maintenance of the timber deck includes stringer strengthening, replacement and tightening of running boards and deck boards and packing between stringers and deck boards to reduce vibration.

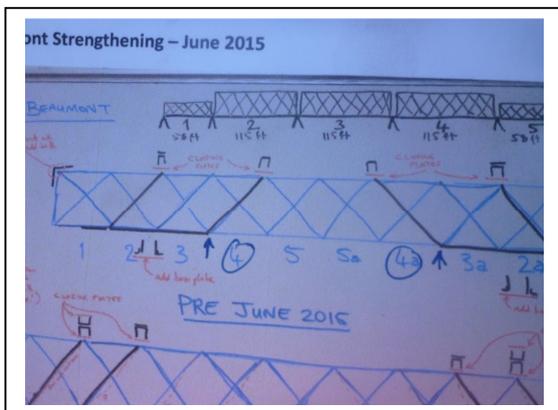
At the time of writing this report the final stage 3 of strengthening of the bridge is underway to permit on-going use by full High Productivity Motor Vehicles (HPMV - increased gross weights from 44 Tonnes up to 62 Tonnes). The strengthening was planned in 3 stages. The first stage included replacement of a damaged compression strut. The second stage of strengthening was completed by the end of June 2015 deadline to permit use by full HPMV at higher allowable stress levels for a limited time. The strengthening work included welding additional plates onto the compression members

(struts) of the truss, to prevent buckling, and bolting of additional plate to the lower chords of the truss to lower the live load stress range, including areas of the lower chord where cracks are most prevalent.

Strengthening Members for Buckling.

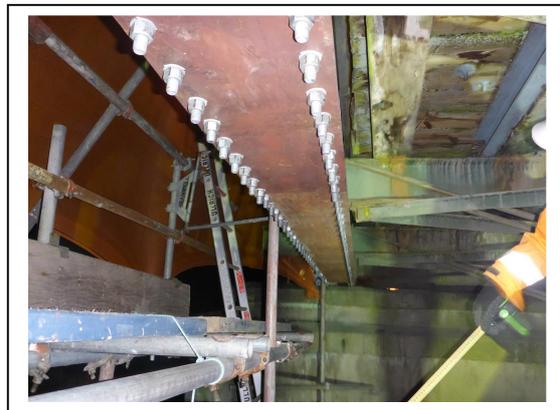
Additional Plate on the bottom chord strengthening.

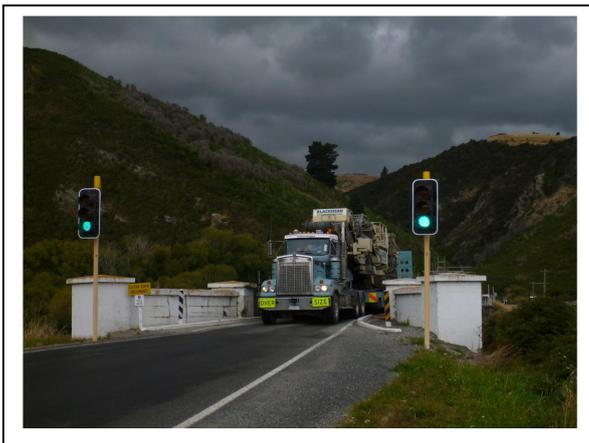
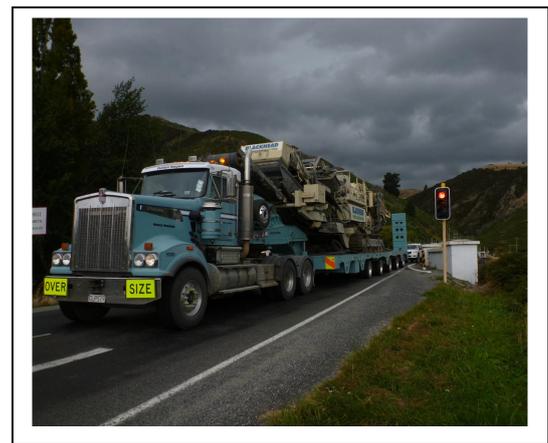
Fulton Hogan Crushing Plant >90T

- iv) Records are not available for the number of overweight vehicles using the bridge. These single loads can be over 100 Tonne in weight. We rely on our updated posting and rating calculations, based on assumed strengths of the wrought iron. But these strengths, as already noted, vary considerably within the structure. We don't have the same level of certainty with how the structure is performing under overweight load compared with a modern steel structure. We rely heavily on our monitoring to pick up any deterioration, but this has limitations due to the potential for the fatigue cracks to deteriorate rapidly.

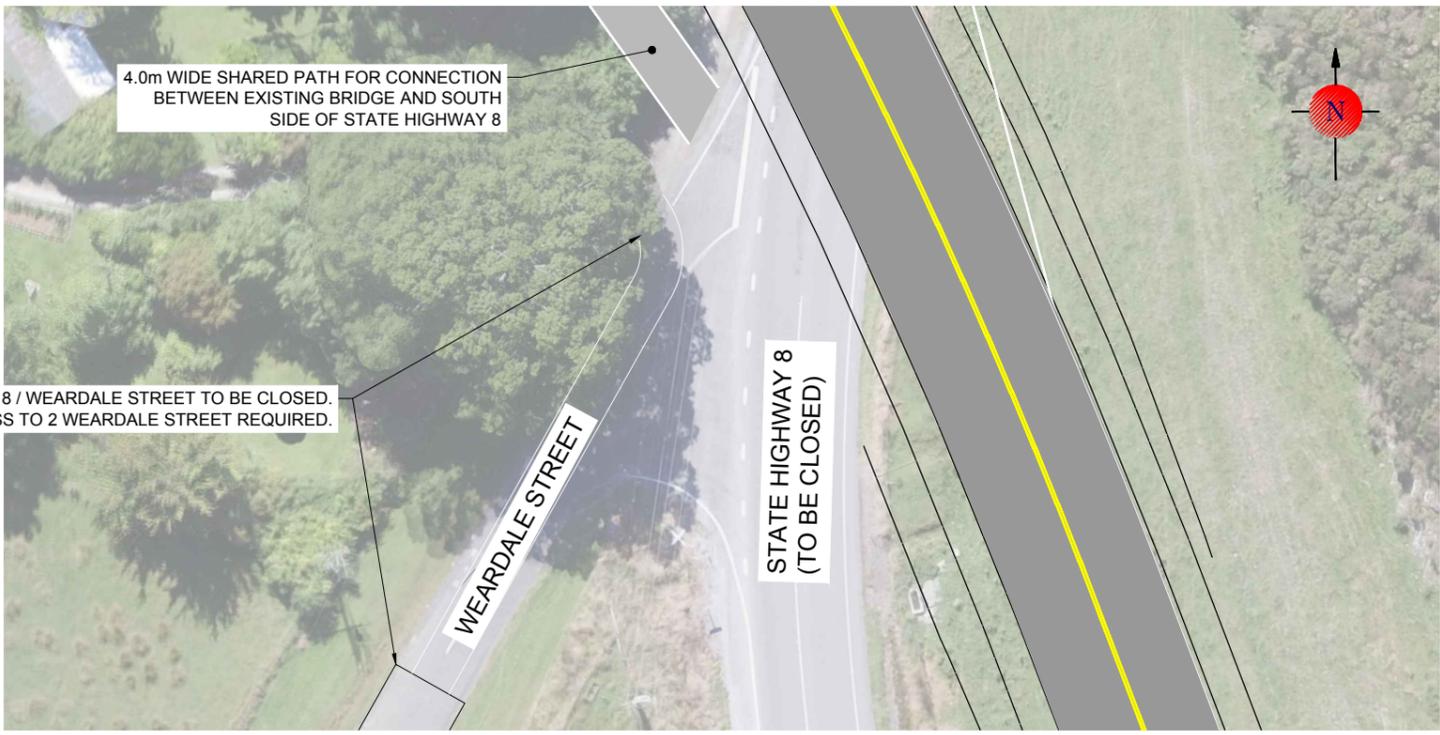
SH8 / WEARDALE STREET INTERSECTION LAYOUT

4.0m WIDE SHARED PATH FOR CONNECTION BETWEEN EXISTING BRIDGE AND SOUTH SIDE OF STATE HIGHWAY 8

STATE HIGHWAY 8 / WEARDALE STREET TO BE CLOSED. ACCESS TO 2 WEARDALE STREET REQUIRED.

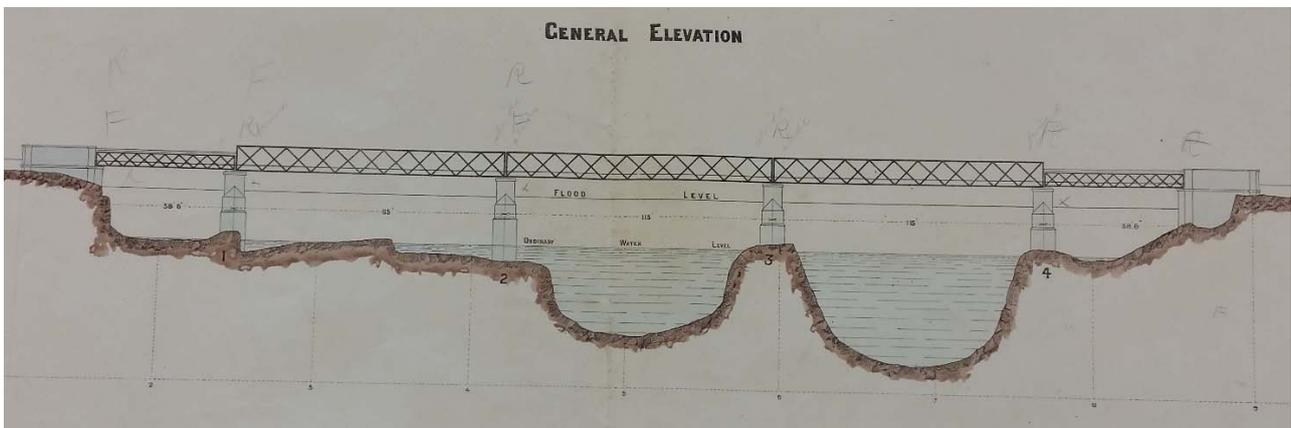
Figure 20: General Elevation of the Beaumont Bridge, 1887.

The lattice girders are connected with rolled wrought iron I-section transoms (also referred to as cross-girders) placed on the bottom chord of the lattice at every intersection. These cross-girders are braced with horizontal cross-bracing. Every second transom projects beyond the bottom chord, and is tied back to the top chord with a diagonal brace. The transoms provide support for the timber bearers (also referred to as beams or stringers) to which the timber decking is fixed. The specification required all timber to be matai, totara or kauri, and a minimum of “three quarter heart”. A contemporary report stated that the decking was “of best totara from the Southland mills” and “of the most durable quality”. The breadth of the deck is 14ft (approximately 4.3m) which, at the time, was reported as providing enough room to pass.⁹² The height of the bridge deck above the average river level was specified in the contract drawings as 30ft (just over 9m) in the hopes of ensuring it would not be susceptible to flooding.⁹³

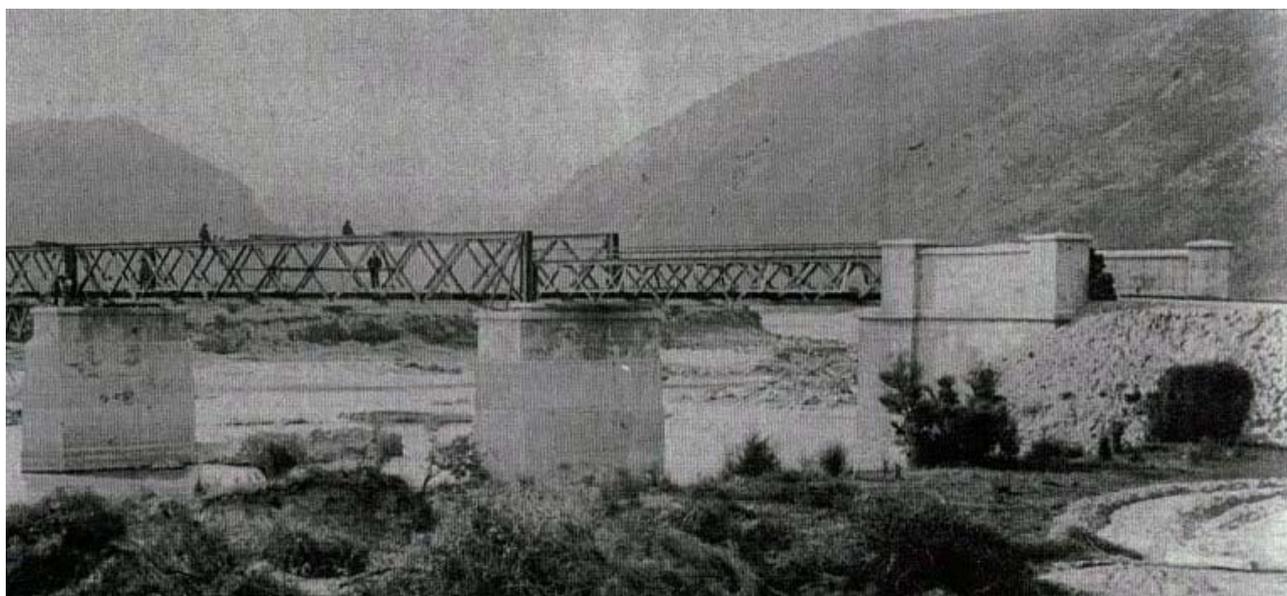
Figure 23: Beaumont Bridge in 1887, thought to be around the time of its opening.

complete the contract by July as required.¹¹⁸ However, this proved to be optimistic. The depth of the river, the strength and the volume of the current, made access difficult, and “it was found necessary to erect a temporary structure of trusses which, to many, had the appearance of a thoroughly permanent work”.¹¹⁹ Difficult weather and delays in arrival of timber for construction of the bridge deck caused further issues;¹²⁰ and, despite having approximately thirty workmen onsite, construction of the superstructure extended into 1887.

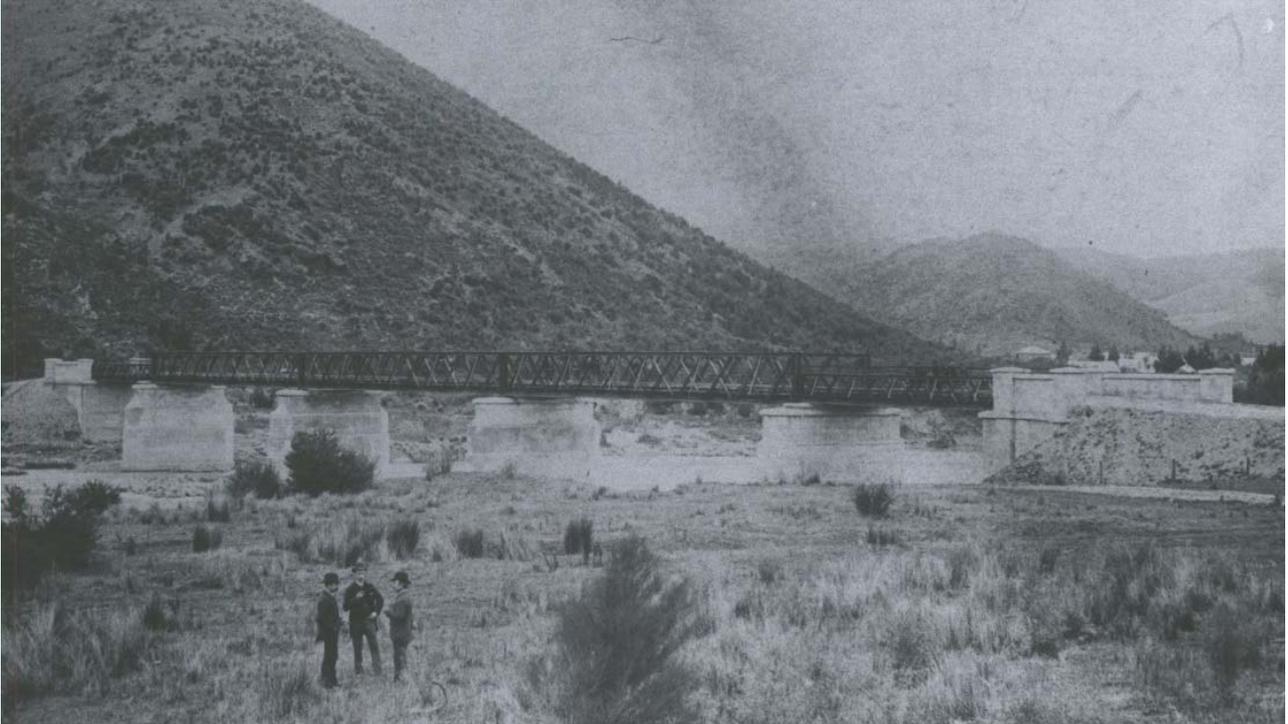
Figure 24: Beaumont Bridge in 1887 shortly after completion.

between wood and iron, were coated with white lead and oil. The cost of the superstructure was £5,000 which, when added to the cost of the piers and abutments, gave a total construction cost of £11,050 – a considerable sum at the time.

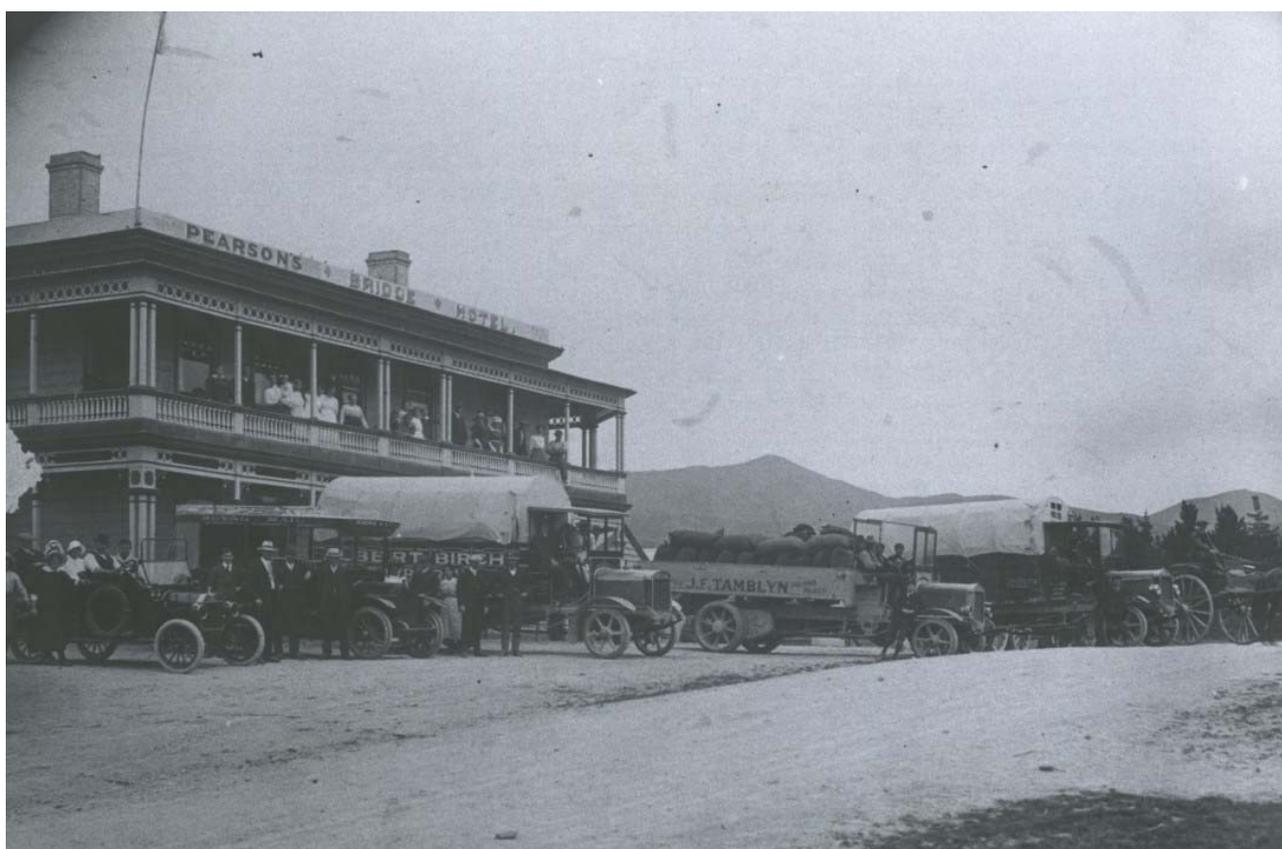
Figure 27: Bridge Hotel with vehicles parked outside, 1918.

This image demonstrates the type of motorised vehicles that were regularly using the bridge (located behind the photographer) by this time. Note the vehicle of J. F. Tamblyn in the centre. In 1926, Tamblyn narrowly escaped dropping through the deck of the Beaumont Bridge into the river while repairs were being undertaken.

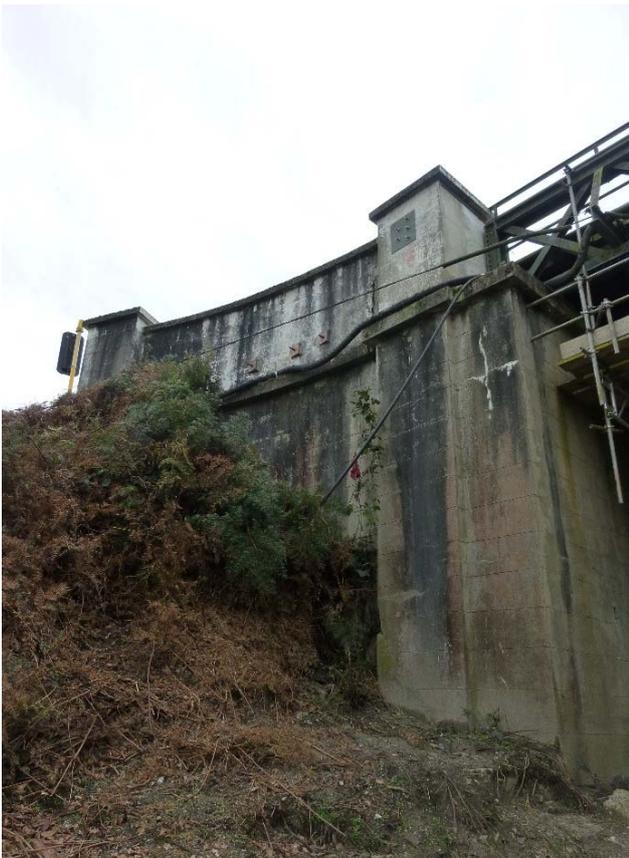
Figure 29: South elevation of west abutment. Staining, microbiological growth and cracking are visible. Note also the strengthening works that have been carried out.

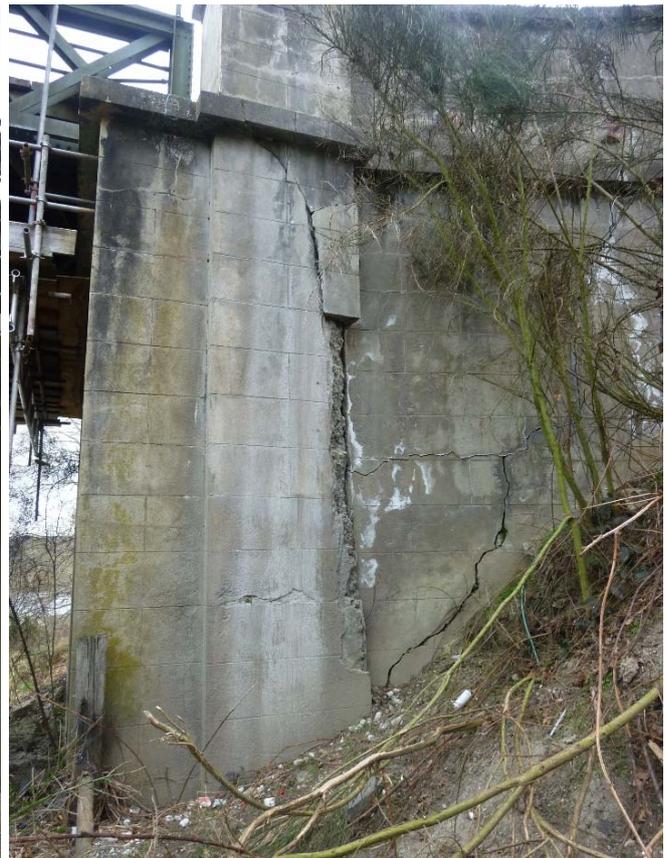
Figure 30: North elevation of west abutment. Serious cracking and delamination of the concrete are visible.

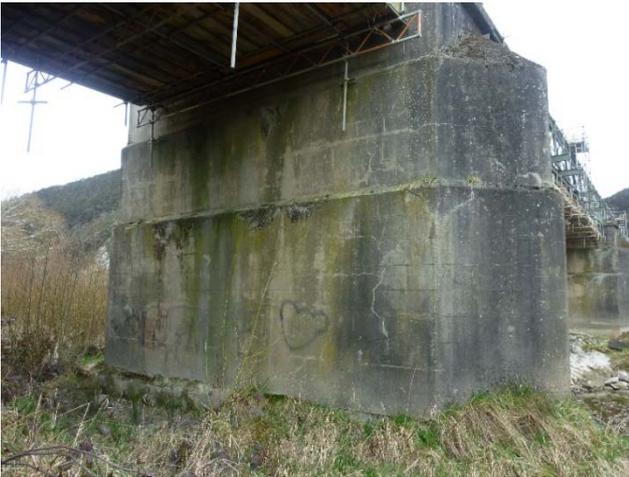
Figure 31: Concrete pier.
Staining, microbiological growth, cracking, and graffiti are visible.

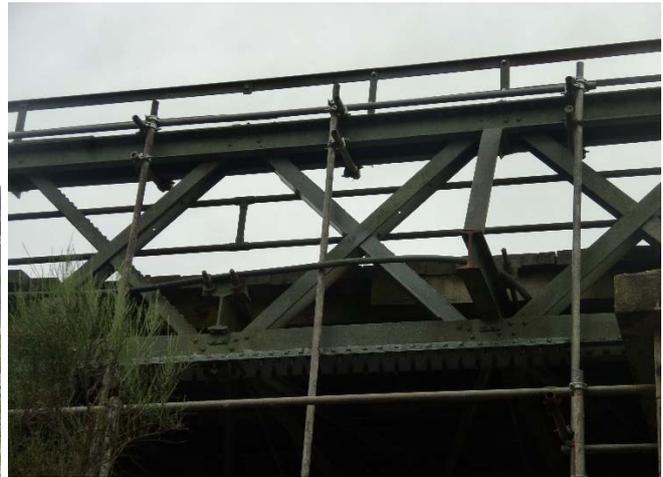
Figure 32: Lattice girder behind scaffold.
Transom ends are visible, intersecting with bottom chord.

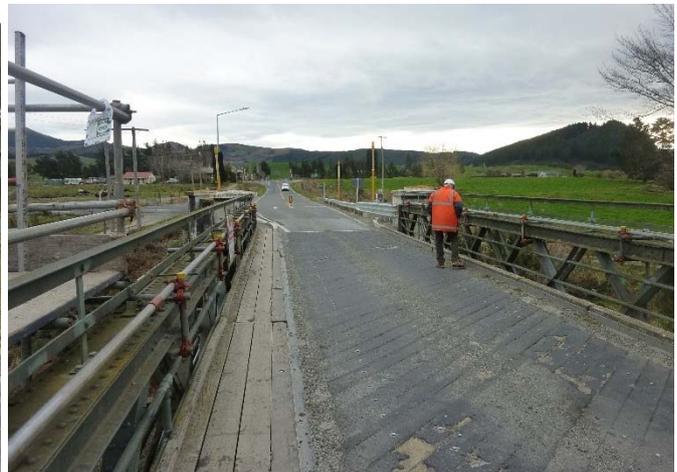
Figure 34: Bridge deck looking west.
The poor condition of the deck surface is evident.

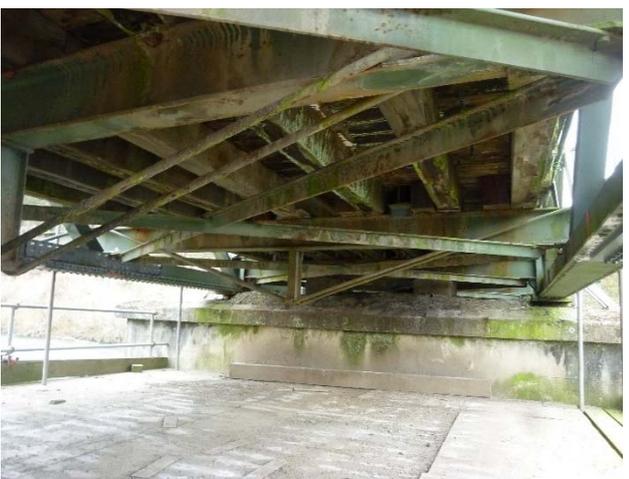
Figure 35: Understructure of the bridge showing king post trusses strengthening transoms and cross bracing below timber deck.
Microbiological growth and accumulation of dirt is evident.

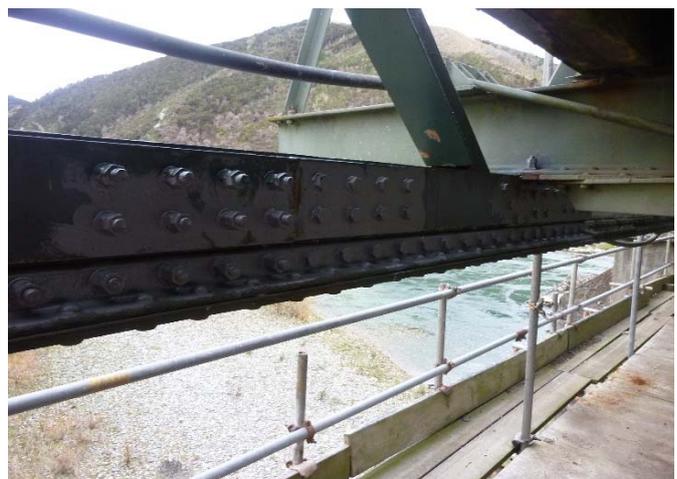
Figure 36: Recent repair of wrought iron bottom chord.

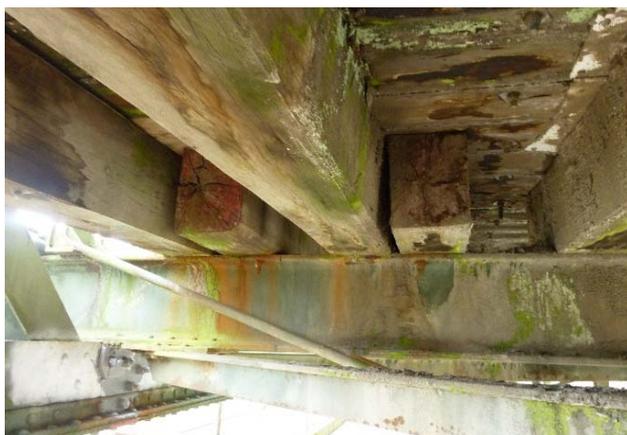
Figure 37: Timber bearers on wrought iron transom.

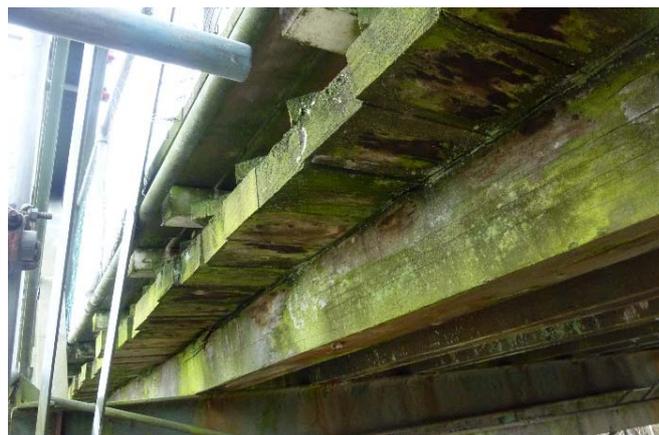
Figure 38: Timber bearers and edge of timber decking.

Microbiological growth and accumulation of dirt is evident.

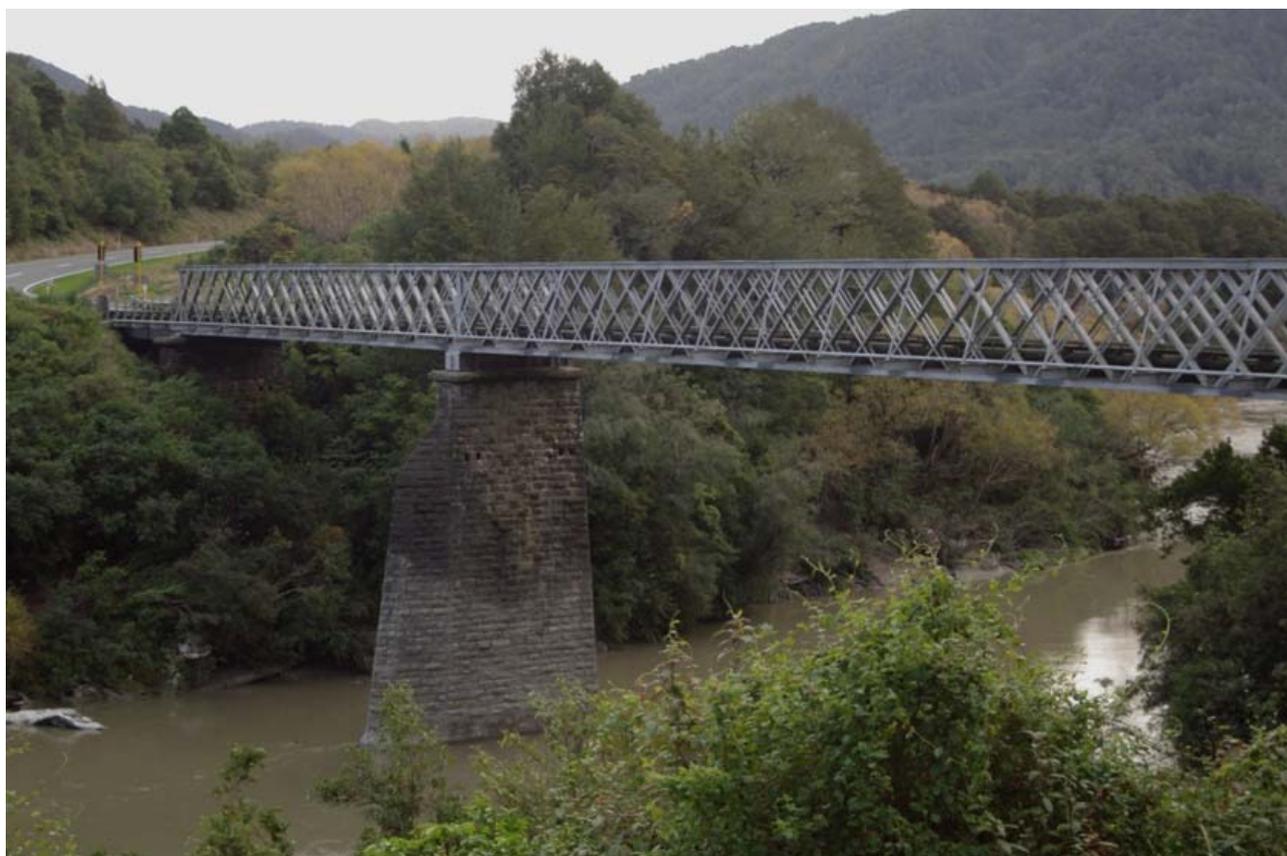
Figure 43: Iron Bridge, Lyell.

The Iron Bridge suffered damage in the Murchison and Inangahua earthquakes, but remains standing and operational as a road bridge. Of the comparisons considered in this section, the Iron Bridge is the most similar to the Beaumont Bridge. It is not listed with HNZPT.

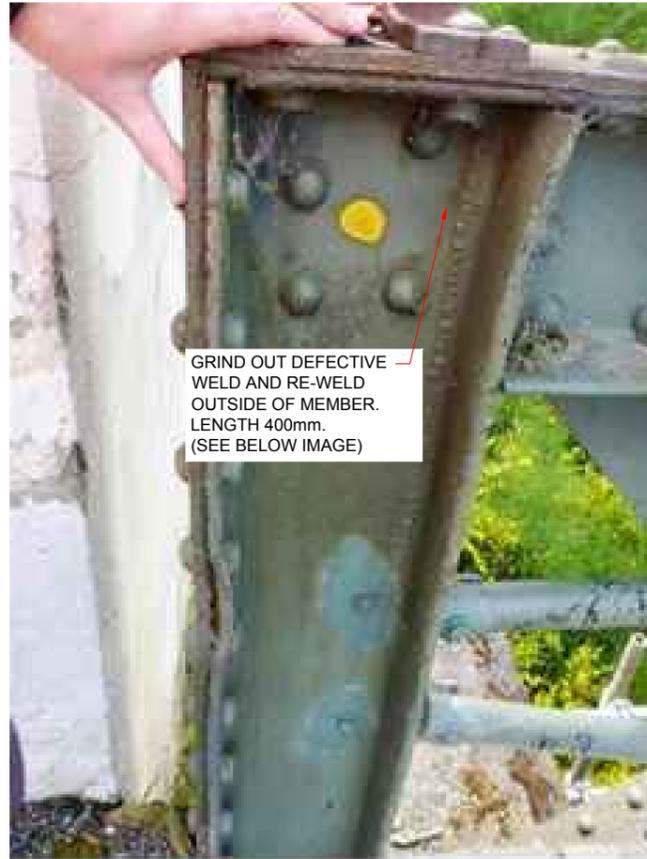
SPAN 1, UPSTREAM BAY 1 END BRACE - WELD CRACK

GRIND OUT DEFECTIVE WELD AND RE-WELD OUTSIDE OF MEMBER. LENGTH 400mm. (SEE BELOW IMAGE)

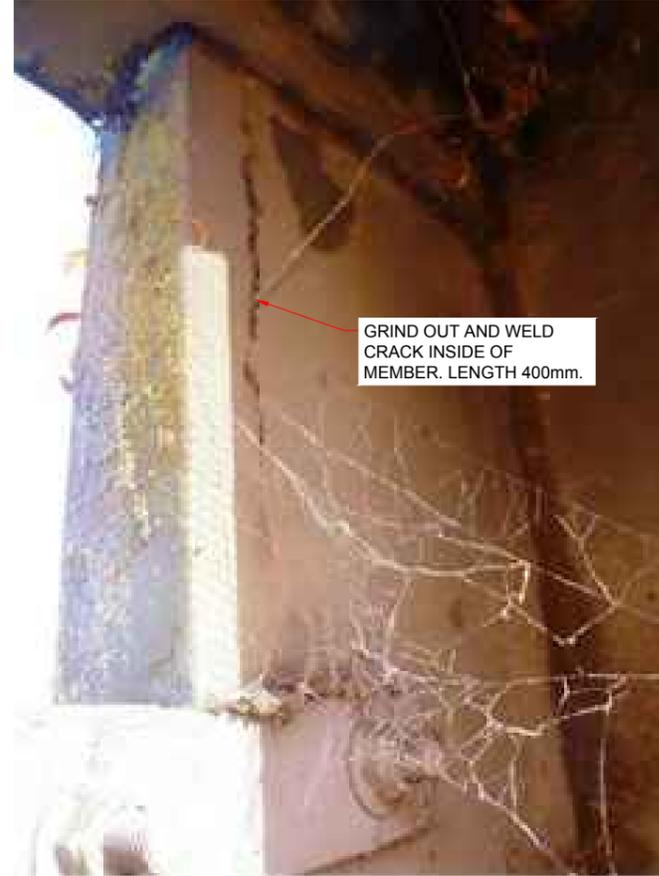
OUTSIDE OF MEMBER

GRIND OUT AND WELD CRACK INSIDE OF MEMBER. LENGTH 400mm.

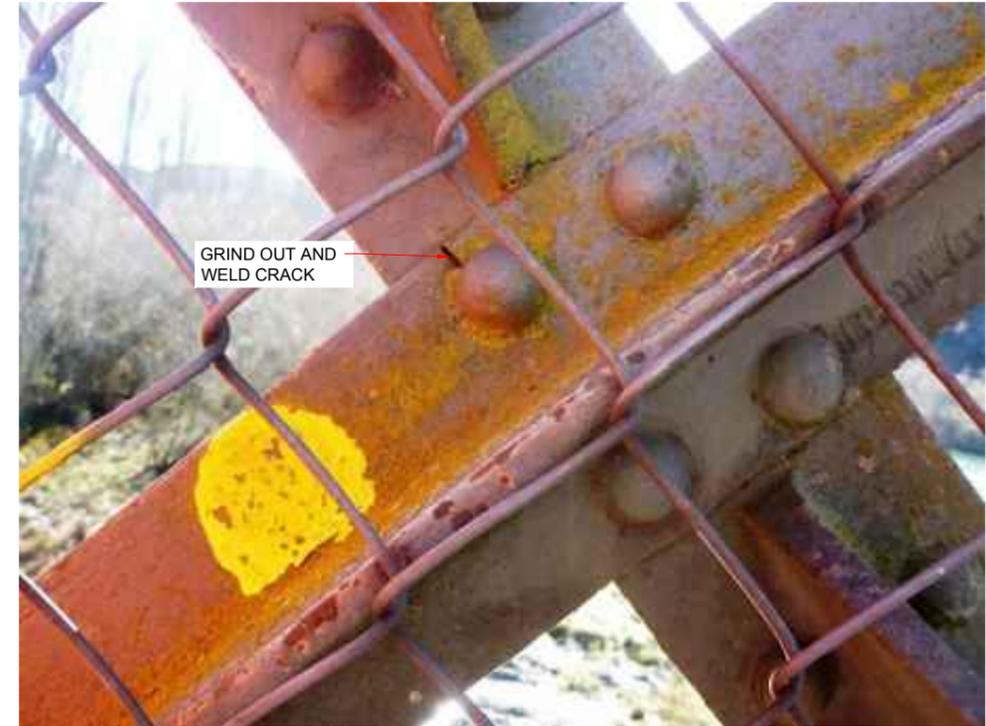
SPAN 2, UPSTREAM BAY 6 TIE- WELD CRACK

GRIND OUT AND WELD CRACK

GAS CUT TIES - PLUG WELD

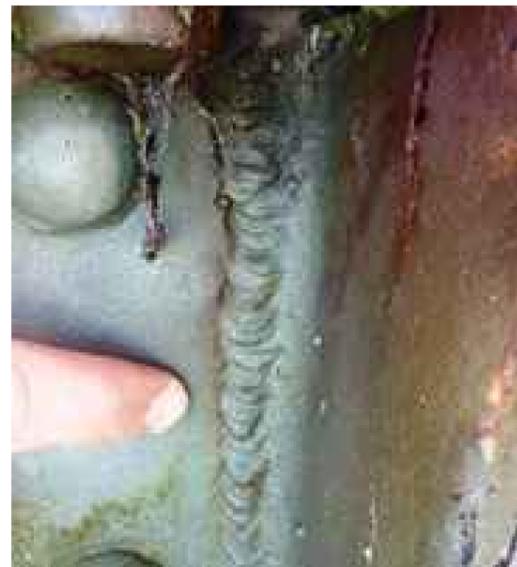
CRACK AT TOP OF WELD

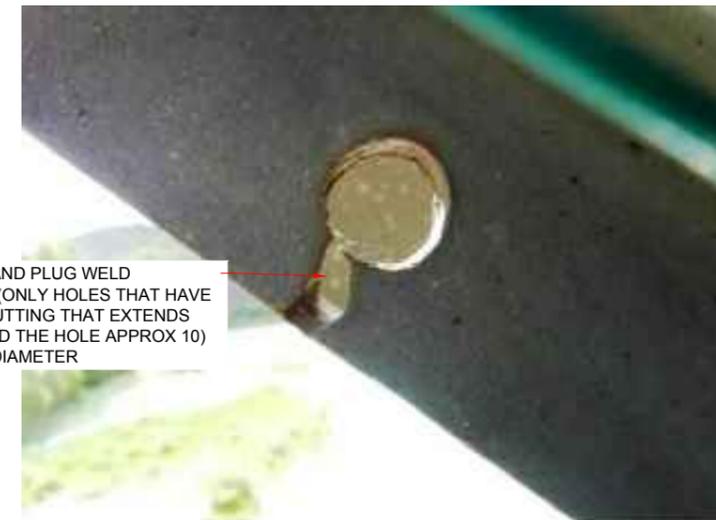
PREP AND PLUG WELD HOLES(ONLY HOLES THAT HAVE GAS CUTTING THAT EXTENDS BEYOND THE HOLE APPROX 10) 10mm DIAMETER

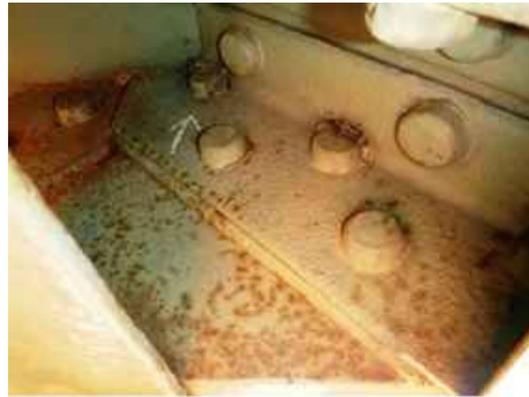
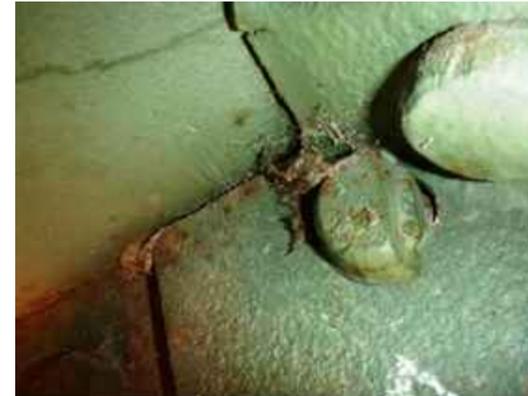
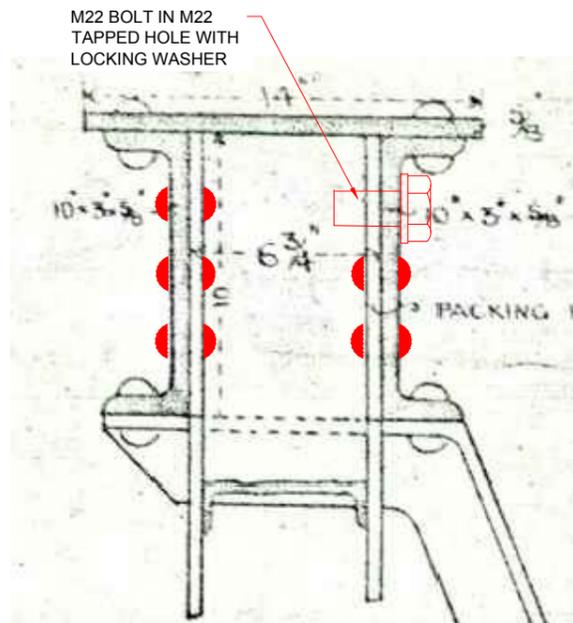
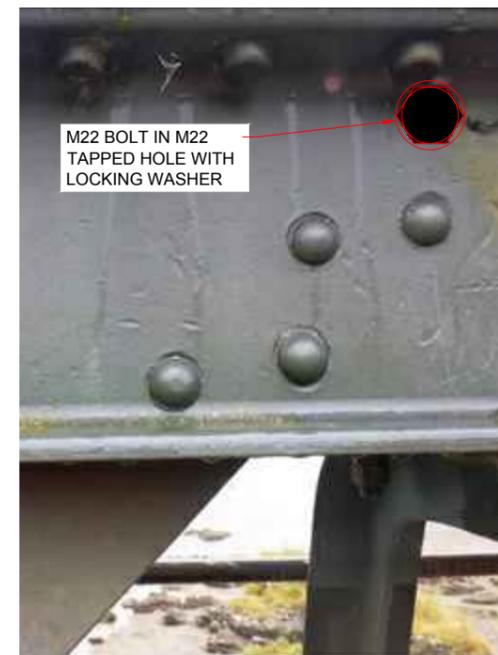
SPAN 3, UPSTREAM BAY3a - REPLACE RIVET WITH TAPPED BOLT

DRILL OUT THE EXISTING RIVET. TAP OUT THE HOLE TO SUIT A M22 BOLT. INSTALL THE BOLT FROM THE OUTSIDE FACE WITH A LOCKING WASHER. DO NOT OVER-TIGHTEN (WE DO NOT WANT TO STRIP THE THREAD ON THE WROUGHT IRON.)

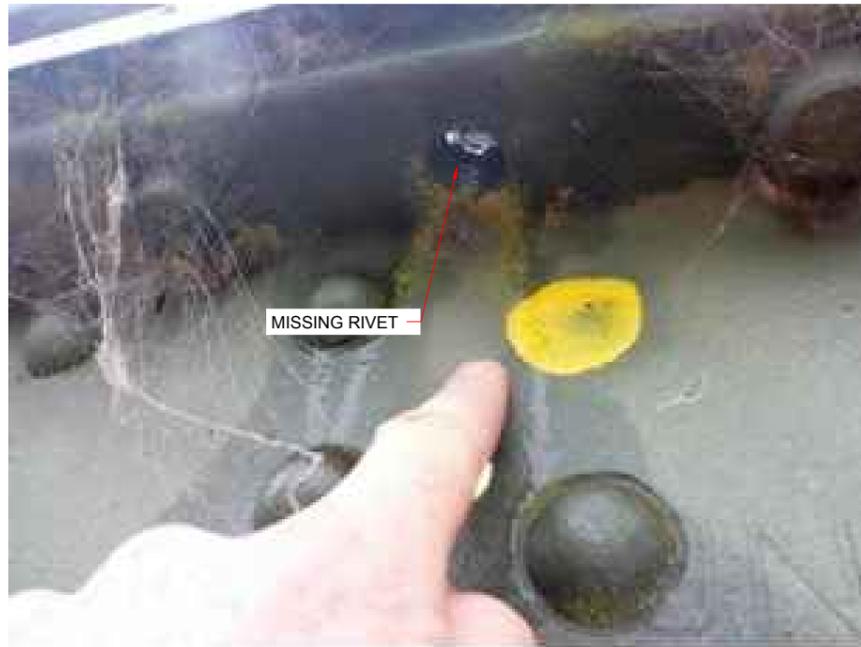
SPAN 4, UPSTREAM, BAY 3a - MISSING RIVET REPLACE WITH BOLT

A RIVET IS MISSING ON THE TOP OF THE TOP CHORD, A M20 BOLT SHALL BE INSTALLED TO REPLACE THE MISSING RIVET. TOTAL PLATE THICKNESS IS 51mm

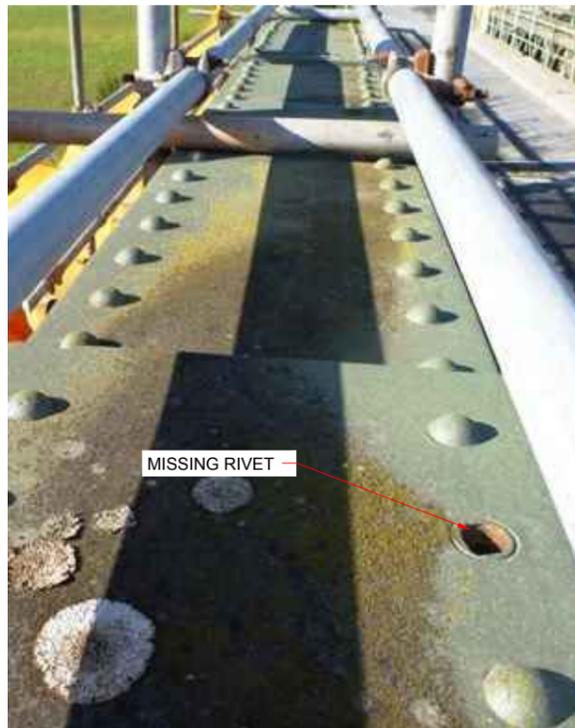
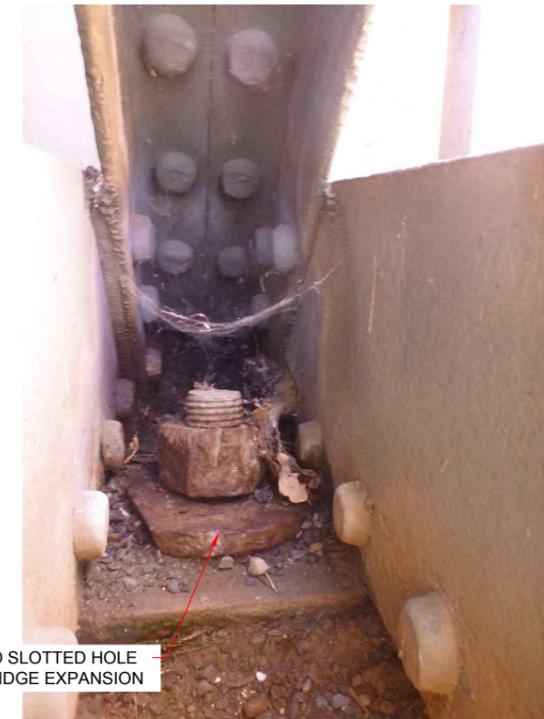
ABUTMENT A EXPANSION ALLOWANCE
(UPSTREAM AND DOWNSTREAM HOLD DOWN BOLTS)
(PROVISIONAL)

REMOVE NUT AND WASHER FROM HOLD DOWN BOLTS AT ABUTMENT A AND CUT A LARGER SLOTTED HOLE IN THE BASE PLATE TO ALLOW THE TRUSS TO SLIDE BACK FURTHER TOWARDS THE ABUTMENT BACK WALL, EXTEND HOLE BY APPROX 50mm, EXTENT TO BE CONFIRMED ON SITE BY ENGINEER. ONCE NUT AND WASHER HAVE BEEN REMOVED. REINSTATE WASHER AND NUT.
