# 11 SEISMIC DAMAGE

## 11.1 INTRODUCTION

This section is intended to provide a strategy for undertaking bridge inspections following a significant earthquake, and to give guidance on where to look for, and how to evaluate, damage to typical highway bridges in New Zealand.

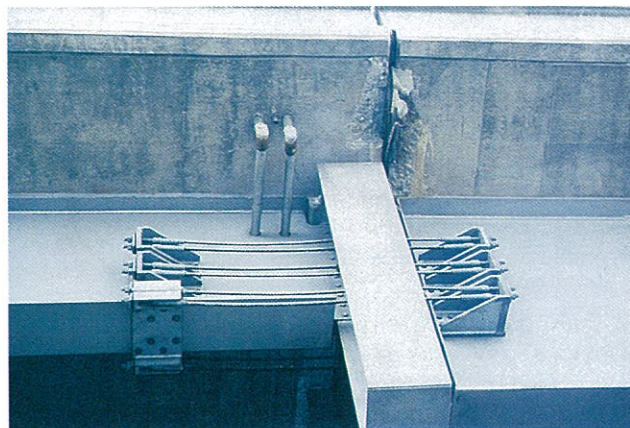
**Figure 11.1: Spalling damage at expansion joint.**

- Evidence of excessive movement of expansion joints during the earthquake;
- Expansion joints closed up;
- Knock-off devices at abutment backwalls displaced backwards and / or upwards by impact;
- Spalling of kerbs and decks either side of expansion joints;
- Buckling of handrails or traffic barriers.

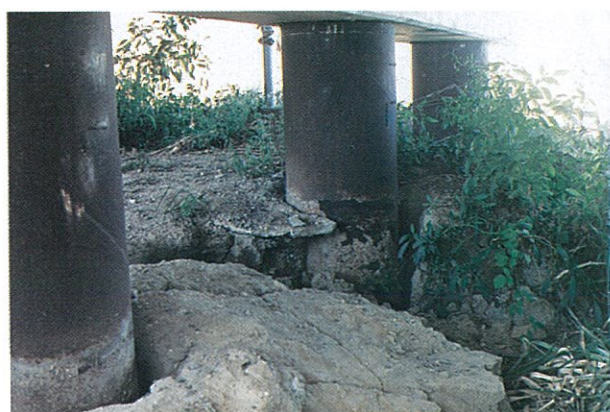
**Figure 11.3: Movement of piles in the ground.**

Tell tale signs are:

- Large relative movements between piles and the soils;
- Relative displacement between pile caps;
- Piers out of plumb.

From each of these signs a deflection of the top of the pile can be measured and a back analysis using a range of soil parameters can be used to indicate the likelihood of pile yielding. The final check is to dig them out and examine them but usually that is not easy to do.
