Human Factors of Overtaking Lane Design: Simulator Data and Research Findings

Transfund New Zealand Research Report No. 203

Samuel G. Charlton, Brett D. Alley
Brenda J. Wigmore, Peter H. Baas

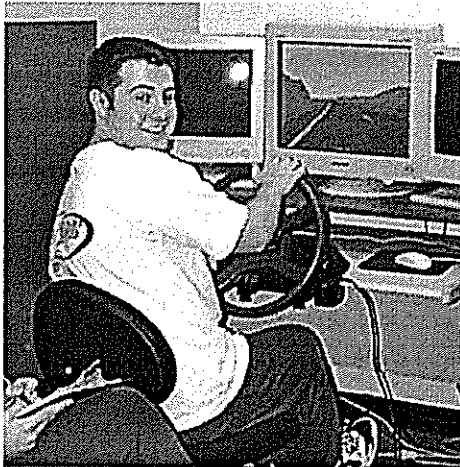
Figure A-1.
Driving simulator configuration.

Vehicle dynamics were provided by interactive non-linear multi-body simulations based on AUTOSIM vehicle models. Factors such as non-linear tyre behaviour, steering geometry, and suspension dynamics can be varied for light vehicles through to large articulated vehicles. Other vehicles can be entered in the driving scenario and controlled enabling, for example, an overtaking situation to be created.

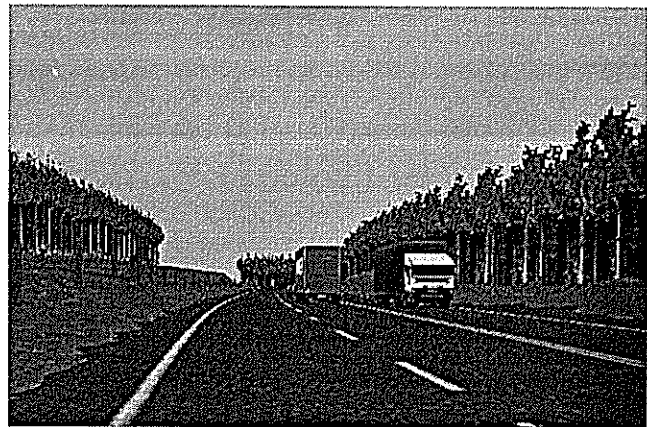
Figure A-2.
Typical simulated road scene.

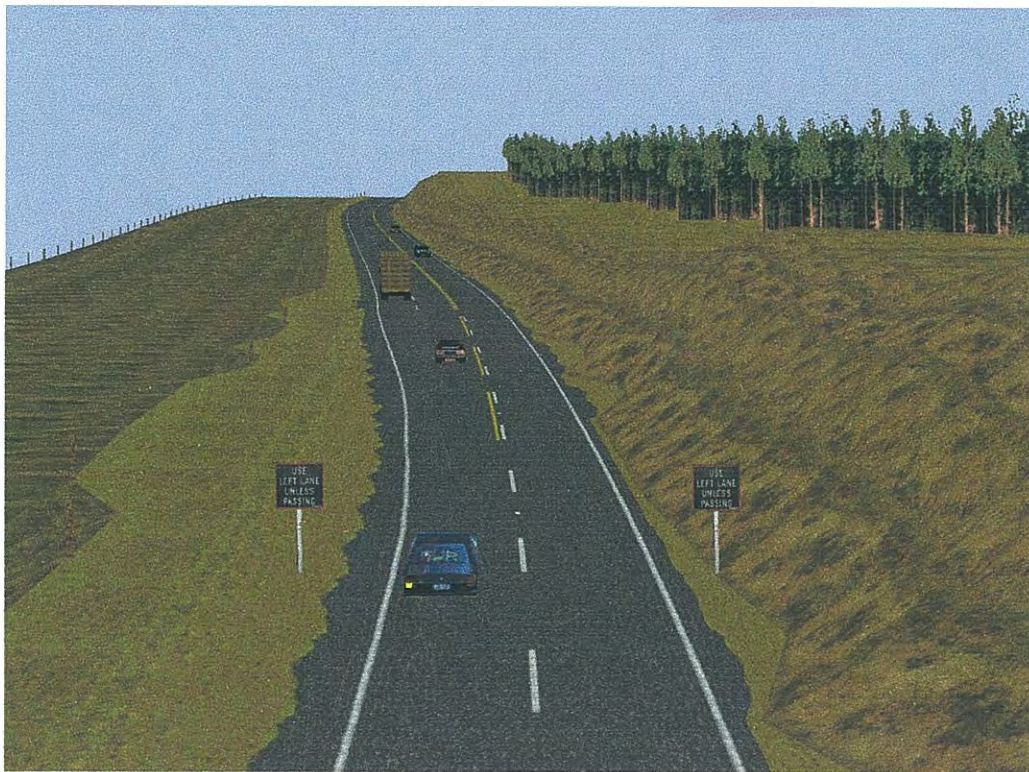
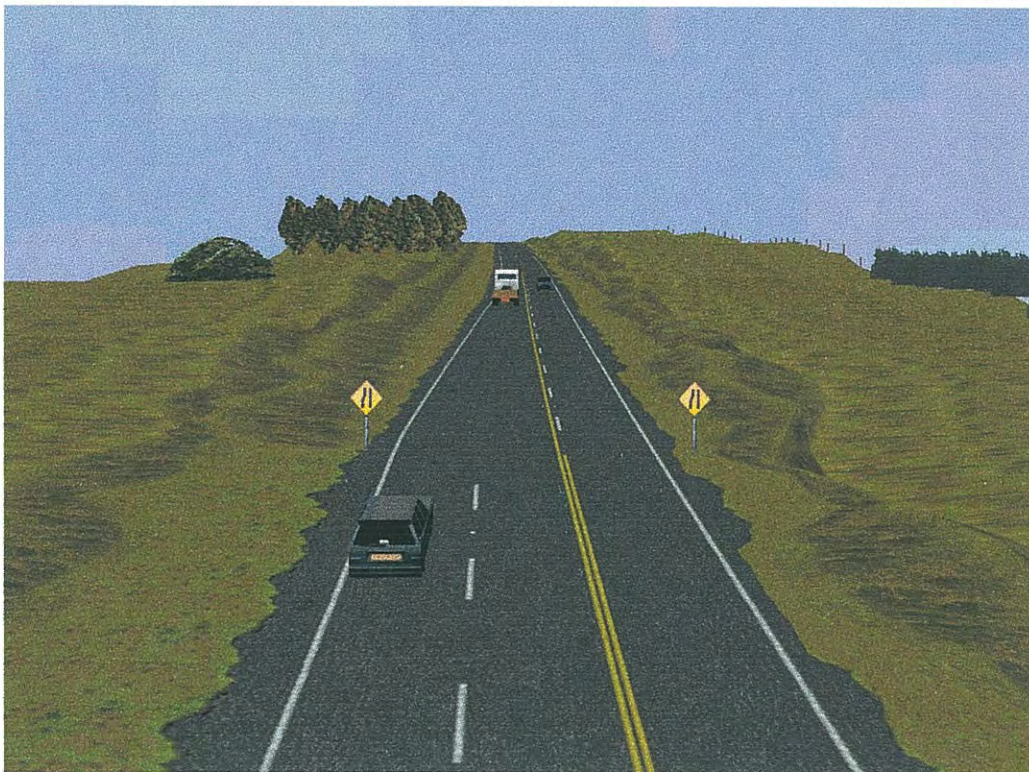
Figure 2. Current NZ Overtaking Lane Treatment as depicted in simulation

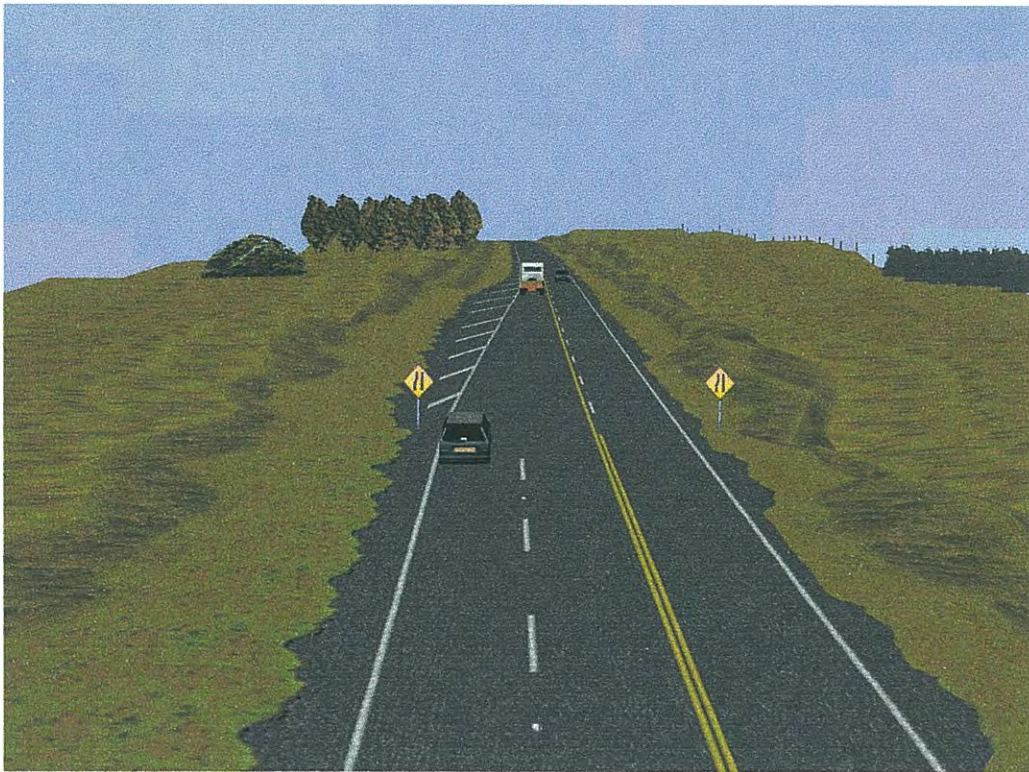
Figure 3. New NZ Overtaking Lane Treatment as depicted in simulation

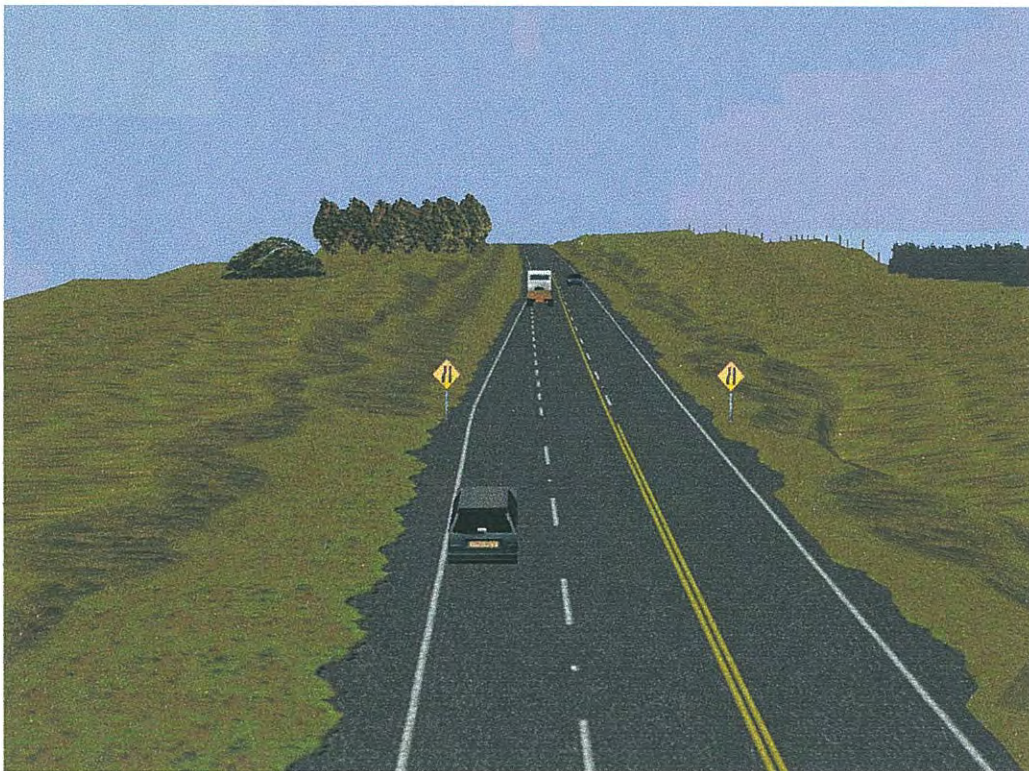
Figure 4. Modified Australian Overtaking Lane Treatment as depicted in simulation

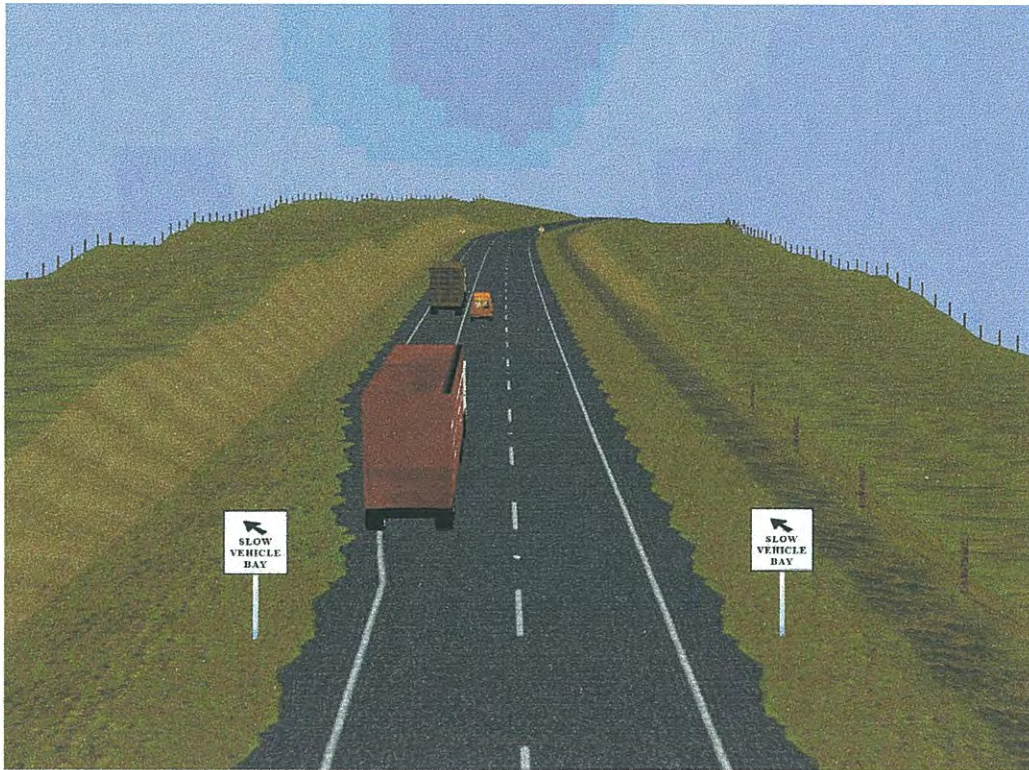
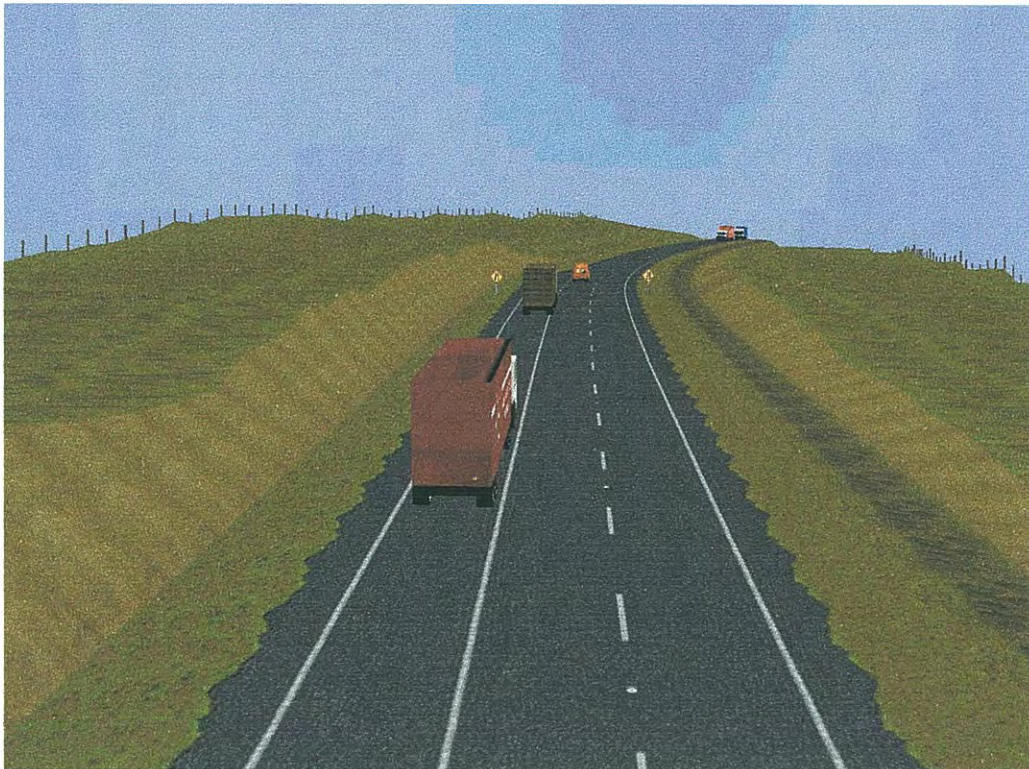
Figure 5. Slow Vehicle Bay Treatment as depicted in simulation

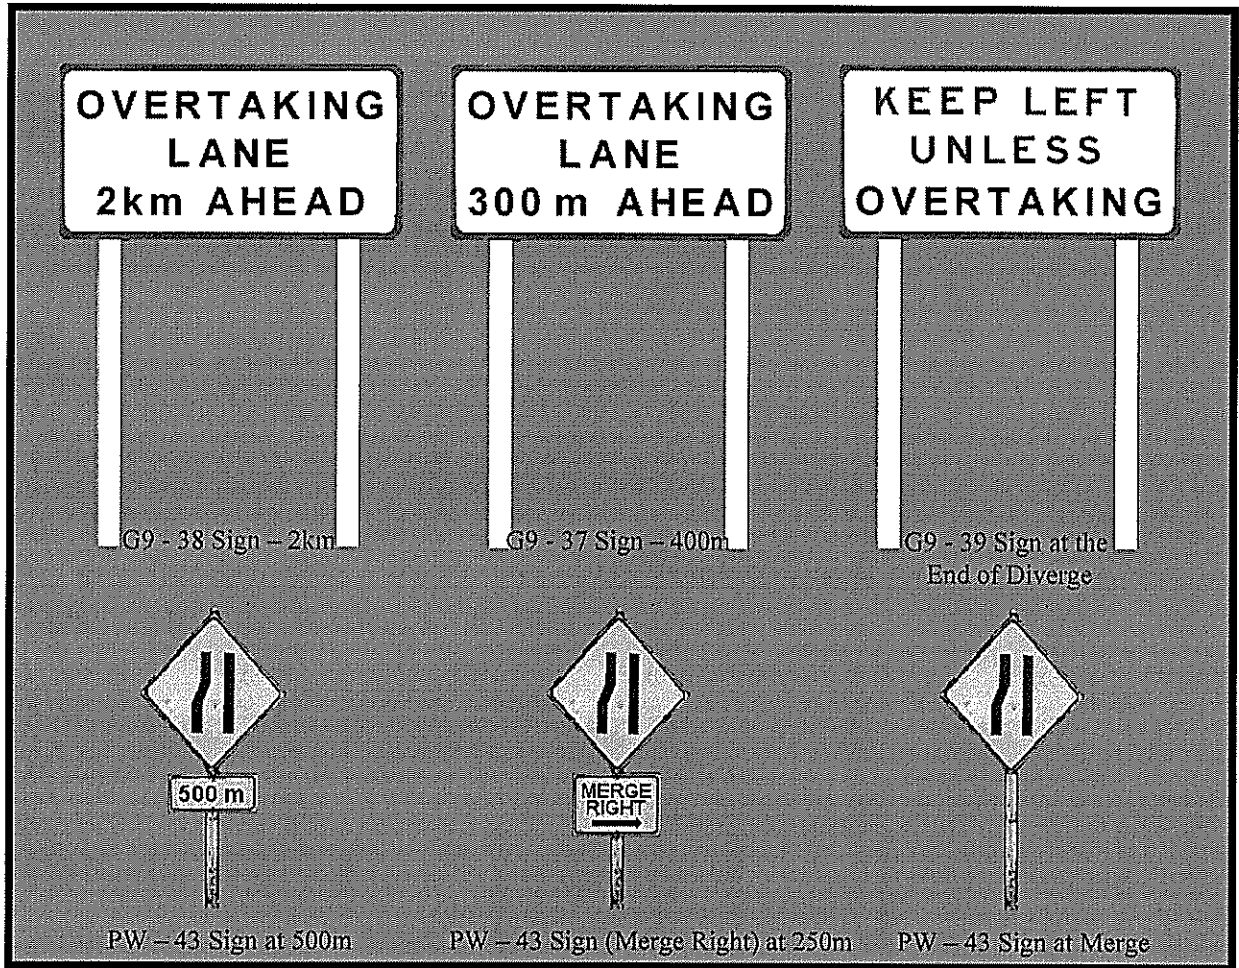
Figure 8. Signage for the Australian treatment
