Trialling pedestrian countdown timers at traffic signals

December 2010

Wanty, DK¹ and SM Wilkie² (2010) Trialling pedestrian countdown timers at traffic signals. *NZ Transport Agency research report no.428*. 38pp.

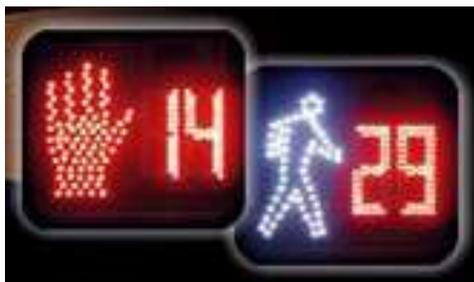
Figure 2-1 Countdown timers used in San Francisco

Only one US study commented on the type and reliability of the timer. The equipment used in San Francisco and studied by Markowitz (2006) was manufactured by GELcore and Dialight (see figure 2.1). The city operations manager reported that the countdown timers were as reliable as conventional signals.

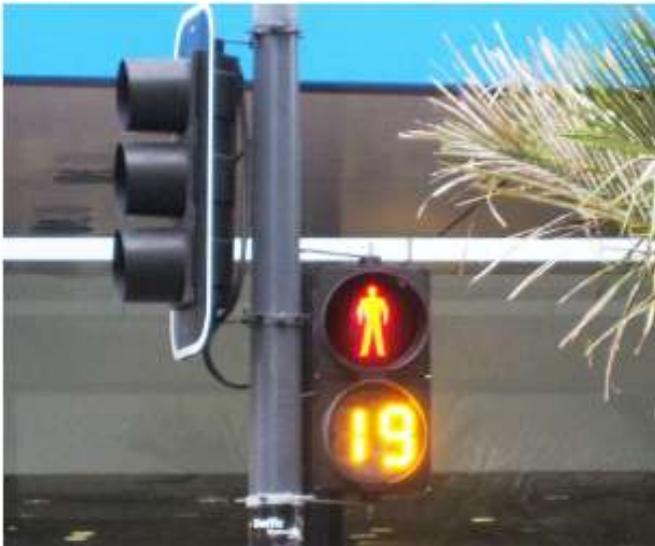
Figure 2-2 Countdown timers used in Auckland city

Opus International Consultants conducted a trial of countdown timers at two intersections in Auckland CBD (Hooper et al 2007). Two-aspect 300mm diameter signals were selected and purchased from Traffic Systems, with the countdown display in the green man aspect. These new countdown timers replaced the conventional pedestrian signals. In discussion with the supplier and researcher, no reliability issues were encountered throughout the trial. The equipment installed in Auckland is shown in figure 2.2.

Countdown timers of the type installed in Auckland have been installed in Singapore and other countries. However, no published research studies could be sourced documenting the quality of the equipment, although Singaporeans supposedly expressed strong endorsement of them and they have now been introduced everywhere in Singapore.

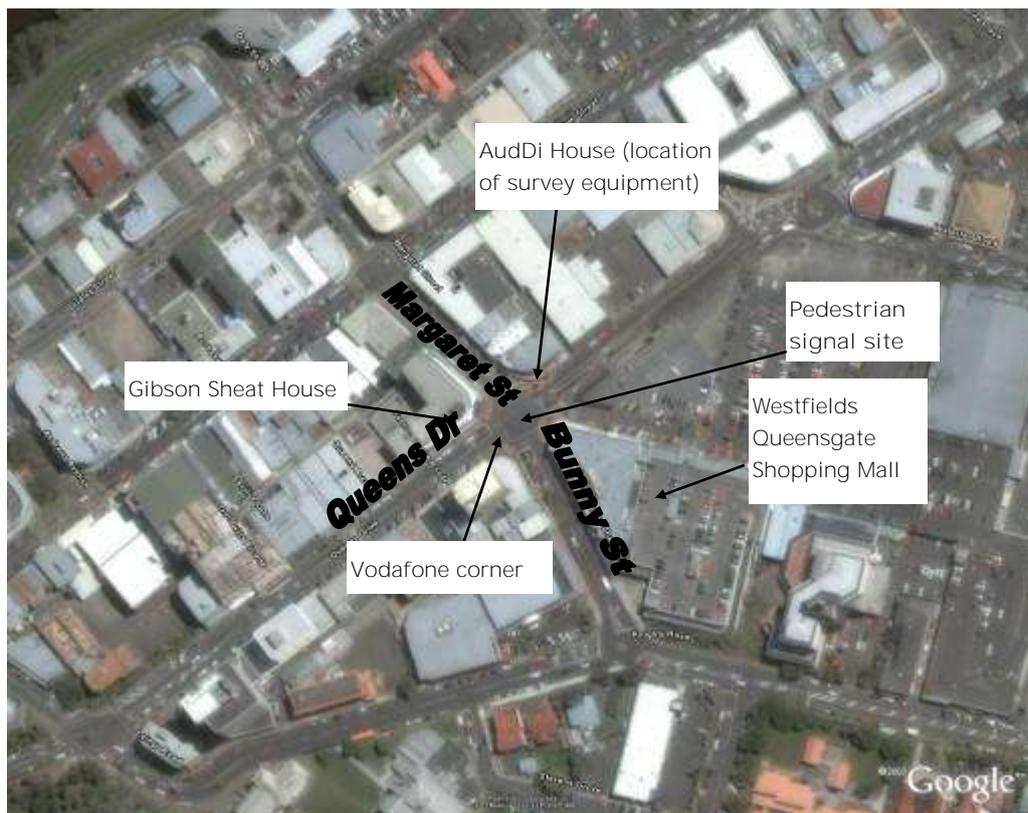
Figure 3-1 Aerial photo of site (source: Google)

The Lower Hutt intersection is shown in the aerial photo below.

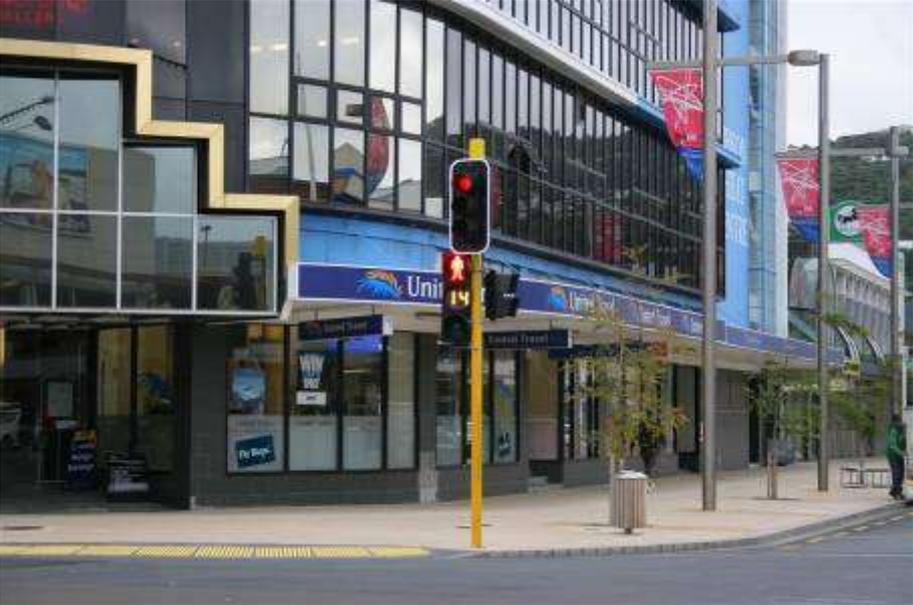
Figure 4-1 Countdown timer on southern side of Queens/Margaret outside Gibson Sheat Building with the side of the existing pedestrian signal in view

A Hutt City Council representative preferred the Auckland city equipment noting a more attractive form of the signal. This was most likely because the existing pedestrian signals were removed and replaced with the new integrated pedestrian signals. Figures 4.1 and 4.2 show the equipment installed at Lower Hutt.

The equipment selected for the trial was based on the Auckland city trial equipment. Traffic Systems built a two-aspect signal in Auckland city with the red man in the top aspect and the green animated man and the countdown timer in the lower aspect. This replaced the traditional pedestrian signals and meant that at the four-leg intersection a total of eight signals were installed.

HTS Group, the contractor, received the equipment on 6 July 2007 and installed it on 16 July. The equipment, which took only about 2½ hours to install, was simple to integrate with the existing traffic control system. Hutt City Council noted that the signals were not clearly visible from all four corners of the intersection, primarily because of the protrusion of the cowls on the signals. The cowls on the signals were removed on 20 July 2007.
