11 February 2014

Temporary Concrete Road Safety Barrier Connections - Notice of Inappropriate Practices

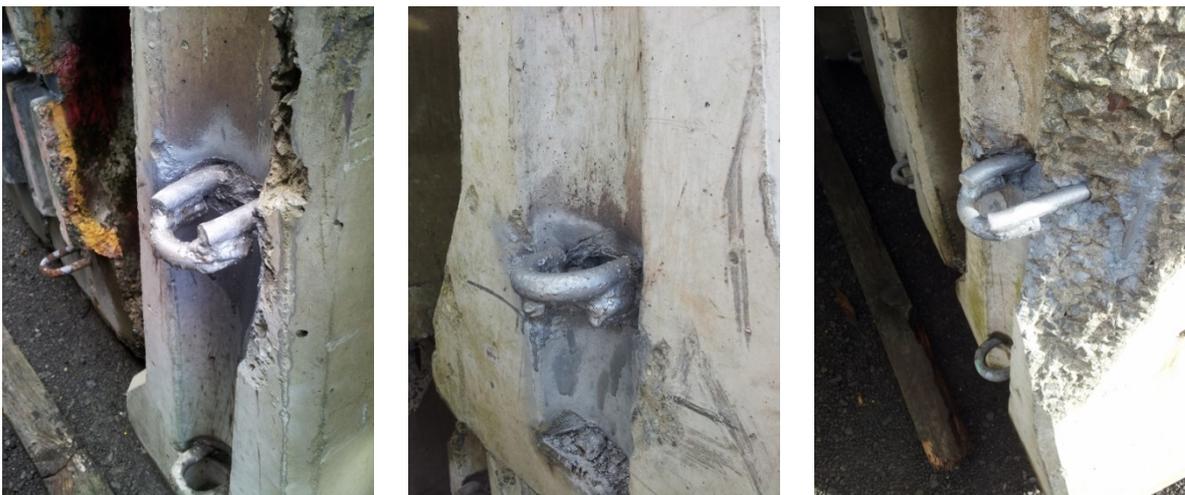
Inappropriate practices in regard to the deployment of the public domain pin and loop connections on temporary concrete road safety barrier include missing pins and the cutting (“gas axing”) and subsequent re-welding of loops as shown in the photos below.

Figure 1: Examples of cut and re-welded loops (plus general damage from mishandling)

The desire to modify the pin and loop connection appears to result from the use of mis-matched Type A and B units which have the loops at slightly different heights to facilitate easy connection

when correctly deployed. Incorrect deployment results in units being mis-aligned vertically with the loop of one unit being “perched” on the next. On-site practices to rectify this include ignoring the misalignment (leaving the units raised above the road surface) and/or use of a sledge hammer or similar to bend the loop downward. Consequently, the pin is forced into the joint, often bending it or the loops further.

This damage compromises removal of the pin during relocation or decommissioning of the temporary barriers. It is at this time that the inappropriate practice of cutting the loops to facilitate pin removal is undertaken, followed by subsequent re-welding of the loops.

Any modification of the pin and loop joint in this manner results in an untested and potentially dangerous connection between temporary concrete road safety barrier units that places both workers behind the barriers and the travelling public at risk.

Any units that have been modified in this fashion or that have suffered joint area damage must be destroyed to prevent their use.

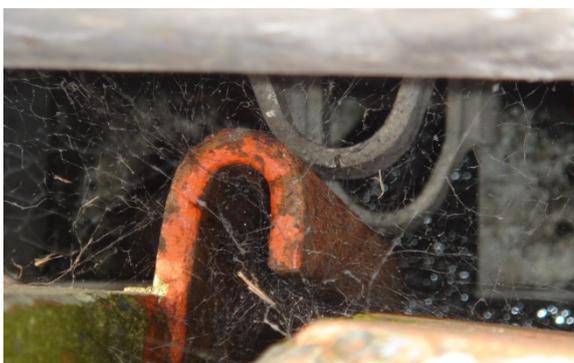
Common issues include incorrect pairing of proprietary and non-proprietary units (see Figure 2 below) and incorrect handling resulting in wrenching open the joints rendering the units un-fit for future use (see Figure 3 below).

Both practices are considered inappropriate as the integrity of the connection is compromised and the connection will fail if impacted.

Figure 2: Incorrect pairing (JJ Hooks on left)

In all cases, the supplier of the proprietary system should be contacted for instruction on correct practices for safe and proper handling of the system units.

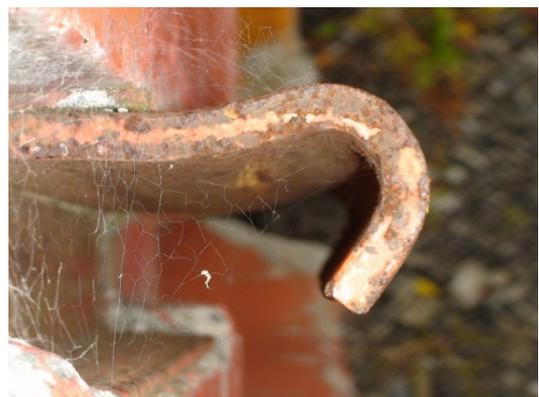
Figure 3: Wrenched joint

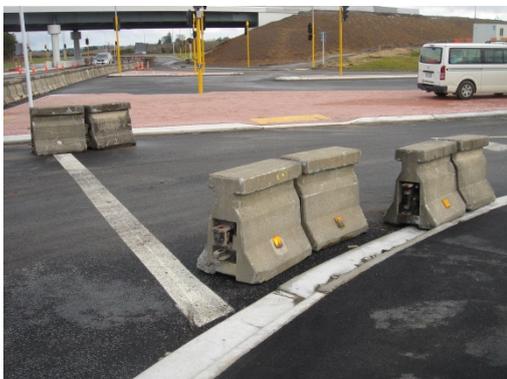
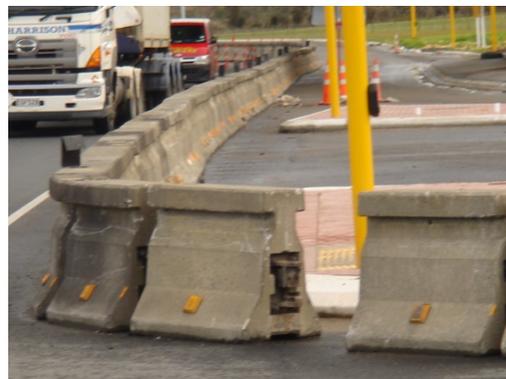
The QMB system (photos below) is a proprietary moveable barrier system utilised on the Auckland Harbour Bridge as a median barrier system to facilitate tidal flow operations whilst providing protection between opposing traffic.

The QMB system is not suitable for use at any other location on the State highway network. Use at other locations is considered a non-compliant activity. Any "retired" units must be scrapped or recycled to prevent their use.
