**PERFORMANCE OF HIGHWAY STRUCTURES
DURING THE DARFIELD AND CHRISTCHURCH
EARTHQUAKES OF 4 SEPTEMBER 2010
AND 22 FEBRUARY 2011**

NEW ZEALAND TRANSPORT AGENCY

Final Revision: 26 February 2012

**Report prepared for New Zealand Transport Agency by:
J H Wood, H E Chapman and P Brabhaharan**

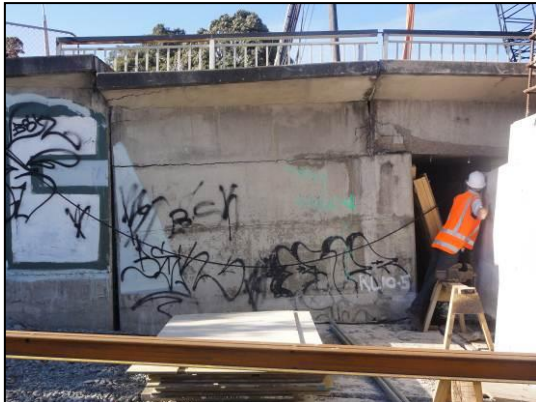
There was damage to a number of the abutment walls in the Christchurch area. The damage in the Darfield earthquake was generally limited to cracking, mainly between the abutment and wing walls due to differential displacement. The extent of damage was probably reduced by the short duration of ground shaking in this earthquake. The damage was much more extensive in the Christchurch earthquake, for example the CCC Ferrymead and Avondale Bridges - see Figures 10 and 11.

Figure 10. CCC Ferrymead Bridge. Lateral spreading damage to abutment wall and piers in the 22 February 2011 Christchurch earthquake.

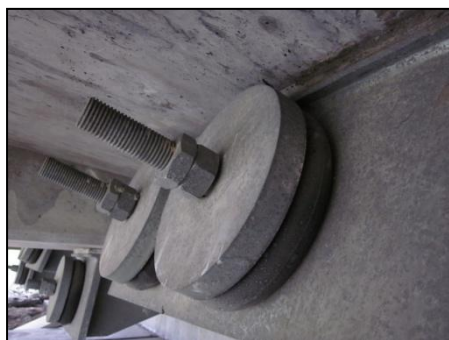
Figure C1
Linkage bars
at north abutment.

- The retrofitted linkage bolts - 10 bolts fitted with toroidal rubber rings at the north abutment (Abutment A) at which the structure is anchored longitudinally - were loose with a maximum gap of about 5 mm between the nuts and steel washers that bear on the rubber rings (Figure C1).

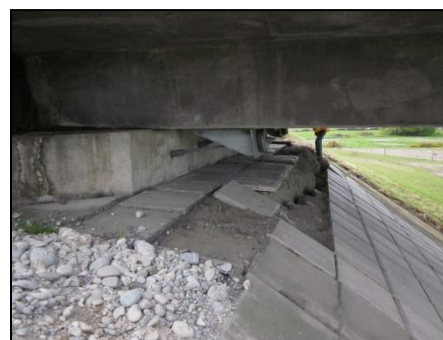
Figure C4
Damaged
paving at
north
abutment.

- Slumping and settlement of the abutment slopes which had displaced the precast concrete paving slabs of the abutment aprons. Soil slumping was worst on the northern slope where the upper paving slabs were dislodged by cracking in the soil (Figure C4).

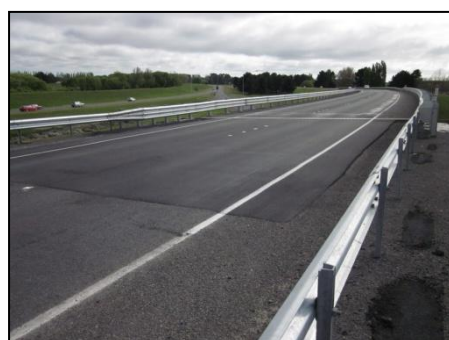
Figure C5
Repaired
pavement at north
approach.

- Lateral spreading of the northern approach fill caused longitudinal cracking of the pavement and cracks near the top of the eastern slope near the guardrail posts. We were told that the need for pavement repair to eliminate the differential steps between the backfill and abutment wall at the northern abutments and pavement damage on the approaches restricted the bridge to a single lane with a 30 km/h speed restriction for four or five days following the earthquake.

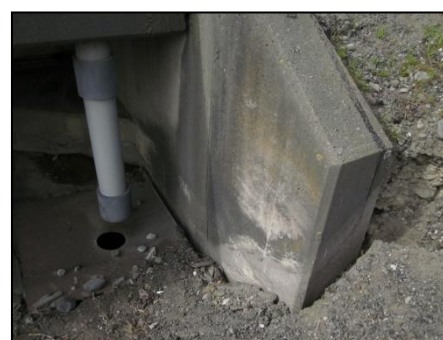
Figure C6
Settlement at
abutment.

- Relative movements between the northern approach embankment and the bridge had twisted several guardrail posts on the approach.
- The settlement and embankment movements had separated and misaligned the superstructure drainage pipes from their connection points on the abutment slopes (Figure C6).

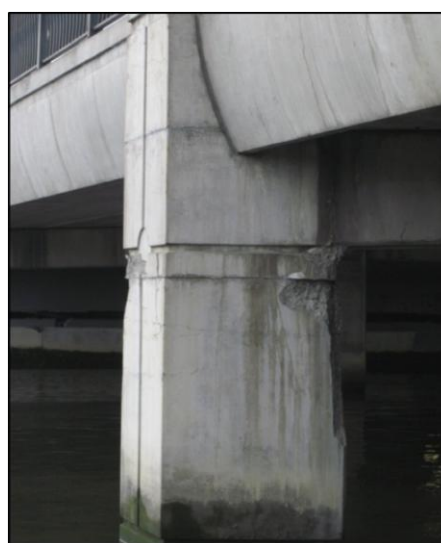
Figure AD4

East column of northern pier.

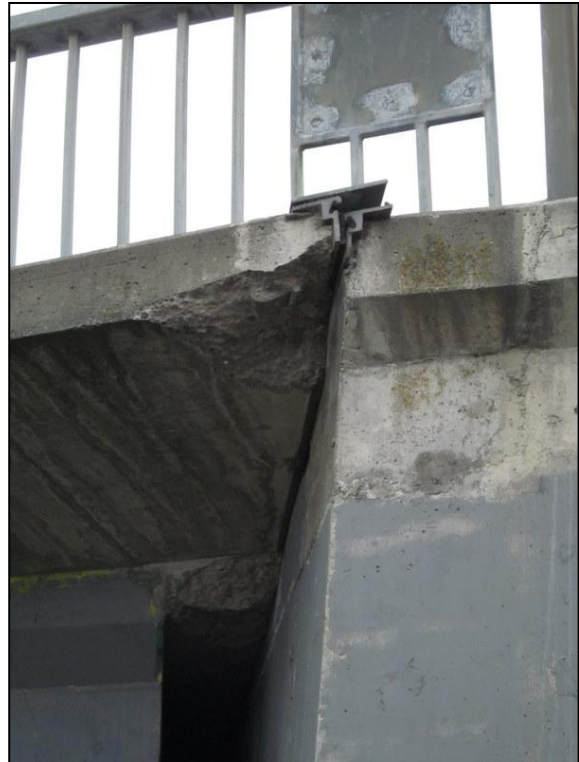
- Closing of the gaps at the abutment deck joints (Figure BS2). There was tight contact at both the north-east and north-west corners of the deck and spalling damage to the deck end at the north-west corner. The design joint gaps were 50 mm and creep and shrinkage would have increased this distance, so the sum of the forward movement of the abutments was more than 100 mm. Most of this movement may have occurred at the west abutment which had rotated more than the east abutment.

Figure BS2
Joint closed at north-west corner.

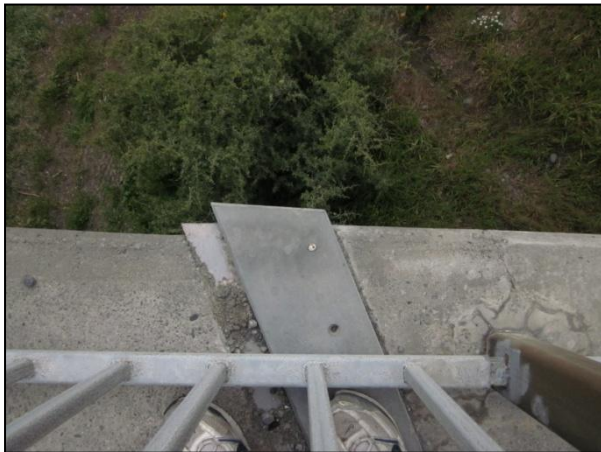
Figure BS3
Horizontal rotation at north-east corner.

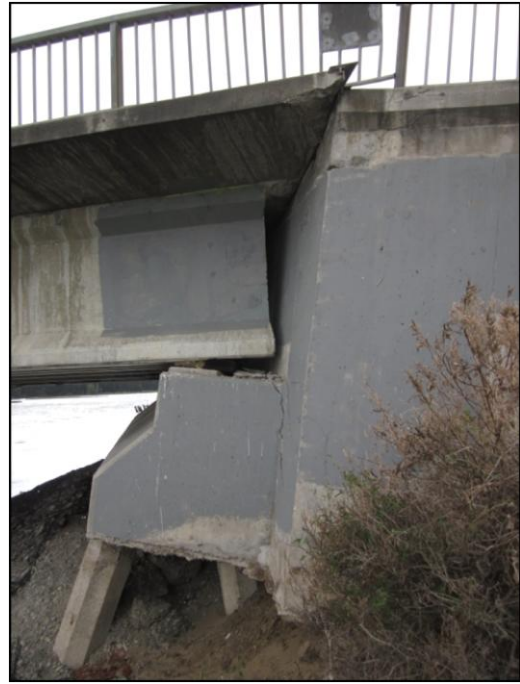
- Lateral spreading of the abutment slopes leading to rotation of the abutments about their horizontal transverse axes. The west abutment was inclined at an angle of about 0.1 radians (6°) measured relative to the ends of the beams at the north side of the abutment. This rotation was apparently caused by liquefaction of sand layers below the water table producing lateral spreading towards the river and resulting in large lateral pressures on the raked piles. The tops of some of the piles supporting the west abutment had fine flexural cracks near their intersection with the bottom of the abutment seating beam.

- Additional lateral spreading and rotation occurred at both abutments (Figure BS6). The rotation at the west abutment had increased from 0.1 to 0.16 radians (6° to 9°) (Figure BS7). The total rotation at the east abutment was about 0.1 radians (6°).
- The apparent rotation of the superstructure about a vertical axis had increased to produce offsets in the deck edges at either abutment of about 150 mm (Figure BS8).
- Deformation and sliding of the beam elastomeric bearings on the abutments had increased.
- There was increased impact damage at deck level at the abutments and damage to the deck joint rubber seals.

Figure BS7
Settlement and rotation at west abutment.

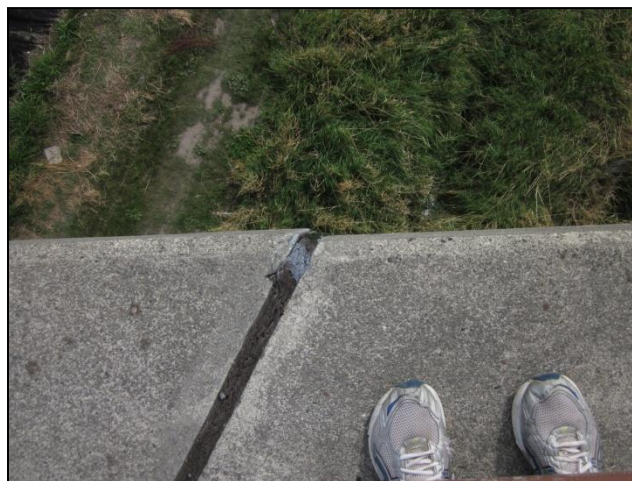
Figure RO2
Horizontal rotation at deck joint.

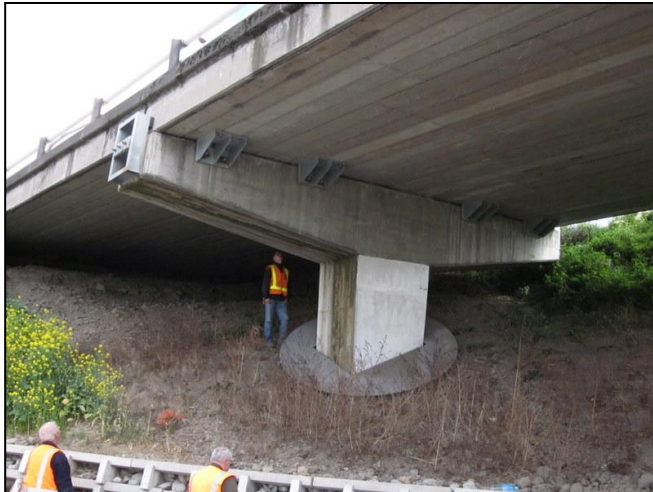
Retrofitting: The Overpass bridges were strengthened in 2009 by fixing fabricated steel shear keys to the underside of the beams at both the abutments and piers to resist longitudinal earthquake loads (Figures PH2 and PH3). Linkage bolts have been fitted between brackets located on either side of the piers by drilling through the tops of the piers to form a tight linkage between adjacent spans. The down-stand of the brackets prevents relative movement between the spans and the piers. Linkage at the abutments has been provided by bolts extending between the brackets and the soil face of the abutment seating, with a 10 mm gap left to allow for temperature movements.

Figure PH2
Pier shear keys and annulus
around pier.

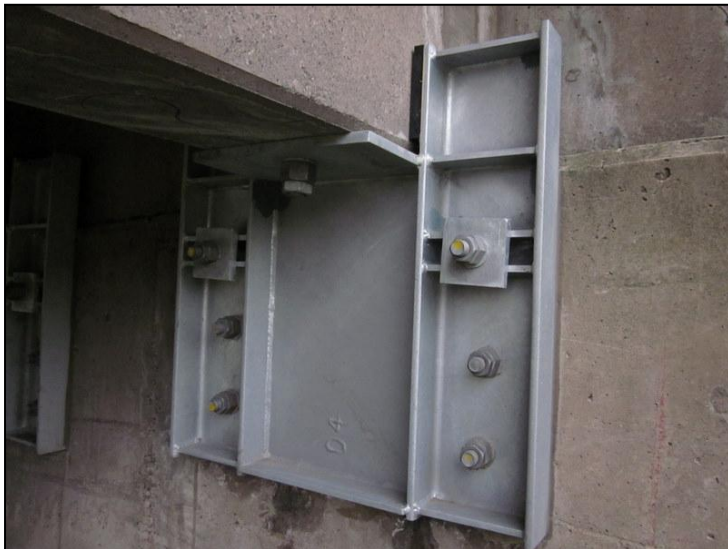
Retrofitting: The Overpass bridges were strengthened in 2009 by fitting fabricated steel shear keys at the abutments, primarily to resist transverse loads. However, each of the nine brackets at each abutment, which are shared by both bridges, is fitted with a 30 mm bolt into the bottom of the beam (Figure HO5). This provides longitudinal restraint in addition to that provided by the original linkage and holding down bolts. Additional linkage bolts were added between the outer beams at each pier (Figure HO6). These were designed to improve the deck diaphragm action.

Figure HO5
Shear key at abutment.

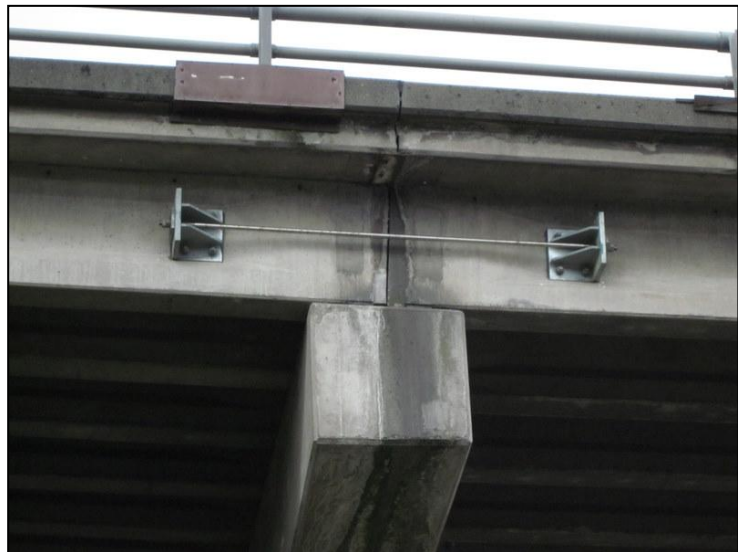
Figure HO6
Linkage bolt at pier.

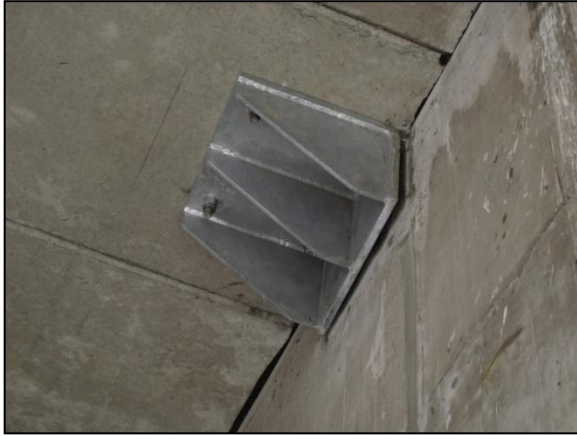
Figure HVO1
Shear bracket on underside of deck units.

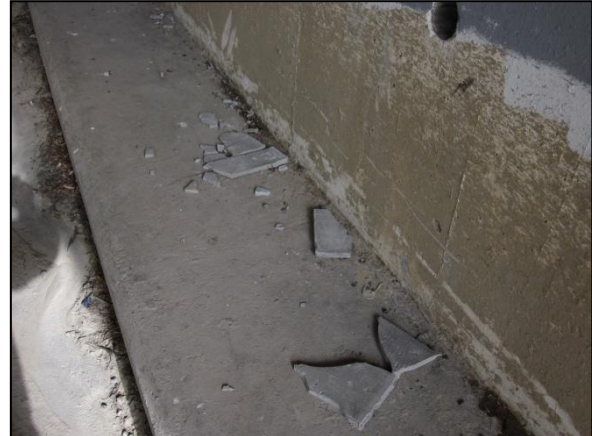
- Damage to previous repairs and some new spalling damage at the ends of the abutment nib walls, deck edges in contact with the nib walls and at the tops of the wing walls. Most of this damage was observed after the first event and was mainly confined to the Lyttelton end of the bridge.
- Loss of mortar between the face of the new shear brackets anchored to the deck and the face of the top of the abutment walls (Figures HVO1 and HVO2). The mortar had not adhered satisfactorily to the concrete or steel brackets and there was no method of retaining the mortar in place. Without it there is a risk of excessive movement leading to damage of the nibs on the abutment walls.
- Relative settlement between the approach pavement and the abutments as evidenced by the strips of recent pavement repair adjacent to the abutments.

Figure HVO2
Mortar on ground from brackets above.

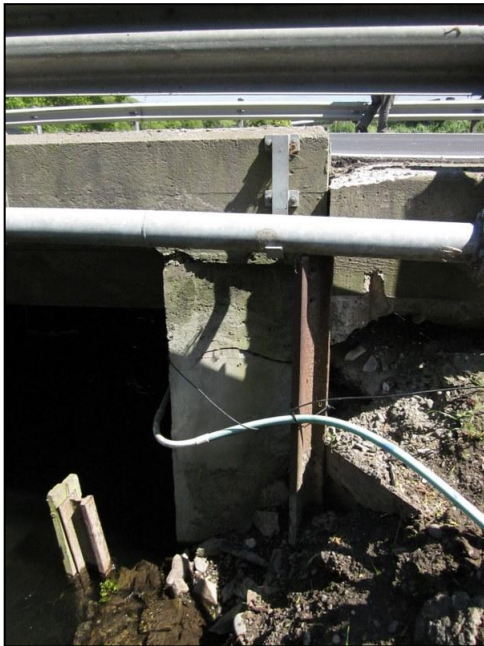
Figure H1
North-east corner.

Structure Strength and Performance Longitudinally: There was clear evidence of soil liquefaction at the site with cracks in the stream banks adjacent to the bridge indicating lateral spreading of the banks towards the stream. The approach fills had settled about 100 mm relative to the bridge with the step at the backfill interface with the abutment walls repaired with new asphaltic seal after the earthquake.

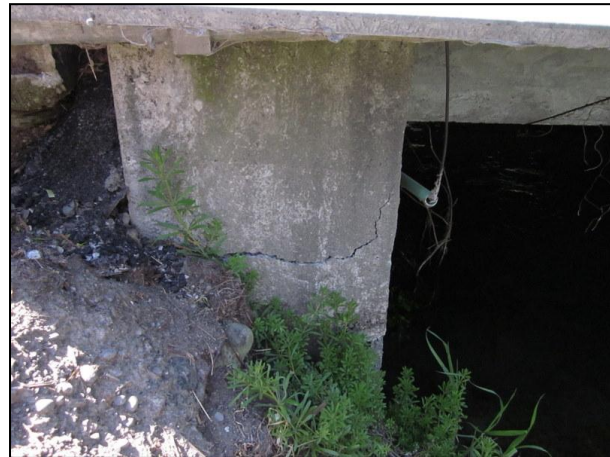
Figure H2
North-west corner.

Liquefaction presumably occurred in sandy soils below the stream bed level, which is about 400 mm below the bottom of the walls. The drawings show the piles founded in gravel at a depth of about 2.2 m below the stream bed so the liquefied layer may not have been very deep. The pile tips are at about 4.6 m below bed level and as there was no obvious settlement of the bridge it is unlikely that liquefaction reached this depth. Because the soil profile is not known in any detail it is not possible to reliably calculate the effects of liquefaction on the bridge. Calculations showed that the walls had insufficient flexural capacity to resist passive Rankine earth pressures. During lateral spreading pressures against restrained structures can be up to about four times greater than Rankine pressures.

The lateral pressures on the piles may have also loaded the base of the walls and contributed to the failures. Failure of the walls from the lateral spreading pressures would therefore be expected. Plastic hinging in the tops of the piles may have also occurred as their combined flexural strength is lower than the flexural strength of the wall.

- Since it is likely that the bridge will need to be replaced, and in view of its small size, no follow-up investigations or analysis are recommended.

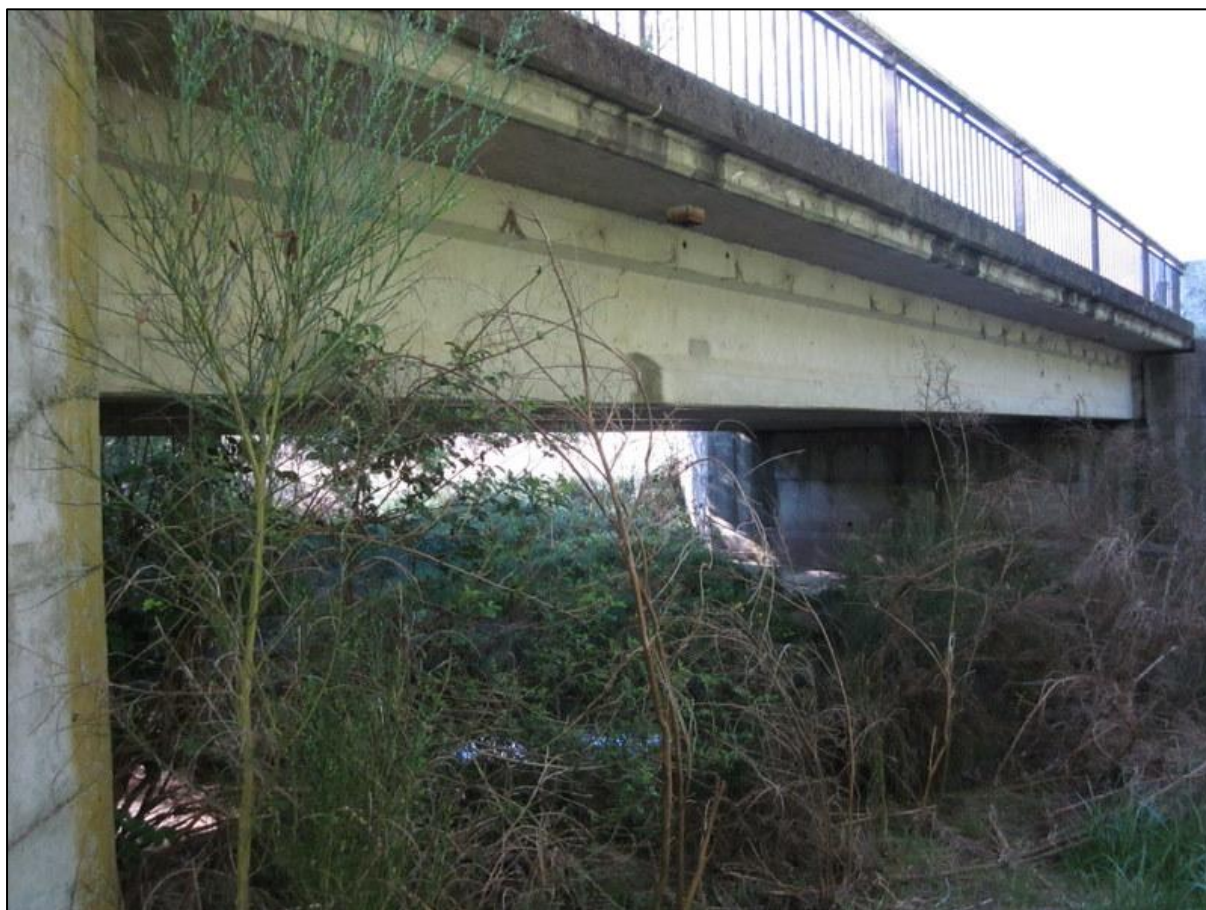
SH77 Wairiri Stream Bridge, looking north.

No structural damage to the bridge was observed during the inspection. Except for piles on the north side of the west end of the bridge the piles were covered by soil and could not be inspected.

The pavement had recently been repaired at both abutments. These repairs smoothed out settlement steps at the abutment interfaces which probably occurred during the earthquake. Although it was not possible to obtain a direct measure of the amount settlement it appeared to be significant and of the order 50 mm.

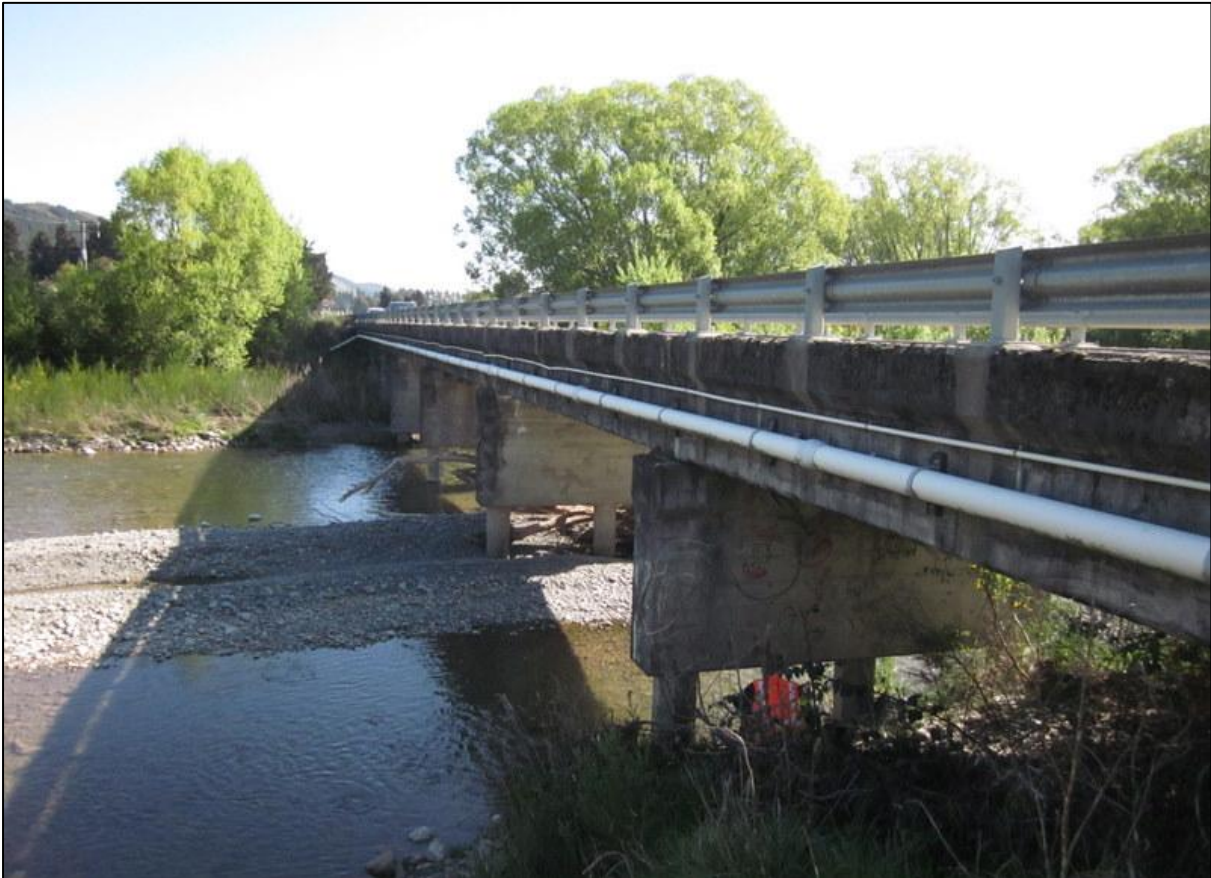
SH77 Selwyn River Bridge, looking south-west.

No significant structural damage to the bridge was observed during the inspection but the following minor points were noted:

- A spall was observed on the top of one of the piles at the west abutment. This spall, or perhaps pile top cracking, may have been present prior to the earthquake. The pile tops, which are the most critical area for damage under transverse response, were not visible at five of the nine piers and at the abutments except for several at the west abutment.

- There were a number of wide cracks in the soil on the river bank slope at the west end of the bridge and gaps between the soil at down-slope sides of the abutment, adjacent pier and the pier closest to the river (the third from abutment). Although the slopes were not steep the surface soil appeared to be very soft. The cracking had probably been caused by lateral spreading from liquefaction but it may have been caused by a shallow slope failure in the soft soil.

- At the west abutment, steps in the concrete kerb lines, repaired pavement, and settlement marks on the front face of the abutment wall and at guardrail posts indicated that the approach fill had settled by about 50 mm at the soil interface with the abutment backwalls. This settlement may have been related to a local area of liquefaction also indicated by the soil spreading on the slope to the river. Settlement of about the same order was evident at the east abutment but it was not clear how much of this had existed prior to the earthquake.

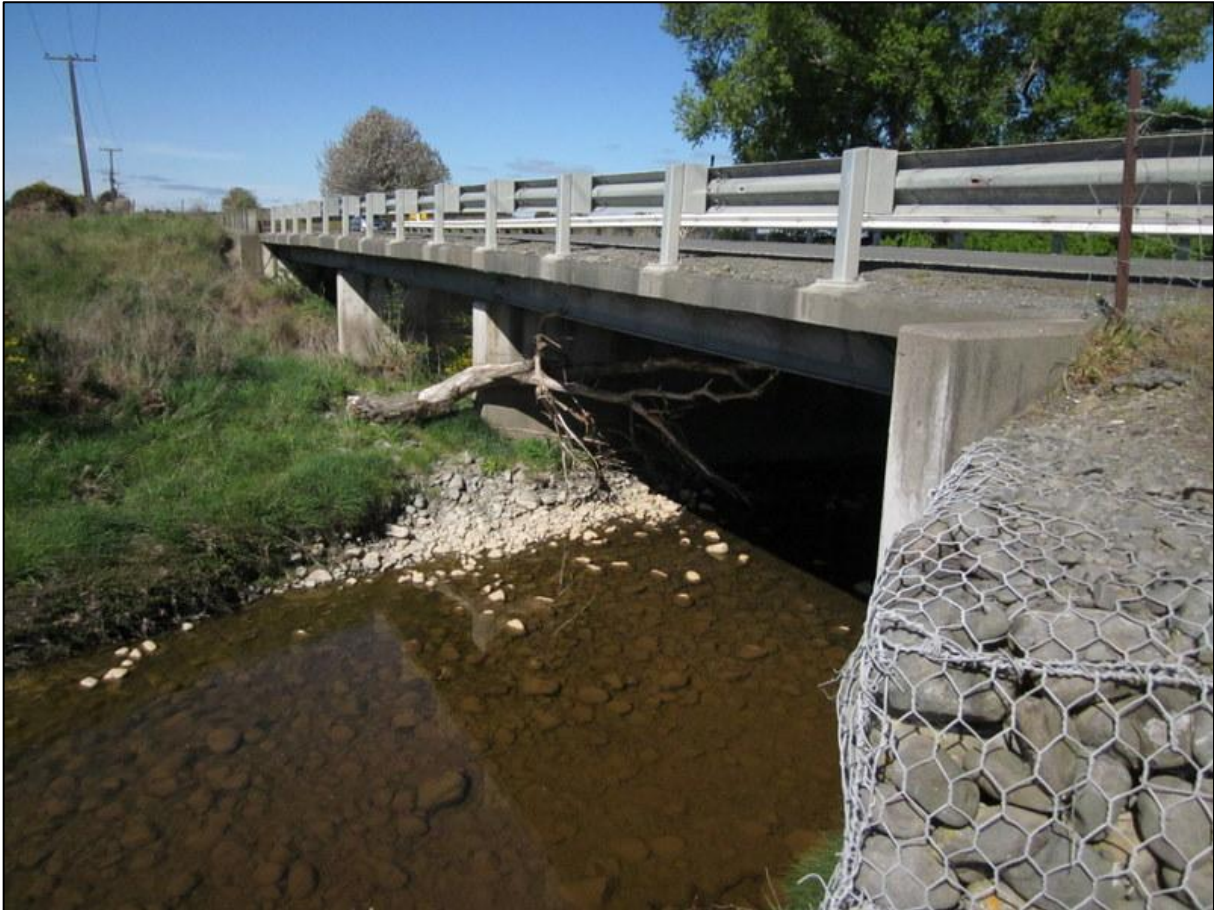
SH77 Waianiwaniwa River Bridge, looking east.

No earthquake related structural damage to the bridge was observed during the inspection. The tops of the piles, where damage might have been expected, were covered by soil at the abutments and water and soil at the piers, so were not inspected.

- There is a big difference between the predicted transverse response acceleration (1 g assuming 5% critical damping) and the acceleration at which the flexural capacity of the tension-side concrete piles in the piers would be reached (0.6g). This difference could be significantly reduced by damping from the soils retained against the abutments. In this case the pier piles would probably not be at risk of damage.
- The tops of the outer concrete piles at the piers should be inspected for a metre below the pier walls for possible flexural damage.

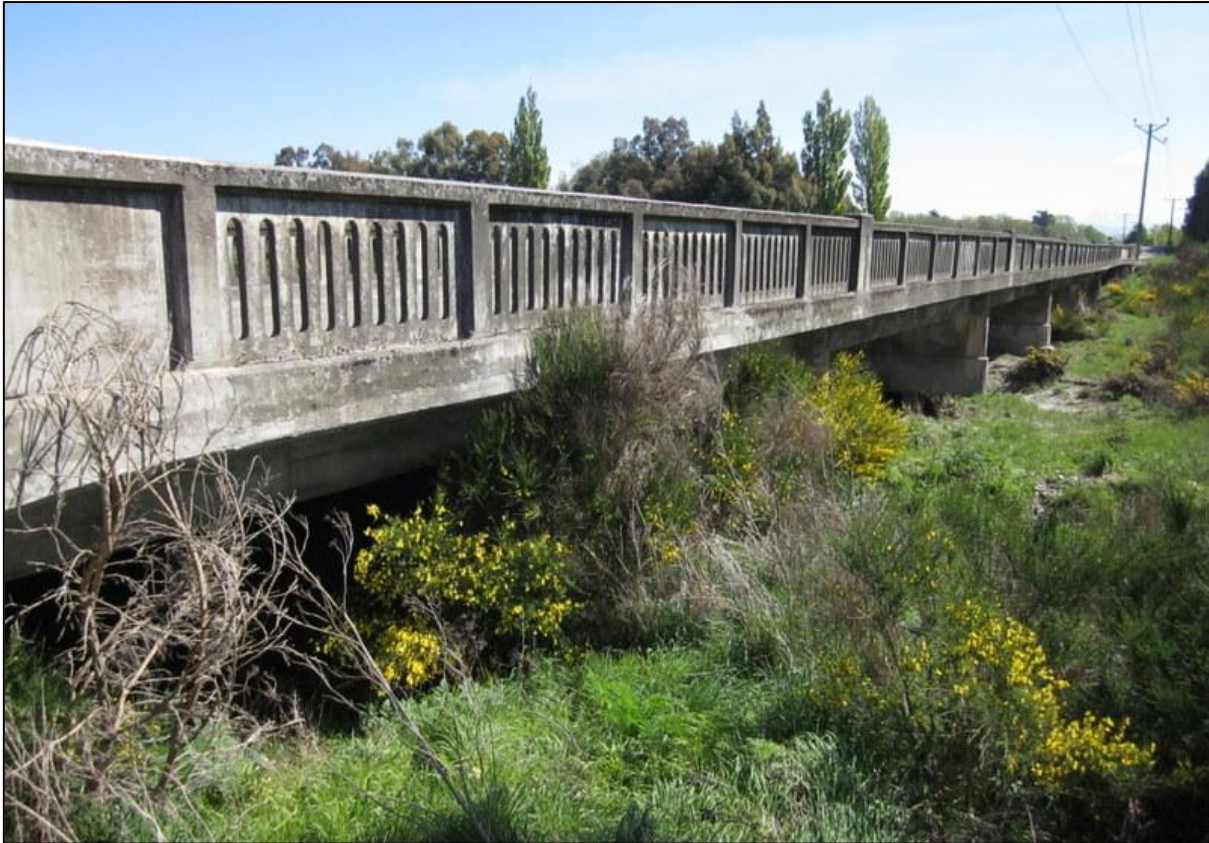
SH77 Hawkins River Bridge, looking west.

Minor earthquake related structural damage to the bridge was observed during the inspection:

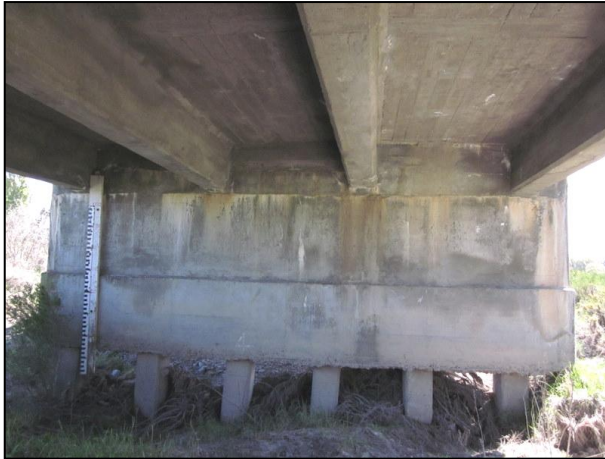
- Spalling and cracking was present in the tops of the piles at the underside of four of the five pier walls (Figures HA1 and HA2). The pile tops were not visible at the central pier. The damage was more pronounced at the second pier from each abutment than at the piers closest to the abutments and was probably caused by transverse response. If the pier piles had suffered cracking damage from longitudinal response this would be at the maximum bending moment points about 1 m below ground level and would not have been visible.

Figure HA1
Pier and piles.

Figure HA2
Spalling in pile under pier
pilecap, probably due to
transverse loading on
bridge.

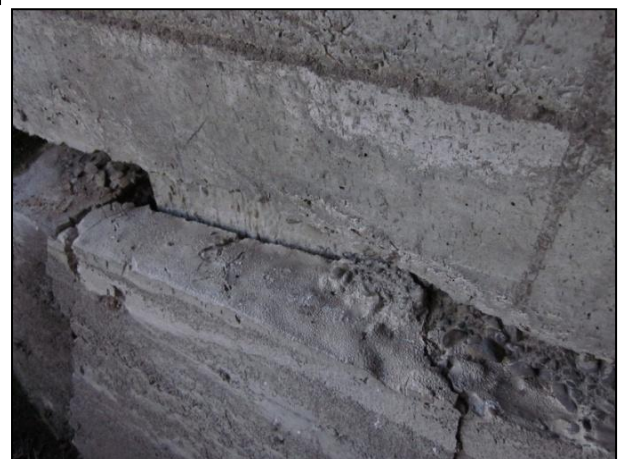
- At both abutments infill concrete has been placed below the underside of the abutment structural wall and around the piles to prevent scour of the abutment backfill. The maximum height of the infill was about 1 metre and it appeared to completely surround the piles. At the west abutment this infill concrete had wide vertical cracks near the interface with the piles. There was also cracking and spalling at the interface of the infill with the structural abutment wall at the east abutment but this was mainly in plaster that had been placed in the gaps in the horizontal construction joint. The cracking damage to the west abutment infill concrete suggested that there had been significant longitudinal movement of the abutments - perhaps of the order of 10 mm (Figures HA3 and HA4).

Figure HA4
Cracking indicating possible
longitudinal displacement.
