New Zealand Transport Agency

**Lessons from the 2016 Kaikoura
Earthquake for Resilience Studies**

Opus International Consultants Ltd

Report No GER 2017 - 29

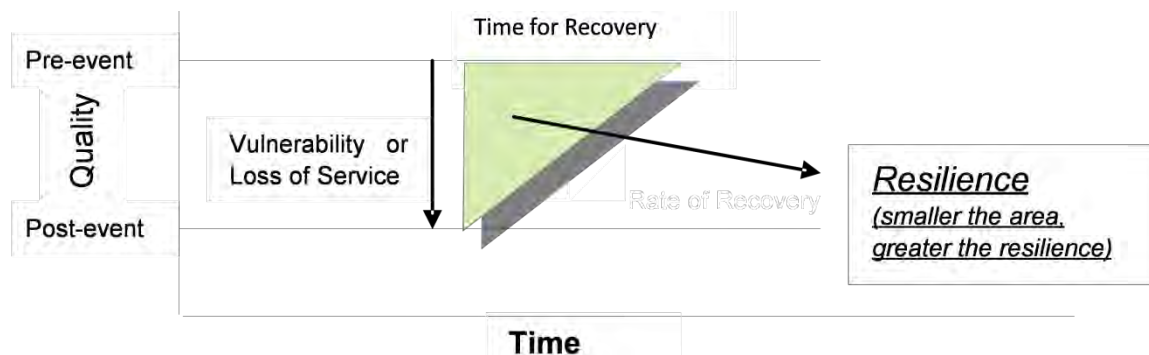
Illustration 2.1 - Resilience of Network

Resilience of roads is dependent on the loss of quality or serviceability, and the time taken to bring the road back into its original usage state. This is shown conceptually in Illustration 2.1 (after Brabhaharan, 2006). The smaller the shaded green area, the more resilient is the lifeline. The greater the area, the poorer is the resilience. Note that this diagram is idealised as it assumes a uniform rate of recovery after event, whereas for longer duration closures, its likely to be more complex, with intermediate stages of partial recovery and the level of service may not be able to be restored to the full pre-event level, or in some cases may be able to be restored to a higher level of resilience (Brabhaharan, 2006). This was borne out in the Kaikoura earthquake as discussed later in the report.

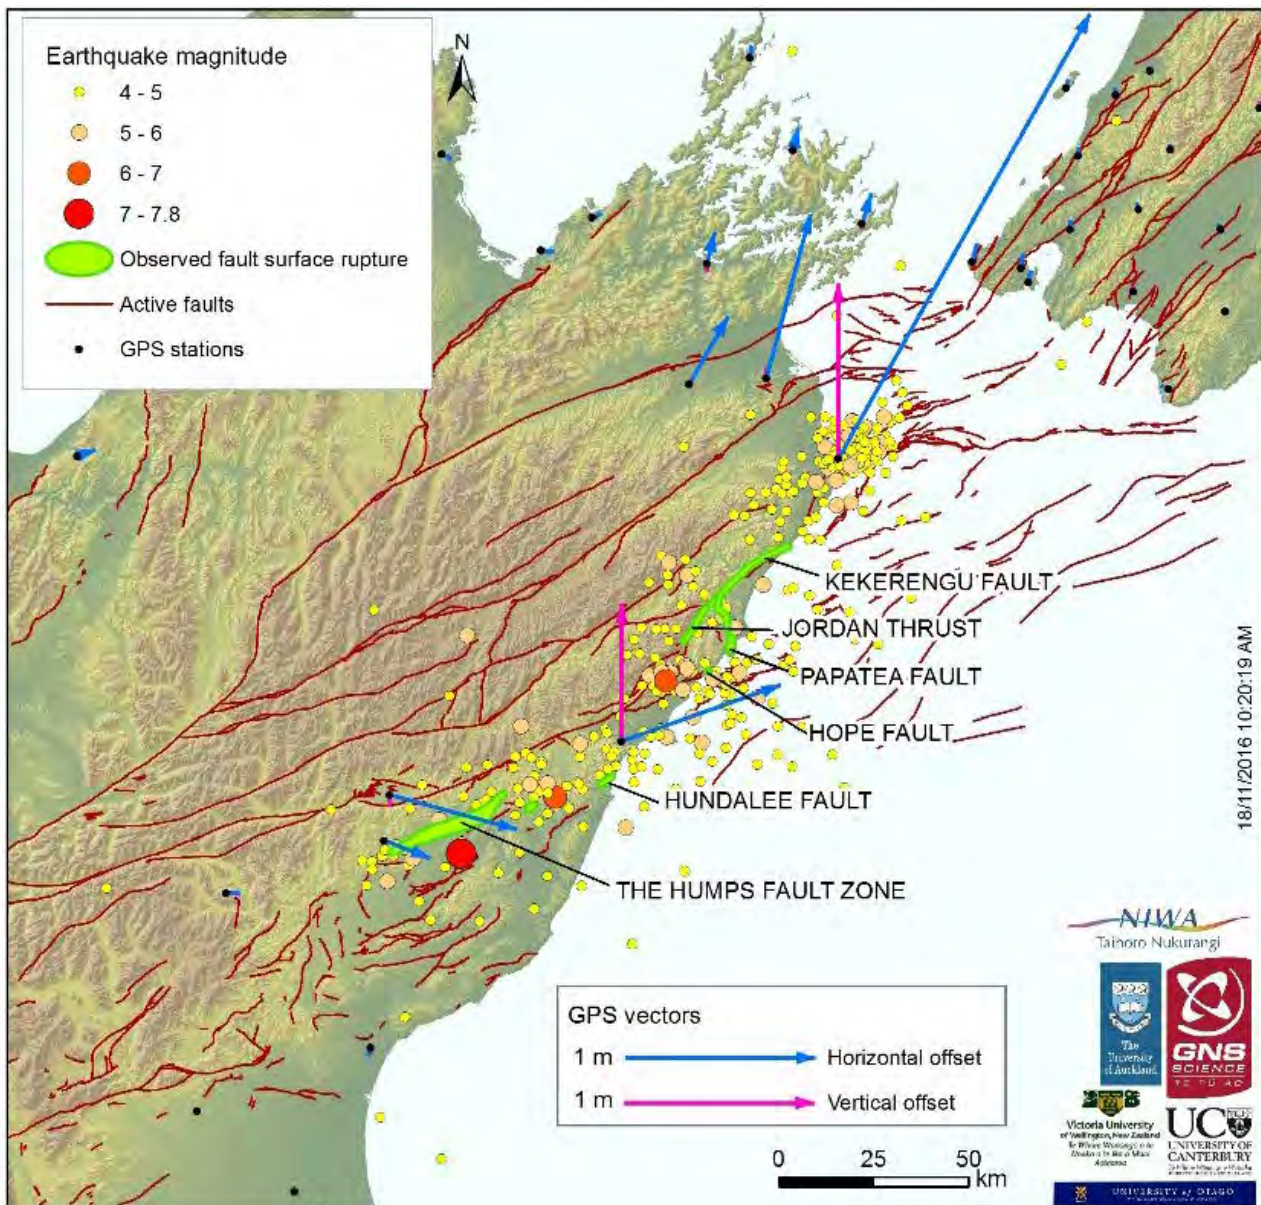
Illustration 4.1. Location of M 7.8 Kaikoura earthquake of 14 November 2016

A severe magnitude 7.8 earthquake struck 15 km north-east of Culverden in the South Island of New Zealand, at 12:02 am on Monday 14th November 2017. This was followed by numerous aftershocks, see Illustration 4.1. The earthquake caused closure of State Highway 1 South (SH 1S) between Ward and Cheviot, and other local roads due to numerous landslides, fault rupture and failure of highway structures. Two people died in the earthquake.

The location of the main 7.8 event, the aftershocks including the magnitude 6.2 and 6.3 events, the so far identified fault rupture zones and active faults in the region are shown on Illustration 4.1.

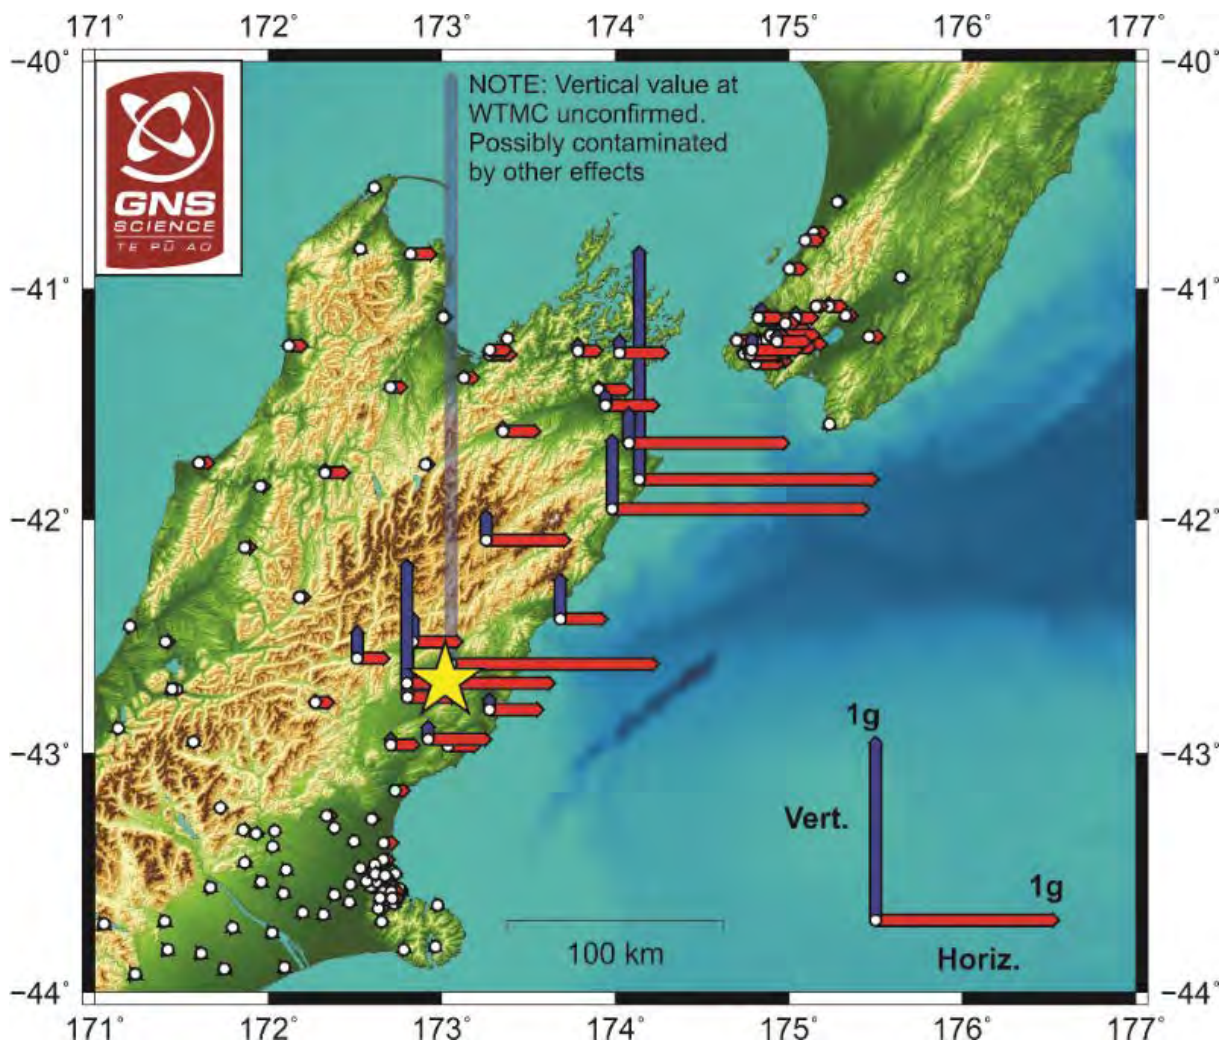
Illustration 4.2. Relative ground accelerations in the Kaikoura earthquake

Ground shaking caused by the Kaikoura Earthquake reached over MMI VIII near the fault rupture, on the Modified Mercalli Intensity Scale and is considered severe. In Wellington, some areas experienced shaking up to MMI VI-VII, which is considered strong.

The ground motions were recorded by Geonet seismographs in the region, with the largest horizontal peak ground accelerations being recorded in Ward Fire Station (1.27g) and the largest vertical ground acceleration being recorded in Te Mara Farm in Waiau (3.22g), although this record may be affected by other factors. The relative magnitudes of the accelerations are shown in Illustration 4.2 and MM intensities on Illustration 4.3.

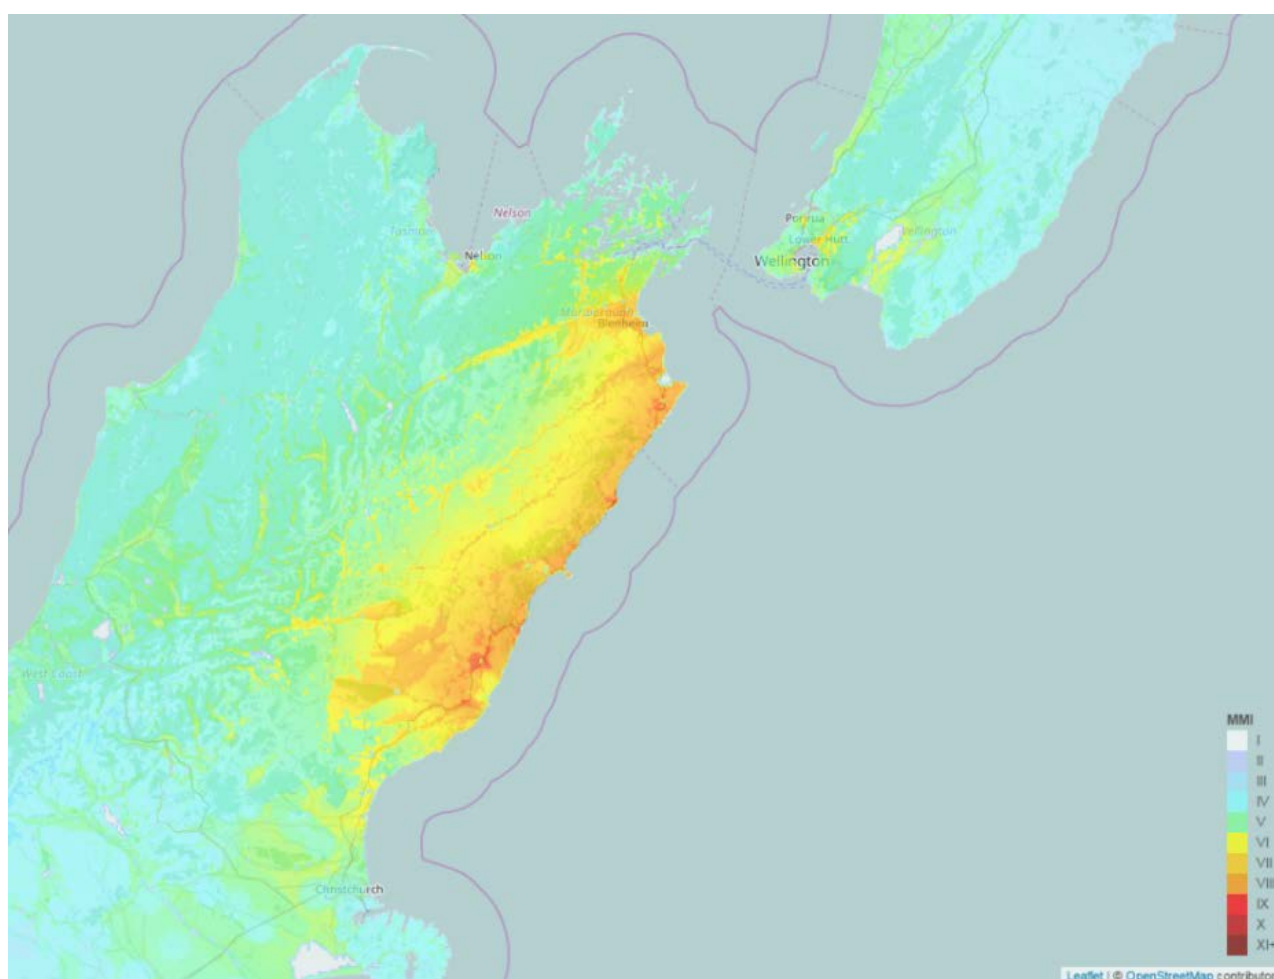
Illustration 4.3. Modified Mercalli Intensity of shaking in the 14 November 2016 main shock

It can be noted that the ground shaking was strongest immediately near the epicentre near Culverden and in the Kekerengu – Ward – Seddon area. The shaking was strong to the north of the epicentre, which could be due to the faults that ruptured towards the north, and the fault rupture directivity effects. The ground shaking attenuated rapidly towards the south, with minimal shaking south of Amberley (57 km south of epicentre), see Illustration 4.3. This map shows that even within the Kaikoura coast section there is significant variability of shaking from MMVII to MM IX.

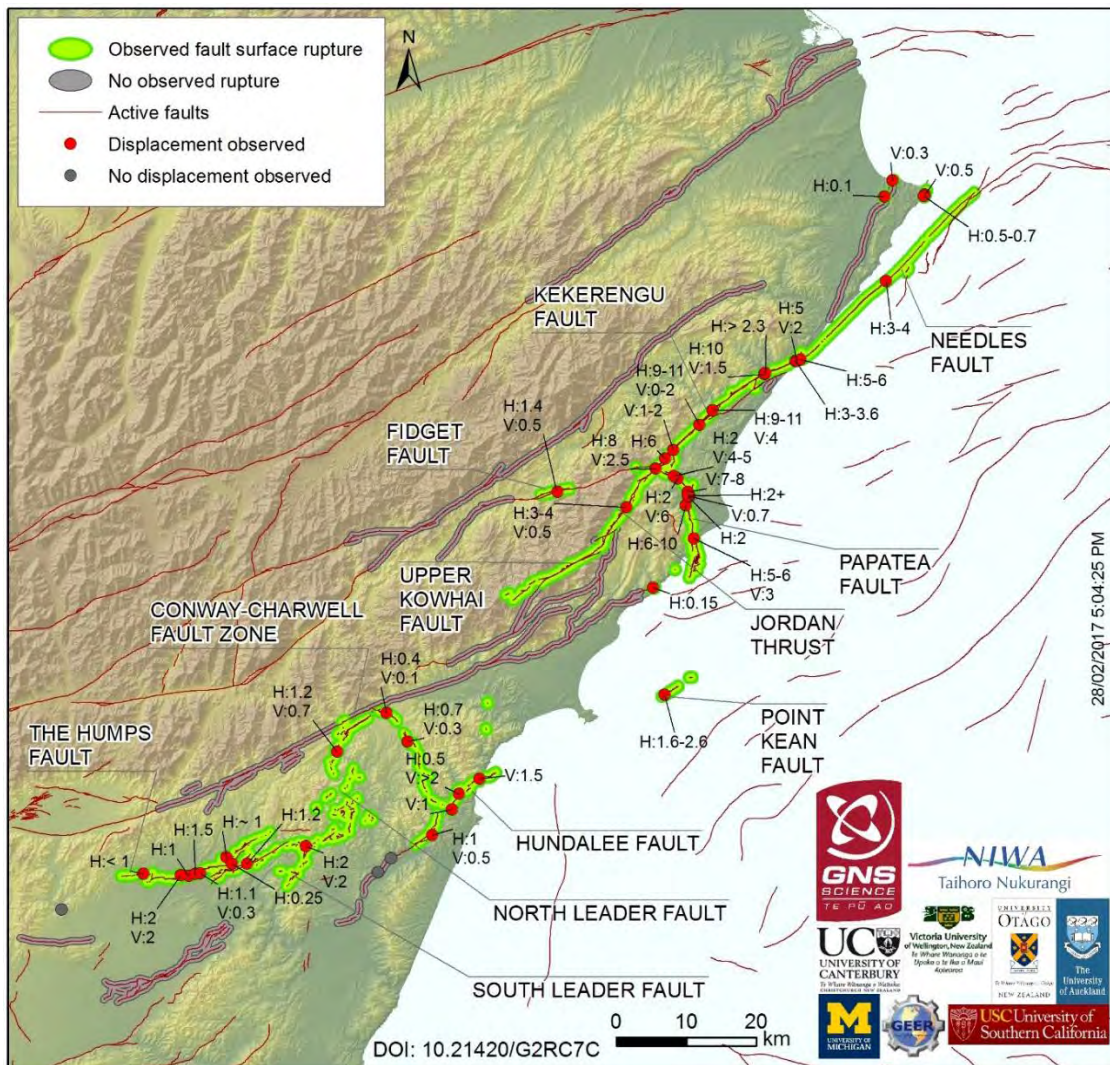
Illustration 4.4. Fault ruptures associated with the Kaikoura earthquake

Reports from Geonet indicate that multiple faults ruptured during the 14th November 2016 event. Other faults have also been identified as being involved in the earthquake. Some of the faults that ruptured are shown on Illustration 4.4.

- Kekerengu Fault - appears to have had up to 10 m of slip
- Papatea Fault (newly identified)
- Hope Fault - seaward segment - minor movement
- Hundalee Fault,
- Humps Fault Zone and
- Emu Plains.

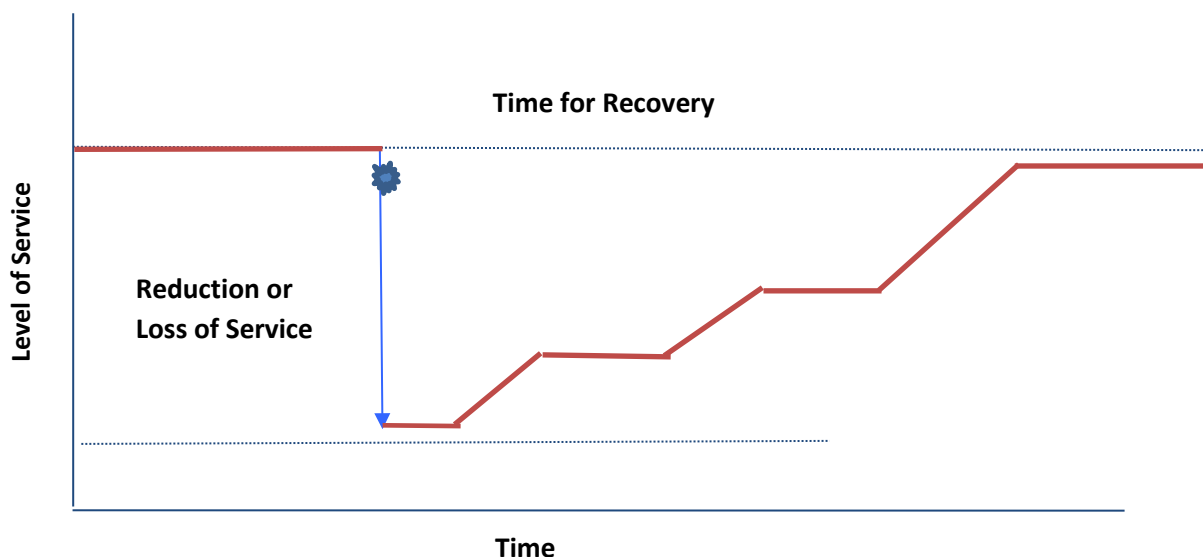
Illustration 7.1 – Staged Recovery of Route after Event, over Time

- 7) A key observation by Brabhakaran et al (2006) that was reinforced following the Kaikoura earthquake was that the restoration of access following an event occurs in stages rather than as a linear process from loss of service to full access as idealised in Illustration 2.1. In many instances particularly following a large event, access may be restored to restricted access, single lane and full access in a number of stages. This is illustrated diagrammatically in Illustration 7.1. It takes some time to move from a reduced level of service to a better level of service, which may remain for some time, before further effort and time to improve the availability more.
