Appendix C

Existing Building Preliminary Assessment

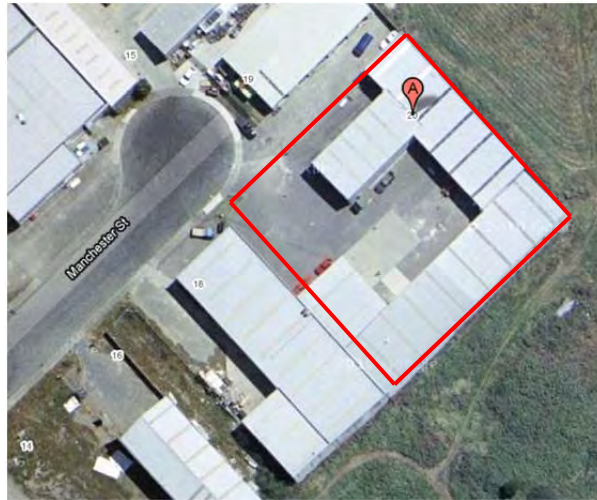
Figure 1: 20 Manchester St – satellite view

This is a series of portal frame buildings situated on the boundary of the construction designation and shown in Figure 1 and Figure 2. The buildings consist of steel portal frames and precast reinforced concrete walls with steel cladding. Due to the construction type these buildings are not expected to be susceptible to visual cracking in the event of slight differential ground movement.

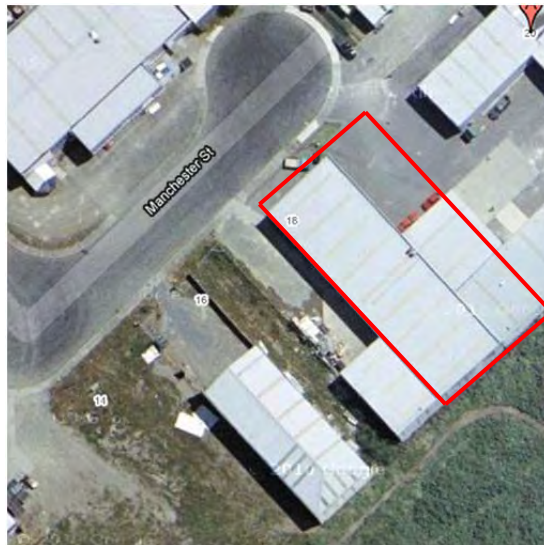
Figure 3: 18 Manchester St – satellite view

This is a portal frame building situated on the boundary of the construction designation and shown in Figure 3 and Figure 4. The building is a steel portal frame structure with some precast reinforced concrete walls and steel and a board material cladding. This building is not expected to be susceptible to visual cracking in the event of slight differential ground movement.

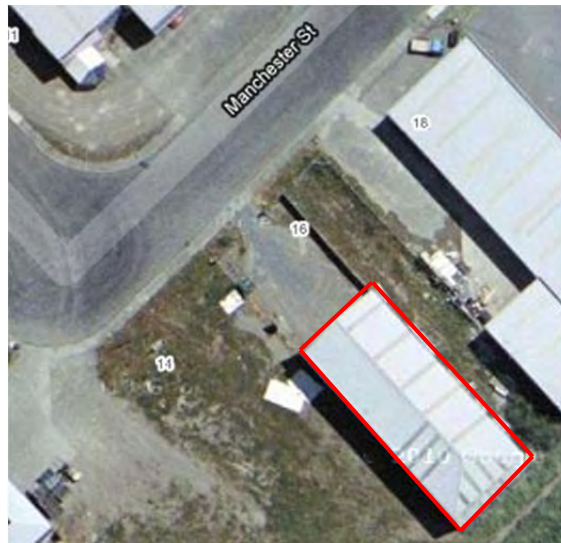
Figure 5: 16 Manchester St – satellite view

This is a portal frame building situated on the boundary of the construction designation and shown in Figure 5 and Figure 6. The building is a steel portal frame structure with a concrete block wall on two faces of the building and steel cladding. The concrete block wall is expected to be reinforced. Due to the concrete block walls it is expected the building will be susceptible to visual cracking in the event of slight differential ground movement.

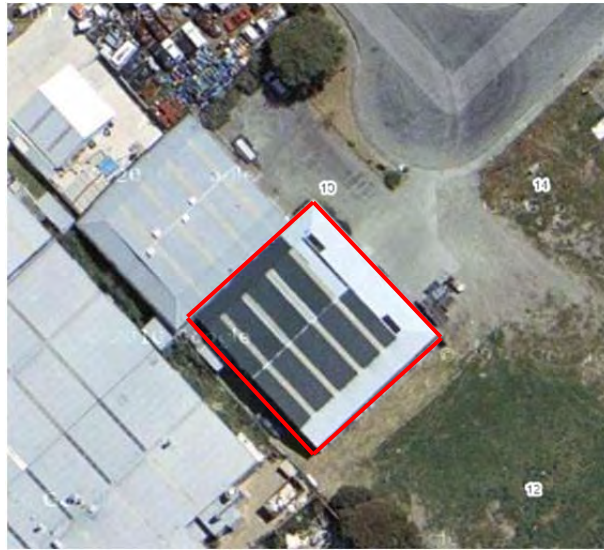
Figure 7: 12 Manchester St – satellite view.

This is a portal frame building situated on the boundary of the construction designation and shown in Figure 7 and Figure 8. The building is a steel portal frame structure with some precast reinforced concrete walls and steel cladding. This building is not expected to be susceptible to visual cracking in the event of slight differential ground movement.

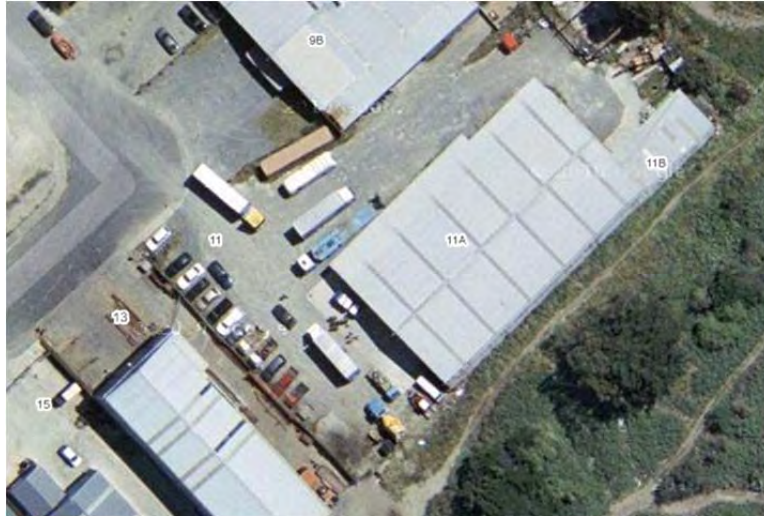
Figure 9: 11 Sheffield St – satellite view

This is a portal frame building situated on the boundary of the construction designation and shown in Figure 9 and Figure 10. The building is a steel portal frame structure with steel cladding and a steel roof. One section of wall approximately 1000mm high was of concrete block construction indicating that there may be more concrete block areas which cannot be seen from the street. Due to the concrete block construction of this building, it is expected that this building will be susceptible to slight differential ground settlement.

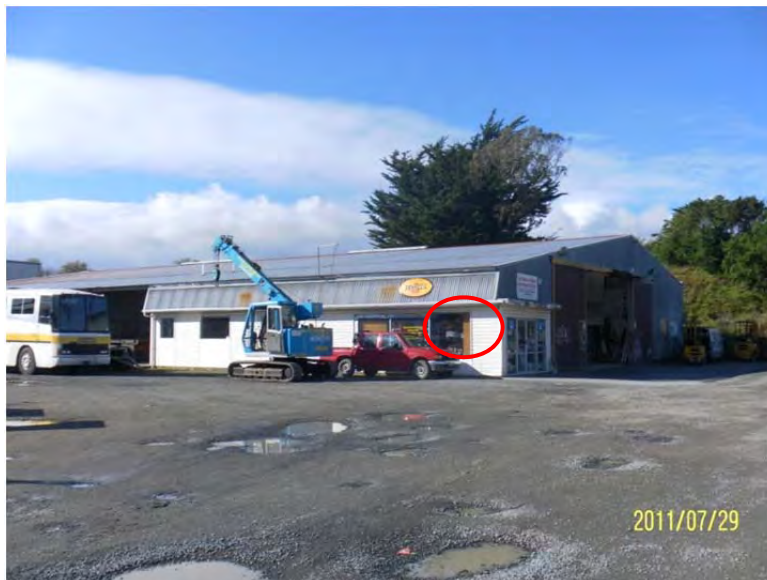
Figure 10: 11 Sheffield St – street view, concrete block area highlighted

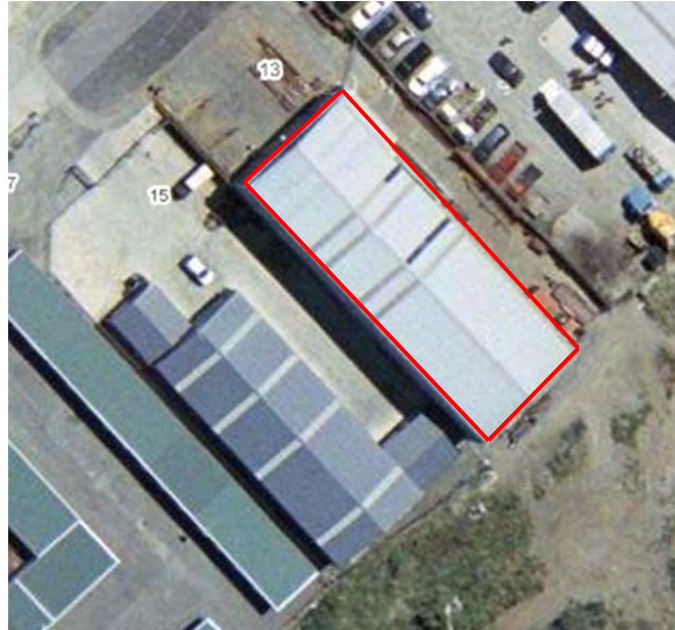
Figure 11: 13 Sheffield St – satellite view

This is a portal frame building situated on the boundary of the construction designation and shown in Figure 11 and Figure 12. The building is a steel portal frame structure with precast reinforced concrete walls. The cladding is mainly timber and steel, but there is also a section of brick about 2000m high and 4000mm long on as shown in Figure 12. Due to the brick area visible the building is expected to be susceptible to slight differential ground settlement.

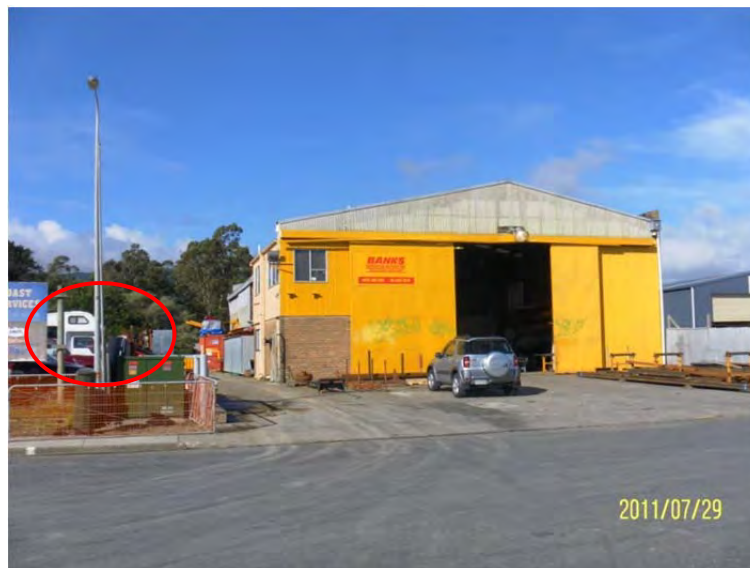
Figure 12: 13 Sheffield St – street view, brick area is highlighted

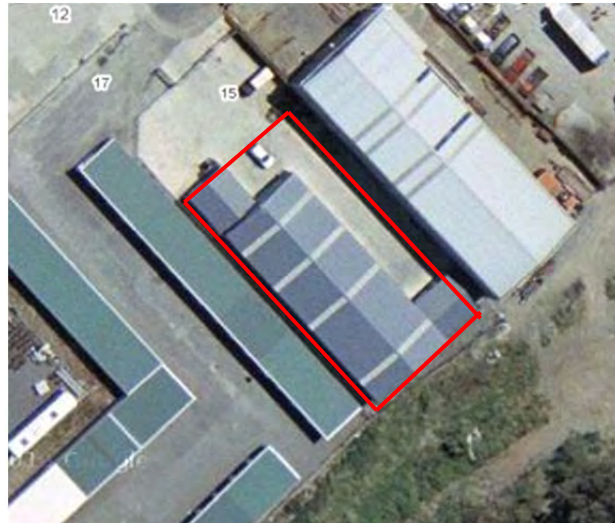
Figure 13: 15 Sheffield St – satellite view

This is a portal frame building situated on the boundary of the construction designation and shown in Figure 13 and Figure 14. The building is a steel portal frame structure with no obvious concrete walls and steel cladding. This building is not expected to be susceptible to visual cracking in the event of slight differential ground movement.

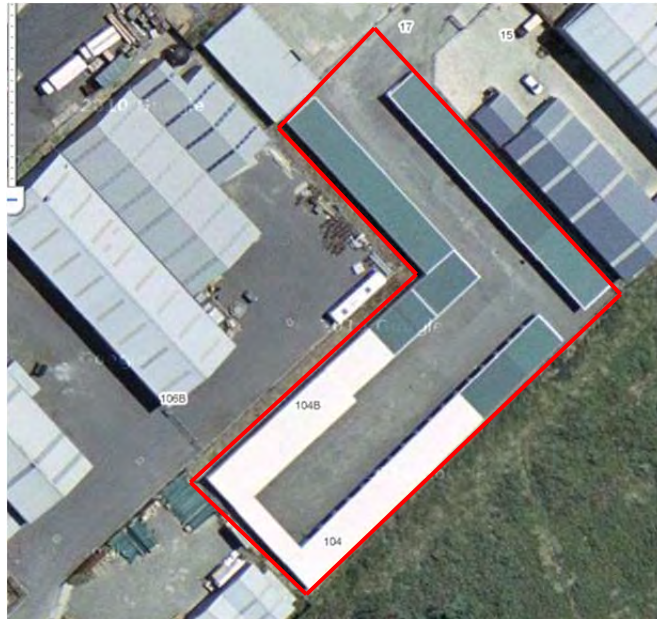
Figure 15: 17 Sheffield St – satellite view

This is a series of 1-storey frame structures located on the boundary of the construction designation and shown in Figure 15 and Figure 16. The buildings are steel clad and likely to be steel framed structures (otherwise timber). The buildings are not likely to be susceptible to visual cracking in the event of slight differential ground settlement.

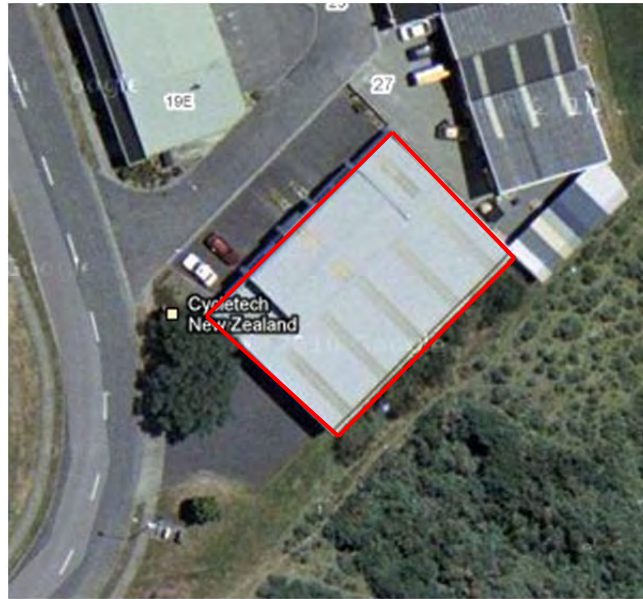
Figure 17: 31 Milne Dr – satellite view

This building is a 2-storey structure located on the boundary of the construction designation and shown in Figure 17 and Figure 18. The material used in the structural system of the building is unknown (*may be steel frame with boxed members similar to the front of 23 Milne Dr*), but there is a wall down one side of the building that is plastered and could be reinforced concrete or concrete block and the building has stucco cladding. Due to this the building is expected to be susceptible to visual cracking in the event of slight differential ground settlement

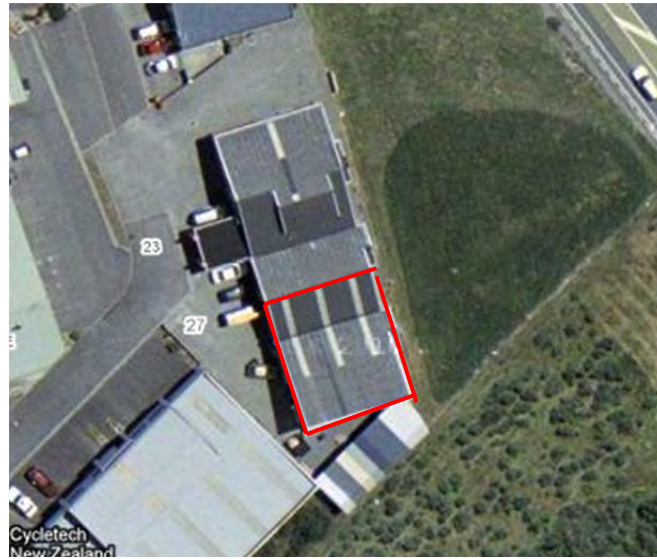
Figure 19: 27 Milne Dr – satellite view

This building is located on the boundary of the construction designation and shown in Figure 19 and Figure 20. It is connected to the building at 23 Milne Drive which can be seen on the left of Figure 20. The building is steel portal frame structure with stucco cladding. Due to the stucco it is expected to be susceptible to visual cracking in the event of differential ground movement.

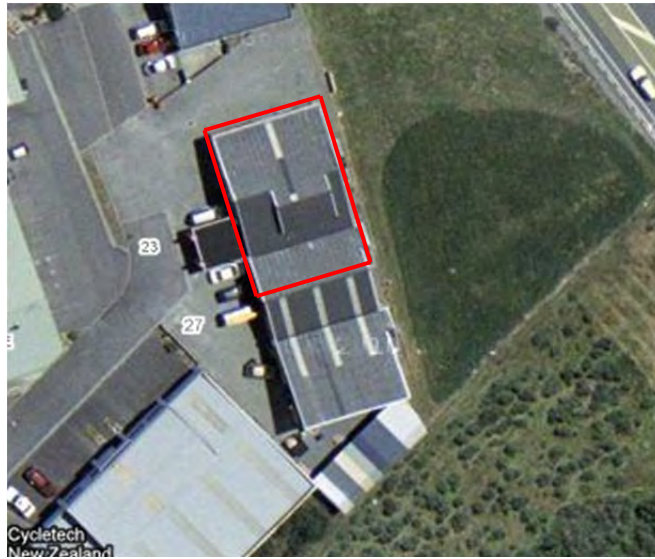
Figure 21: 23 Milne Drive – satellite view

This building is located 20m from the boundary of the construction designation and is shown in Figure 21 and Figure 22. It is connected to the building at 27 Milne Drive which can be seen on the right of Figure 22. The building is steel portal frame structure with stucco cladding. Due to the stucco it is expected to be susceptible to visual cracking in the event of differential ground movement.

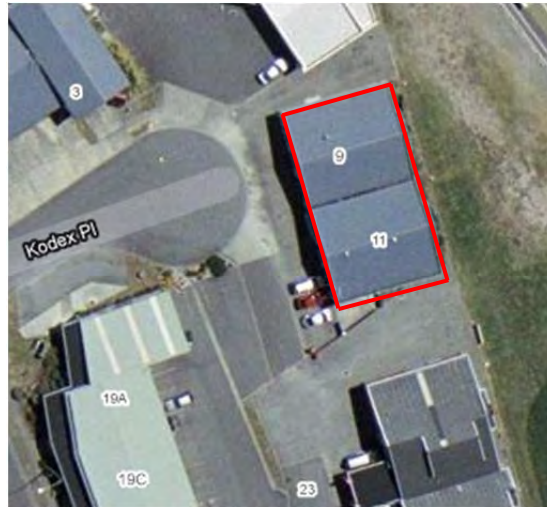
Figure 23: 11 Kodax PI – satellite view.

This building is located on the boundary of the construction designation and is shown in Figure 23 and Figure 24. It is a portal frame structure with stucco cladding. Due to the stucco cladding this building is expected to be susceptible to visual cracking in the event of slight differential ground settlement.

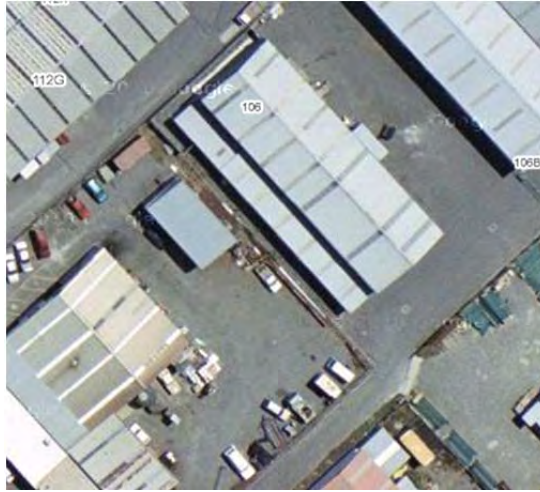
Figure 25: 106A Kapiti Rd – satellite view

This building is located 50m from the construction designation and is shown in Figure 25 and Figure 26. The main structure is a steel portal frame with a smaller concrete block structure attached to it. The main structure has both steel cladding and concrete blocks. The concrete blocks would be expected to be reinforced. Due to the concrete blocks this structure is expected to be susceptible to visual cracking in the event of slight differential ground settlement.

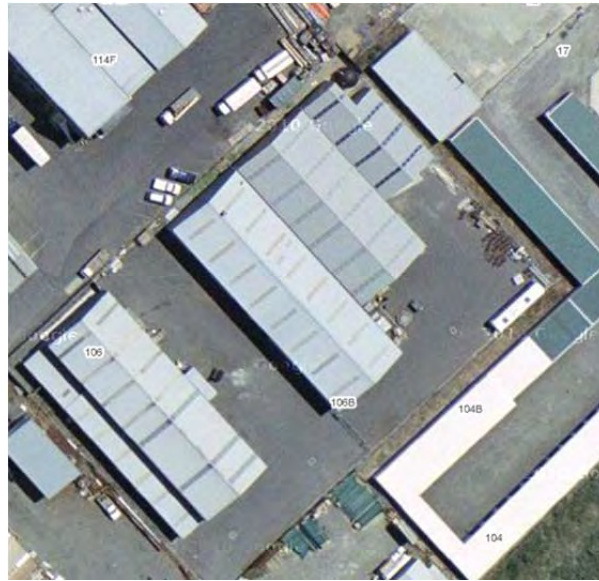
Figure 27: 106B Kapiti Rd – Satellite view

These buildings are located 50m from the construction designation and are shown in Figure 27 and Figure 28. The structures consist of a steel portal frame and concrete block and steel cladding. The concrete blocks would be expected to be reinforced. Due to the concrete blocks this structure is expected to be susceptible to visual cracking in the event of slight differential ground settlement.

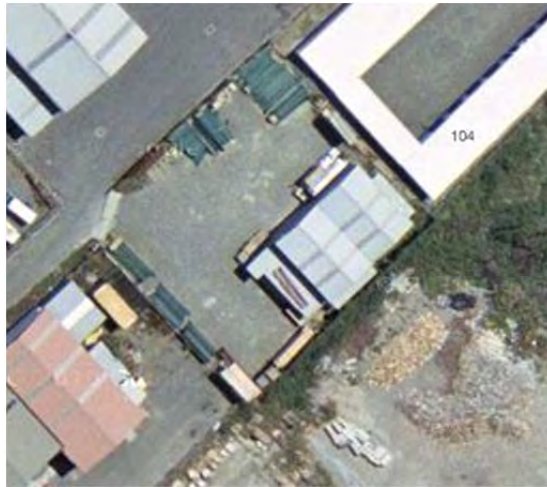
Figure 29: 104 Kapiti Rd – satellite view

This building is located on the boundary of the construction designation and is shown in Figure 29 and Figure 30. It is a steel portal frame structure with steel cladding and a small timber structure on the side. This structure is not expected to be susceptible to visual cracking in the event of slight differential ground movement.

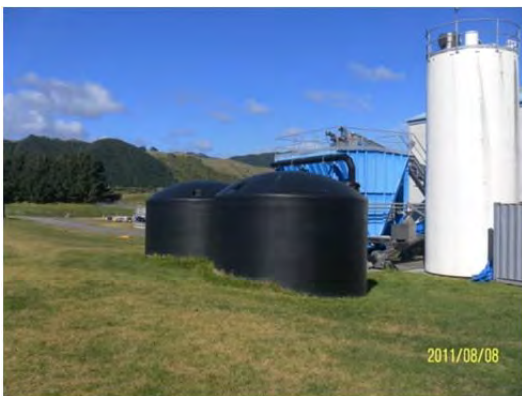
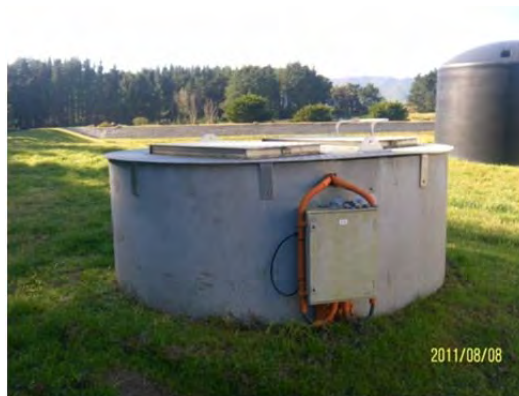
There are a number of small concrete tanks at various locations around the site which are of plastic or reinforced concrete construction. These are not expected to be susceptible to slight differential ground and therefore have not been shown individually. Two typical constructions are depicted below.
