# **Pavement maintenance patch trials December 2017**

Arnold, G, G Mudgway and O Dickin (2017) Pavement maintenance patch trials. *NZ Transport Agency research report 635*. 103pp.

**Keywords:** maintenance, patches, potholes

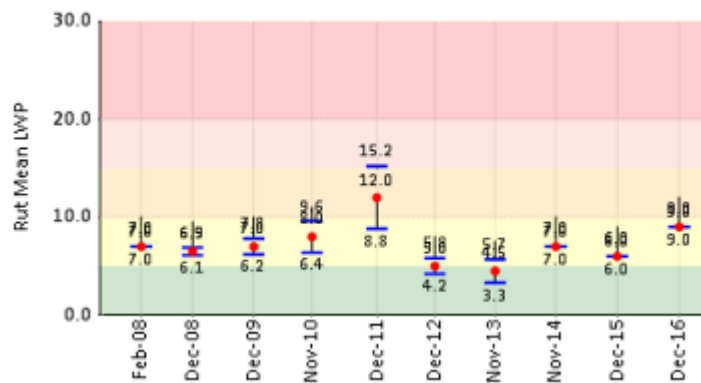
**Figure 3.2 SH27-RS46 RP 17965-17980 1.5% full depth granular digout patch location**

Full depth granular reconstruction	<p>RP 17965 – 17980 inc Rut = 7mm Roughness (NAASRA counts per km) = 90</p> <p>Deformation, block cracking and potholes repaired before</p>

Maintenance patch type	Trial location	Traffic in ESA (when failure occurred)	10th percentile FWD results prior to construction	Discussion on prediction of performance from FWD
	SH27-RS46-17965-17980 (increasing side)	500,000 ESA – 16 months	D0 = 1.23 mm D0-D200 = 0.330 Predicted life = 1 year Subgrade CBR = 2	
Mill and AC inlay	SH24-RS0-2093-2112	Only minor damage on edges at 479,000 ESA – 16 months. Life estimated 3 years or 1.5 MESA (perhaps higher).	D0 = 1.66 mm D0-D200 = 0.465 Predicted life = 1 year Subgrade CBR = 2	SH24 site when compared with SH26 and SH27 the FWD deflections are good predictor as a shorter life is obtained for the SH24 site with the highest deflection and curvature.
	SH26-RS80-13582-13592 (decreasing side)	Not failed after 150,000 ESA – 16 months	D0 = 0.66 mm D0-D200 = 0.174 Predicted life = 142 years Subgrade CBR = 9	
	SH27-46-17455-17471 (decreasing side)	Not failed after 500,000 ESA – 16 months	D0 = 1.09 mm D0-D200 = 0.218 Predicted life = 1 year Subgrade CBR = 3	It appears a criteria for long life for thin asphalt is $D0 < 1$ mm and $D0-D200 < 0.2$ mm. This is supported by the results.

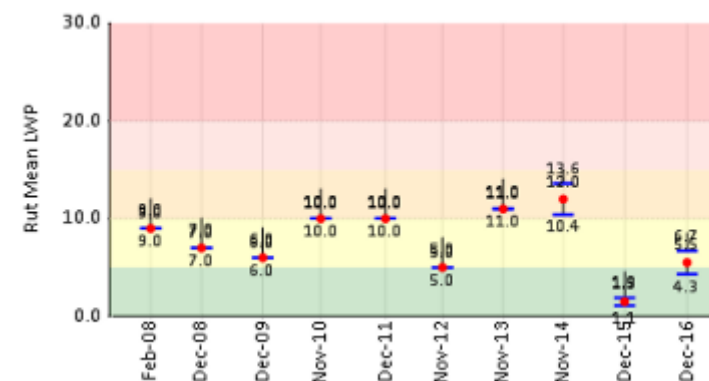
**Figure 3.3 SH27-RS46 RP 17455-17471 1.5% mill and AC inlay patch location**

Mill and AC inlay	<p>RP 17455 – 17471 dec Rut = 14 mm Roughness (NAASRA counts per km) = 40</p> <p>Deformation, block cracking and potholes repaired before</p>

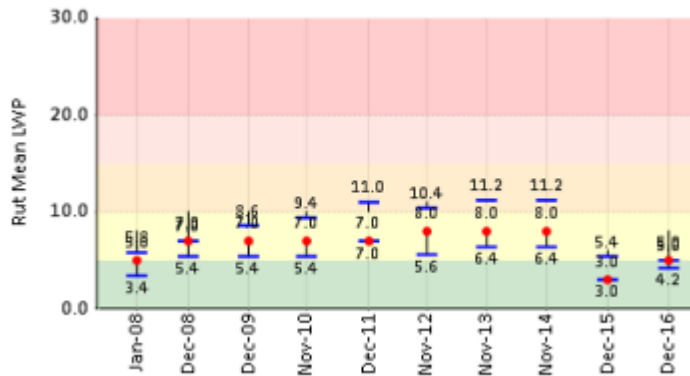
Figure 3.4 SH26-RS80 RP 13394-13434 full depth granular reconstruction patch location

Full depth granular reconstruction	RP 13394 – 13434 dec Rut = 11 mm Roughness (NAASRA counts per km) = 125  Flushing and shoving

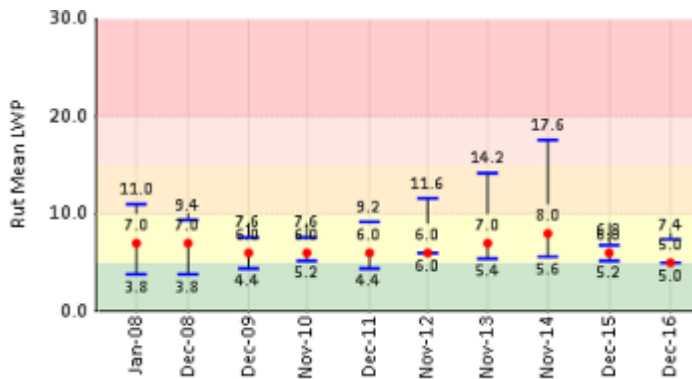
Figure 3.5 SH26-RS80 RP 13612-13642 3% cement stabilisation patch location

SH26 – RS80	
3% cement stabilisation	RP = 13612 – 13642 dec Rut = 18 mm Roughness (NAASRA counts per km) = 131  Shear failure and cracking

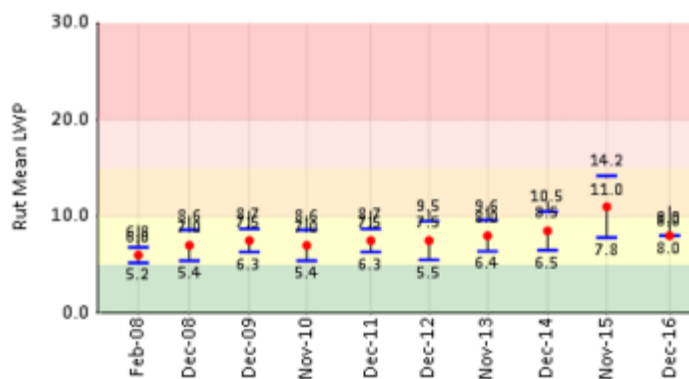
Figure 3.6 SH26-RS24 RP 2102-2122 mill and AC inlay patch location

Mill and AC inlay	RP = 2102–2122 inc Rut = 14 mm Roughness (NAASRA counts per km) = 170 Shear failure

Mill and AC inlay	SH24-RS0-2093-2112	Only minor damage on edges at 479,000 ESA - 16 months. Life estimated 3 years or 1.5 MESA (perhaps higher).	At 16 months some cracking and edge failure with rutting <5 mm.
	SH26-RS80-13582-13592 (decreasing side)	Not failed after 150,000 ESA - 16 months	At 16 months the site had not failed but the Hawkeye survey showed high rutting up to 18 mm which needed confirmation.
	SH27-46-17455-17471 (decreasing side)	Not failed after 500,000 ESA - 16 months	At 16 months the site had not failed but rutting was as high as 13 mm on either end of patch from the Hawkeye survey. This needed confirmation with a straight edge.

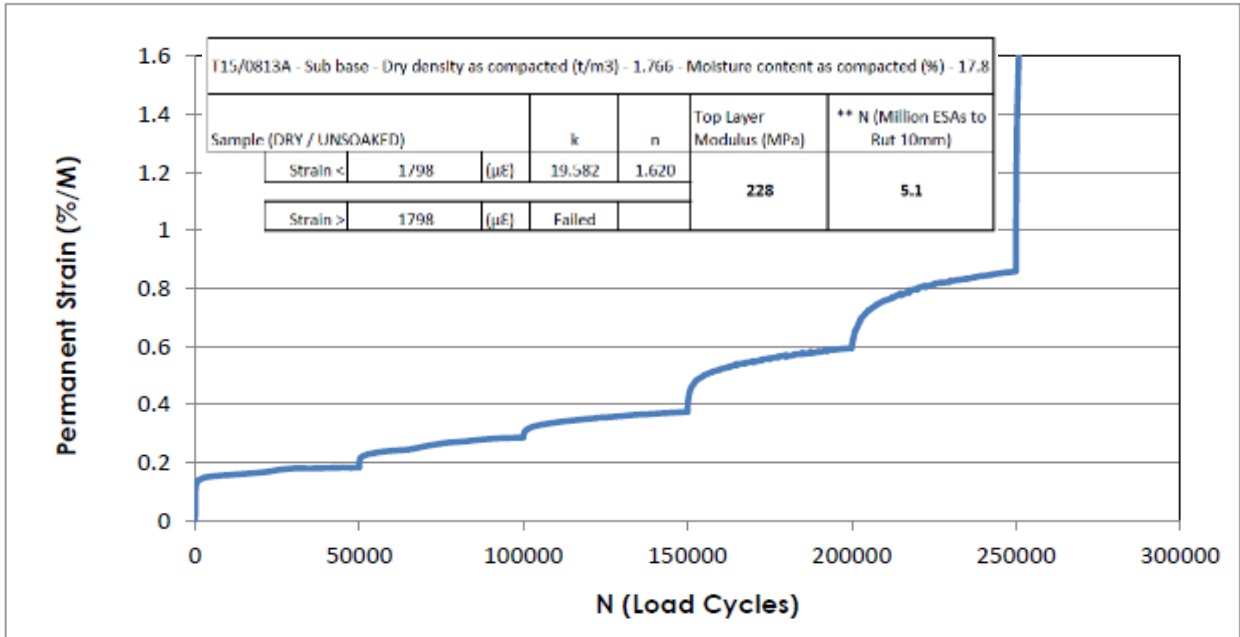
Figure A.2 SH24 RP0/1.08 subbase blend of TP1-4 RLT lab ref T15/0813A

The repeated load triaxial (RLT) tests on the in-situ basecourse (figure A.3) and subbase (figure A.2) show the material is around average to just below average in rut resistance when compared with a *TNZ M/4:2006* basecourse. However, the test repeated after soaking the aggregate showed rapid failure (figure A.4) and indicates the aggregate is more moisture sensitive than a new M4 aggregate.

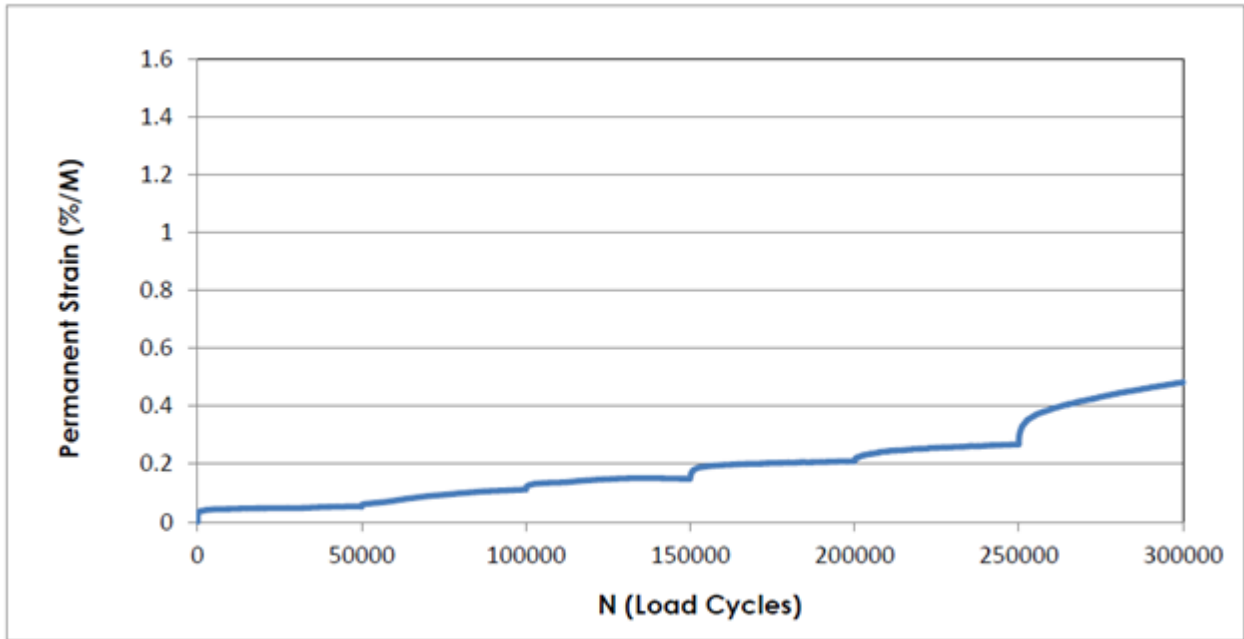
Figure A.6 SH26 RP80/13.7 subbase blend of TP7 lab ref T15/0818A

The RLT tests on the in-situ basecourse (figure A.3) and subbase (figure A.2) show the material is around average to just below average in rut resistance when compared with a *TNZ M/4:2006* basecourse. However, the test repeated after soaking the aggregate showed rapid failure (figure A.4) and indicates the aggregate is more moisture sensitive than a new M4 aggregate.

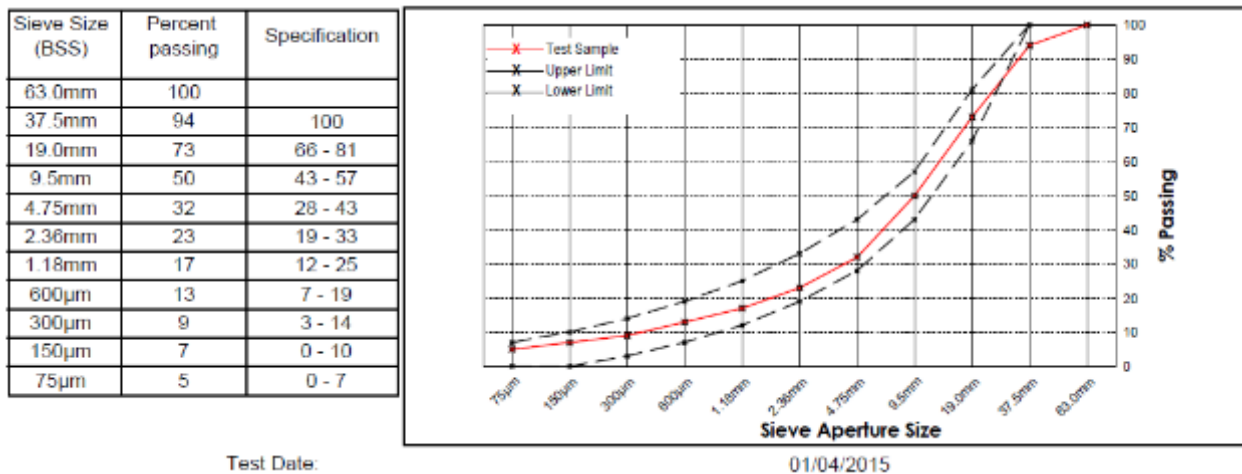
Figure A.9 Particle size distribution in- situ basecourse SH26 TP5-8

PSD, PI tests were conducted on the in-situ aggregate. Results show the aggregate is well graded (figure A.9) and has excessive clay particles with a PI of 20.

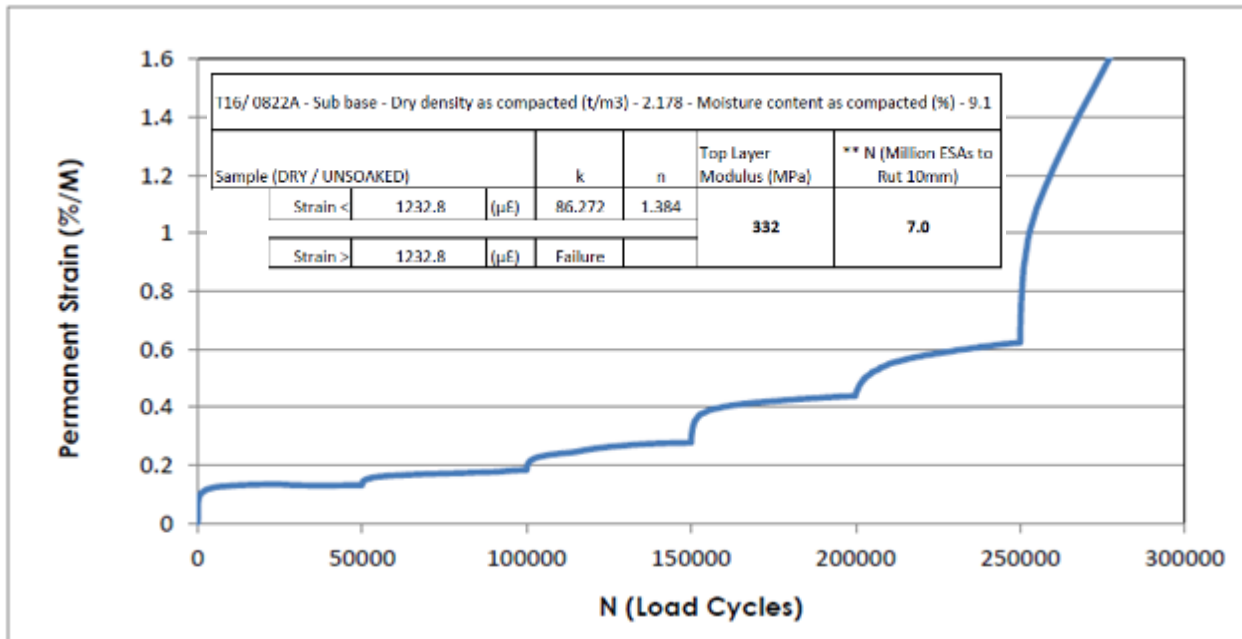
Figure A.10 SH27 RP46 subbase RLT lab ref T15/0822A

The RLT tests on the in-situ basecourse (figure A.11) and subbase (figure A.10) show the material is below average in rut resistance when compared with a *TNZ M/4:2006* basecourse. However, the test repeated after soaking the aggregate showed rapid failure (figure A.12) and indicated the aggregate was more moisture sensitive than a new M4 aggregate.

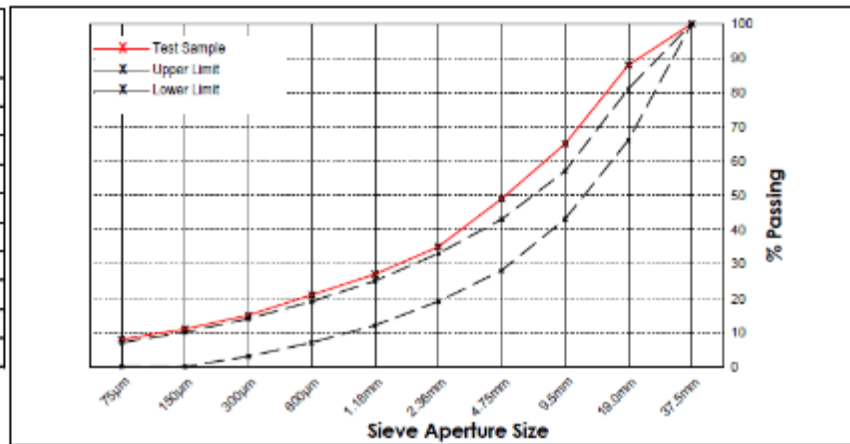
Figure A.13 Particle size distribution in- situ basecourse SH27 TP9-12

PSD PI tests were conducted on the in-situ aggregate. Results show the aggregate is very finely graded (finer than M4, figure A.13) and is high in clay particles with a PI of 23.

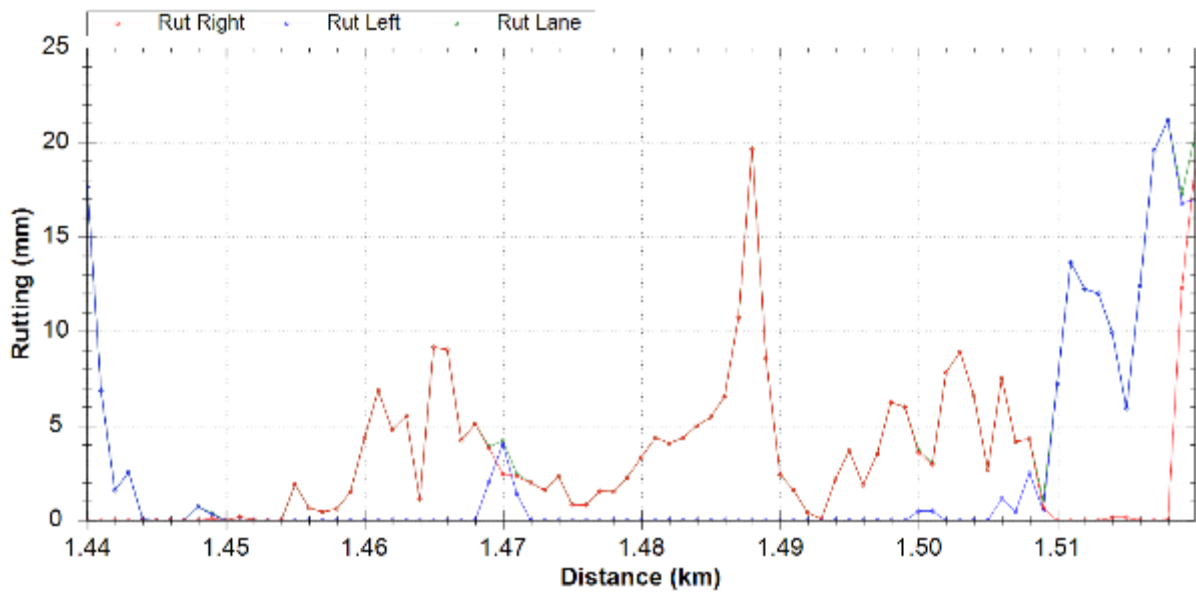
Figure C.4 Hawkeye rut measurement for 3% cement in- situ stabilisation at 16- month inspection

This site was rut filled with asphalt and hence as shown from the Hawkeye rut measurements the rutting is minimal (figure C.4 - distance 1.44 to 1.50 km).

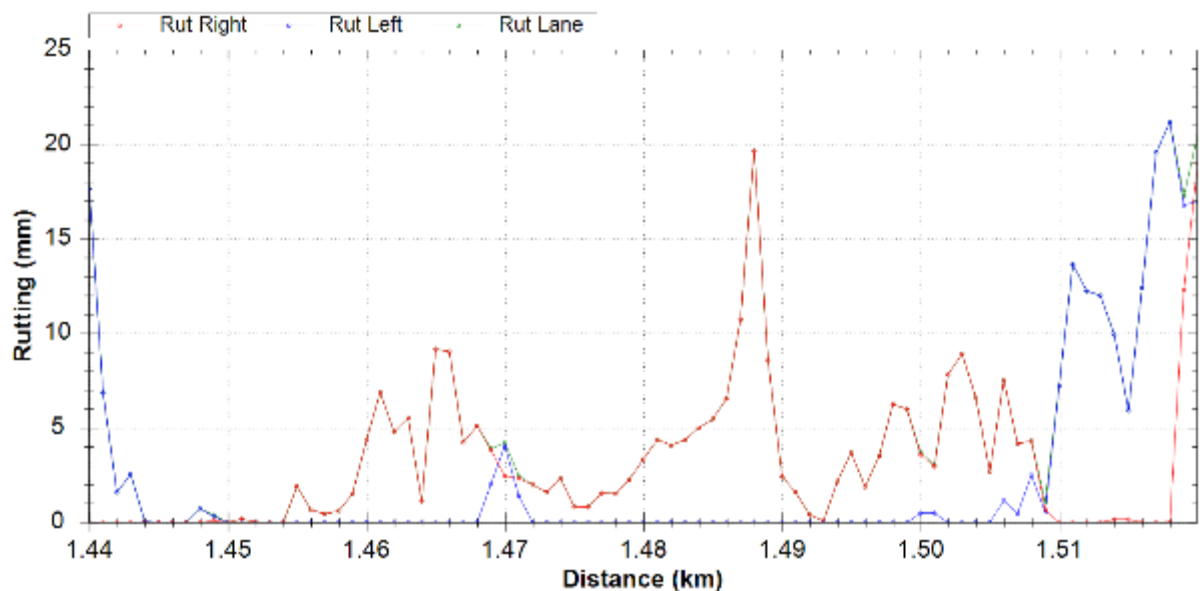
**Figure C.7** Hawkeye rut measurement for 1.5% cement in- situ stabilisation at 16- month inspection (1.50 to 1.52 km)

This site was rut filled with asphalt and hence as shown from the Hawkeye rut measurements the rutting is minimal (distance 1.50 to 1.52 km).

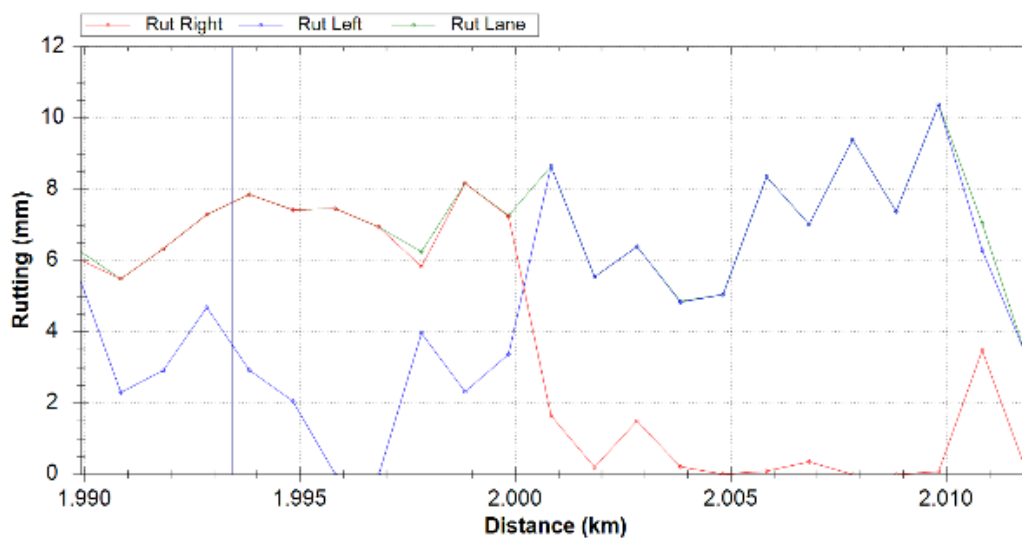
**Figure C.10** Hawkeye rut measurement for granular full depth construction at 16- month inspection (1.992 to 2.011 km)

In the Hawkeye rut measurements the rutting is as high as 10 mm at the far end of the site as shown by the blue line for the 'rut left' in figure C.10 (distance 1.992 to 2.011 km).

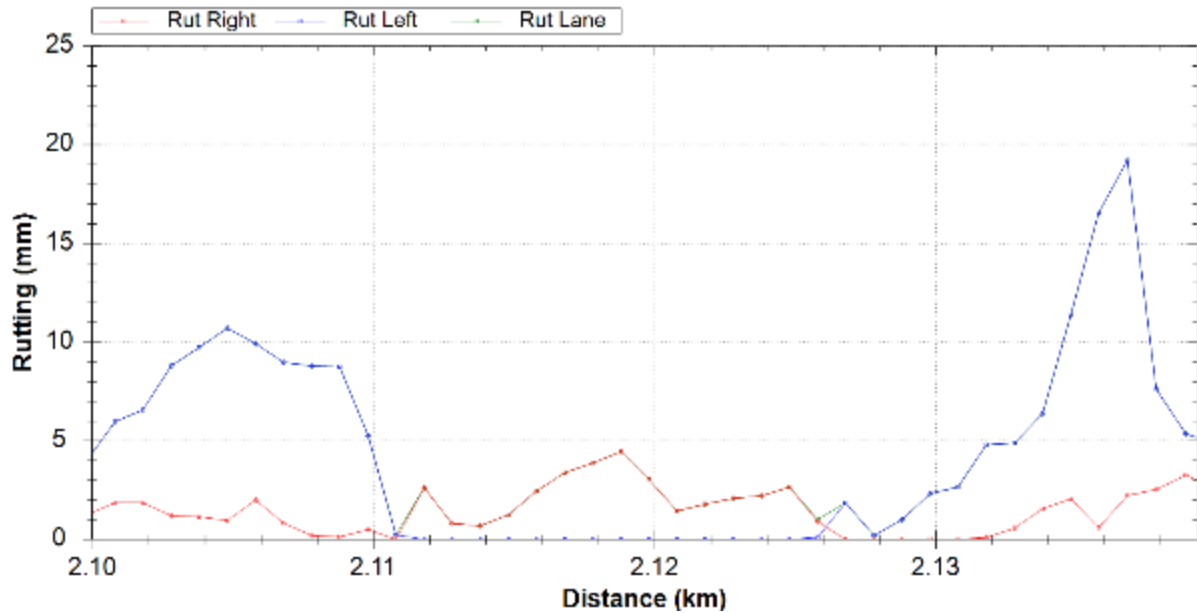
Figure C.13 Hawkeye rut measurement for mill and AC inlay at 16- month inspection (2.123 to 2.143 km)

In the Hawkeye rut measurements the rutting is as high as 5 mm as shown by the blue line for the 'rut right' in figure C.13 (distance 2.123 to 2.143 km).

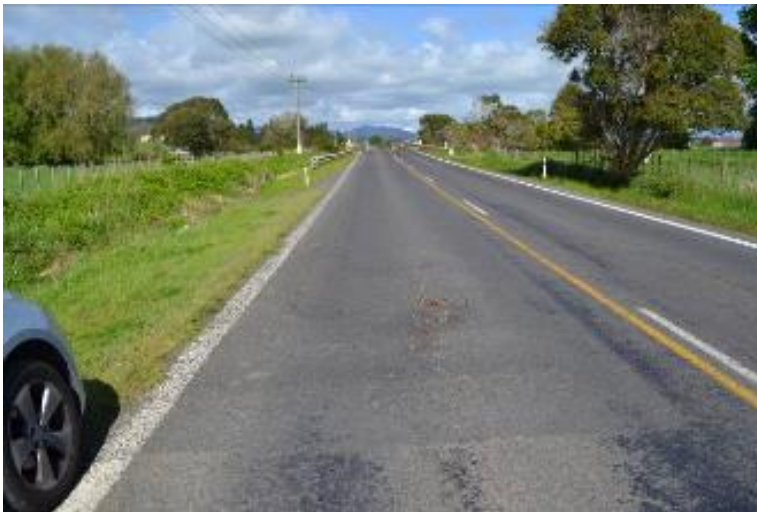
**Figure C.14 3% in- situ stabilisation – SH26–RS80–13577–13584 (decreasing side) – 3- month inspection**

No pavement damage after three months as shown in figure C.14.

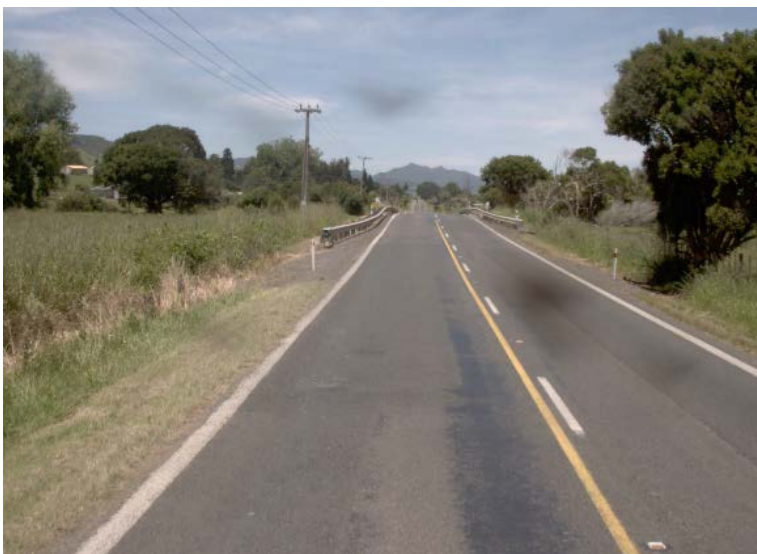
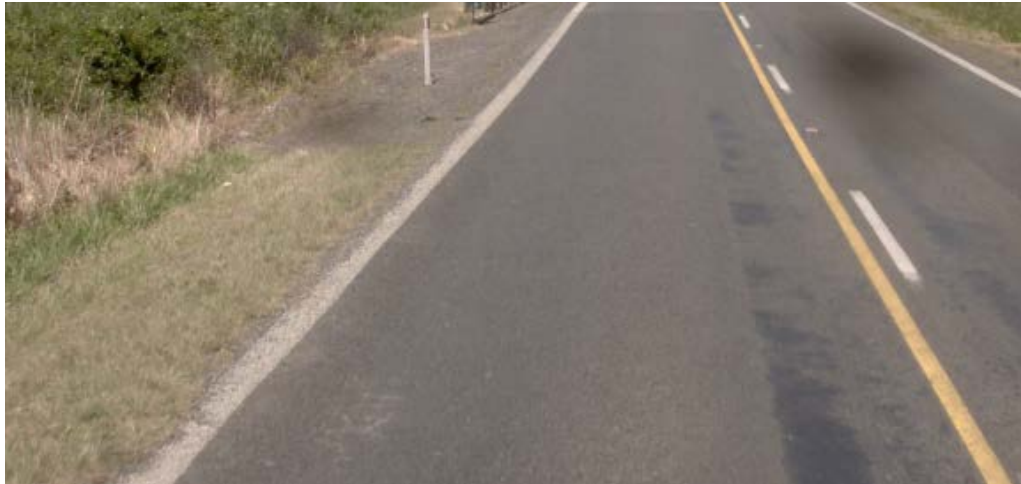
No pavement damage except some alligator cracking in the first 2 m of the outside wheel path as shown in figures C.15 and C.16.

**Figure C.15 3% in- situ stabilisation – SH26–S80–13577–13584 (decreasing side) – 16- month inspection**

**Figure C.16 3% in- situ stabilisation – SH26-RS80-13577-13584 (decreasing side) – 16- month inspection**

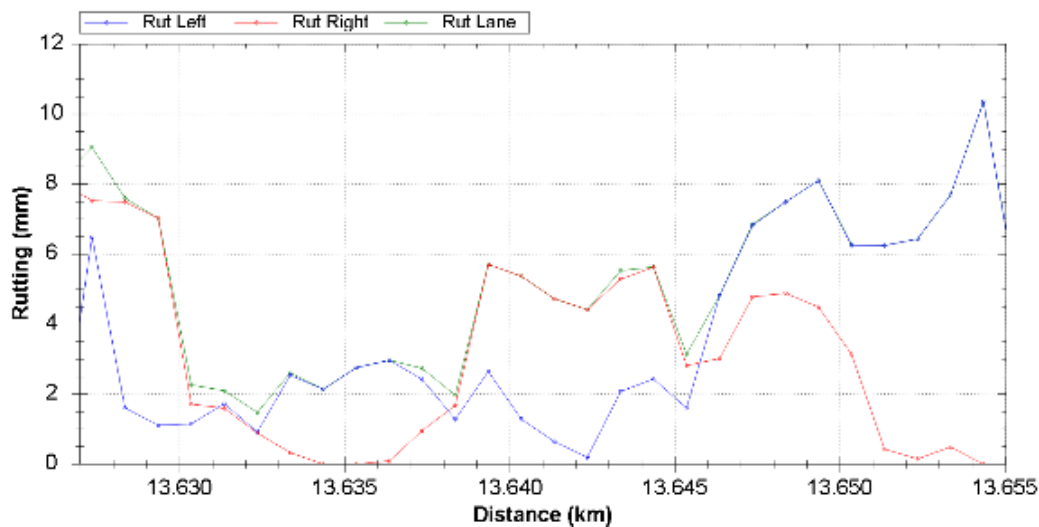
**Figure C.17 Hawkeye rut measurement for 3% cement in- situ stabilisation at 16 month inspection (SH26 – RS80-13625-13655 (decreasing side))**

The Hawkeye rut measurements shows the rutting ranges from 2 mm to 10 mm as shown in figure C.17 (distance 13.625 to 13.655 km).

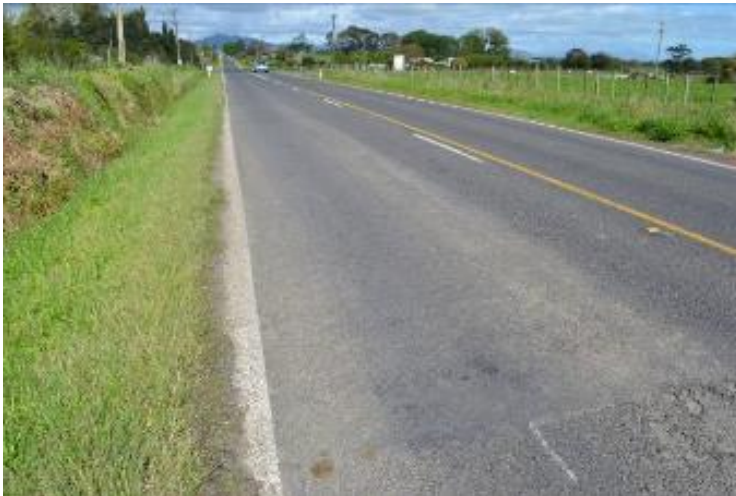
**Figure C.18** 1.5% in- situ stabilisation - SH26-RS80-13304-13364 (decreasing side) - 3- month inspection

No pavement damage.

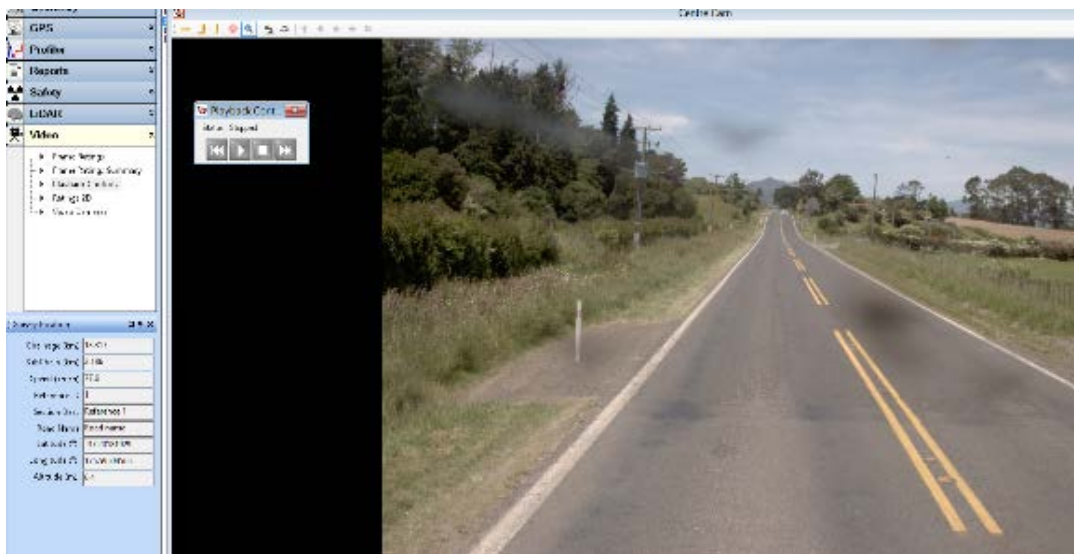
**Figure C.19** 1.5% in- situ stabilisation - SH26-RS80-13304-13364 (decreasing side) - 16- month inspection

No pavement damage.

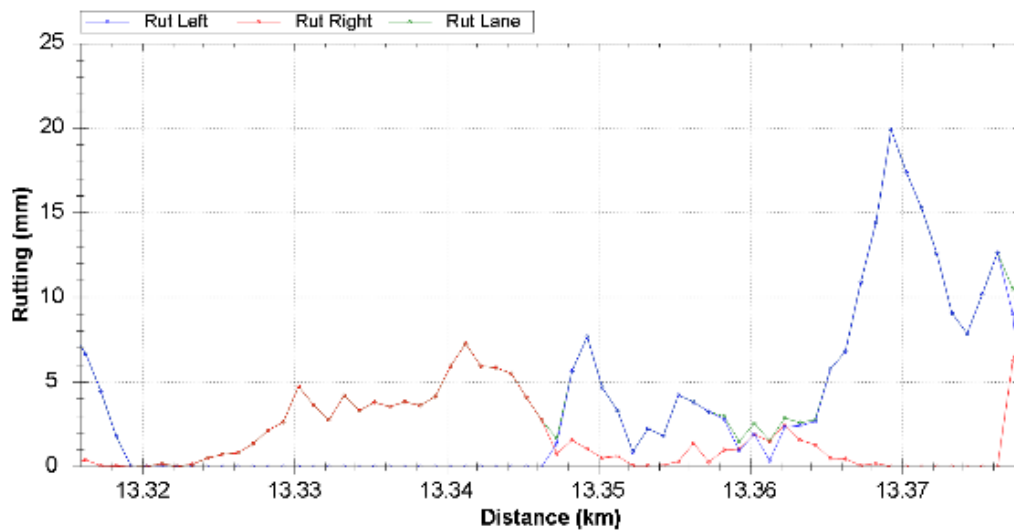
Figure C.20 Hawkeye rut measurement for 1.5% cement in- situ stabilisation at 16- month inspection (SH26 – RS80-13304-13364 – decreasing side)

This site has minimal rutting (<5 mm) and as shown from the Hawkeye rut measurements the rutting is minimal (distance 13.204 to 13.364 km)

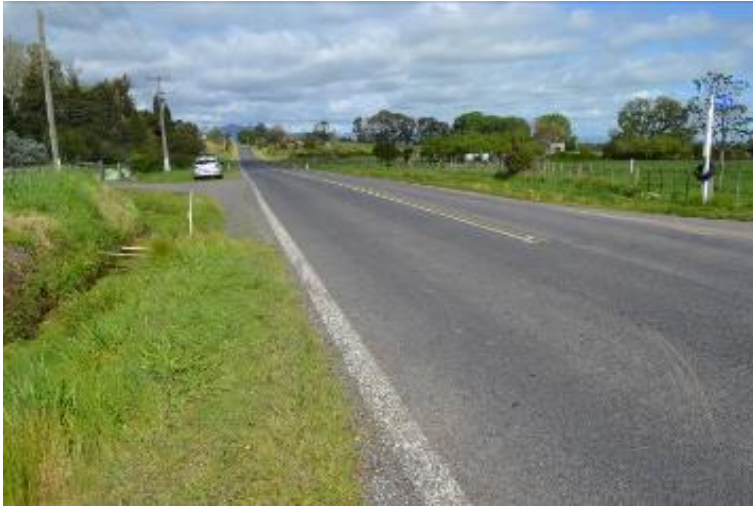
**Figure C.22 Full depth granular reconstruction – SH26-RS80-13394-13434 (decreasing side) – 3- month inspection**

No pavement damage.

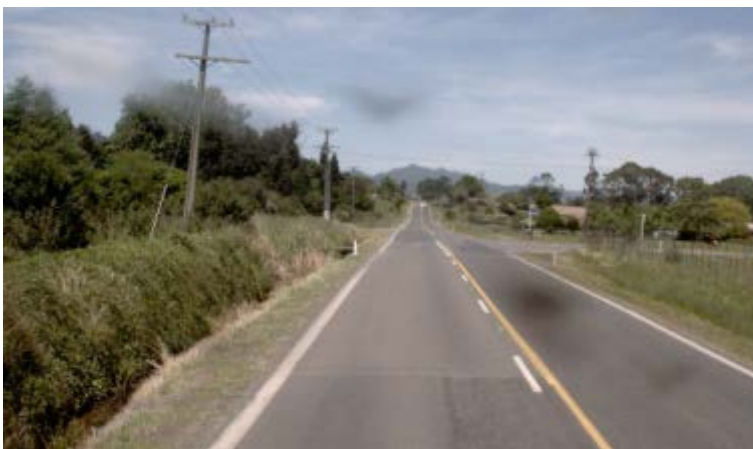
**Figure C.23 Full depth granular reconstruction – SH26-RS80-13394-13434 (decreasing side) – 16- month inspection**

No pavement damage but some minor rutting in the right-hand wheel track.

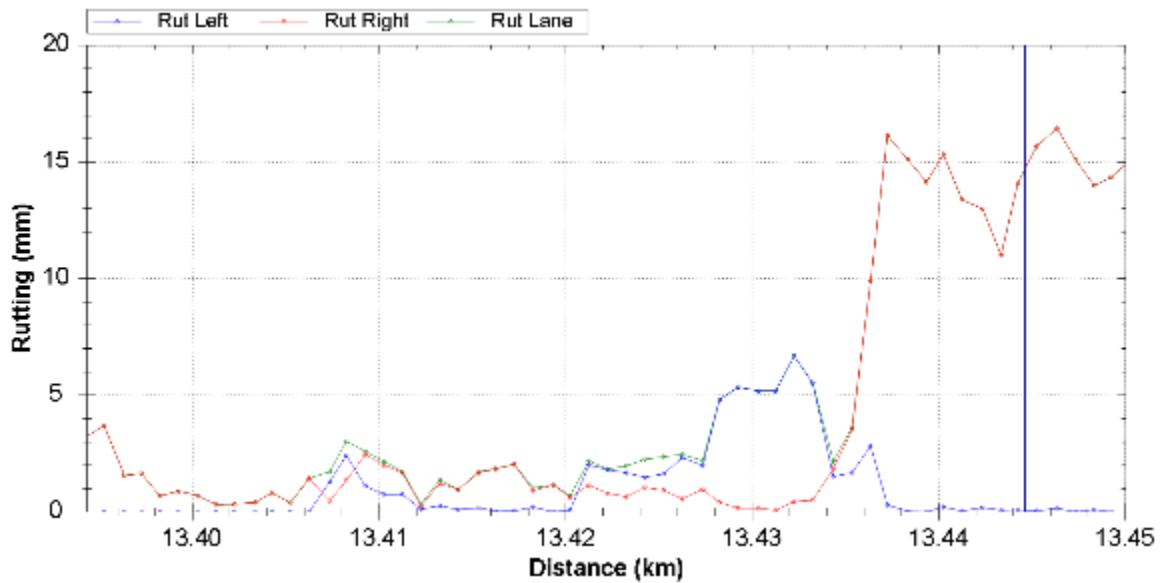
**Figure C.24** Hawkeye rut measurement for granular full depth construction at 16- month inspection (13.407 to 13.447 km)

Rutting from the Hawkeye Survey in November 2016 shows within the patch only (13.407 to 13.447 km) there is some rutting (15 mm deep) at the very beginning of the patch in the inside wheel path (13.435 to 13.447 km). In the rest of the patch the rutting is very low – less than 3 mm.

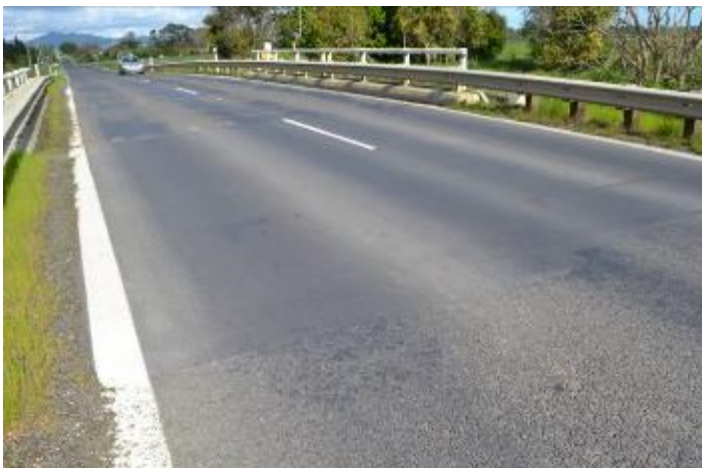
**Figure C.25** Mill and AC inlay – SH26–RS80–13596–13606 (decreasing side) – 3- month inspection

No pavement damage after three months as shown in figure C.25.

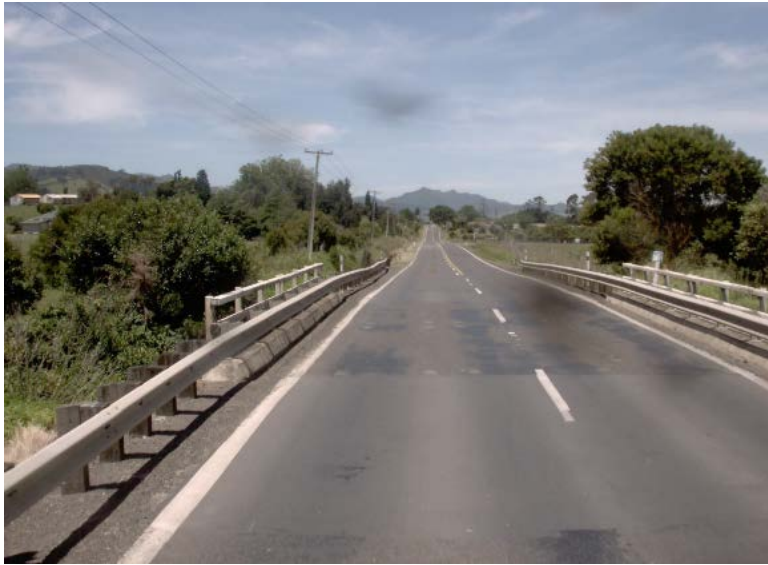
Figure C.26 Mill and AC patch - SH26-RS80-13596-13606 (decreasing side) - 16- month inspection

No pavement damage.

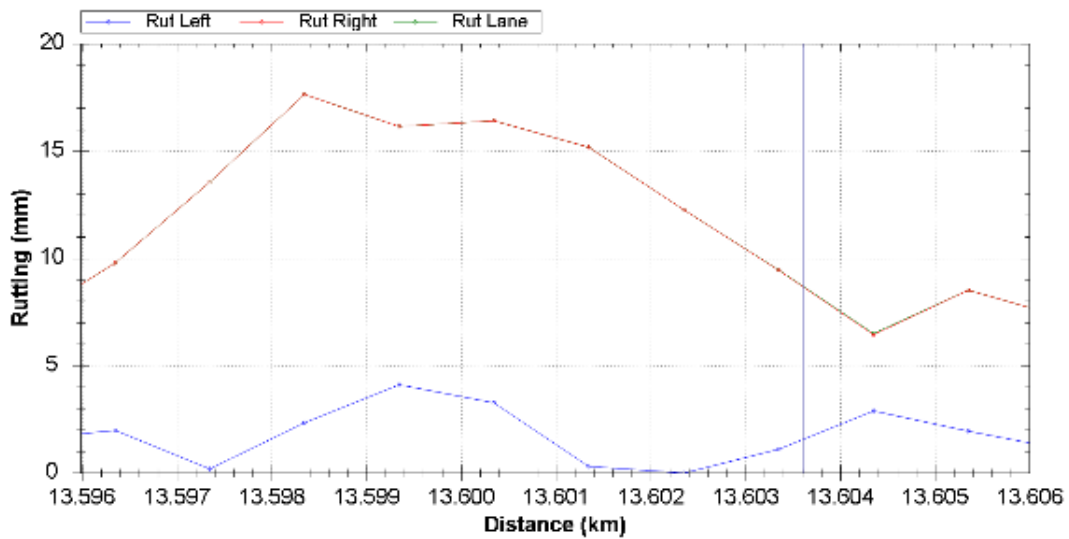
Figure C.27 Hawkeye rut measurement for mill and AC inlay at 16- month inspection SH26-RS80-13.596-13.606 (decreasing side)

In the Hawkeye rut measurements the rutting is as high as 18 mm as shown by the red line for the 'rut right' in figure C.27 (distance 13.596 to 13.606 km).

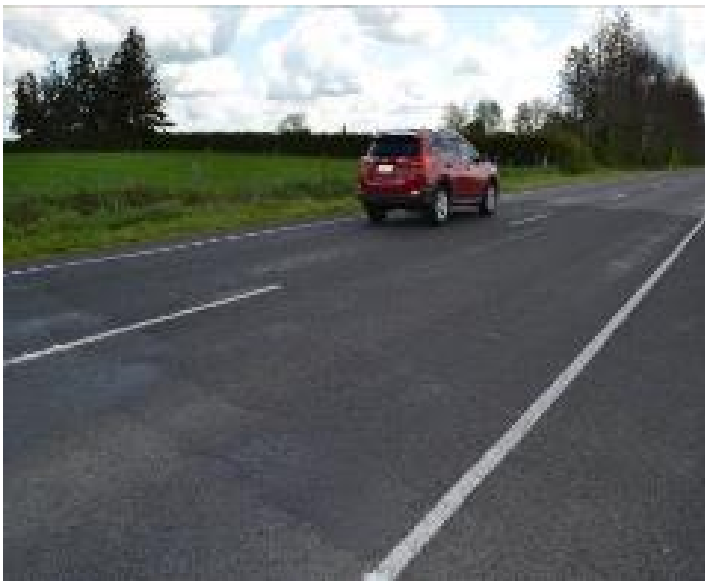
**Figure C.28 3% in- situ stabilisation – SH27–RS46–17982–18012 (decreasing side) – 3- month inspection**

No pavement damage after three months as shown in figure C.28.

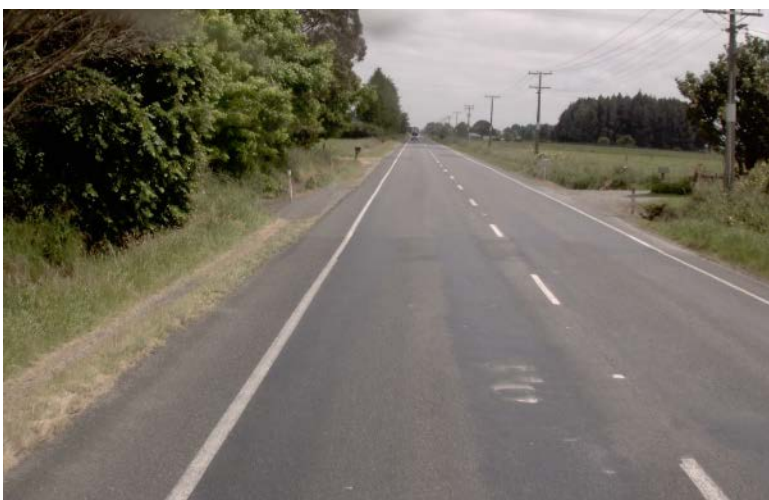
**Figure C.29 3% in- situ stabilisation – SH27–RS46–17982–18012 (decreasing side) – 16- month inspection**

No pavement damage except some large block cracks around 1 m in length in middle of inside wheel tracks as shown in figure C.29.

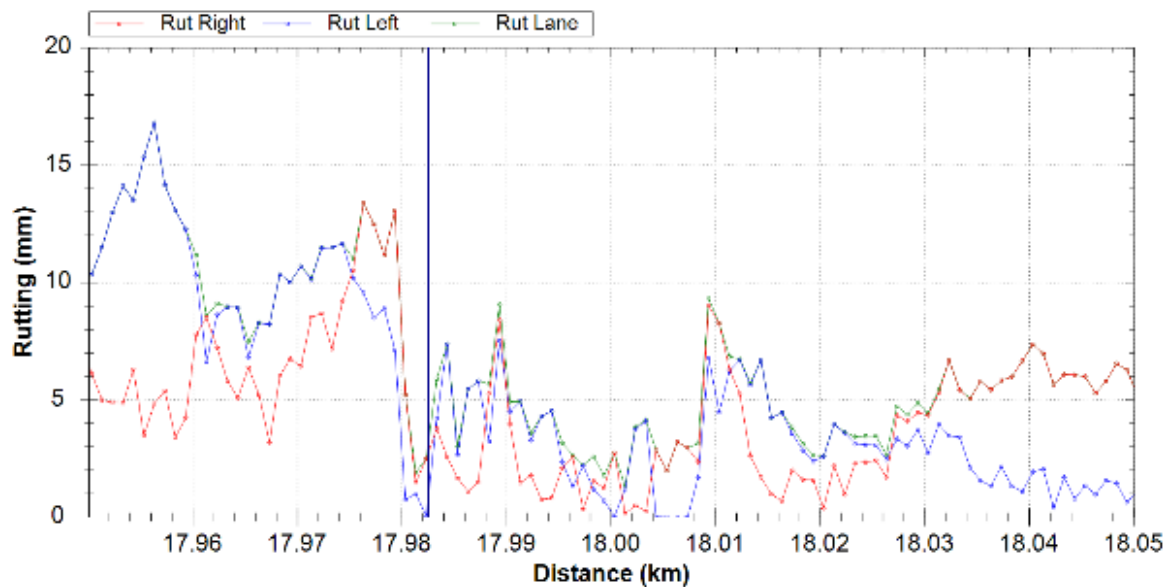
**Figure C.30 Hawkeye rut measurement for 3% cement in- situ stabilisation at 16- month inspection (SH27-RS46-17982-18012 (decreasing side))**

The Hawkeye rut measurements show the rutting ranges from 2 mm to 9 mm with most of the rutting under 5 mm as shown in figure C.30 (distance 17.982 to 18.012 km).

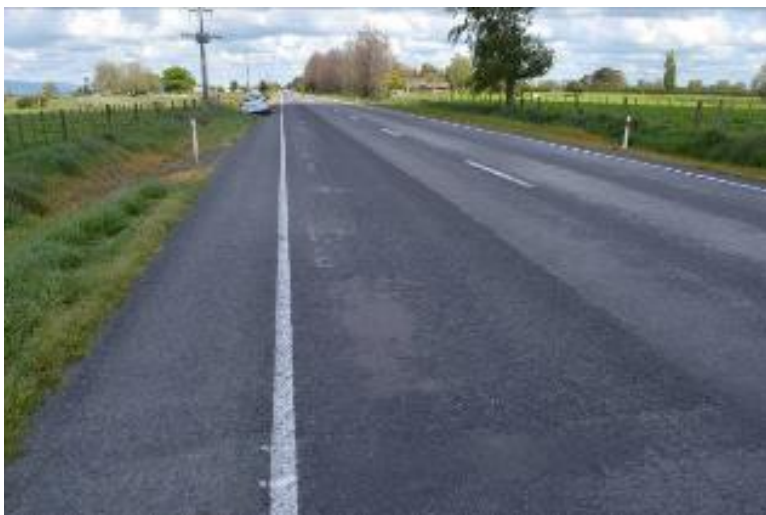
**Figure C.31 – 1.5% in- situ stabilisation – SH27-RS46-17430-17466 (decreasing side) – 3 month inspection**

Some cracking in the wheel paths.

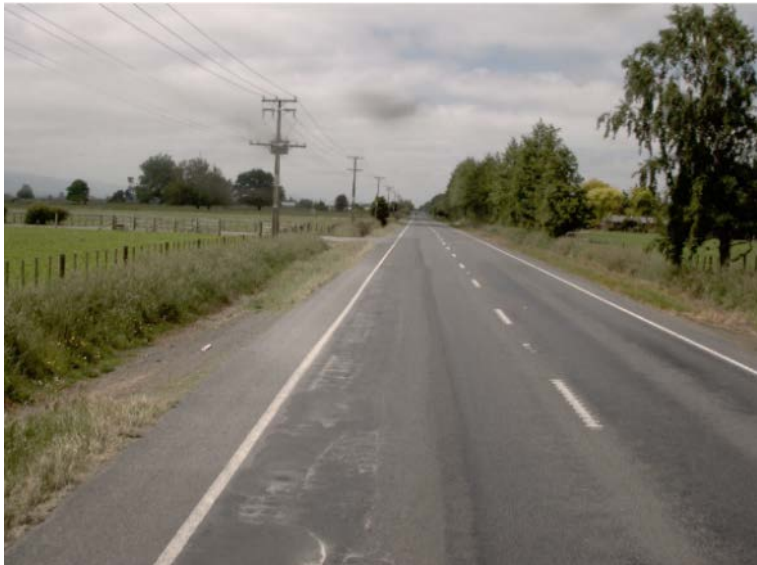
**Figure C.32 1.5% in- situ stabilisation – SH27-RS46-17430-17466 (decreasing side) – 16- month inspection**

Alligator cracking in 100% of the outside wheel paths with some asphalt patching.

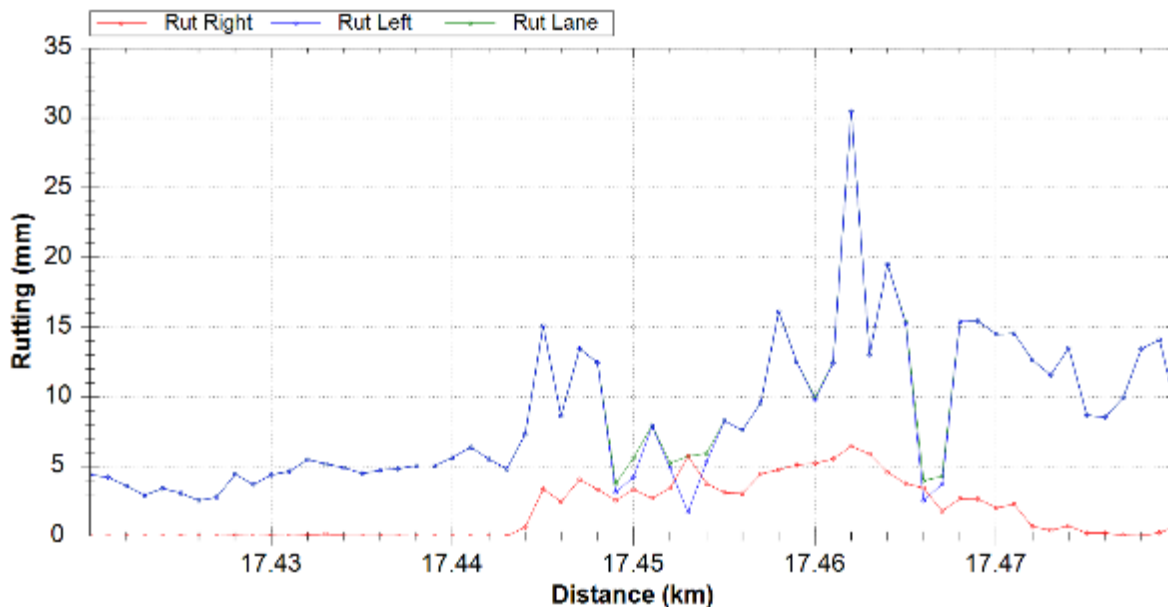
**Figure C.33 Hawkeye rut measurement for 1.5% cement in- situ stabilisation at 16- month inspection (SH27-RS46-17430-17466 (decreasing side))**

This site has some points in the outside wheel path with rutting as high as 15 mm but most of the rutting is less than 5 mm. As shown in the Hawkeye rut measurements the rutting is minimal (SH27-RS46-17430-17466 (decreasing side)).

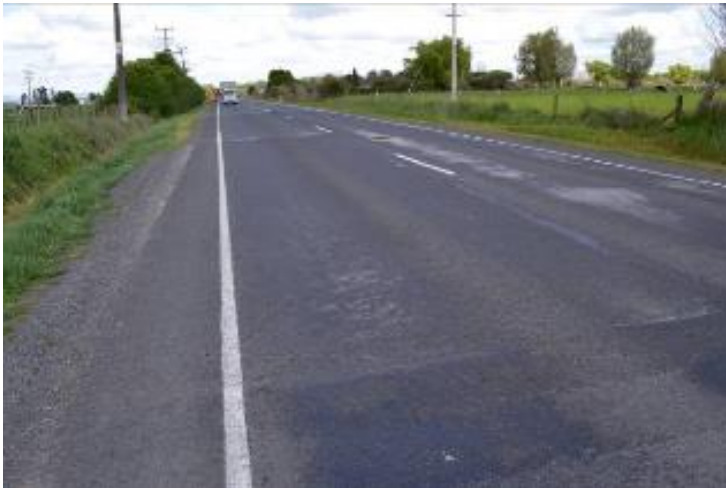
**Figure C.34 – Full depth granular reconstruction – SH27-RS46-17965-17980 (increasing side) – 3- month inspection**

There was cracking in half of the left-hand wheel path.

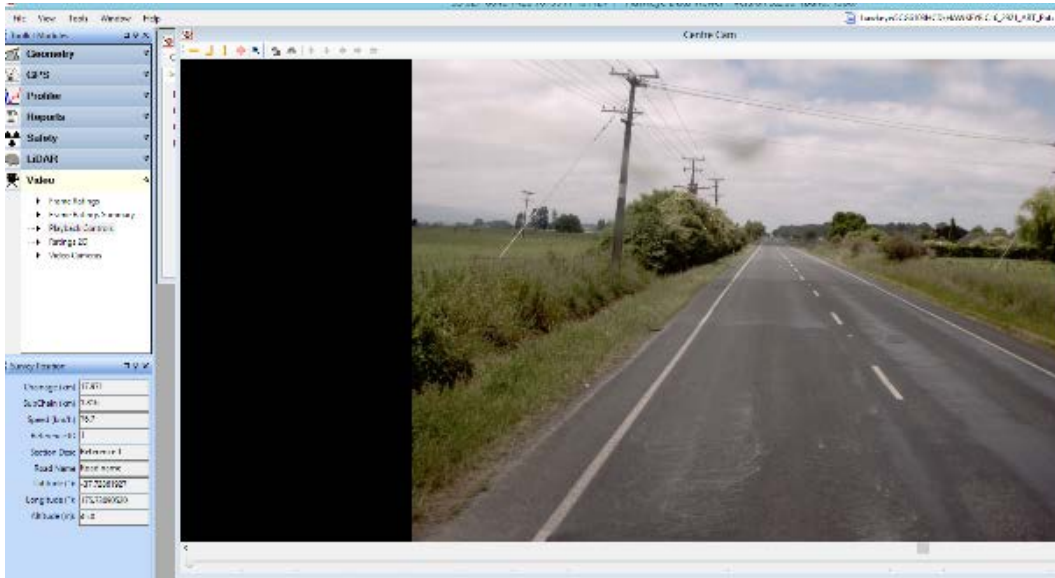
**Figure C.35 Full depth granular reconstruction – SH27-RS46-17965-17980 (increasing side) – 16- month inspection**

Cracking and rutting in most of both wheel paths.

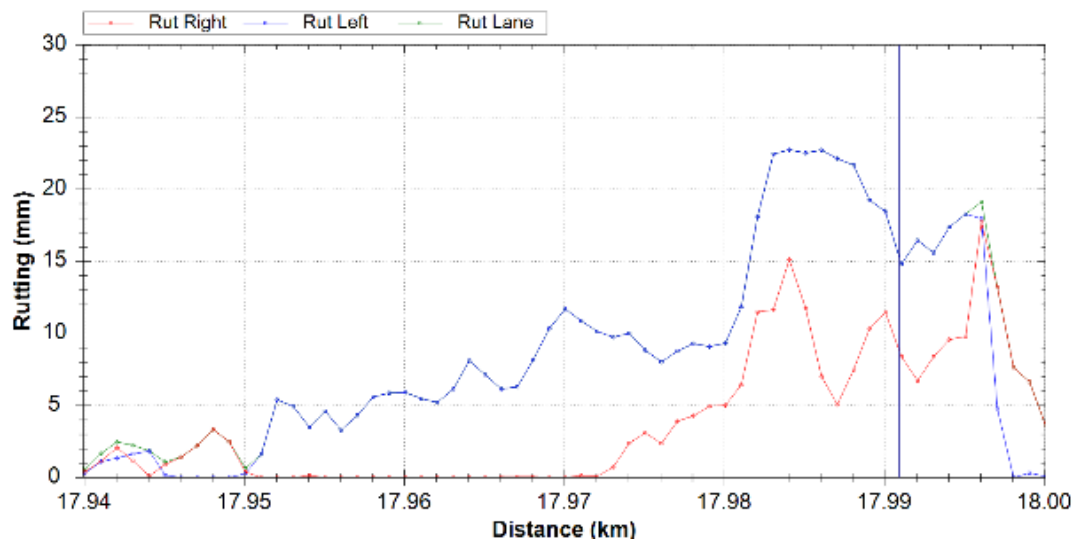
**Figure C.36 Hawkeye rut measurement for granular full depth construction at the 16- month inspection (SH27-RS46-17971-17991 (increasing side))**

Rutting from the Hawkeye Survey in November 2016 shows within the patch only (17.971 to 17.991 km) there is significant rutting in the outside wheel path of 15 to 23 mm and the inside wheel path 5 to 15 mm (17.971 to 17.991 km).

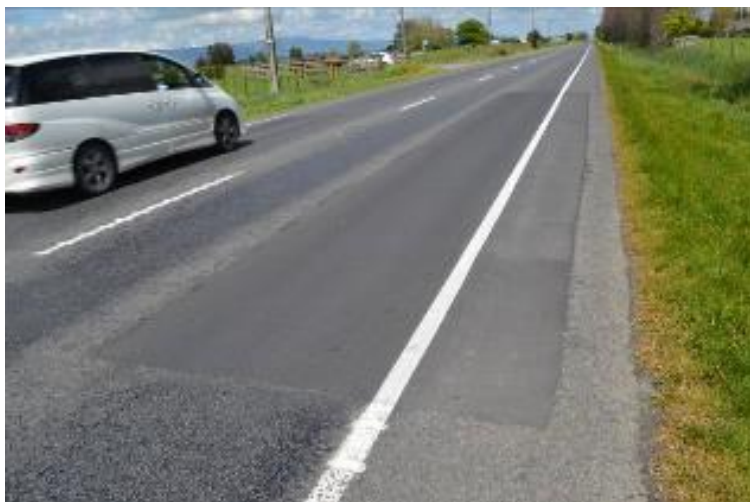
**Figure C.37 Mill and AC inlay – SH27-46-17455-17471 (decreasing side) – 3- month inspection**

No pavement damage after three months as shown in figure C.37.

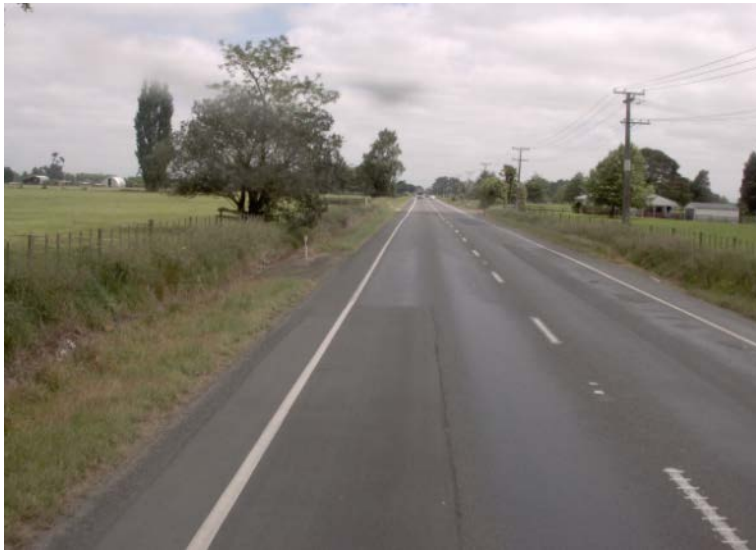
Figure C.38 Mill and AC patch - SH27-46-17455-17471 (decreasing side) - 16- month inspection

No pavement damage.

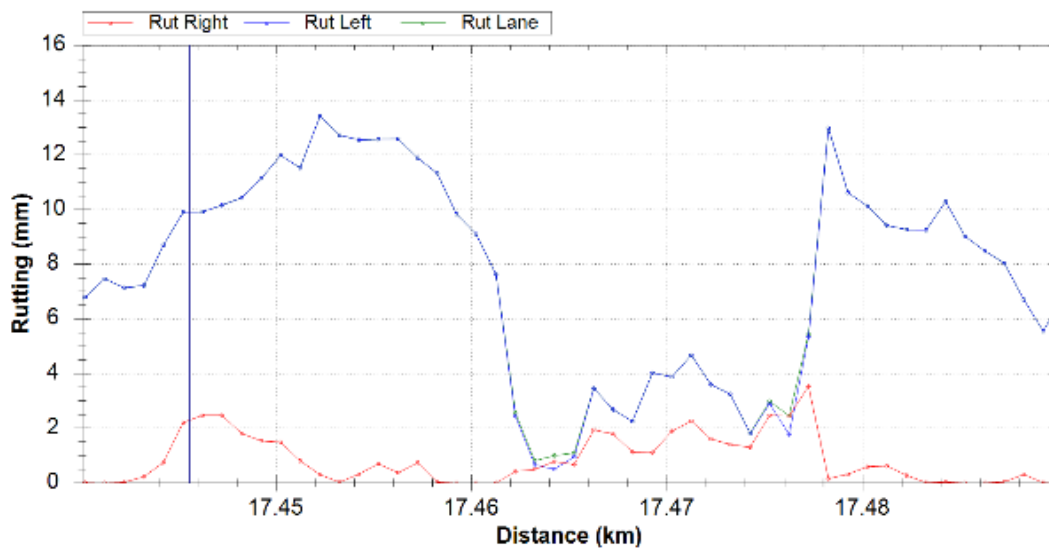
Figure C.39 Hawkeye rut measurement for mill and AC inlay at 16- month inspection SH27-RS46-17445-17485 (decreasing side)

In the Hawkeye rut measurements the rutting is as high as 13 mm as shown by the blue line for the 'rut left' in figure C.39 (distance 17.445 to 17.485 km), although there is a section in the middle of the patch where the rutting is less than 4 mm.
