+ NZTA National Resilience
PBC
Regional Risk Assessment Summary

Prepared for
New Zealand Transport Agency
Prepared by
Tonkin & Taylor Ltd
Date
April 2020
Job Number
1011128.v3

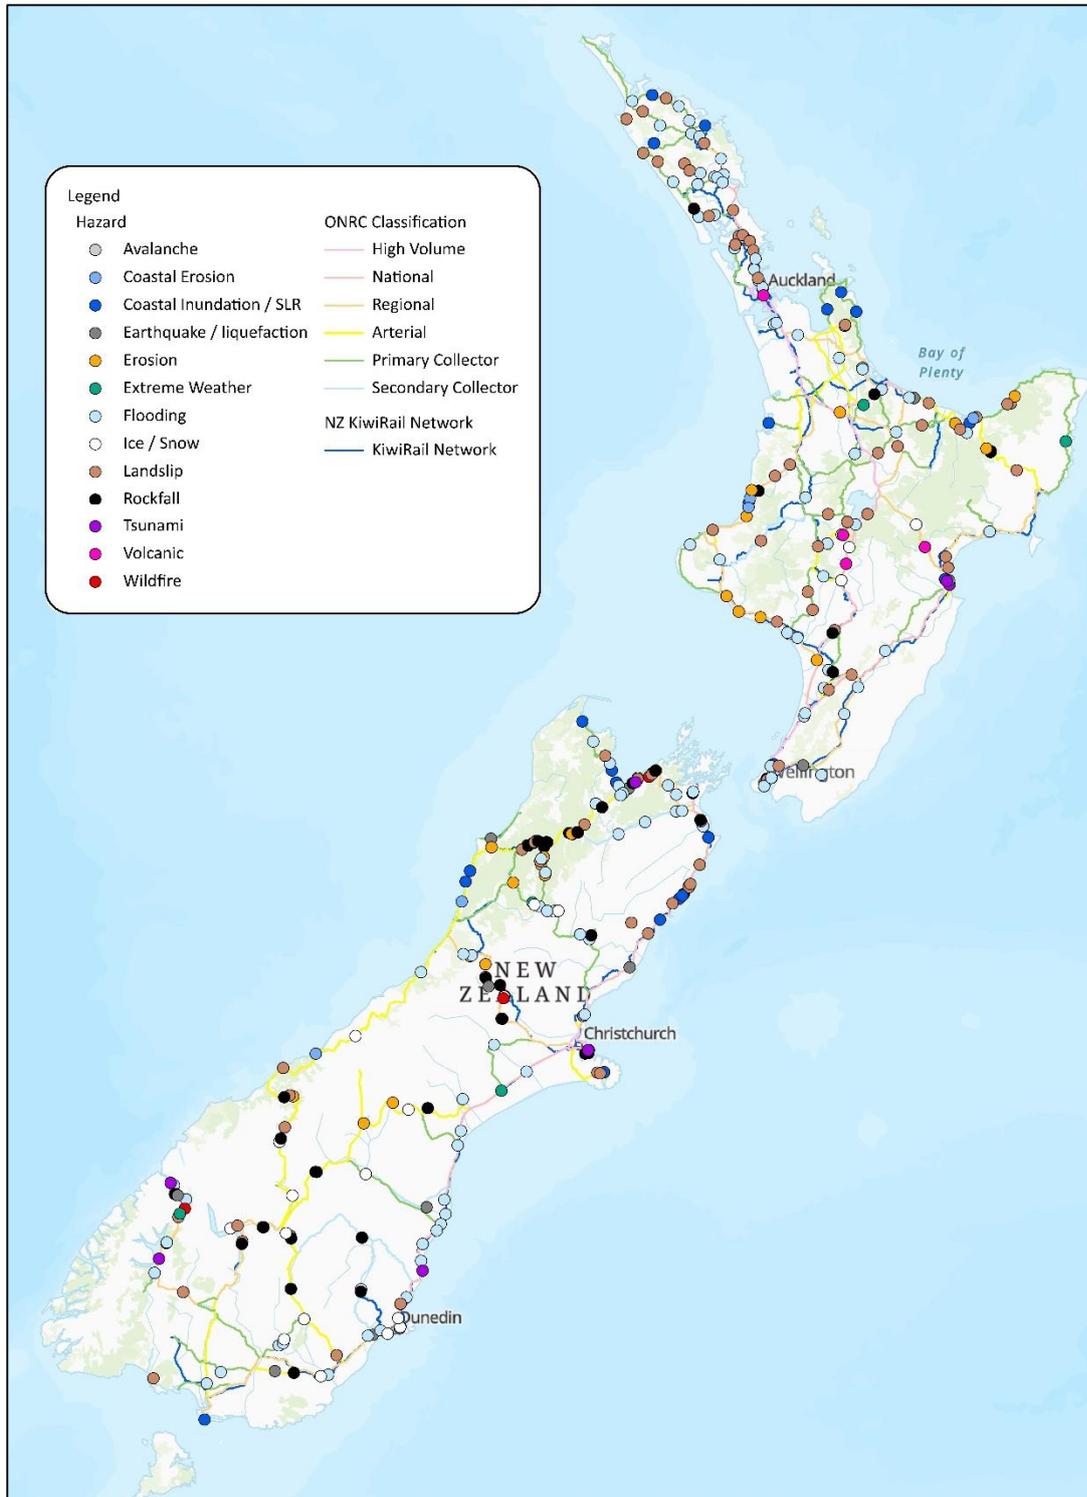
Some 370 risks were identified across the whole country (Figure 2.1). In accordance with the approach set out in the *Portfolio Risk Assessment Methodology Report*. The risks are grouped by regions that correlate with the Transport Agency NOC areas.

Figure 2.1: Distribution of risks by hazard type

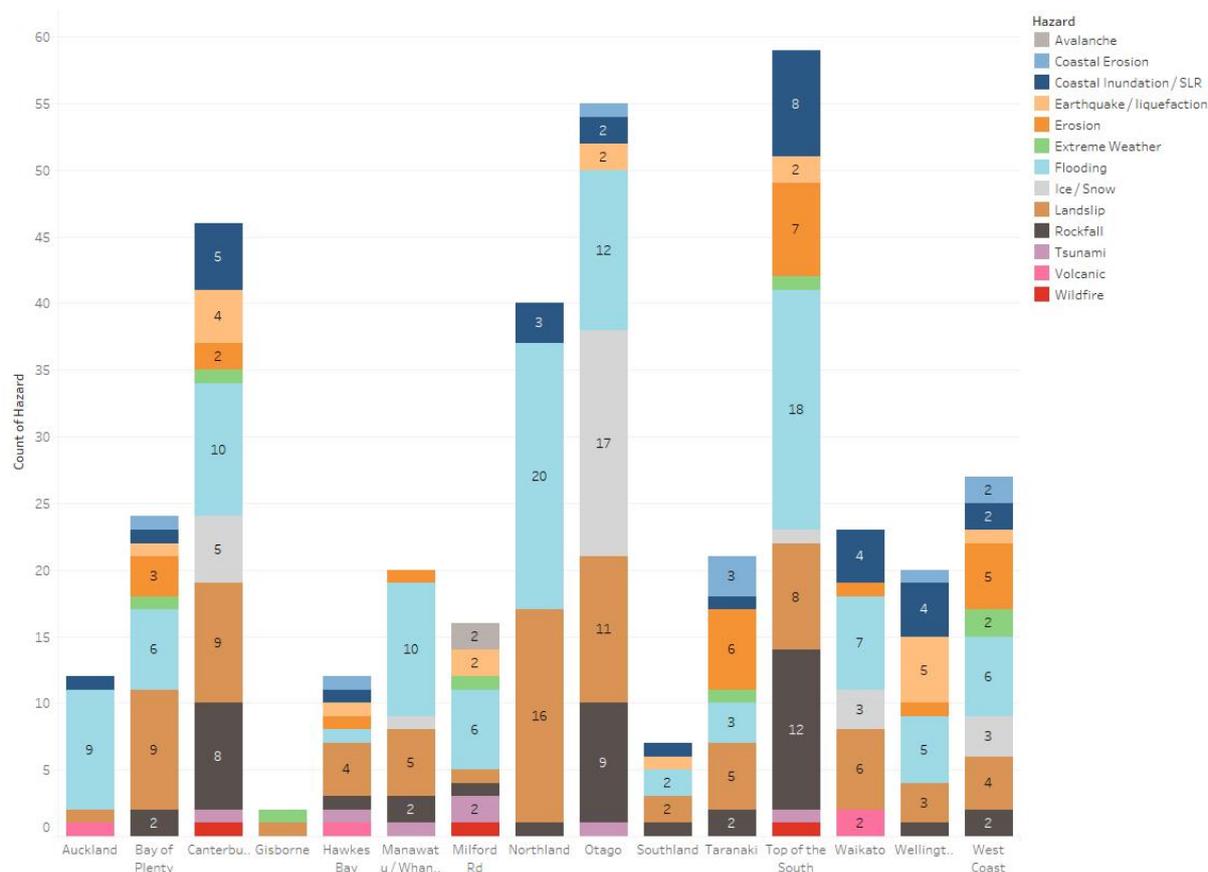
Figure 2.2 shows the risks by region according to hazard type. The Top of the South (Marlborough, Nelson and Tasman Districts), Otago and Canterbury have the greatest number of risks across the regions, with the majority of these being related to flooding, landslip, rockfall, snow and ice. The lowest numbers of risks are within the Gisborne¹, Auckland², Hawke's Bay and Southland regions.

The most common hazard is flooding, followed by landslip.

Figure 2.2: Summary of the number of risks by region and hazard type

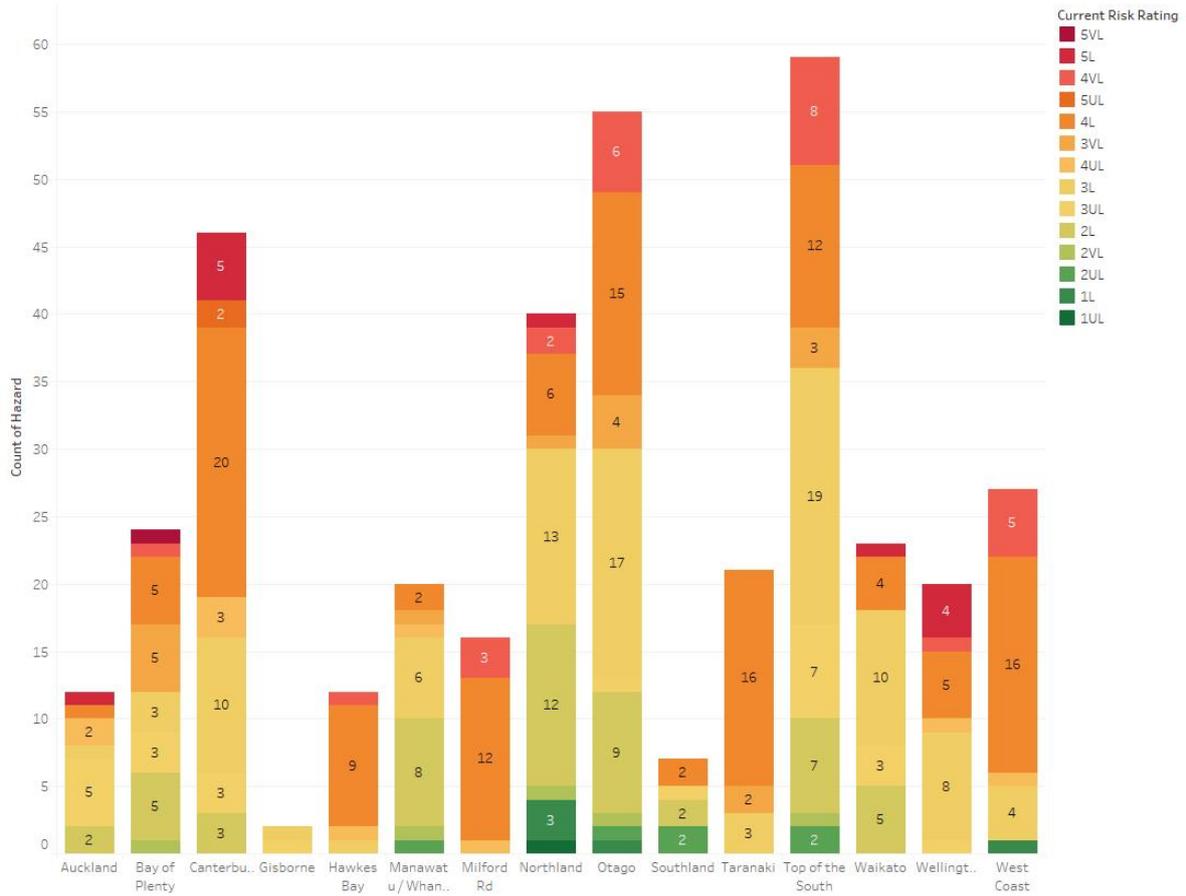
Figure 2.3 presents the present-day risks within each region along with the risk rating as determined during the regional stakeholder workshops. Since participants were asked to focus on the most important risks within their region, there is likely a natural bias towards higher risks.

Figure 2.3: Summary of the number of present day risks by region and risk rating

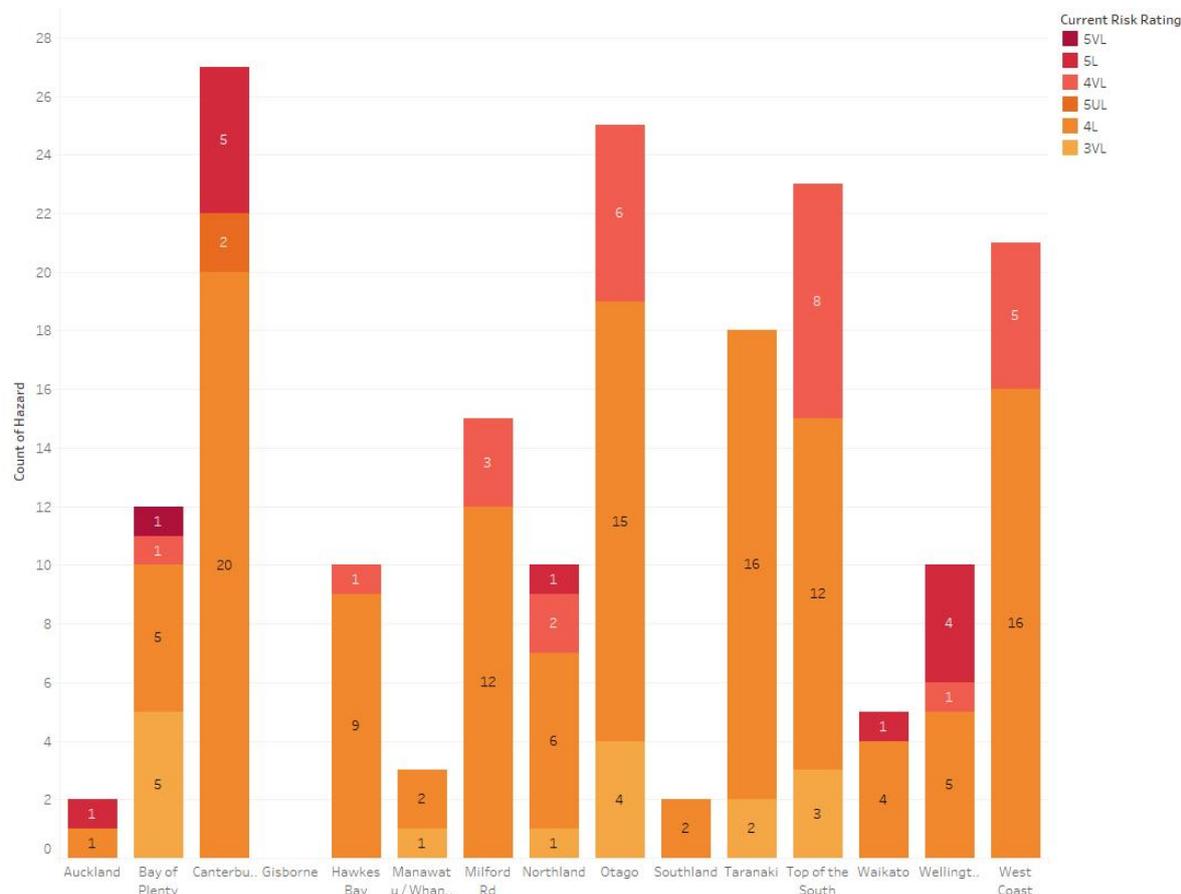
Figure 2.4 shows the extreme (5VL, 5L, 4VL) and major (5UL, 4L, 3VL) risks, broken down by subcategory. As shown, Canterbury, Otago, Top of the South (Marlborough, Nelson and Tasman Districts), West Coast have the highest numbers of extreme and major risks, with Auckland, Southland and Gisborne⁴ identifying the lowest number. The Bay of Plenty has the only 5VL⁵ extreme risk.

Figure 2.4: Summary of number of major and extreme risks by region

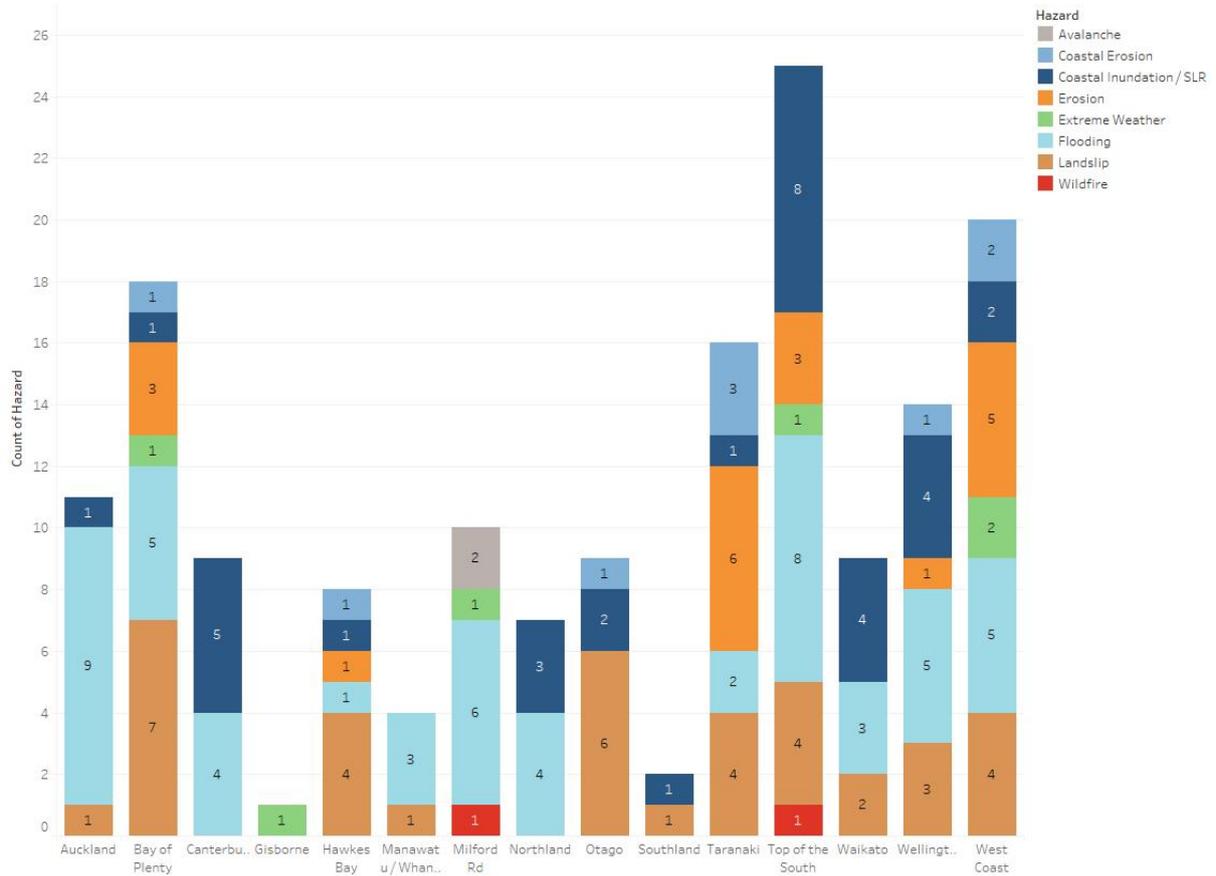
In total, approximately 160 climate change related risks were identified throughout the country. These relate to coastal inundation and sea level rise (SLR), erosion (both coastal and along river banks), flooding, rainfall induced landslips, extreme weather, wildfire and avalanche (Figure 2.5). The highest number of identified climate risks are within the Top of the South, West Coast and Bay of Plenty regions.

Figure 2.5: Summary of the number of climate related hazards by region

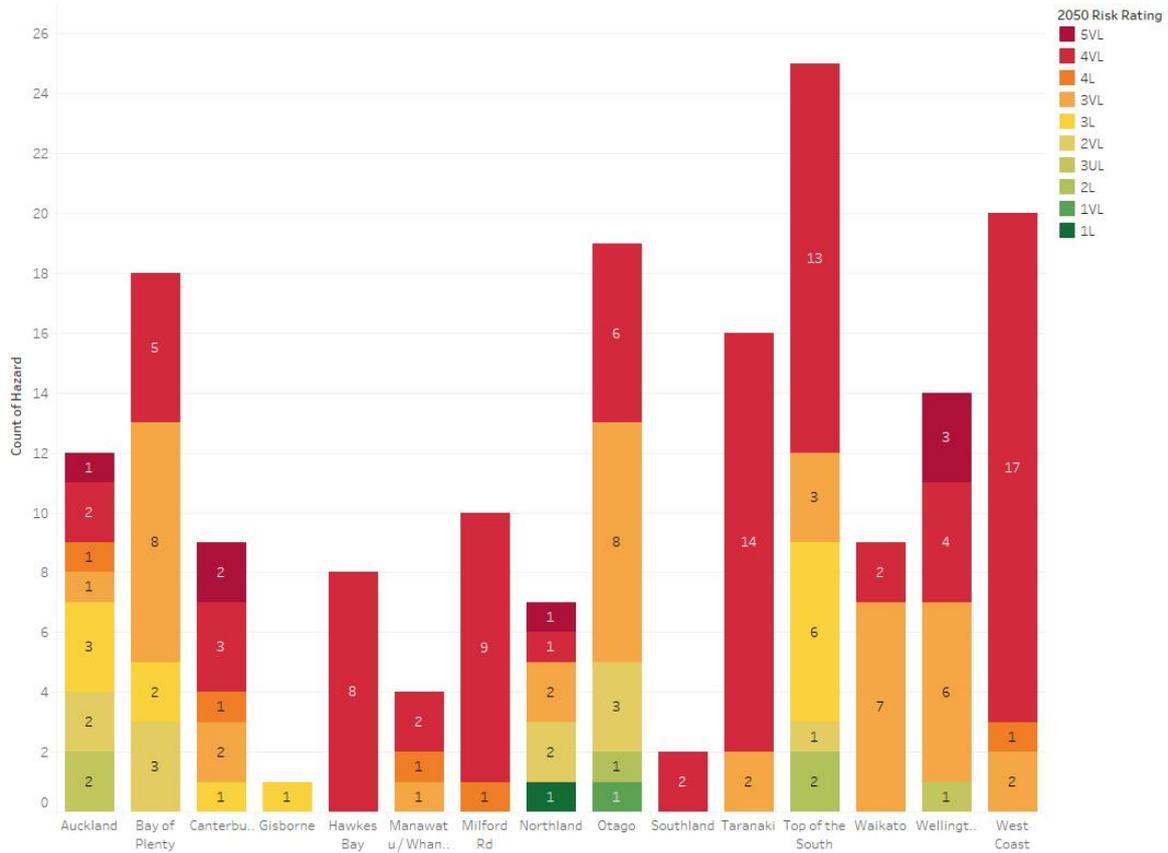
Figure 2.6 illustrates the same risks within each region along with the risk rating as determined during the regional stakeholder workshops.

Figure 2.6: Summary of climate related risks in 2050 by region

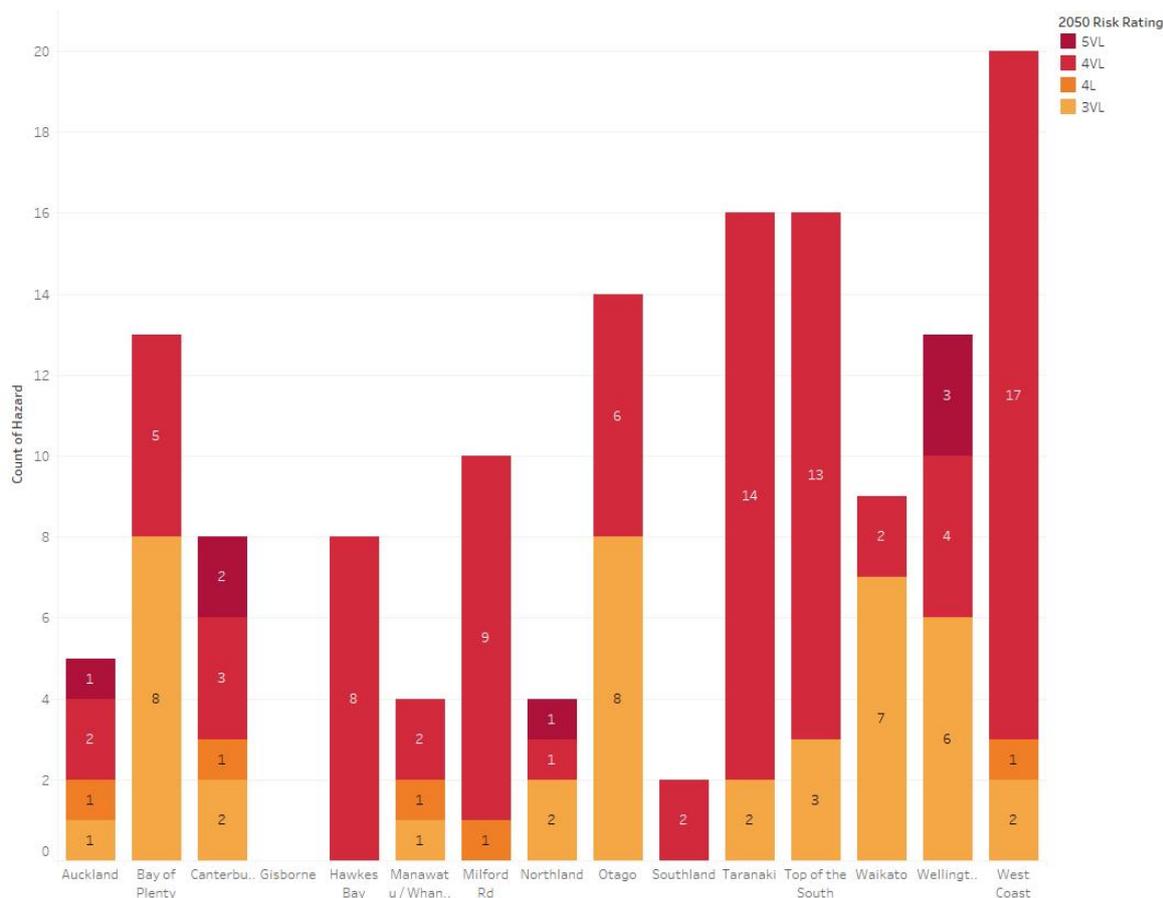
Figure 2.7 shows only the extreme (5VL, 5L, 4VL) and major (5UL, 4L, 3VL) risks, broken down by subcategory. The highest numbers of extreme and major risks occur within the West Coast, Top of the South, Taranaki, Otago and Bay of Plenty.

Figure 2.7: Summary of major and extreme climate related risks in 2050 by region

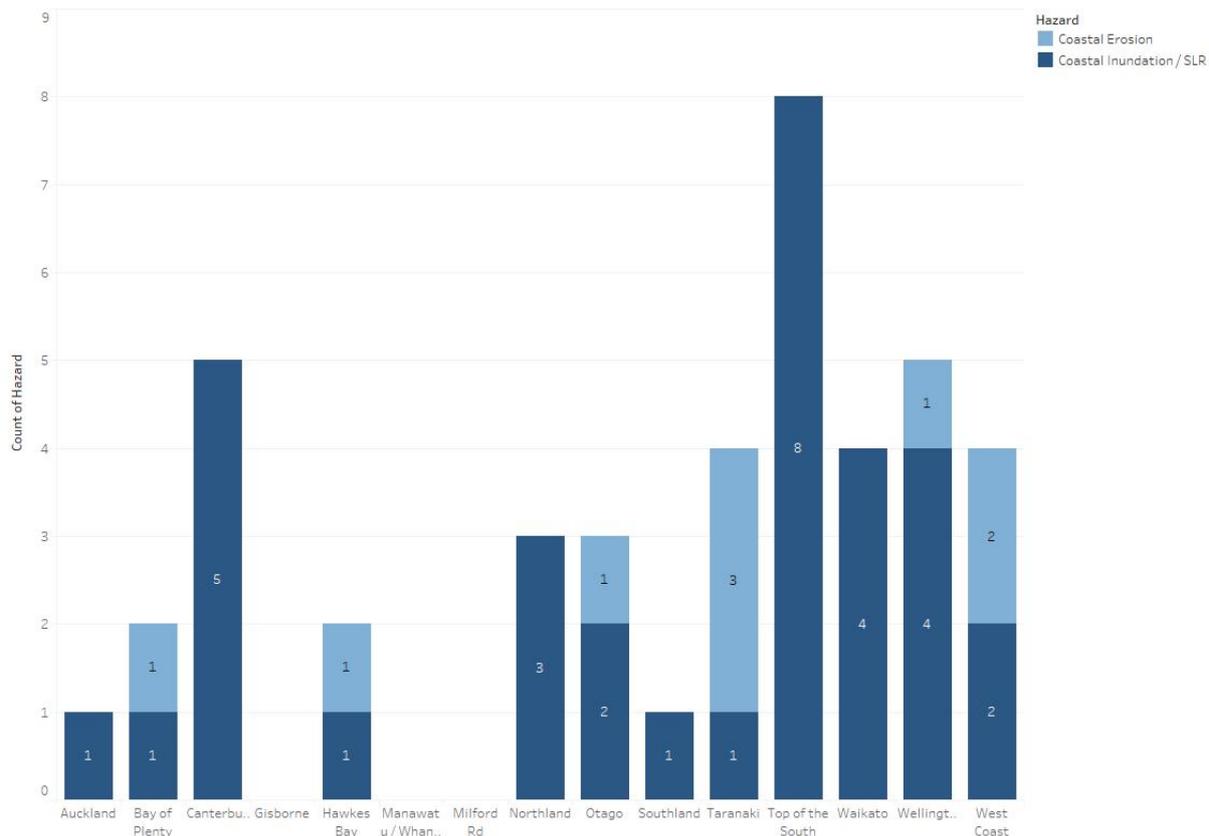
This section summarises the coastal climate related risks identified and rated. Top of the South, Wellington and Canterbury have the greatest number of coastal risks of which the majority relate to coastal inundation and SLR (Figure 2.8).

Figure 2.8: Coastal climate related hazards by region

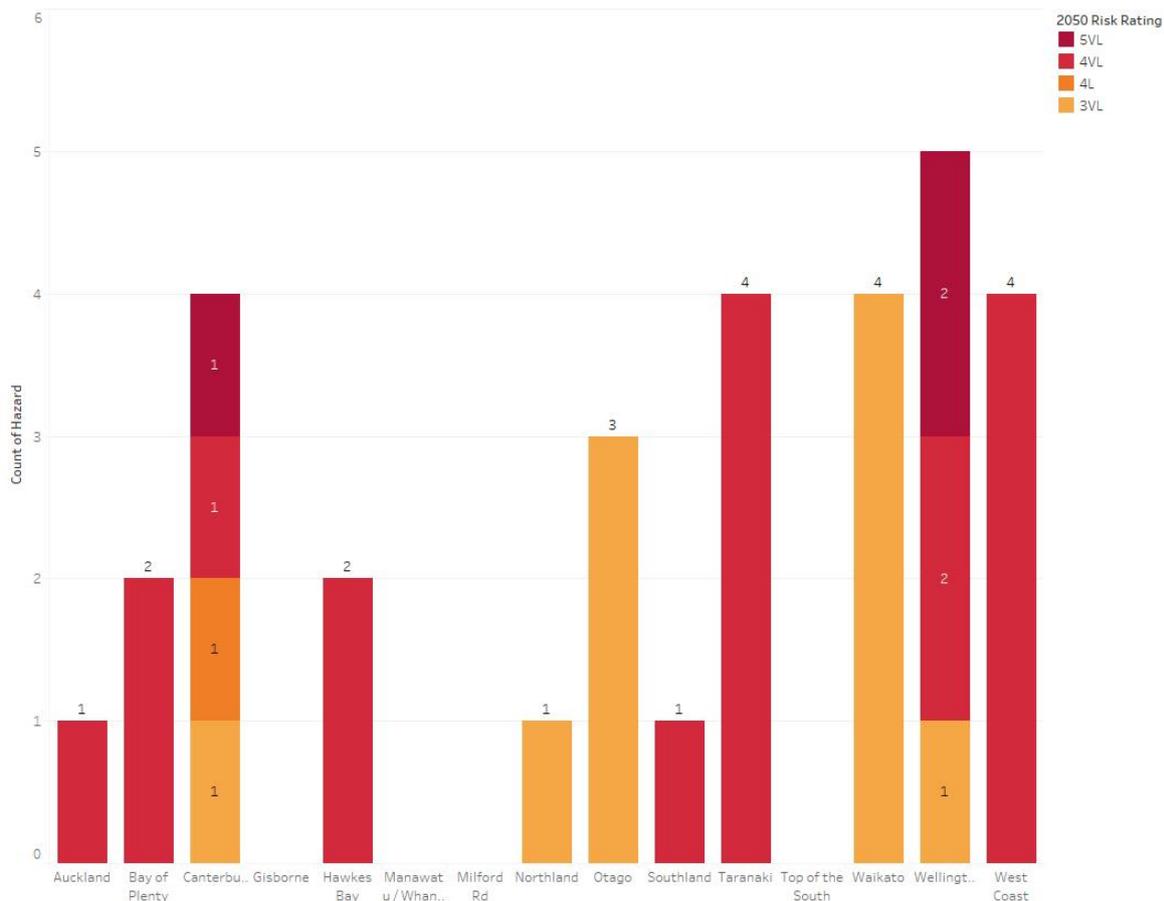
Figure 2.9 details the extreme (5VL, 4VL, 4L) and major (3VL) coastal climate-related risks by region. Wellington, Canterbury and the West Coast show the greatest number of extreme and major coastal climate related risks with both Wellington and Canterbury having risks rated at 5VL in the future.

Figure 2.9: Major and extreme coastal climate related hazards with 2050 risk rating

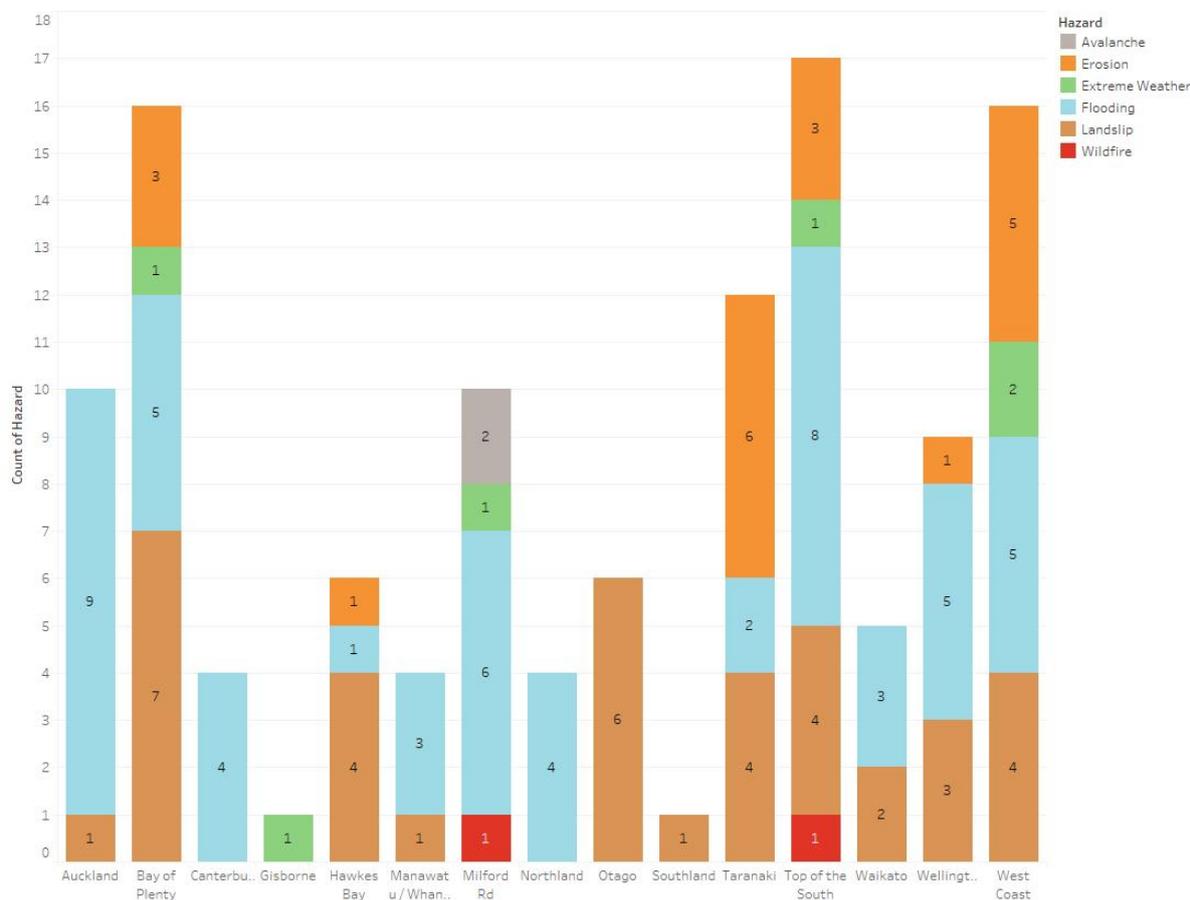
The following summarises the other (non-coastal) climate related hazards including erosion along riverbanks, extreme weather, flooding, avalanche, rainfall induced landslip and wildfire. Similar to the coastal hazards, Top of the South has the greatest number of non-coastal climate related hazards, specifically flooding and landslip (Figure 2.10). This is followed equally by the Bay of Plenty and the West Coast.

Figure 2.10: National summary of non-coastal climate related hazards

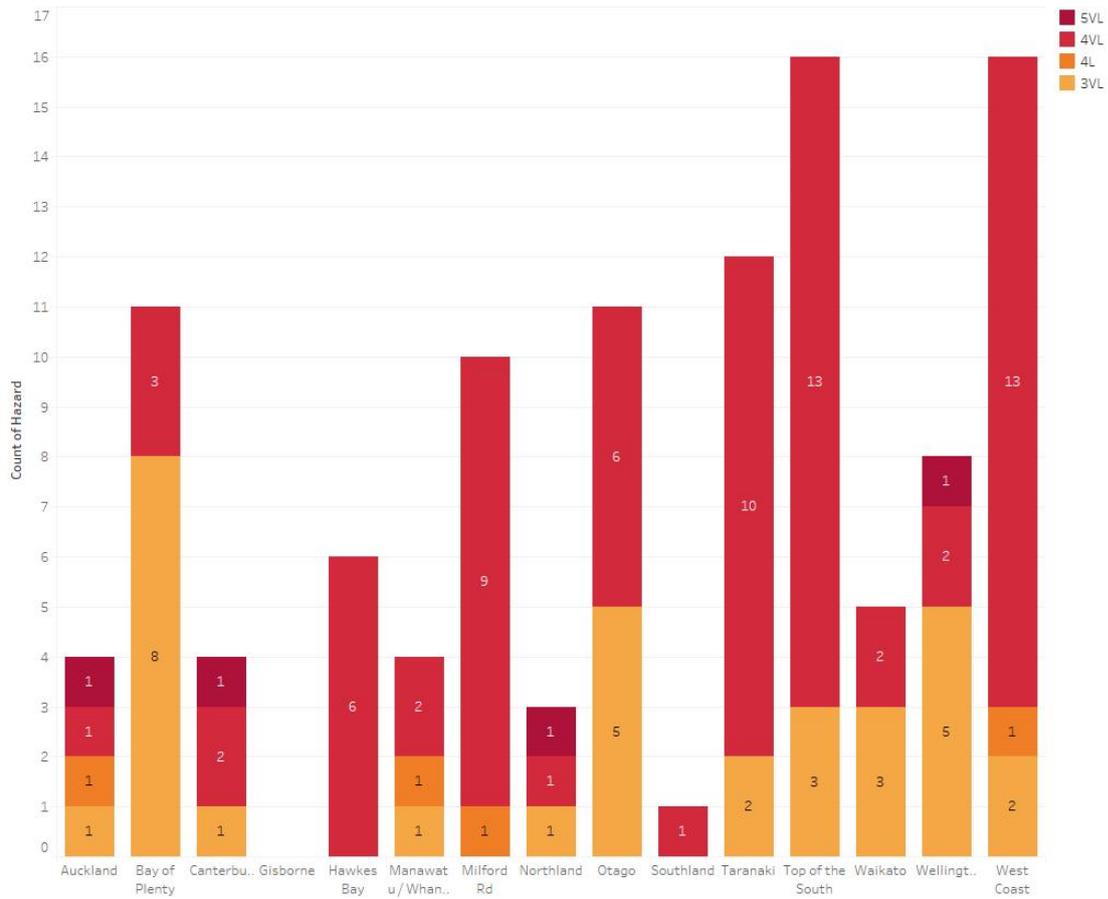
Figure 2.11 details the extreme (5VL, 4VL, 4L) and major (3VL) non-coastal climate related risks by region. West Coast, Top of the South and Taranaki show the greatest number of extreme and major non-coastal climate related risks with Northland, Wellington, Canterbury and Auckland having risks rated at 5VL in the future.

Figure 2.11: National summary of extreme and major non-coastal climate related hazard with 2050 risk rating
