Site Specific Environmental Management Plan

– Peka Peka to Ōtaki Project

BR04: Rahui Road Underpass (Bridge 4)

FCCL-EV-MPN-0034

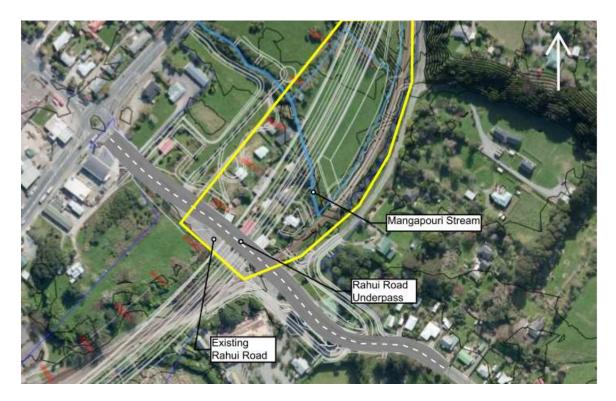
Figure 1: General location of works outlined in yellow

Bridge 4 (chainage 2070) is located to the north of the existing road alignment and to the west of the existing NIMT rail line. The existing rail line passes through the location of the bridge 4 eastern abutment which is being realigned to pass under the bridge. The site is generally a flat residential area with services running along Rahui Road, a number of which have now been realigned. The existing State Highway is approximately 150m north-west of the proposed underpass.

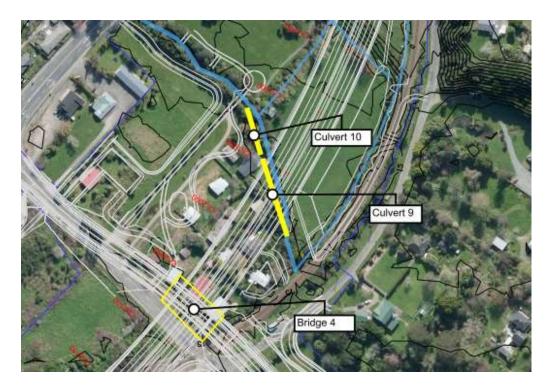
Figure 2: Location of Culvert's 9 and 10 north of Bridge 4

Two permanent culverts are to be constructed in the earlier stages of Bridge 4 construction:

- Mangapouri Stream main alignment (Culvert 9)
- Mangapouri Stream rail (Culvert 10)

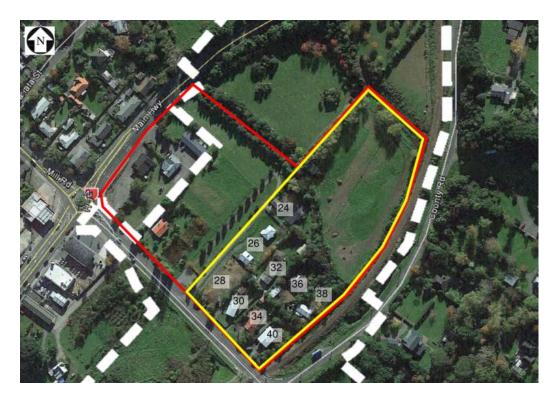
Figure 3: Historic market garden outlined in red with the area of potential works outlined in yellow (the area outside of the yellow boundary will not be impacted by these works).

As part of the AEE for the Project, a Phase One Contaminated Land Assessment was prepared by URS. This report identified land parcels within the Project boundary that had the potential to be contaminated and required further investigation. The location of works proposed in this SSEMP encroaches on one of these identified sites at 24-40 Rahui Road (referred to as the Rahui Road Northern Market Garden Site), which has been confirmed as being a site where activities listed on the Hazardous Activities and Industries List (HAIL) has occurred (namely persistent pesticide use and asbestos in soils). The definition of 'Site' in reference to contaminated land is the general HAIL location identified in figure 3 below.

- Additional requirements for management of soils within the temporary stockpile area will be actioned as follows:
 - Soils will be located within sediment controls to prevent sediment discharge off-site to land or water (refer to Figure 3 for the 'site' boundary in yellow). There is currently no clean water catchment running to the stockpile location. If this changes due to progression of works in the general area, clean stormwater will be diverted away from the stockpile location using clean water diversion bunds.

- Potential dust discharge from the temporary stockpile will be mitigated by the use of temporary stabilisation measures if required (i.e. polymers, temporary mulch, geotextile covers) to ensure that there is no discharge to air beyond the boundary of the site (refer to Figure 3 for the 'site' boundary in yellow).

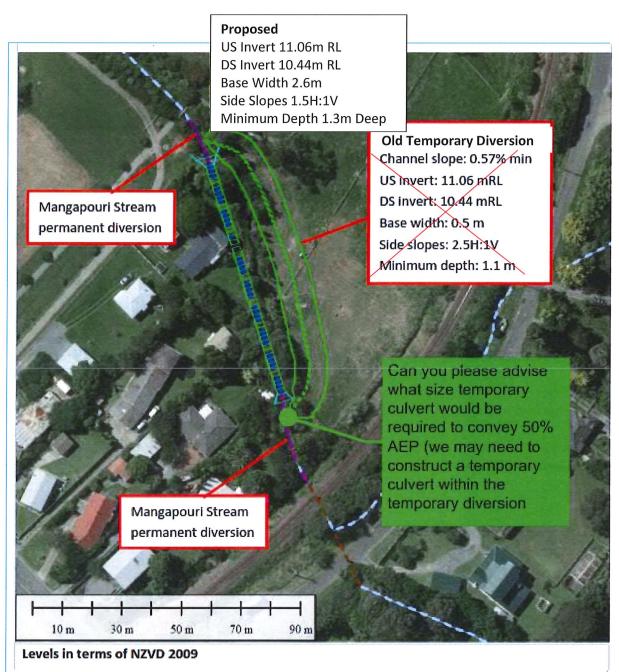
We propose the following arrangement of culvert and channel sized for a 2 year ARI flood discharge of 7.7m³/s:

A **twin 1200mm diameter** culvert to with a 1.3m deep, 2.6m wide channel with 1:1.5 side slopes. This allows for 200mm culvert embedment for fish passage too.

Figure 1: Initially proposed arrangement without culvert crossing.

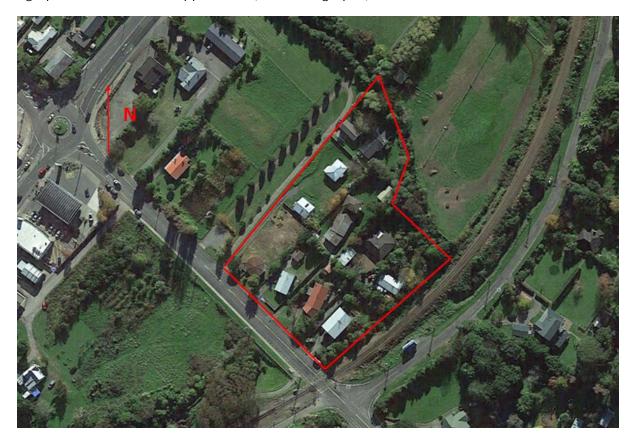
Figure 2 - Rahui Rd site area and layout prior to removal of the buildings (Source: Google Earth Pro 2017)

A contaminated land specialist completed a site walkover inspection of the Kiwirail designation on 21 September 2017 and at the Rahui Rd site on 27 September 2017. Relevant observations made at the time of the inspections are summarised below. Key site features are shown on Figure 2 and selected photographs are included in Appendix B (Site Photographs).

The Rahui Road section of the property currently contains vacant residential buildings and the remains of previously demolished buildings. The buildings are constructed of wood, brick, metal, corrugated plastic, aluminium composite material and fibrolite with concrete slabbing. There is a driveway running along the western boundary of the site. A stream runs along the north eastern boundary flowing in a north westerly direction towards the coast. The site is predominantly covered with topsoil and vegetation. Closer inspection of the soil revealed fragments of metal, ceramic and rock. Multiple stockpiles were present. The ground is generally flat lying.

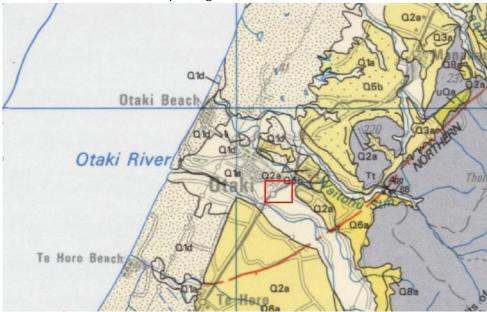
Figure 3 - Published geology of the Ōtaki area (source: Begg and Johnston⁸).

The Rahui Rd site and Kiwirail designation are located on an area of mostly flat, alluvial deposits which is described as 'well-sorted floodplain gravels'.⁷

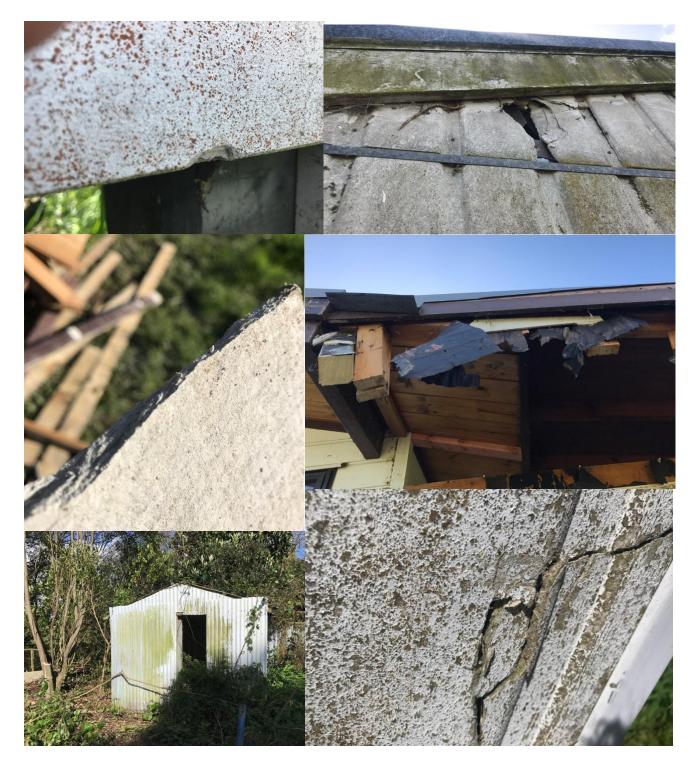
The buildings are constructed of wood, brick, metal, corrugated plastic, aluminium composite material and fibrolite with concrete slabbing (photos taken: September 2017)
