RAMM ROAD CONDITION RATING & ROUGHNESS

ROAD ASSESSMENT
AND MAINTENANCE
MANAGEMENT SYSTEM

PFM 6

RAMM - ROAD CONDITION RATING AND ROUGHNESS MANUAL

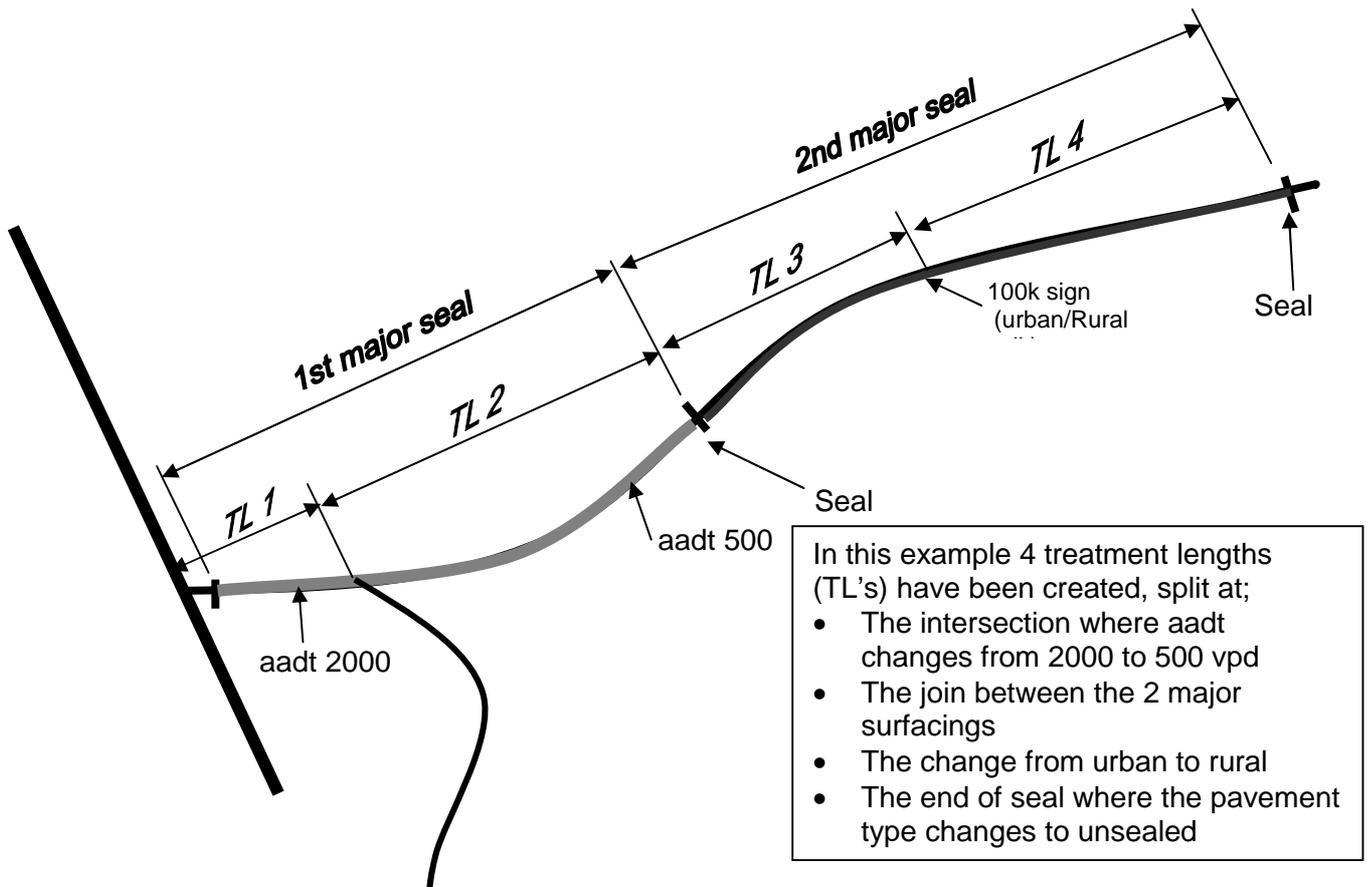
Figure 1

The process defines initial treatment lengths by finding the widest surfaces within each road but splits these at changes in;

- ADT
- Number of lanes
- Pavement Type
- Pavement Use
- Urban/Rural flag

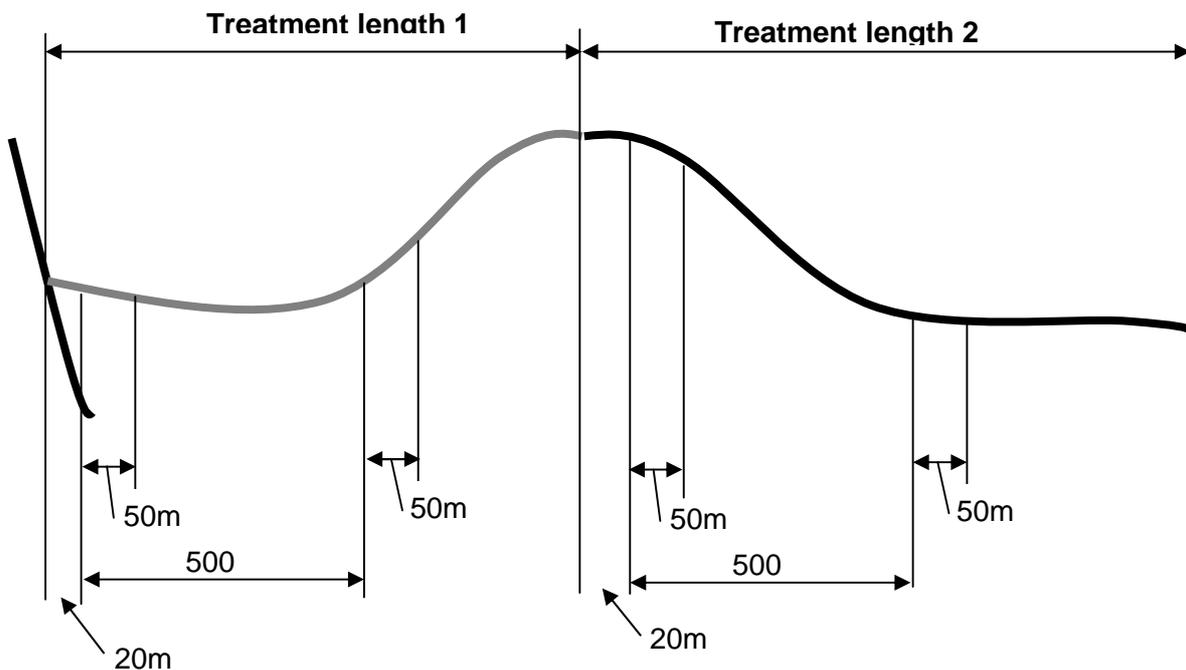
Figure 2 Inspection lengths set at 10% sampling at 500m intervals

The *aurorate* process in RAMM for Windows allocates inspection lengths based on the percentage and minimum lengths specified. Aurorate will define the first section 20m in from the beginning of treatment length. Each subsequent inspection within a treatment length is defined at the stated interval.

Figure 2 shows the relationship between the treatment length and the inspection length.

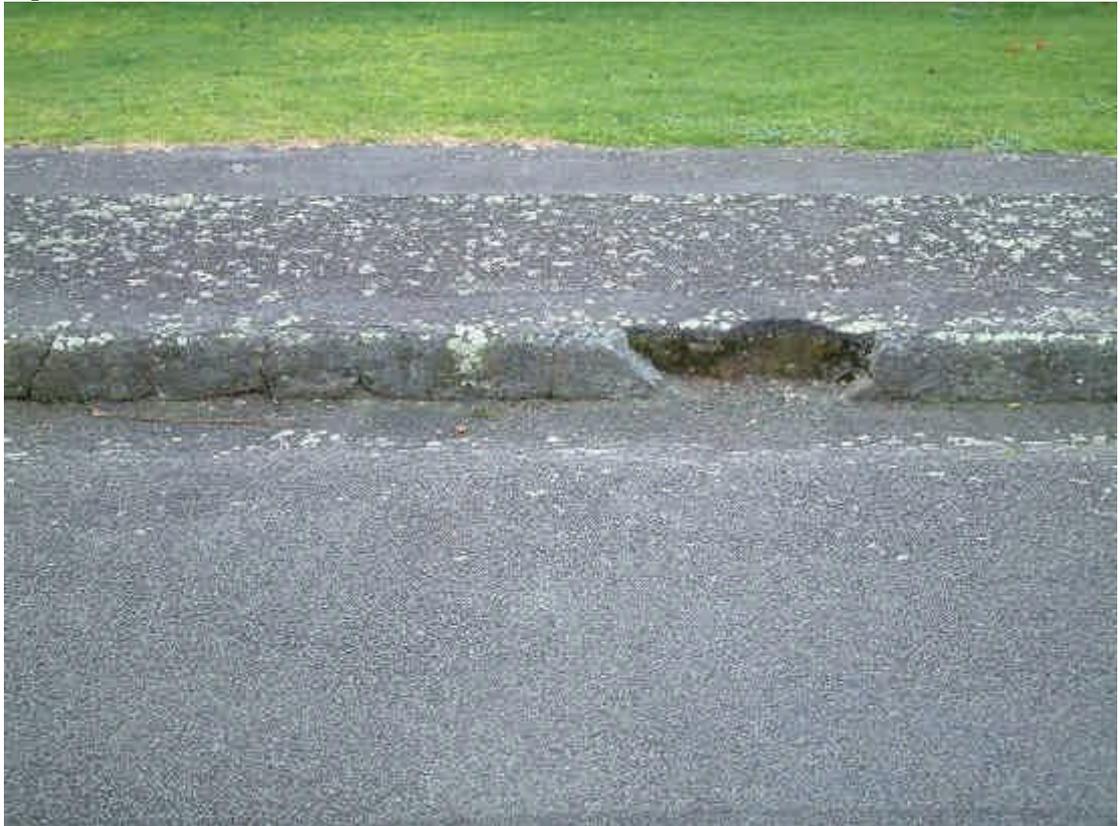
- (i) Example of a badly broken kerb and channel that is readily leaking water through to the sub-base of the carriageway.

The photos below show broken channel, inadequate kerb block joints and separation between channel and back of kerb

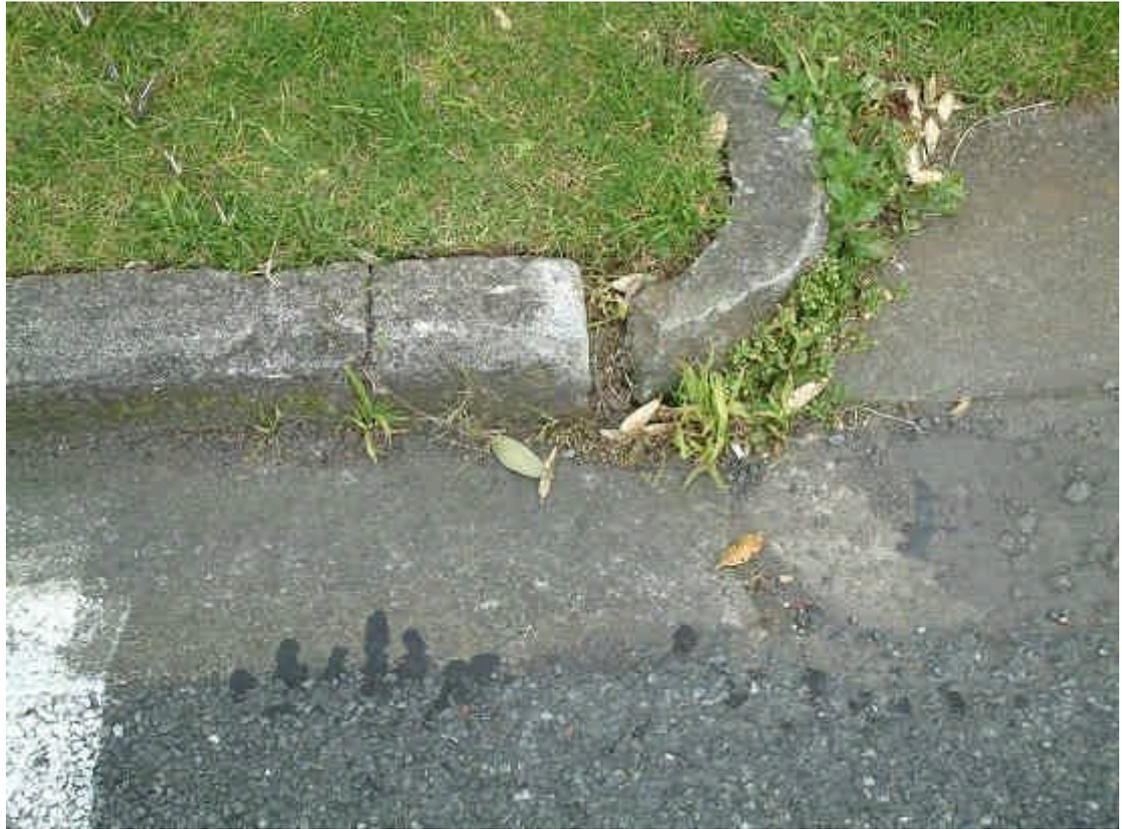
(ii) A broken section of channel adjoining a vehicle crossing.

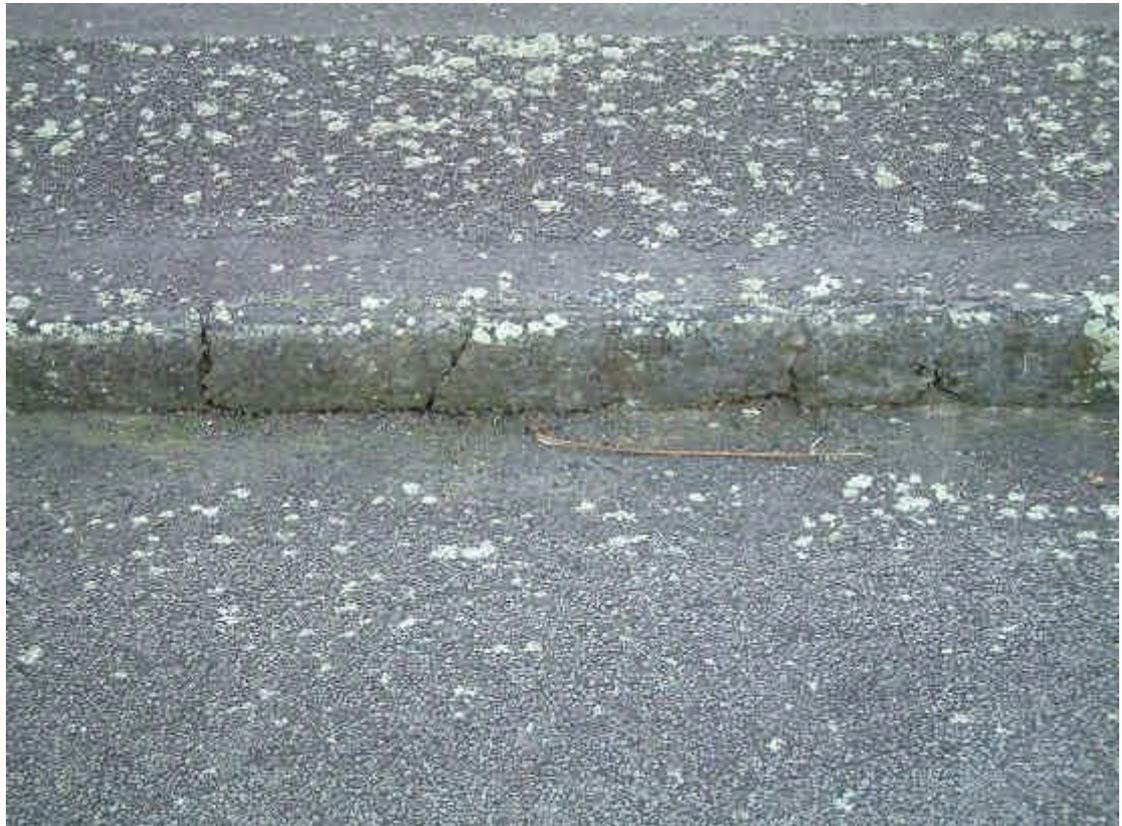
(iii) Separation between the channel and the kerb upstand is to be rated as broken.

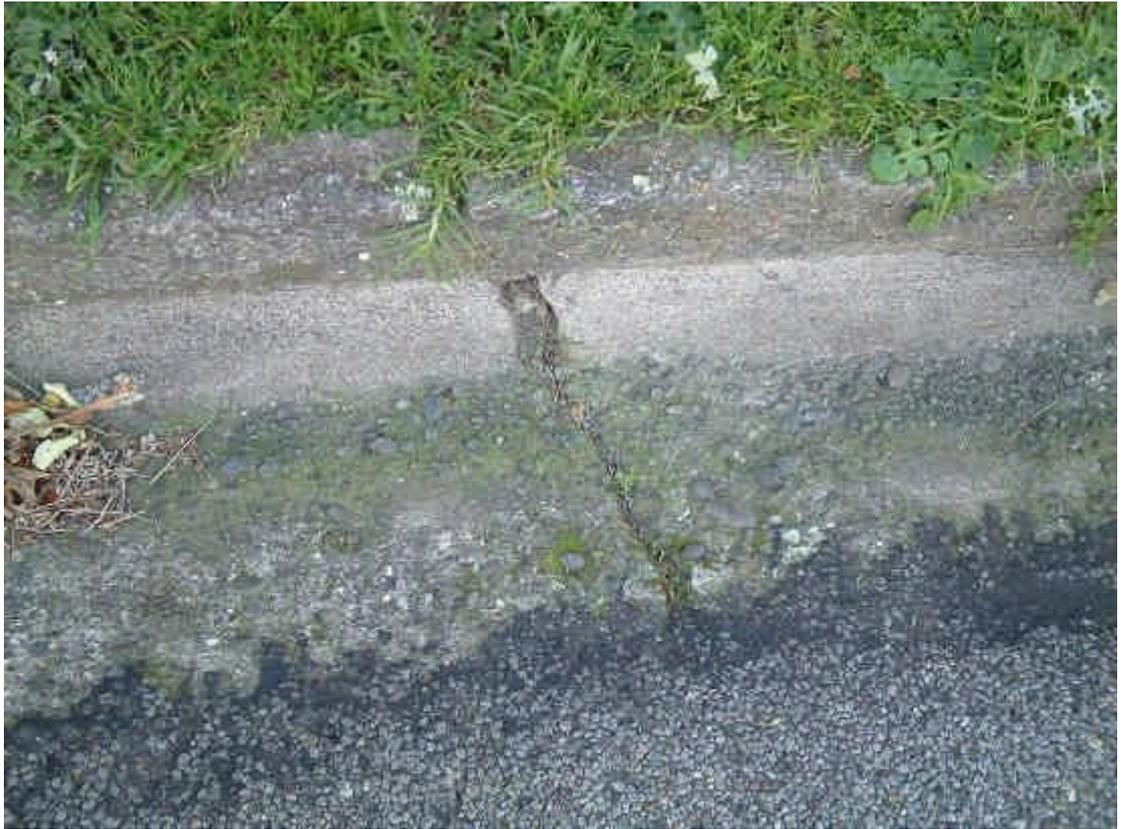
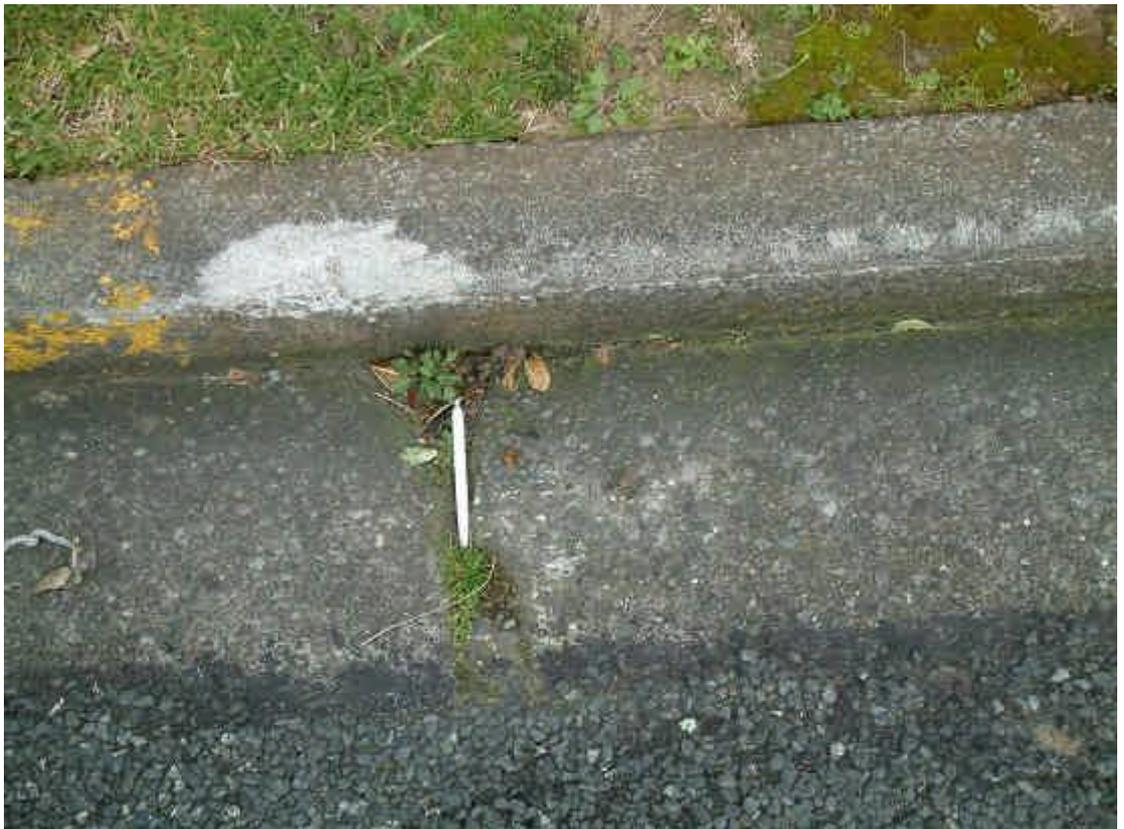
(iv) A single crack $>10\text{mm}$ wide at the surface is rated as 1m of broken channel.

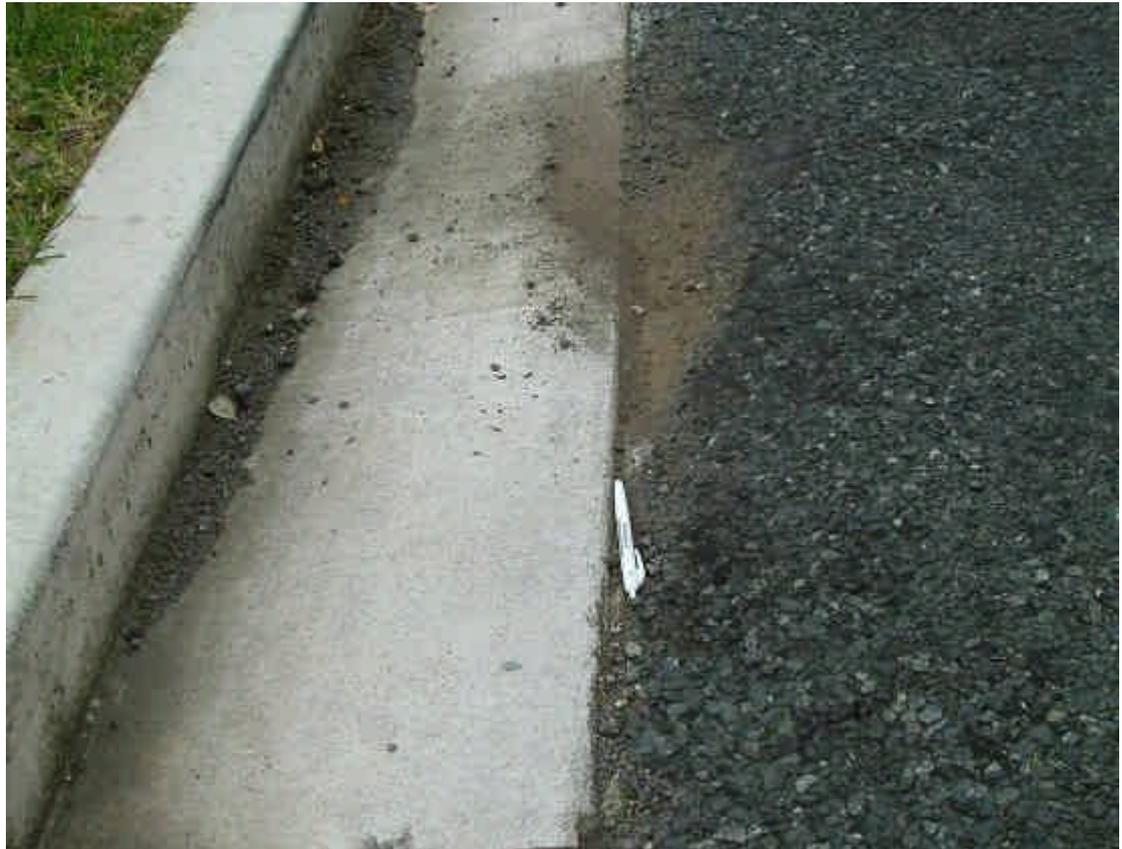
- (i) The photo above shows the lip of channel above the carriageway. A pen such as the one in the photo is an easy way of measuring height differences.

If the lip of channel is 10mm, (the height of a Bic pen), or more higher than the carriageway surface then the length of kerb affected is recorded. Where there is also broken carriageway surface, this height will have to be estimated from a straight edge placed on the carriageway surface and extended to the channel edge.

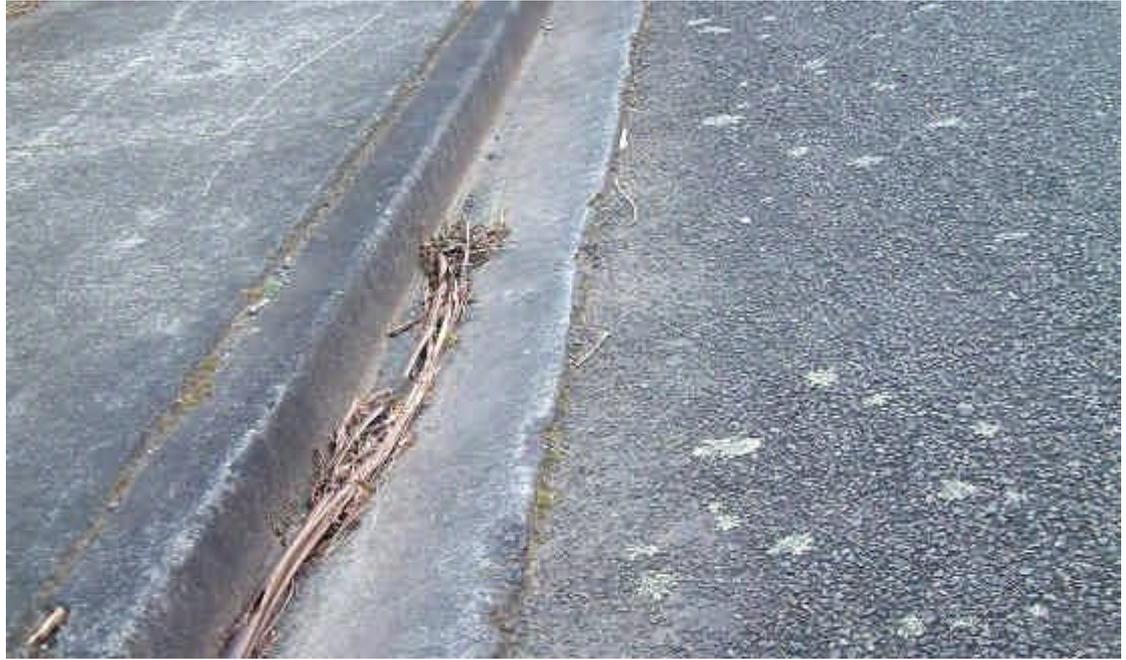
- (ii) Another good example of a kerb where the lip is higher than the carriageway surface.

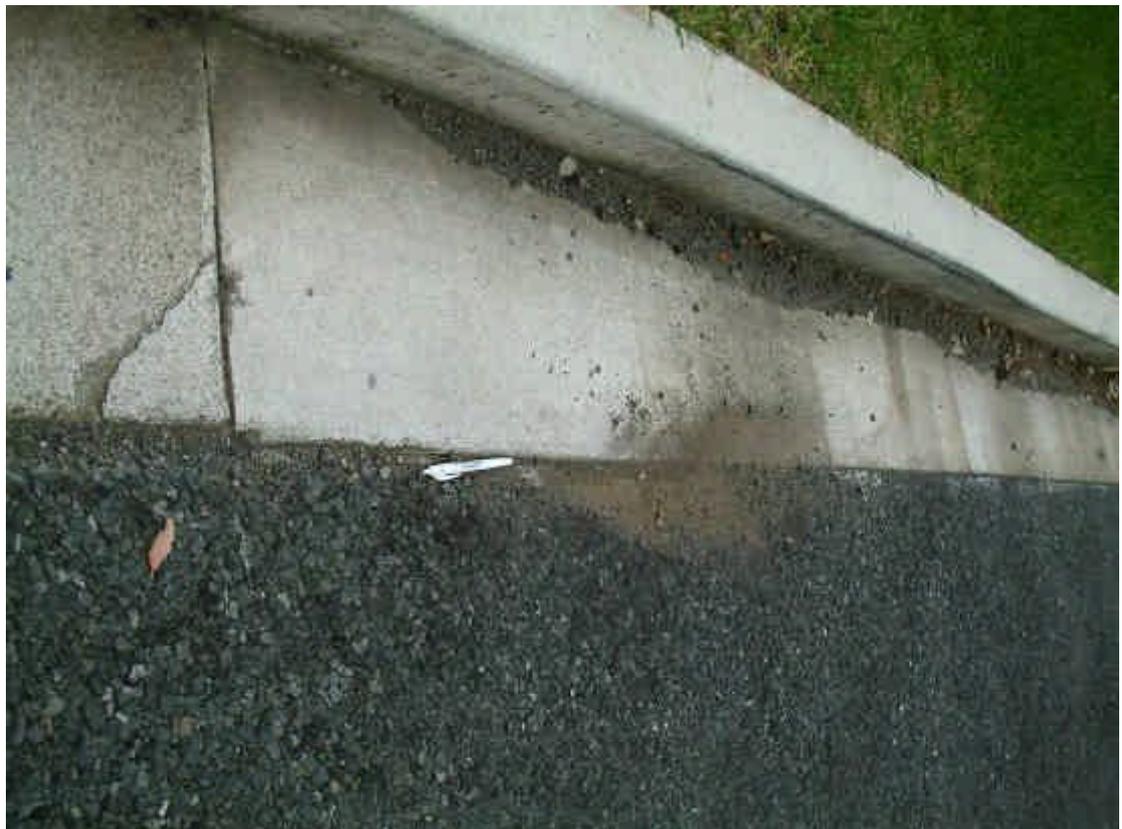
- (i) The photo above shows a break in the carriageway surface alongside the channel.

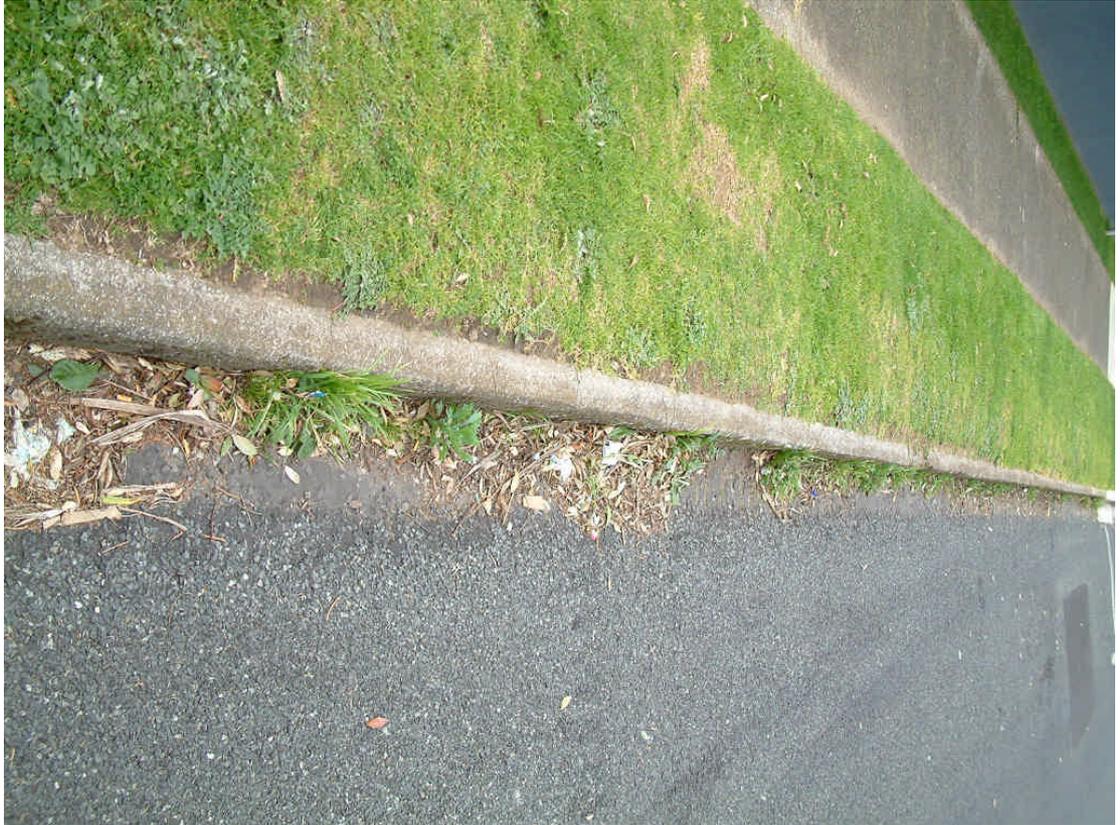
(i) Kerb and channel blocked by debris and weed growth.

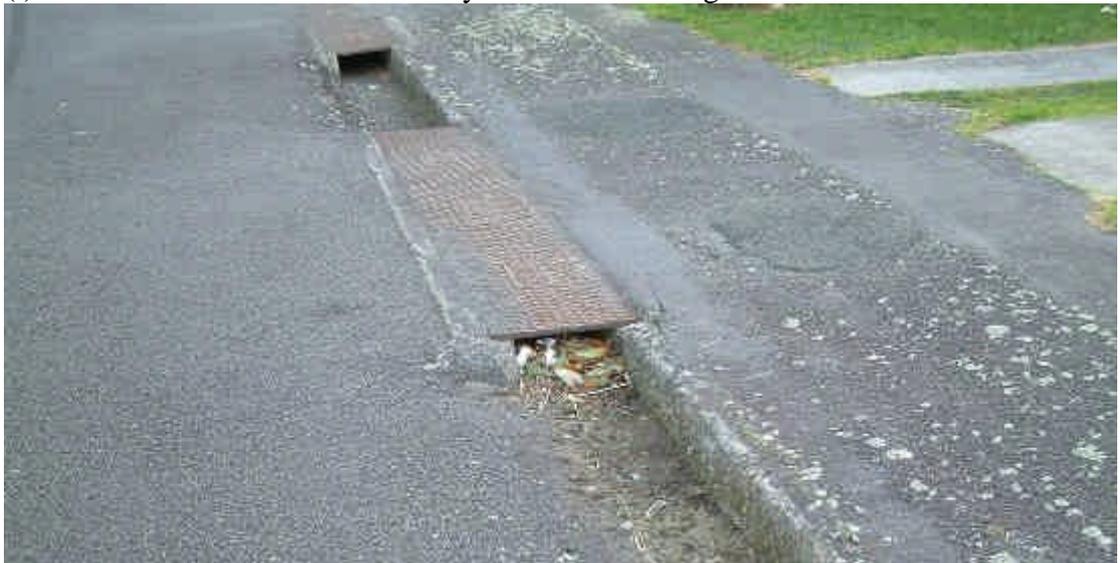
(ii) Kerb and channel blocked by badly maintained plate crossing. In this case the length of the crossing would be recorded as blocked

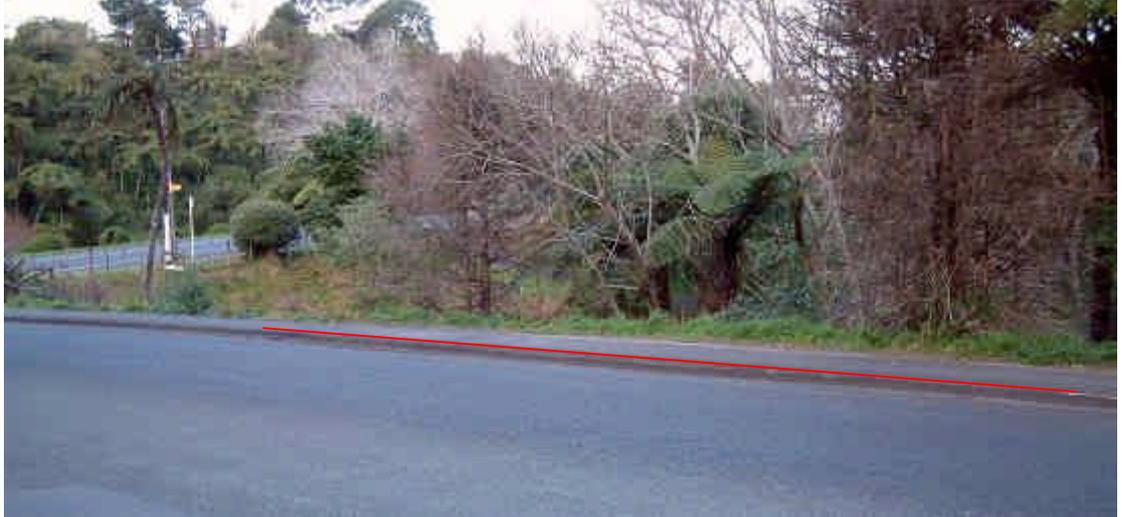
(i) An example of uphill grade in Kerb and Channel.

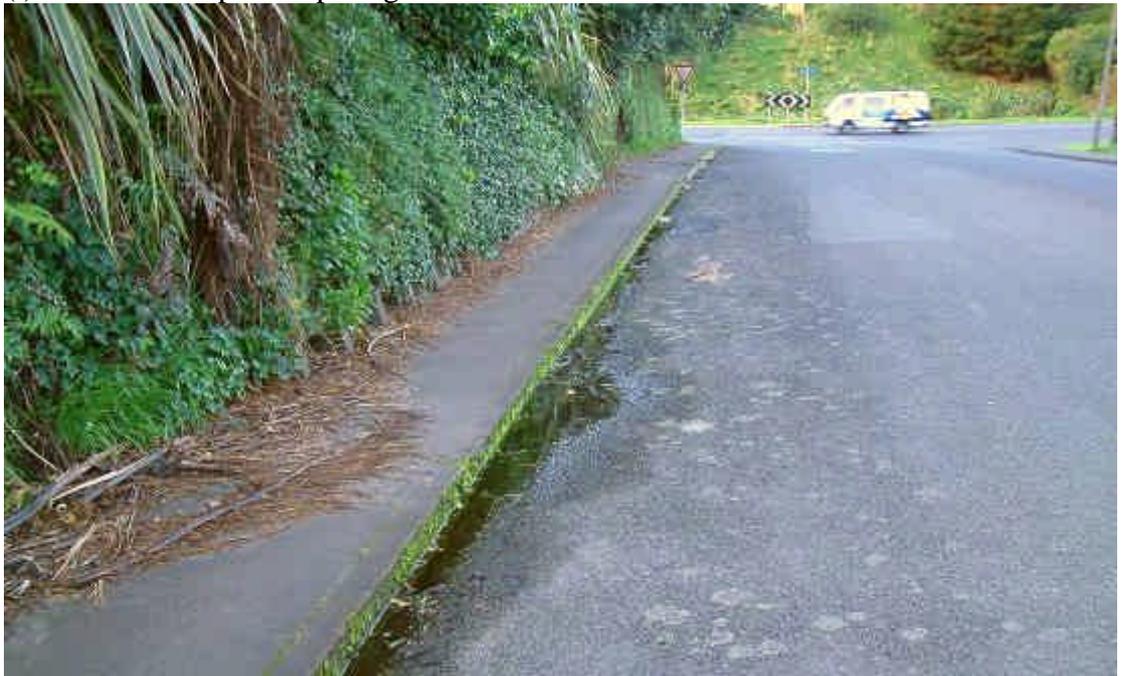
(ii) Water ponding in a channel can indicate uphill grade

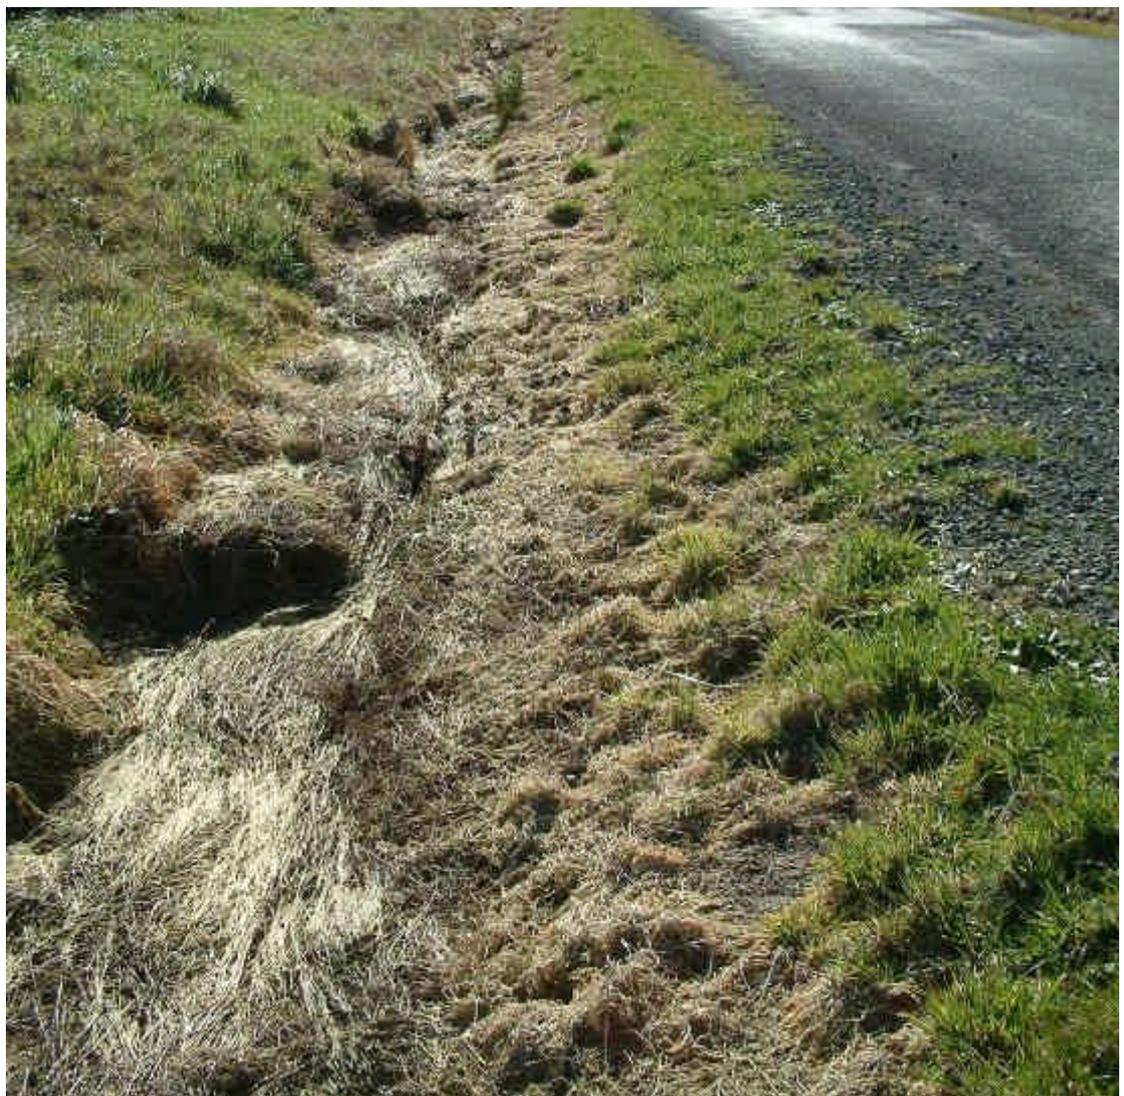
(i) ESWC blocked by a solid mass of vegetation.

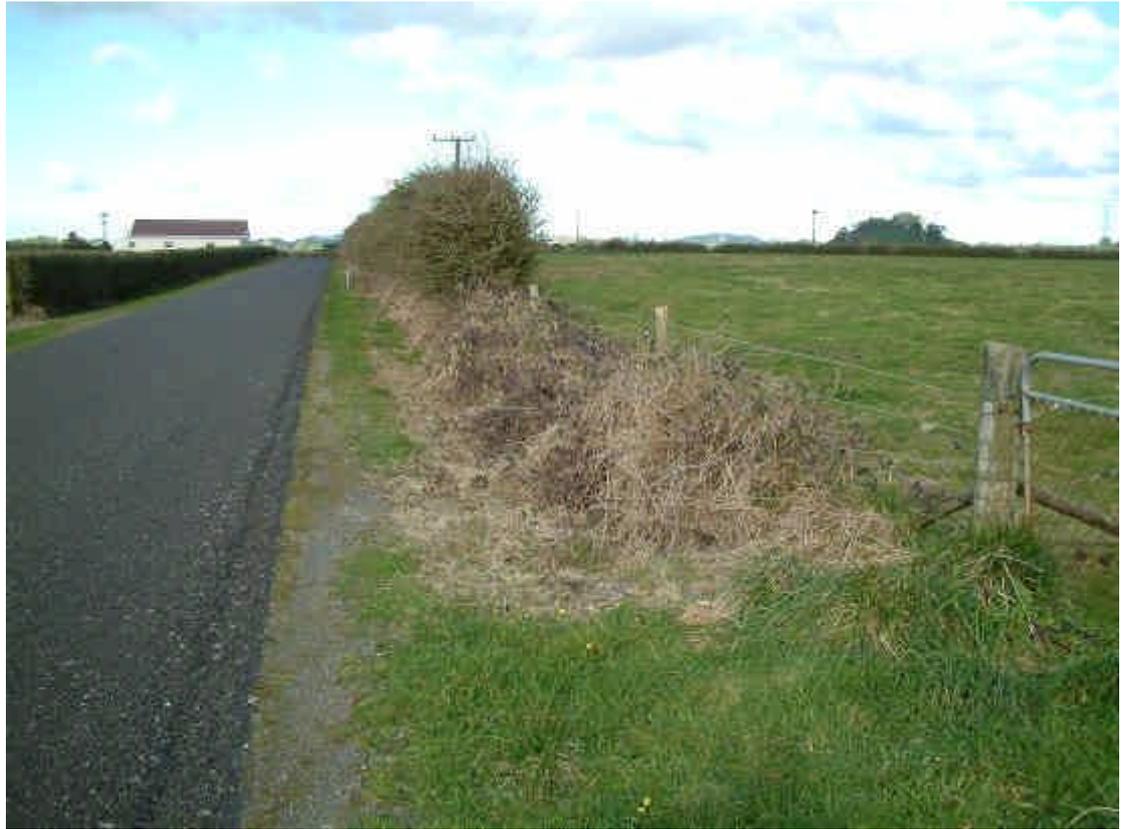
(ii) ESWC blocked by weed growth.

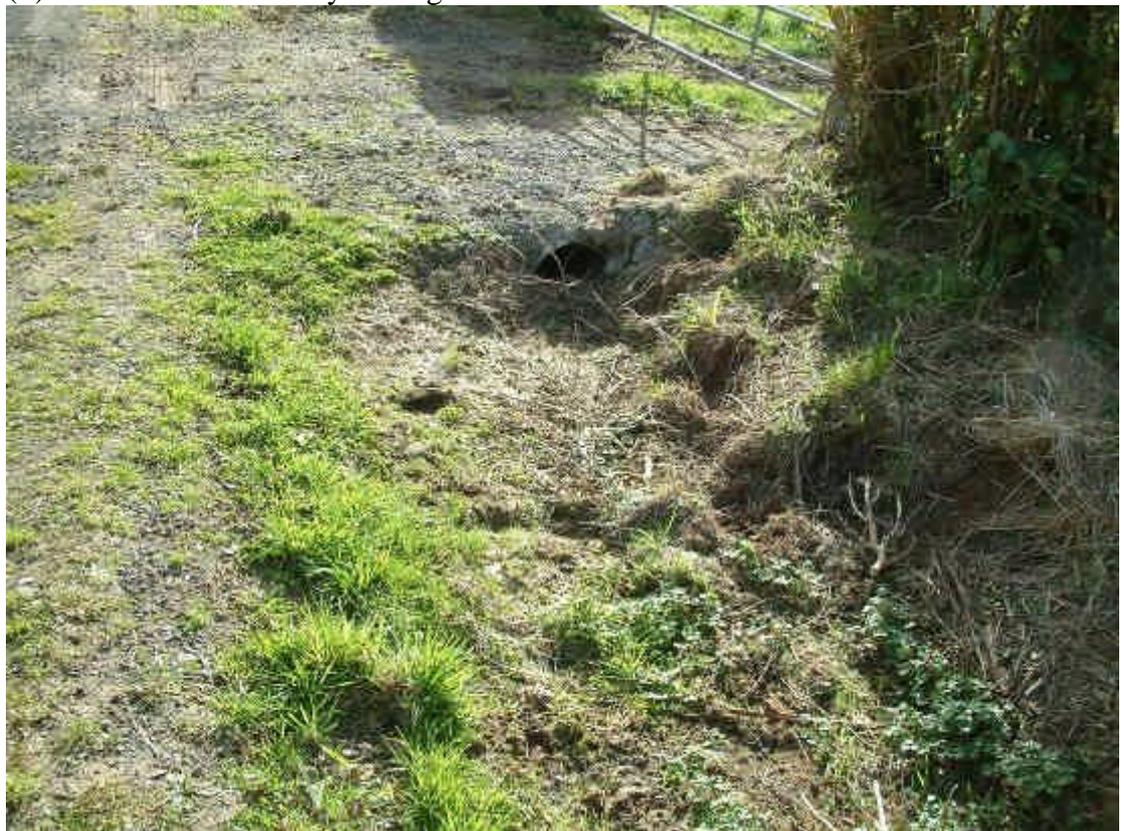
(iii) ESWC, culvert that has been blocked. The inlet for the culvert can just be seen. The length of the culvert is recorded as blocked

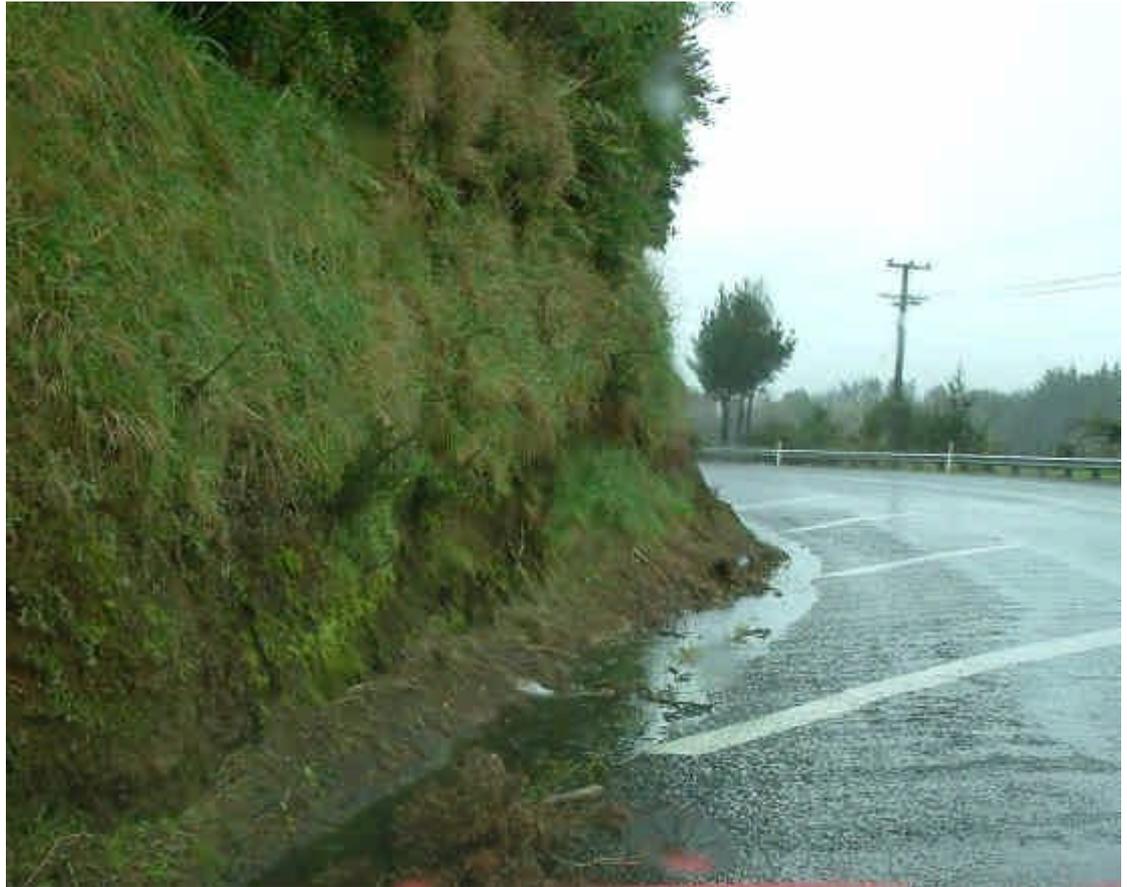
ESWC Blocked by a slip

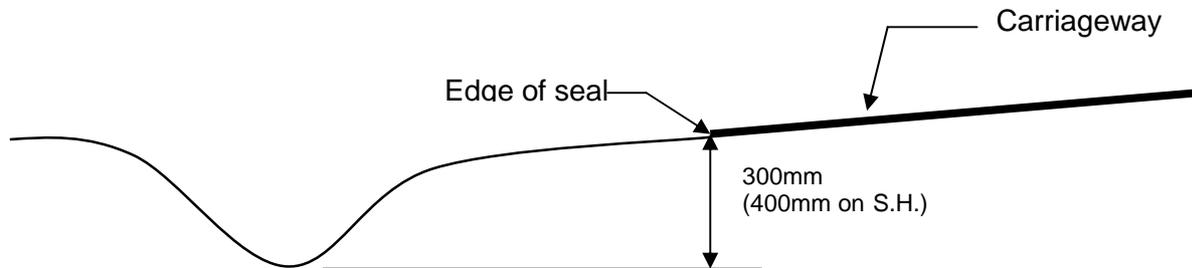
This rating is for recording the length of ESWC where the depth of the adjoining pavement surface to the invert is less than 300mm (400mm for state highways).

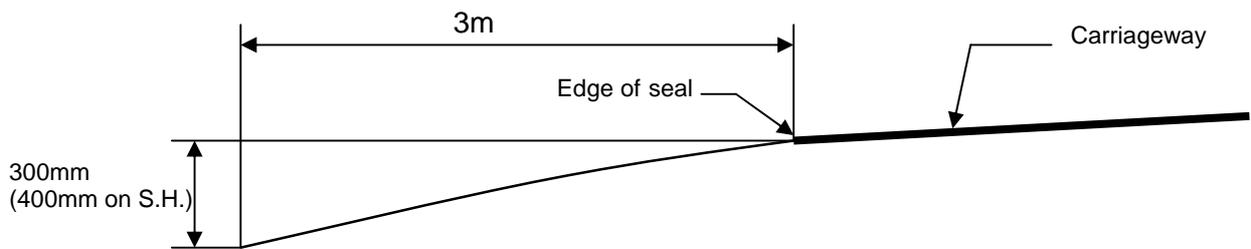
Where there is no defined ESWC but the ground falls away from the carriageway, the depth is assessed at a point 3m from the edge of seal.

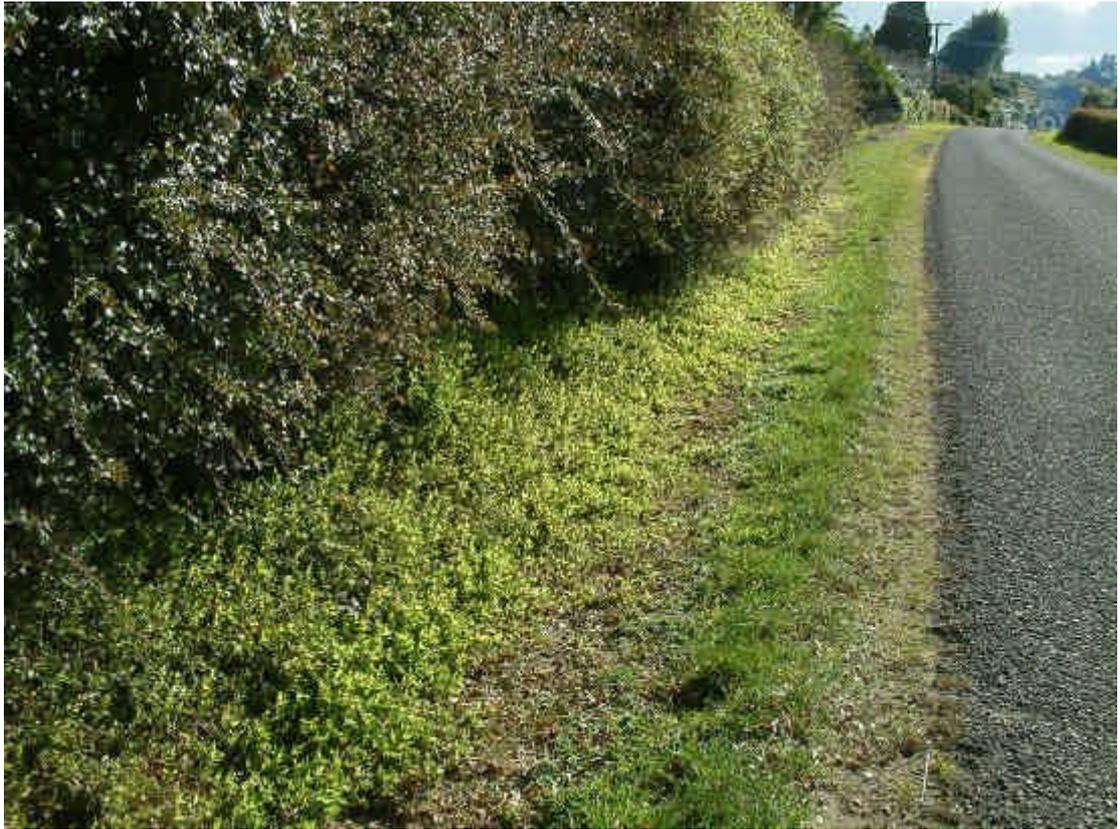
(i) The photo above shows an inadequate ESWC.

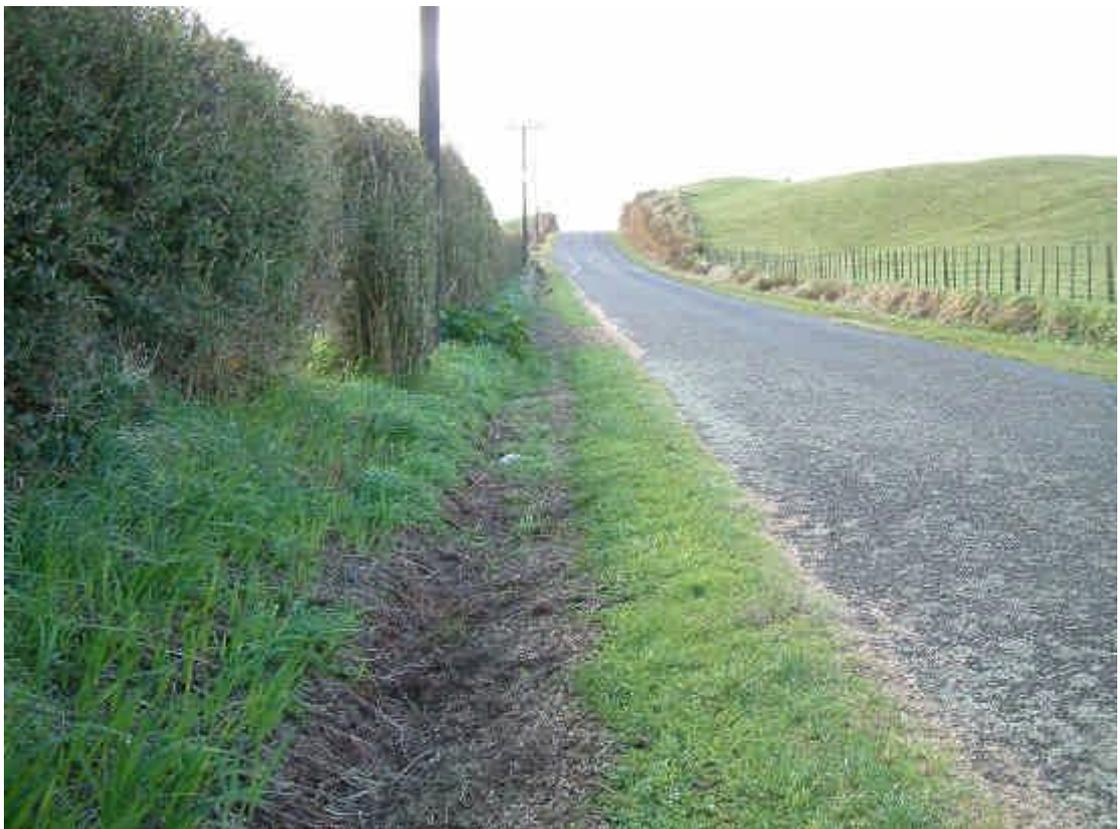
(ii) Inadequate ESWC because of the depth of the channel. the weed growth in this photo would slow water down but would not cause it to pond

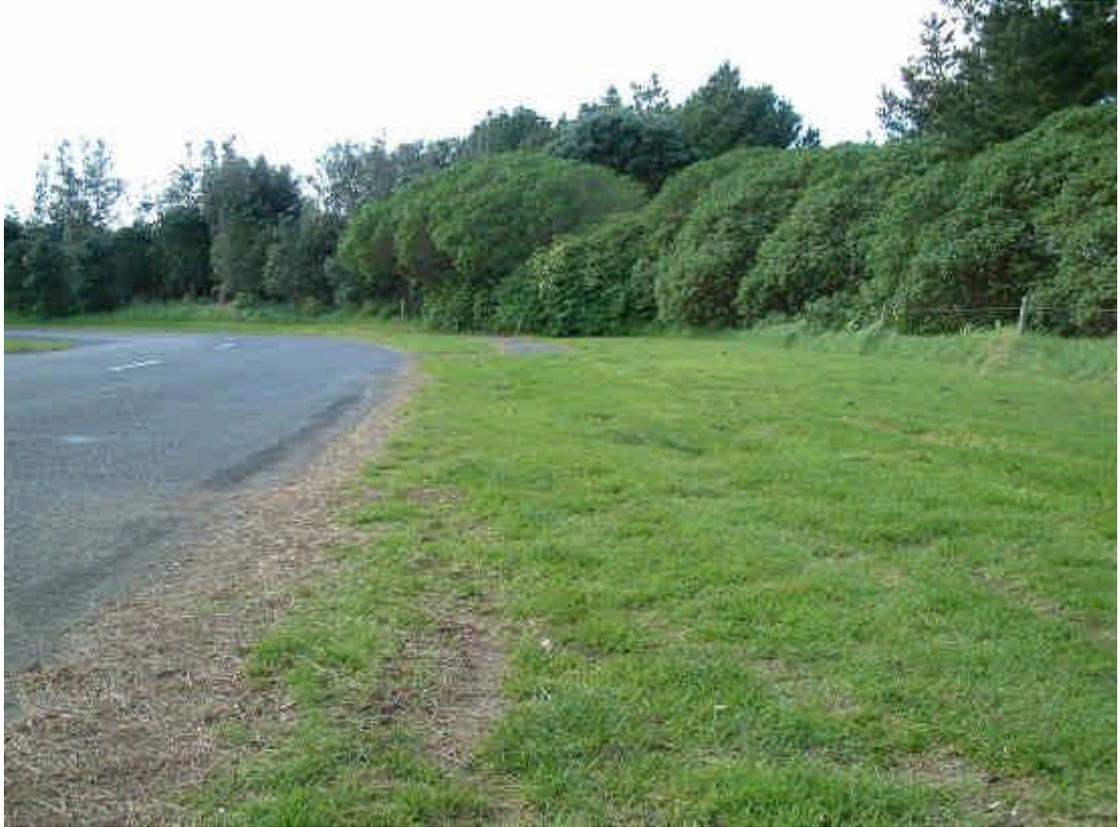
- (iv) The photo above is a case where a SWC does not exist. It is rated as inadequate if there is not 300mm of fall 3m out from the edge of the carriageway

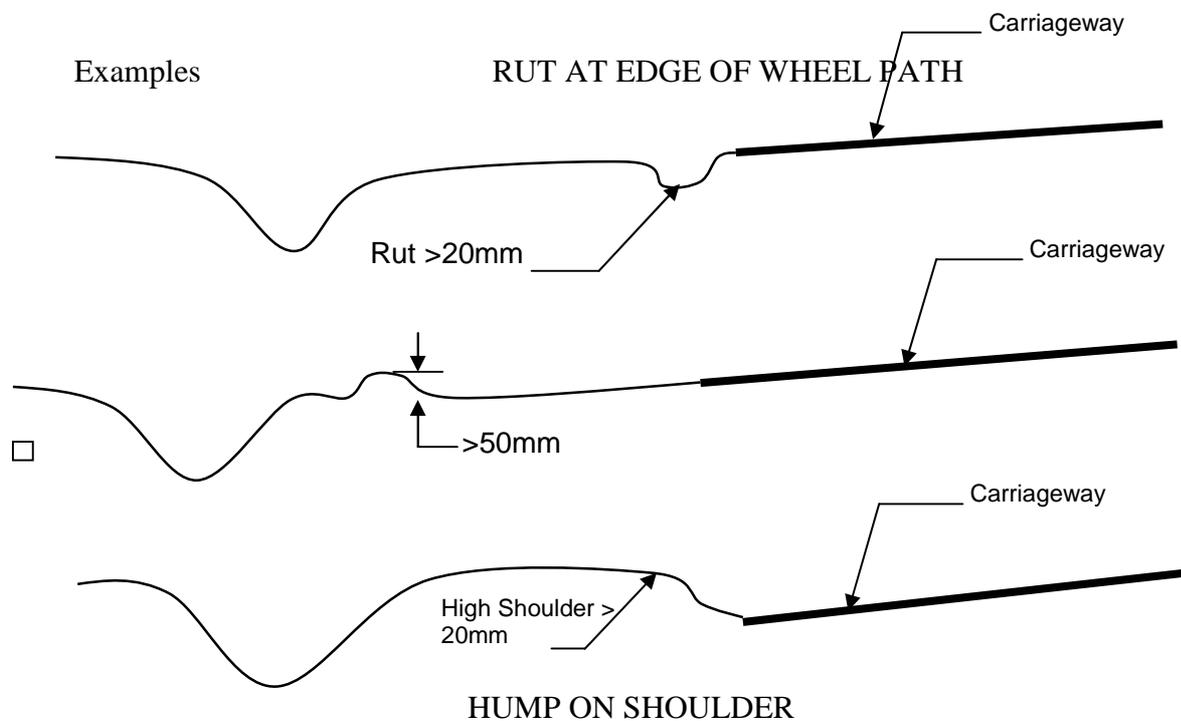
LOW SHOULDER (SHOULD NOT BE RATED AS INADEQUATE)

Typically high shoulders with edge rutting would be rated as ineffective shoulders. Low shoulders that do not impact the flow of water should not be rated.

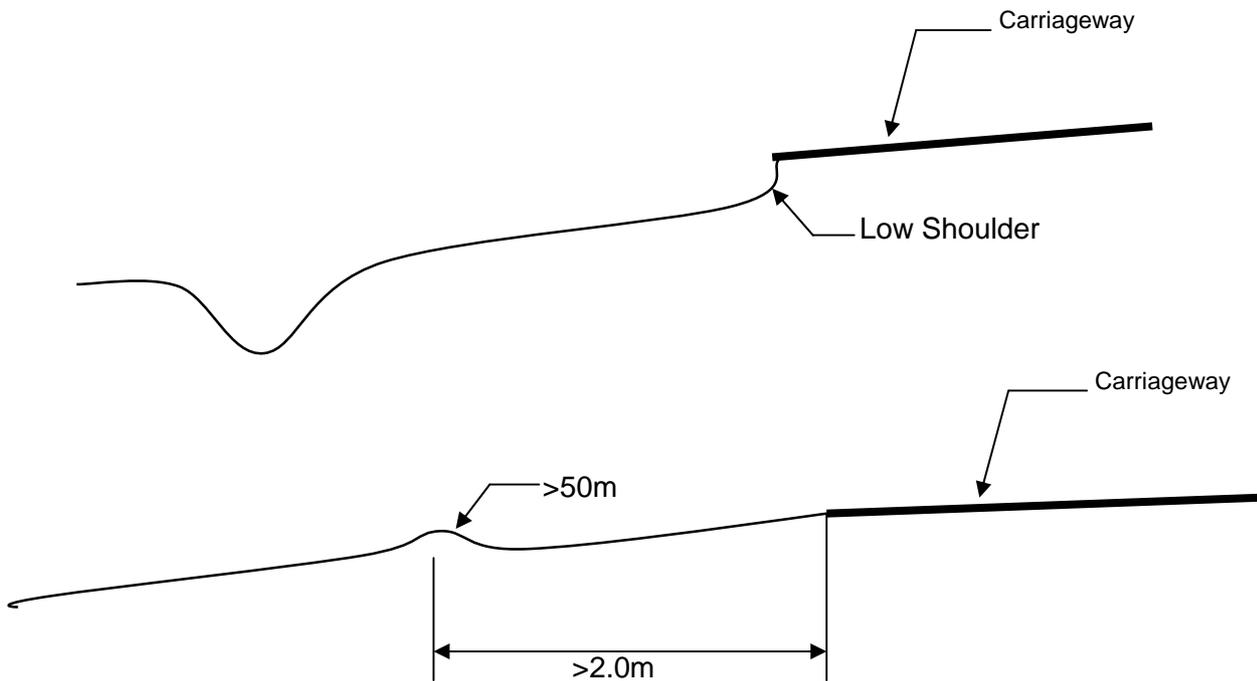
- (ii) Another common problem is when the shoulders have been metalled too high and so cause water to flow along the carriageway. If the grass on the shoulder is not mown or cleared a problem can arise with the collection of material so that the shoulder builds up above the carriageway level.

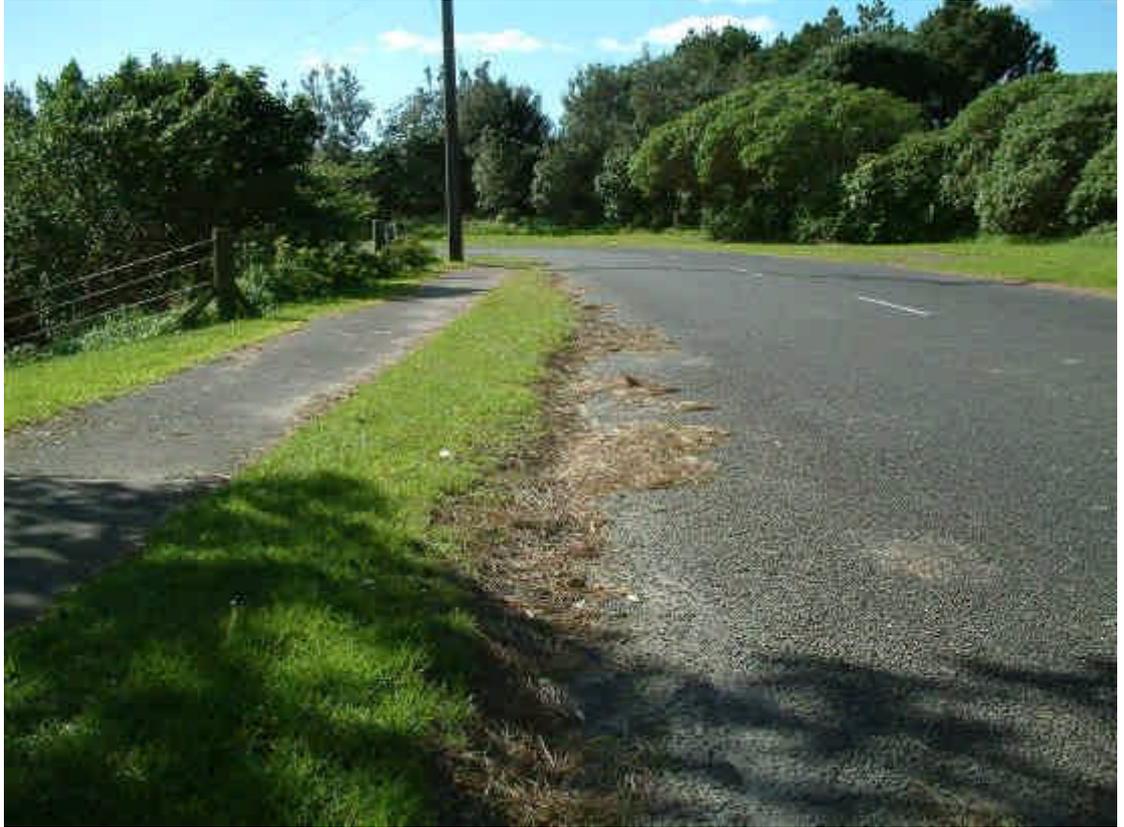
Ineffective Shoulder. In this case the shoulder is higher than the carriageway
